RETRORFIT GUIDEBOOK:

A Resource for Carnegie Library Building
Owners to Meet ADA Requirements while
Preserving Historic Integrity.

Stacey Renee Henderson
Final Masters Terminal Project

Spring 2013
Historic Preservation Program
University of Oregon

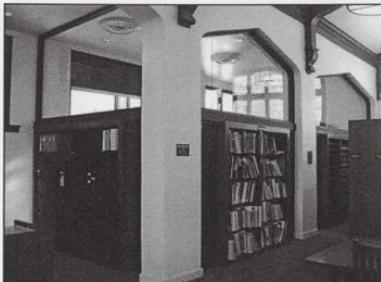
These forms help define the interior space of the reading rooms. Glass was used as infill to not detract from the original character of the space. Image taken by Stacey Henderson.

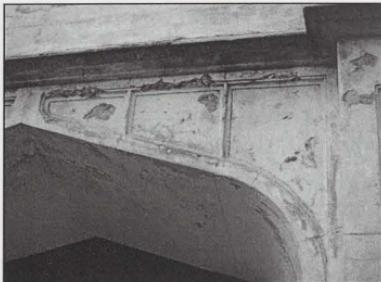
Areas of deterioration should be repaired before being replaced. Image taken by Stacey Henderson, 2013.

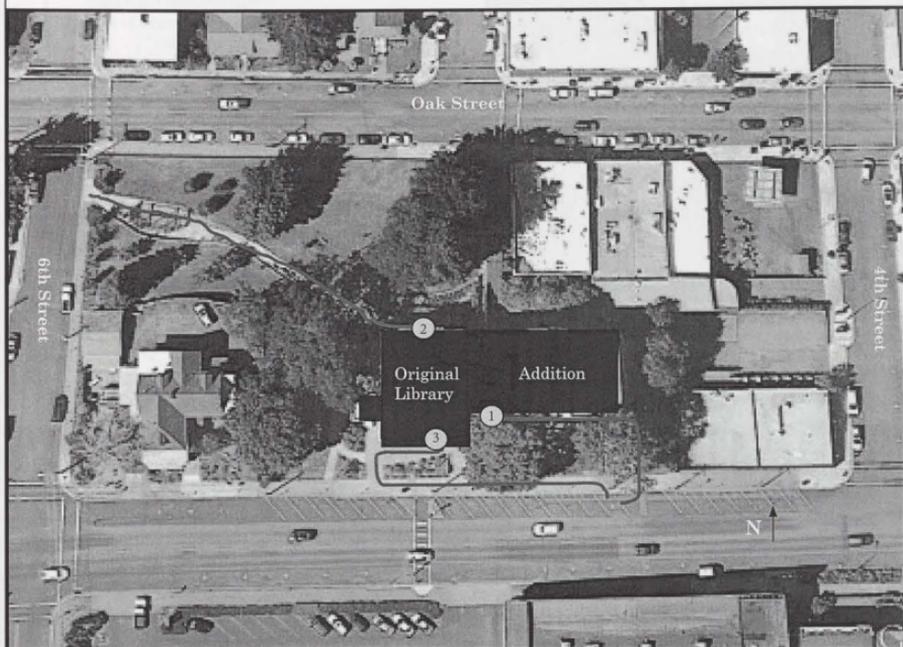
Hood River Challenge: Sloped Site

Site of the Hood River Library
Altered Google Earth image, 2013.

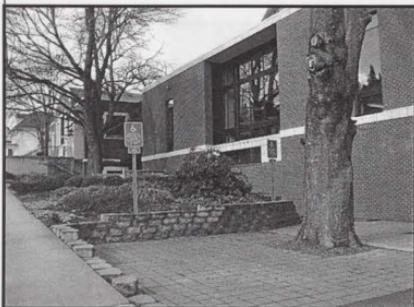
Accessible Parking Spots
Photo Taken by Stacey Henderson 2013

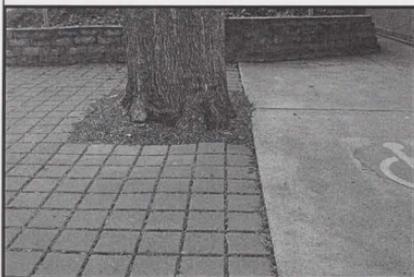
Pavers and pavement were used, it's important to pay attention to level surfaces when changing materials. Photo taken by Stacey Henderson 2013

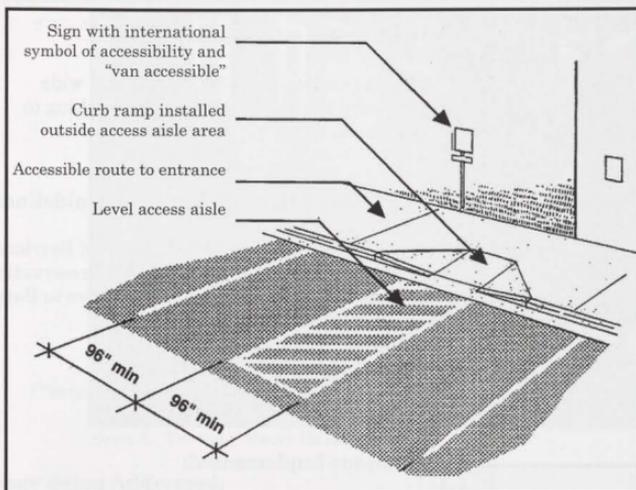
Accessible Parking Diagram⁹⁹

Spaces shall be minimum 96" wide with an aisle of 96" for maneuvering in and out of car.

Parking should be located on the shortest accessible route to main accessible entrance.

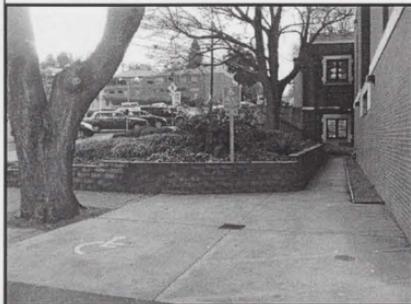
Route 1: added 2003
Taken by Stacey Henderson 2013

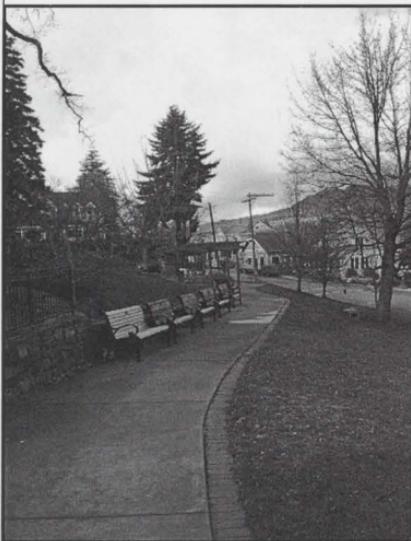
Route 2: added 2005
Taken by Stacey Henderson 2013

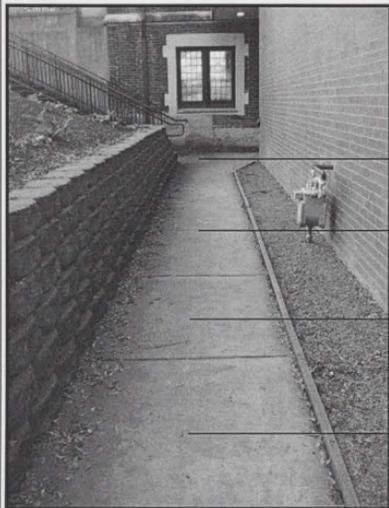
Minimum clear width of an accessible route is 36".

Uneven paved surfaces can be a tripping hazard to many.

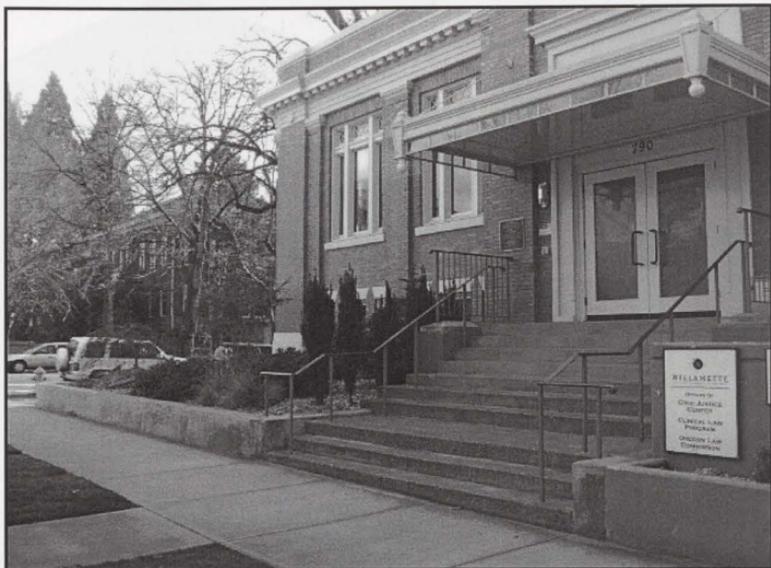
The ADA, as well as many building codes, dictate guidelines and regulations for safe stair design. There is a certain minimum height and width the stairs must achieve to make them comfortable to climb, and there needs to be handrails to help with balance. Often times, stairs on historic buildings were not built according to current ADA and code requirements. Usually they are too steep, the treads are too narrow, or there are unsafe handrails.

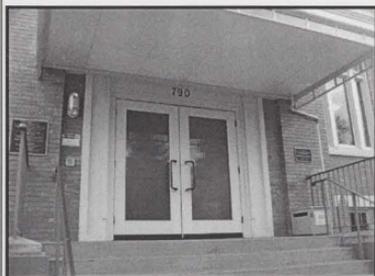
An awning was added to cover the small platform at the top of the stairs. This helps create a protected space from the rain, and keeps the surface dry to prevent slipping. Taken by Stacey Henderson 2013

- *New railings*- that extend past the top and bottom of the stairs according to ADAAG 4.9.
- *New paved stairs*- unsure of when this was done, but it was probably to replace deteriorating steps with ones compliant with current rise-run ratios.
- *Awning*- Provides protection for users from the rain, while helping to keep that surface area dry to prevent slipping. The design is also compatible with the existing look of the facade, as to not detract from the historic fabric.

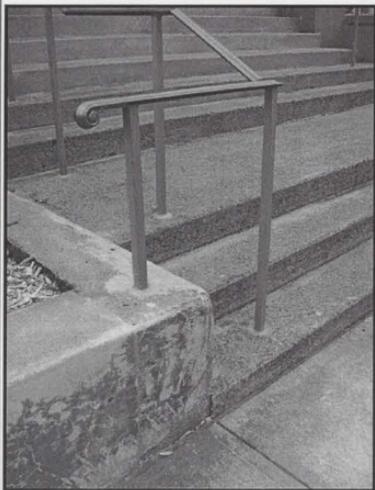
New railings were installed according to current ADA regulations. Their design is minimal, and the materials and style do not detract from the library facade. Taken by Stacey Henderson 2013

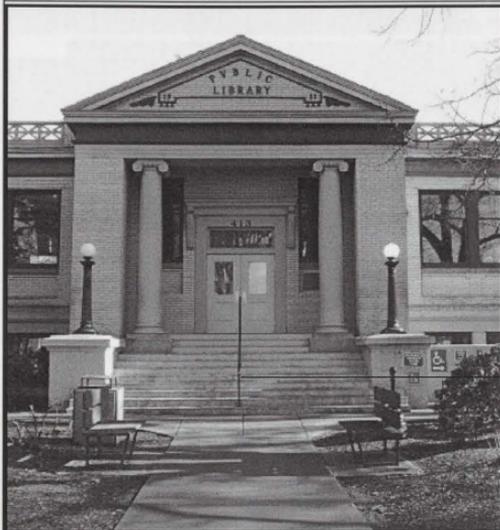
It is important for outside stairs to be illuminated by enough lighting fixtures so they are visible and safe for users.

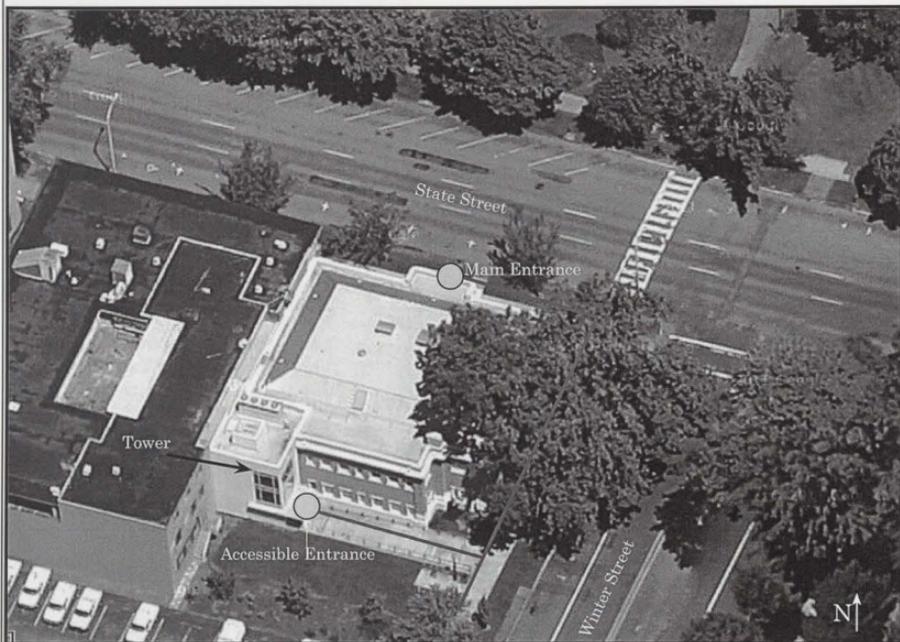
Site of the Salem Library: Altered Google Earth Image, 2013.

As stated before, this building only had one original entrance and it is not accessible by wheelchair. A successful solution was implemented on the south facade as shown in the image, to incorporate an accessible entrance in a minimal way. A straight, gradual, relatively short ramp was installed on the South facade, leading to an accessible entrance and vertical circulation tower. (The vertical circulation tower includes an elevator and staircase that go through all floors.)

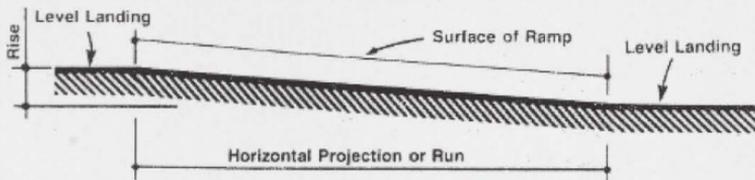
Ramp Diagram: ADAAGs Section 4.6 Figure 16

Required Maximum Slope 1:12: (one inch of rise to every twelve inches of ramp)

Addition of a permanent ramp is a good way to accommodate for level changes and slopes on the site. They do cause a permanent impact on the site effecting the historic integrity.

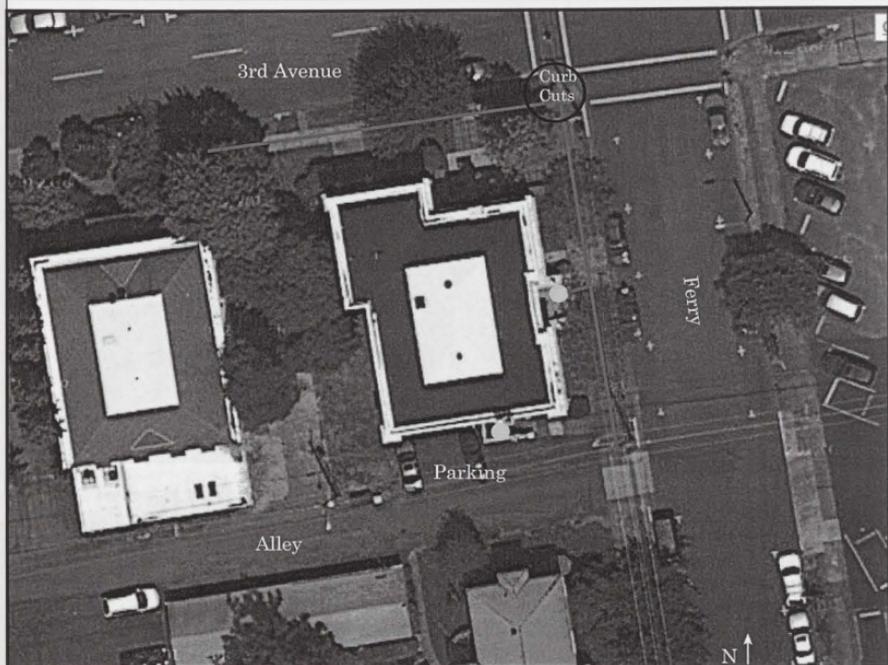
Challenge: No designated parking or accessible path

Site of the Albany Library: Altered Google Earth Image, 2013.

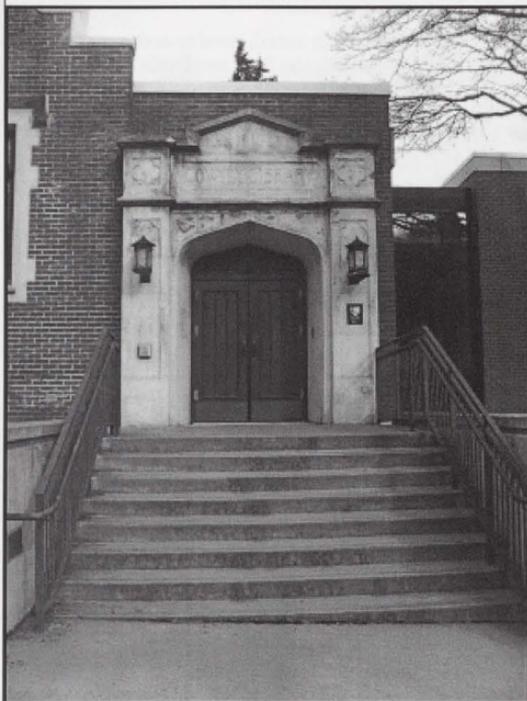
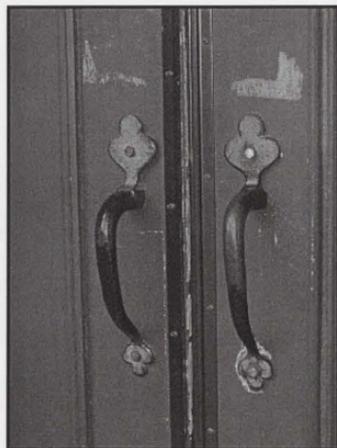
Hood River Challenge: Heavy Original Doors

Images taken by Stacey Henderson 2013

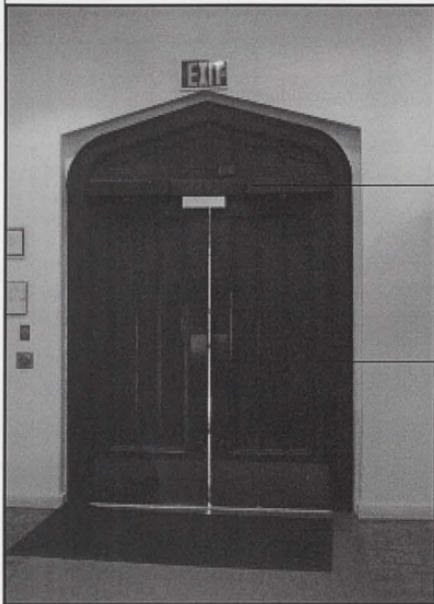
Minimum clear width when doors are open is 32 inches.

Automated doors and power assisted doors: automatic door shall comply with ANSI A156.10.

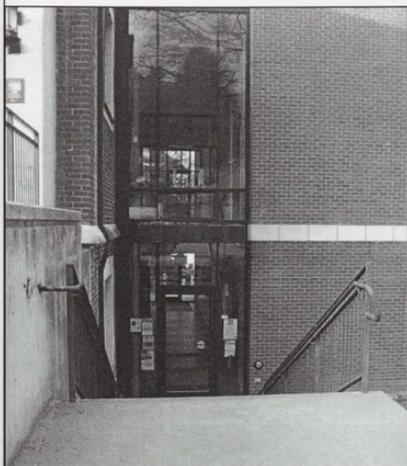
Glass connection between the new and old building.
Taken by Stacey Henderson 2013

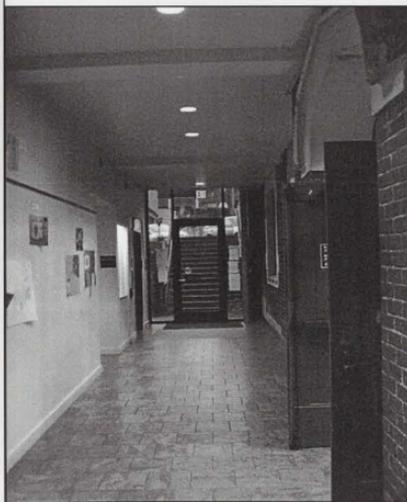
Interior view of the glass circulation knuckle.
Taken by Stacey Henderson 2013

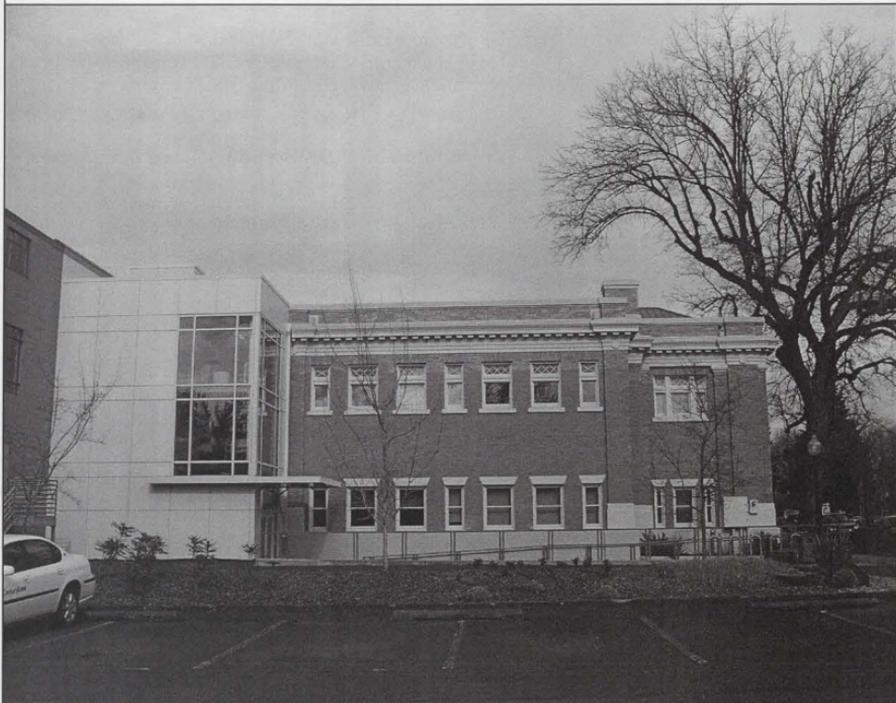
View of the South facade and vertical circulation tower. Taken by Stacey Henderson 2013

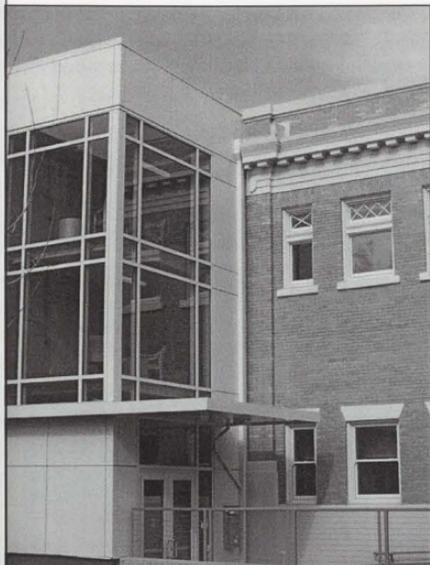
Circulation Tower
Taken by Stacey Henderson 2013

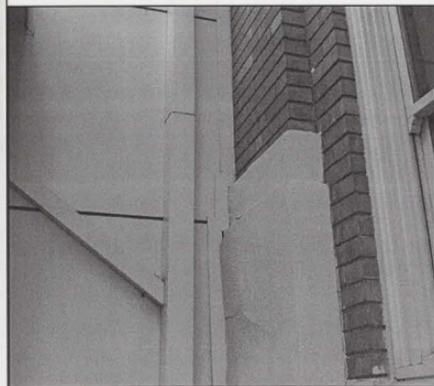
Connection to Historic Building
Taken by Stacey Henderson 2013

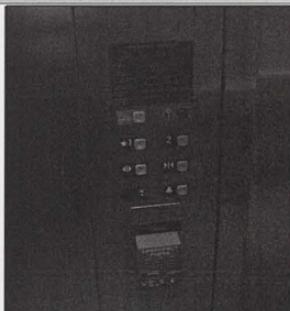
If there is an existing elevator, replacing signs with new ones can help with navigation. Signs as shown above with contrasting colors, brail, and raised numbers aid those who may struggle with their sight.

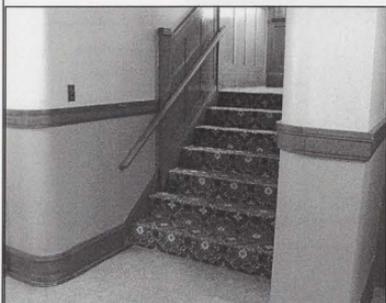
Handrail added on the wall to aid with balance.

- Although some historic fabric was replaced, the overall original design intent of the stairs remains unaltered.

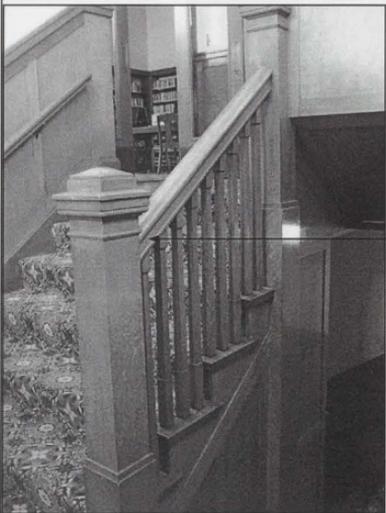
Existing handrail is an acceptable shape to grab and stable.

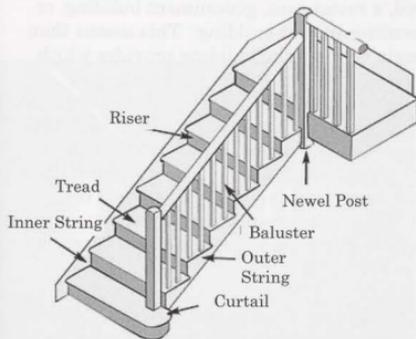
Basic Stair Diagram and Terminology

Steps shall have uniform riser heights and uniform tread widths.

Repair or replace worn stair treads, or balusters. It is important to make sure that new materials are compatible to the existing historic stair.

Install new compliant handrails. These can be designed to fit with the existing stair, and either replace the handrail that is there, or be installed to the outside of it.

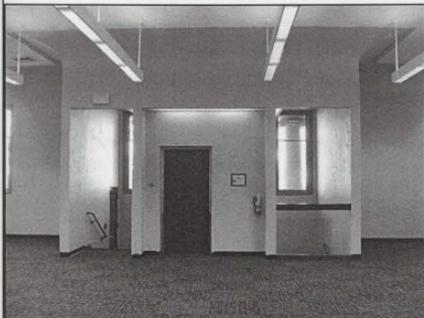
Elevator installed in the 80s interferes with the original staircase, but provides direct access from the basement to the main room.

- Elevator installed in the 80's interferes with original main entrance, and it does provide direct access from the parking.
- The first floor of the building was originally open plan, so although some materials have been changed, keeping it open is cohesive with the original design intent.

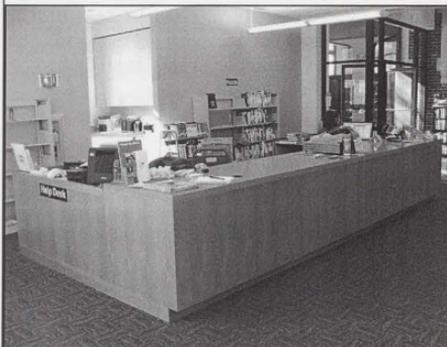
Check out desk located centrally between the original building and addition.

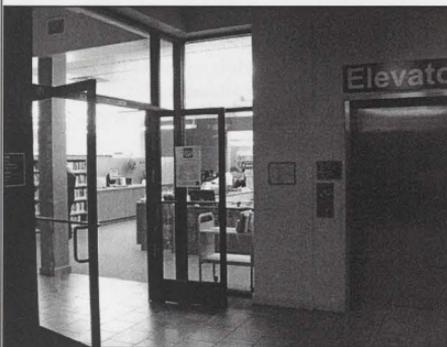
Check out desk is also located next to the main elevator, for ease of exits and book returns.

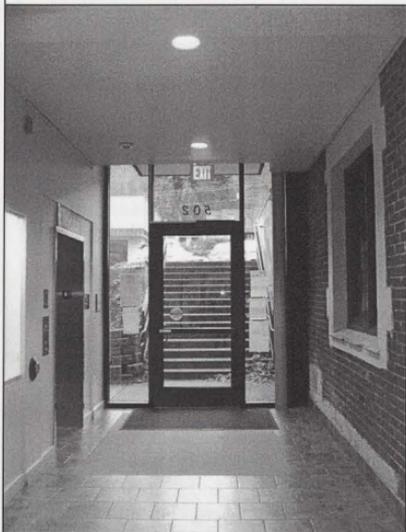
Main entrance, located in addition.
Image taken by Stacey Henderson, 2013.

- New flooring materials- the tile and carpet are not the original materials for the space.
 - These mobile entry carpets can cause tripping as they move around and the edges curl up. It is important to pick one that is as flush and stable as possible, so they do not cause a tripping hazard.
- Because the permanently installed carpet does not start for a foot after entering the building, an additional carpet was purchased.
 - These can have a significant visual impact on the space, so it is important to pick compatible material.
 - The colors of these stone tiles and carpet do not detract from the materials of the historic Carnegie library building, making them a compatible choice.

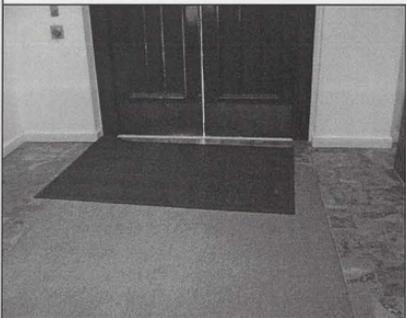
Original historic entrance with new flooring.
Image taken by Stacey Henderson, 2013.

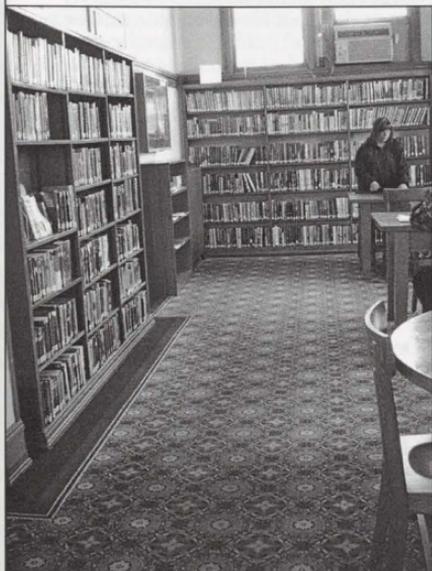
Historically replicated carpet.
Image taken by Stacey Henderson, 2013.

- The low pile (short length of the carpet) and sturdy nature of it help for those who are ambulant disabled.
 - Carpet is a slip-resistant material.
 - Resiliance of carpet is more desirable than a dense tile or stone.
 - Acoustic qualities of carpet help to muffle noise which is appropriate for library reading rooms. (Carpet creates a quiet acoustic environment.)
- The replicated carpet pattern and colors help to preserve the integrity and original design intent of the spaces in the library.
 - Changing the pattern or colors could of drastically altered the feeling of the space.
 - This was a good solution to ensuring there is a reasonably safe and suable material while preserving the interior space.

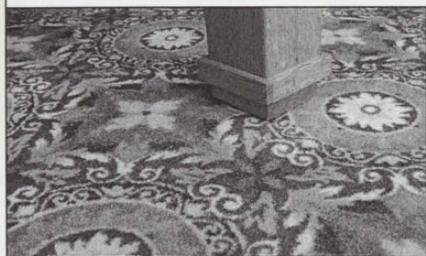
Close up of the carpet.
Image taken by Stacey Henderson, 2013.

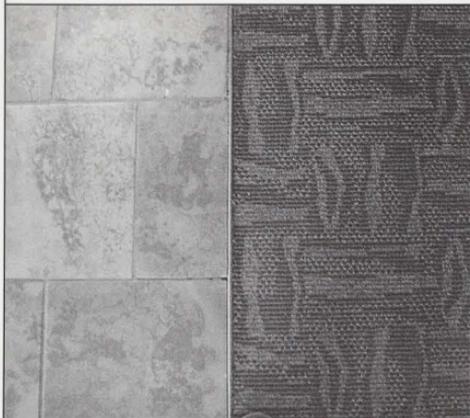
Carpet and carpet tile shall be securely attached, with a maximum pile thickness of 1/2".

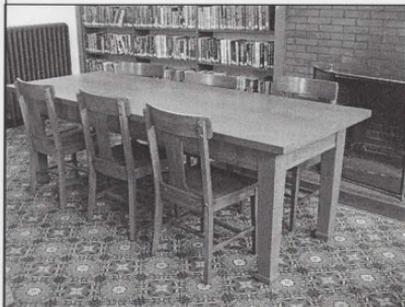
Albany Challenge: Original Tables

Heights needed to be adjusted to allow more room to sit between the chair and the table.

- The holes were filled with a compatible material, and blend in with the table top.
- Each piece of wood was added inconspicuously to the bottom of a table leg, in the same wood as the table.

This makes the table more comfortable and usable without altering the furniture or original appearance of the furniture.

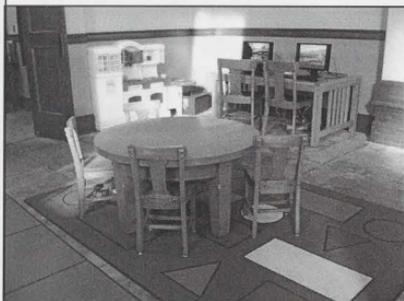
Original children's reading room furniture.
Image taken by Stacey Henderson, 2013.

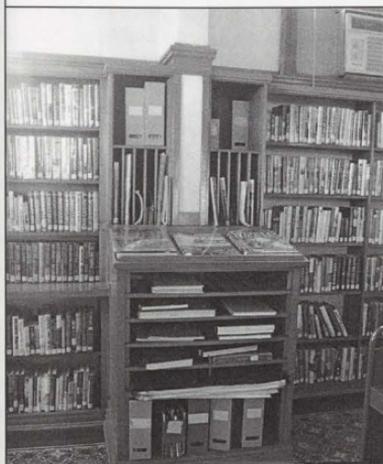
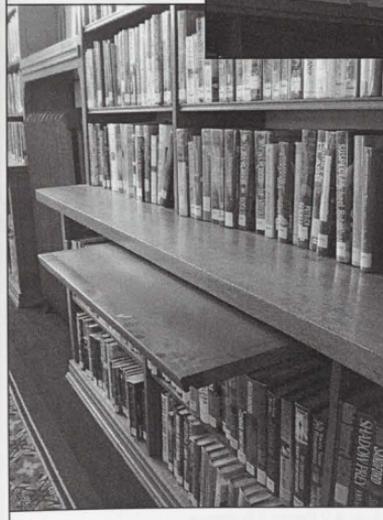
Analysis: Original Shelving

Preserving original bookshelves while keeping them useful for the library.

- The built in shelving has no parts that protrude above the ground that would be unsafe.
- The shelving is spaced to allow for maximum movement.
- Most of the shelves remain at an accessible height, but there were also step stools provided for those who could not reach the top shelf.
- Signage in contrasting colors with large lettering are placed in plastic holders at the top of each shelf to label where the books are. This creates minimal impact to the shelving.
- Shelf at waist height is helpful to those who can't hold all of their books while browsing.

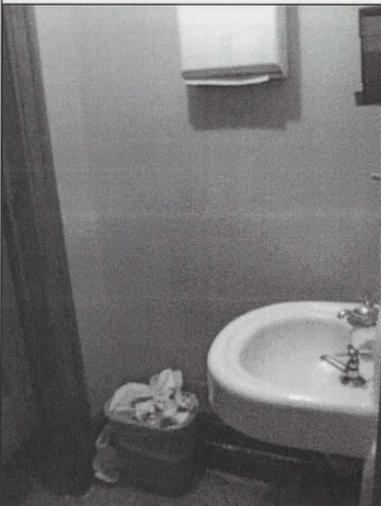
The main sink area next to the stall.
Image taken by Stacey Henderson, 2013.

- The fixtures that have been added such as a towel and soap dispenser, cause little impact to the existing restroom, while making it more comfortable to use.
- Adding grab bars in the restroom is a low impact way to make the toilet stall more accessible and easy to use.
 - It is ideal to have the grab bars on both sides and one behind the toilet for maximum maneuvering support.
- New modern toilets can be installed that comply with required ADA dimensions.

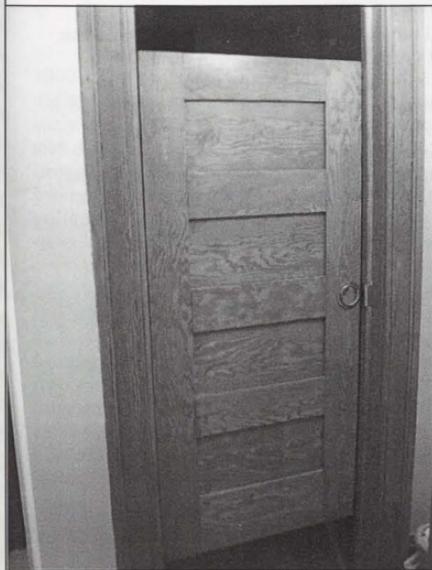
Challenge: Solutions for Adapting the Restrooms

The door leading to the stall in women's restroom.
Image taken by Stacey Henderson, 2013.

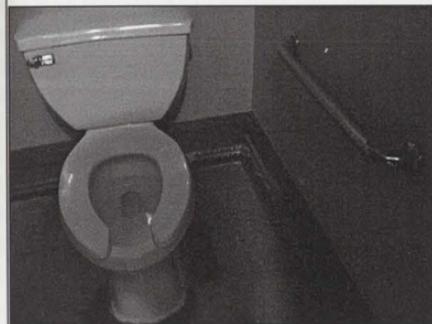
Grab bar added to toilet stall, and new toilet.
Image taken by Stacey Henderson, 2013.

The ADAAG 4.17.6 suggests grab bars to be placed beside and behind the toilet. This is a low impact, affordable way to make the restroom more compliant with accessibility guidelines.

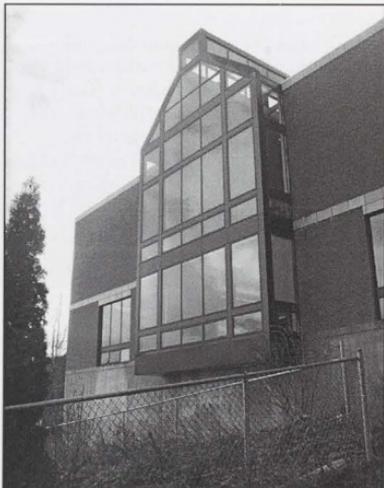
Central feature of addition that mimics Georgian detail on the front of the historic building.
Image taken by Stacey Henderson, 2013.

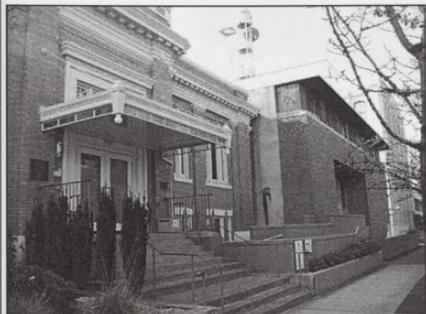
Salem Connected to Neighboring Building

The neighboring building is built close to the library. Image taken by Stacey Henderson, 2013.

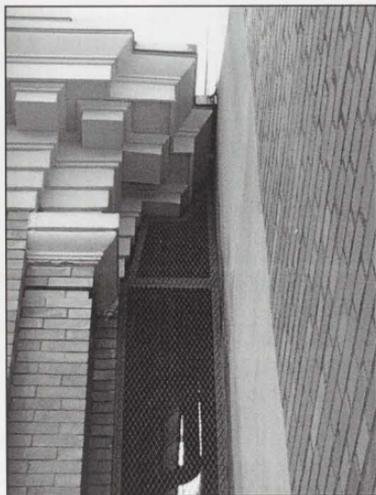
The two buildings technically don't touch as seen here. The screen prevents animals from getting in the gap.

- The buildings technically do not touch each other except at one point in the back (as seen in the image).
- Wire mesh has been placed at each end to prevent debris or animals from living in the gap. This mesh visually recedes, giving the illusion of a gap between the buildings, and not detracting from the historic building.

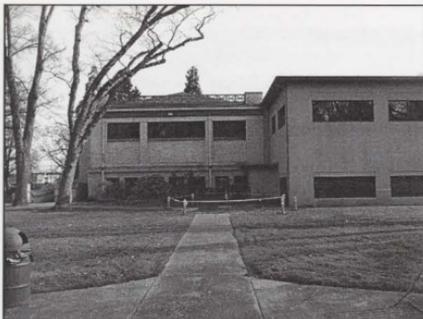
Addition to Increase Square Footage of the Building

Right: Addition to the original library.
Image taken by Stacey Henderson, 2013.

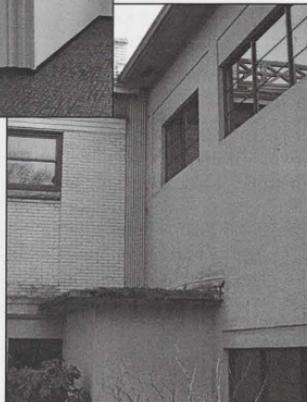
Transition material
between the addition and
original building.
Images taken by Stacey
Henderson, 2013.

The addition was added in 1951.
