FEASIBILITY AND APPLICATION OF DENDROCHRONOLOGY IN OREGON  
UTILIZING DOUGLAS FIR: A CASE STUDY IN SOUTHWESTERN OREGON

A TERMINAL PROJECT

Presented to the Interdisciplinary Studies Program: Historic Preservation  
and the Graduate School of the University of Oregon  
in partial fulfillment of the requirements  
for the degree of  
Master of Science

June 2014

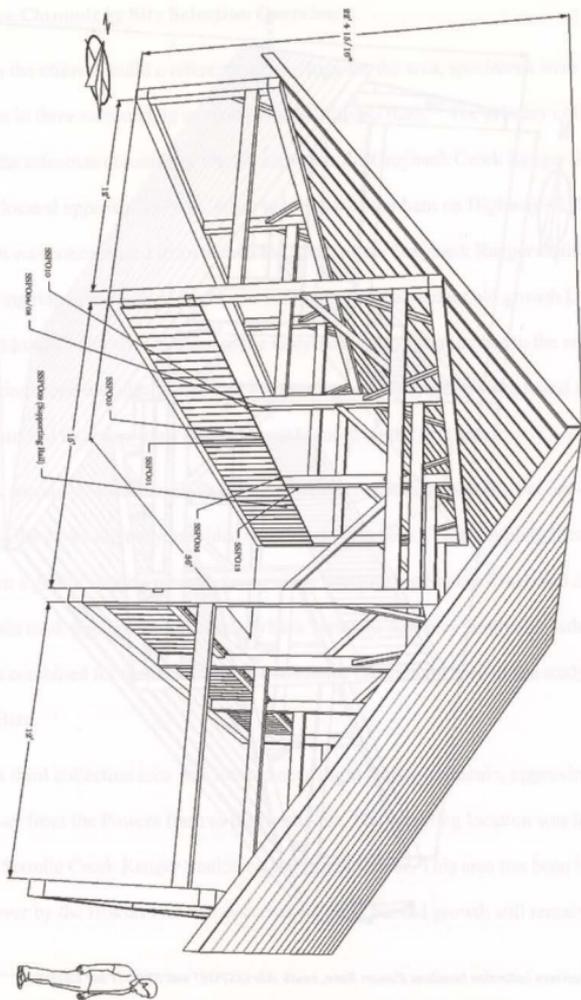
Figure 3 Specimen collection locations Powers Barn, north side (SSPO06 not labeled)

Sample ID	Sample Type	Species	Dating Attempted	No. of Rings	Wane Present	Timber Type
SSPO01	S	PM	Yes	110	No	Milled lumber, board
SSPO02	S	PM	Yes	102	No	Milled lumber, board.
SSPO03	C	PM	Yes	54	Yes	Hewn post. Last 10 years not measured. Broken core.
SSPO04	C	PM	No	N/A	Yes	Hewn post. Fragmentary Core.
SSPO05	S	PM	Yes	91	Yes	Milled Lumber, board.
SSPO06	S	PM	Yes	71	No	Milled lumber. Eastern door frame
SSPO07	S	PM	Yes	90	No	Milled lumber, cross brace. Sapwood present. Unknown provenance
SSPO08	C	PM	No	22	Yes	Hewn post.
SSPO09	C	PM	Yes	61	Yes	Milled lumber, board.
SSPO10	S	PM	Yes	53	Yes	Milled lumber, board.
SSPO11	C	PM	Yes	38	No	Milled Lumber, cross brace. Unknown provenance
SSPO12	C	PM	Yes	64	Yes	Hewn post. Duplicate of SSPO03.
SSPO13	C	PM	No	N/A	Yes	Hewn post. Fragmentary core.
SSPO14	C	PM	Yes	56	Yes	Hewn post.
SSPO15	C	PM	Yes	43	Yes	Hewn post.
SSPO16	C	PM	No	41	Yes	Duplicate of SSPO15
SSPO17	C	PM	No	42	Yes	Duplicate of SSPO15

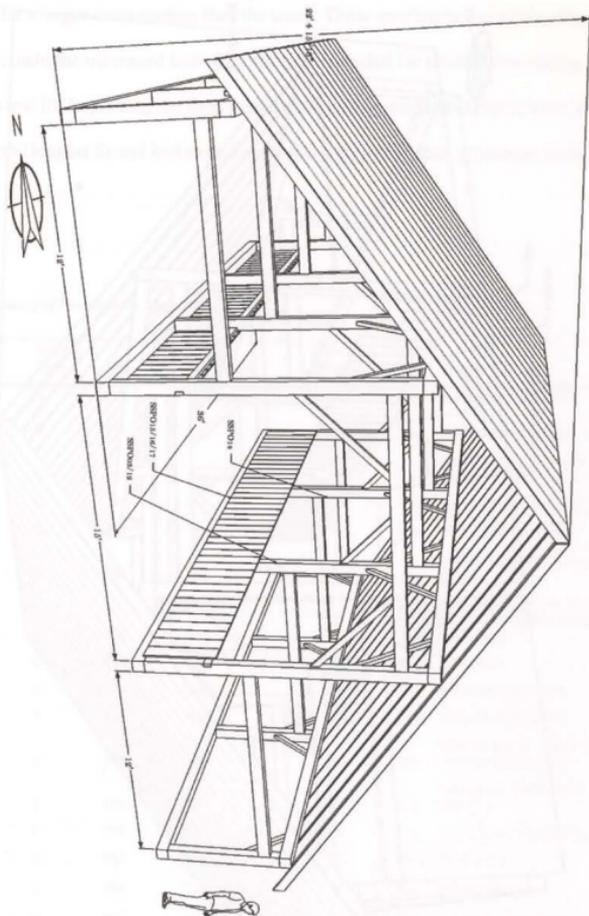
Figure 4 Specimen collection locations Powers Barn, south side (SSPO07 and SSPO11 not labeled)

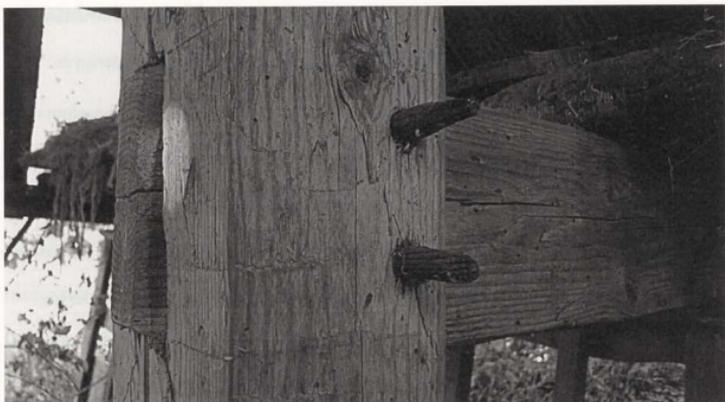
*Figure 5 Hewn post and beam intersection with trunnels, layout lines and hewing marks*

The frame of the barn is constructed of approximately 8-inch square hewn posts and beams with a housed through-tenon that is secured with riven and rounded 1-inch Douglas fir pegs (trunnels). The posts and beams were evidently squared with an ordinary axe, as the hewing marks are small, curved and perpendicular to the length of the log rather than parallel or angled which is typically found when a broad axe is used. The cross braces of the barn are made of (possibly band-sawn) 2 3/4" x 4" x 6' long milled timber and placed into mortises in the hewn posts and beams. The cross braces are not secured into the mortise with either nails or pegs, only a friction fit. The vertical posts rest on an approximately 8-inch square hewn sill, which in turn rest on rough fieldstone piers that are located at the junction of the vertical posts to the sill.

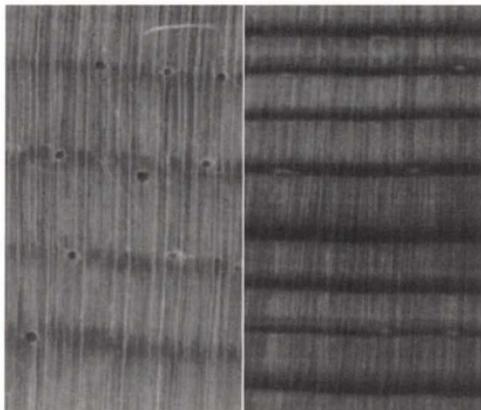
Figure 6 *Ponderosa pine* (Jeffery pine identical) (left) and Douglas fir (right), note resin canals (Hoadley, 1990)

The two of most common trees located within the Cave Junction area are Jeffrey pine and Douglas fir and both are a common construction material in the region with Douglas fir being the preferred species. Jeffrey pine is commonly found on the serpentine soils that are found throughout southwestern Oregon. Jeffrey pine and its biological cousin ponderosa pine are characterized by numerous medium resin canals found evenly distributed throughout the wood and an abrupt earlywood/latewood transition.<sup>44</sup> Douglas fir however, only has sporadic resin canals of medium size and its heartwood is distinctly reddish brown (Figure 6).<sup>45</sup> Upon microscopic analysis, it was found that all specimens from the barn were of Douglas fir, which was used for both the hewn frame members and all the dimensional lumber found in the structure.

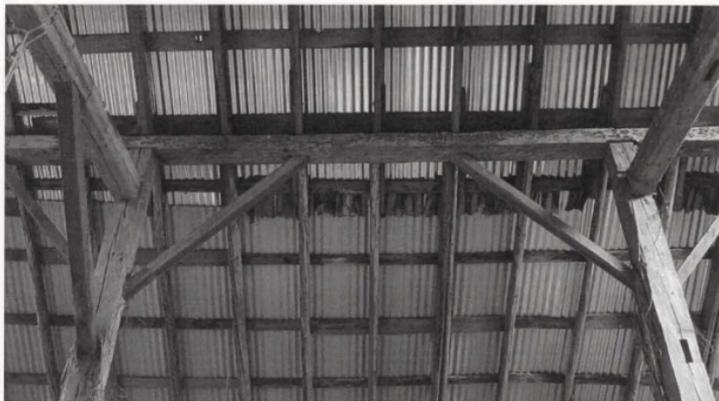
*Figure 11 Center bay ceiling, view of cross bracing, remnant cedar shakes, round rafters and replacement milled rafters in roof peak*

The roof of the barn is composed of a variety of components and appears to have been replaced or repaired, perhaps as many as two or three times as evidenced by different construction techniques and materials. The rafters found in the peak of the barn on the eastern half are composed of milled wood measuring approximately 2 x 6" with nailing surfaces (purlins) composed of perpendicularly applied Douglas fir planks measuring 1-inch thick of varying widths and lengths. This nailing surface is also found throughout the remainder of the roof and in sections it appears that this is similar to the original nailing surface for the roofing material. The rafters in the western half of the structure and in the lower reaches of the roof in the remainder of the structure are composed of peeled round Douglas fir poles of approximately 4 inches in diameter.

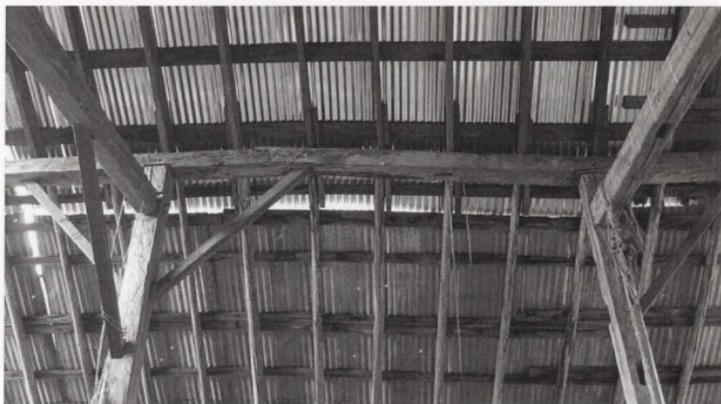
*Figure 12 Center bay ceiling (south), view of cross bracing, nailing surfaces, round rafters, replacement rafters and broken beam in center of photo*

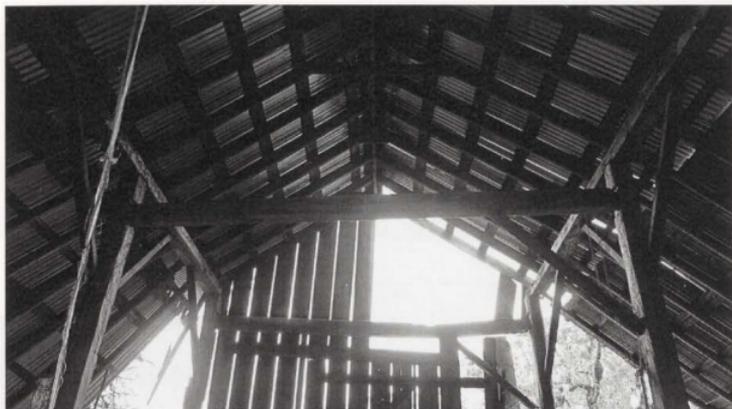
*Figure 13 View looking east at replaced roof section and supporting structure*

According to the Oregon SHPO Historic Resource Record the roof may have been replaced in the 1960s, although it does not specify to what extent or which sections of the roof were replaced. There is some indication that the sections containing the peeled Douglas fir poles are original since these are the only locations that still contain remnants of cedar shingles that were apparently the original roofing material. The roof is currently sheathed in a corrugated galvanized metal roofing material. Sections of the roof have been replaced over time as indicated by bright new metal roofing in some areas and other areas having roofing that has been weathered and rusted.

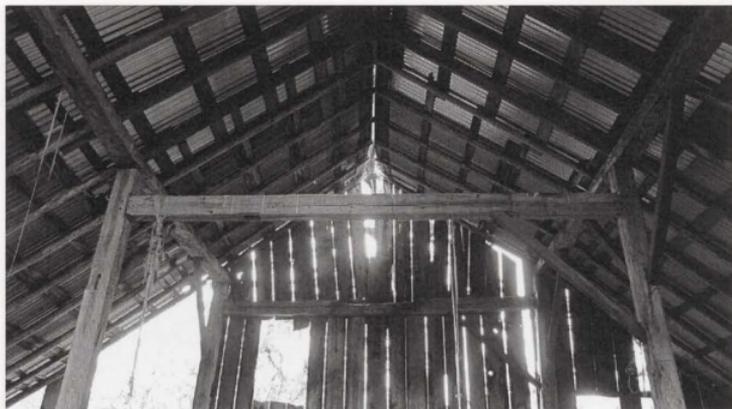
*Figure 14 View looking west at round rafters and supporting structure*

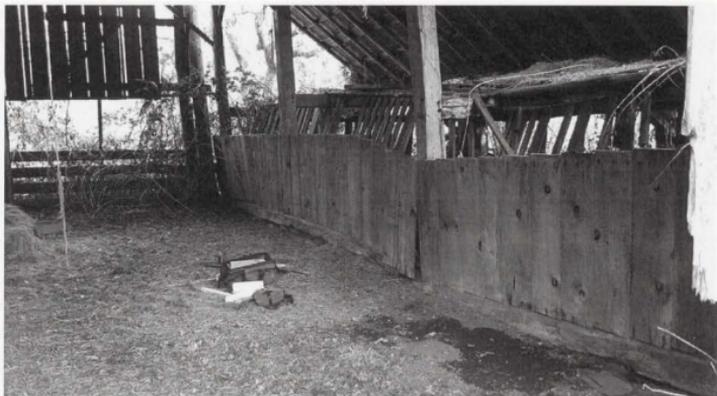
*Figure 15 South interior partition, looking southeast. Note remnant sill, improvised hayracks and mow*

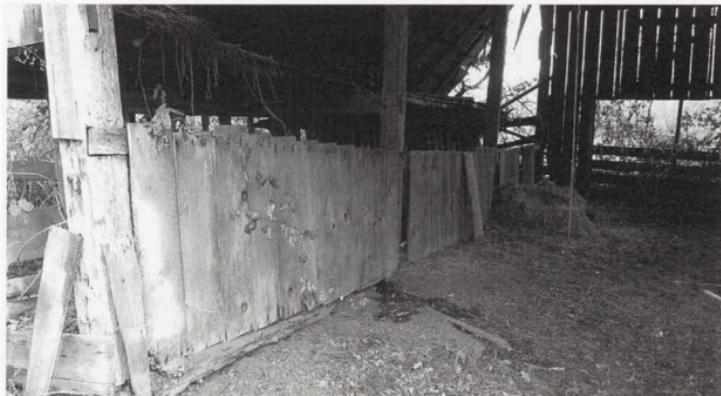
*Figure 16 North interior partition, looking northeast. Note remnant sill, improvised hayracks and mow*

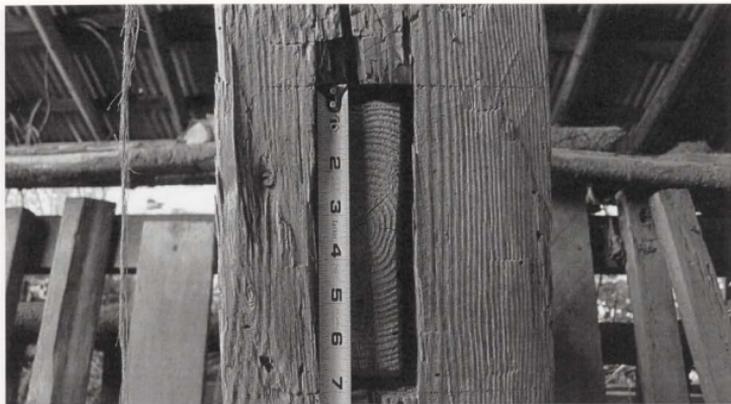
*Figure 17 Through tenon detail, note layout lines and low number of rings in tree cross-section*

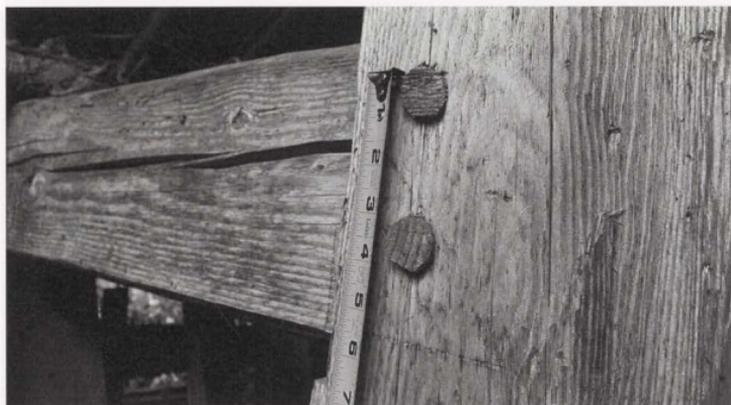
*Figure 18 Pegging of through tenon detail, note 1" Douglas fir pegs and layout lines*

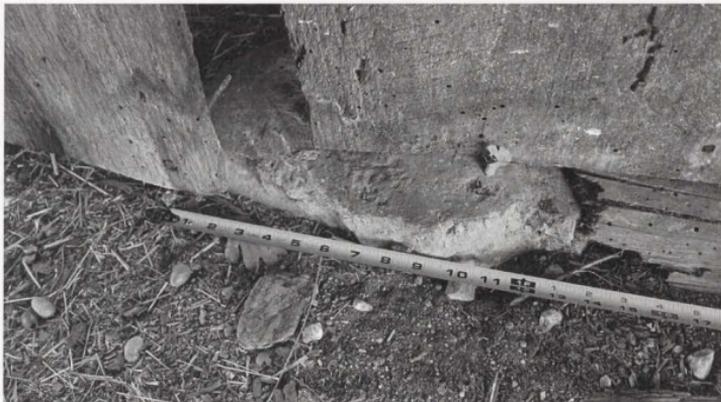
*Figure 20 Fieldstone pier foundation under a post*
