FLUVIAL GEOMORPHIC HISTORY OF THE VIRGIN RIVER IN RESPONSE TO
TAMARISK COLONIZATION AND REMOVAL

A THESIS

Presented to the Department of Geography
and the Division of Graduate Studies of the University of Oregon
in partial fulfillment of the requirements
for the degree of
Master of Science

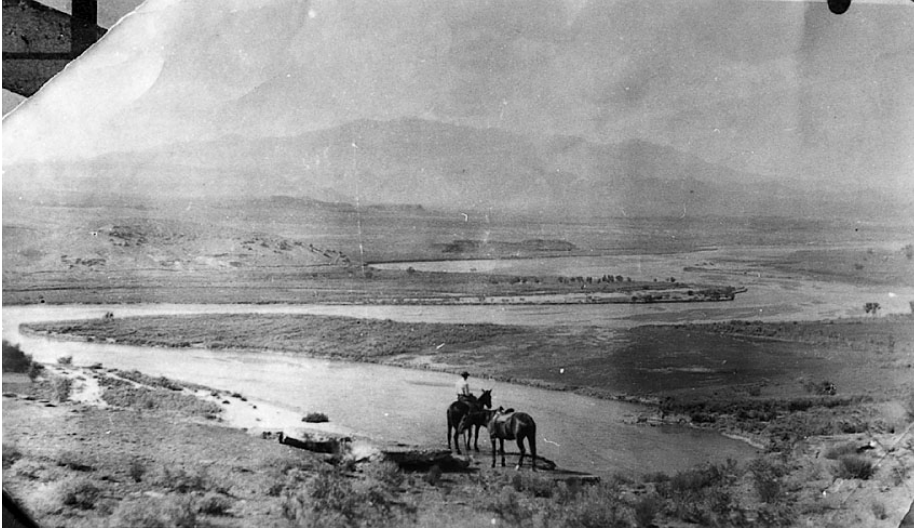
Figure 3

Virgin River South of St. George, early 20th Century

The channel is a single-thread, meandering shape with a floodplain that's dominated by shrubs and scrub (Washington County Historical Society, n.d.)

On-the-ground imagery from the late 19th/early 20th centuries provides some insight into historical channel conditions. Figures 3 and 4 show a single thread meandering channel shape with a floodplain that is dominated by shrub and scrub, with some large trees being prevalent in figure 4. These trees are most likely native cottonwood and willow, however the images are too grainy to be certain. Conversely, figures 5 and 6 show a larger, more open and braided channel shape that differs from images 3 and 4. While unknown variables such as discharge and flood events can limit analysis between images, we are able to get a general idea of the channel and riparian vegetation conditions for the Virgin River during this time period.

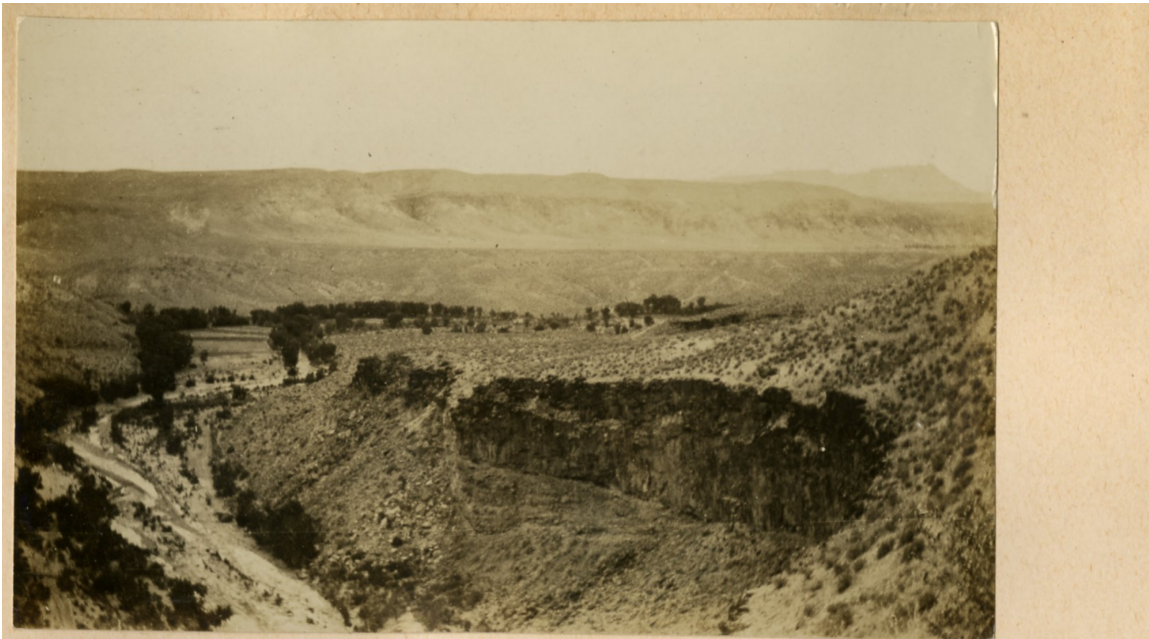
Figure 4

Virgin River near Hurricane, 1900

Like figure 3, the channel has a single thread, meandering shape. Large trees are prevalent across the riparian zone. (Washington County Historical Society, n.d.)

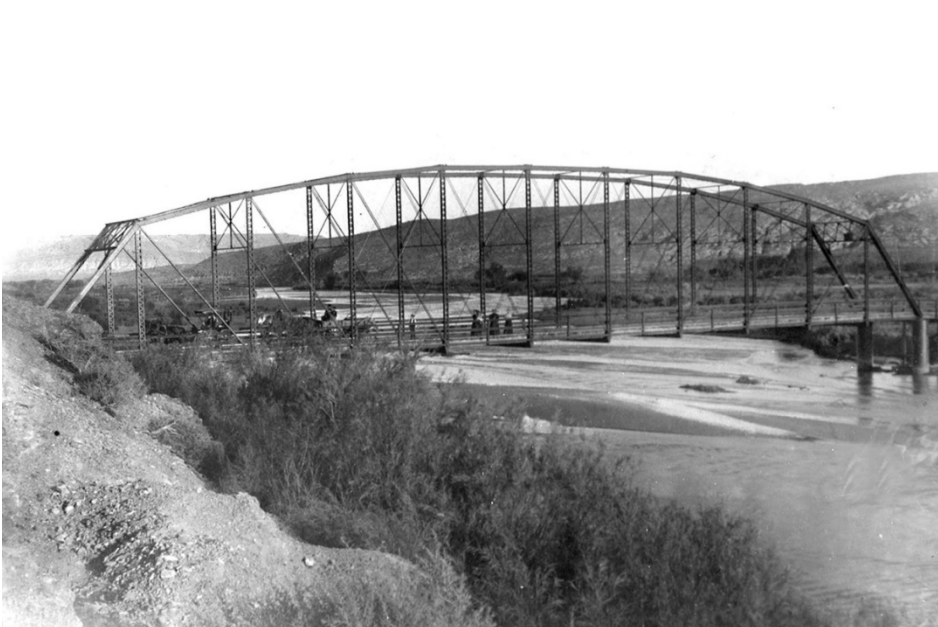
Figure 6

Virgin River bridge in St. George, 1912.

Like figure 4, the channel is more of a braided pattern with large shrubs dominating the floodplain. (Washington County Historical Society, n.d.)

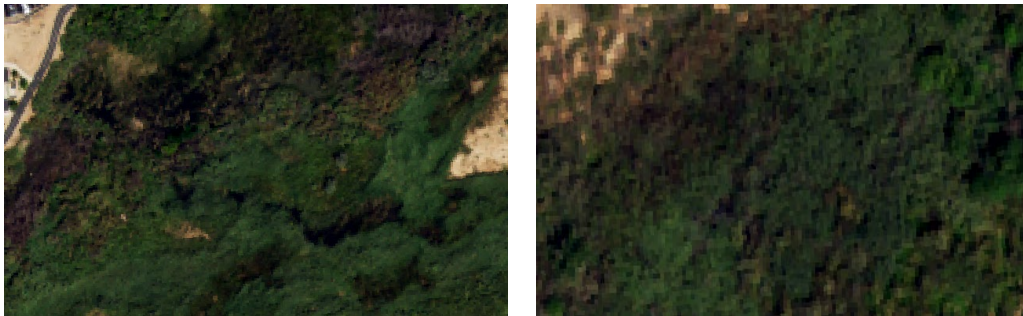
Figure 8

Visual example of dense, non-tamarisk woody vegetation from aerial imagery

Aerial view of DNTWV using on-the-ground observed sites from the 2018 NAIP imagery.

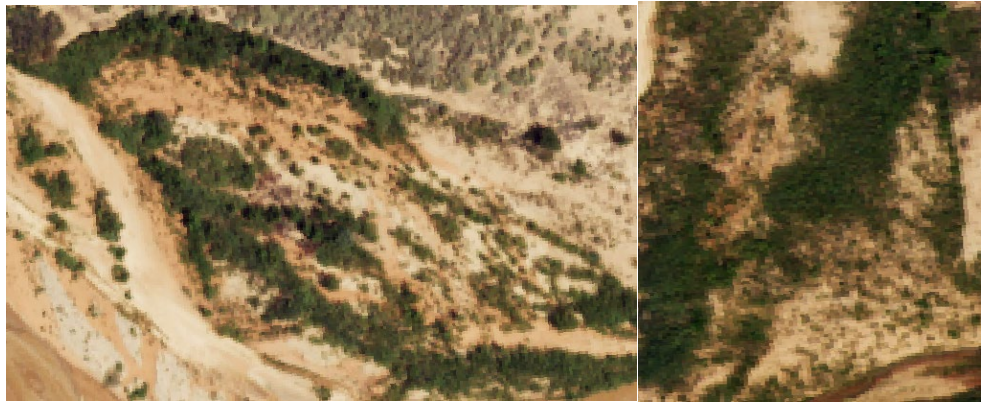
Figure 9

Visual example of SNTWV from aerial imagery

Aerial view of SNTWV using on-the-ground observed sites from 2018 NAIP imagery.

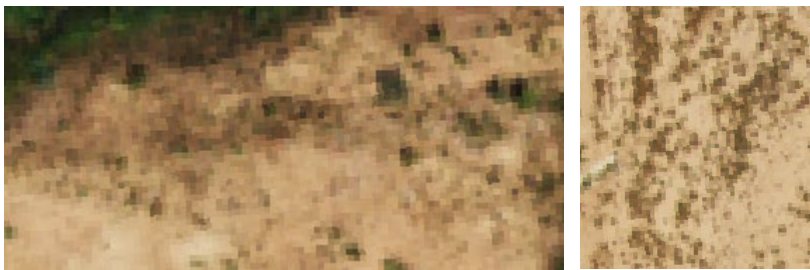
Figure 10

Visual example of shrubs/herbaceous communities from aerial imagery

Aerial view of shrubs/herbaceous using on-the-ground observed sites from 2018 NAIP imagery.

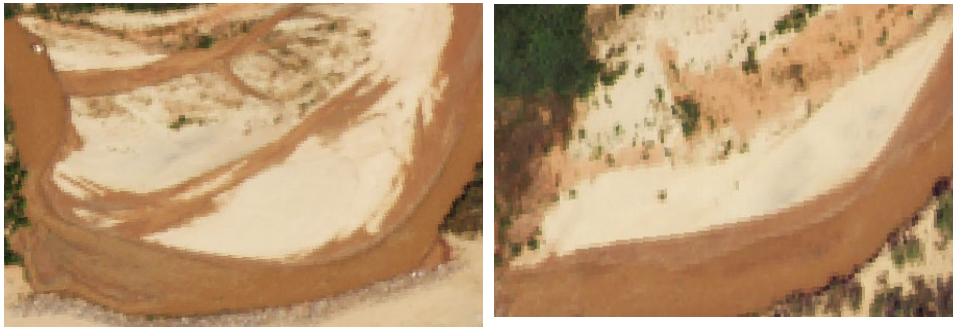
Figure 11

Visual example of Bare Soil from Aerial Imagery

Aerial view of bare soil using on-the-ground observed sites from 2018 NAIP imagery.

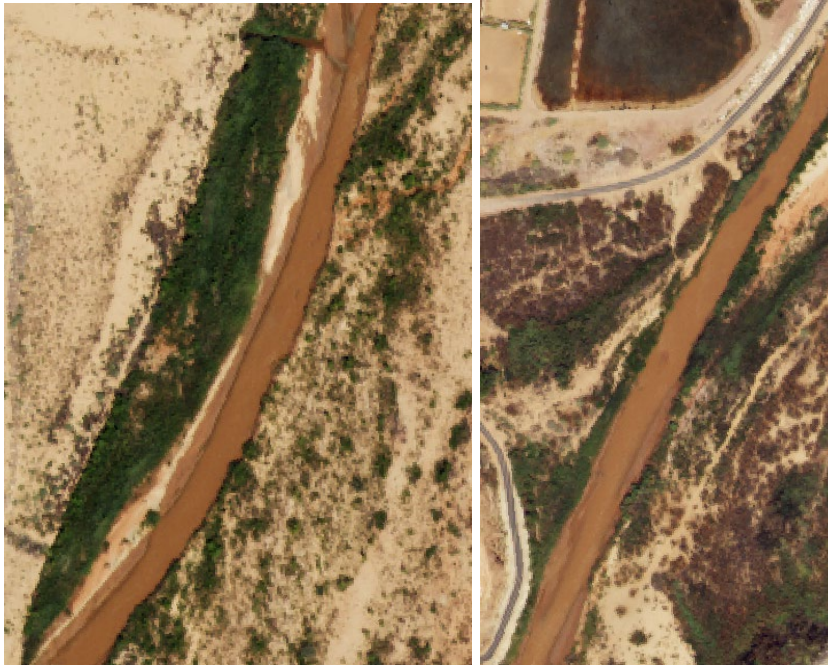
Figure 12

Visual example of the active channel from aerial imagery

Examples of easily identifiable active channel margins using 2018 NAIP imagery.

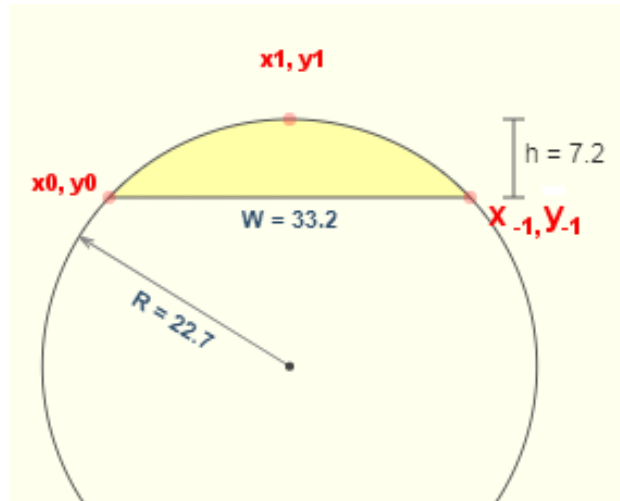
Figure 14

Diagram of Radius of Curvature Values

Diagram that visualizes radius of curvature (Unknown author, n.d.)

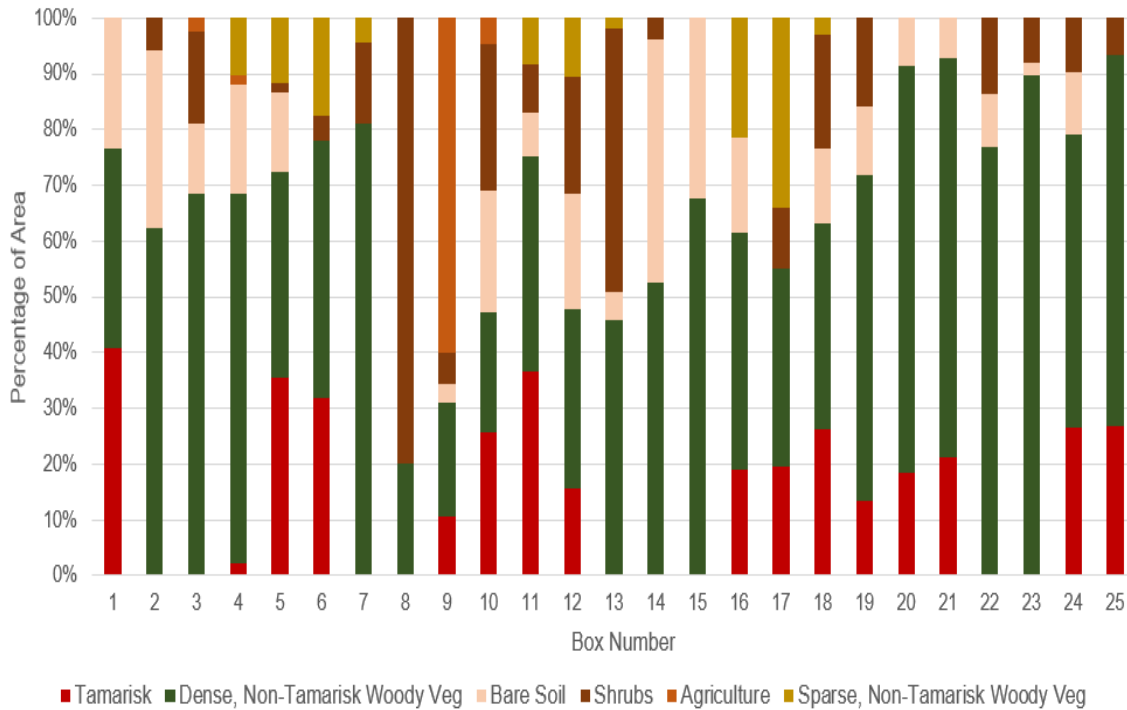
Figure 18

Vegetation community area (1976)

Vegetation community area of the St. George reach in 1976, excluding the river channel.

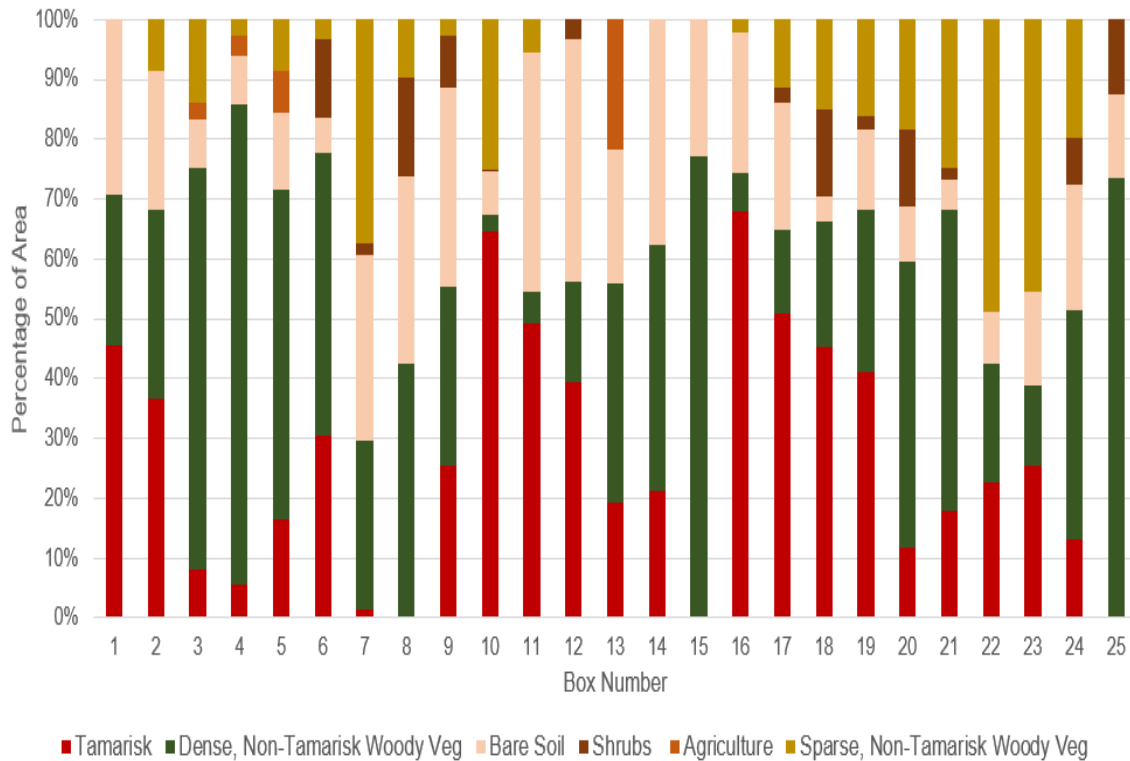
Figure 26

Vegetation community area (2014)

Vegetation community area of the St. George reach in 2014, excluding the river channel.

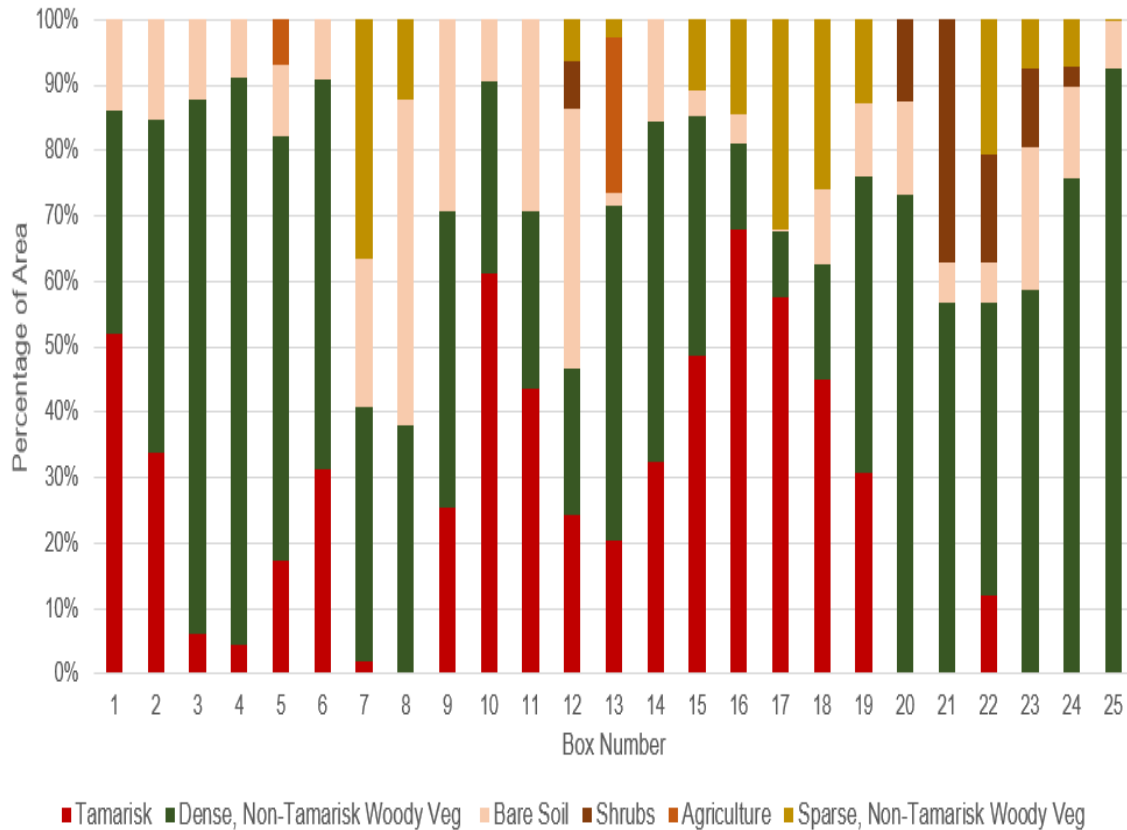
Figure 30

Vegetation community area (2018)

Vegetation community area of the St. George reach in 2018.

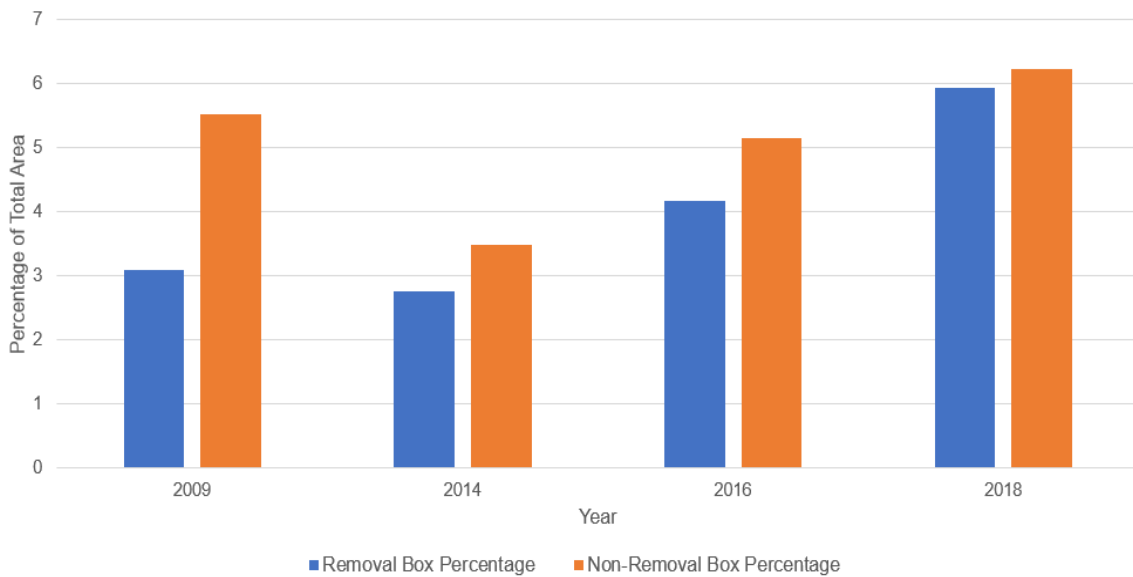
Figure 37

Changes in channel area percentage by removal status

Changes in channel area by removal status for the pre-removal (2009) and post-removal (2014-2018) years.

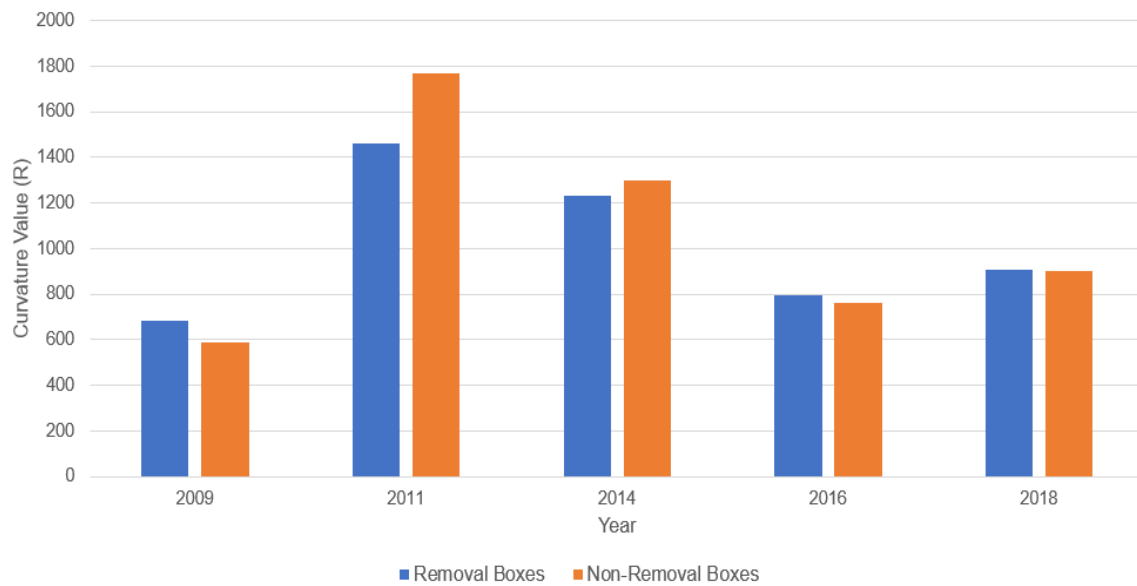
Figure 40

Changes in channel curvature by removal status

Changes in channel curvature by removal status.

increase in curvature compared to the 2009 imagery, which was the peak year of tamarisk colonization, the values for removal and non-removal sites are nearly identical. This is inconsistent with the findings of Keller et al. (2014), who found that channel sinuosity increased in removal boxes at a greater rate than in non-removal boxes.
