Little Boxes on the Hillside:

An Inventory and Analysis of Wildfire Lookout Structures in the
Pacific Northwest Region 06 of the United States Forest Service

Terminal Project

Prepared by Megan Berryoung

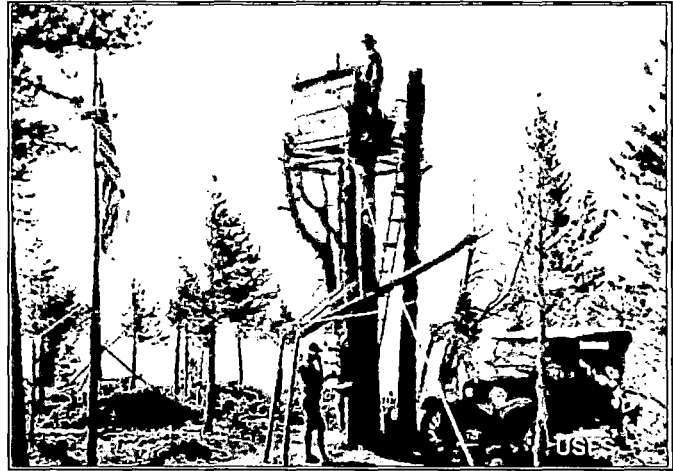
Rangers testing a firefinder from a Crow Nest. Photo from 1911.

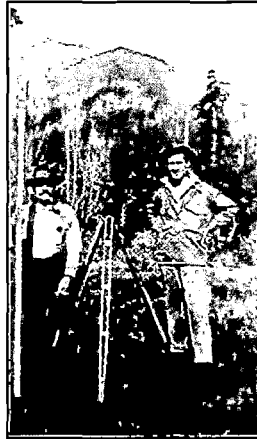
Olympic National Forest Supervisor and District Ranger using alidade. Date unknown

An alidade is a surveying tool that is used to measure distance through triangulation of horizontal and vertical angles from a reference point (Hill, 2013: 5-6). This is done through a scope on a flat plane, tripod, or platform in conjunction to a datum on a topographical map and a scoping device that provided an azimuth, similar to a sexton. The stands were generally chest height with a square plane top, roughly two to three feet in height, and a map affixed to it (Carricker, 1991: 27). Many early fire detection structures and patrol points utilized alidades, sometimes placed plainly on a stump, to locate the fire.

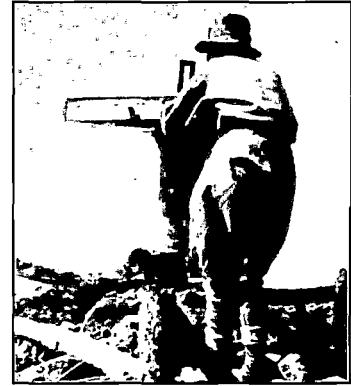
S.L. Hoover with an alidade on a stump at Maiden Peak in 1921, Deschutes NF.

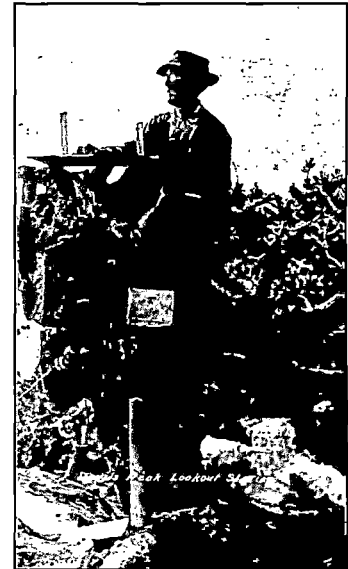
Devil's Peak "Iron Mine telephone and a crude temporary alidade whittled from shakes. - E.W. Smith, 1915", NPSHistory.com

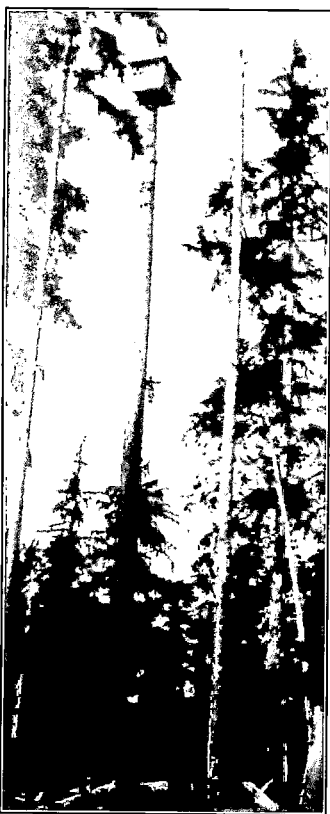
Eagle’s Aerie spar tree lookout on Cook Creek constructed in 1929. Notice man standing on rung halfway up the tree, Olympic NF.

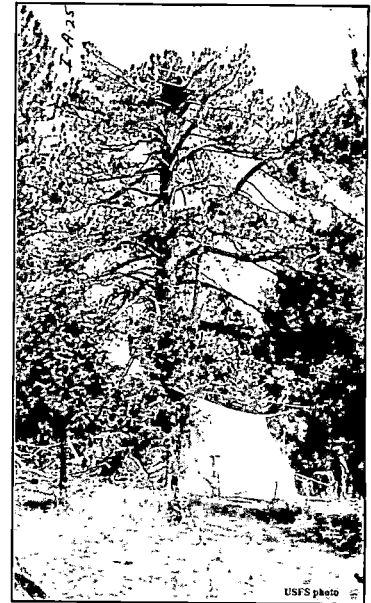
Stephenson Tree Platform with rag camp below, Crooked River National Grasslands. Date unknown.

This type of lookout has a wide range in variability and they were also sometimes described as being synonymous to a tree platform. An important component to spar trees that set them apart as an architectural style is that they are an anchor point for mechanized logging. A spar tree is selected for its height, strength, health, and location within a stand. After the tree is selected, it is limbed and topped. Block and tackle are added to the tree in order to affix a cable for dragging felled trees to a staging area (decks or landings) for transportation--called yarding. The strength of a spar tree is

meant to withstand the weight and pressure of yarding felled trees. Their height is significant too because they contribute to some of the tallest of the tree lookout structures. Another difference between Spar Tree lookouts and other tree lookouts is that Spar Trees supported both platforms and enclosed cabs.

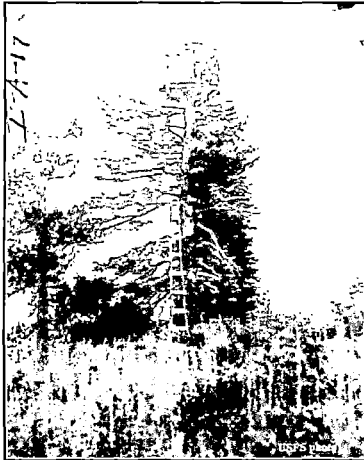
Wolf Mountain West, built c.1921
(photo from 1923), Ochoco NF

Crow nests are similar in design to tree platforms and they are distinguished by a wooden platform with an enclosed catwalk on the top of large spar trees. This platform could support the weight of the person as well as the Alidade. These trees were sometimes completely limbed and the top removed. Ladders were still used to reach the Crow Nest platform; however, variations of spiral ladders made of metal spikes were also used. In some instances, a series of platforms were built connecting two or more treetops to leverage the view available. Watchmen would take up residence at rag camps at either the base of a lookout tree or in a flat clearing adjacent to the lookout. There are no known surviving

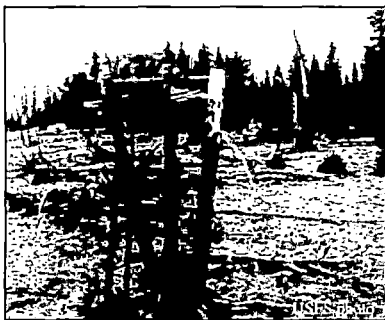
Monument 83 Platform Tower built
sometime in the 1920s (photo
c.1930), Okanogan-Wenatchee
NF.

Platform towers are less common and were placed in areas to cover blind spots. These structures were often temporary and constructed in the event of an emergency. Some towers are free-standing and others incorporate living trees and snags. Platform towers are made with at least three to four pole legs and a plank floored platform, ranging from 6 to 10 sq. feet (Swift, 1993: 1; Carricker, 1991: 30). The top platform was for an alidade to triangulate the location of

the smoke. These towers were not uniform in style or construction and the builders often used what resources were available on site. Due to their temporary nature, platform towers were moved or abandoned as the Forest Service invested in more permanent live-in structures. Platform towers are for observation-only and are the first example of the Forest Service's attempts in creating a free-standing lookout. There are only four Platform Towers remaining in Region 6.

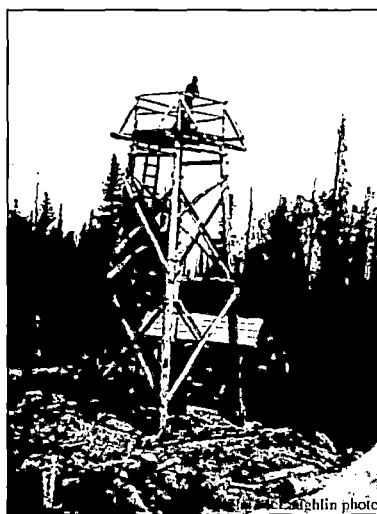
Salmo platform tower on the South
side c.1929 with a cabin at the
base, Colville NF.

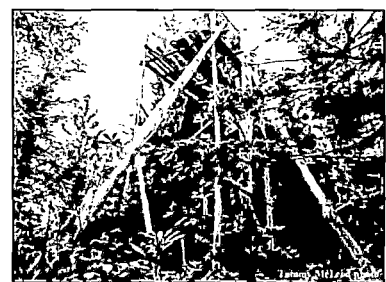
Ned Hill Platform Tower built in
1933, Olympic NF.

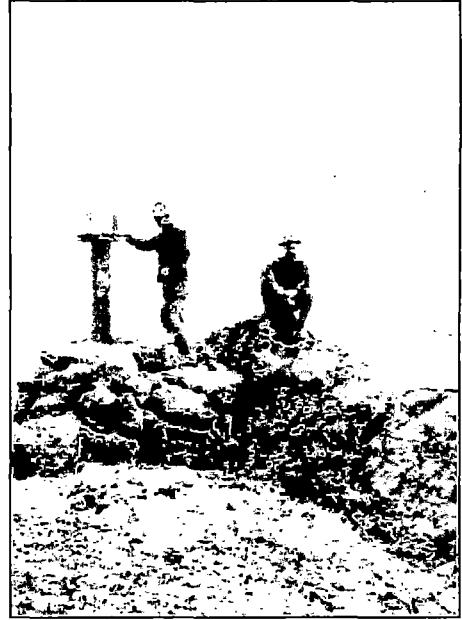
Osborne Fire Finder on a rocky knoll
c.1915, Rogue River-Siskiyou NF, USFS
photo.

William Bushnell Osborne, Jr., created the “Osborne Fire Finder” in 1910-1911 while working for the Engineering office for the USFS on Mt Hood in Oregon. This tool was a great technological advancement and proved to be highly effective in triangulating a smoke over the alidade. The instrument is essentially a round disc on a level stand with a map of the surrounding area under a dial with compass degrees etched on the rim. The watchman can swivel the Fire Finder to ‘sight-in’ the direction of the fire. This allows the watchman to precisely pinpoint the location of a fire within 1/60th of a degree (Hill, 2013: 38; Kresek, 1985: 29). The device was simpler to operate than the alidade and less fragile. Many versions of the Fire Finder were produced¹⁹ as they were later incorporated into the center of the lookout structure; however, the Osborne was the preferred device. Some historic fire lookouts still have an operable fire finder’s remaining in the cab.

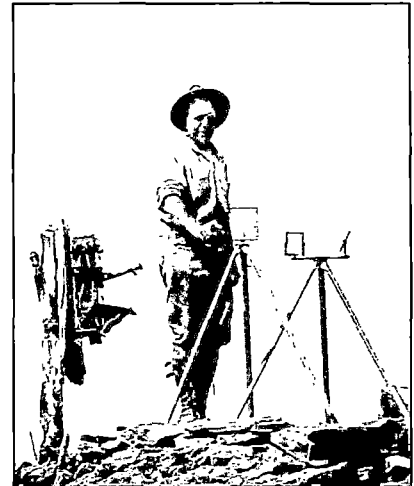
Ranger Smith using a Heliograph in
1912 on Black Butte Lookout in
California--Region 5. U.S. Forest
Service photo courtesy of the Forest
History Society, Durham, N.C.

A heliograph consists of a system of mirrors and shutters on tripods that are positioned to reflect sunlight. By manipulating the shutters and creating flashes, the watchmen were able to communicate from long distances. The Forest Service explored this form of communication between fire watchmen as well as the ranger districts during the early 1910’s. Heliographs were first used and largely successful in the Southwest Region of the Forest Service in Arizona and New Mexico; however, they proved challenging in the Pacific Northwest due to lack of sun exposure. “Its flash could carry 50 miles or more in clear air, and its message could be delivered in a matter of minutes, which meant a fire crew could be working on a new fire many days earlier.” (McCarty, 2010).

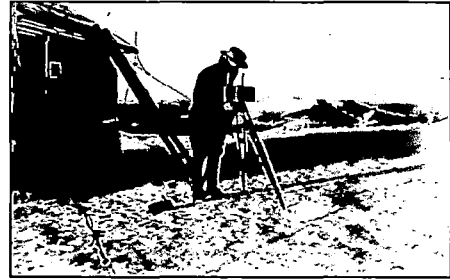
Dispatcher Phelps leveling panorama camera. Fremont NF, 1928. Photo Courtesy of the Forest History Society, Durham, NC.

In the 1930s, Region 6 used panoramic photographs to recreate the viewshed from lookouts. These were used to record and identify physical attributes on the landscape to better provide precise location data of smokes. Each photograph has a horizontal reference line that correlates with the elevation of the lookout and a vertical scale is provided to correlate with the line of sight (DOI, 1958: 6.9). There are usually a set of three photographs that cover the entire viewshed from the lookout—often taken from the rooftop. These, along with a fire finder, were valuable tools to aid the watchmen in locating and describing landscape features like drainages and peaks, especially at night.

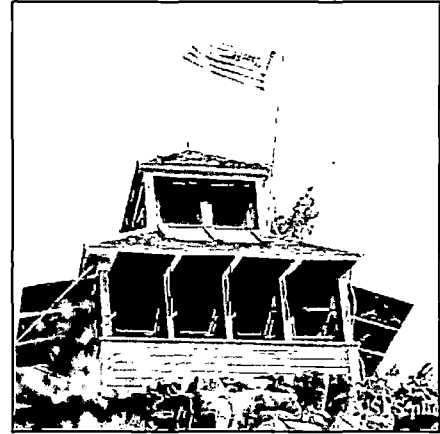
Dutchman Peak (1925), D-6 on Rogue River-Siskiyou NF. Photo from 1925.

The D-6 lookout came in a pre-cut kit that was packed to the lookout location and assembled by the watchman. The wood frame construction kit included a 12' x 12' floor plan with a 6' x 6' cupola centrally located on a hipped cedar shingle roof; the cupola also has a hipped roof. The design for the envelope would be clad with either a double "v" rustic or clapboard siding. Both the main elevation and the cupola would have wooden awning windows and shutters on all four sides. The interior included either tongue-in-groove wall cladding and flooring or a wallboard sheathing like Celotex, an insulated fiberboard sheathing. The D-6 lookout was the most prolific lookout until the L series was designed to replace it.

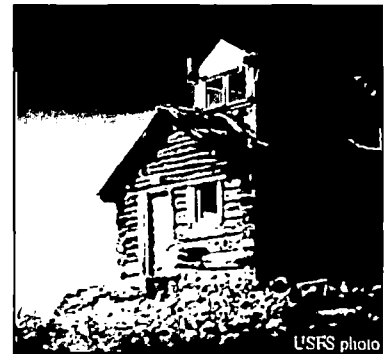
Monument 83 (est. circa 1920s), D-1 Cupola, Okanogan-Wenatchee NF (found later to be in British Columbia), Photo c. 1930s

The D-1 style (also sometimes referred to as the L-3) was a regional adaptation originally developed on the Flathead National Forest in Montana by D.L. Beatty (Hill, 2013: 25; (Hartmans, 1991: 27). A D-1 is characterized by a 14' x 14' log cabin with dovetail-notching and a gabled roof and a "quarter-sized gable roofed cupola" (Swift, 1993: 1). This style is widespread throughout Idaho and Montana and to a lesser extent in Oregon and Washington. The only surviving D-1 was constructed by the Okanogan-Wenatchee and it was later determined that the lookout was actually located in British Columbia. This lookout is now Canada's southernmost lookout.

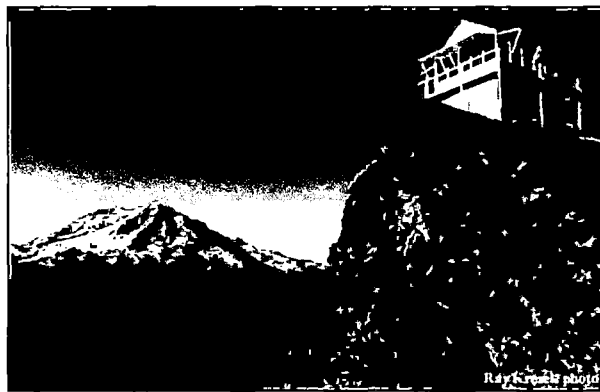
High Rock (1929) L-4 Gable, Gifford Pinchot NF. Photo from 1987, Ray Kresek.

The model got rid of the second story cupola and combined the living quarters with the observation platforms into a single story. The L-4 model also introduced a unique awning-inspired shutter system where wooden panels were mounted horizontally over the two-over-two

windows to provide shade and better visibility in the summer. In the winter, these panels are lowered to cover and protect the windows from winter storms. The model also included materials for a wood-shingled roof and materials for a tongue-in-groove interior and exterior siding. The model could be placed on the ground or elevated on a timber or pole tower. This versatility of the L-4 is what makes this model stand out against its counterparts.

The L-4 live-in lookout was not only designed to accommodate the ranger and his gear but also provided a kitchen with cupboards, a bed, and an Osborne Fire Finder. The earliest L-4 models had a gabled roof and were replaced with a hipped roof in 1932 (Atwood et al., 2004: 57). There have been five variations of the L-4 over the 40 years it has been in service including the L-4-A, the L-4-AR, the L-4 Gable, L-4 Hip and the Standard '36 (Swift, 1993: 1; Carricker, 1991: 38). Other models in the L series that were constructed in Region 06 include the L-5 and the L-6.

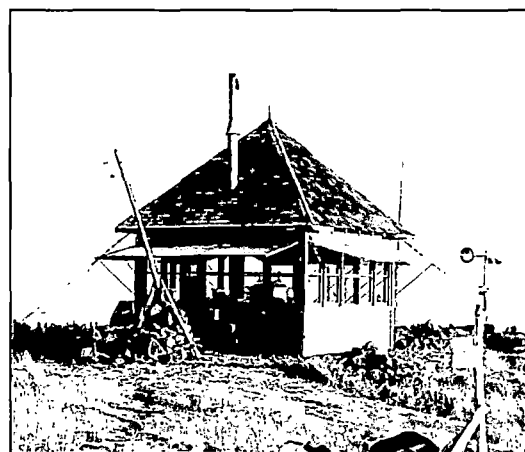
Calamity Butte (1927) C.C. Hall Special (L-4-AR), Malheur NF. Photo from 1942

The L-4-A was the first model in L series. Developed by Region 05 from 1917 to 1923, the L-4-A is a 14' by 14' live-in house with a very steep pitched hip roof and was never in service in Region 06. However, Region 06 took the initial design on the L-4-A and made alterations known as the L-4-AR, or locally known at the C.C. Hall Special (Swift, 1993: 1). Changes to the 4-A design included changing the six windows per side to five with one upper and one lower pane. The door and entryway on the L-4-AR replaced the middle window while the rest of the design configuration remained the same. The L-4-AR is distinctively identified by its very steep

hipped roof²¹ with minimal eaves. The L-4-AR model was first built in 1923 and the last one in 1929—a total of six years.

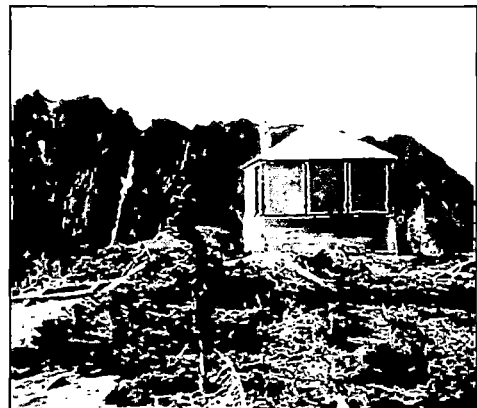
Meebee Pass c.1935, willhiteweb.com

The L-5 originated in Region 05, the Intermountain Region, and is a much smaller version of the L-4 models. The L-5 is a 10' x 10' precut wood-frame cab with a hipped roof and was constructed primarily at secondary lookout points during the 1930s (Atwood, 2004: 59). The L-5 was also a designation given to several 14' x 14' gable log cabins in Idaho and Montana which can make this designation confusing (Kresek, 1998: 11; Atwood, 2004: 59). Until this survey, it was believed that there were no more remaining L-5 lookout cabs in Region 6; however, there are two remaining— Pig Iron on the Umpqua and Meebee Pass on the Okanogan-Wenatchee. This model was generally used as a secondary lookout.

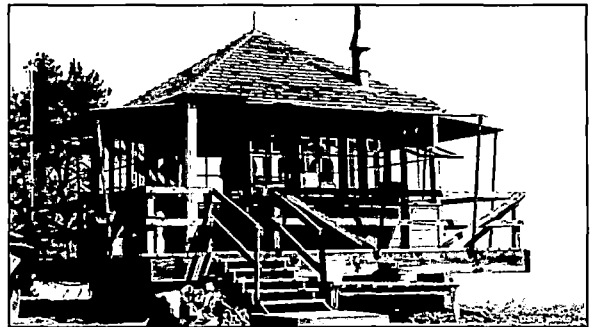
Buckhorn Mountain L-4 hip lookout on the Wallowa-Whitman, USFS photo c.1952.

The L-4 Hip was an adaptation of the Region 1 gable design and is essentially the same composition as the L-4 Gable but with a hipped roof, also keeping with the same low-pitched roof. Earlier examples of the L-4 Hip have nine-pane windows while later incarnations are four-

paned. The first L-4 hip was built at the end of the Intermediate period in 1932 with the last one constructed during the Great Depression in 1936 (Swift, 1993: 1; Throop, 2005: 58). Region 05 then adapted this style and called it the C-3.

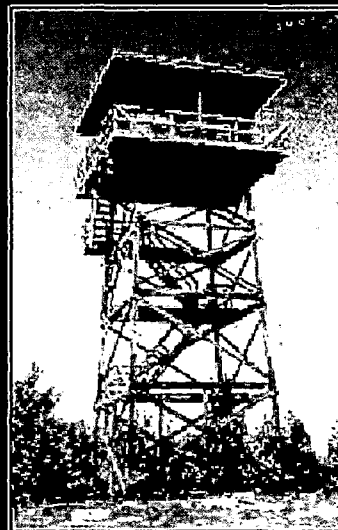
TIMBER MOUNTAIN R-6, 1959

Timber Mountain, NHLR photo

The Region-6 (R-6) Flat Top was first introduced in 1953 and was the Forest Service's modern and updated model to replace previous styles. The materials needed to construct the R-6 are too large to be packed in and required the use of a helicopter (Atwood, 1994: 61-63). The R-6 was designed to lower costs and reduce hazards from re-shingling the L-4 hipped roof by replacing it with a modern and sleek flat tarred roof with widely overhanging eaves. The exterior is clad in laminated exterior cedar plywood on textured 1-11 fir and the cab is surrounded by a catwalk.

The R-6 is 15' x 15' with single-light windows, rather than multi-pane, and lack window coverings or shutters. Earlier cabins have, "seven windows per wall with four lights each and an open soffit. Later models had one light above and one larger light below and closed soffits" (Atwood, et al., 2004: 91-92). In all cases, the interior was furnished with an Osborne Fire Finder.

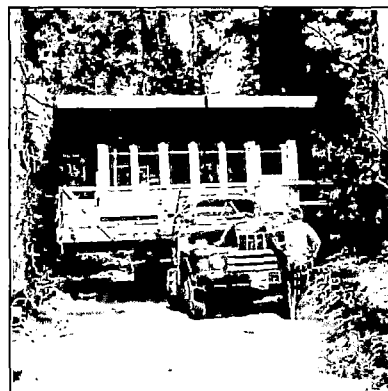
Antelope R-6 lookout preassembled and being transported to the site in 1974 (above). A crane is used to place the R-6 on the tower structure (below). USFS photos.

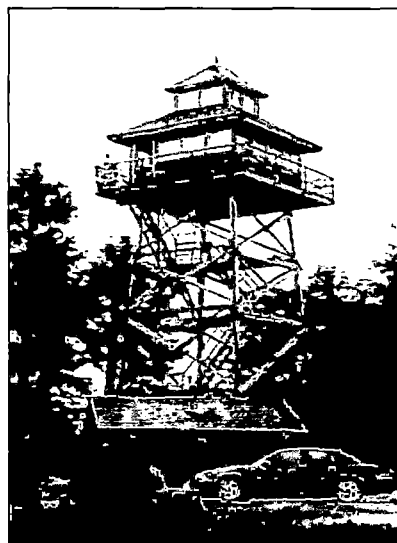
Warner Mountain Cupola Cabin Replica on the Willamette NF, Sue Bula photo, 2000.

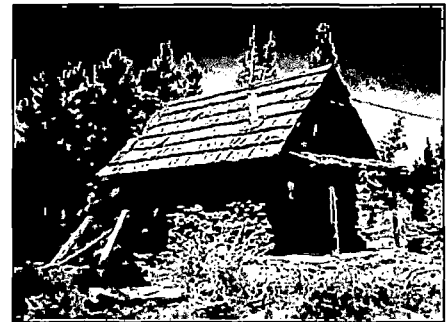
Walker Mountain cabin in the Deschutes National Forest.

The cabin lookouts that remain range from hand-hewn slant-walled to stone and wood. The Walker Mountain on the Deschutes was one of four original lookout stations on the forest and is the oldest administrative structure on the forest. The Walker Mountain lookout is the only lookout to be constructed using stone in the composition. Of the cabins that remain, they are all

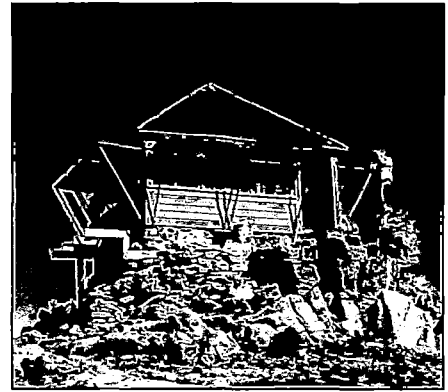
Mule Peak L-4-AR "Hall Special"
c.1988, Rod Jones photo

Currently, there are two L-4-AR Hall Specials standing in Region 06—both in Oregon. The Calamity lookout on the Malheur has been in continual use for over 65 years. Mule Peak lookout on the Wallowa-Whitman is located in the Eagle Cap Wilderness and is inactive. Both are from the Intermediate period (1912-1932). The L-4-AR is a Live-in lookout.

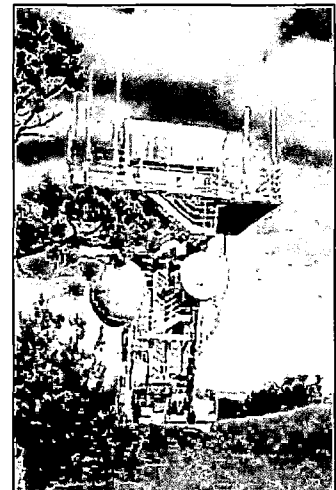
Pelican Butte lookout. Howard Verschoor photo.

Pelican Butte on the Fremont-Winema National Forest has been modified to accommodate radio equipment and has hence been voted Oregon's Ugliest Lookout by the Fire Fighter Lookout Association (FFLA). Pelican Butte was originally constructed as an L-4 in 1935 on a cable braced pole tower (PT) and was replaced with

an R-6 on a treated timber (TT) in 1954. In 1986, a cable television company placed a 10' x 10' metal cab on a 20-foot metal tower to accommodate their equipment. It is unclear where they pilfered the cab and tower and it is only staffed by fire during emergency incidents. CL-100/106 lookouts are Observation-only.

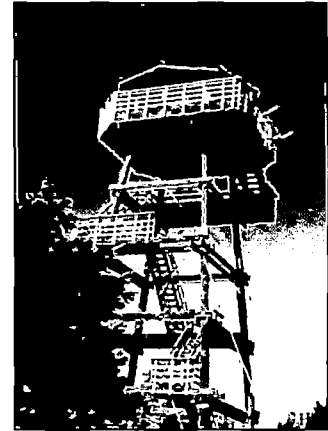
Sisi Butte c.1997 on Mt Hood. Howard Verschoor photo.

It is unknown how many octagonal lookout structures exist. There are three Octagon's in Region 06—all in Oregon and all from the Modern & Contemporary period (1961-2010). The oldest of these Octagons is Sisi Butte on Mount Hood that was constructed in 1977. This Octagon replaced the previous L-4 that was used as an AWS site during WWII. Octagons are placed on pole towers that average around 40-feet in height and are surrounded by a catwalk. Octagons are Live-in lookouts.

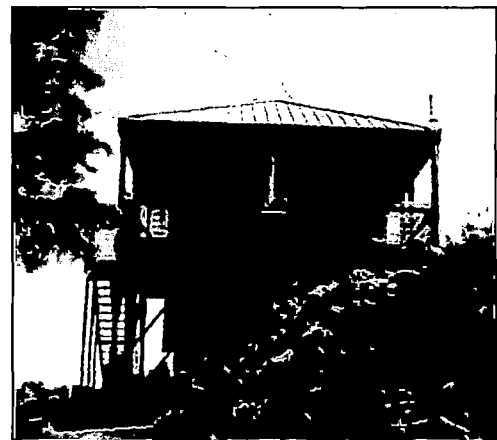
Dog Mountain Lookout House, Howard Verschoor photo, date unknown.

In 1997, the Fremont-Winema National Forest constructed a two-story house on Dog Mountain. The house's floor plan is 15' x 15'. The upper story is used for fire detection and the first story was constructed for living quarters. The house is actively staffed every year for fire detection. This patrol point was originally established in the 1910s with an Adelaide and was staffed by a female watchman, Bertha Covert, during WWII (NHLR Dog Mountain). The only House lookout is a Live-in lookout.

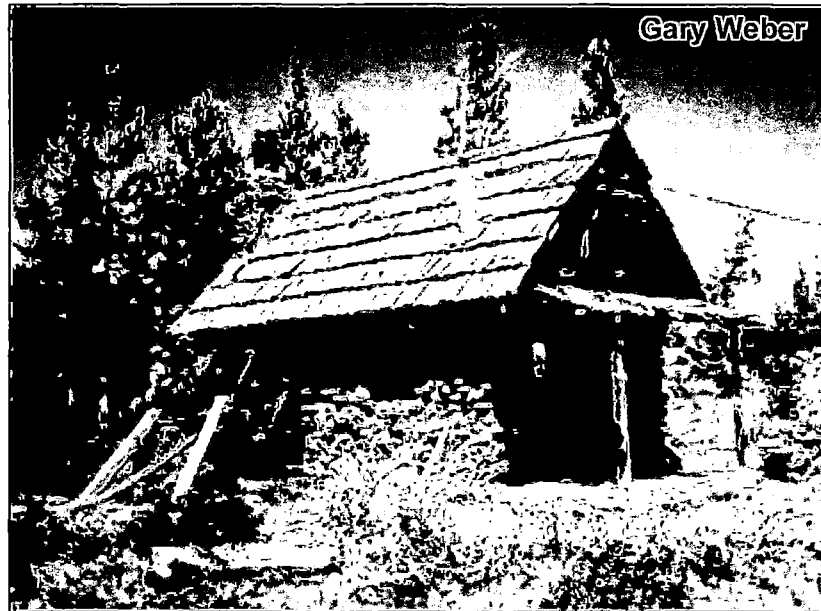
Walker Mountain Lookout Cabin

Year Built: 1917
Ranger District: Crescent
Lat/ Long: 43.3052/ -121.7170001
Access: Road
Current Use: Inactive
NRHP Status: Eligible

Partners: Unknown
Deferred Maintenance: \$79,154.00
Replacement Value: \$79,154.00

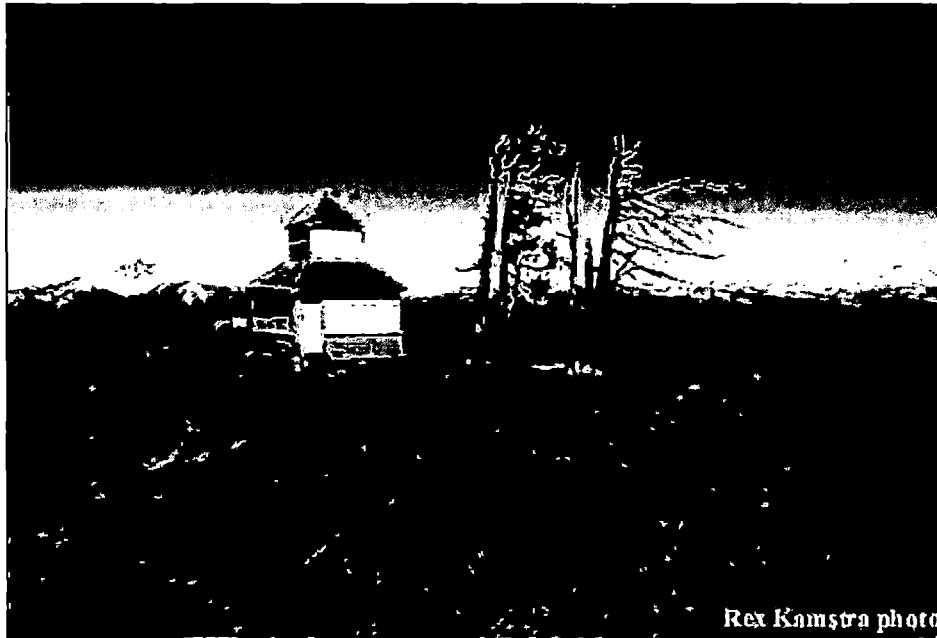
Black Butte D-6 Cupola

Year Built: 1922
Ranger District: Sisters
Lat/ Long: 44.40001/ -121.6365
Access: Trail
Current Use: Inactive
NRHP Status: Listed

About: Originally a crow's nest with a tent camp, this D-6 cupola replaced the crow's nest in 1922 and was in-use well into the 1990's. The lookout unfortunately has limited visibility so an 82-foot-tall wooden tower with a 7x7 observation-only cab was constructed on the butte in 1934³⁸. The D-6 served as ground quarters for watchmen when the tower was originally constructed. A log cabin was constructed in 1980³⁹ to be replacement ground quarters and work began on a new 65-foot-tall treated-timber tower in 1994. According to the World-Wide Lookout Library (WWLL), "All structures remained on the summit, making this one of the most unique on-site historic collections of lookouts anywhere" (Rex Kamastra). The D-6 is currently inactive, and a yurt is used as sleeping quarters for the watchmen. The structures on Black Butte are a popular and scenic hiking destination in the summer months.

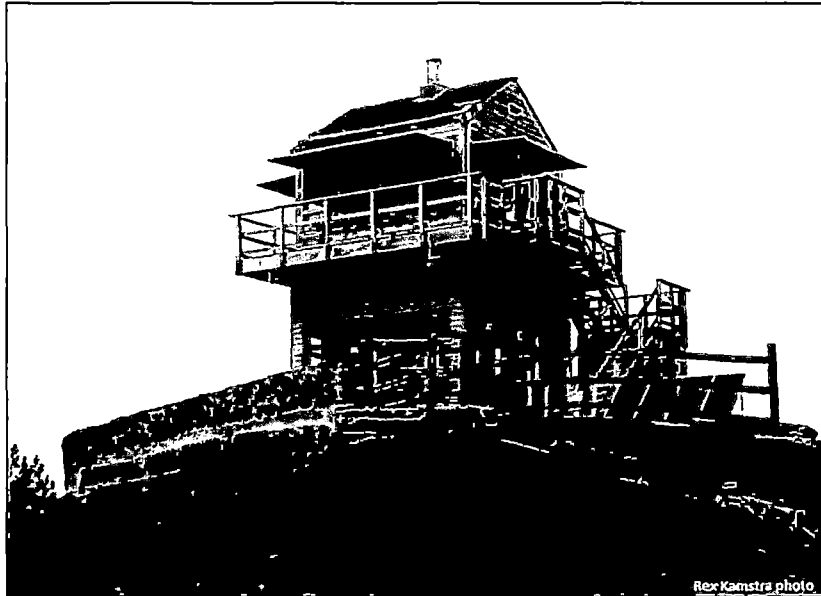
Lava Butte c. 2013

About: This site has had many alterations (see photos on following page) and boasts the highest number of reported fires. Located on a lava cone, Lava Butte was originally developed in 1932 with an L-4 gable. The lookout was replaced with an R-6 Flat cab in 1957 and the lower level was developed into a visitor's center in 1960.

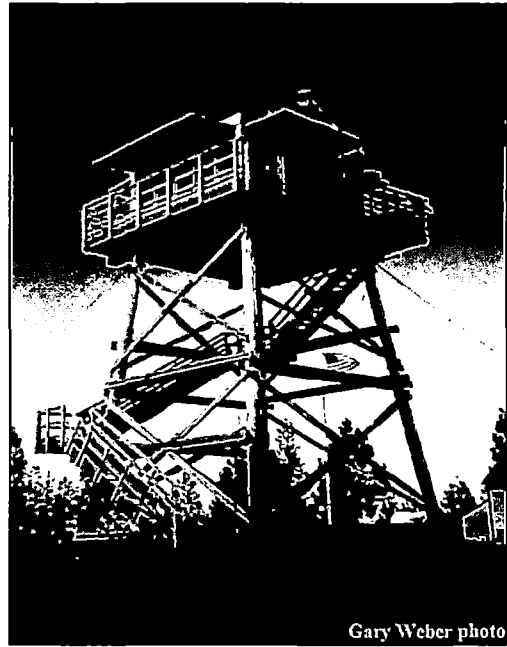
20' Replica Lookout Tower

About: This 20-foot-tall L-4 wooden pole tower with a gable roof is a replica of the original 1932 30-foot-tall L-4 on East Butte (see photo left). The Forest Service replaced the original in 1995 and it is still in active use for wildfire detection from May to September.

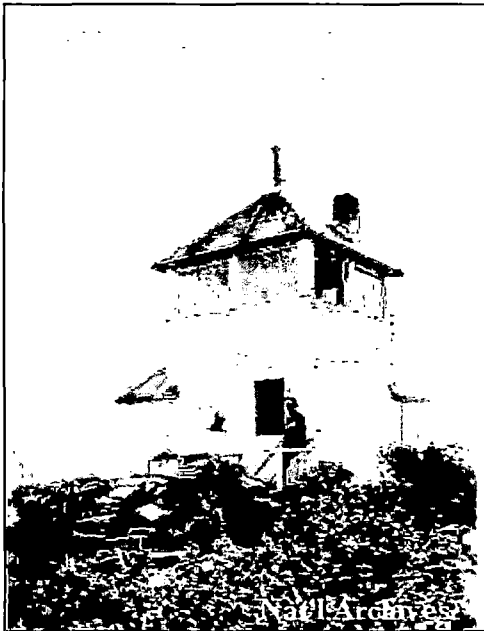
Calimus Butte Cathedral in 1920's

About: Calimus Butte originally served as a patrol point in 1919 and a 16'x16' cabin with 12'x12' cupola was built in 1920 a couple hundred feet from the north summit. A 14'x20' cupola cabin was replaced by present cupola cabin in 1930 and has been used as an active fire lookout every year since 1931. In 1932, this area saw heavy fire activity and even had "four crank-type phone lines converging on the lookout" (NHLR). The Klamath Indian Agency operated the lookout until a couple years prior to the Termination act of 1961 when the Klamath District of the Oregon Department of Forestry took over management of the lookout. This parcel of forest was sold to the Winema NF in the mid 1970's and now the Fremont-Winema retains ownership and management of this lookout.

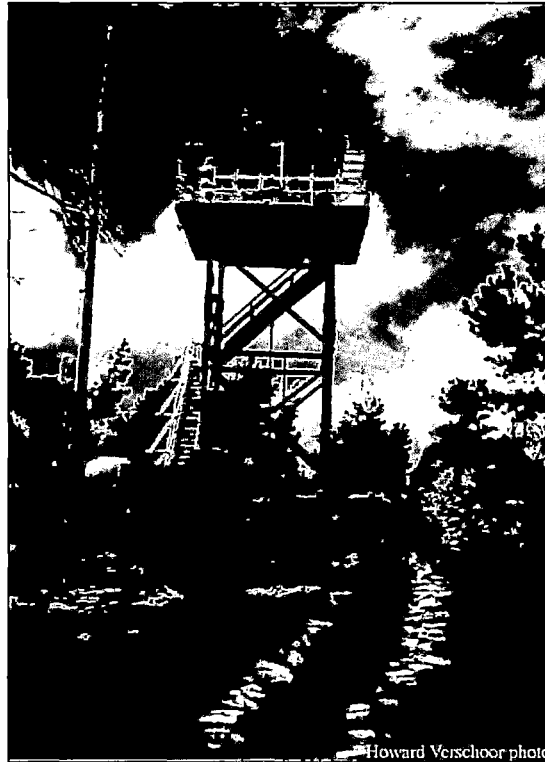
Bald Mountain c. 1997

About: Originally, Bald Mountain was a patrol point and according to the NHLR, "A telephone line was strung from the Oatman Ranger Station to Bald Mountain in 1917...[and] fire-finding equipment was established at the site in 1918." In 1928, a rare 12'x12' Aermotor live-in cab was established on the site and only a few were ever constructed. In 1932, a 20' wooden L-4 treated timber tower replaced the Aermotor and in 1941, the Fremont NF built the present L-4 with a hipped roof and a catwalk on a 29' 6" treated timber tower. There are stone walls and landscaping paths leading to site and flagpole. The Bald mountain lookout has been evaluated as eligible for inclusion in the NRHP however, it is not currently listed in the Oregon SHPO database.

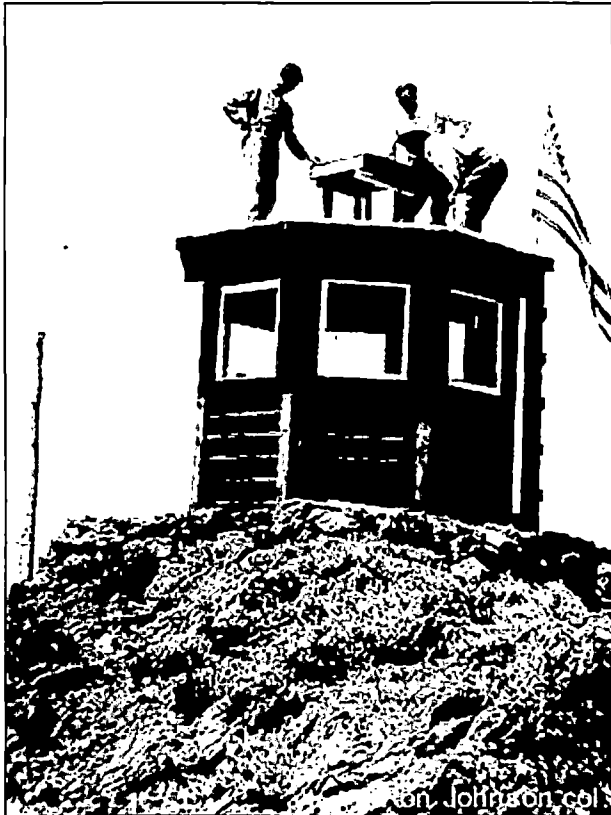
Hager Mountain c.1912

About: Hager Mountain was originally established with an Octagon in 1912. An L-4 hip replaced the octagon in 1938. In 1967, an R-6 replaced the L-4 and in 1992, the flat roof was replaced with a hip. This R-6 is a recreation rental in the winter months from November 15th to May 15th. The RSFMP in 2008 increased the operating season from May 15th to November 15th and sought to increase the recreation fee at the site.

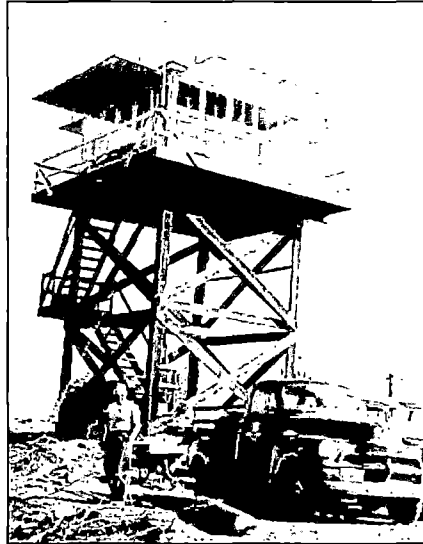
Pelican Butte Lookout c.1954

About: The Pelican Butte lookout was originally established in 1954 with a L-4 on a treated timber tower. In 1966, the L-4 was replaced with a R-6 cab with a catwalk on a 20-foot treated timber tower. In 1986, a cable company received a Special Use Permit to use the mountaintop as a relay station and according to the NHLR, they “proffered the present metal 10’x10’ cab on a 20’ metal tower as part of the bargain”. The lookout is currently used by fire during high fire danger or emergency fire events.

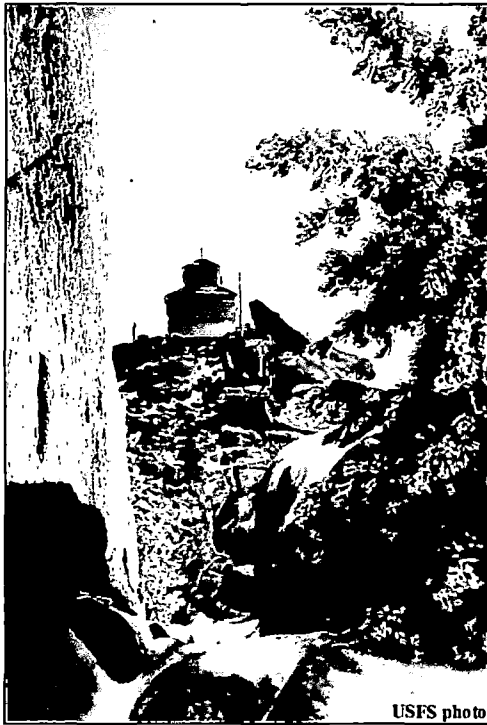
Dog Mountain Lookout c.1926

About: Dog Mountain was first used as a patrol point with an Alidade in the 1910's. During WWI, Bertha Covert (c.1918) was one of many women that staffed lookouts during the nationwide manpower shortage. A D-6 Cupola was established in 1926 and replaced in 1947 with an L-4 for "\$2,700" (NHLR). A modern 15'x15' two-story lookout house was established onsite in 1997. According to NRM, the "slope of ground exceeds maximum incline".

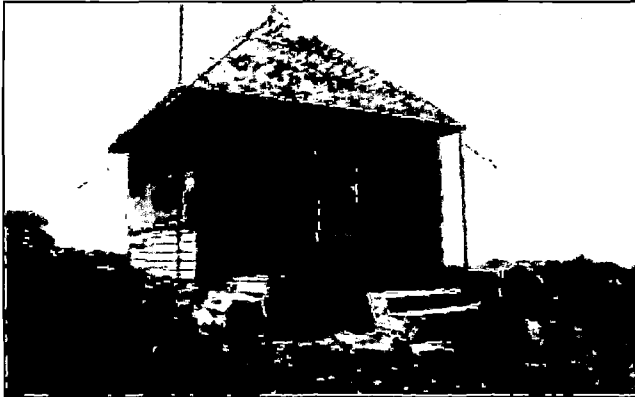
Calamity Butte Lookout, photo c. 2017

About: Calamity Butte houses two unique lookouts—one being an L-4-AR Supervisor Hall Special ground house (building No. 4003). The L-4-AR ground house is a 14'x14' wooden cab and was a Region 5 design/ California-model. There is a garage and wooden toilet also onsite. These secondary buildings as well as the lookout are eligible for inclusion in the NRHP and they are all in very poor condition. Construction of an Octagon onsite began in 1996 and is currently staffed by fire. The butte has been continually used for fire detection for over 65 years.

The FMP recommends the following for the maintenance of the site:

- Complete a structural inspection of the lookout and tower by a qualified structural engineer
- Complete an inspection of the lightning protection by a qualified contractor to ensure the safety of the system
- Replace the toilet building with a modern vault toilet
- Allow the garage and old lookout to “melt” into the ground by not investing scarce maintenance funds in either building” RSFMP, 2017: 84-85

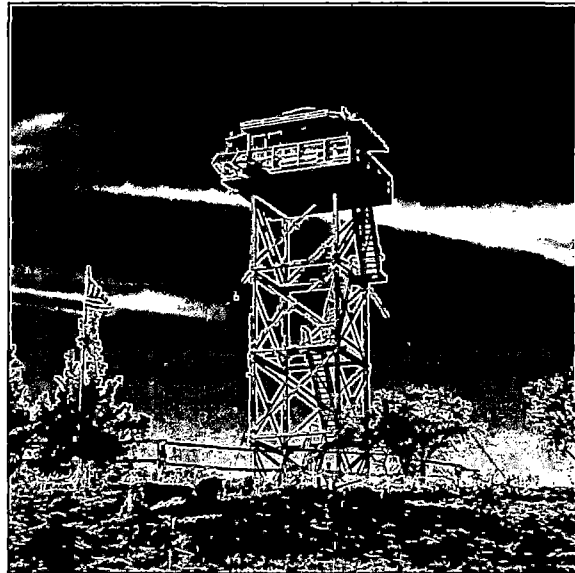
Dry Soda Lookout

About: The Dry Soda lookout is a 14' x 14' L-4 cab with a hipped roof and catwalk on a USFS 60' CT-2 wooden tower. A Rappelling platform was added at 45-feet (date unknown) and is actively staffed in the summer for fire detection. There is an old wooden toilet circa 1941, a small storage shed, and a modern CXT toilet are also onsite. The lookout is in fair condition—the guy wires are loose, a few cross-bracing members are split, and several of the wooden steps are cracking. This site was determined eligible for inclusion in the NRHP in 2010.

The FMP recommends the following for the maintenance of the site:

- Complete a structural inspection of the lookout and tower by a qualified structural engineer
- Complete an inspection of the lightning protection by a qualified contractor to ensure the safety of the system
- Upgrade the propane system and tank
- Tighten the guy wires and repair any structure deficiencies
- Decommission the old toilet (#1724) in place by not investing any further maintenance funds in this building" FMP, 2017: 52-53

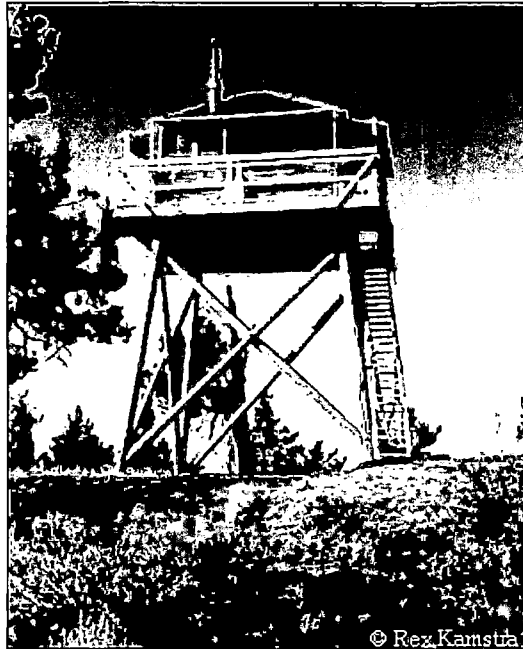
About: The Fall Mountain Lookout is a 14'x14' L-4 cab and wooden catwalk in an 18ft pole tower. The tower structure was replaced in 1953 and it is currently available to rent from May to November.

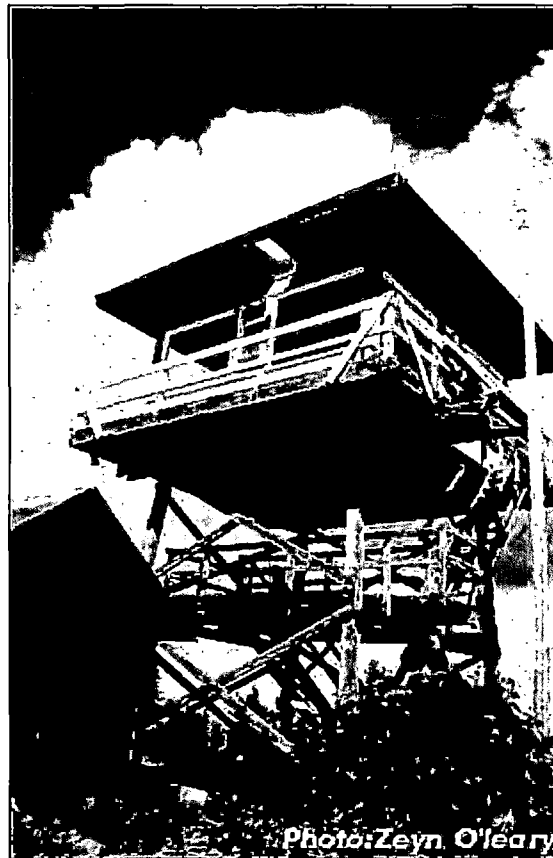
Mount Pisgah Lookout

Year Built: 1964
Ranger District: Lookout Mountain
Lat/ Long: 44.4570441/ -120.2526802
Access: Road
Current Use: Fire Detection
NRHP Status: Eligible

About: 14x14' R-6 flattop live-in cab w/ catwalk on a 20-foot treated timber tower. The current lookout on Mount Pisgah is the fifth lookout to be placed on site. According to the WWLL, the lookout had a "10' platform built here in 1918, replaced by a 35' platform and accompanying cabin in 1923. A cab was constructed atop the existing tower in 1929, followed up by a 20' L-4 tower in 1933. In addition, there were patrol points 1 mile north (burned in a 2008 forest fire) and 3 miles east. The present 20' treated timber R-6 flat tower, built in 1964, is staffed every summer."

Partners: Unknown
Deferred Maintenance: \$6,157.66
Replacement Value: \$77,979.19

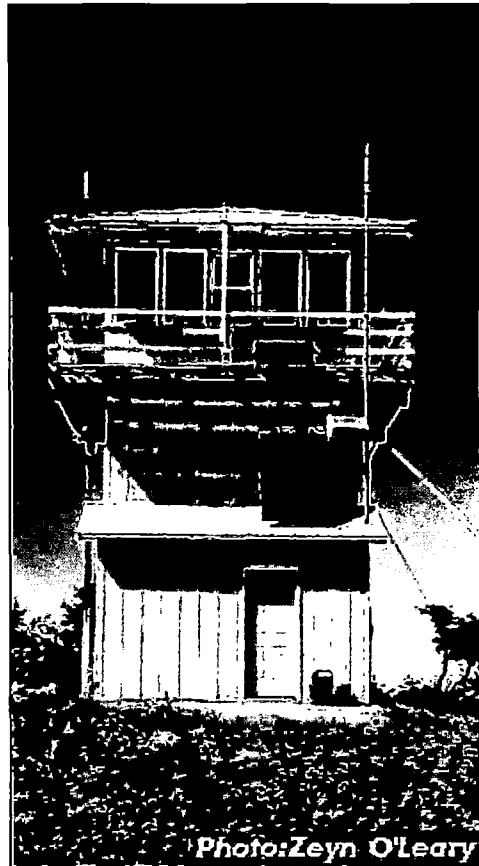
Photo: Zeyn O'Leary
Stevenson Mountain Lookout

Year Built: 1963
Ranger District: Lookout Mountain
Lat/ Long: 44.58973/ -120.50185
Access: Road
Current Use: Fire Detection and Communication Site
NRHP Status: Unevaluated

About: According to the WWLL, "a crow's nest was developed in the mid-1920s, with ground cabin living quarters added in 1929. The tree was replaced by a 60' wooden tower in 1934. The present 3-story enclosed ODF cab, built in 1962-63 3/4 mile west of the previous tower, is staffed by the Forest Service. It is located on private land with no public access".

Partners: ODF
Deferred Maintenance: \$113,673.75
Replacement Value: \$267,357.22

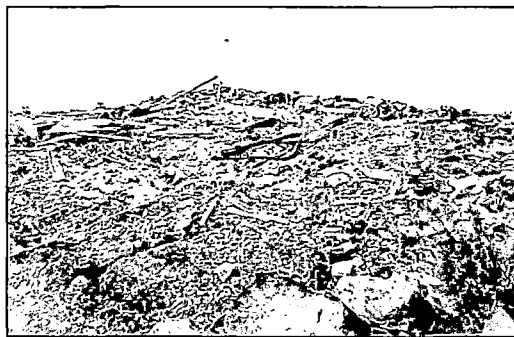
Bolan Lookout, USFSRRSNF Facebook page

Year Built: 1953
Ranger District: Wild Rivers
Lat/ Long: 42.0156/ -123.4595167
Access: Road
Current Use: **GONE- Wildfire 2020**
NRHP Status: Unevaluated

About: Originally, Bolan mountain was established with a cupola cabin in 1917 on a log crib base. This was replaced in 1953 with a 14 x 14-foot L-4 cab with a hipped roof on a 15-foot treated timber tower. The legs have since been removed and the cab has been placed on a stone foundation. The catwalk was expanded recently and a deck was added on one side. Burned down in 2020. It used to be on the Recreation Rental program.

Partners: Unknown
Deferred Maintenance: \$2,073.08 (before it burned down)
Replacement Value: \$45,680.26

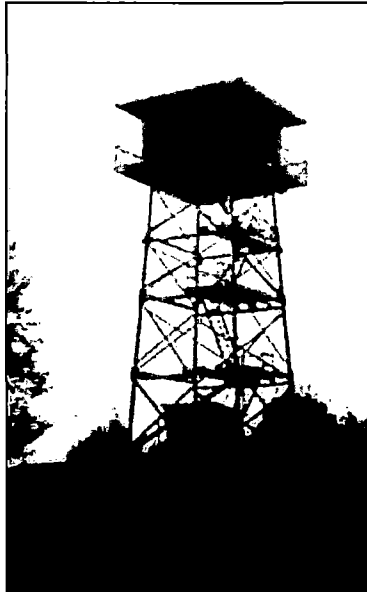
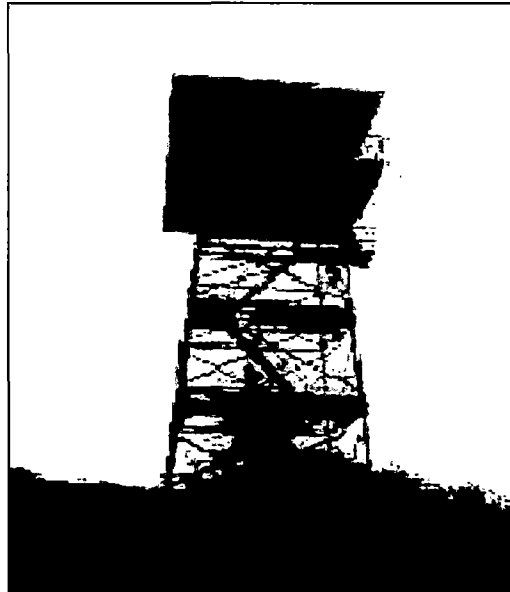
QUAIL PRAIRIE LOOKOUT

Year Built: 1963
Ranger District: Gold Beach
Lat/ Long: 42.24183/ -124.04563
Access: Road
Current Use: Inactive
NRHP Status: Unevaluated

About: The R-6 cab is on a 41-foot treated timber tower. It was built to replace Long Ridge lookout which was damaged in the Columbus Day storm of 1941. The lookout was a part of the recreation rental program but it received damage in recent years and is no longer open to the public.

Partners: Unknown
Deferred Maintenance: \$30,449.57
Replacement Value: \$96,863.93

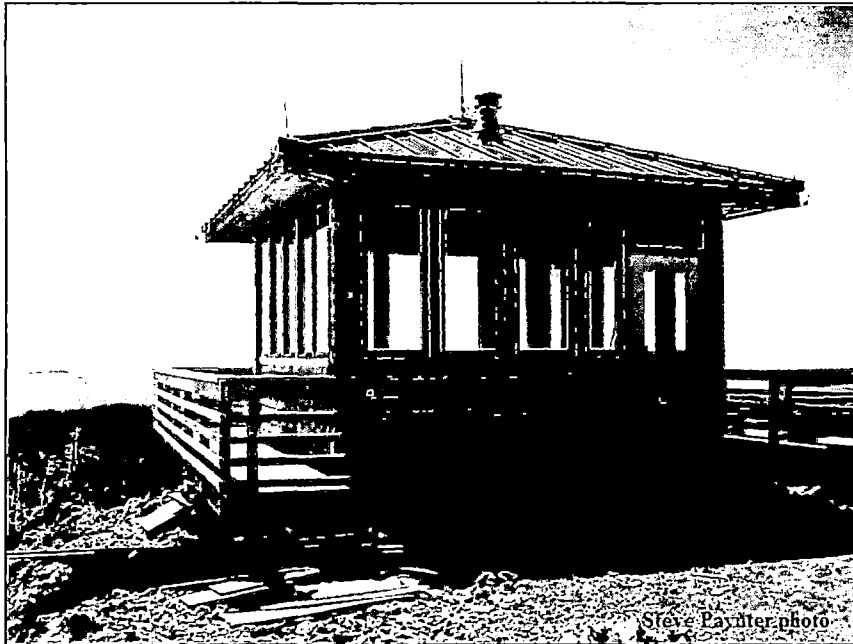
Snow Camp Lookout c.2005

Year Built: 2004
Ranger District: Gold Beach
Lat/ Long: 42.3441667/ -124.1652778
Access: Road
Current Use: Recreation Rental
NRHP Status: Unevaluated

About: Snow Camp was constructed as a replacement for #4015 (Warner Ridge) in 2004. Forest Service supplied materials and volunteers provided the labor. The R-6 hipped 15' x 15' ground cab is designed to accommodate one or two overnight guests. The original cabin was destroyed in Biscuit fire (2002). New is ground cab w/ metal hip roof and catwalk

Partners: Unknown
Deferred Maintenance: \$3,526.84
Replacement Value: \$137,040.77

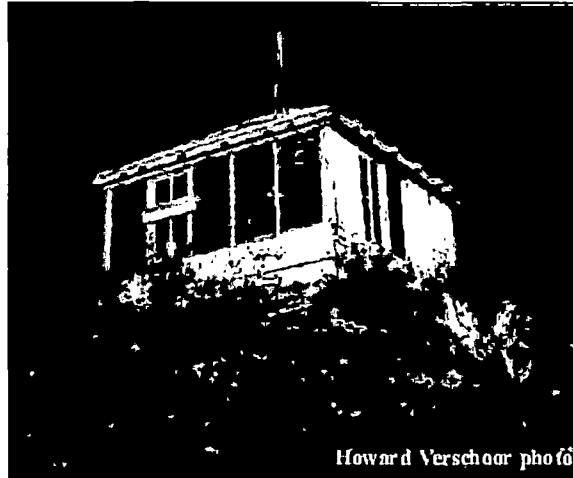
Watson Butte Lookout

Year Built: 1937
Ranger District: Diamond Lake
Lat/ Long: 43.292236/ -122.2741278
Access: Road
Current Use: Inactive
NRHP Status: Unevaluated

About: Watson Butte is an L-4 hip ground cab. The cab is in poor condition from being inactive and major hazards need to be abated.

Partners: Unknown
Deferred Maintenance: \$51,736.55
Replacement Value: \$51,736.55

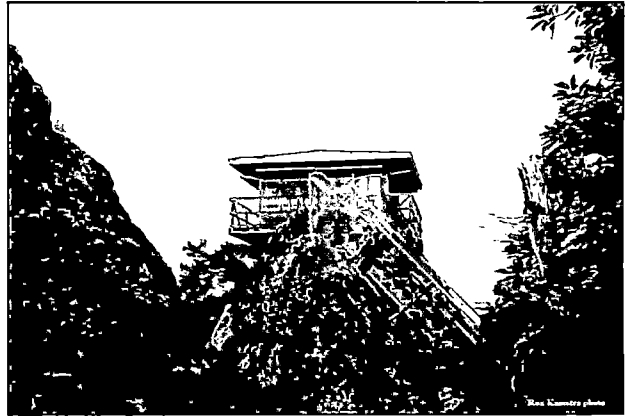
Acker Rock Lookout c.2008

Year Built: 1964
Ranger District: Tiller
Lat/ Long: 43.05196/ -122.646124
Access: Trail
Current Use: Recreation Rental
NRHP Status: Unknown

About: According to the NHLR, "Perched on a high rock formation 2000' above the valley floor, Acker Rock Lookout offers a stunning view of the mountain's northwest of Crater Lake National Park. Originally the site of an L-4 constructed in 1934, it was replaced by a R-6 flattop ground house in 1964".

Partners: Unknown
Deferred Maintenance: \$15,924.61
Replacement Value: \$95,369.06

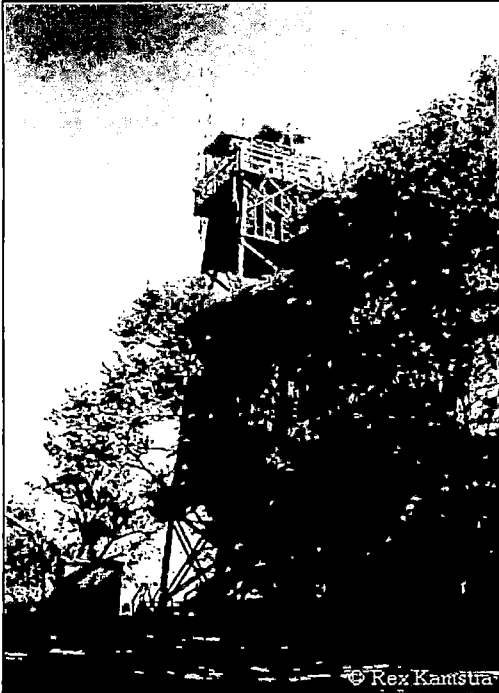
Unity Ranger Station Lookout

About: The Unity Ranger Station lookout is a 6' x 6' (likely Aermotor but could be an L-6) cab on a 60-foot treated timber tower. Located in the town of Unity, the lookout is wrapped in Christmas lights and celebrated as the town Christmas tree. Due to major hazards, the lookout is planned for decommissioning and demolition.

Partners: Town of Unity
Deferred Maintenance: \$86,142.53
Replacement Value: \$86,142.53

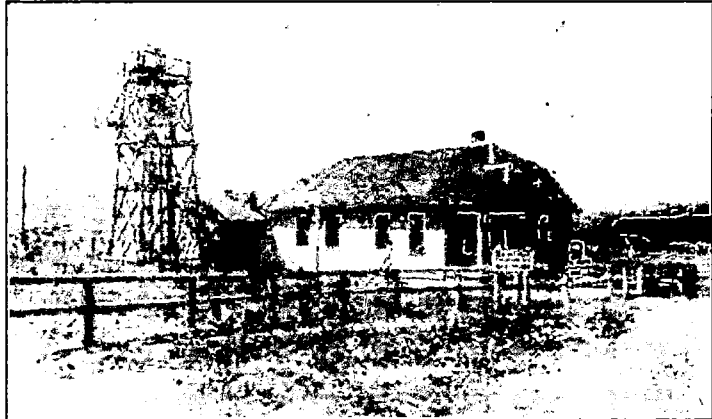
Unity Guard Station c. 1935, National Archives

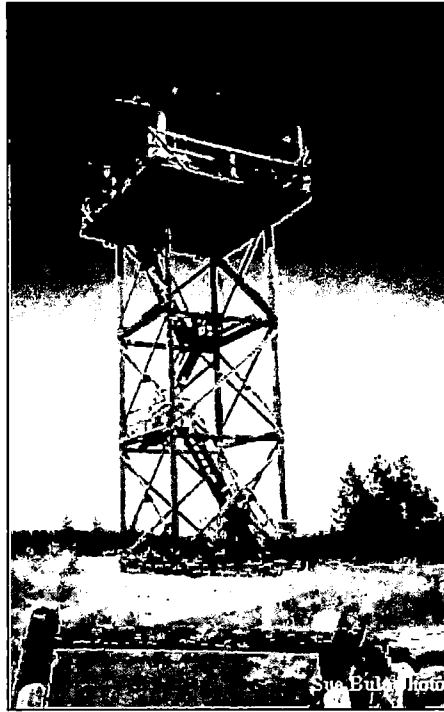
Red Hill Lookout

About: Red Hill lookout is an L-4 cab on a 40-foot treated timber tower. Major hazards need to be abated if it is to be converted into a recreation rental. According to the WWLL, Red Hill was, "developed with a pole platform and a tent in 1917, a 26' pole tower with 10x10' cab was built in 1936. The present 40' treated timber L-4 tower, built in 1947, is available for emergencies".

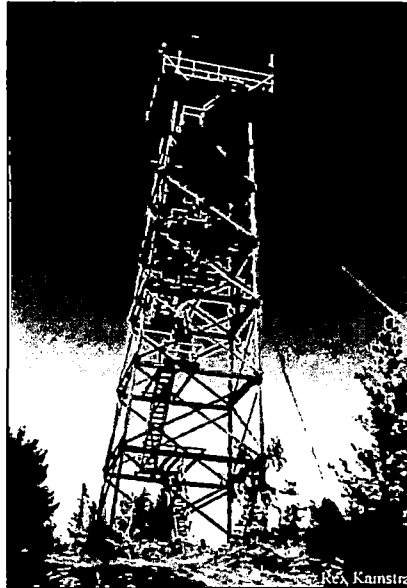
Johnson Rock Lookout

Year Built: 1952
Ranger District: La Grande
Lat/ Long: 45.1254642/ -118.4030822
Access: Road
Current Use: Fire Detection
NRHP Status: Unevaluated
About: Johnson Rock is a L-4 cab on an 82-foot treated timber tower.

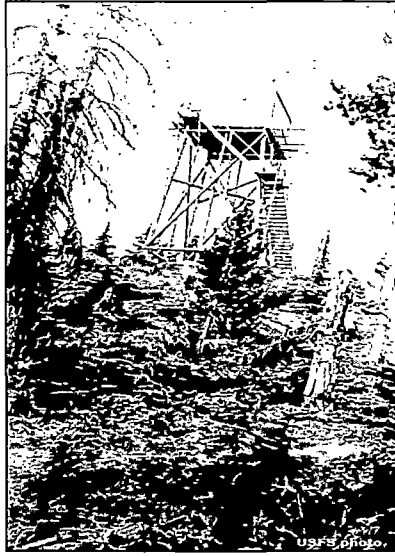
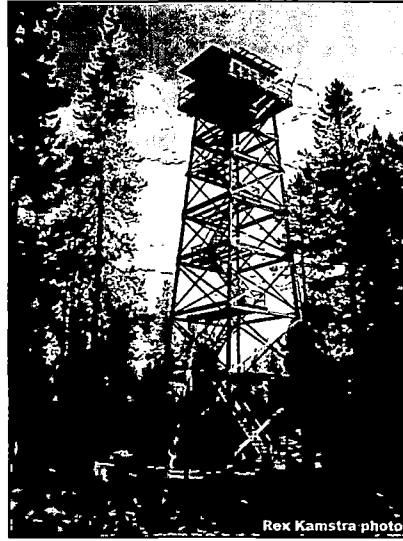
POINT PROMINENCE LOOKOUT

Point Prominence Lookout c. 1930s

Point Prominence Lookout c.2007

About: Point Prominence was originally established in 1931 with a L-4 cab on a 30-foot pole tower. It was replaced in 1954 with the current L-4 cab on an 82-foot treated timber tower. According to the FFLA, the "new cab was built 1/8 mi east of 1931 location".
