Little Boxes on the Hillside:

An Inventory and Analysis of Wildfire Lookout Structures in the
Pacific Northwest Region 06 of the United States Forest Service

Terminal Project

Prepared by Megan Berryoung

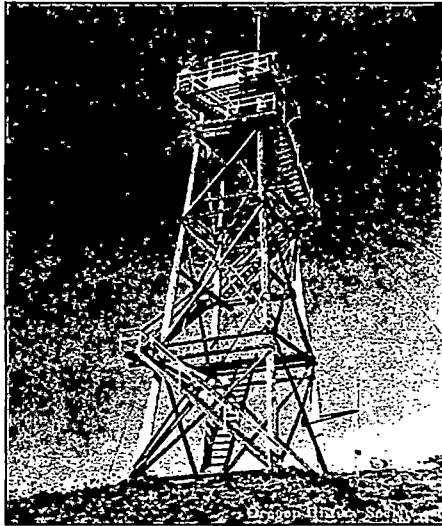
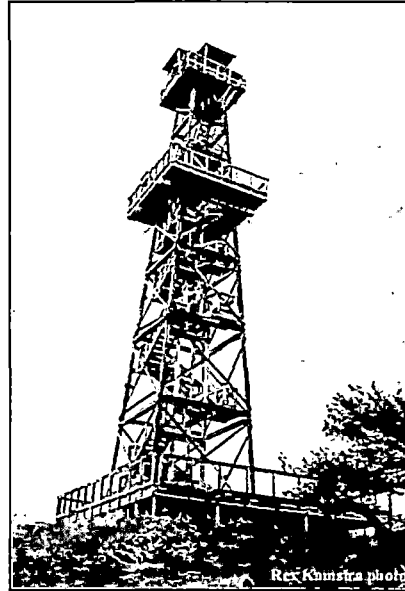
Hat Point Lookout c.2002

About: Hat Point is a 7' x 7' L-6 cab with a catwalk on an 82-foot treated timber tower with a wooden deck platform foundation. The tower was restored in the 1980's and an observation deck was added around the tower at 60-feet.

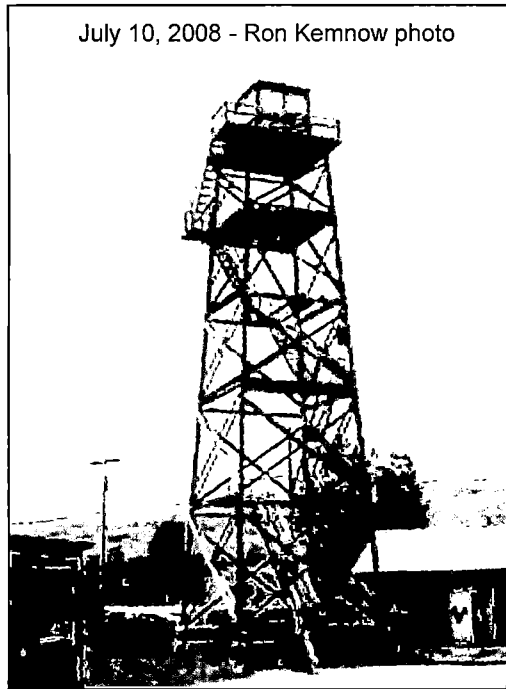
Halfway (Pine) Ranger Station Lookout c.2008

About: According to firelookout.com, "this 52' treated timber tower with 7x7' cab was built in the yard of the Pine Ranger Station in 1938". The lookout is planned for decommissioning and demolition because of major hazards.

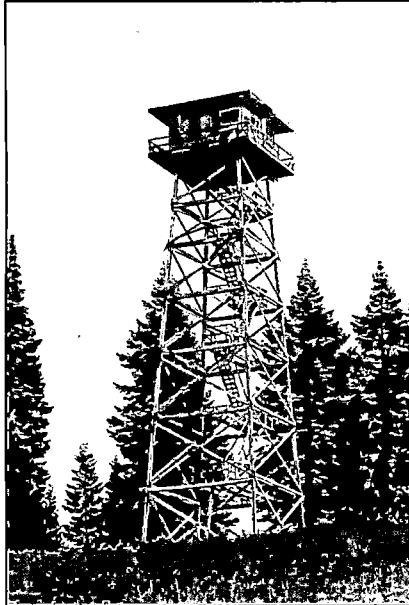
McGraw Mountain 2015. Dennis Poulin photo, peakbagger.com

About: McGraw Mountain is a R-6 cab on an 82-foot timber tower. The lookout is planned for demolition due to major hazards. Originally, the peak had a L-4 on a 10-foot pole tower in 1934.

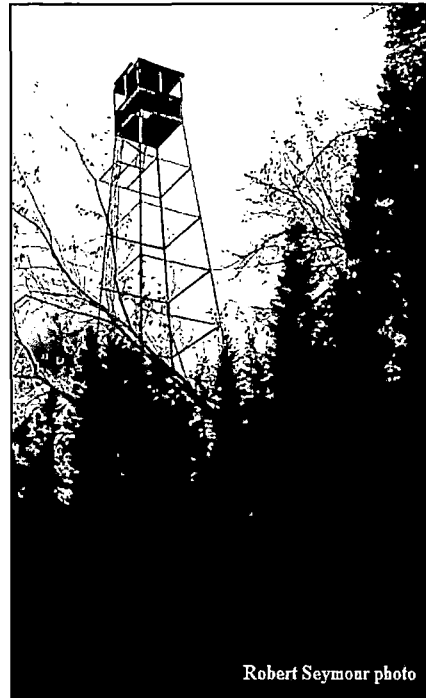
Saddleblanket Mountain Lookout
c.2007

About: Saddleblanket Mountain lookout is a 6' x 6' Aermotor lookout on a 70-foot steel braced tower. Due to major hazards and aerial coverage of the area, the lookout was abandoned and the Forest tried to sell the lookout in 1969. According to the NHLR, "the 70-foot tall Aermotor type LX-24 tower with a 7x7 cab was erected in 1927. This is the oldest lookout structure remaining on the National Forest and the only 6'x6' Aermotor constructed on the Forest". The sizes that the NHLR gives for the cab are contradictory and should be remeasured.

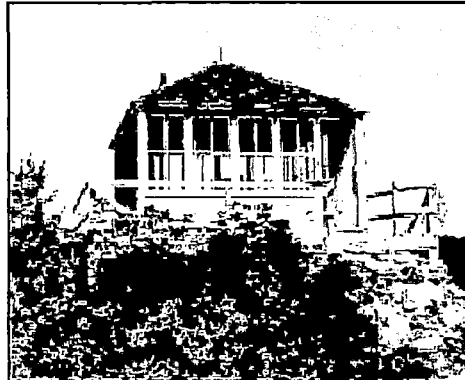
Gold Butte Lookout, NHLR

About: The Gold Butte L-4 ground cab with a catwalk was built by the CCC in 1934. Originally, the CCC built a complex at Gold Butte that included a garage and cabin that hosted the AWS during WWII--these structures are no longer standing. According to NRM, the lookout was, "renovated to historic standard by Sand Mt Society in 2006. According to the WWLL, "this L-4 ground cab, built in 1934, was last used in the 1970's. The Sand Mountain Society completely restored the structure, literally tearing the cab down to ground level and starting over due to rot and insect damage".

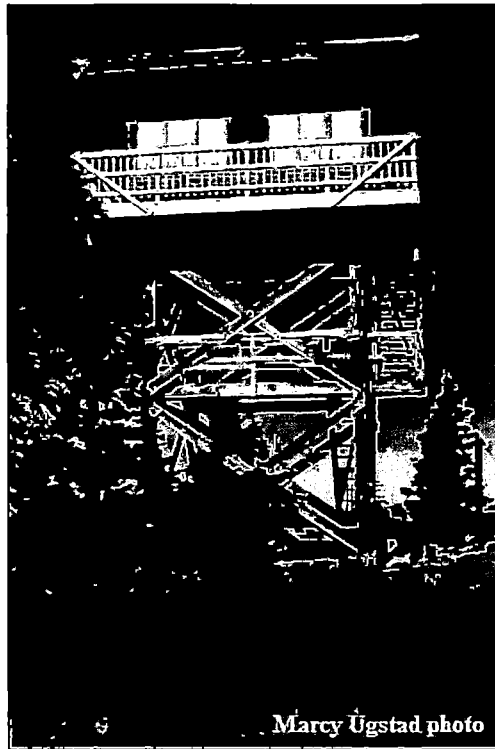
Indian Ridge Lookout c.2006

About: Originally, Indian Ridge was established with a cathedral in 1918. It was replaced with the current R-6 with a catwalk on a 20-foot treated timber tower.

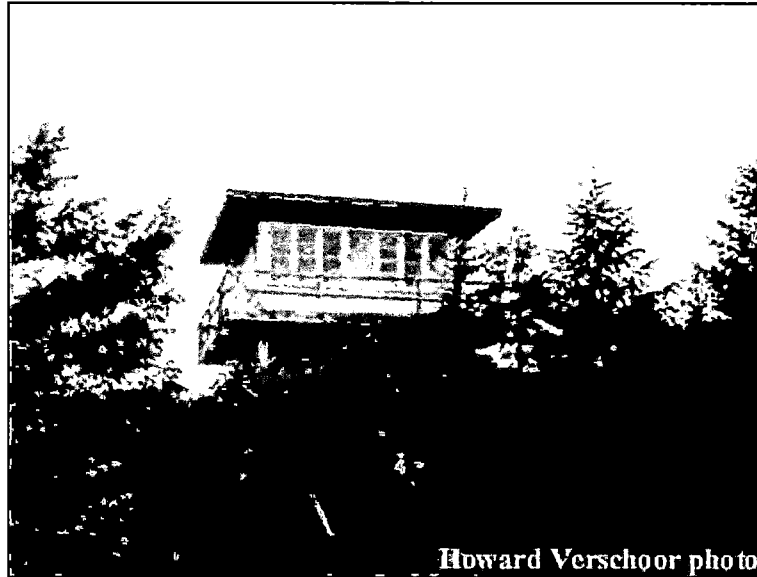
Little Cowhorn Lookout

About: Little Cowhorn lookout is a R-6 cab on a 4-foot wooden foundation. The lookout was partially restored in the 1990's and is located off a popular trail.

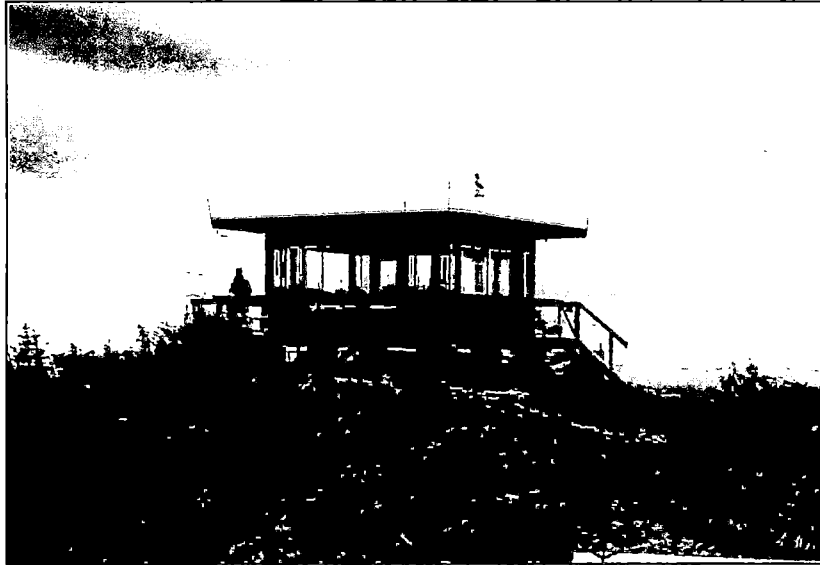
Coffin Mountain lookout 2009, Ron Kemnow photo

About: According to firelookout.com, Coffin Mountain is a, "long-time lookout site, the first structure was a cabin and platform tower built in 1906. This was replaced by a D-6 cupola cabin in 1921, followed by an L-4 cab in 1936. The present modified R-6 flat cab, built in 1984, is staffed in the summer". The lookout is located in the Middle Santiam Wilderness.

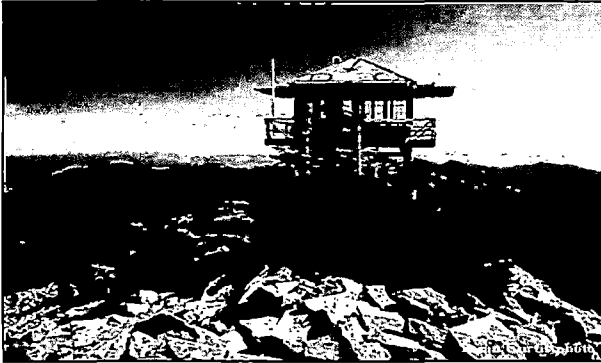
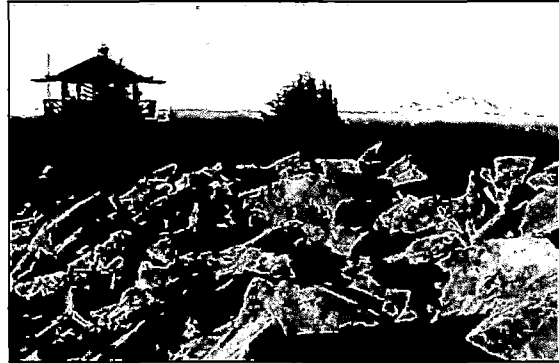
GRANITE MOUNTAIN LOOKOUT (06050500152)

Granite Mountain Lookout c.1985

Granite Mountain Lookout, NHLR USFS photo

Year Built: 1955
Ranger District: Snoqualmie
Lat/ Long: 47.417075/ -121.481106
Access: Trail
Current Use: Fire Detection (volunteers, June to September)
NRHP Status: Unevaluated
About: Granite Mountain is a L-4 hip cab on a 10-foot treated timber tower.

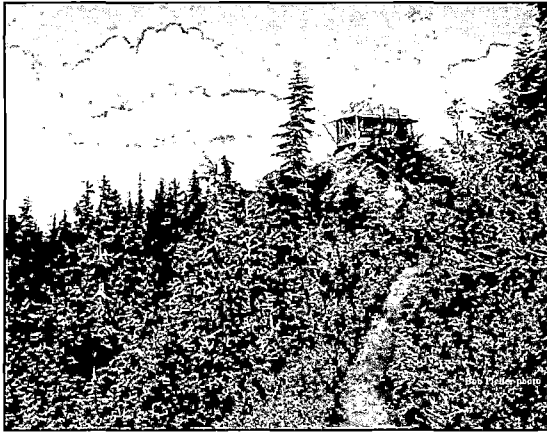
EVERGREEN MOUNTAIN LOOKOUT (06050600012)

Evergreen Mountain Lookout c.2004

About: Evergreen Mountain is a L-4 ground house on a stone foundation. The road to the lookout washed out and it is only accessible via a 7-mile trail. The AWS staffed the lookout 24/7 during WWII. Materials were airlifted to the site by the 141st Army Reserve Aviation Battalion.

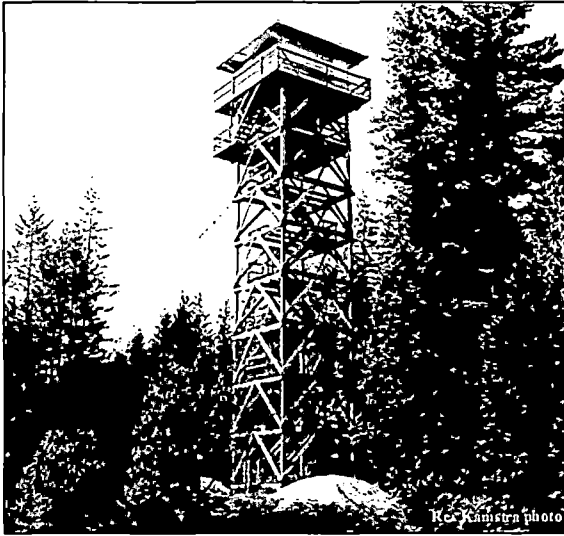
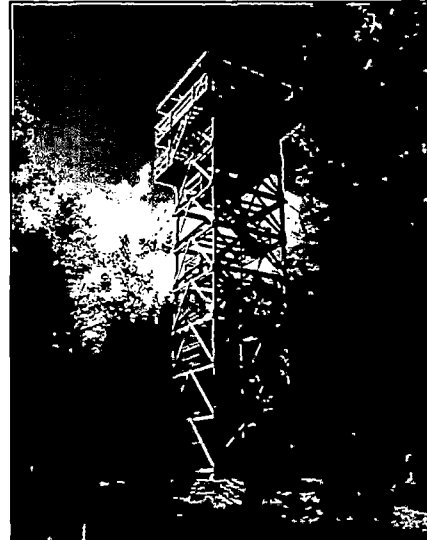
HEYBROOK LOOKOUT (06050600011)

Heybrook Lookout c.2001. Photo courtesy the Dave Bula collection and Rex Kamastra

Heybrook Lookout, Gary Weber 2009

About: According to the WWLL...” Heybrook was developed in 1925 with a platform tower, replaced by a 45' tower with L-4 cab in 1932. In 1964, the present 67' treated timber tower was built with an R-6 flat cab. Promptly abandoned in 1970, volunteers worked on constructing a new cab during the late 1990's. The lookout may be added to the Recreation Rental program in the future”.

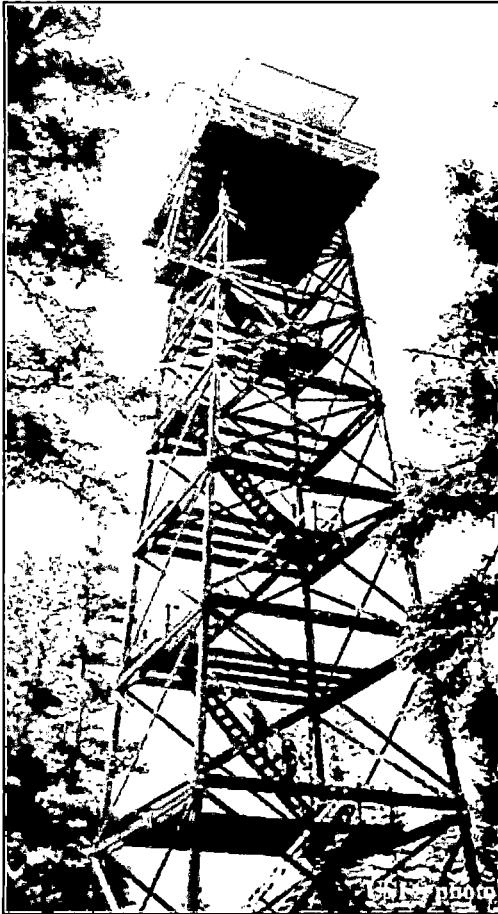
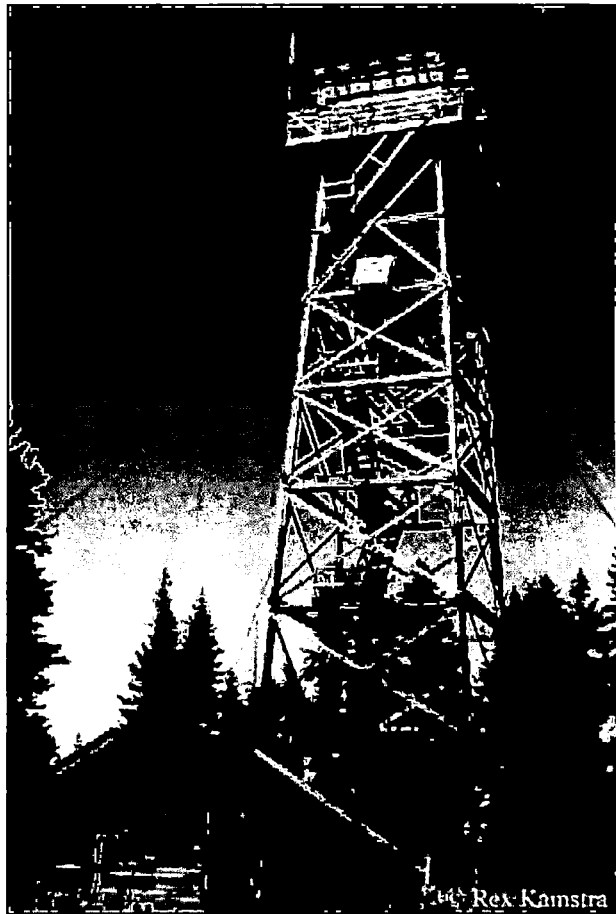
BIG BUTTE LOOKOUT

Big Butte Lookout c.1959

Big Butte Lookout, WWLL

About: Big Butte lookout is a L-4 cab on a 73-foot CT-4 pole tower. According to NRM, a tree fell on the guy wires in 2010 and caused extensive damage.

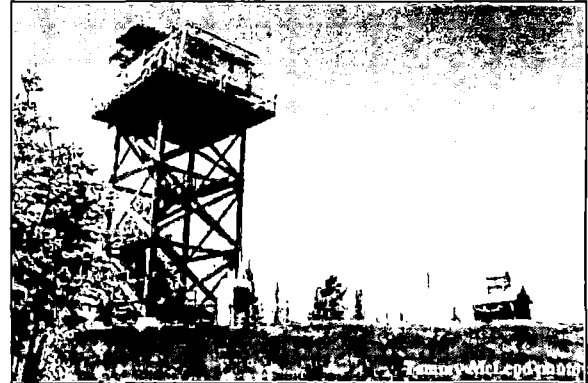
L-4 Tower in foreground with Log Cabin Cupola in background

About: Located in the Pasayten Wilderness, Monument 83 is the northernmost lookout in Washington and the Region. Originally, the point was established with a rag camp and tree platform in the 1920's. The forest built a D-1 cupola in 1930 and it was later found to be in Canada once the 49th parallel was established. The forest built the current L-4 cab and catwalk on a 30-foot treated timber tower on concrete blocks on the U.S. side of the peak.

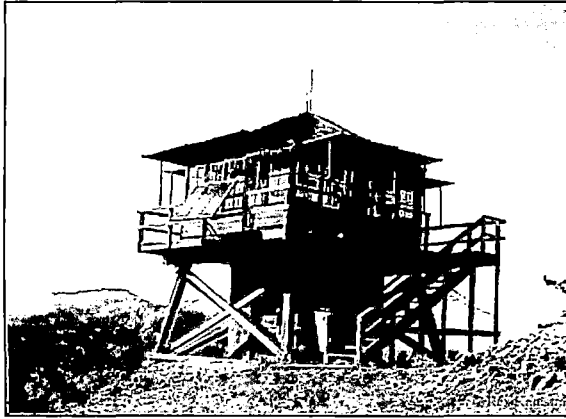
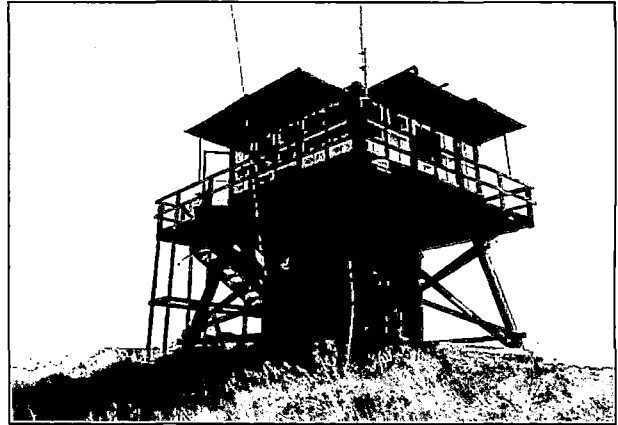
STELIKO POINT LOOKOUT

Steliko Point Lookout

Steliko Lookout c. 2009, NHLR Gary Weber

About: This L-4 cab with a catwalk is on a 10-foot treated timber tower. According to a condition assessment from 2014, the lookout is in poor condition. According to NRM, "Minimize Impact Strategy Tactics (MIST) strategically placed lookouts in the Wenatchee National Forest".

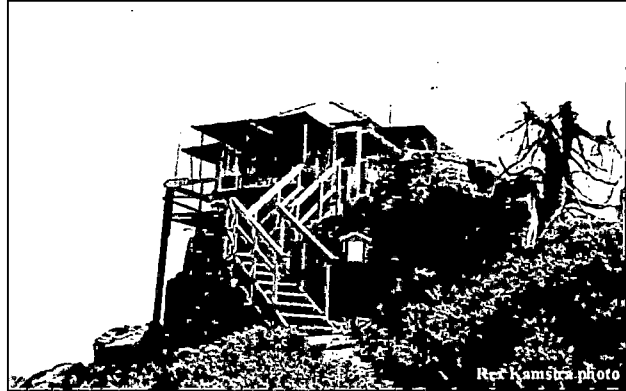
Sugarloaf Mountain Lookout c.2000

About: Sugarloaf is a L-4 cab was constructed in 1933 and moved to the site in 1949--it replaced the original cupola cabin. The outhouse and garage were destroyed in 1994 during the Tyee-Hatchery Fire. This lookout is also sometimes called, Sugarloaf Peak.

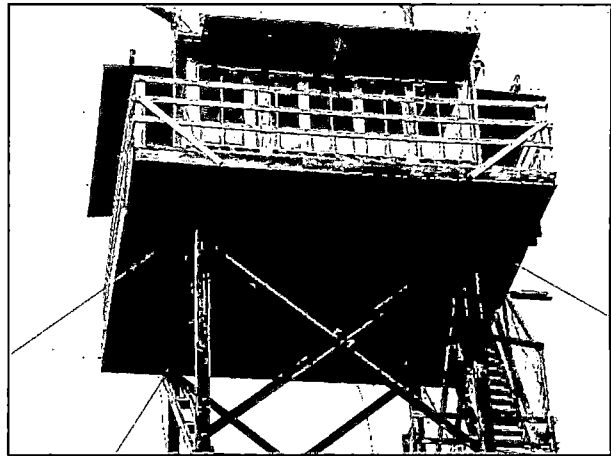
Funk Mountain Lookout cab, DAHP c.2006

About: Funk Mountain is a L-4 cab on a 40-foot treated timber tower. According to the NHLR, Funk Mountain was, "first established as a tree platform in 1914, Funk Mountain Lookout is one of the oldest in the Northwest still in existence. A ground L-5 cab was added in 1935 and replaced in 1943 by the current L-4 cab with catwalk on a 40' treated timber tower. Used sporadically for the past decade, it was returned to service by the Okanogan National Forest in 2000".

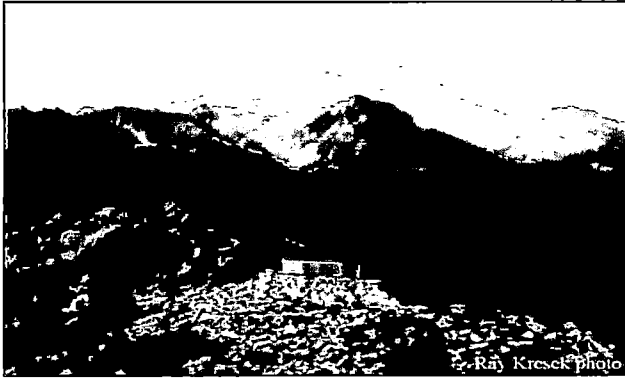
ALPINE LOOKOUT

Alpine Lookout c.1979

About: Alpine lookout is a R-6 ground cab with the recent addition of a hipped roof. Alpine was originally established in 1920 with an alidade, a crank-telephone, and a rag camp. An L-4 was placed on the peak in 1936 and was replaced with the R-6 in 1975.

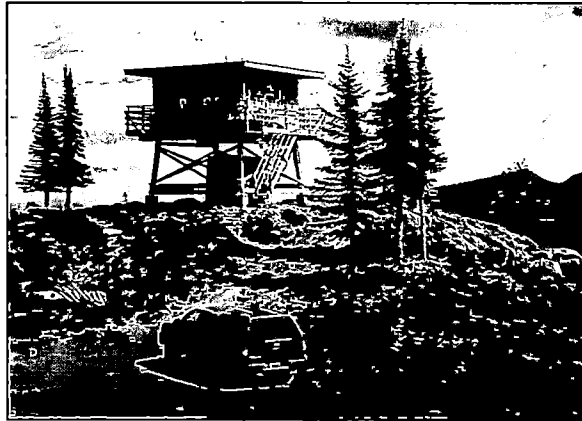
SALMO MOUNTAIN LOOKOUT (0 6210500137)

Salmo Mountain Lookout c.2018, NHLR courtesy of Nicholas Muto

Year Built: 1965
Ranger District: Sullivan
Lat/ Long: 48.96824/ -117.102908
Access: Road
Current Use: Inactive
NRHP Status: Unevaluated

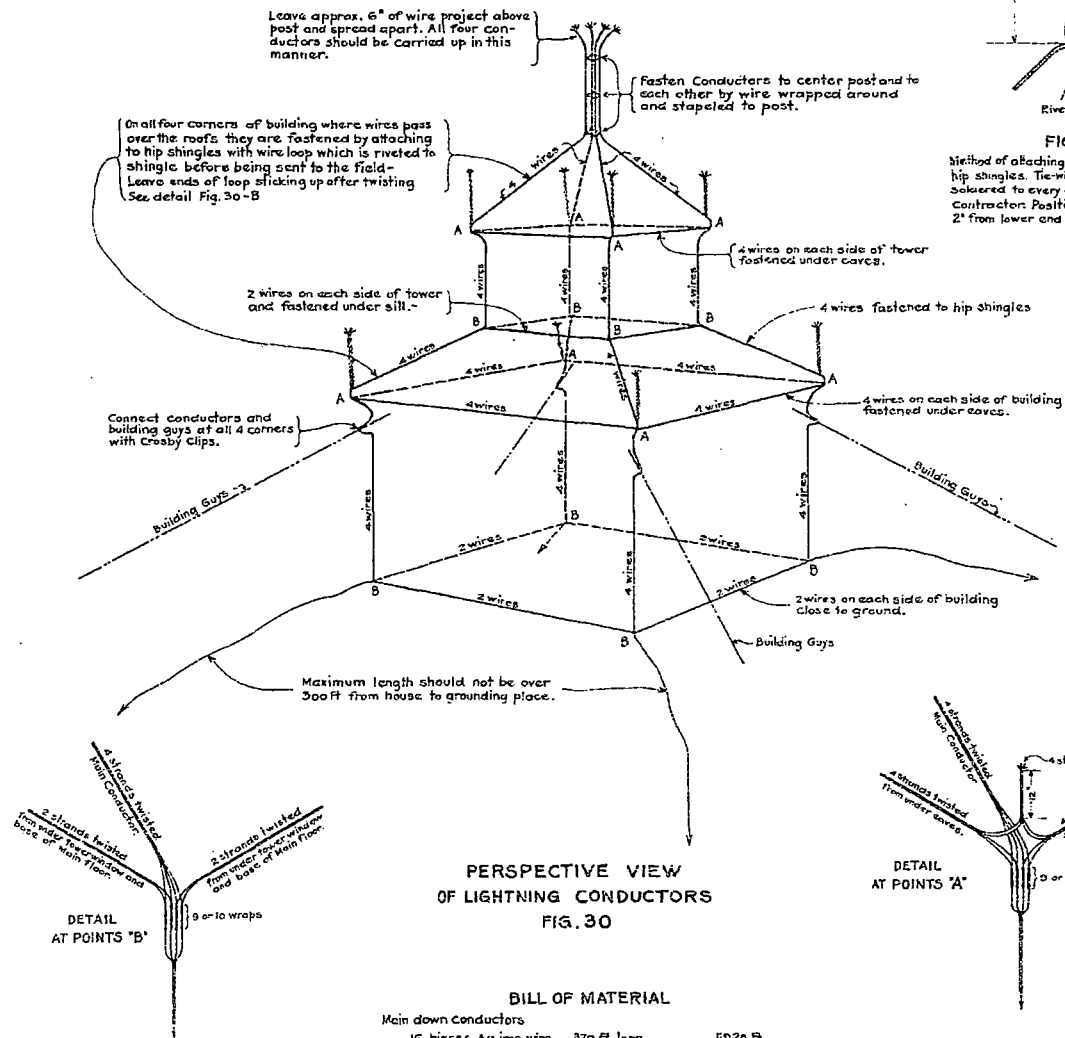
PERSPECTIVE VIEW
OF LIGHTNING CONDUCTORS
FIG. 30

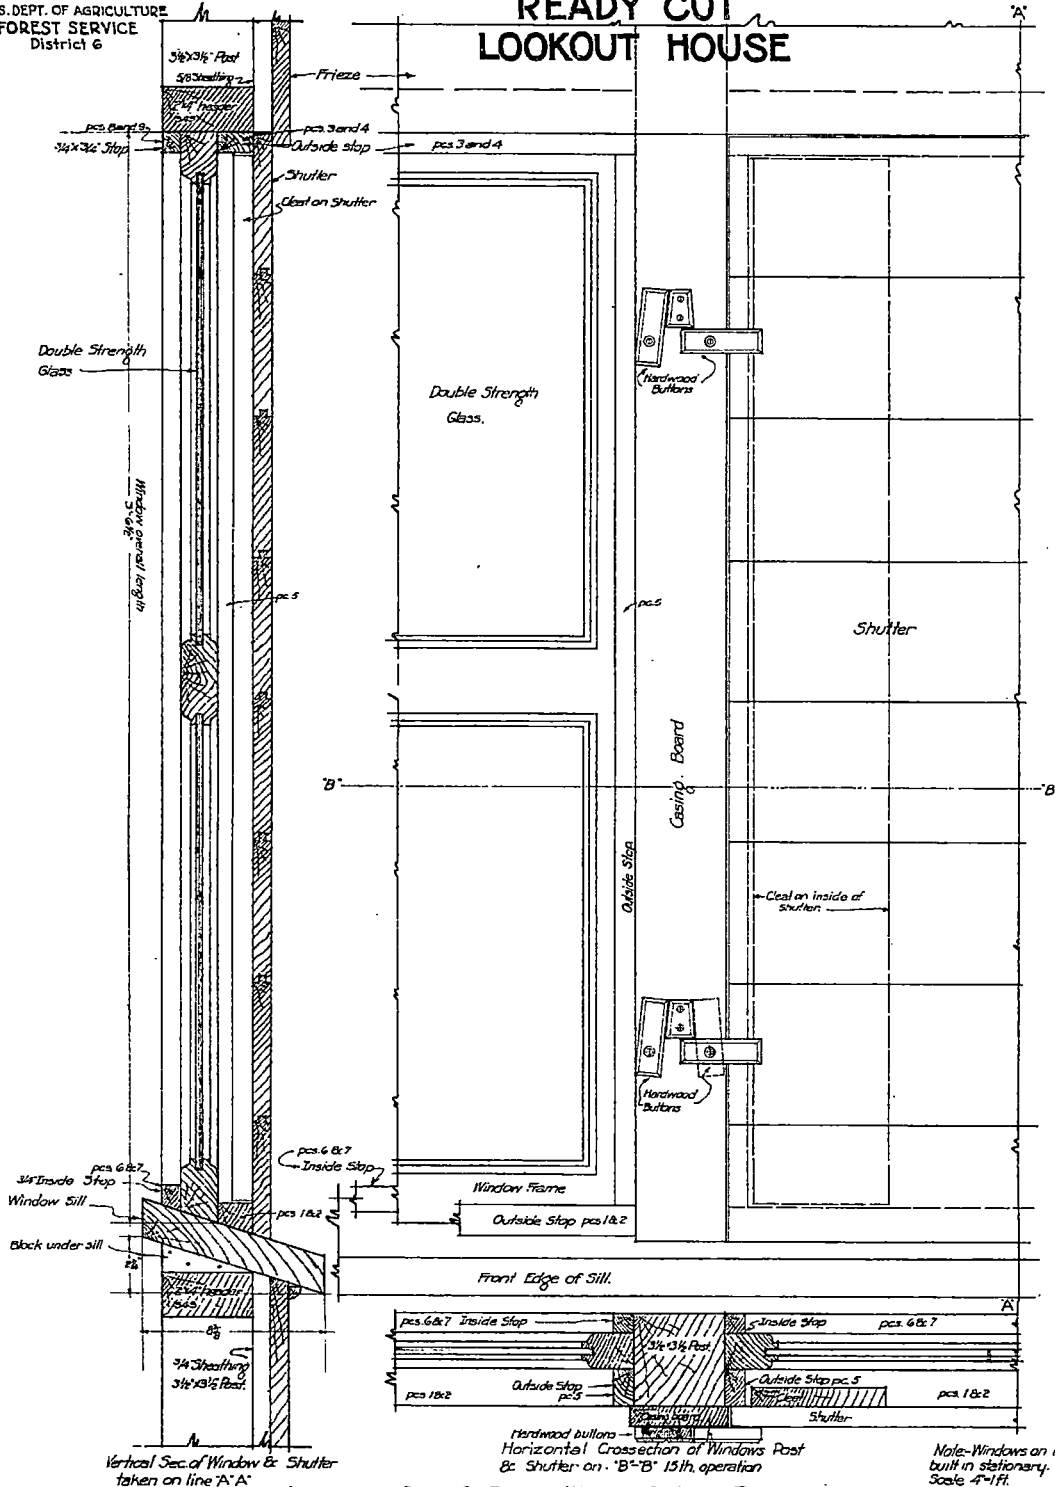
DETAIL OF FRAMING WINDOWS ON LOWER FLOOR FIG. 20a

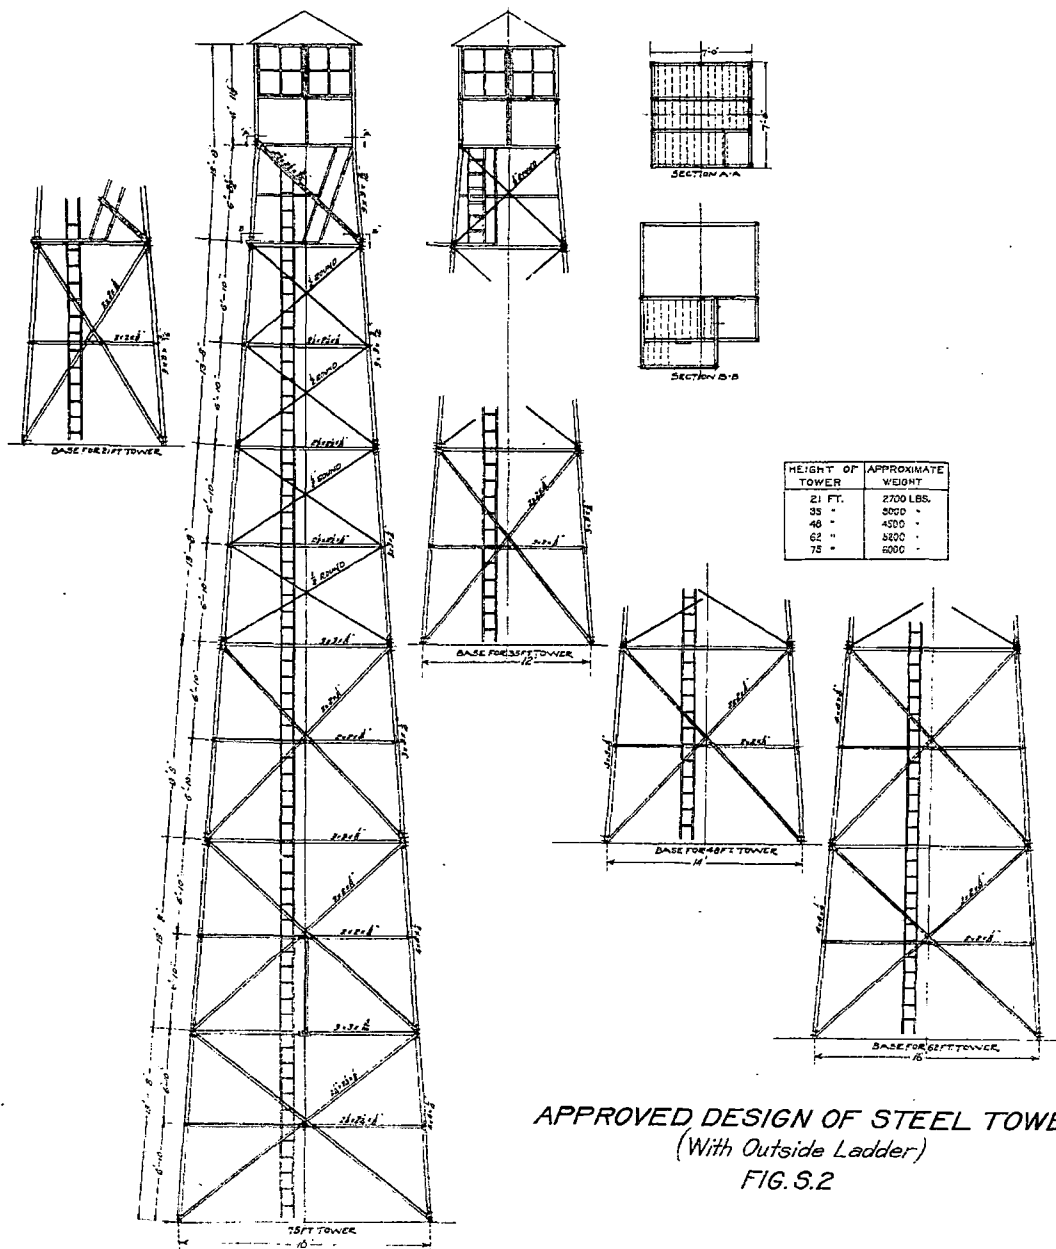
APPROVED DESIGN OF STEEL TOWER
 (With Outside Ladder)
 FIG. S.2

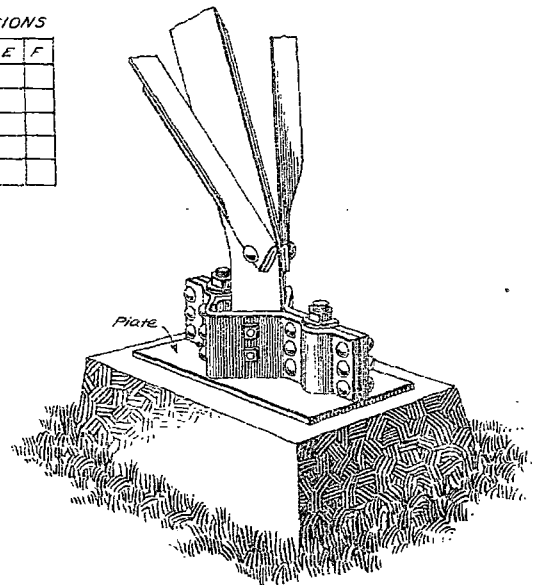
PERSPECTIVE VIEW OF FOOT OF TOWER, SHOWING METHOD OF FASTENING TOWER TO FOUNDATION

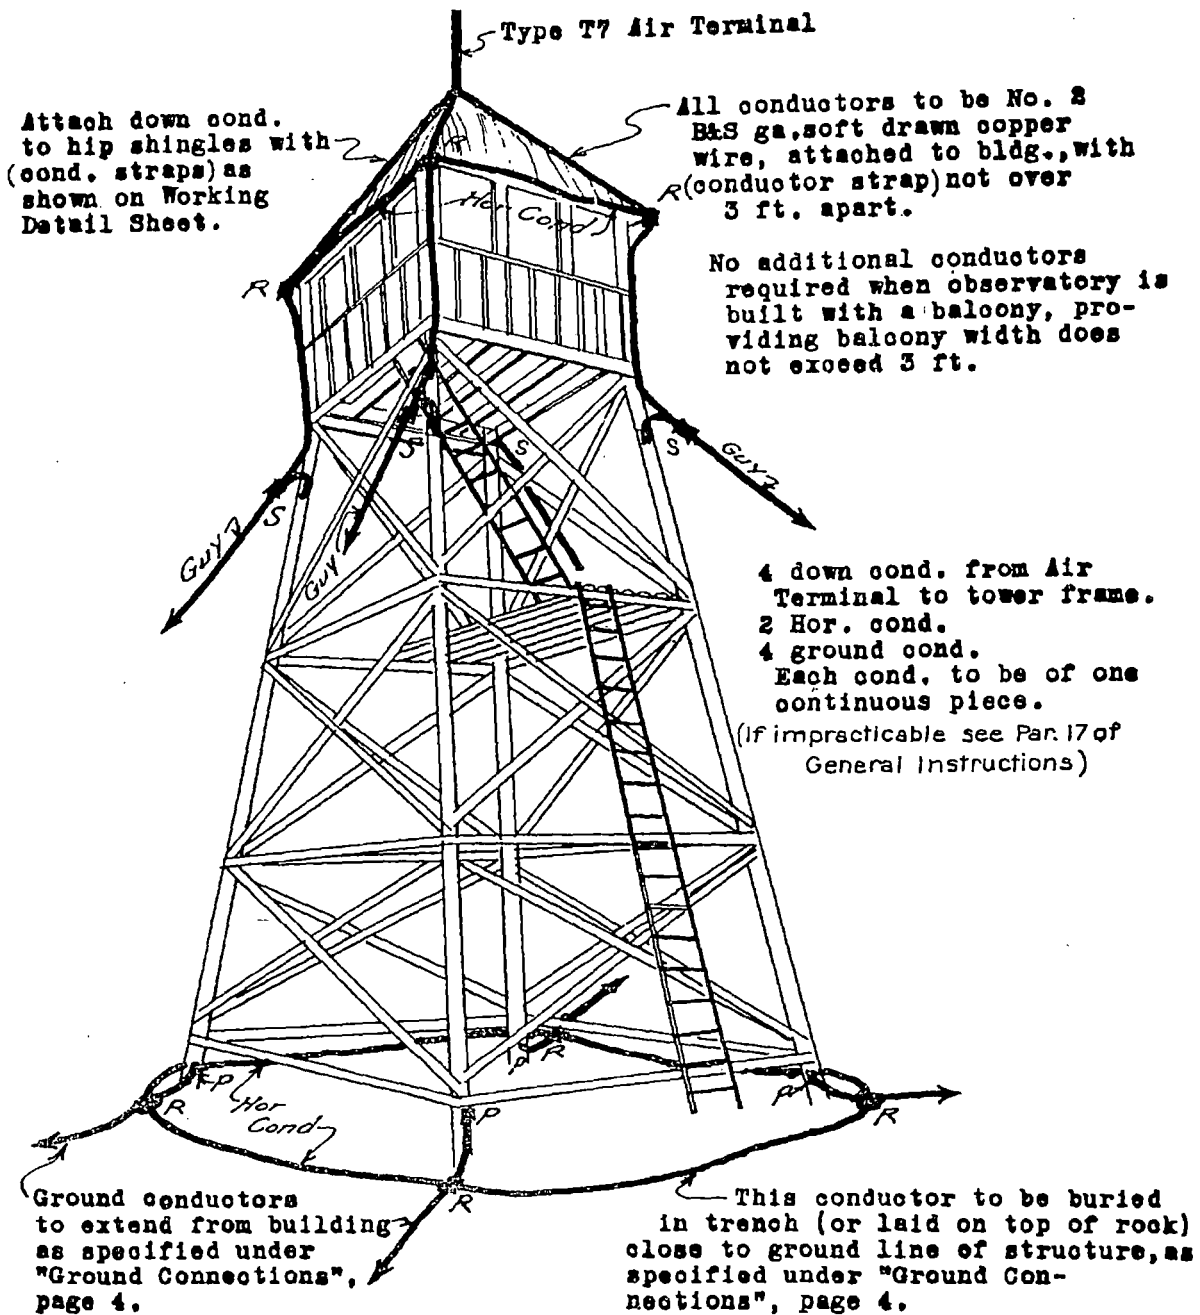
STEEL TOWERS WITH WOODEN INCLOSED OBSERVATORIES

See Working Detail Sheets for description of S, R, P, and Air Terminal connections, T7.

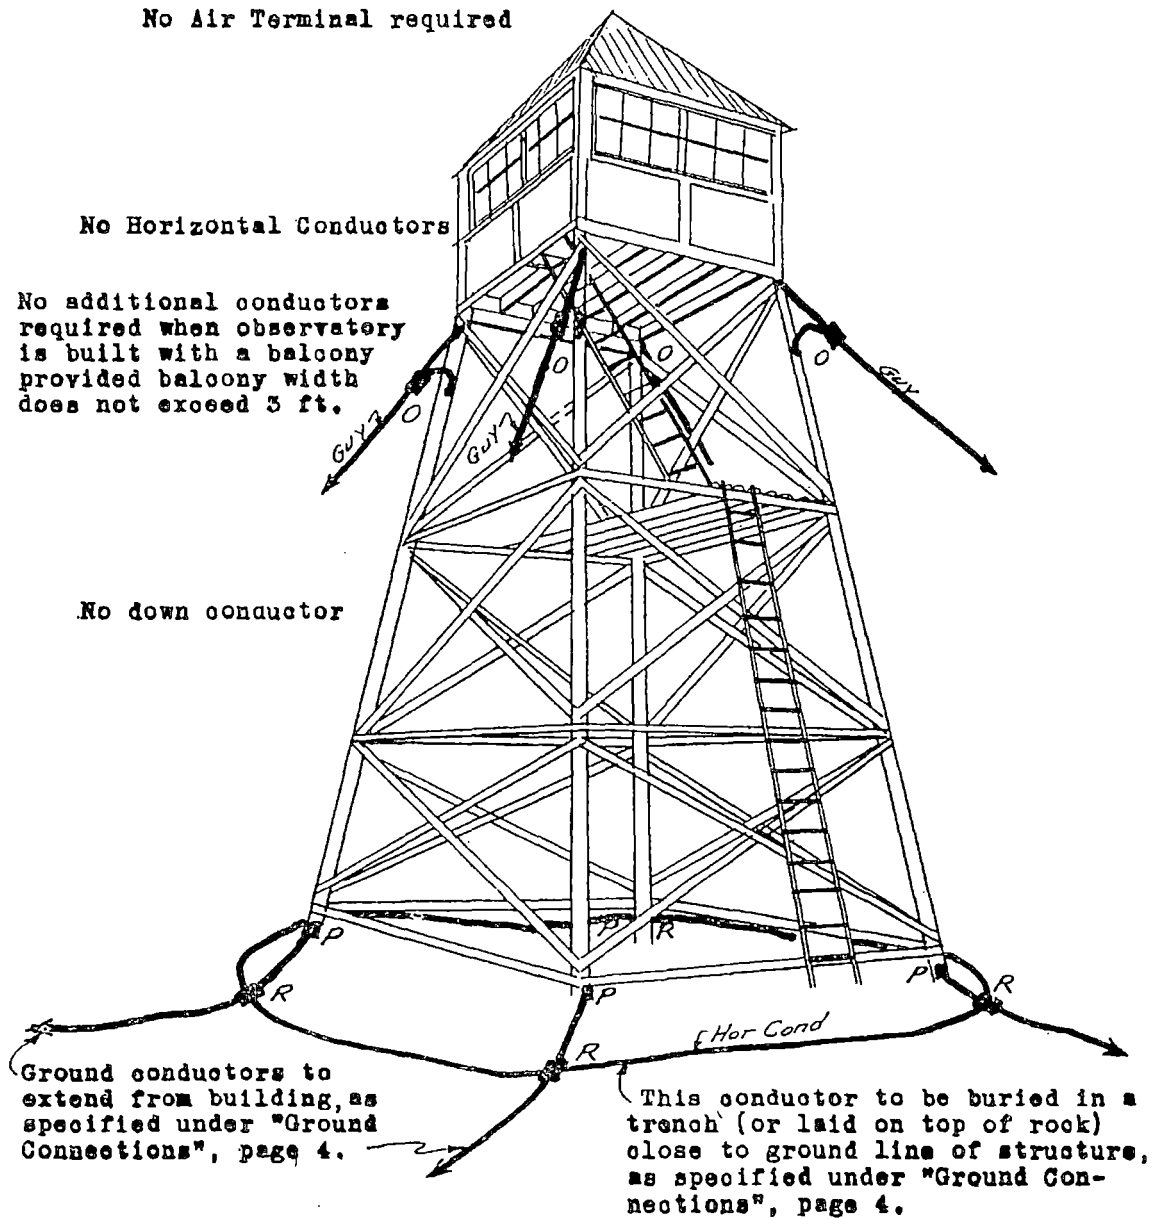
See Working Detail Sheets for description of connections R, O, P.

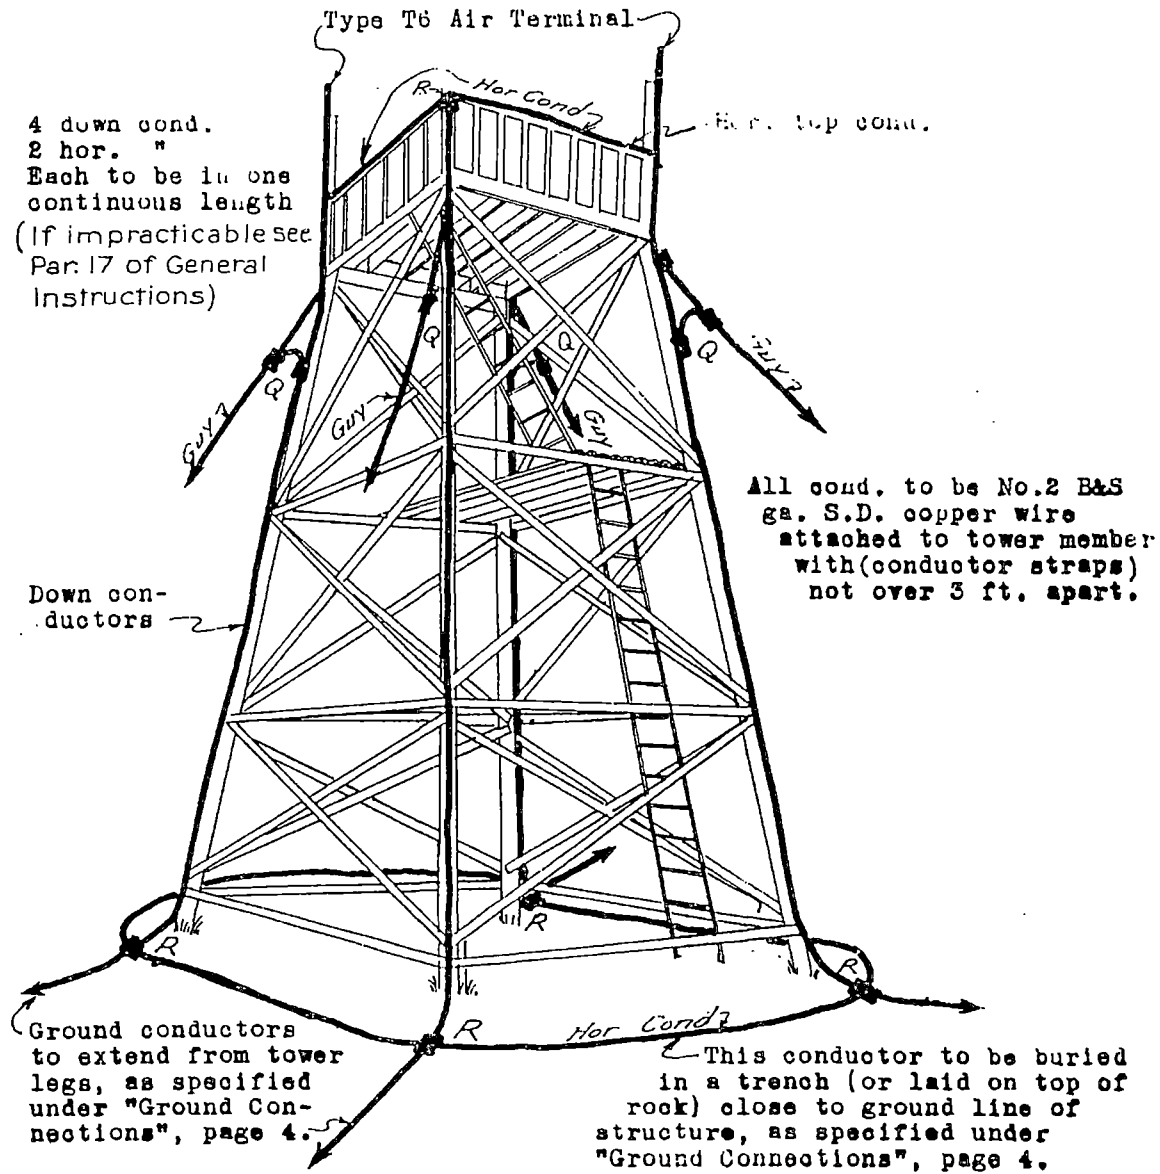
PROTECTION AGAINST LIGHTNING
 WOOD TOWERS WITHOUT INCLUDED OBSERVATORIES

See Working Detail Sheets for description of connections
 at R, Q, and Air Terminals, T6.

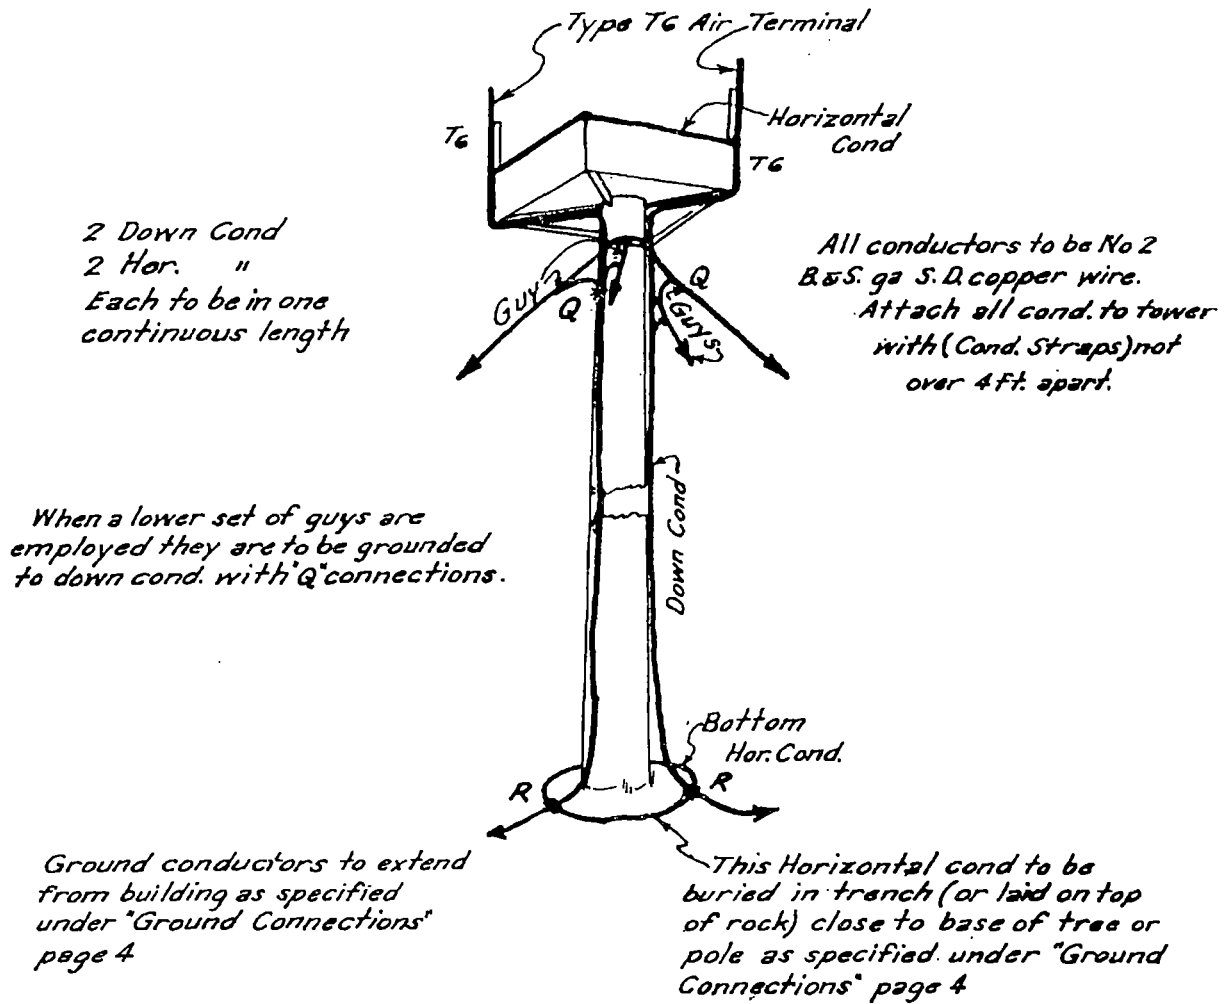
Pole or Tree Towers Without Inclosed Observatories

See Working Detail Sheets for description of connection at Q- R, and at Air Terminals. T-6
