HISTORY AND PRESERVATION OF STAINED GLASS IN  
THE PACIFIC NORTHWEST: THE POVEY BROS.  
GLASS CO. OF PORTLAND, OREGON

A THESIS

Presented to the Interdisciplinary Studies Program: Historic Preservation  
and the Graduate School of the University of Oregon  
in partial fulfillment of the requirements  
for the degree of  
Master of Science

December 1999

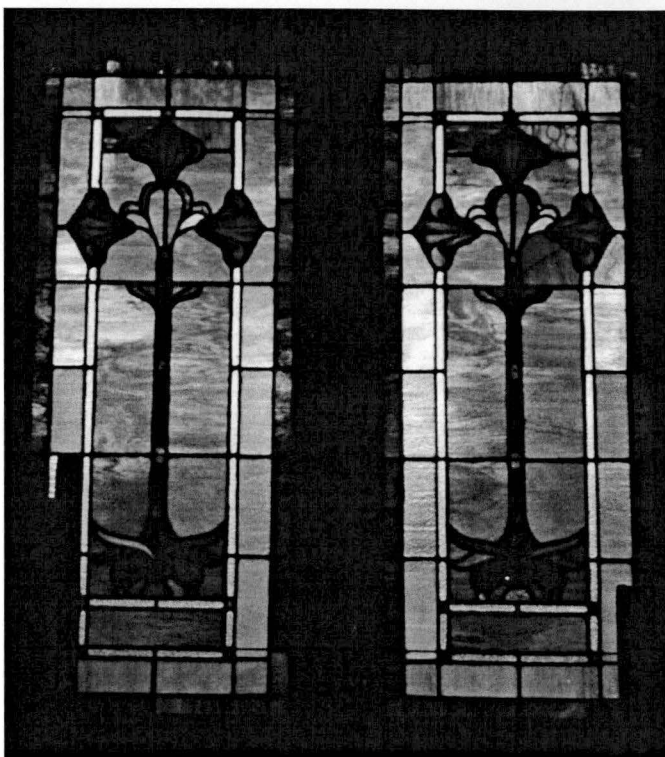
Figure 2. This window, designed by Povey Bros. for the United Presbyterian Church in Albany, Oregon, is made almost entirely of milky, opalescent glass.

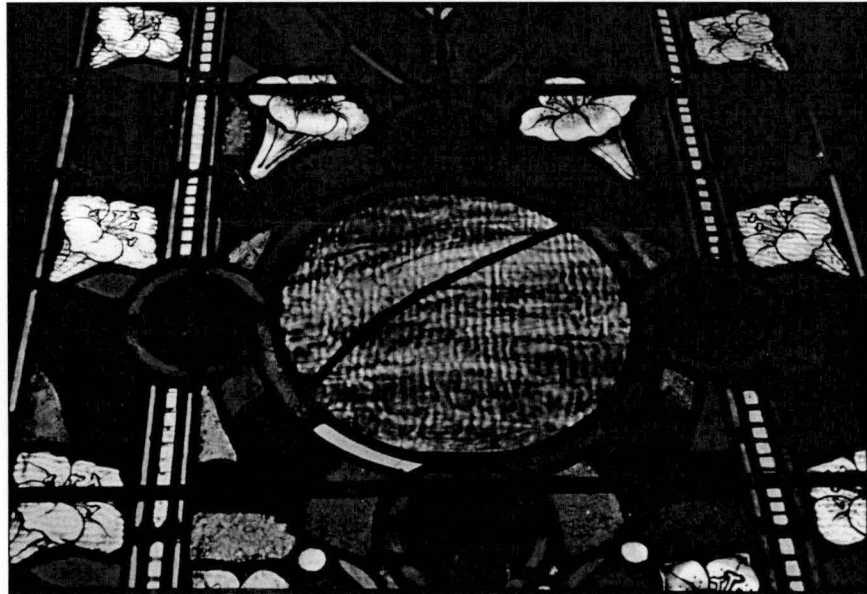
Figure 22. A possible use of the mended effect at the Old Church in Portland.

Polly Povey Thompson (ca. 1980s) reported that her father sometimes used a “mended effect” in certain windows. This effect involved designing intentional mends into a window to give it an antique look. Although it is difficult to tell an intentional mend from a later repair of an actual break, the panel of “Consider the Lilies” seen at the Old Church in Portland appears to make use of the mended effect, with a diagonal came line passing through a large blue circle of glass (Figure 22).

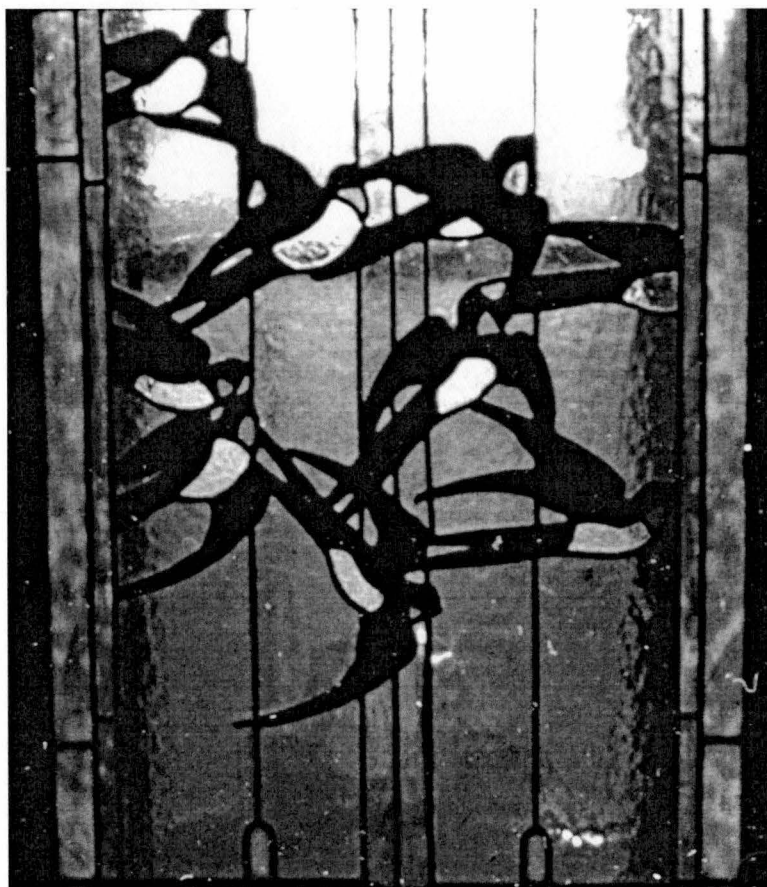
Figure 37. Sheet metal birds applied to glass (Polly Povey Thompson Collection).

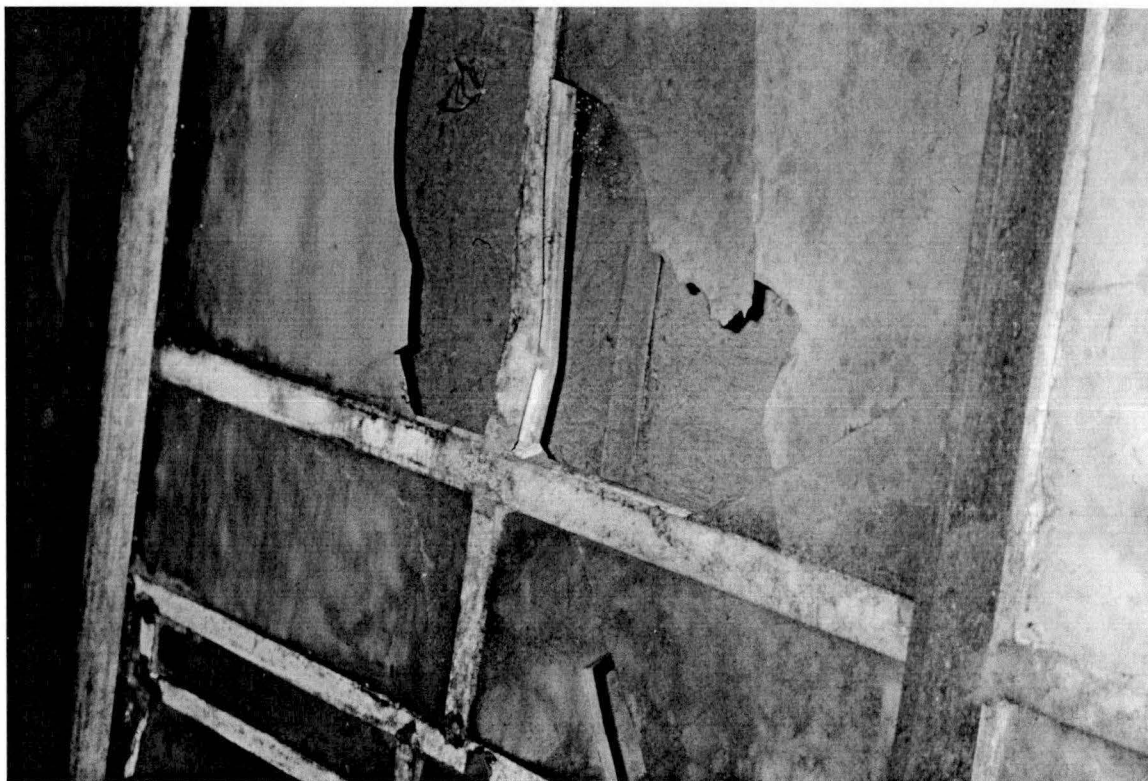
Figure 42. These Povey windows were removed from Johnson Hall at the University of Oregon and stored, unboxed, in a leaky warehouse for many years.

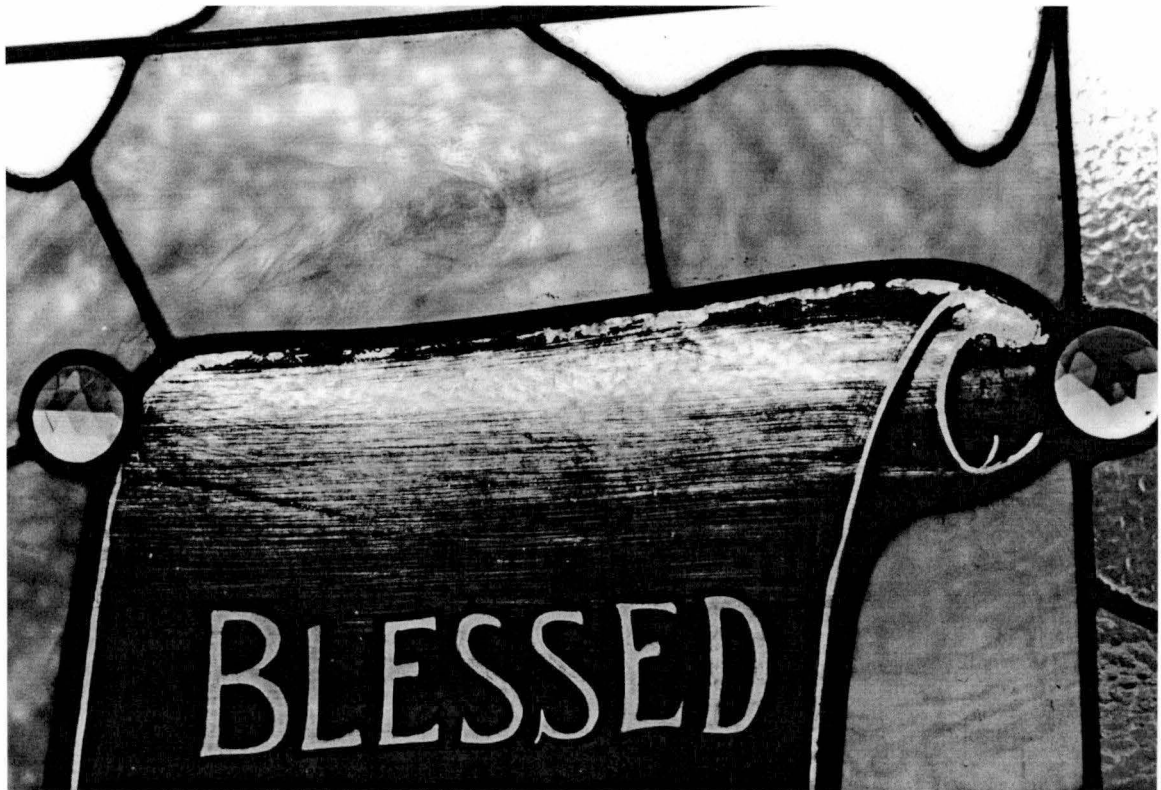
Figure 58. Damaged paint is visible along the top of this scroll in one of the 1897 windows.

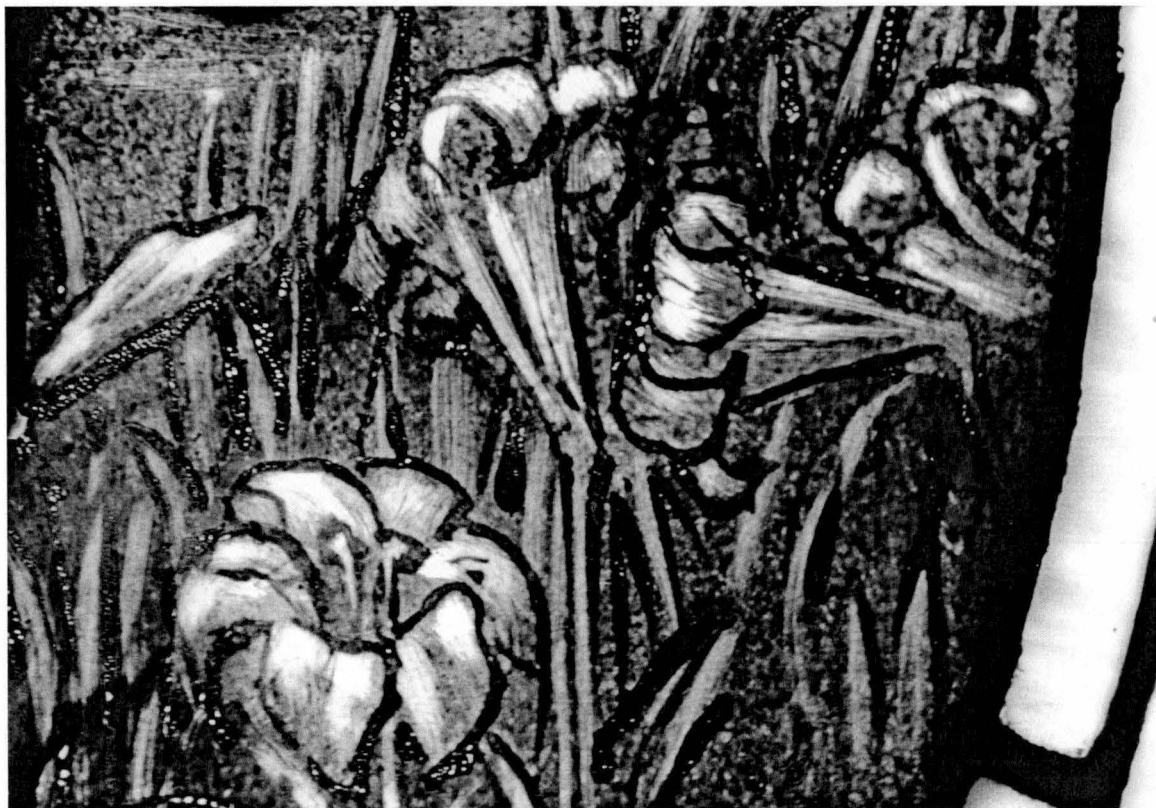
Figure 59. Frying can be seen in the trace lines which frame these lilies.

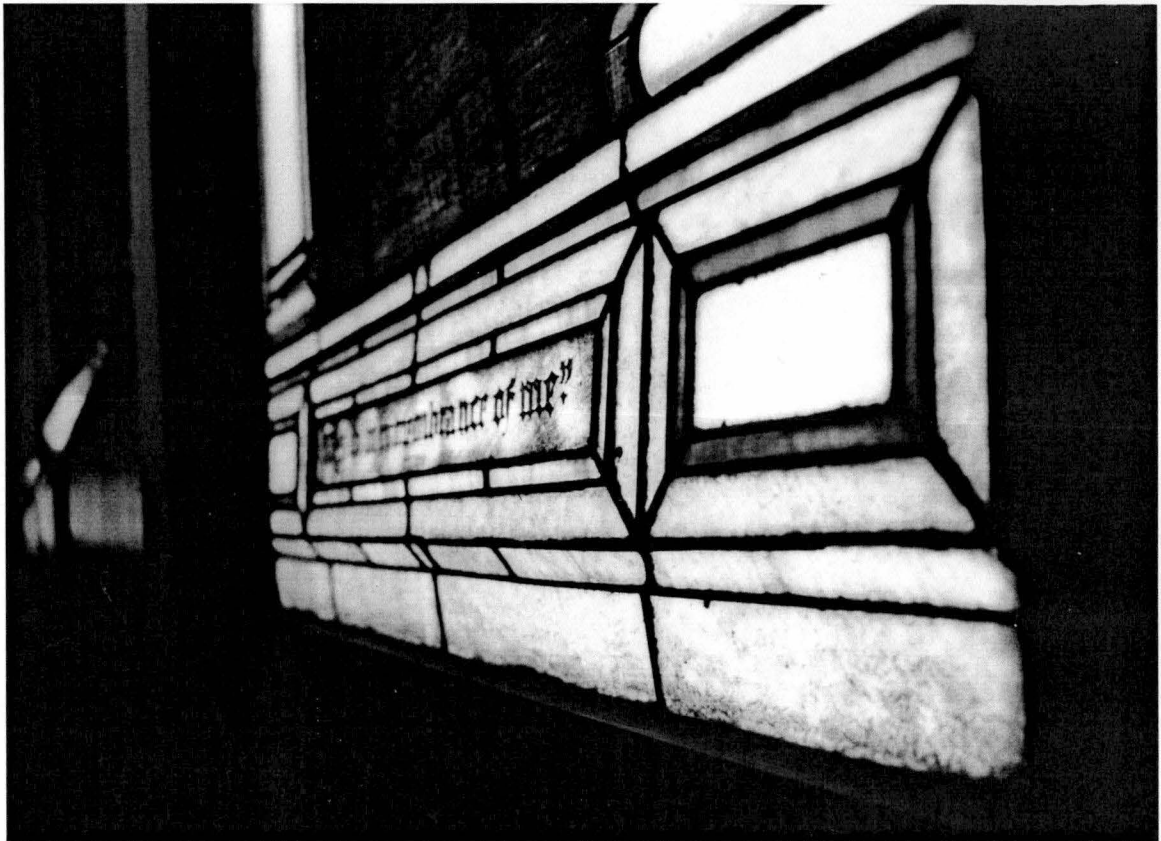
Figure 61. The nameplate in this sanctuary window is clearly bowing out of plane.

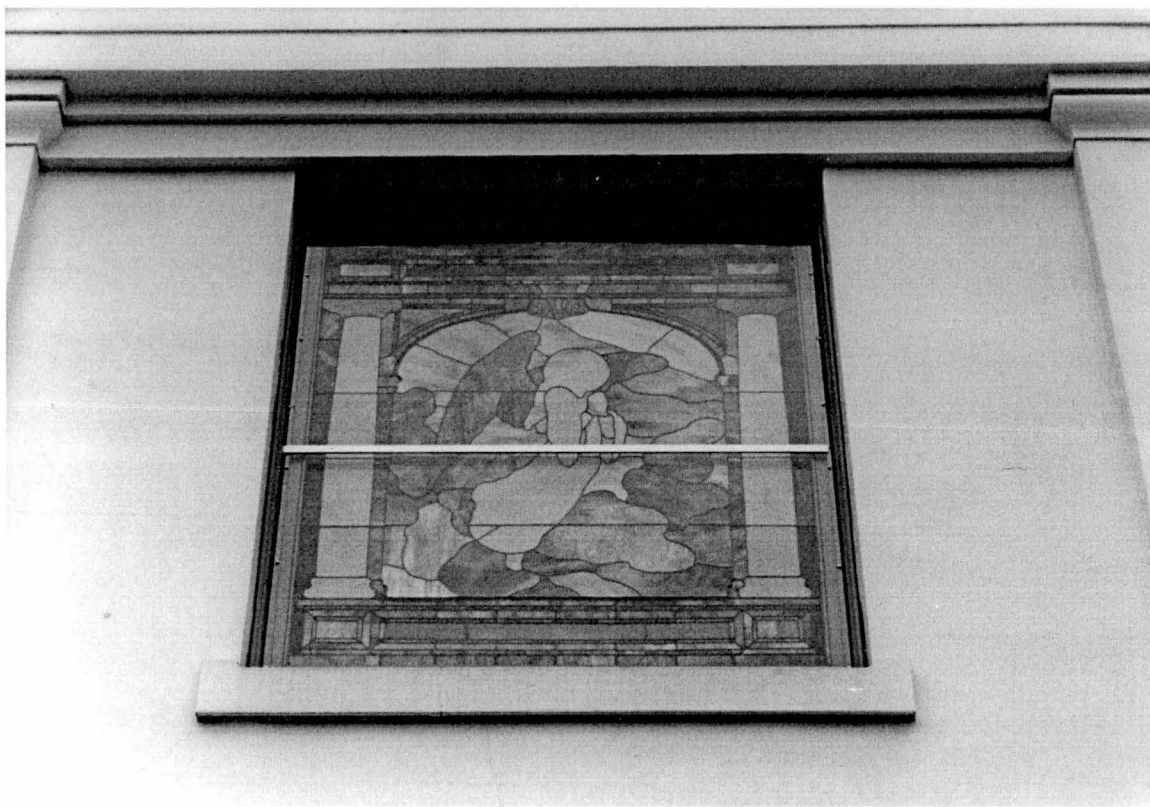
Figure 64. Protective glazing covers the sanctuary windows on the exterior.

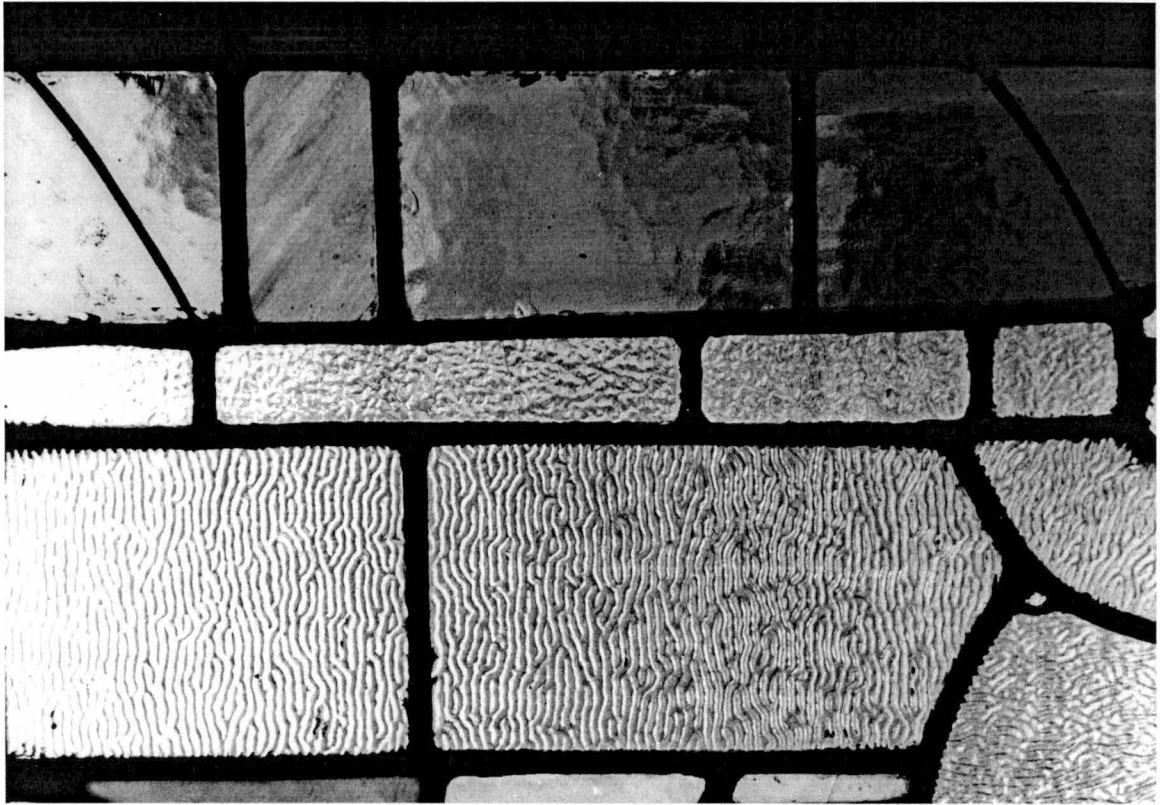
Figure 66. Old repairs are visible along the top of this window.
