LANDSCAPE RESOURCE SURVEY
 University of Oregon Campus Heritage Landscape Plan
 Eugene, Lane County, Oregon • Spring 2007

Gerlinger Entrance Green (w)

Landscape Resource Survey
GERLINGER ENTRANCE GREEN

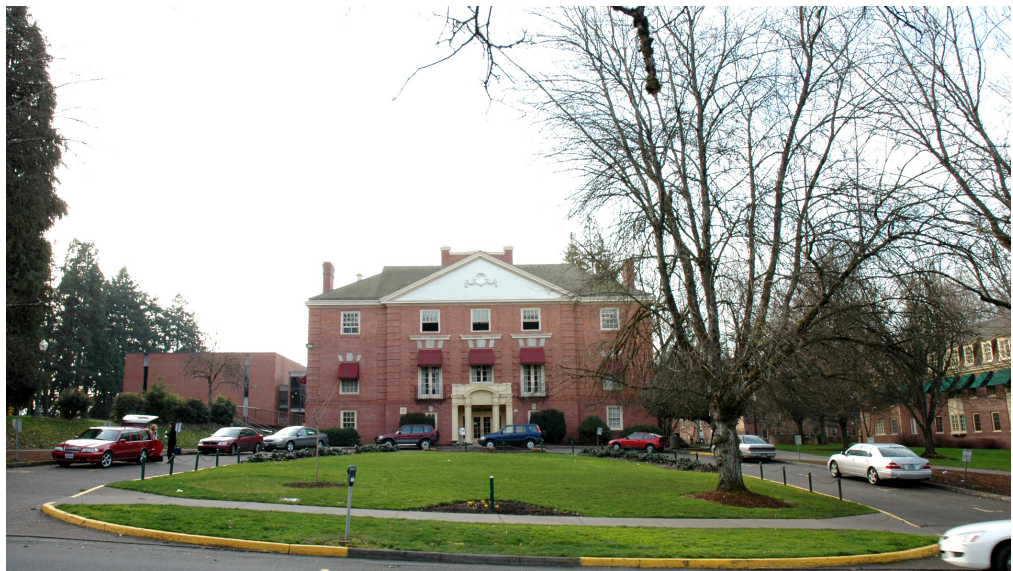
View looking west at Gerlinger Hall.

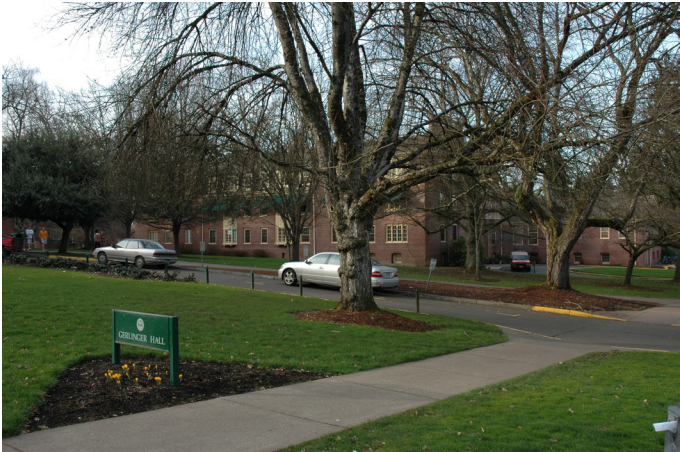
Northwest view across the Green and towards Hendricks Hall.

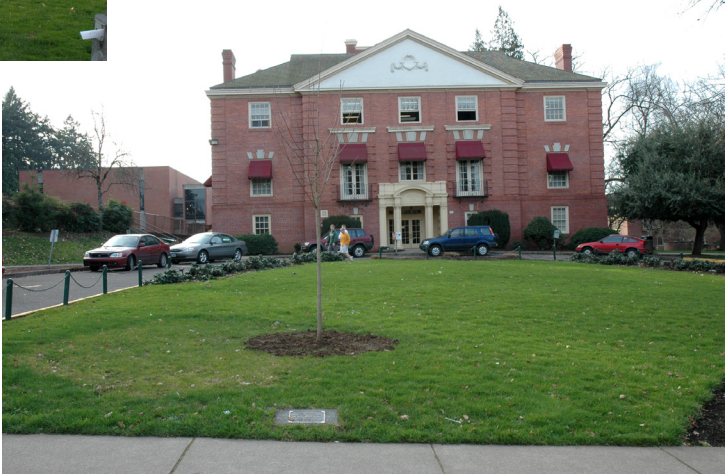
View west from University Street towards Gerlinger Hall.

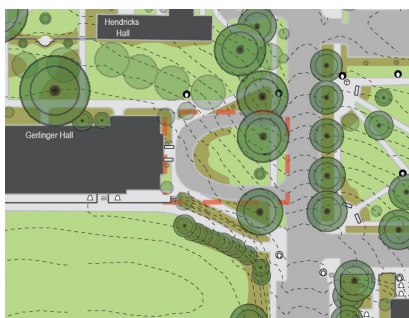
The Gerlinger Green is on a plane that slopes uniformly to the northeast (see diagram below). It has unobstructed southern exposure and high solar access.

The area's topography.

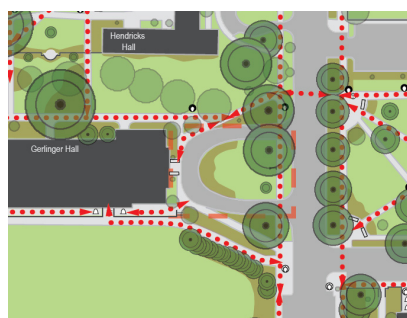
Diagram showing circulation paths.

The University Street sidewalk along the east edge of the Green is an important north-south connector on campus (see diagram, pg.6). The Knight Library Axis provides an east-west pedestrian corridor. There is no circulation across the interior of the turnaround area, effectively discouraged by a knee-high chain link fence along the western edge.
