DAMASCUS NATURAL FEATURES INVENTORY

NATURAL HAZARDS REPORT

July, 2007

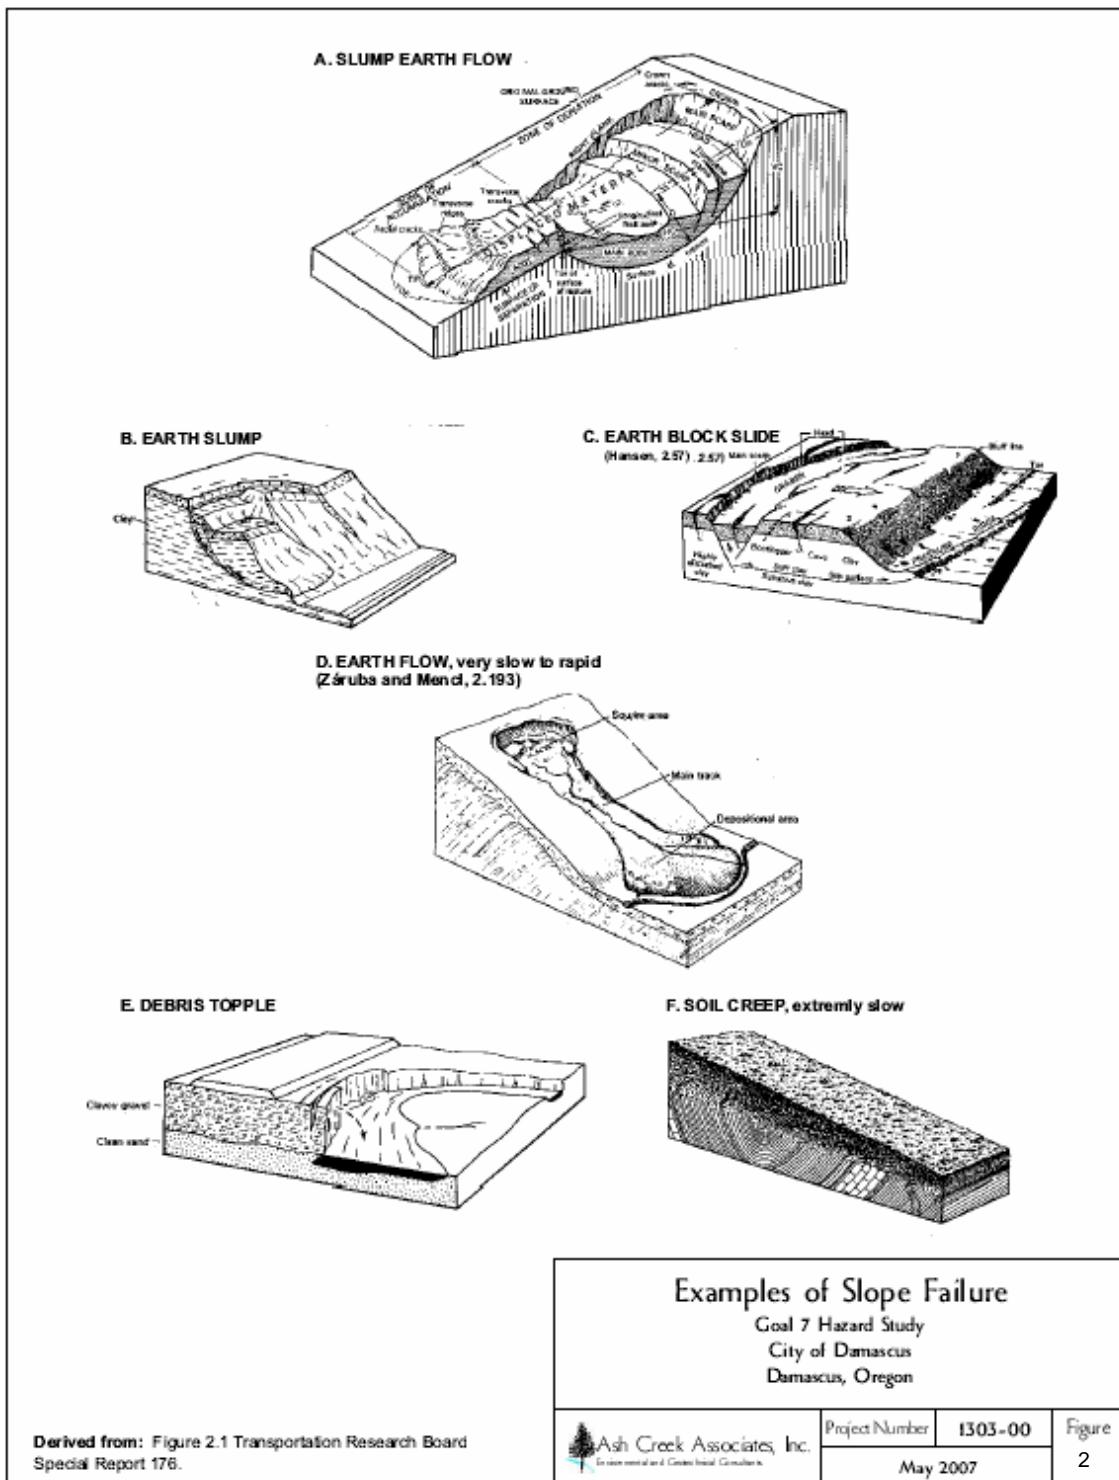
Figure 2. Examples of Slope Failure.

Schuster and Krizek, 1978; and Turner and Schuster, 1996) provides examples of slope movements that might be found in the study area. In subsequent discussions, the project team may refer to particular features by Figure 2A, 2B, etc. While in the field the project team's observations included, but were not limited to:

- Sharp breaks in slope can be uppermost scarps of over steepened ground formed when a block of soil breaks loose and slumps downward (Figure 2A, 2B, 2C, 2D). The scarps are generally parallel to the contours, are usually arc-shaped, and are higher near the center of the arc and feathering out toward the sides.

- Cracks and bulges running downslope (perpendicular to the contours) can be shear zones at the slide margins (Figure 2A, 2B, 2C). Often surface water encounters “sag ponds” or flattened slope areas, and flows parallel to the scarp, turning downslope and following the shear zone (Figures 2A, 2B).

- Pavement and curb cracks, fence misalignment, and other surface feature indicators can reflect ground movement from soil creep (Figure 2F). In forested areas, very slow and minor movements can be totally obliterated by topsoil, sod, brush, etc., whereas rigid structures such as curbs, pavement, retaining walls, etc., or those in visual alignment, can reflect very small movements (such as the undulating roadbed pictured here).

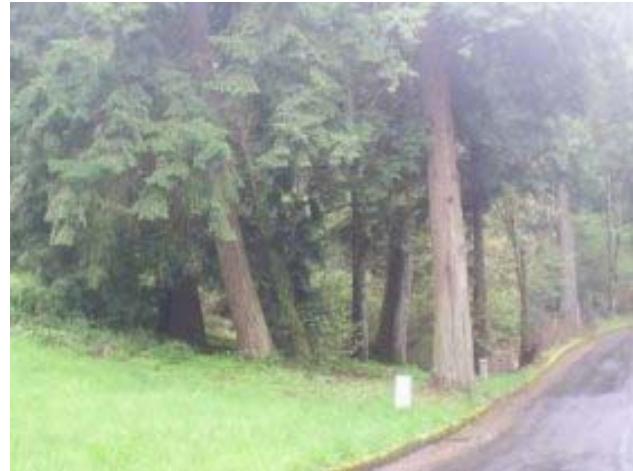
Older trees undergoing recent movement

- “Pistol-butted” evergreen (fir, cedar, etc.) trees, indicative of ground movement and subsequent attempts by the trees to correct themselves to a normal vertical growth. Only one or two deformed trees in a grove or forest would not be indicative of ground movement; their growth patterns could have been altered by ice loading, wind, or animal activity during early stages of development.

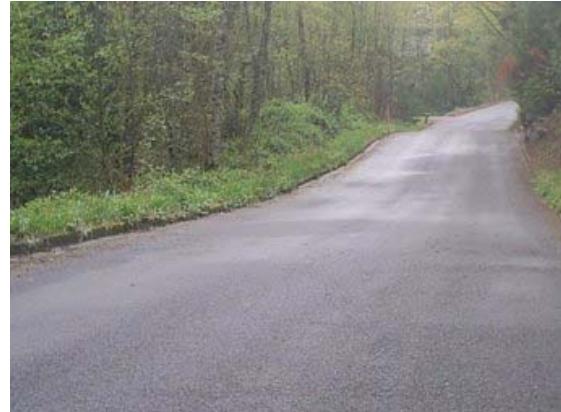
Soil creep: undulating pavement and curbs

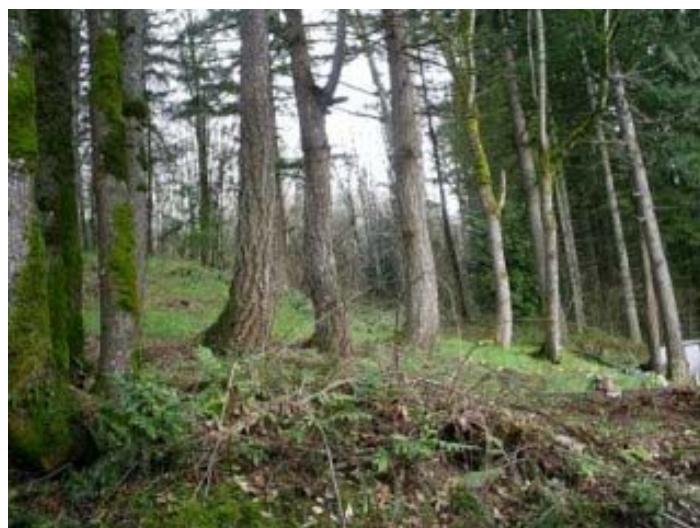
Trees as indicators of slope movement

Movements may be on the order of a few millimeters or centimeters per year, and may not be detectable on an annual basis. Soil creep can cause shallow-rooted evergreen trees to tilt downslope, and as they right themselves they may develop pistol-butted trunks similar to areas of slow moving landslides.

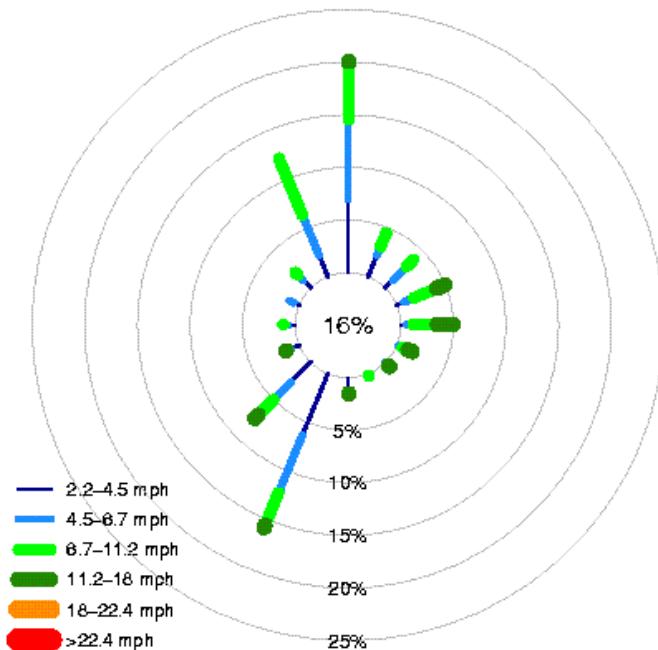
Wind Rose – AM – Sep – N 45°26.25' W 122°28.75'

Shows average wind speeds and directions during September. Prevailing winds are mainly from the N and SW, but E winds are a factor (Source: Ventilation Climate Information System, Joint Fire Science Program).

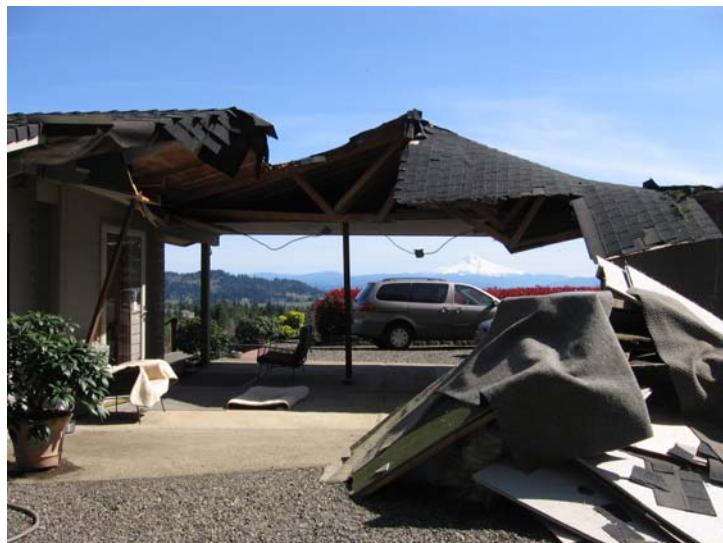
Damage to Damascus home from windthrown timber. This occurred during the December 2006 windstorms.

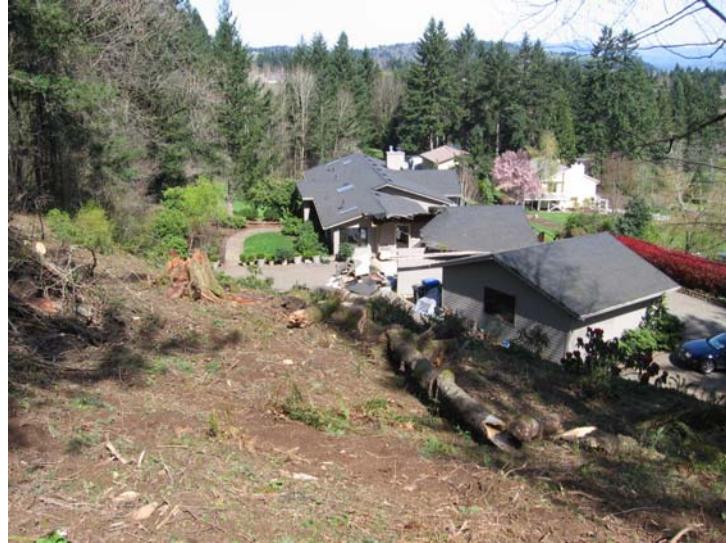
SW winds from December 2006 storm blew over a mature Douglas-fir on a ridgeline, which landed on this home in Damascus.

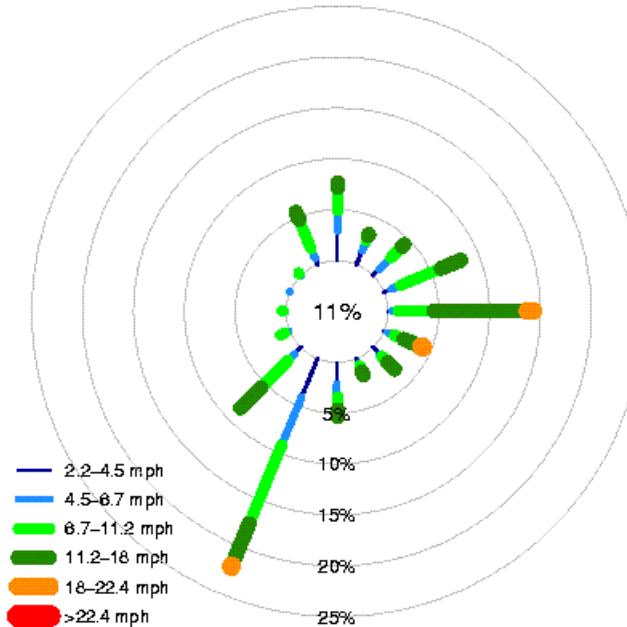
Wind Rose – PM – Jan – N 45°26.25' W 122°28.75'

Shows average wind speeds and directions during January. Prevailing winds are mainly from the SW and E (Source: Ventilation Climate Information System, Joint Fire Science Program).

In the Damascus area, prevailing winds during winter include winds out of the southwest and east (Figure 4). Generally, exposed ridges are more susceptible to such winds, but there are so many variables that influence whether wind damage will actually occur, including tree health, tree density, soil conditions, and micro-wind patterns that it is very difficult to predict windthrow occurrence.

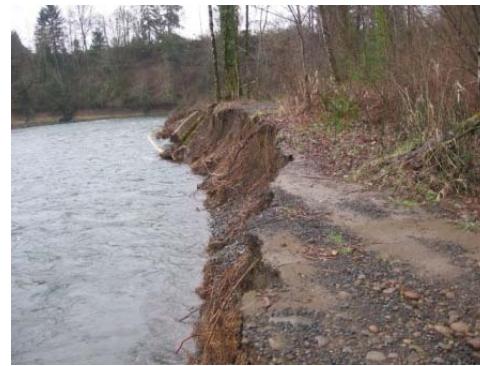
Flooding of the Clackamas River has shifted the river's course. This bank has lost up to 100 feet in recent years.

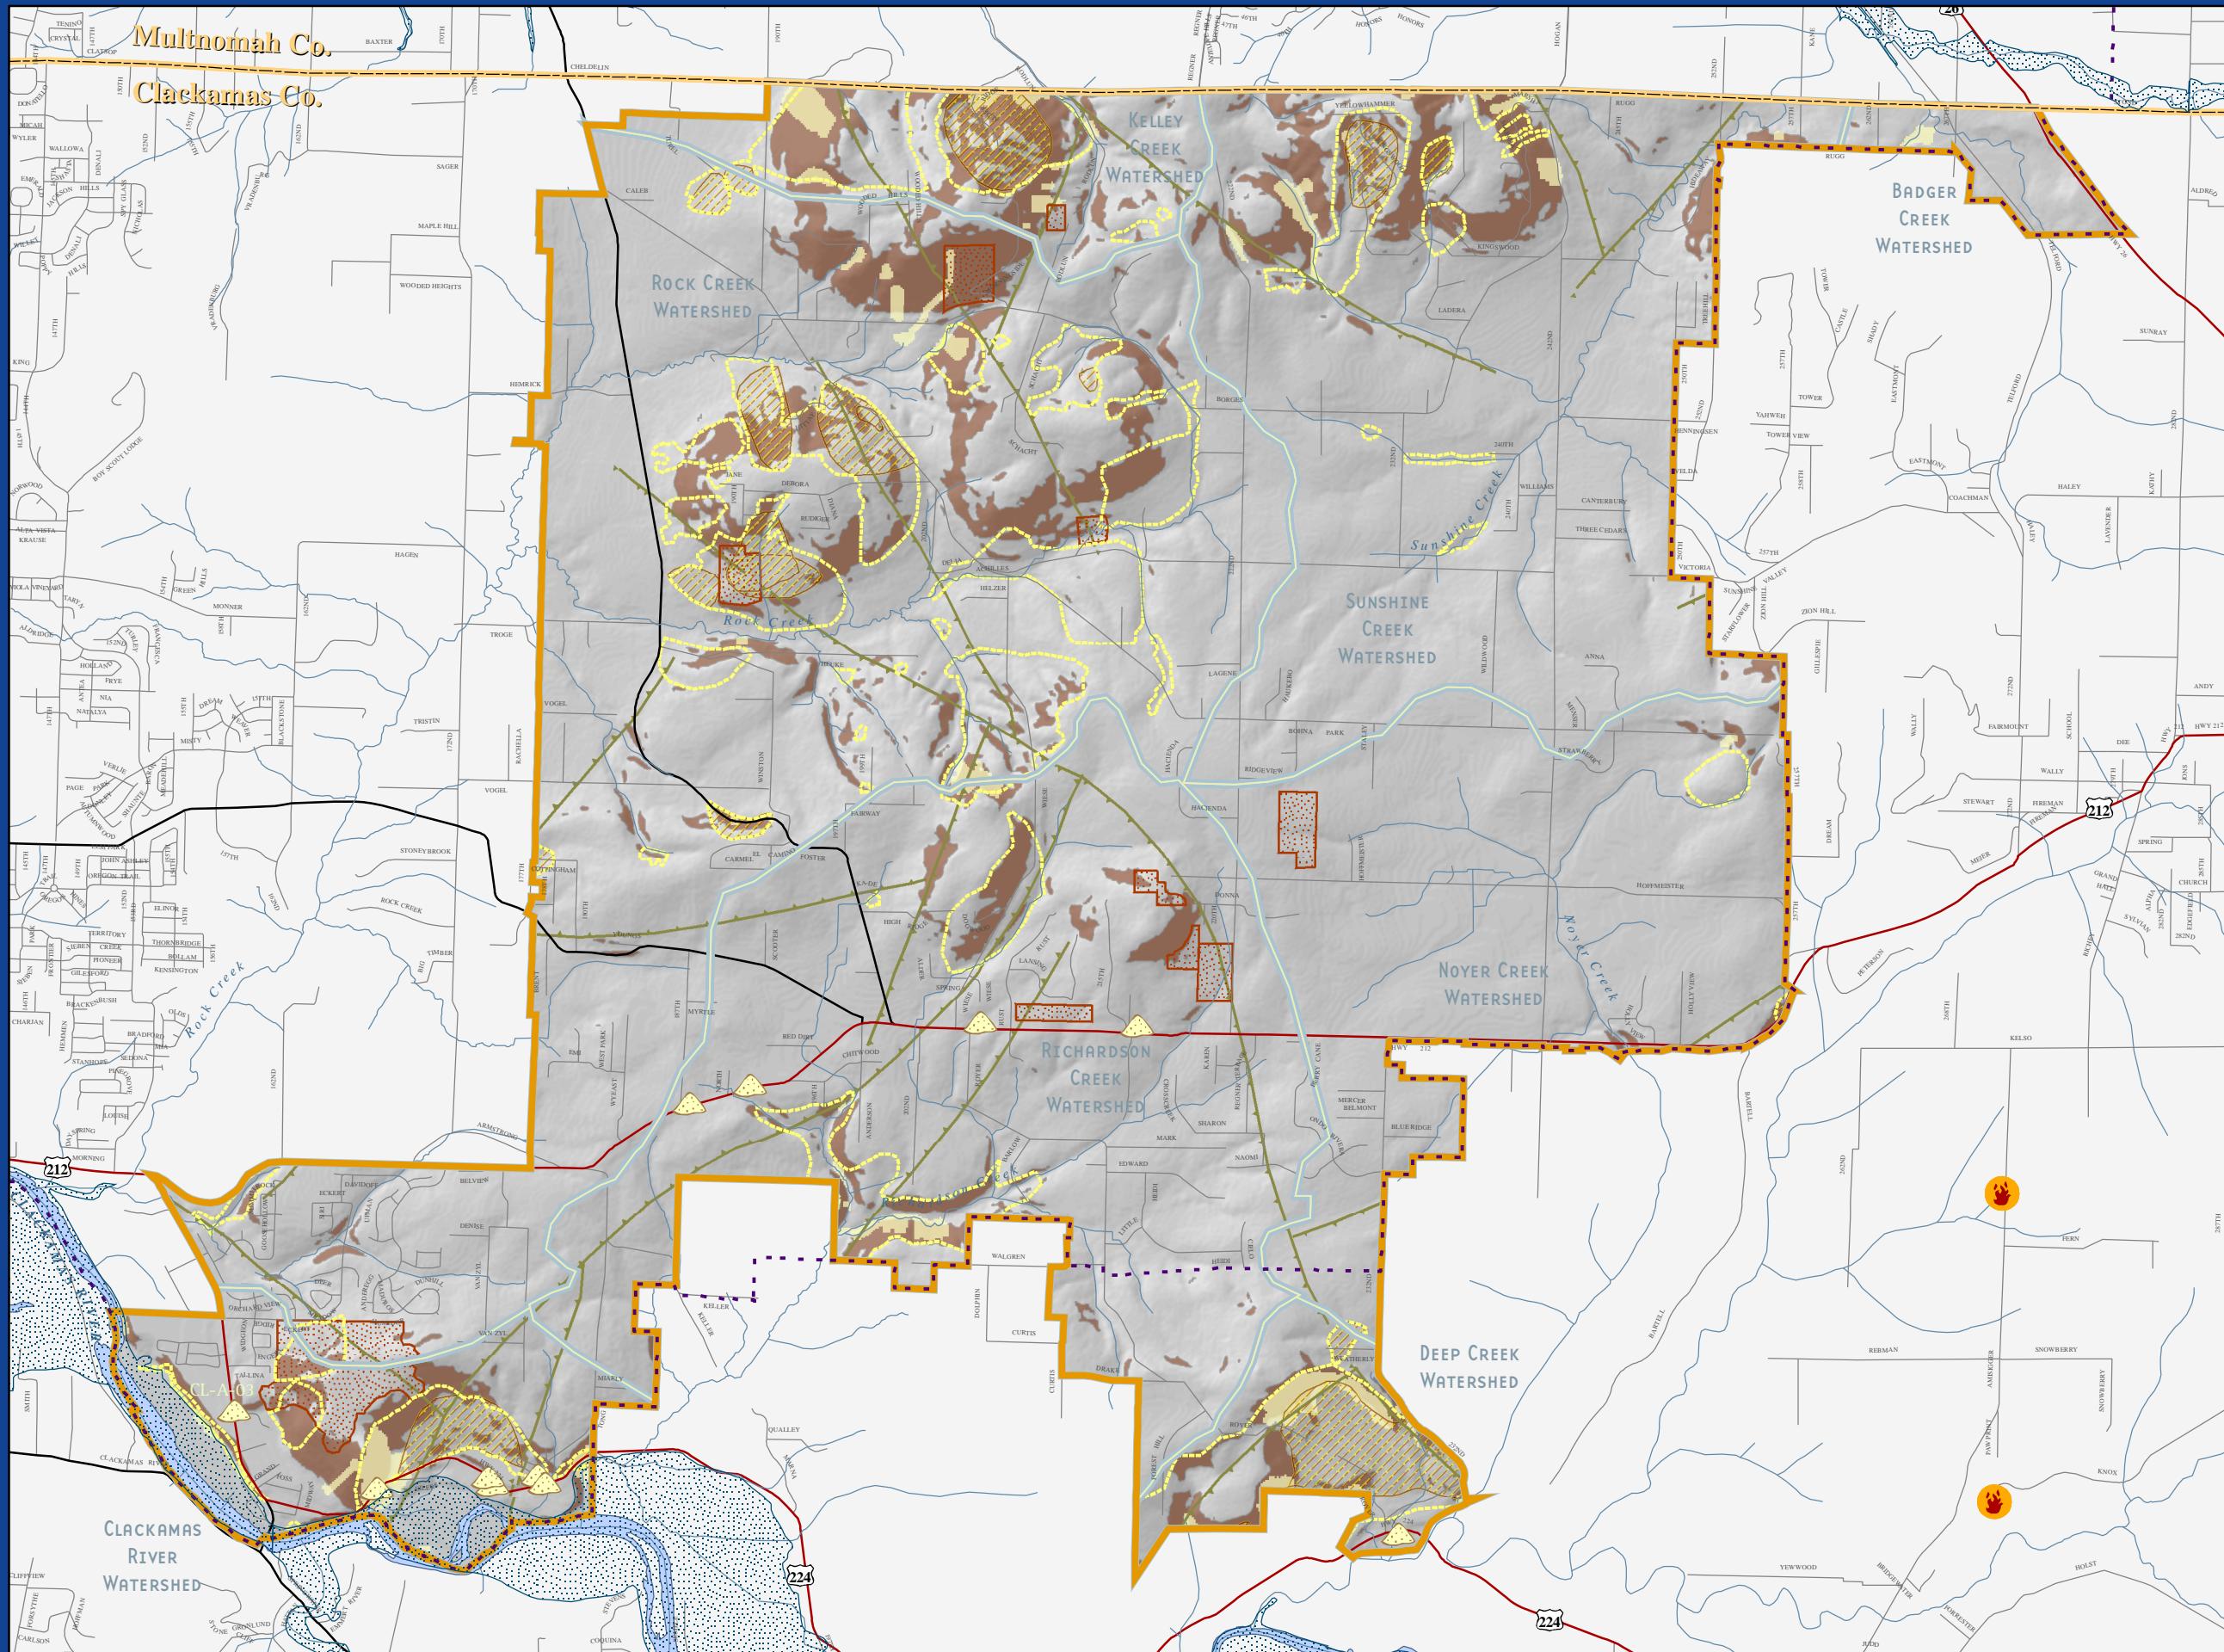
NATURAL HAZARDS INVENTORY - FIGURE 1

Natural Hazard Features

The slope hazard areas used for this study generally place slopes in two categories of steepness: 0 to 25 percent and greater than 25 percent slopes. In the project team's opinion, these categories are appropriate for the geologic conditions within the Damascus area. The Schlicker and Finlayson Hazard Maps (Bulletin 99) show five slope categories but their study covered a very large area with greater varieties of geologic conditions. Slopes greater than 25 percent are shown on the Natural Hazard Map (Figure 1). The total area encompassed by steep slopes in Damascus is 1,030 acres.
