ABBREVIATED PRELIMINARY ASSESMENT

RUTH #1 MINE

Willamette National Forest
Marion County, OR

Revised
October 2004

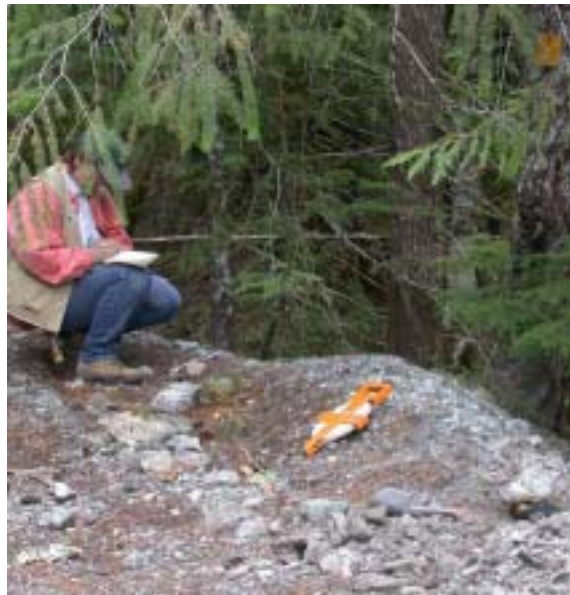
The waste rock pile for Level 5 was used to construct the haul roads. Approximate depth of this material is 3 feet and approximately 16 feet wide. It is unclear as to the exact length of road that was built from waste rock material. However, based on visual observations of the area, an approximate volume of material in the roadway, ore car rails, and miscellaneous piles is 945cy. Battle Axe Creek is approximately 30 to 40 feet below the road and the adit drainage discharges into the river. There are signs of material leaving the site and migrating down to the river.

Photo 4. Level 5: Lower Road Segment by Washed out Bridge.
Niton Sample ID 33. Lead 4568 mg/kg. Material Approximately 3' Deep.
(photo by D. Boles)
