# CHAPTER 1 CHARACTERIZATION OF THE WATERSHED AND CURRENT CONDITIONS

The Powder/Pondosa 13 and Powder/Keating Watershed 29 (herein referred to as the watershed) is that portion of the Keating Valley and the drainage system of Big Creek and the Powder River that flow into the Powder River at mile \_\_\_\_\_. The watershed is dissected by state Highway 203 and starts at the Catherine Creek summit, stretching mostly south and east from there (see Map 1.1). The unincorporated cities of Medical Springs, Keating and Pondosa are located within the watershed.

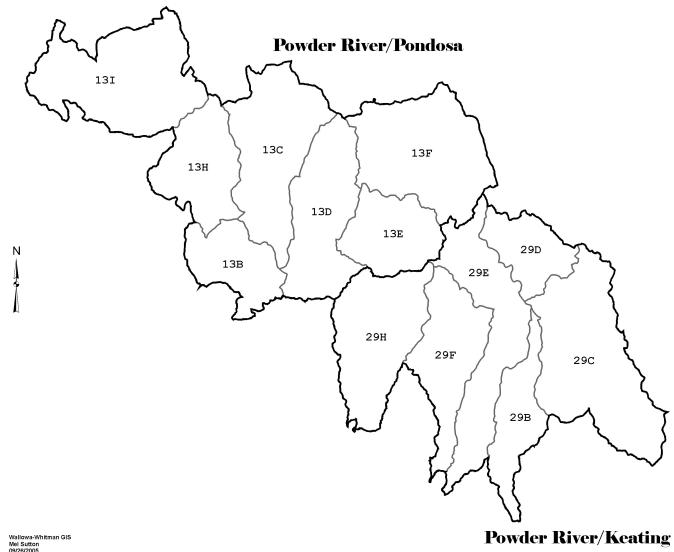
The watershed is further divided into 13 subwatersheds (see map 1.2)
