University of Oregon

Campus Tree Plan

October 2001
Updated July 2008

University of Oregon Campus Tree Plan

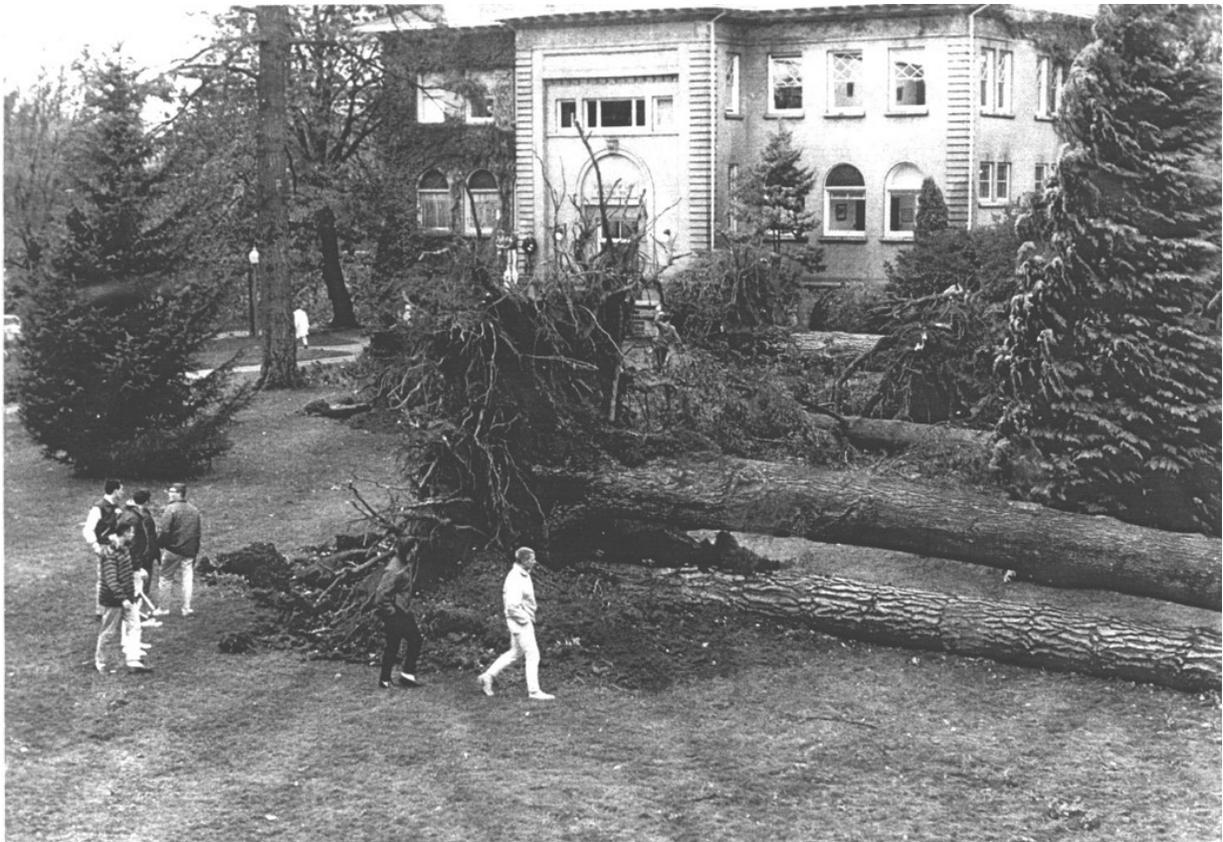
Old Campus Quad after the 1962 Columbus Day storm (Fenton Hall is in the background).

By the time the devastating Columbus Day storm hit in 1962, the campus tree canopy had reached a level of maturity that defined the quintessential character of the central campus as we know it today, with many large-canopy species. Unfortunately, a great number were blown down during the storm—some of the oldest and largest—leaving large, open spaces in the central campus area.

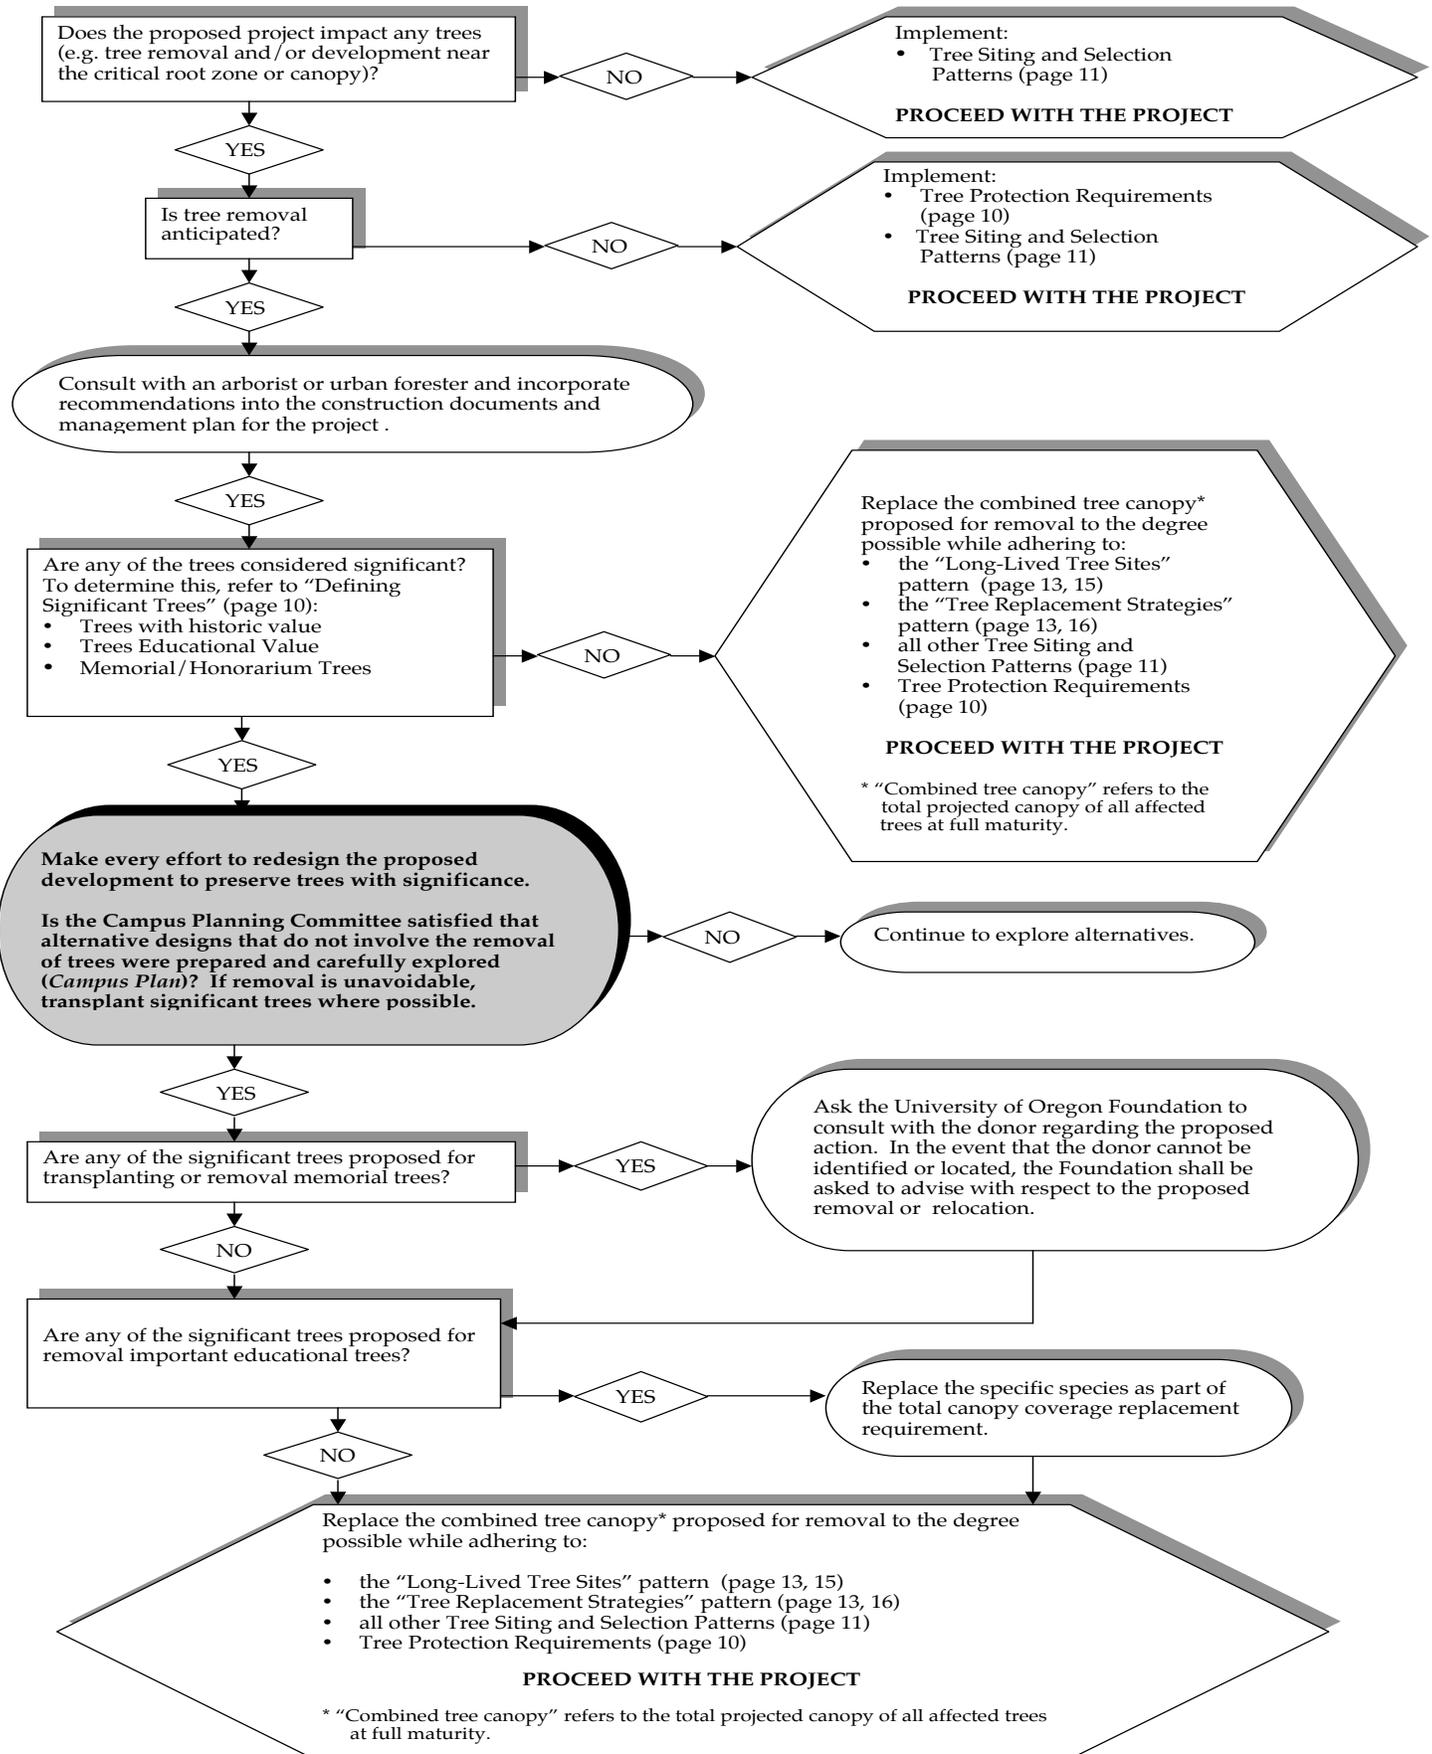
4.1.1 Table: Decision Tree

Every development project on campus must adhere to the steps covered in the following flow chart:

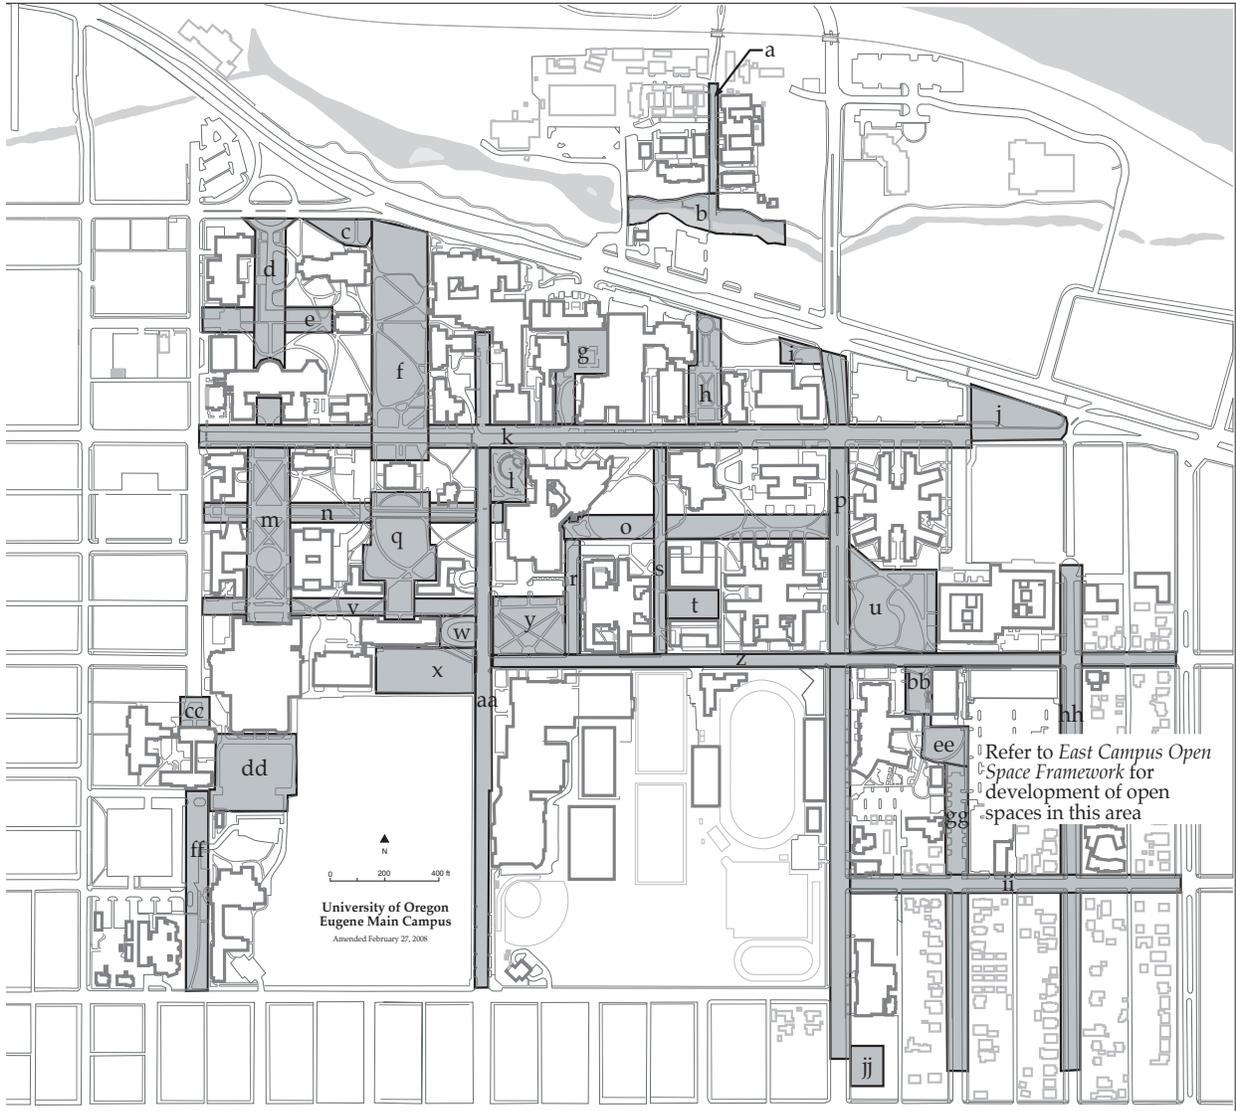
<p>Quadrangles and Malls (p. 21)</p> <p>m. Memorial Quadrangle</p> <p>f. Old Campus Quadrangle</p> <p>q. Women's Memorial Quadrangle</p> <p>Axes and View Corridors (p. 23)</p> <p>k. 13th Avenue Axis</p> <p>z. 15th Avenue Axis</p> <p>ii. 17th Avenue Axis</p>	<p>p. Agate Street Axis</p> <p>gg. Columbia Axis</p> <p>d. Dads' Gates Axis</p> <p>e. Deady Hall Walk Axis</p> <p>s. Emerald Axis</p> <p>a. Gallery Walk Axis</p> <p>n. Johnson Lane Axis</p> <p>v. Knight Library Axis</p> <p>hh. Moss Axis</p> <p>r. Onyx Axis</p>	<p>o. Promenade</p> <p>ff. Southwest Campus Axis</p> <p>aa. University Street Axis</p> <p>Greens (p. 32)</p> <p>i. Agate Entrance Green</p> <p>jj. Agate Hall Green</p> <p>l. Amphitheater Green</p> <p>j. Bakery Park Green</p>	<p>ee. East Campus Green</p> <p>w. Gerlinger Entrance Green</p> <p>x. Gerlinger Field Green</p> <p>bb. Glenn Starlin Green</p> <p>u. Humpy Lumpy Green</p> <p>cc. Kincaid Green</p> <p>t. Living-Learning Center Green</p> <p>b. Millrace Green</p>	<p>g. Onyx Green</p> <p>h. Science Green</p> <p>dd. Southwest Campus Green</p> <p>y. Straub Hall Green</p> <p>c. Villard Hall Green</p>

As noted in the "Designated Open Space" pattern, every tree that helps form or reinforce the identity of these designated open spaces should be afforded extra care. In addition, the "Long-lived Tree Sites" pattern gives priority to planting trees in designated open spaces. For this reason, this plan focuses on defining the desired character of the tree canopy for the **bolded** Designated Open Spaces (refer to map, 6.1.1. Designated Open Spaces on page 19).
