Bend Watershed Analysis

Deschutes National Forest

September 30, 1998

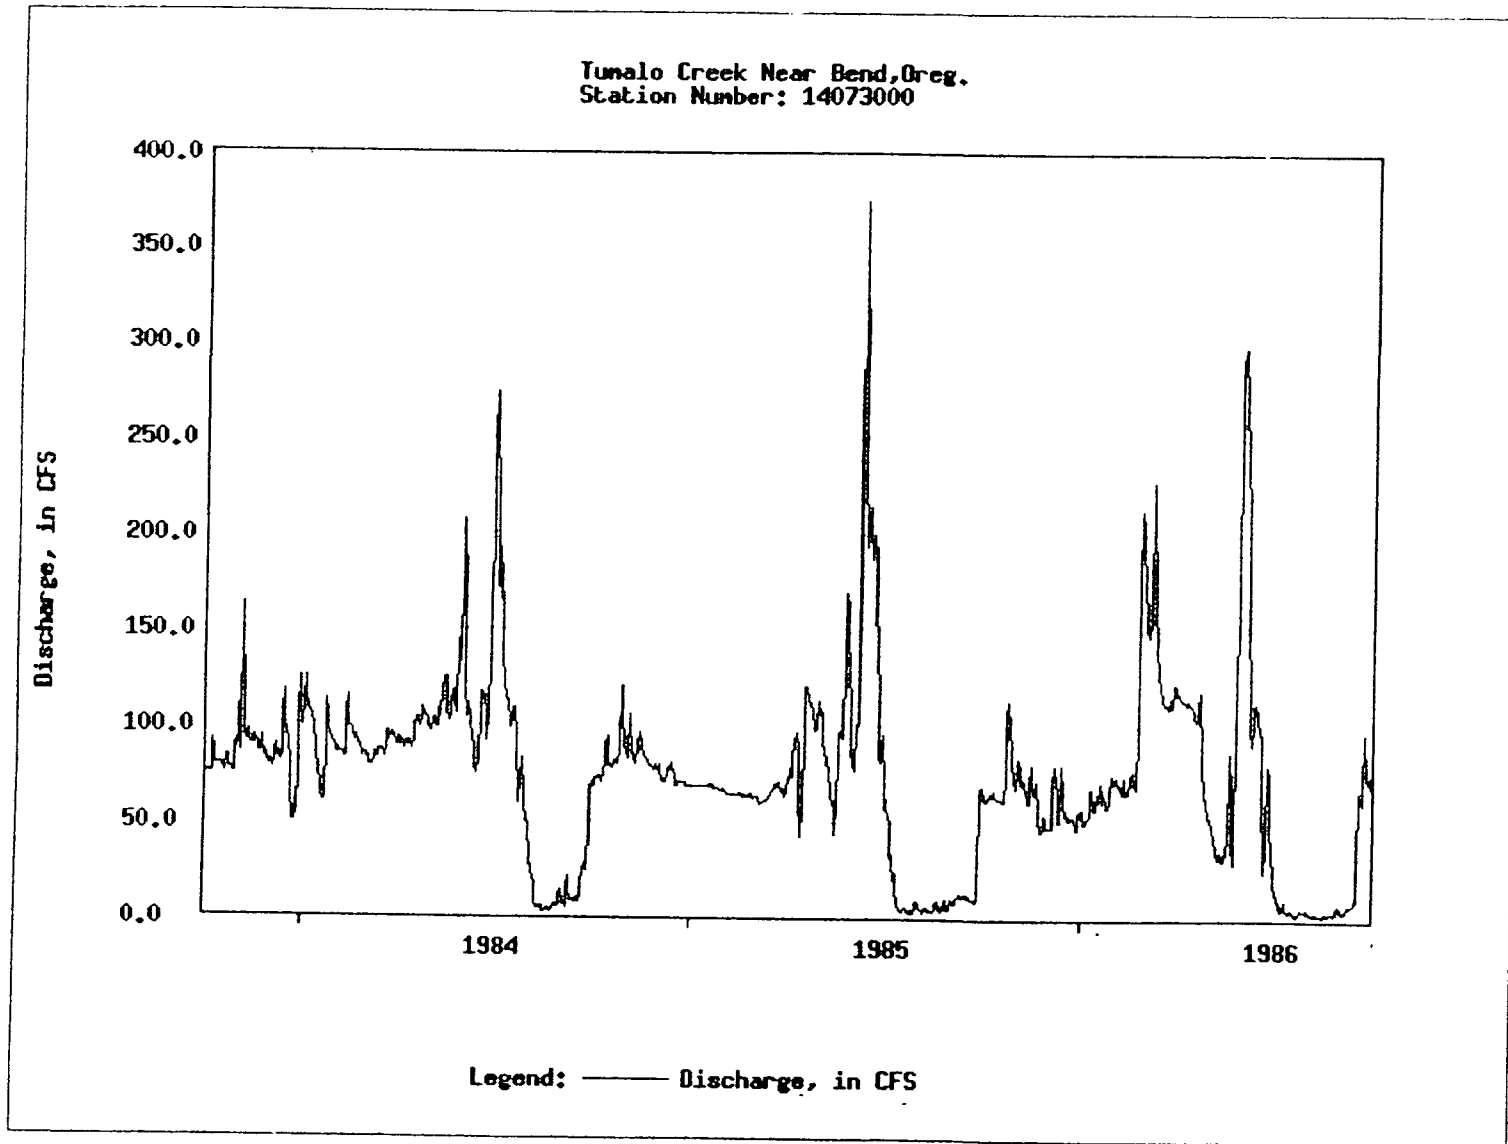
TUMALO CREEK STREAMFLOW

(Below Columbia Southern Diversion)

Annual flows within this section of Tumalo Creek have generally been approximately 50 cfs during the winter months, 300 to 400 cfs during spring run-off, and less than 5 cfs during summer irrigation months. Low summer flows have resulted in a reduction of fish habitat and modified hydrological conditions. The 1998 flow during the summer irrigation season was approximately 40 cfs due to a change in policy by the Tumalo Irrigation District to divert its water below Shevlin Park, a policy which is expected to continue into the future.
