Portland Downtown Riverfront Habitat Opportunities

Prepared By:
Fishman Environmental Services, LLC

August 2002

Fish and Wildlife Habitat Enhancement Opportunities along the
Willamette River, between the Ross Island and Steel Bridges

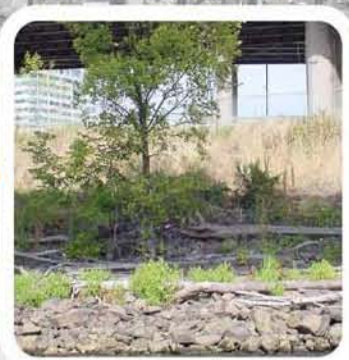
Steel Bridge/Floating Walkway: The rip rap shoreline with some bare ground under the freeway has a low terrace containing a few scattered trees and shrubs. Extensive shade exists because of the overhead freeway.

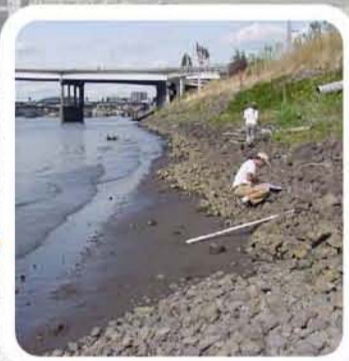
Morrison Bridge East: A steep, rock-armored bank is constrained by a narrow river channel and trail/freeway development at the top of bank. Scattered non-native vegetation exists on the bank.

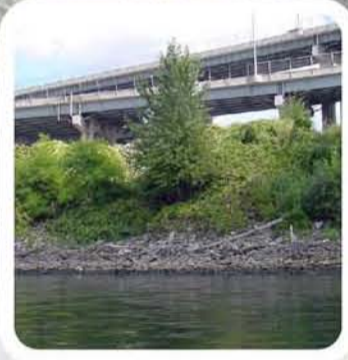
Eastbank Crescent: This is a fairly steep, rip rap covered bank with non-native blackberry as the dominant vegetation. The near-shore area is shallower nearest to the Hawthorne Bridge.

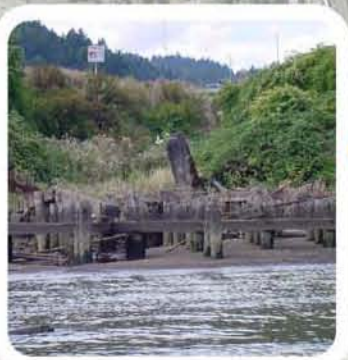
Zidell Ross Island Bridge: The inactive industrial site riverbank has rock rip rap and construction debris, and remnants of a pile-supported dock. Sparse bank vegetation is dominated by non-native blackberry.

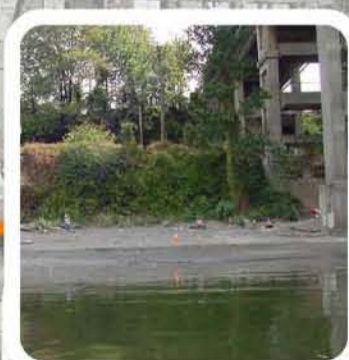
East-side Ross Island Bridge: The site has a gradually-sloping sand/gravel beach and a steep, high bank dominated by non-native vegetation.

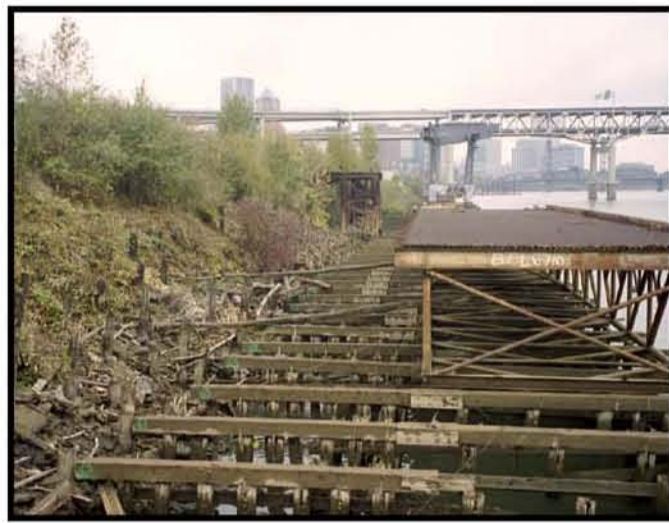
Opportunity Site: Zidell/Ross Island Bridge

Existing site conditions reflect the industrial history of the site: banks are armored with rip rap and construction debris; a large portion of the shoreline has remnants of a piling-supported dock; bank vegetation is dominated by Himalayan blackberry; and areas of the site have sub-surface contamination.

The project design includes establishment of riparian vegetation on the bank, and gravel bars just offshore.

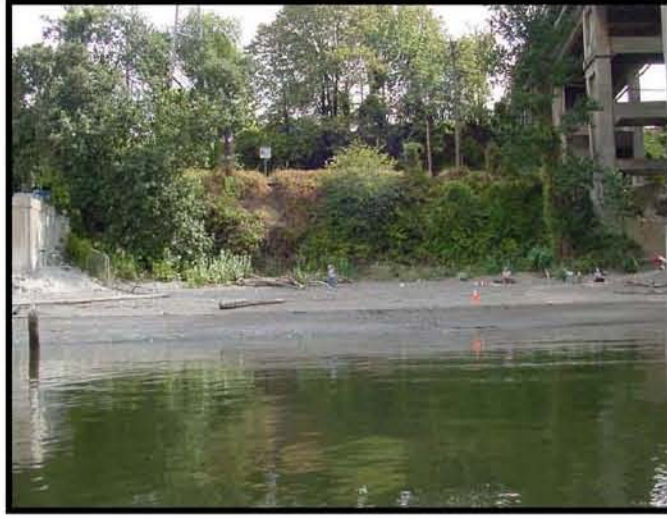
Opportunity Site: East-side Ross Island Bridge

Site E1 is an open-space area with a gradually-sloping sand-gravel beach ending inland at a steep, high bank. The bank is covered with invasive non-native plants dominated by Himalayan blackberry. An industrial use occupies the site immediately north (downstream). South (upstream) of the Ross Island Bridge is a shoreline with a fairly intact riparian area that can be used as a model for enhancement projects in the downtown reach.

This site provides a good opportunity for habitat enhancement by creating a planting terrace on the lower shore, starting at the base of the steep bank and extending towards the river.

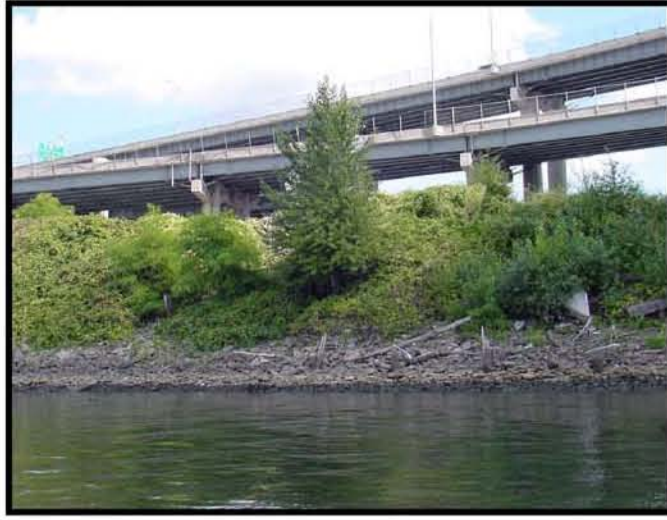
Opportunity Site: Eastbank Crescent

This is the site of the Eastbank Esplanade Phase III for which a preliminary design has been developed by PDC and the City. The existing condition of the site is a fairly steep rip rap and rubble bank covered by Himalayan blackberry and other non-native plants. A few trees exist at or near the top of bank. River depth off the bank is moderate to deep, except for a shallower area near the Hawthorne Bridge. The land above the bank is vacant, with the exception of a bike-pedestrian trail connecting to OMSI. The overhead freeway dominates the site visually.

Interim benefits to fish and wildlife habitat can be achieved fairly simply, until the Phase III design is implemented. Eradication and control of blackberry and other invasive species would establish space for using joint planting to establish native shrubs on the existing rip rap bank. Existing trees would be protected, and additional trees and shrubs would be added on a created terrace near the top of bank. In and above-water habitat would be added by anchoring floating planted breakwaters off-shore.

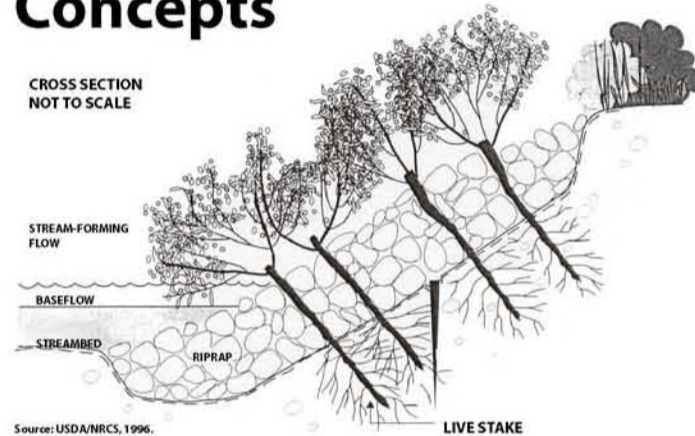
Concept 1: Planting existing rip rap - Native shrubs are planted, using live stakes, into the spaces between existing rip rap pieces at and above the elevation of persistent woody vegetation. This can be accomplished using a track hoe with a vibrating "stinger" and manual labor.

Concept 2: A planting terrace is excavated near the top of the existing bank. Native shrubs, trees and groundcover are planted and maintained on this new terrace.

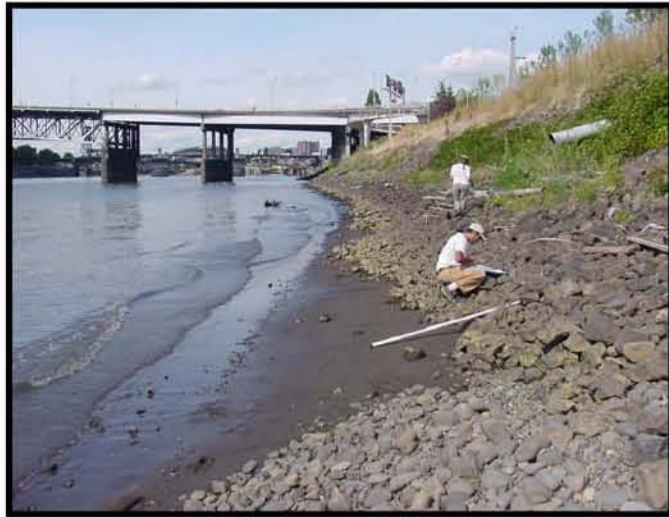
Opportunity Site: Morrison Bridge East

Much of this section of the Eastbank consists of steep rip rap bank with sparse, mostly non-native vegetation. There are no opportunities to change the bank cross section because the river cross section in this reach is narrow and straight, and the Eastbank Esplanade and freeway constrain the position of the top of bank.

The most effective enhancement of this section is joint planting the existing rip rap, and adding habitat structural and vegetation elements.

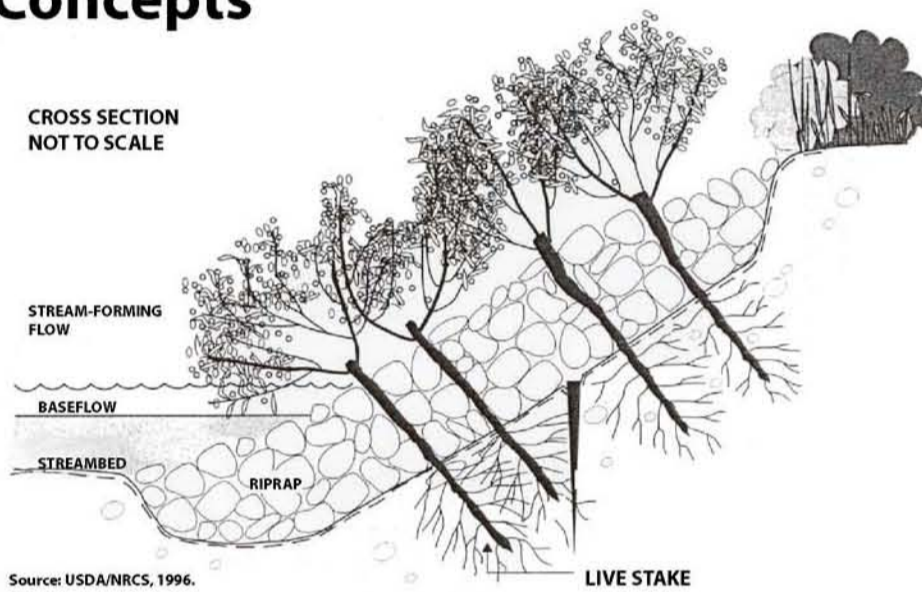
Concept 1: Plant existing rip rap - native trees and shrubs can be planted into the spaces between existing rip rap pieces at and above the elevation of persistent woody vegetation.

Concept 2: Place habitat/vegetation structures on the bank - Different types of habitat/vegetation structures can be anchored to the bank and beach. Structure types can include: tree bundles fabricated from smaller coniferous trees (i.e. Christmas trees); and coconut fibre logs anchored in place and used as a planting substrate for willows and emergent plants.

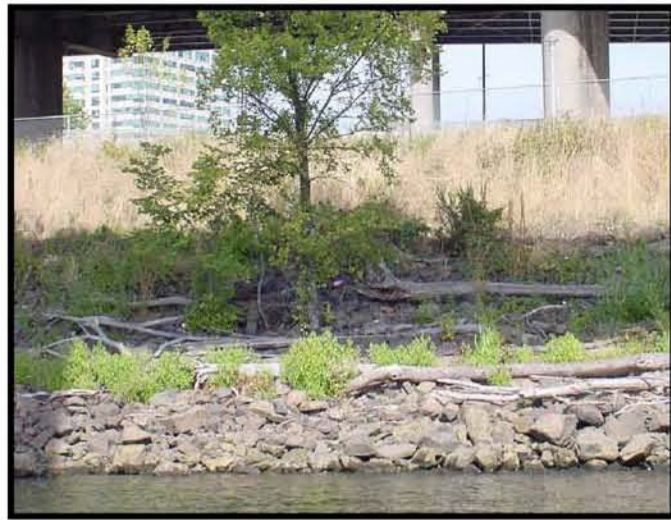
Opportunity Site: Steel Bridge/Floating Walkway

The shoreline inside the Eastbank Phase I floating walkway is rip rap and, in some areas, bare ground. The dominant feature of this area is the overhead freeway that produces varying amounts of shade, thus limiting vegetation growth. Scattered red alders occur on the shore, and limited amounts of groundcover vegetation. Many portions of the area are too shaded to support plants.

Opportunities exist to add trees and shrubs in areas that receive adequate light. The water area between the floating walkway and the shore

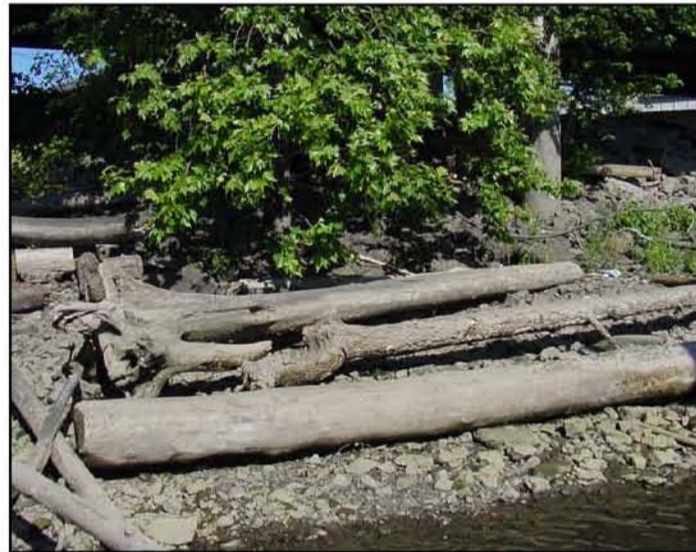
Concept 1: Plant riparian trees and shrubs in rip rap and bare ground areas where light is adequate to support plant growth. Protect plantings from beaver and nutria grazing.

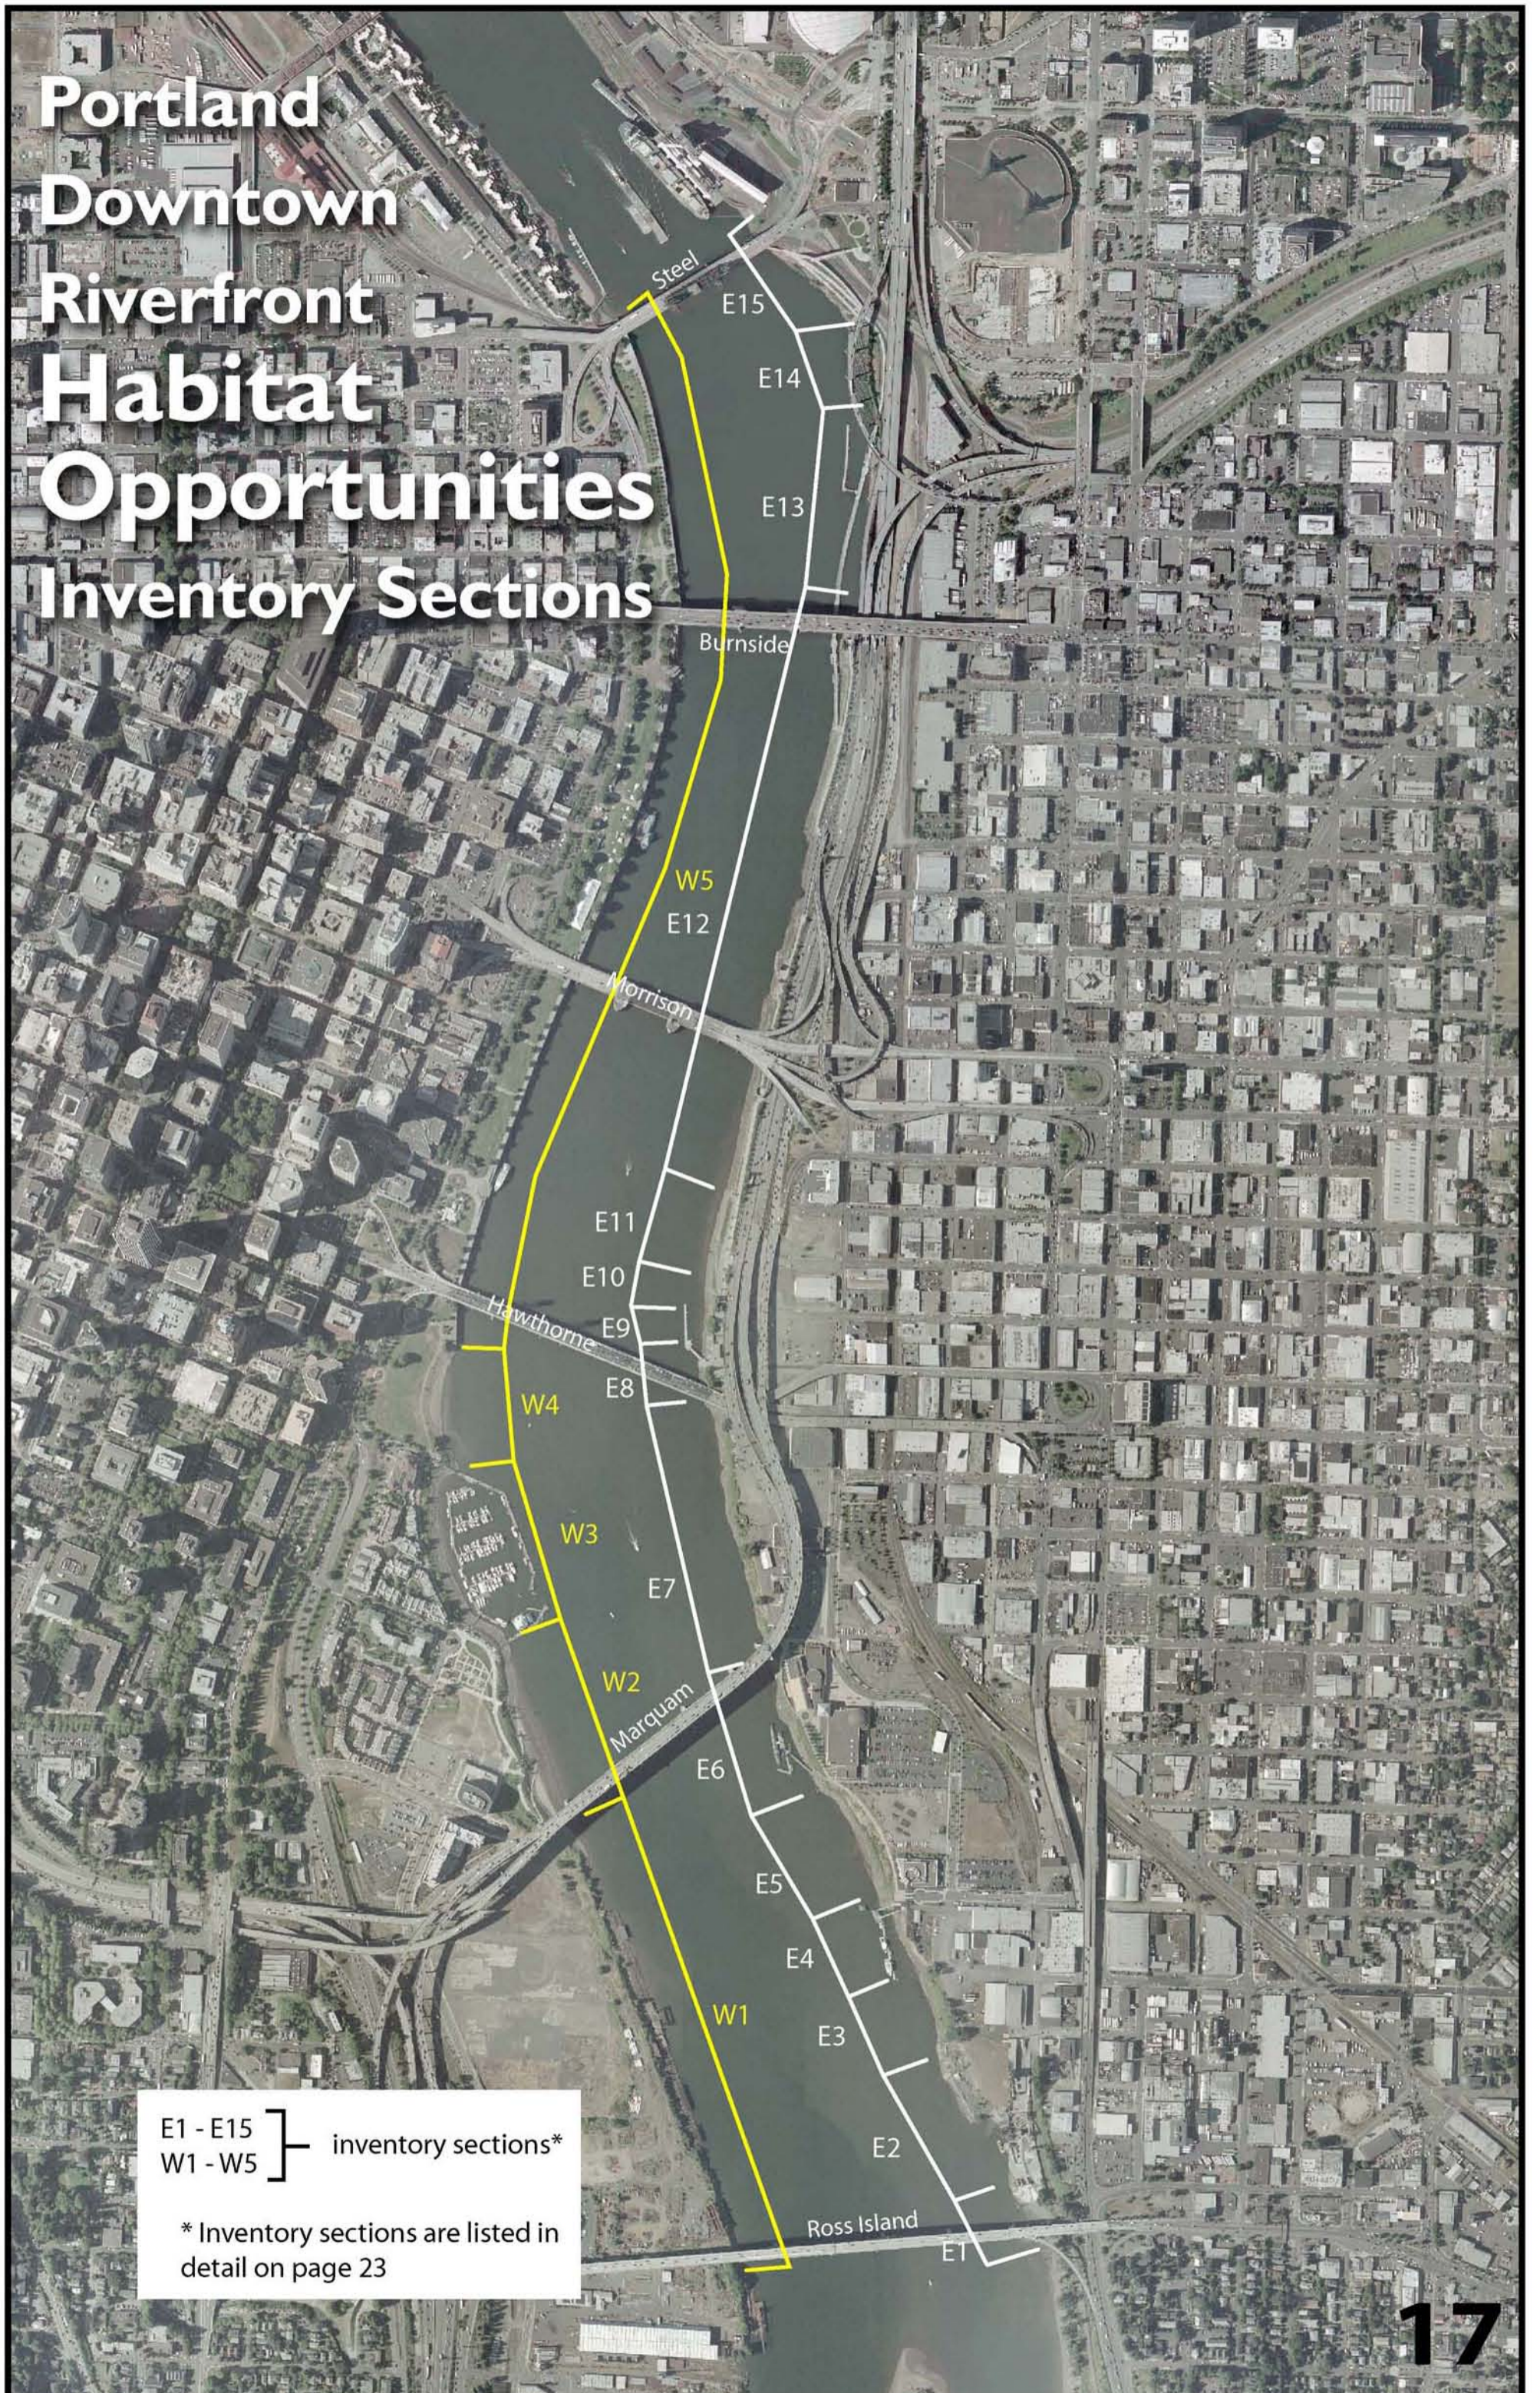
Portland Downtown Riverfront Habitat Opportunities Inventory Sections

E1 - E15 } inventory sections*
W1 - W5 }
* Inventory sections are listed in detail on page 23

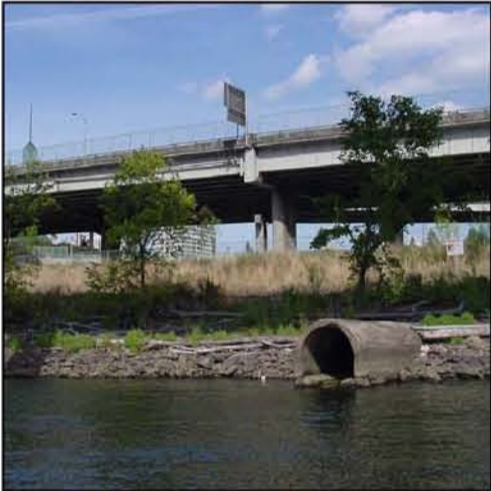
E3	Hbb is dominant; willow also present.	black cottonwood (Populus trichocarpa [balsamifera], FAC), native, Oregon ash (Fraxinus latifolia, FACW), native, Himalayan blackberry (Rubus discolor, FACU), invasive		4	Not Present	N/A	Medium	RIPRAP	ROCK	Yes	Yes		enhancement potential: control blackberry, plant native shrubs
E4	other veg: orchard grass, traveler's joy, hedge bindweed, dock, moth mullein, Piper's willow, Sitka willow, Hbb, sweet pea, brome, reed canarygrass. Douglas spirea, coast pine and Doug fir planted at top of slope. Zone 2: purple loosestrife and maddog	perennial ryegrass (Lolium perenne, FACU), non-native	B1, B2	4	Not Present	N/A	Medium	RIPRAP	FILL	Yes	Yes		PILINGS AT END. 1 purple loosestrife plant observed. Enhancement opportunities: control/eradicate loosestrife before it gets out of hand; look at potential to plant trees and shrubs at the riprap-grass interface, perhaps pulling the slope back at that point, installing a short retaining wall, and thereby creating a planting terrace.
