HISTORIC STRUCTURE REPORT

Elk Lake Guard Station

Deschutes National Forest

Prepared by Jennifer Self in fulfillment of partial requirements for
Historic Structure Report graduate course, AAAP 610.

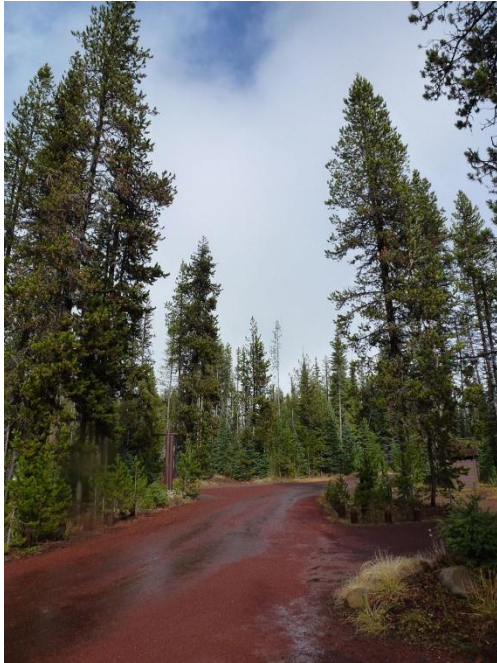
*Image 12:
Site, Lodgepole pine forest and red
cindercone pavement*

- Overall the site and immediate setting is in good condition and maintains a high level of integrity given its remote location and lack of surrounding development.

- Trim any vegetation that is touching or is in close proximity to the roof and exterior walls.
- Maintain proper clearance and fuels reduction around the building to mitigate losses from wildfire.
- Monitor tree and tree root growth to ensure it is not causing damage to the building's foundation.
- Remove trees which are too close to the building and potentially damaging the structure due to root system undermining the foundation or branches growing too close to the building.⁹
- Improve trail and overall connection from the guard station to the lake shoreline.
- Maintain and retain the appearance of a red cinder paved roadway to the guard station.

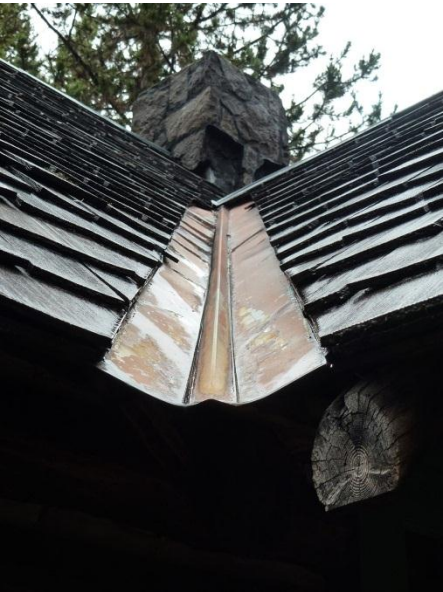
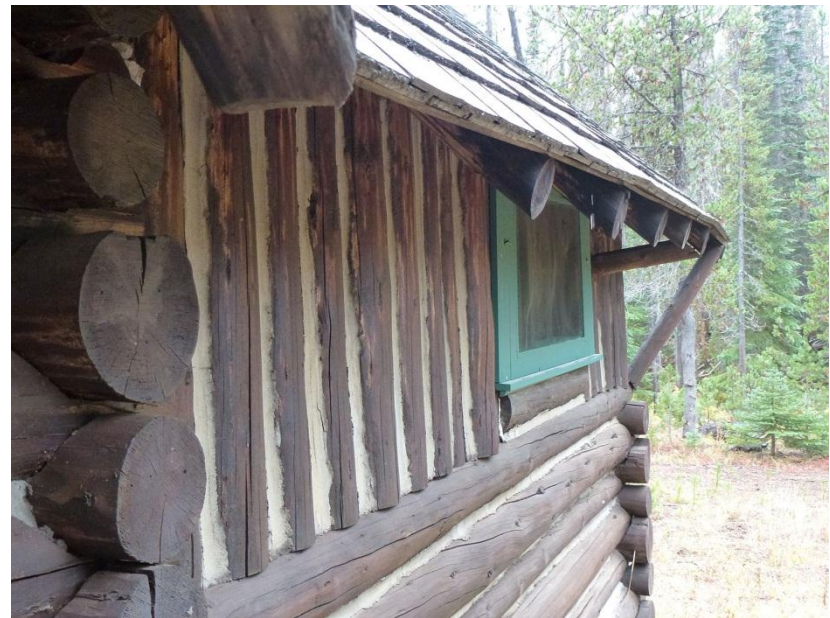
*Image 20, 21:
Roofing details*

- Consult with a structural engineer to determine if the structural integrity of the roof is being threatened by heavy snow loads at the southwest corner.

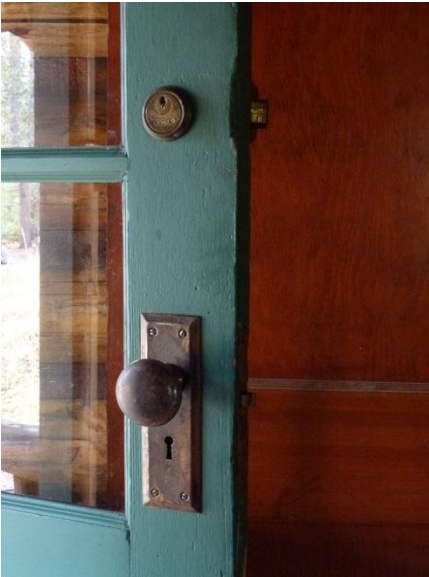
Image 26:
Door hardware

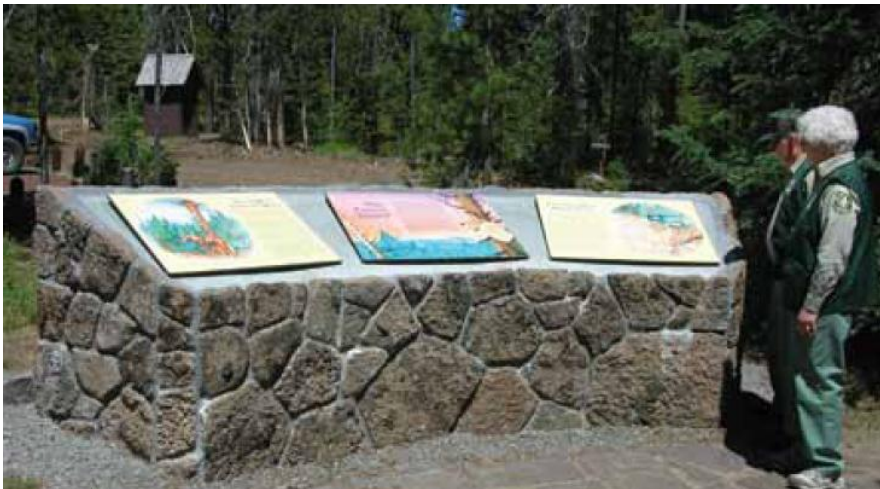
Image 28:

Outdoor interpretive panels

- Ensure the guard station is listed on emergency management GIS maps and layers. Doing so will aid in relaying the importance of the historic resource during hazard events and inform personnel of its existence.
- Ensure PIT volunteers are trained to accommodate disabled visitors in the outdoor interpretive space.
- Ensure electrical outlets and fixtures are cleaned during the opening of the building for seasonal use.

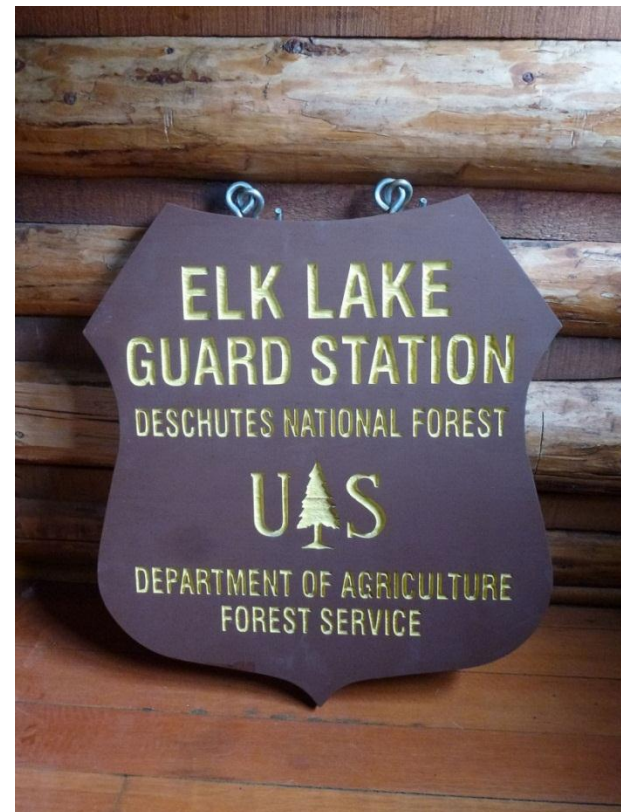
Image 29:

*The Elk Lake Guard Station's outdoor sign
takes refuge from the winter inside.*
