# **University Housing Thermal Testing Report**

**Energy Studies in Buildings Laboratory  
Center for Housing Innovation  
University of Oregon  
Eugene, OR 97403, U.S.A.**

**September 1995**

**U.S. Department of Energy Contract No. DE-FC51-94R020277**

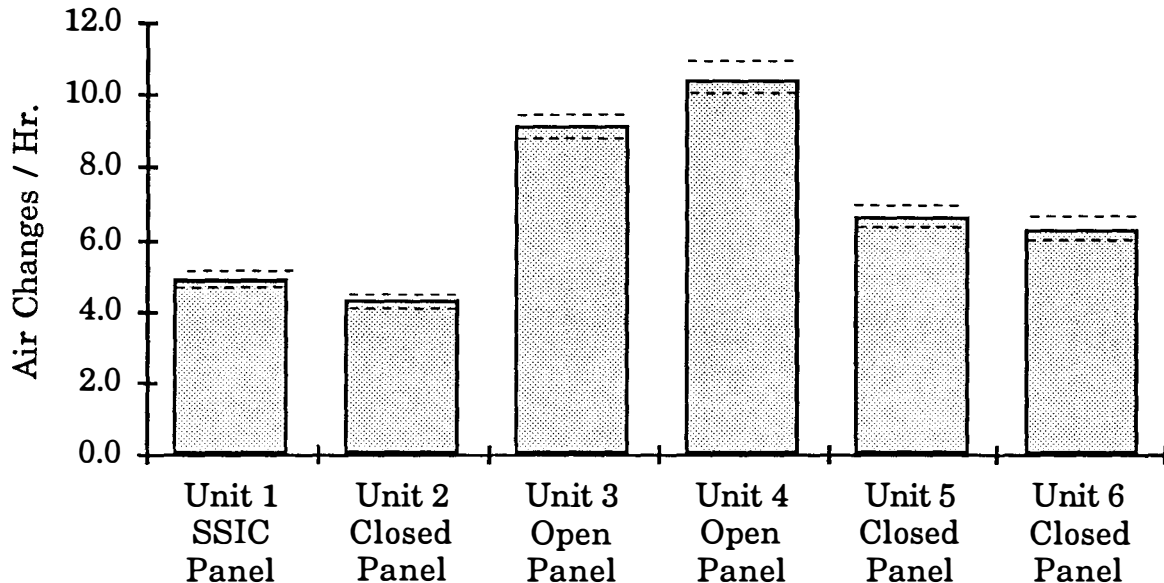
**Figure 4-1  
Air Changes per Hour at a House Pressure of 50 Pascals**

Results of the infiltration tests indicate that the open panel units were the least airtight. ACH<sub>50</sub> results, Figure 4-1, indicate that the 1 1/2 story open panel units were the least airtight followed by the 2 story closed panel units, the 1 story SSIC panel unit, and the 1 story closed panel unit, respectively. A plot of ELA, Figure 4-2, and SLA, Figure 4-3, also indicated that the 1 1/2 story open panel units were the least airtight. When the ELA's were adjusted to account for leakage due to windows and doors and leakage through the ceiling, Figure 4-4, the 1 1/2 story open panel units were again the least airtight. Furthermore, the ELA minus estimated ELA of windows, doors and ceiling joints and penetrations was divided by joint length of panel-to-panel joints, panel-to-slab joints and panel-to-ceiling joints to account for difference in size and configuration of the units, as shown in Figure 4-5. The open panel units are again the least airtight. Figures 4-4 and Figure 4-5 suggest that the high ELA for the open panel units is linked to the

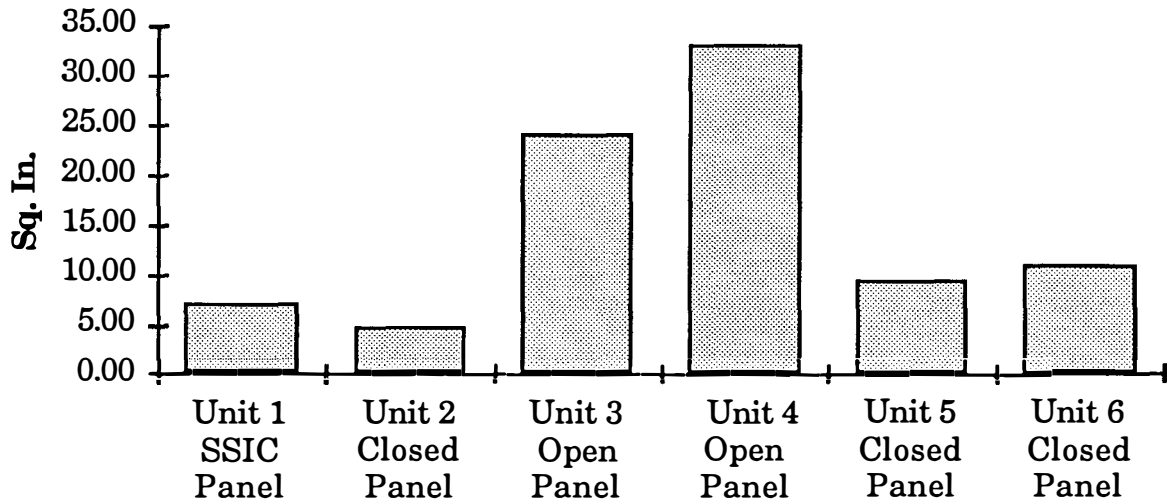
**Figure 4-4  
(ELA) - (Estimated Leakage Area of Windows, Doors and Ceiling Joints and Penetrations through the Ceiling )**

The estimated leakage area shown in Figure 4-4 reflects the leakage area associated with panel type and panel installation. However, Figure 4-4 does not reflect differences in the size of panels and their configuration. Consequently, the estimated panel leakage area was normalized by joint length of the panels for each unit to account for differences in design. Joint length included panel-to-slab joints, panel-to-ceiling joints and panel-to-panel joints. As can be seen in Figure 4-5, even when the estimated leakage area attributable to the panel is normalized by the joint length, the 1 1/2 story open panels are still the least airtight.

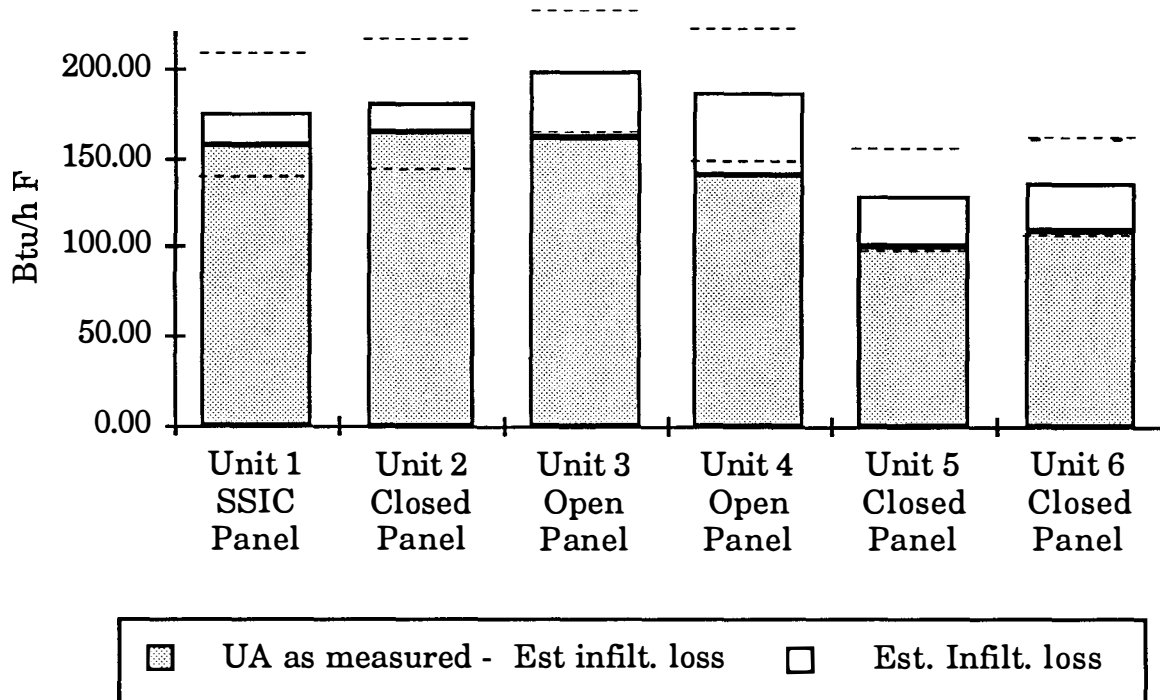
**Figure 4-8  
(UA as Measured) Including Infiltration Estimation**

Coheating tests indicated the 2 story closed panel units had the lowest overall thermal transmittance (UA), followed by the 1 story SSIC unit, the 1 story closed panel unit, and the 1 1/2 story open panel units respectively, Figure 4-8. When the coheating results were adjusted to account for heat loss due to infiltration and normalized by theoretical UA to account for differences in design, the 1 story SSIC unit, 1 story closed panel unit, and the 1 1/2 story open panel units did not perform as well as predicted by theoretical UA values. The significant problems

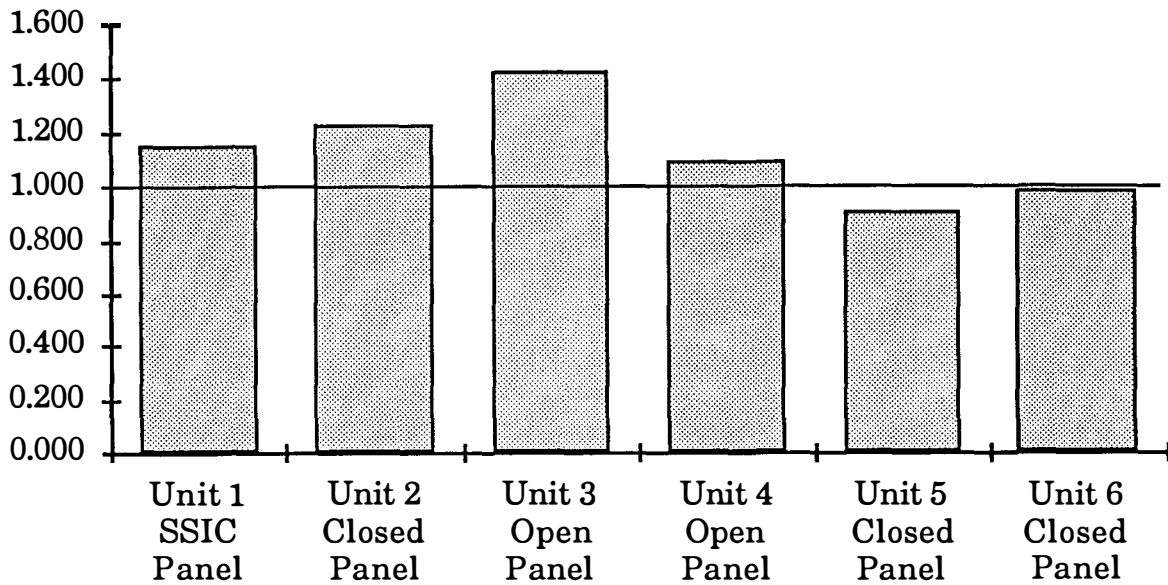
**Figure 4-9**  
**(UA as Measured) - (Infiltration) Normalized by Theoretical UA Values**

The normalized results in Figure 4-9 reflect the relative performance of each unit as seen in the initial "as measured results." Unit 1 SSIC panel, Unit 2 closed panel unit, Unit 3 open panel, and Unit 4 open panel all have as measured performance greater than theoretical UA values, suggesting problems with the thermal envelope. Infrared scanning of Units 1 and 2 revealed significant problems related to the placement of insulation around the transition from a vaulted roof to a flat roof over the bathroom. Thermographic imaging also revealed deficiencies in insulation in both the wall panels and roof areas of Units 3 and 4. Unit 3 also had the most significant instances of poorly installed insulation of all the units.

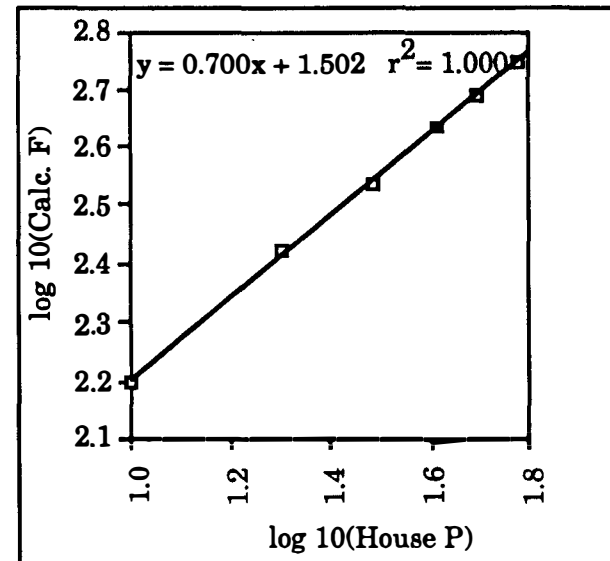
Passive Vent: Taped  
 Home: U of O, Unit 3  
 Date: 15 Nov 93  
 House Floor Area: 800 sq. ft  
 House Volume: 5981 cu.ft.  
 House Surface Area: 1965 sq.ft.  
 Special Note: No Forced Air

CFM4 = 137.20 cfm - from curve fit  
 CFM10 = 272.27 cfm - from curve fit  
 ELA = 38.90 sq. in @ 4 Pa  
 EqLA = 80.02 sq. in @ 10 Pa  
 CFM = 907.46 cfm - from curve fit  
 ACH50 = 9.10 air changes per hour at 50 Pascal  
 ACH50/20 = 0.46 estimate of natural ACH by Persily  
 ACH50/N = 0.34 estimate of natural ACH by Sherman  
 SLA = 3.38 dimensionless specific leakage area

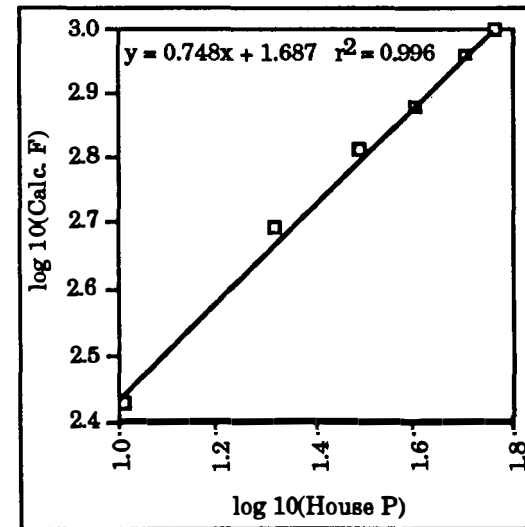
CFM4 = 183.43 cfm - from curve fit  
 CFM10 = 353.18 cfm - from curve fit  
 ELA = 52.00 sq. in @ 4 Pa  
 EqLA = 103.80 sq. in @ 10 Pa  
 CFM = 1116.26 cfm - from curve fit  
 ACH50 = 10.43 air changes per hour at 50 Pascal  
 ACH50/20 = 0.52 estimate of natural ACH by Persily  
 ACH50/N = 0.39 estimate of natural ACH by Sherman  
 SLA = 4.16 dimensionless specific leakage area

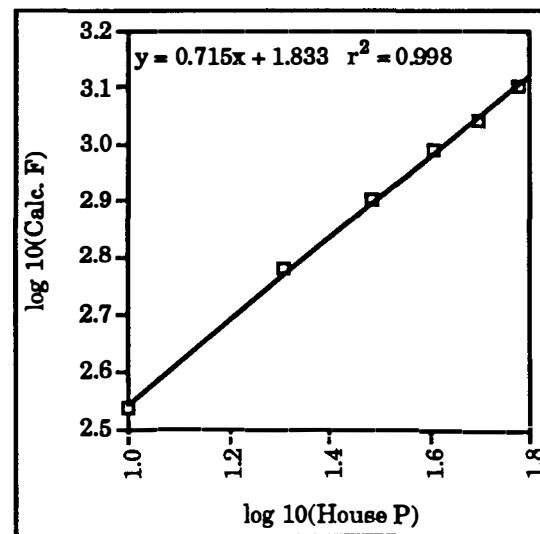
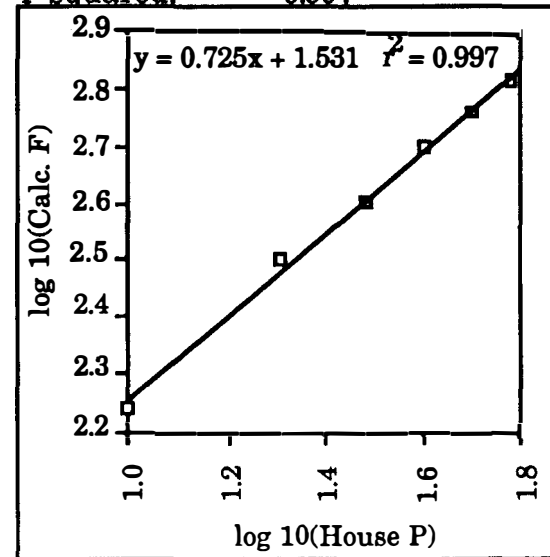
Passive Vent:	Taped	BPA Vents:	Closed		
Home:	U of O, Unit 6	Address:	Eugene, OR		
Date:	20 Nov 93				
House Floor Area:	713 sq. ft	Indoor Air Temp (F):	70	C=	21
House Volume:	5552 cu.ft.	Outdoor Air Temp (F):	40	H=	0.8
House Surface Area:	1721 sq.ft.	Air density factor:	0.9713	S=	1
Special Note: No Forced Air				L=	1.4
				N=	23.52

**Regression Output**  
 X Coefficient: 0.725  
 Constant: 1.531  
 r: 0.998  
 r squared: 0.997

CFM4 = 92.79 cfm - from curve fit  
 CFM10 = 180.30 cfm - from curve fit  
 ELA = 26.31 sq. in @ 4 Pa  
 EqLA = 52.99 sq. in @ 10 Pa  
 CFM = 579.10 cfm - from curve fit  
 ACH50 = 6.26 air changes per hour at 50 Pascal  
 ACH50/20 = 0.31 estimate of natural ACH by Persily  
 ACH50/N = 0.27 estimate of natural ACH by Sherman  
 SLA = 2.56 dimensionless specific leakage area
