A RESTORATION AND PRESERVATION PLAN
FOR THE J.M. MOYER HOUSE
BROWNSVILLE, OREGON

June 1987

A TERMINAL PROJECT

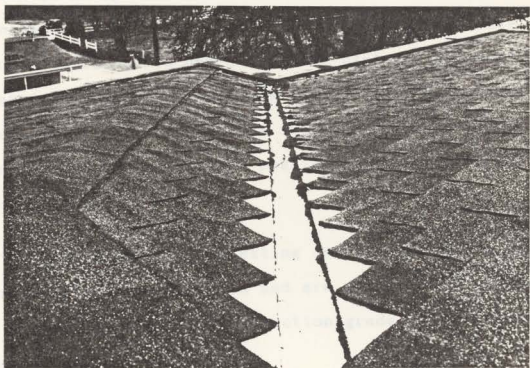
shingles and blocking water drainage (see fig 10). The old, reconstructed cresting is laying in a pile on the west edge of the main roof and might damage the roofing material and interfere with drainage (see fig 9).

Figure 10: Roofing; looking southeast.

RECOMMENDATIONS: All organic material should be removed from the roof surface to ensure proper drainage and minimize deterioration of the shingles. Routine cleaning also will help keep gutters free from debris. The reconstructed cresting that is laying on the west side of the main roof should be removed (see section 6.5).

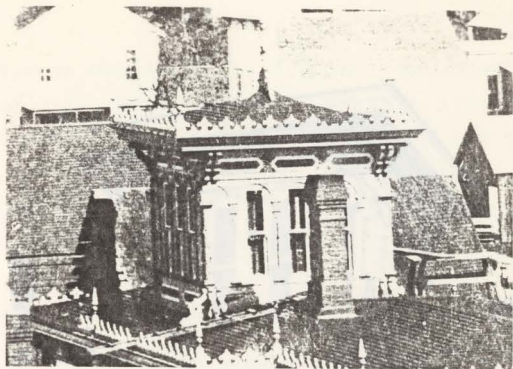
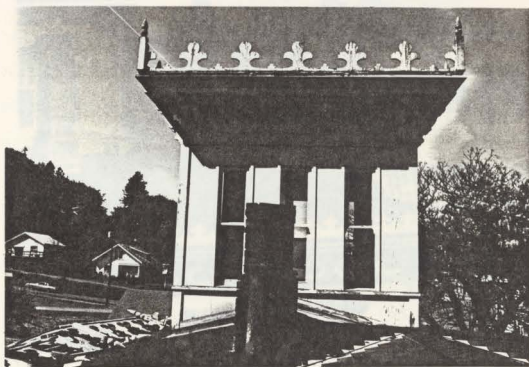
Condition/Problems: The present cupola is in fair condition but in need of scraping and painting. The wood shingle roofing is deteriorating badly. Caulking around the flashing at the base of the cupola is cracking.

Figure 11: A. Original cupola, ca. 1890. Linn
County Historical Museum.
B. Existing reconstructed cupola.

RECOMMENDATIONS: It is recommended that the cupola be repaired and not reconstructed at this time. The wood shingles on the roof should be replaced with asphalt composition shingles until

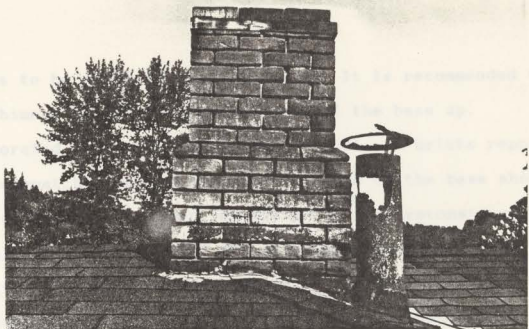
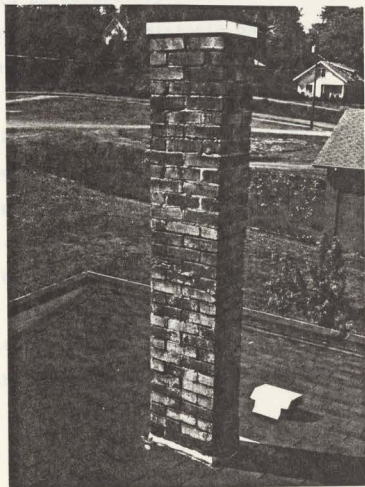
Conditions/Problems: Both chimneys are in bad condition, especially the one in the back ell, and are unstable because of their deteriorating mortar joints and bricks. The furnace vent adjacent to the upper chimney is deteriorating badly.

Figure 13: A. Furnace vent and original chimney base located on south end of main roof.
B. Chimney on back ell.

RECOMMENDATIONS: It is recommended that all the chimneys be restored, as they were a prominent feature of the original design. The chimney base on the main portion of the house

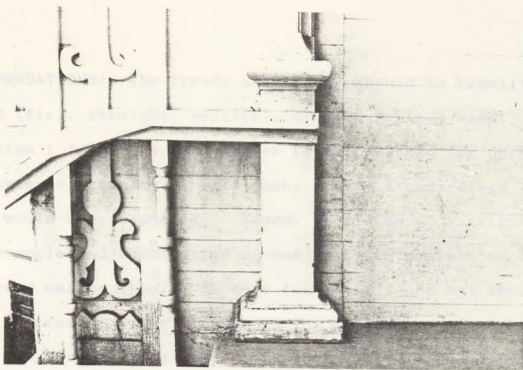
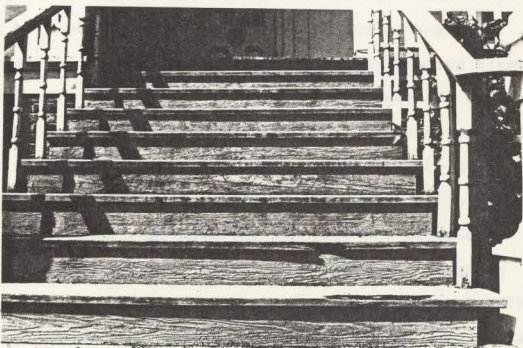
Condition: The stair treads and risers are in poor to fair condition due to deterioration from excess moisture. The newels, handrails and balusters are in poor condition. Elements are loose and deteriorating, and in need of repair.

Problems: The treads and risers are deteriorating from excess moisture, primarily due to poor design and age. Fungal growth and insect infestation can be seen on the underside of the steps. The handrail and balusters are loose and suffer from dry rot. The newel post wooden members are splitting and warping, and the joints are loose.

Figure 14: A. North post pedestal and cap located on front porch.

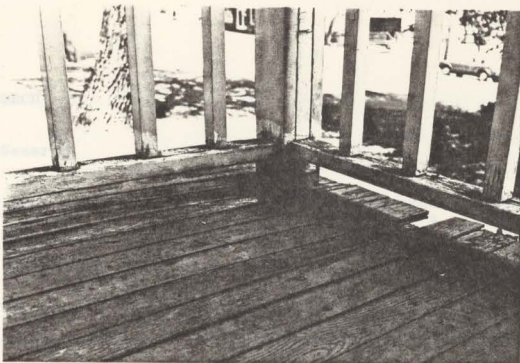
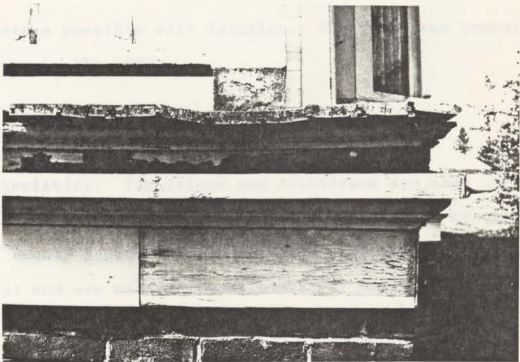
Problems: The deterioration of the decking is causing the front north porch column to settle which could lead to serious damage to the porch structure. This is evident in the north arch which is starting to pull away from the settling post. Sections of the top molding and trim boards are suffering from dry rot.

Figure 15: A. Front porch decking.

RECOMMENDATIONS: It is recommended that the decking be removed and the supporting joist inspected for dry rot. Preservative-treated full dimension 1 inch x 4 inch tongue and groove boarding running the full width of the porch should be used for the decking. Decking boards should be slightly sloped away from the body of the house, usually 1/8 inch to 1/4 inch per foot and laid in the direction of the slope. The trim detail under the decking should be maintained in the restoration. The top molding and trim boards need replacing. As the top molding trim piece does not appear to be original, the molding under the east bay window water table should be used as a guide for the molding profile.

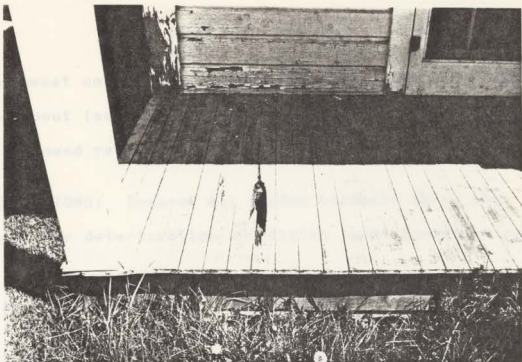
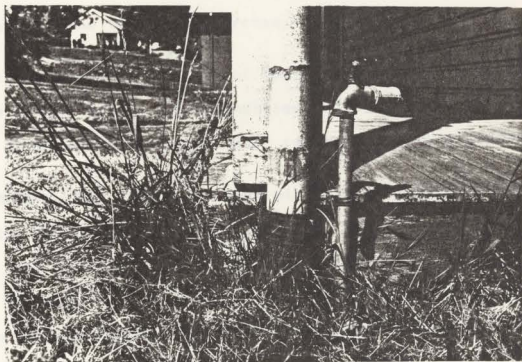
Figure 16: A. Decking and north post on west porch.
B. Drain pipe connection at southern post on west porch.

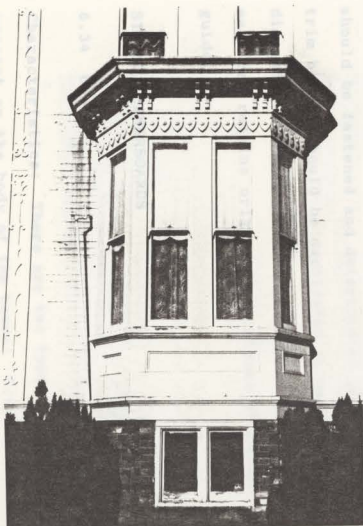
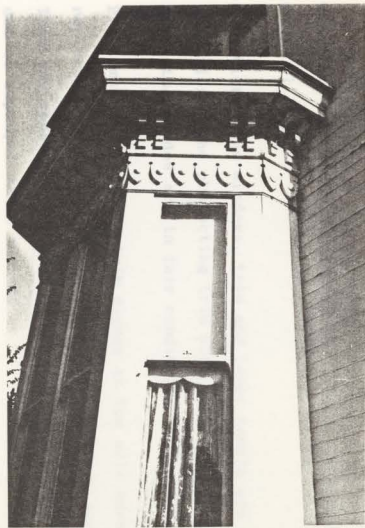
Problems: Deteriorating roofing on the bays is causing water damages on the entablature below and is potentially damaging to the interior of the bays, particularly the frieze panel paintings. There are no gutters or downspouts on the bays or adequate slope to allow water run-off.

Figure 21: A. Bay window; east elevation.
B. Detail of bay window's cornice; north elevation.

RECOMMENDATIONS: It is recommended that the roofing be replaced with a metal roofing material which extends over the cornice forming a drip edge. Copper is recommended because of its finish and long life span. Nails used in the copper roofing should also be copper because of the corrosive effect of incompatible metals. Galvanized sheet metal could also be used for roofing but it is subject to rusting if not maintained or painted regularly. Care should be taken in removing any previous roofing material or roof substructure so as to prevent damage to the interior bay frieze paintings. Replace any deteriorating elements of the roof's structure. Build the roof up to achieve a slight slope to help with water run-off. A 2 inch total rise is adequate.

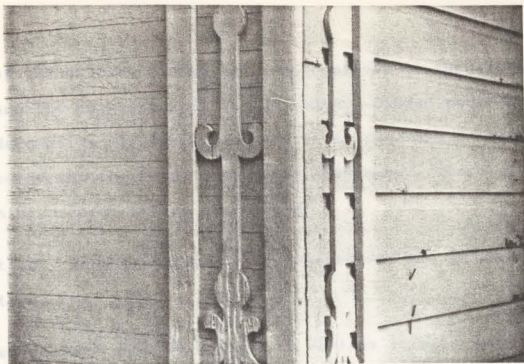
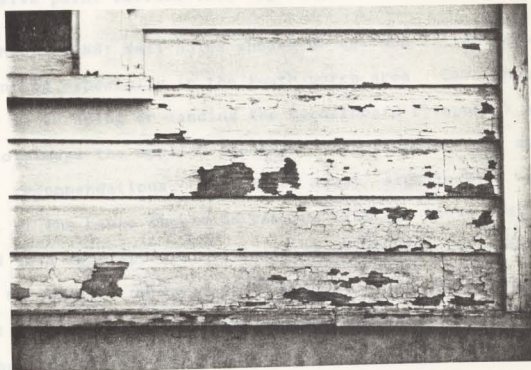
Figure 22: A. Juncture of flush and shiplap sidings; north elevation.
B. Deterioration of paint on siding on ell; north elevation.

Problems: Bare wood is exposed at various locations on the elevation, due primarily to exterior water problems leading to excessive paint failure (see fig 22b).

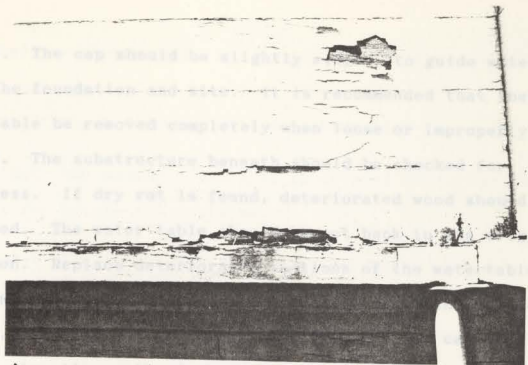
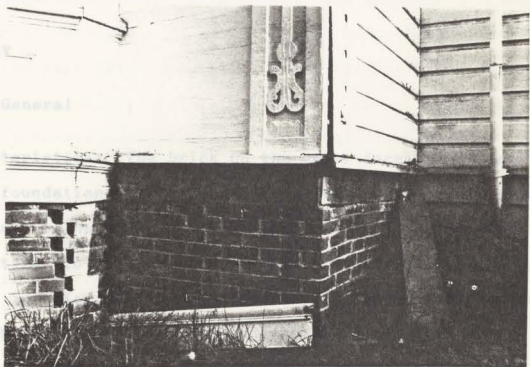
Conditions: It is in poor to fair condition, suffering primarily from water damage which is especially evident in the projecting cap (see fig 23a). Watertable caps are loose. Caulking, which is cracking, was added to the joints where the cap butts up against the house on the top and bottom.

Problems: The caulking underneath the watertable cap was added previously to secure the board. The caulking has leveled out the board, so that the board does not have the proper slope. This has caused the board's deterioration. Some portions of the watertable caps have been completely replaced by a board with inadequate slope; water does not run off properly. This is evident on the north elevation, especially on the bays, where the watertable caps are deteriorating. The watertable boards on the northwest corner of the front portion of the house have fallen off the building because of water damage (see fig 23b). These boards are not original, indicating a continuing problem. The watertable cap on the ell of the north elevation does not have a cove molding and is loose.

Figure 23: A. Watertable cap; east elevation.
 B. Deteriorating watertable and cap; north elevation.

RECOMMENDATIONS: If installed properly, the watertable cap should interlock with the siding and no caulking should be

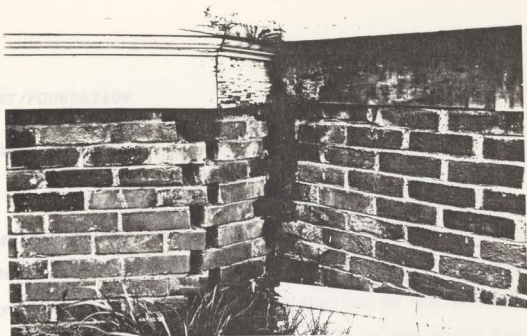
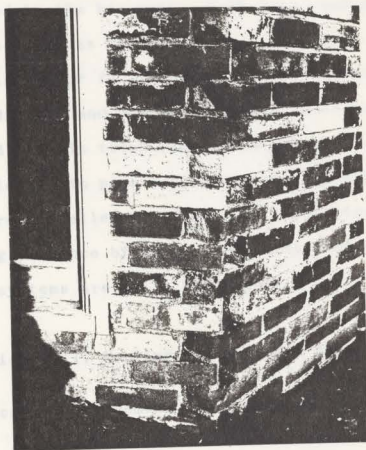
accurately reconstructed. Originally they were solid corner joints, not open joints (see fig 24b). Bricks in the basement are thought to be from the original foundation.

Problems: Moss is growing on some of the brick work around the front porch caused by high moisture content in the basement. A few bricks are starting to spall at the base of the porch and on the north elevation (see fig 24a).

Figure 24: A. Condition of bricks and water-
table; north elevation bay.
B. Detail of open corner joints on
south bay window foundation.

RECOMMENDATIONS: It is recommended that all moss be cleaned off the brick surface by hand. Plants and grass clippings should be kept away from the brick foundation to allow for proper ventilation. Future restoration plans should include a more accurate restoration of the brick foundation facing. The type and color of the mortar, and the size, uniform color and the texture of the brick should be considered in restoration. The present foundation does not accurately represent the original brick foundation.

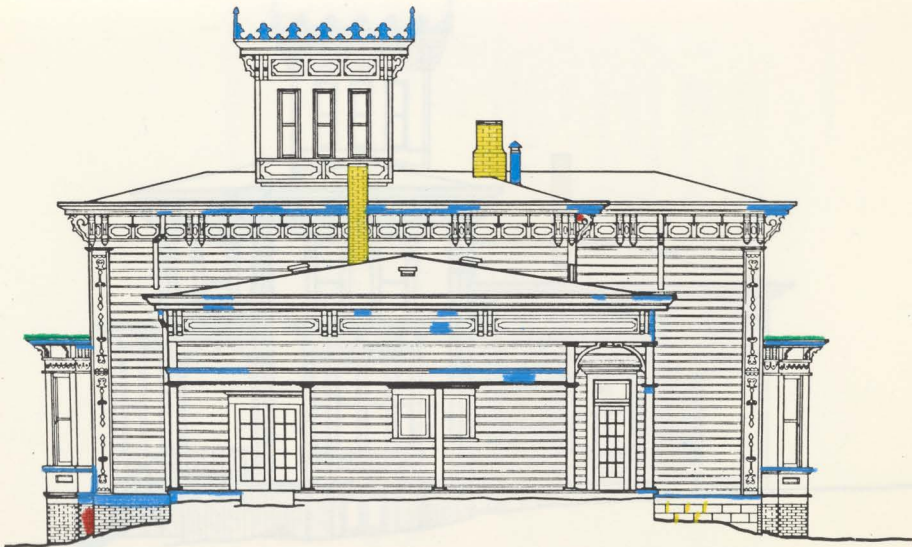
WEST ELEVATION

GENERAL PROBLEM AREAS

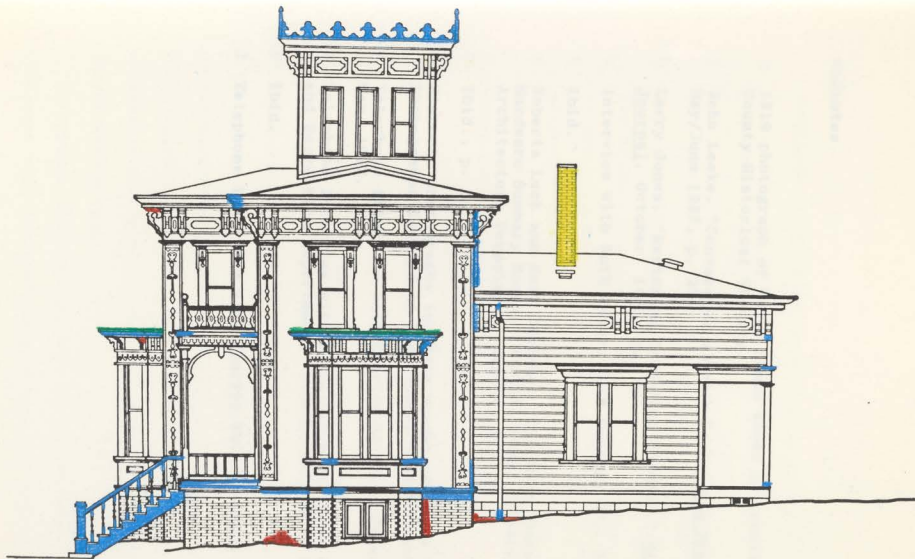
Figure 28
99

NORTH ELEVATION

GENERAL PROBLEM AREAS

- REPAIR OR REPLACEMENT NEEDED
- BRICK OR MORTAR DETERIORATION
- INSECT INFESTATION OR MOSS GROWTH
- STANDING WATER

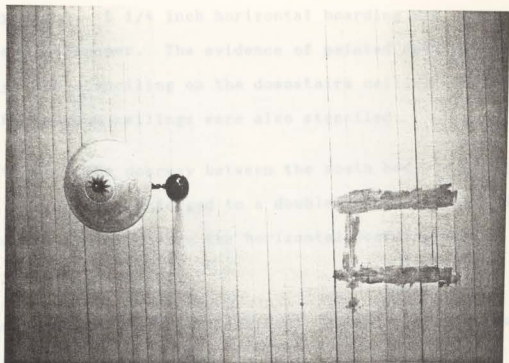
Brief Description: The north and south bedrooms' ceiling boards are 3 inch wide and run north/south. In 1982, ceiling boards close to the center of both rooms were cut out and then patched so insulation could be blown into the attic space (see fig 30b). This has damaged the continuity of the ceiling

Figure 30: A. Interior of north bedroom; looking north.
 B. Patching in ceiling boards; should be north bedroom.

extracted or exposed to be used as a pattern for new wall covering (see section 7.16, wallpaper recommendations). Ceiling stenciling or painting should be uncovered and restored (see section 7.15). Damage from insulation holes should be repaired to decrease their visibility.

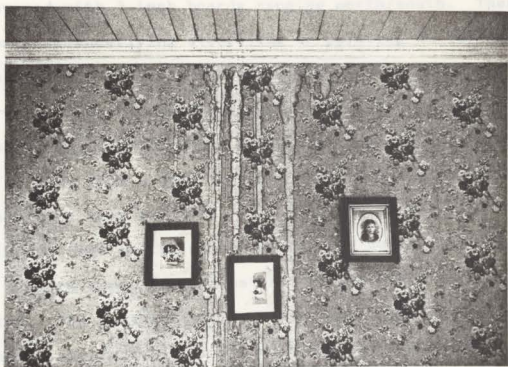
soffit at various points indicate that the gutters are not soldered or draining properly (see fig 9). Interior leakage through the roof structure from backed-up gutters is evident in the middle upstairs bedroom which could lead to rot in the ceiling framing (see fig 33b).

Brief Description: The bedroom's building material dimensions and features are the same as in the north and south bedrooms (see section 7.4). However, the middle bedroom differs in that it has diagonal wainscoting around its perimeter and a more finished baseboard with molded trim, similar to that of the downstairs rooms (see fig 33a). Water stains are present on the west wall and ceiling boards, attributed to leaks from backed-up gutters (see section 6.1 and fig 33b).

RECOMMENDATIONS: The water staining on the ceiling boards and west wall has been caused by water backing up in the gutters and water leaking through the roof framing and onto the

Figure 33: A. Interior of middle bedroom; looking southeast.
 B. Water staining on west wall of middle bedroom.

interior surfaces (see fig 33b). Routine maintenance of the gutters and downspouts should be performed to guard against further interior water damage (see sections 6.1-6.2).

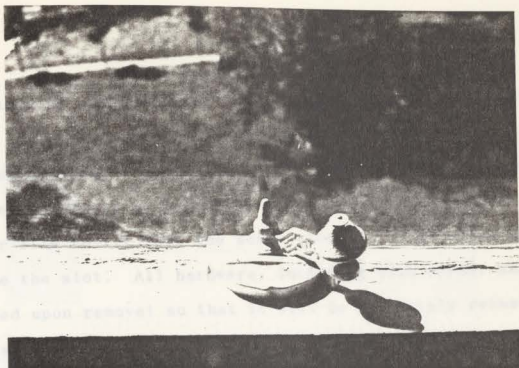
Brief Description: The hardware on the doors and windows is in fair to good condition. A majority of the window locks are intact with the exception of a few broken pieces (see fig 40a). Approximately one half of the sash cords and pulleys are still present. Multiple layers of paint cover the hardware, rendering most of the window hardware inoperable. The bedroom door hinges are typical of most of those in the house (see fig 41a). Various types of door knobs and lock boxes were installed at different times. Ceramic knobs, located on the interior of the bedroom doors, seem to be original (see fig 40b). It is unknown whether the glass knobs, which appear on the exterior or hall-side of the bedroom doors, are original.

Figure 40: A. Window lock; south bedroom.
B. Detail of ceramic door knob
and lock box; middle bedroom
door.

RECOMMENDATIONS: When individual rooms are being painted or restored it is recommended that the hardware be removed and stripped of paint to expose their original finish surface. Originally the hardware was probably either left unfinished or finished with a clear laquer. Movable parts should be lubricated and replaced in their original location. Care should be taken not to damage hardware or the surrounding area when removing pieces. Before attempting removal of painted hardware it is recommended that a razor be used to carefully cut an edge around the pieces through the paint layers. This will minimize the risk of breaking the hardware

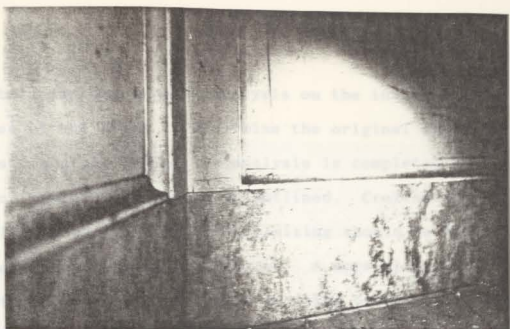
Figure 42: A. Marbelizing on baseboard located under window seat in parlor.

RECOMMENDATIONS: Care should be taken not to destroy the section of marbleizing under the window seat in the bay. This is valuable evidence which can be used in future interior finish restoration.

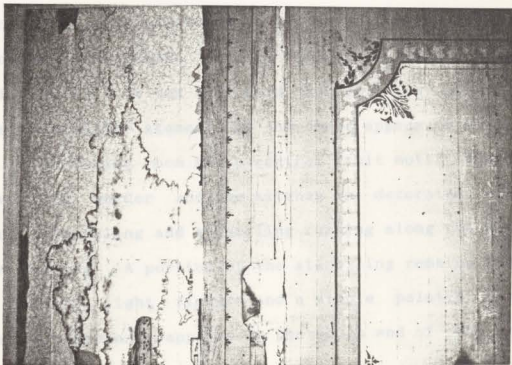
Previous Restoration/Rehabilitation: The ceiling painting and stenciling were uncovered in the 1970s. The ceiling border stenciling indicates the location of the wall which originally divided the room into two (see fig 47b). Boards used to patch the ceiling on the west end have remnants of wallpaper and stenciling on them. Stencil patterns from the kitchen and wallpaper from the sitting room are present on these boards. There are holes in the ceiling from tacks which once secured the cloth used as backing for the wallpaper that covered the ceilings. The horizontal wall boards were covered in the mid 1970s with gypsum board due to their deteriorating condition. Since only a portion of the wainscoting was left in the dining room, it was completely reconstructed. The wood and v-joint

Figure 47: A. Painted fruit motif in center of diningroom.
 B. Ceiling stenciling showing former location of wall; diningroom.

RECOMMENDATIONS: If any future restoration of the wainscoting occurs, the hallway wainscoting should be used as a model for its detailing. Any paint lines on ceilings should not be covered or removed.

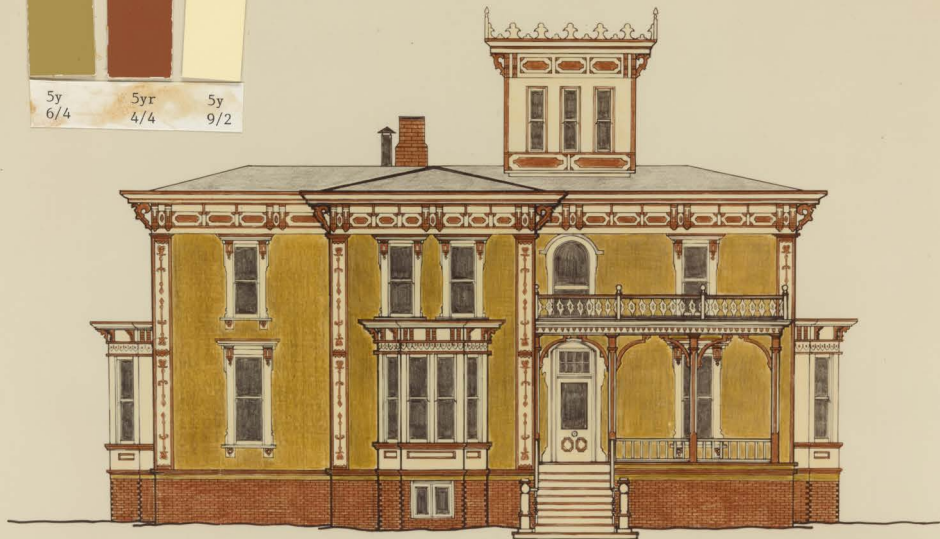
Figure 51: Recommended paint scheme.

scheme. The older of the two photographs (see fig 5) appears to show an "interim" color scheme in one of the trim accent colors changed from light to dark. The more recent photo (see fig 6) corresponds to the second paint layer: yellow, dark brown and cream. This is the last paint layer before multiple white layers occur in the sequencing. Figure 50 relates the paint layers with the corresponding architectural elements and associated photographs (see fig 51 for color rendering of recommended paint scheme and selected Munsell color samples).

It is recommended that the Moyer house be painted olive, the first body color, (5y 6/4), dark brown (5y 4/4), and cream (5y 9/2) the interim color scheme (see fig 51), for the following reasons: (1) it is shown in fig 5, which provides excellent documentation of the paint scheme in relationship to each architectural element, and (2) it represents the older of the two paint schemes depicted in the photographs which is more representative of the period of the house's construction and reflects a very popular color scheme used in the 1880s. Rich, dark greens, greys, browns and olives were common in the Victorian age, often referred to as the "muddying" or browning of America.

A rendering of the recommended color scheme can be found in figure 51 and a list of architectural elements and their appropriate colors in Appendix D.

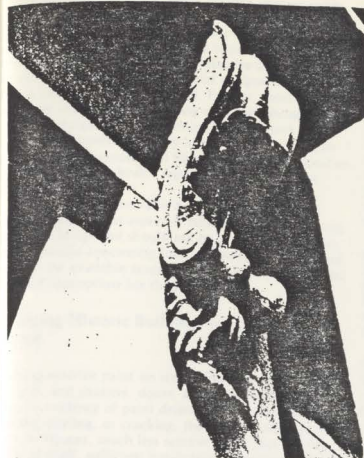
Although paint problems are by no means unique to historic buildings, treating multiple layers of hardened, brittle paint on complex, ornamental—and possibly fragile—exterior wood surfaces necessarily requires an extremely cautious approach (see figure 1). In the case of recent construction, this level of concern is not needed because the wood is generally less detailed and, in addition, retention of the sequence of paint layers as a partial record of the building's history is not an issue.

Fig. 1 Excessive paint build-up on architectural details such as this ornamental bracket does not in itself justify total paint removal. If paint is cracked and peeling down to bare wood, however, it should be removed using the gentlest means possible. Photo: David W. Look, AIA.

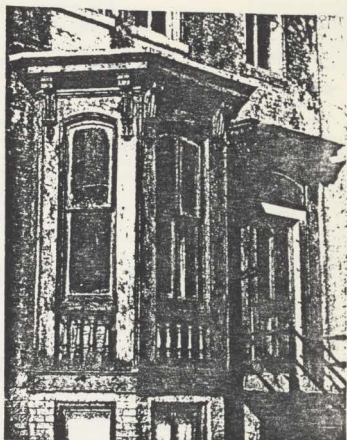
Fig. 2 A traditionally painted bay window has been stripped to bare wood, then varnished. In addition to being historically inaccurate, the varnish will break down faster as a result of the sun's ultraviolet rays than would primer and finish coats of paint. Photo: David W. Look, AIA.

been identified, the general approach should be to remove paint to the next sound layer using the gentlest means possible, then to repaint (see figure 2). Practically speaking as well, paint can adhere just as effectively to existing paint as to bare wood, providing the previous coats of paint are also adhering uniformly and tightly to the wood and the surface is properly prepared for repainting—cleaned of dirt and chalk and dulled by sanding. But, if painted exterior wood surfaces display continuous patterns of deep cracks or if they are extensively blistering and peeling so that bare wood is visible, then the old paint should be completely removed before repainting. The only other justification for removing all previous layers of paint is if doors, shutters, or windows have literally been "painted shut," or if new wood is being pieced-in adjacent to old painted wood and a smooth transition is desired (see figure 3).

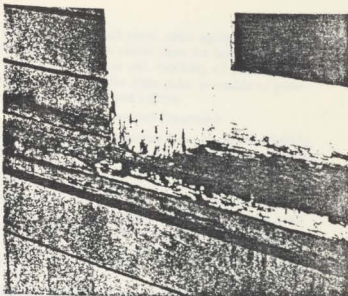
Fig. 4 Paint films wear unevenly depending on exposure and location. Exterior locations which are susceptible to accelerated deterioration are horizontal surfaces such as window sills. These and similar areas will require repainting more often than less vulnerable surfaces. In the case of this window sill where paint has peeled off and adjacent areas have cracked and alligatored, the paint should be totally removed. Prior to repainting, any weathered wood should be rejuvenated using a solution of 3 cups exterior varnish, 1 oz. paraffin wax, and mineral spirits/paint thinner/or turpentine to make 1 gallon. Liberal brush application should be made. This formula was tested over a 20-year period by the U.S. Department of Agriculture's Forest Products Laboratory and proved to be just as effective as water-repellent preservatives containing pentachlorophenol. After the surface has thoroughly dried (2-3 days of warm weather), the treated surface can be painted. A high quality oil-base primer followed by two top coats of a semi-gloss oil-enamel or latex-enamel paint is recommended. Photo: Baird M. Smith, AIA.
