RESTORATION AND PRESERVATION PLAN WITH DRAWINGS FOR
THE WOODEN BALUSTRADE AND URNS THAT EMBELLISHED
THE ROOF STRUCTURE OF VILLARD HALL

December 1988

A THESIS PROJECT

Presented to the Interdisciplinary Studies Program:
Historic Preservation,
the School of Architecture and Allied Arts,
and the Graduate School of the University of Oregon
in partial fulfillment of the requirements
for the degree of
Master of Science

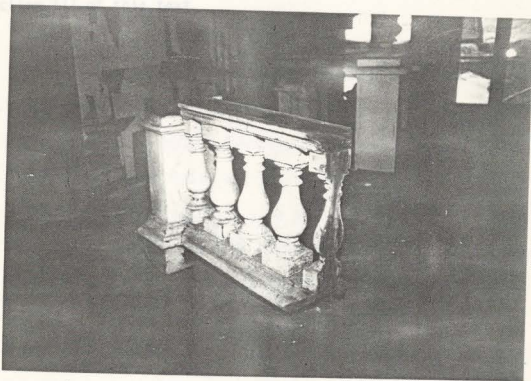
FIGURE 20. Balustrade Remains From the Morris M. Marks House Built in 1882--The Front-Entry Porch: 1988 View (Photograph retrieved from attic of house.)

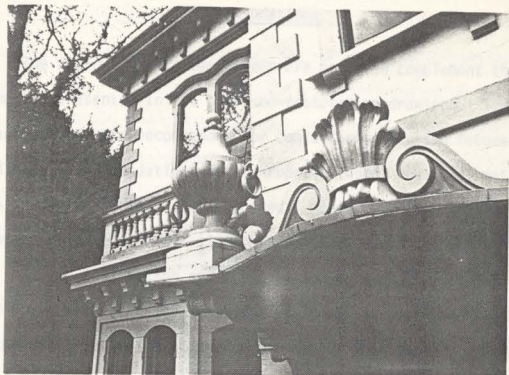
FIGURE 32. Glass Fiber-Reinforced Polymer Finial on the Kamm House in Portland, Oregon: 1988 View

The recommendation that seasoned Oregon cedar be the material implemented in the proposed restoration was arrived at after other substitute materials were explored as possible replacements. The glass fiber-reinforced polymer finials examined in Portland were found to have several advantages to the cedar replacement (see Figures 31 and 32); however, it was still concluded that cedar in combination with a galvanized-metal internal framework best balanced the criteria for the selection of materials as established by the Secretary of the Interior's Standards for Rehabilitation.

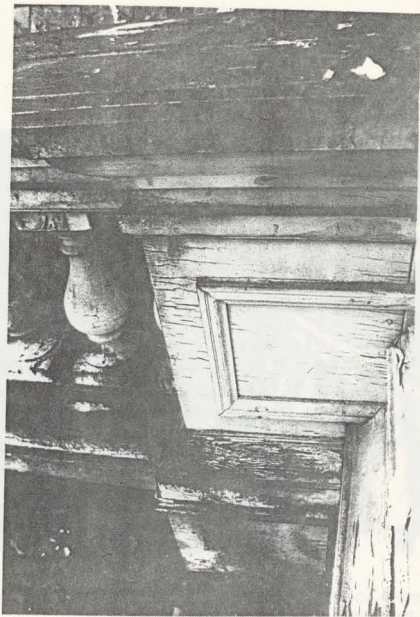
PHOTOGRAPH 1. Detail of Existing Engaged Pedestal on the North-Elevation Roof-Line Balustrade: Remodeled Circa 1949 (Note historically inaccurate flat-moulding profiles and the use of plywood.)

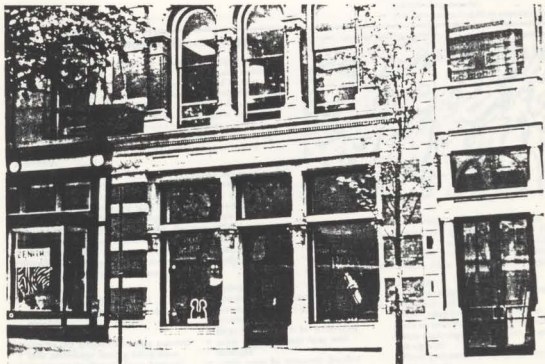
The new cast aluminum storefront replaced the lost 19th-century cast-iron original. Photo: Sharon C. Park, AIA.

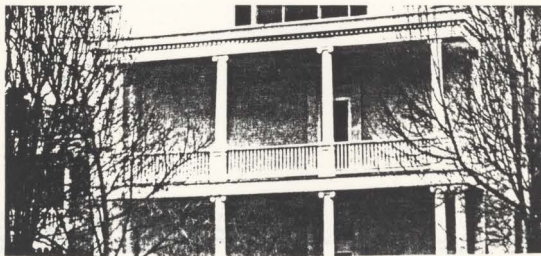
Columns were repaired and a capital was replaced in epoxy on this 19th-century 2-story porch. Photo: Dell Corporation
