HISTORIC STRUCTURES REPORT:

THE EDUCATION BUILDING AND COMMERCE HALL,
(THE WEST AND EAST WINGS OF THE GILBERT COMPLEX)
ON THE UNIVERSITY OF OREGON CAMPUS, EUGENE

A TERMINAL PROJECT
BY DAVID ADAM SINGER

UNIVERSITY OF OREGON
HISTORIC PRESERVATION DEPARTMENT
MARCH 2000

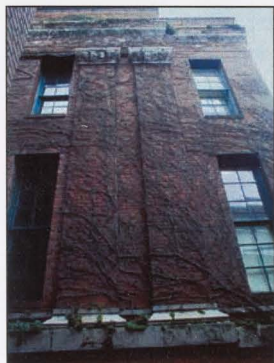
FIGURE 11: PILASTERS AT NORTH ELEVATION.
NOTE VINES AND GROWTH.

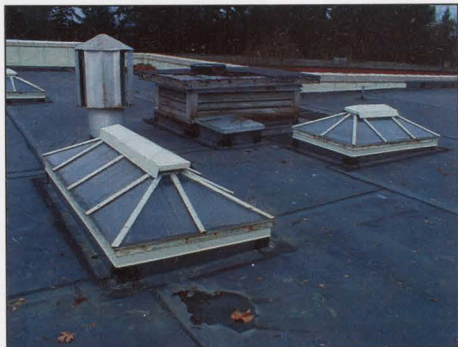
There are five historic gabled skylights on the roof of different sizes. Each is 4 foot 6 inches wide. Two measure 7 feet, two measure 6 feet and one measures 8 feet in length. The skylights use metal framing and mullions with a sheet metal ridge cap. Some of the glass appears original, and some has been replaced. The glass is set into the mullions with a silicon sealant. According to project documents, the skylights were cleaned, resealed and repaired during the 1992 re-roofing. Water leakage was present on the inside of several skylights. According the maintenance worker in charge of the repair, the new caulking did not appear to be dried or cracking badly, but the leak was due to a spotty application of sealant. Finish nails

were pushed through holes in the metal mullions where rivets or screws historically would have been installed. New 16 oz. Copper flashing was installed around the skylights during the 1992 re-roofing. The largest skylight measuring 14 feet by 6 ½ feet was removed and in-filled during the re-roofing.

FIGURE 35: GABLED SKYLIGHTS WITH OPERABLE VENT CAPS

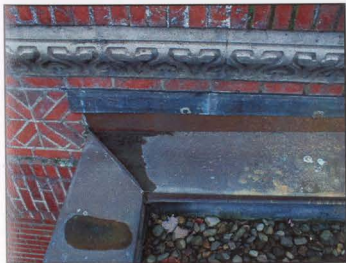
FIGURE 57: FLASHED CONNECTION AT THE TOP OF THE 1951 ADDITION.

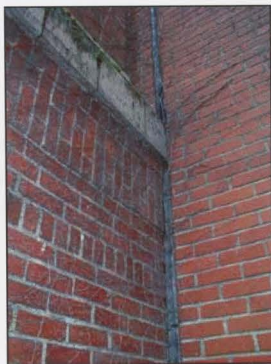
FIGURE 58: DETAIL OF THE EXPANSION JOINT SEAM BETWEEN COMMERCE HALL AND THE 1951 ADDITION

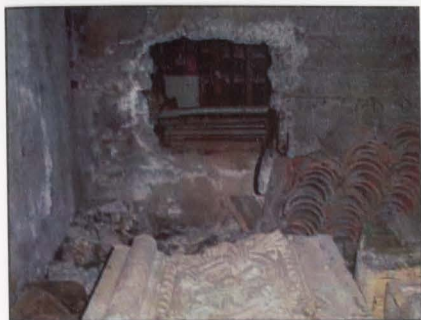
FIGURE 102: STAIR VAULT
Hidden access to the stair vault of the Education Building was found off the mechanical room, 112. The terra cotta was found in this space. A pilaster capital and a stack of terra cotta roofing tiles are pictured in the foreground.

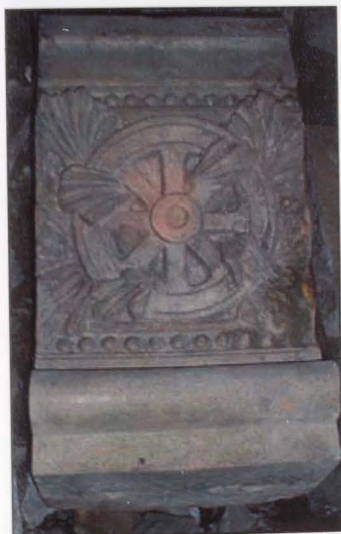
FIGURE 103: PILASTER CAPITAL
Type: Pilaster capital
Number: 1 each
Glazing: Glazed buff clay body
Size: 27"x15 1/2" x 14"
Condition: Good condition
Original Location: Extra piece

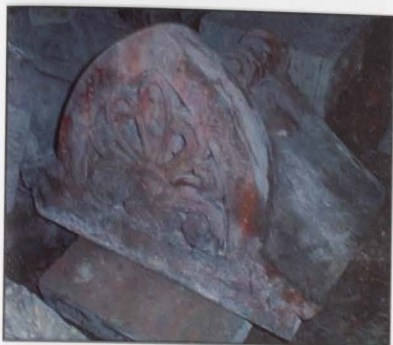
**FIGURE 104: CROWN PIECE**

Type: Crown piece
 Number: 3 total (1 pictured)
 Glazing: Unglazed red clay body
 Size: 27"x17"x19" at front
 Condition: Good Condition
 Original Location: Commerce

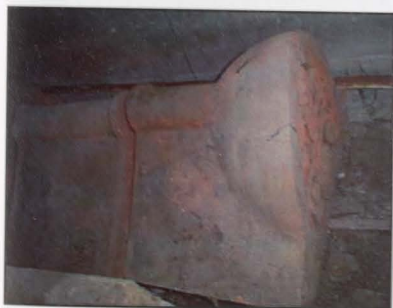
**FIGURE 105: CROWN PIECE**

Type: Crown pieces
 Number: 2 Pictured
 Glazing: Unglazed red clay body
 Size: 27"x17"15" at center
 Condition: Good condition
 Original Location: Commerce

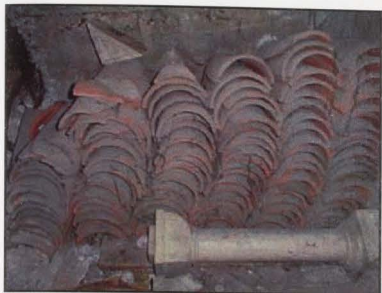
**FIGURE 106: ROOFING TILES**

Type: Roofing tiles

Condition: Good to poor

Original Location: Commerce

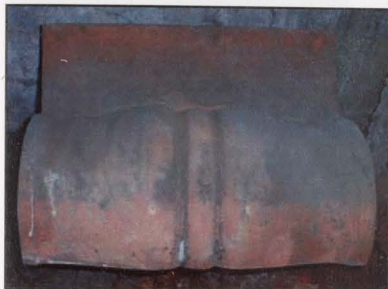
**FIGURE 107: EAVE CAP**

Type: Eave cap

Condition: Good condition

Original Location: Commerce

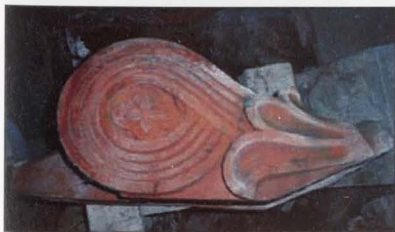
**FIGURE 108: EAVE CAP**

Type: Eave cap

Condition: Good condition

Original Location: Commerce

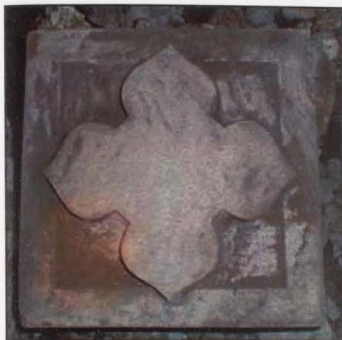
**FIGURE 109: QUATREFOIL IN RELIEF**

Type: Quatrefoil in relief
 Number: 1 each
 Glazing: Glazed buff clay body
 Size: 10 ½" square x 4"
 Condition: Good
 Original Location: Extra piece

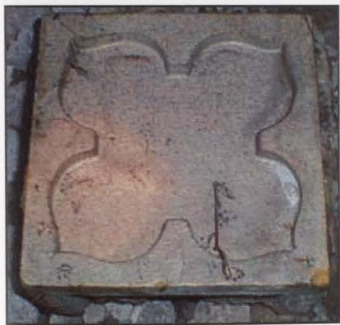
**FIGURE 110: QUATREFOIL INSET**

Type: Quatrefoil inset
 Number: 9 each
 Glazing: Glazed buff clay body
 Size: 8" square x 4"
 Condition: Good to fair
 Original Location: Commerce

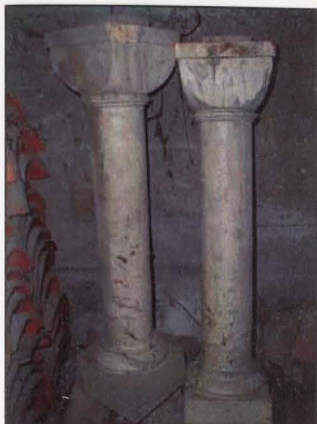
**FIGURE 113: BALUSTER**

Type: Baluster
 Number: 2 each
 Glazing: Glazed buff clay body
 Size: 27"x6"x6"
 Condition: Good condition
 Original Location: Extra piece

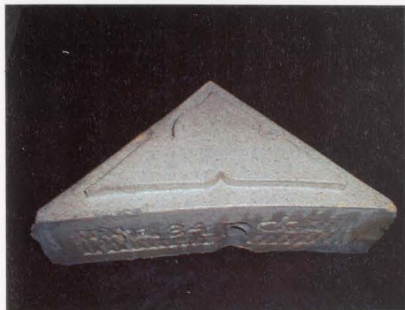
**FIGURE 116: CORNER DETAIL**

Type: Corner detail

Condition: Good condition
