# *Preserving the Institution*

A Preservation Strategy for the impending closure  
of the Sonoma Developmental Center

**BRIAN MATUK**

University of Oregon June 2016

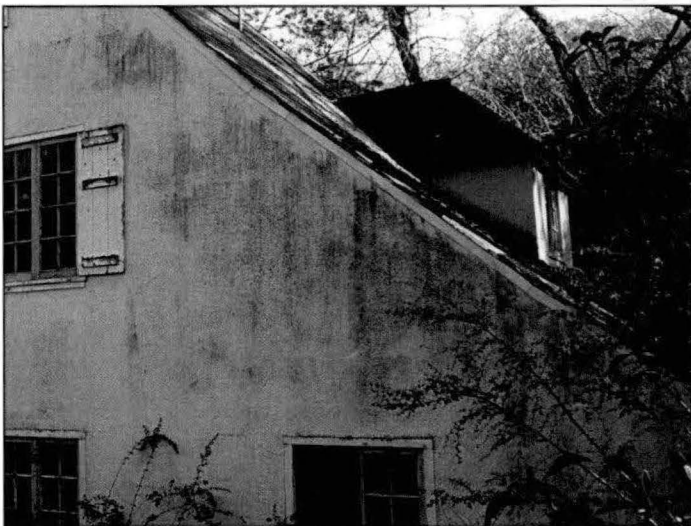
**Photograph A.4.** Severe moisture infiltration on exterior stucco.

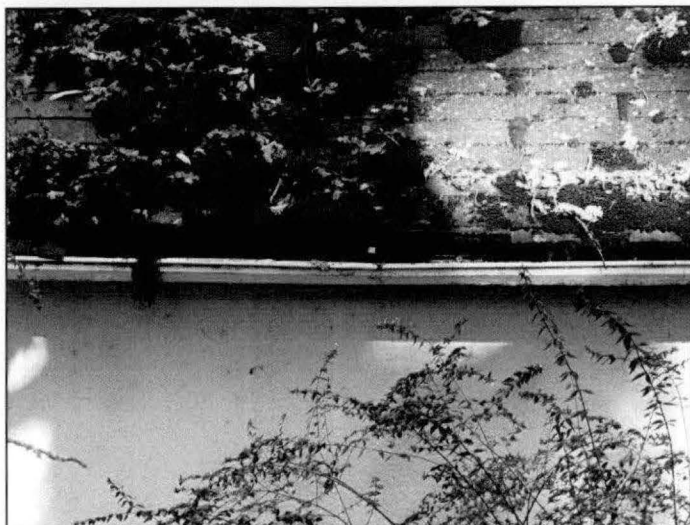
**Photograph A.5.** Severe biological growth on composite shingle roofing.

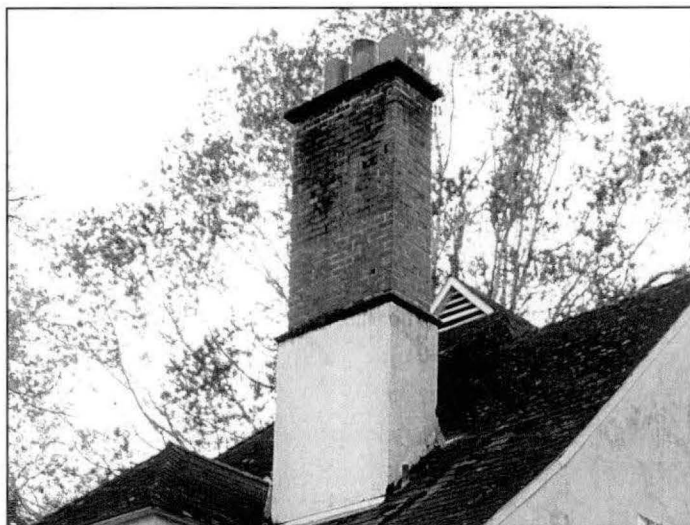
**Photograph A.6.** Moderate biological growth on brick chimney.

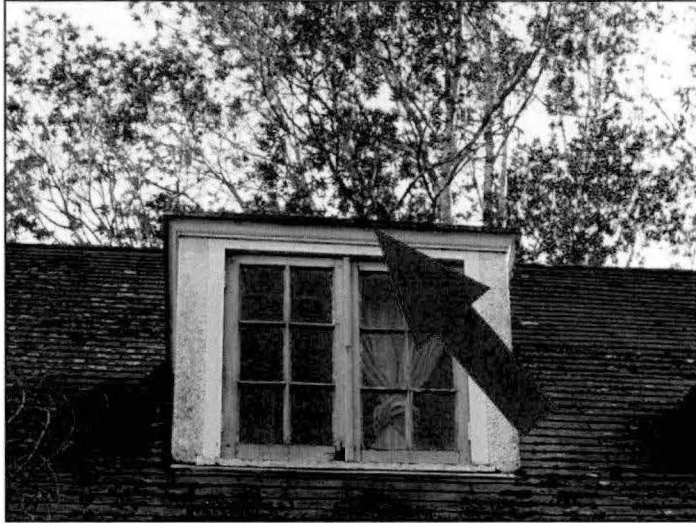
Photograph A.7. Severe corrosion of metal flashing.

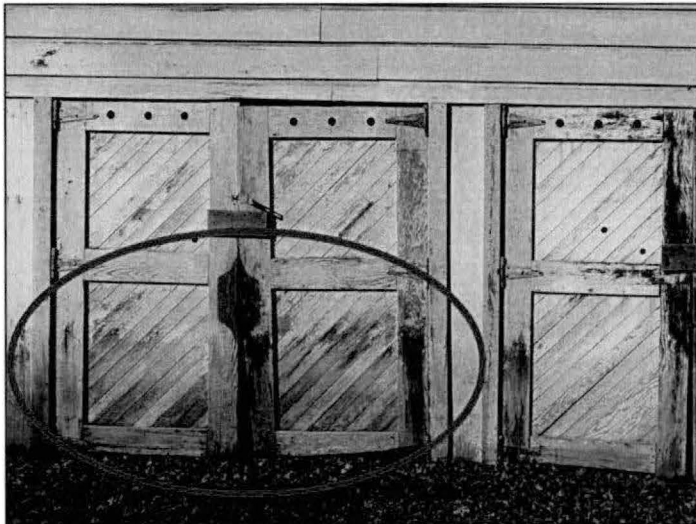
**Photograph A.12.** Rising damp on wood siding and wood double doors.

Although the building is already vacant, it is advisable to assess the condition of the wood doors and wood siding, and treat the moisture infiltration issue if the moisture content appears to be more than 20%.<sup>2</sup> If extensively decayed, consider replacing as few sections as possible to remediate the issue.

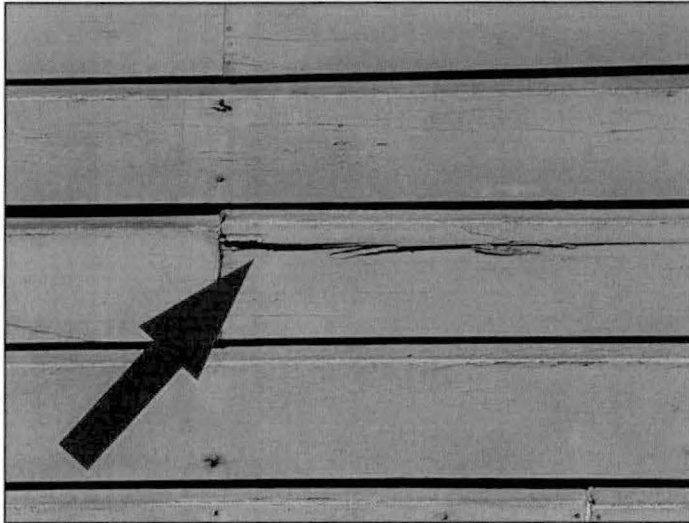
**Photograph A.13.** Minor checking of wood siding.

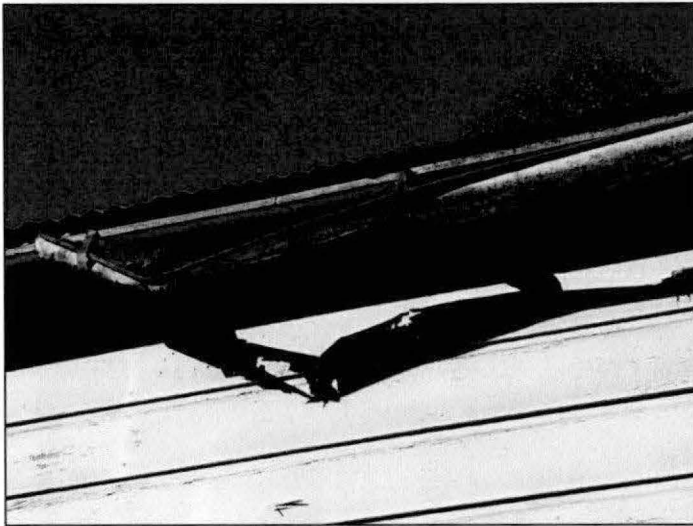
**Photograph A.15.** Broken and separating gutters.

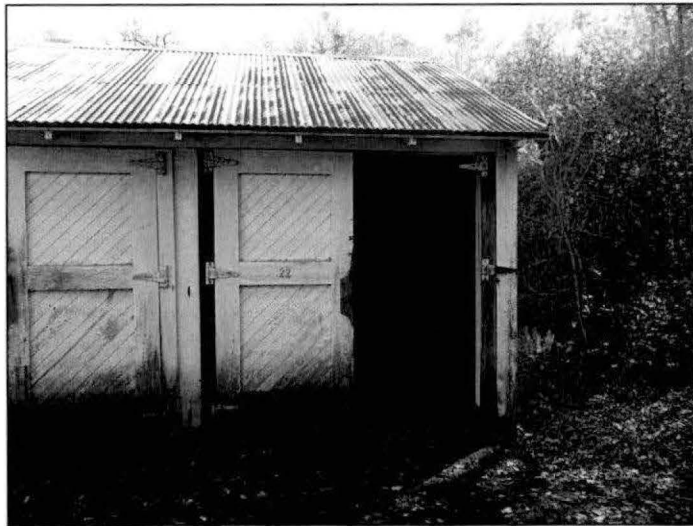
| Acacia Court Garages - Condition Issues | | | | | | |
|---|---|---|---|---|---|---|
| Other Elements | Missing garage door on western bay of upper level | | | | | |

**Photograph A.16.** Missing garage door on upper level.

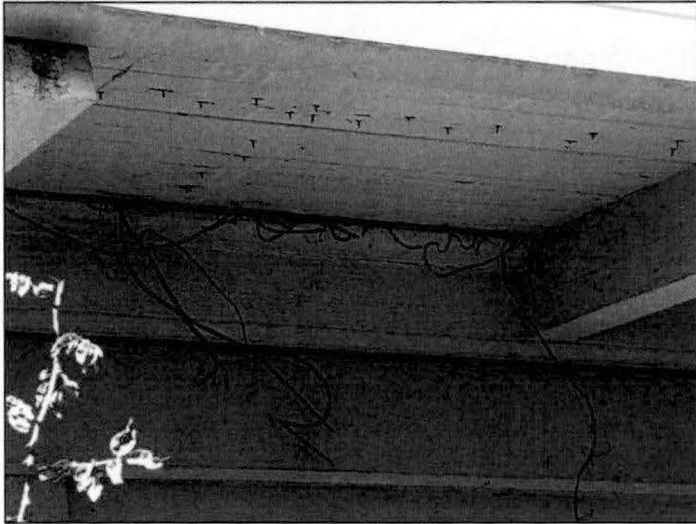
**Photograph A.24.** Climbing vegetation between the skip sheathing and the eaves.

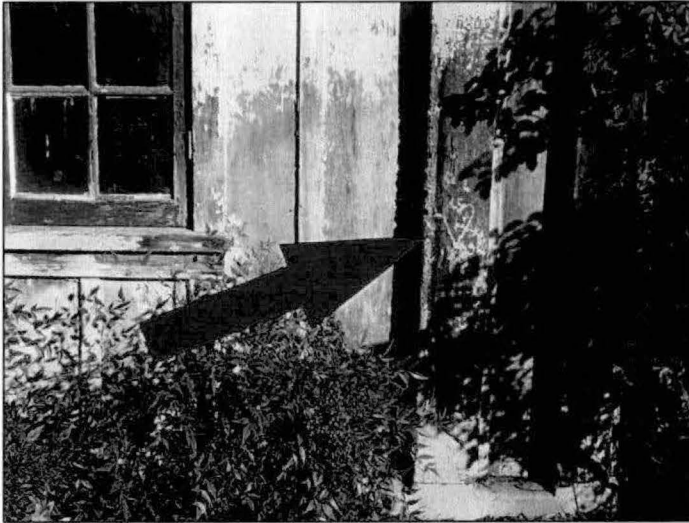
**Photograph A.26.** Vandalism in the form of carvings in the wood siding.

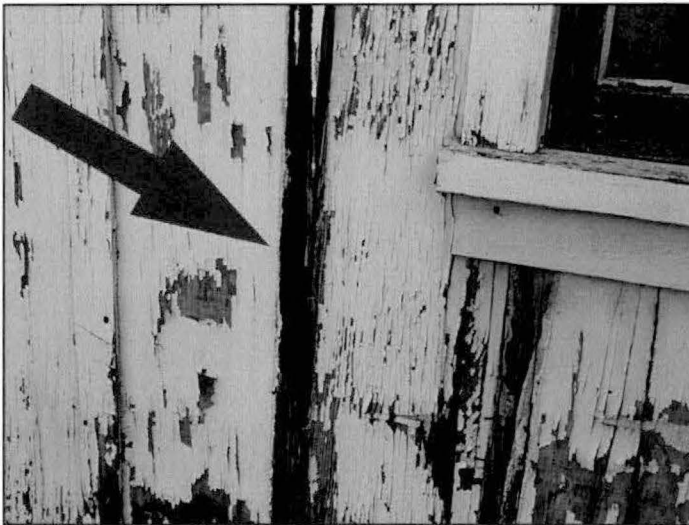
**Photograph A.27.** Missing wood battens.

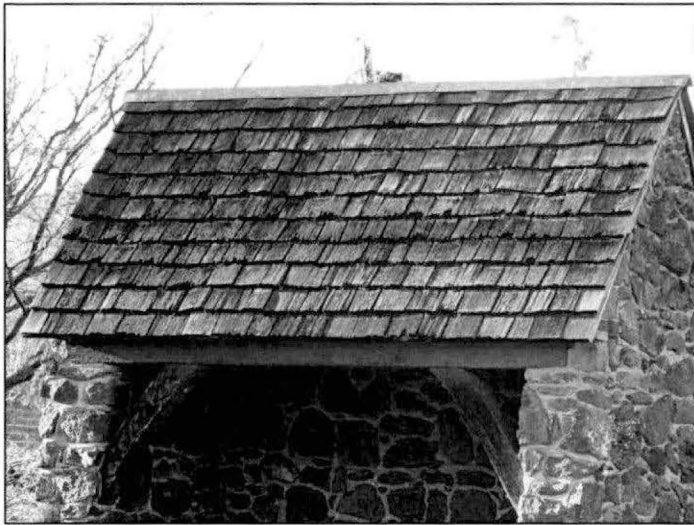
Photograph A.31. Biological growth on roof.

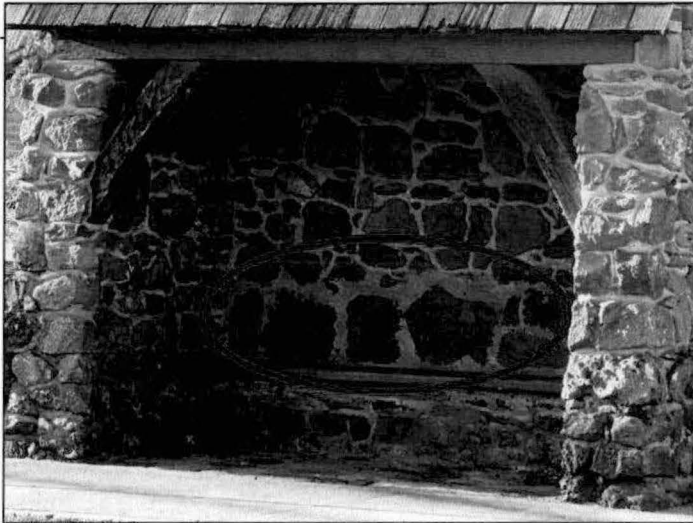
It appears that there has been some poor repointing on the interior, directly above the wood bench. Although the mortar substance of this repointing appears to be appropriate, the method did not respect the existing tooling depth, nor did it preserve the small stones that interspersed the larger ones.

**Photograph A.32.** Inappropriate repointing on interior wall.

Correcting inappropriate repointing is costly and will not be necessary unless the area shows signs of fracturing, excessive moisture infiltration, spalling, or other damaging effects to the joints or masonry units. If none of these red flags are raised, it might be more cost effective to wait until the area needs to be repointed again to correct the issue—even though it might be visually unappealing and diminishing to the historic character. Given the sloppy aesthetics of the poor repointing jobs, the affected areas will likely need to be repointed sooner than if the action was carried out appropriately.<sup>2</sup>

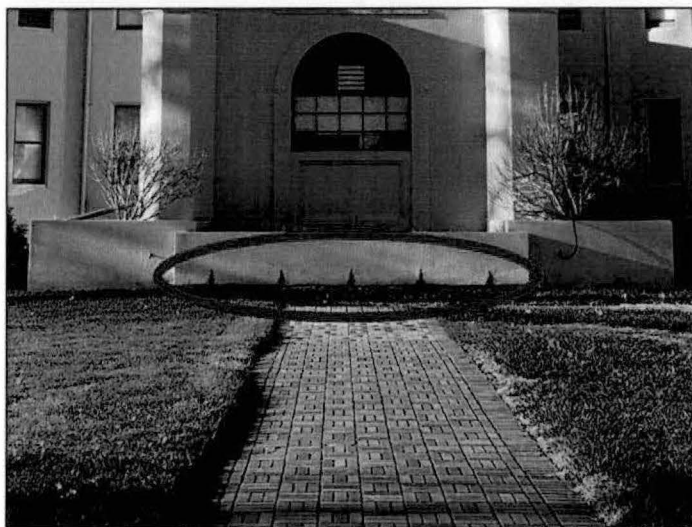
**Photograph A.38.** Minor moisture infiltration on sill wall due to five drain openings allowing water to drain onto the stucco.

There are five drain openings near the base of the building, which is causing water to drain onto the building's exterior, showing evidence of moisture infiltration. The drainage issue should be remediated before any repairs to the concrete are carried out. A suggested fix could reroute the drain openings, or for the drain openings to channel into gutters for drainage away from the base of the building. The affected stucco should be assessed as to the extent of the damage, to determine if the damage warrants treatment.

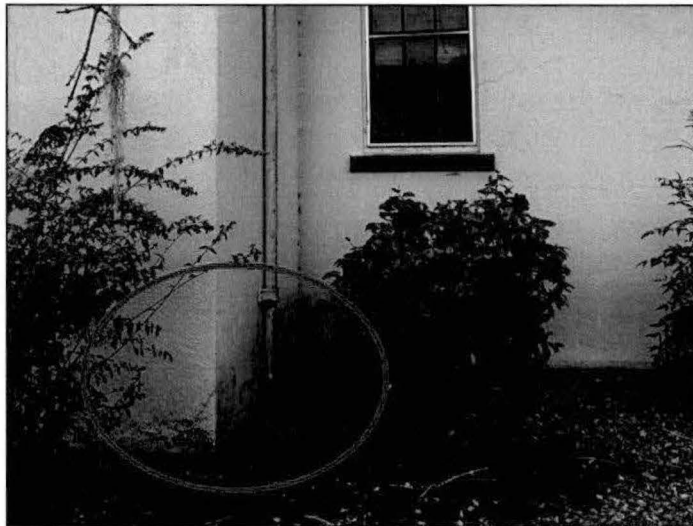
Photograph A.41. Minor rising damp on stucco.

The rising damp on the stucco is likely caused by the broken and corroding gutter system, presenting the opportunity for water to pond at the base of the building. The ponding issue should be remediated as soon as possible. The gutter system should be repaired or replaced before any remediation to the stucco is carried out.

The affected stucco should be assessed as to the extent of the damage, to determine if the damage warrants treatment.

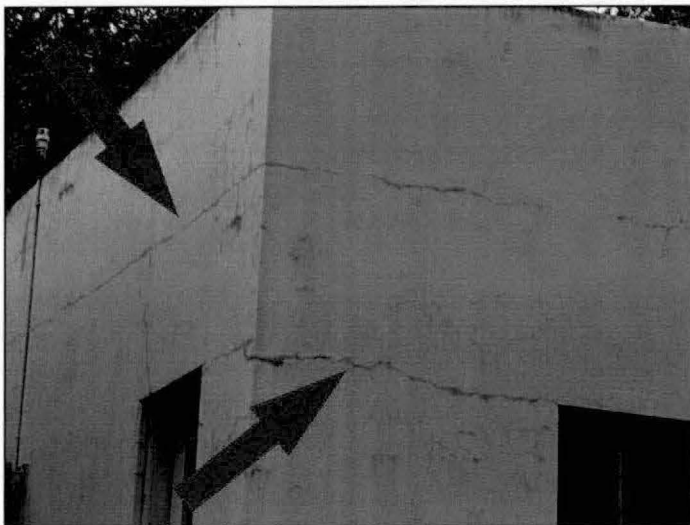
**Photograph A.45.** Severe hairline cracking with rust stains on stucco wall.

Several stucco exteriors at SDC exhibit hairline cracking. However, due to the fact that the hairline cracking has rust stains, there is a great probability that there is extensive moisture infiltration, causing corrosion of the substrate. This issue should be assessed immediately and thoroughly to determine if there is corrosion that needs to be addressed.

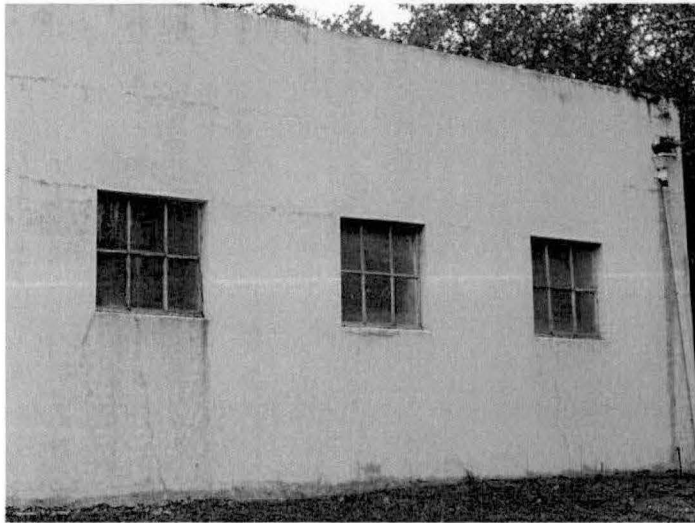
Due to the severity of the corrosion, and the potential for the corrosion to affect the exterior stucco, the windows should be removed, deglazed, and stripped of the corrosion. Then, the

Photograph A.46. Corroding metal windows.

windows should be primed and the glazing should be reinstalled before resetting the window into the opening.<sup>1</sup>

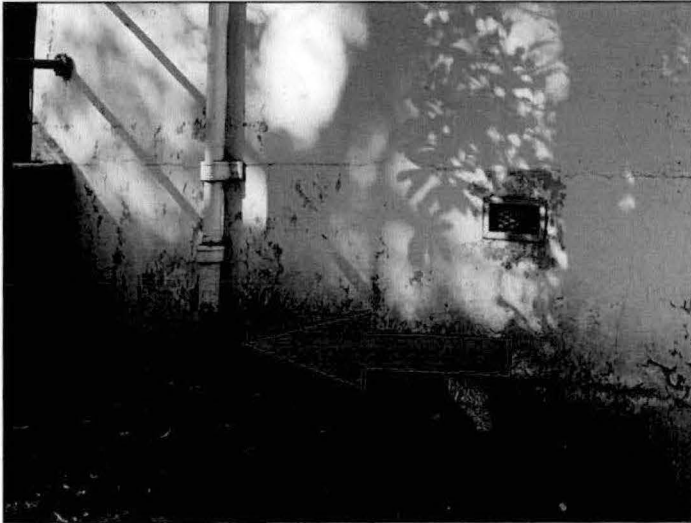
Photograph A.54. Broken downspout.

A broken downspout should be replaced with an operable one. This is to arrest any moisture infiltration to those areas directly attributed to a defective gutter system, if applicable.

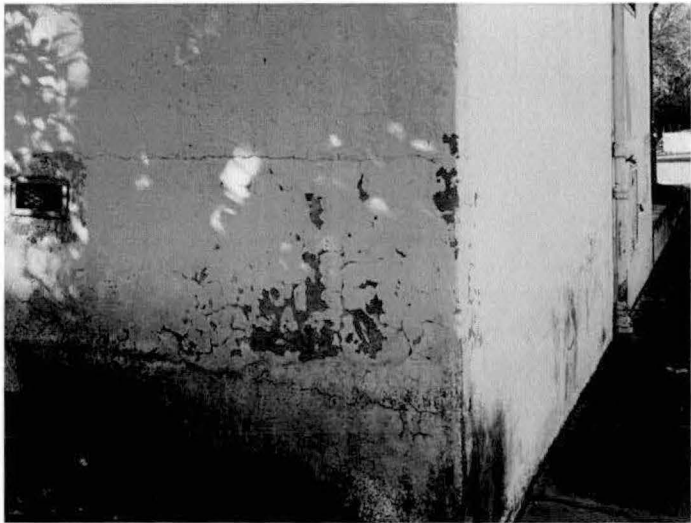
Photograph A.55. Chipping of exterior paint on concrete.

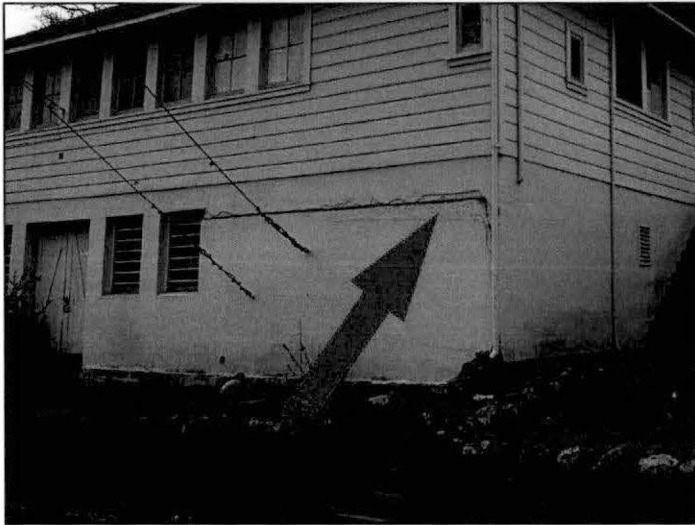
**Photograph A.64.** Severe cracking of concrete.

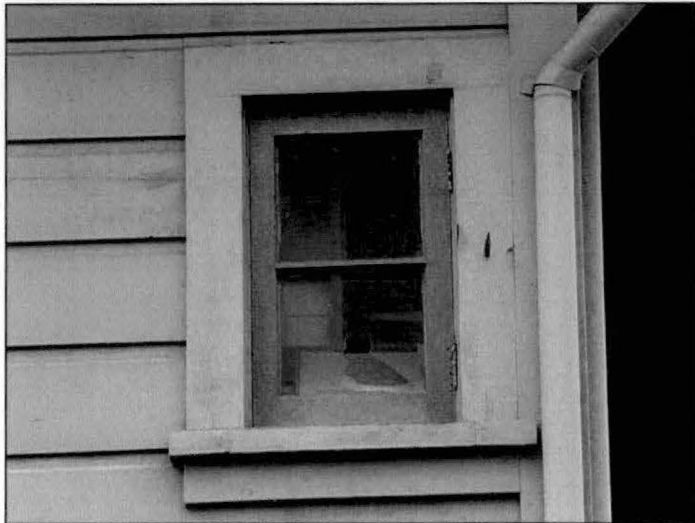
**Photograph A.66.** Broken window glazing on upper level of northeast elevation.

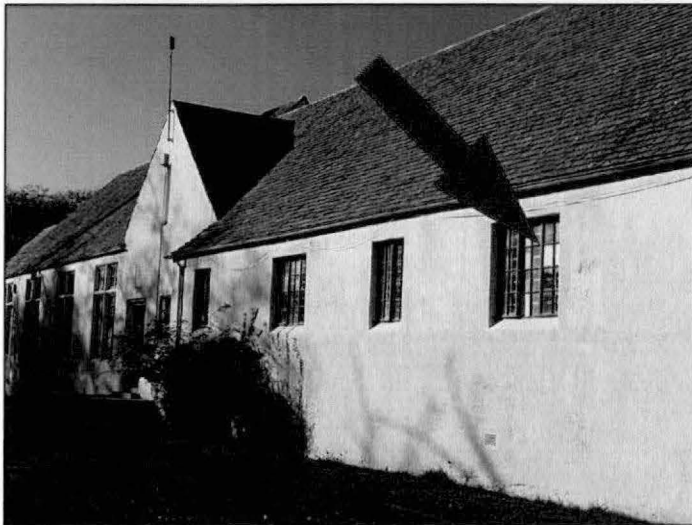
**Photograph A.70.** Broken window glazing replaced with opaque material.

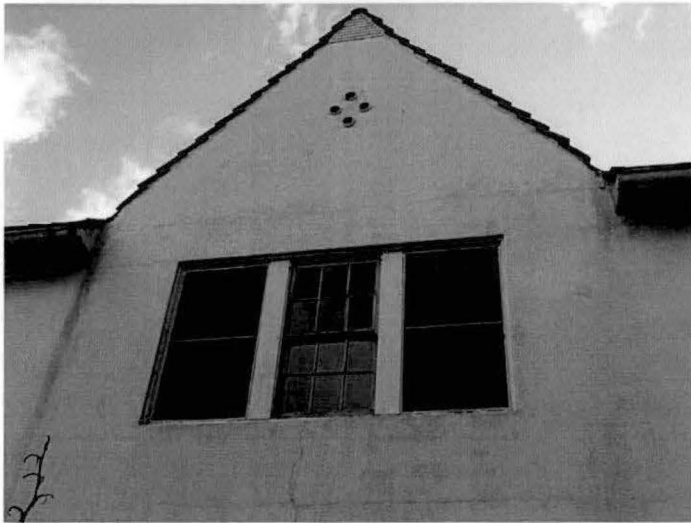
The moisture infiltration in the end gables appear to be caused by water draining down the exterior, due to the lack of a gutter system on the majority of the west elevation, broken downspouts, and little to no eaves. The wall should be assessed as to the extent of the damage, to determine if the damage warrants treatment. It might be wise to consider installing a gutter system on this northwest elevation that is mostly hidden from view, in order to retain the eave-less character of the Eclectic English Revival style.

**Photograph A.80.** Moderate moisture infiltration of stucco.

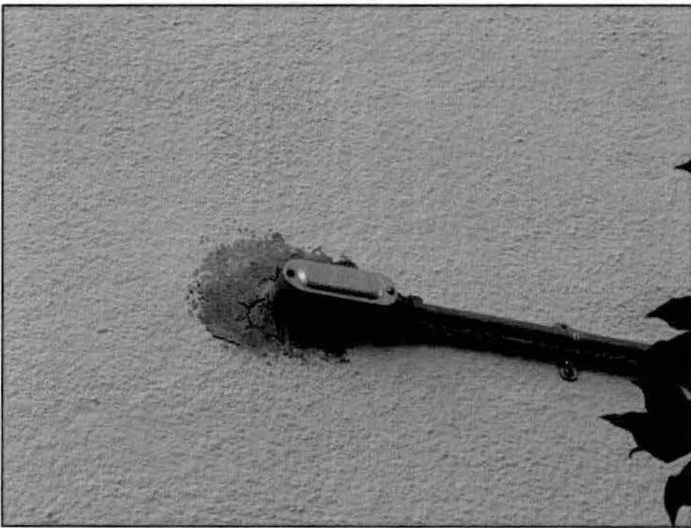
**Photograph A.81.** Inappropriate repair/patching to accommodate new metal conduit.

Areas of stucco have been removed to accommodate metal conduits, however, the patching has been applied with inappropriate material that is not compatible with the surrounding stucco. The patch should be assessed for its moisture infiltration potential, and should be replaced if it could retain moisture. If not, the patch should not be replaced at this time.

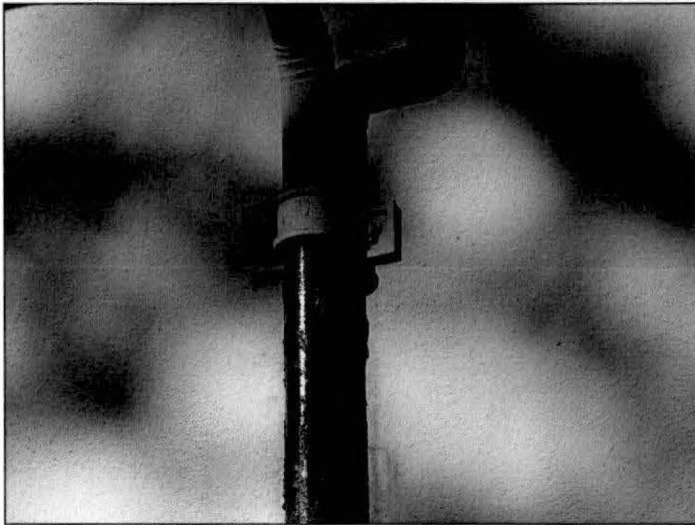
**Photograph A.82.** Corroding and leaking downspout.

Due to the severity of the corrosion, the affected sections of the gutters appear to be irreparable, and should be replaced. This will prevent excessive drainage onto the stucco exterior and will alleviate ponding near the base of the building.

A broken downspout should be replaced with an operable one. This is to arrest any moisture infiltration to those areas directly attributed to a defective gutter system, if applicable.

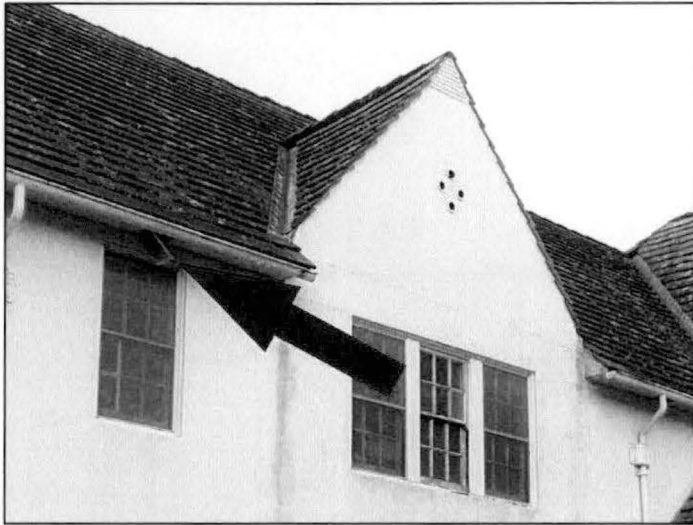
**Photograph A.84.** Vent screen is detaching from the vent in the eave.

The vent should be reattached immediately to prevent bird intrusions or excessive moisture infiltration.

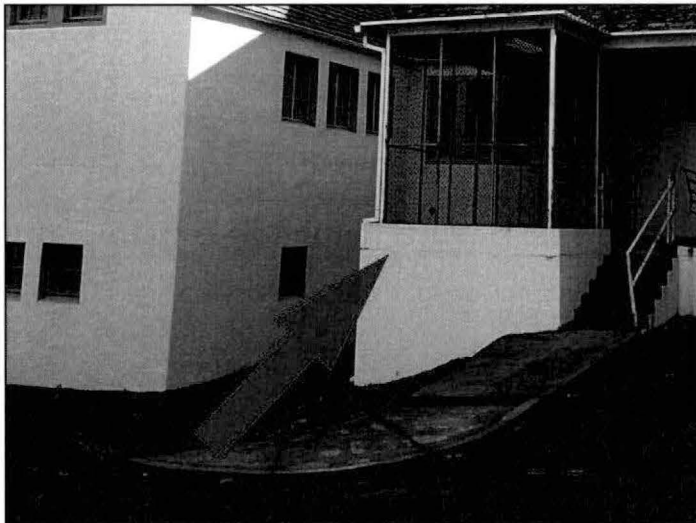
Photograph A.88. Minor hairline cracking of concrete.

Several stucco and concrete exteriors at SDC exhibit hairline cracking. Like with stucco, hairline cracking is not a cause for alarm, but can lead to further damage and secondary effects if not corrected or if the cracking enlarges. Due to the building's impending vacancy, it might be wise to patch the hairline cracks in order to avoid excessive moisture infiltration during vacancy.

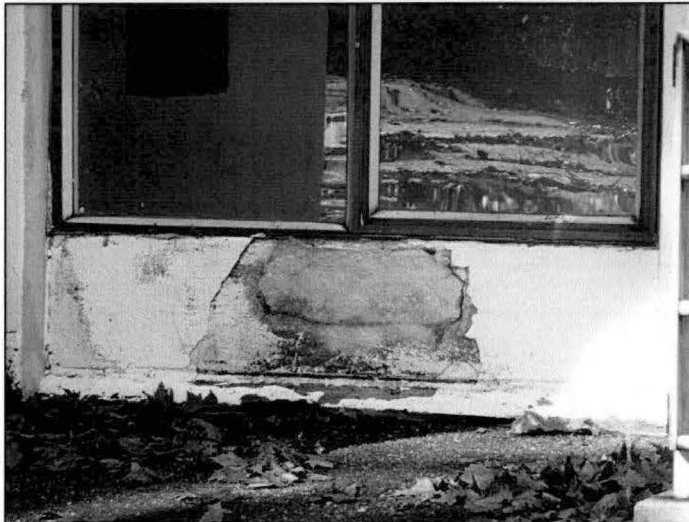
**Photograph A.89.** Moderate spalling of concrete.

Due to the potential for major underlying issues, any spalling of concrete should be further investigated. The affected area should be assessed to determine if there is any corrosion of the substrate. If corrosion of the substrate is the cause, then the appropriate steps should be taken to remediate the issue before the missing concrete is patched. If the spalling is due to rising damp or other moisture infiltration issues, then the cause of the moisture infiltration should be remediated before carrying out any concrete patching.

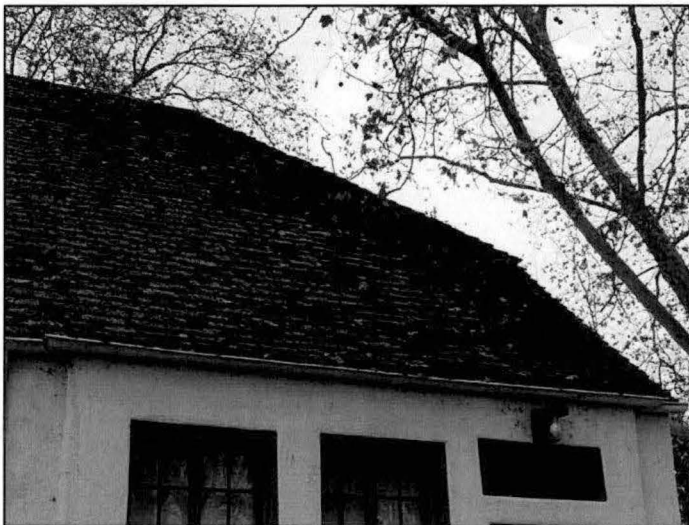
**Photograph A.90.** Moderate biological growth on roof tiles.

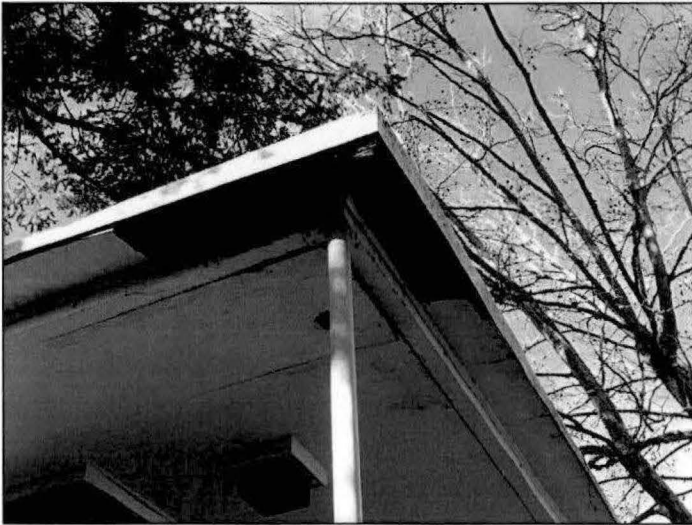
Due to the rust staining around the affected area, it appears that the broken soffit boards were likely affected by a moisture infiltration issue. An assessment should be performed on the area, and if there are leaks in the roof, the affected roof system should be repaired immediately. After remediating the underlying cause of

**Photograph A.91.** Broken soffit boards on porch overhang.

the soffit board damage, it is advised to replace the missing sections to avoid further deterioration.

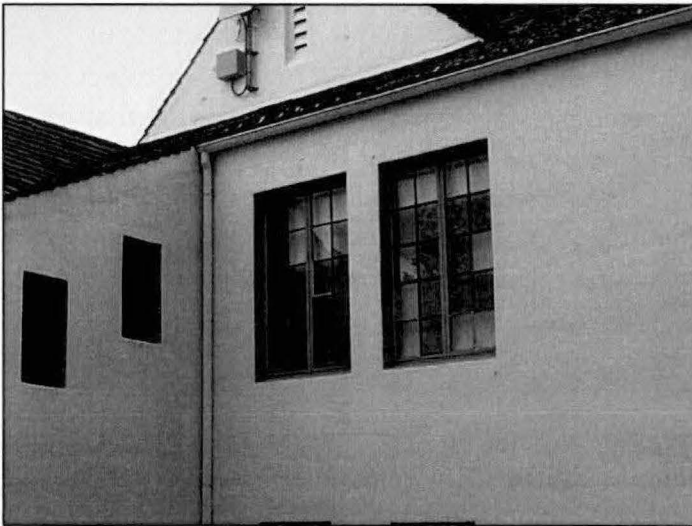
*Several window glazings have been replaced with an opaque material - Urgency Score 1*

**Photograph A.92.** Several window glazings have been replaced with an opaque material.

Considering the building's vacancy status, the opaque material is not advised to be replaced with glazing at this time.

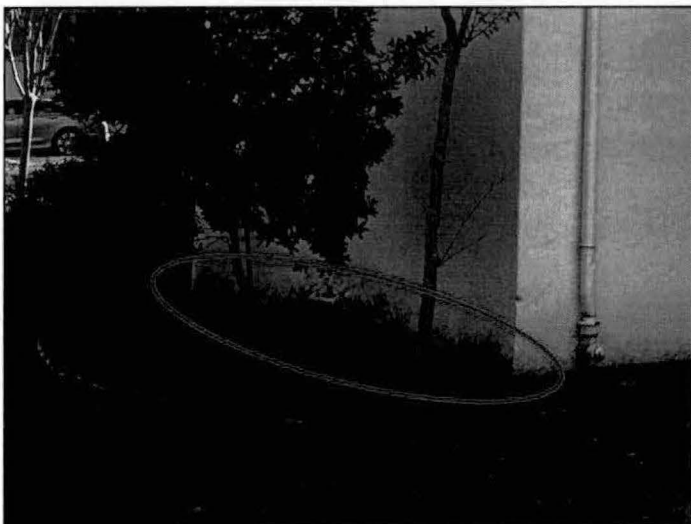
**Photograph A.96.** Moderate chipping of concrete at soil level, due to splashback.

It appears that the chipping of concrete is related to moisture infiltration and splashback, likely caused by water draining off the eave-less and gutter-less gable ends. It might be wise to consider installing a gutter system to these gutter-less gable-ends that is mostly hidden from view, in order to retain the eave-less character of the English Cottage style. This will assist in redirecting drainage away from the building's base.

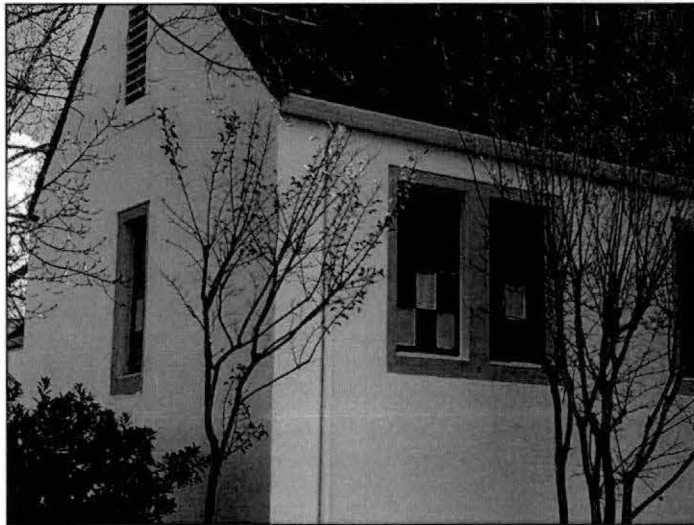
Photograph A.98. Several areas of window glazing have been replaced with an opaque material.

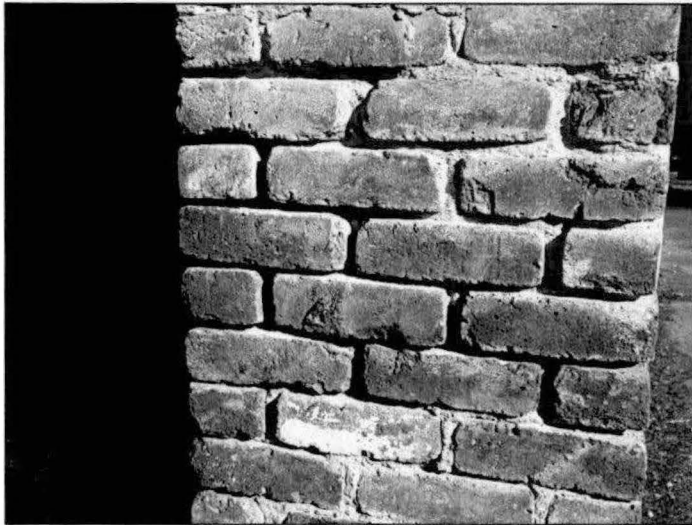
Photograph A.106. Severe missing mortar in brick walls.

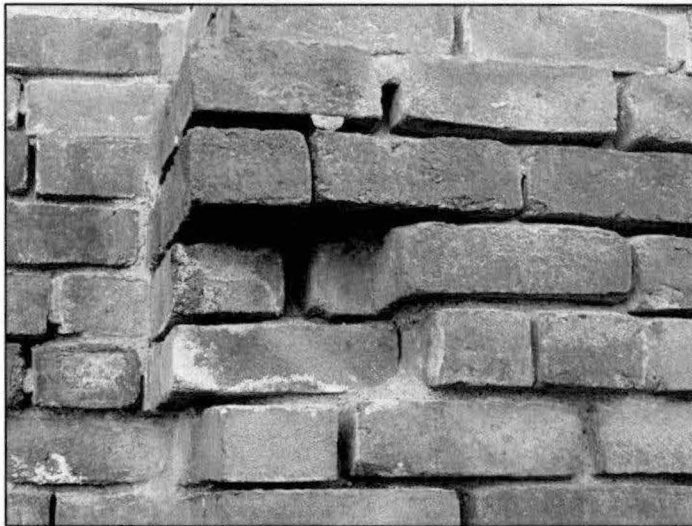
Photograph A.107. Missing bricks.

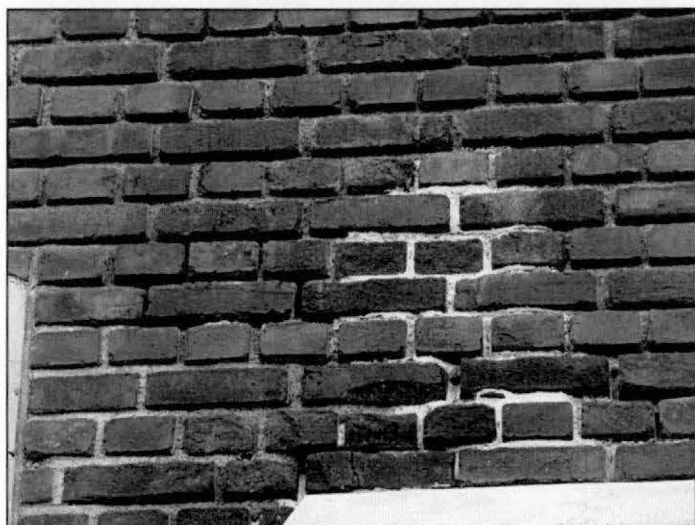
Photograph A.108. Inappropriate repointing.

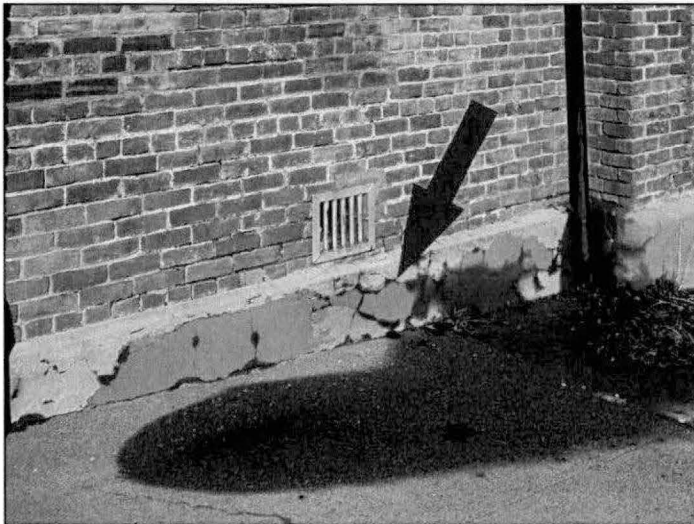
**Photograph A.110.** Severe hairline cracking on concrete foundation.

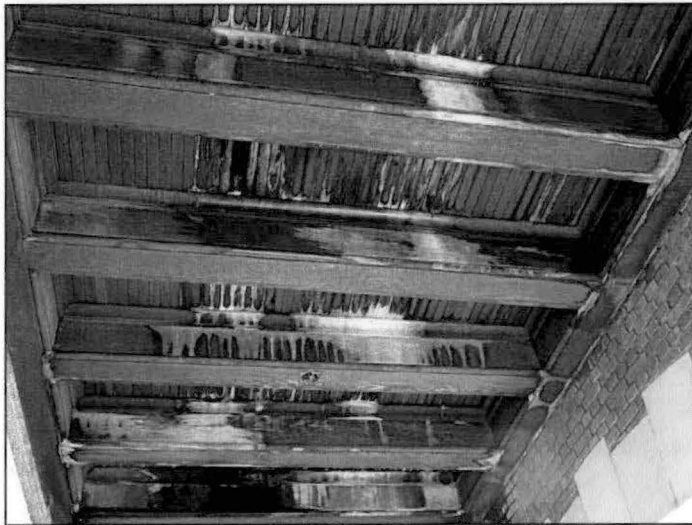
**Photograph A.112.** Severe moisture infiltration of wood sheathing in projecting entry porch.

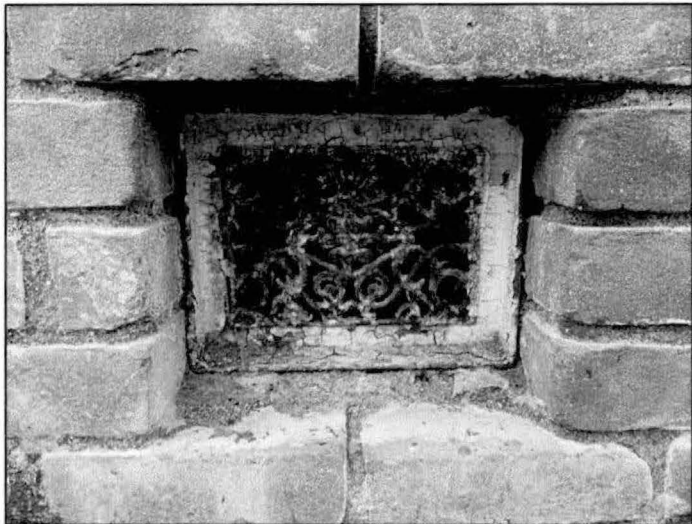
**Photograph A.113.** Severe corrosion of metal vent.

Due to the severity of the corrosion, the metal vents and metal mesh screens should be detached from the building, the rust be removed, and then be prepared, primed, and applied a topcoat. Before these metal elements are reattached, the affected exterior surfaces should be cleaned of any rust staining.

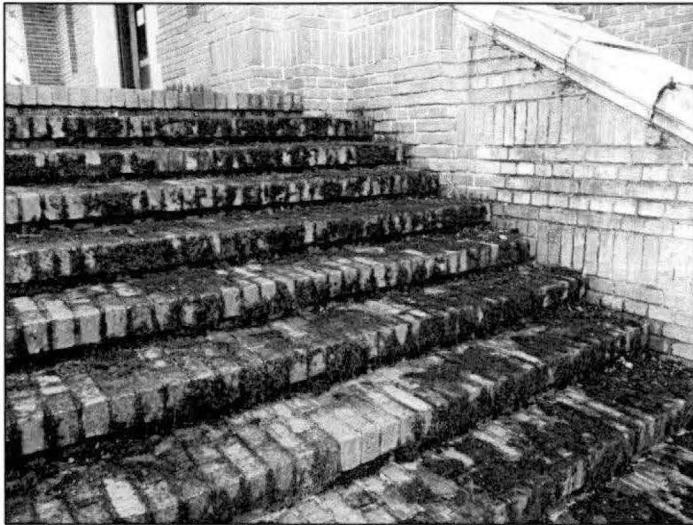
**Photograph A.114.** Biological growth on brick stairs.

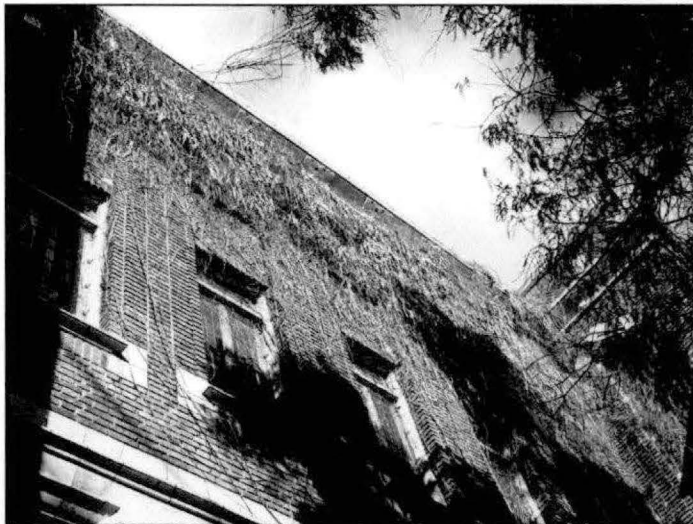
**Photograph A.115.** Severe climbing vegetation at the eaves on the north elevation.

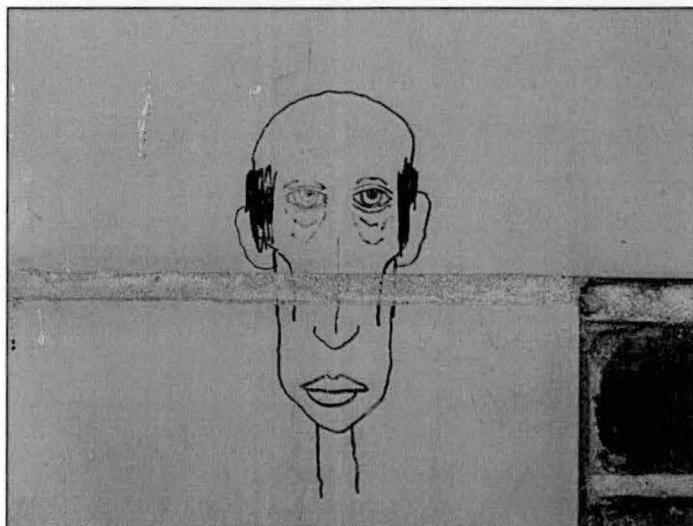
**Photograph A.116.** Minor vandalism on terra cotta surround of main entry door.

Due to the potential damaging nature that chemicals can have on terra cotta surfaces, it is advised to hire a consultant to determine the most appropriate and most conservative method for removing the vandalism. Although the building is vacant, and the vandalism is not causing further damage to the building, any visible vandalism can convey an image of inattention which can attract more vandalism or intrusions.

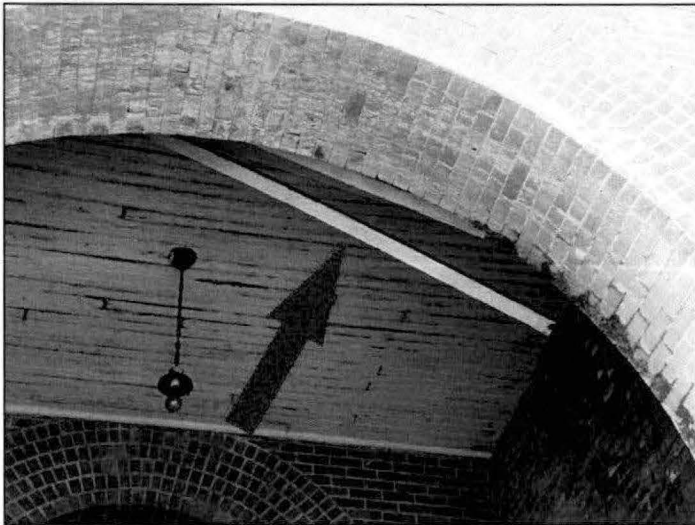
The cause of the detaching wood sheathing should be investigated to determine if there is an underlying issue. After the root cause is identified (if any), then the sheathing should be assessed for

**Photograph A.118.** A few pieces of wood sheathing in the inset porch are detaching.

damages. If there are no signs of significant decay, then the existing wood sheathing should be reattached.

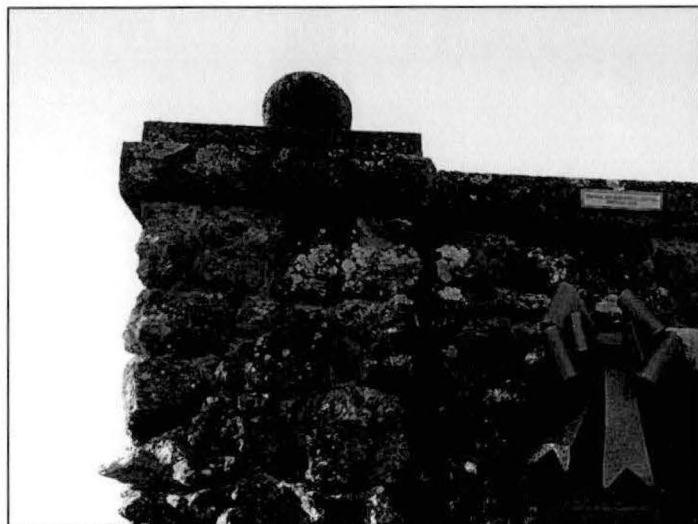
**Photograph A.123.** Biological growth on stone pier of the Main Gates.

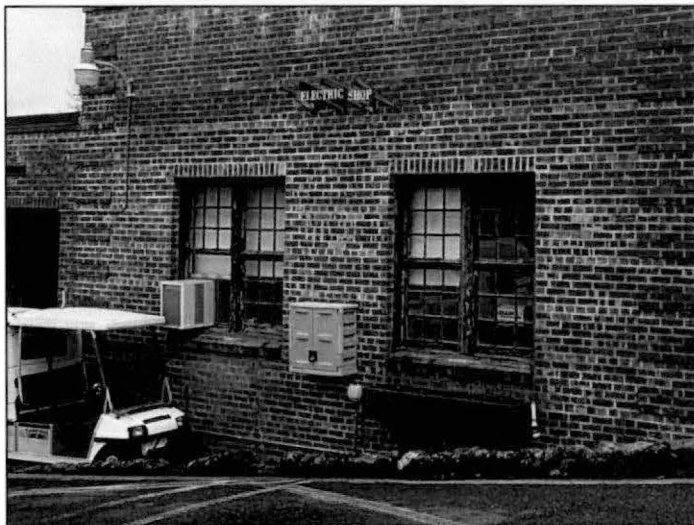
**Photograph A.127.** Inappropriate repointing of the brick surrounding the windows.

Correcting inappropriate repointing is costly and will not be necessary unless the area shows signs of fracturing, excessive moisture infiltration, spalling, or other damaging effects to the joints or masonry units. If none of these red flags are raised, it might be more cost effective to wait until the area needs to be

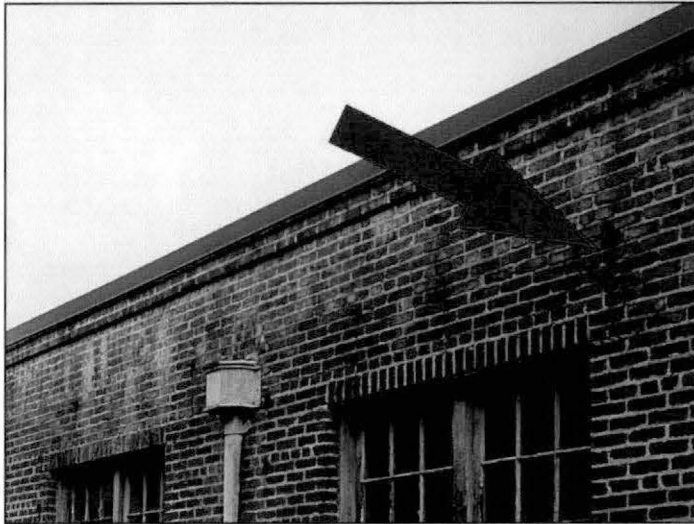
**Photograph A.128.** Moderate rust staining caused by the corrosion of exterior metal components.

### *Moderate rust staining on brick - Urgency Score 2*

Due to the fact that the rust staining appears to be caused by corrosion of exterior metal components, there is no cause for alarm. However, rusting metal can expand, potentially causing the surrounding brick to spall. The corroded components should be removed and replaced, and the affected bricks should be gently cleaned.

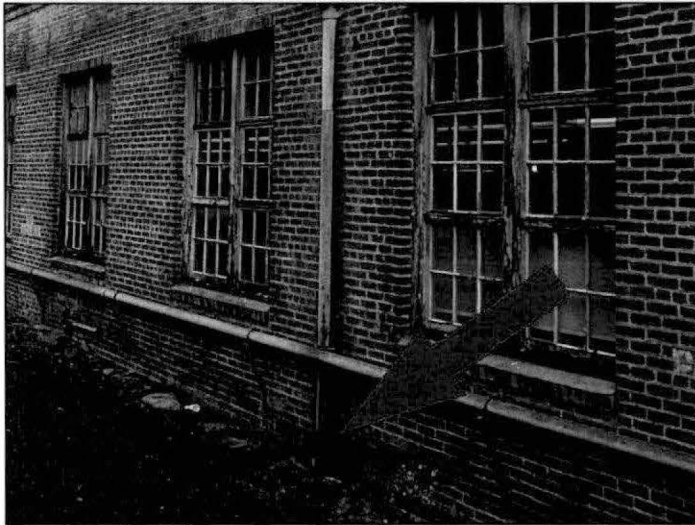
**Photograph A.130.** Corroding and broken downspout.

#### *Corroding downspouts - Urgency Score 2*

Due to the severity of the corrosion, the affected sections of the gutters appear to be irreparable, and should be replaced. This will prevent excessive drainage onto the stucco exterior, and will alleviate ponding near the base of the building.

The broken downspouts should be replaced with operable ones immediately. This is to arrest any moisture infiltration to those areas directly attributed to a defective gutter system, if applicable. Where there are leaks in areas of otherwise operable downspouts, the leaking areas should be patched.

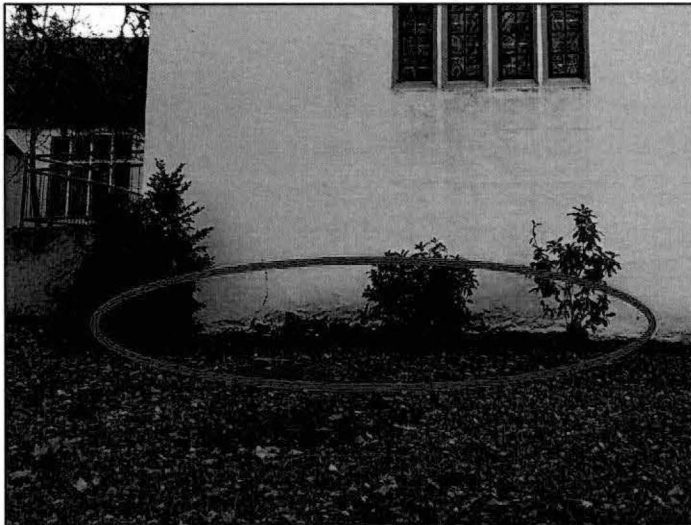
Photograph A.135. Minor rising damp on concrete.

The rising damp on the concrete is likely caused by the unmaintained gutter system, presenting the opportunity for water to pond at the base of the building. The ponding issue should be remediated as soon as possible. The gutter system should be repaired and cleaned of debris before repair to the concrete is carried out.

The affected concrete should be assessed as to the extent of the damage, to determine if the damage warrants treatment.

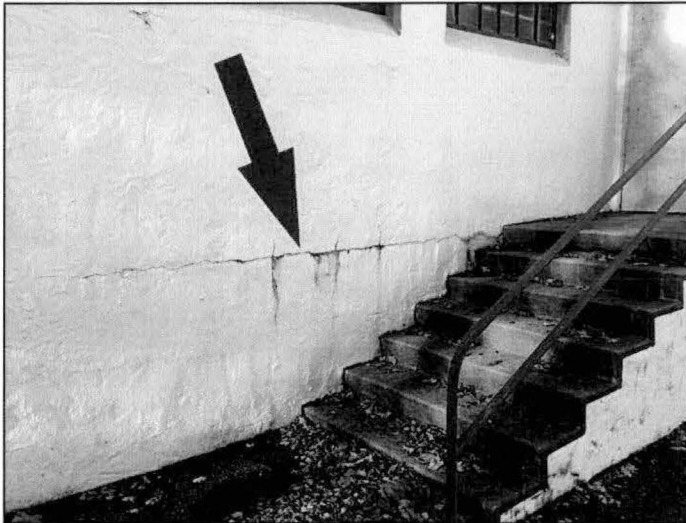
**Photograph A.136.** Moderate cracking in concrete.

### *Moderate cracking in concrete - Urgency Score 2*

The cracking in the concrete should be thoroughly assessed to determine whether it is an "active" crack, where an underlying issue might need to be addressed, or an "inactive" crack that will not cause extensive damage if left untreated. However, cracks in concrete can lead to moisture infiltration, and should be patched to avoid moisture infiltration. The results of an assessment will determine what steps to take to remediate an underlying problem, if necessary.

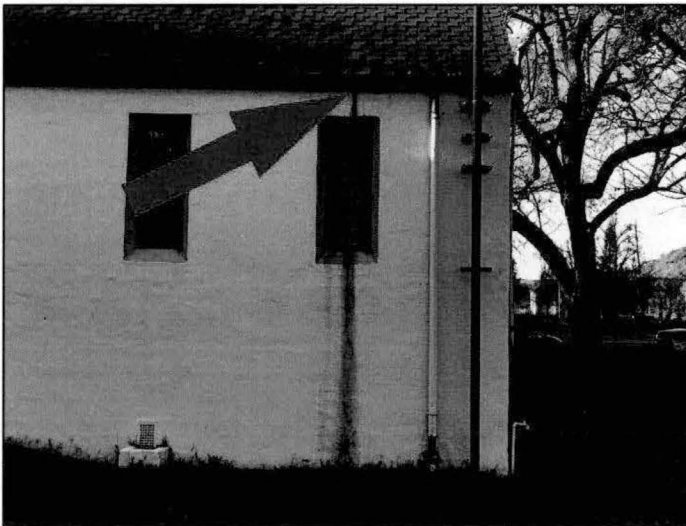
**Photograph A.137.** Corroding and leaking gutter.

The broken downspouts should be replaced with operable ones. This is to arrest any moisture infiltration to those areas directly attributed to a defective gutter system, if applicable.

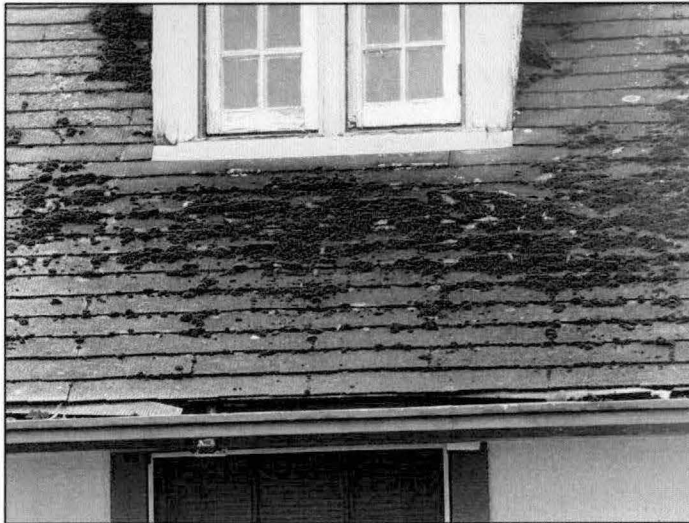
**Photograph A.142.** Moderate biological growth on composition shingle roofing.

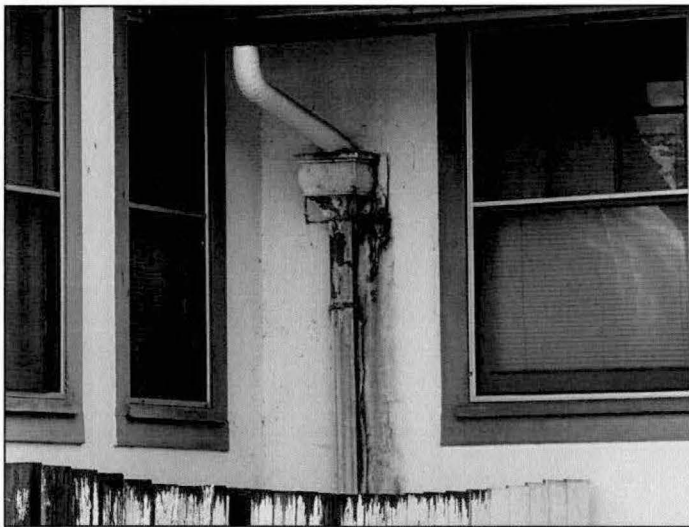
**Photograph A.143.** Corroding and leaking downspout.
