# *Preserving the Institution*

A Preservation Strategy for the impending closure  
of the Sonoma Developmental Center

**BRIAN MATUK**

University of Oregon June 2016

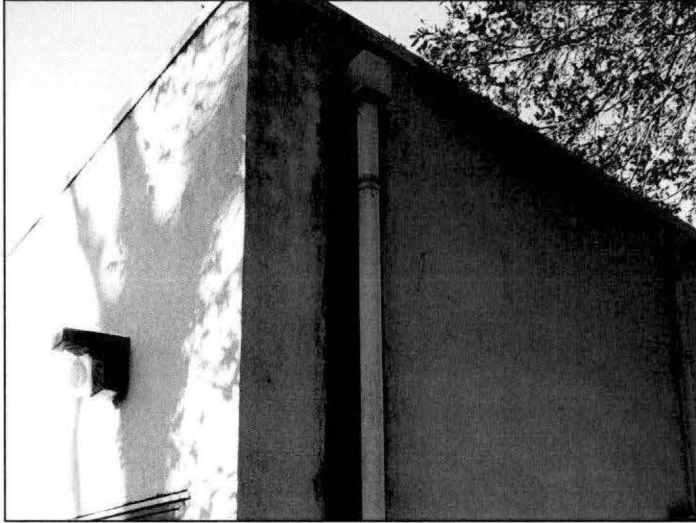
**Photograph A.149.** Leaking gutter system.

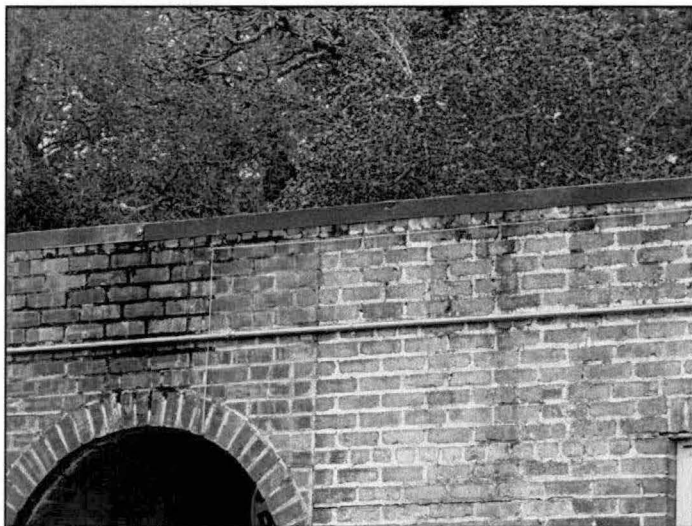
**Photograph A.154.** Severe efflorescence on brick exterior.

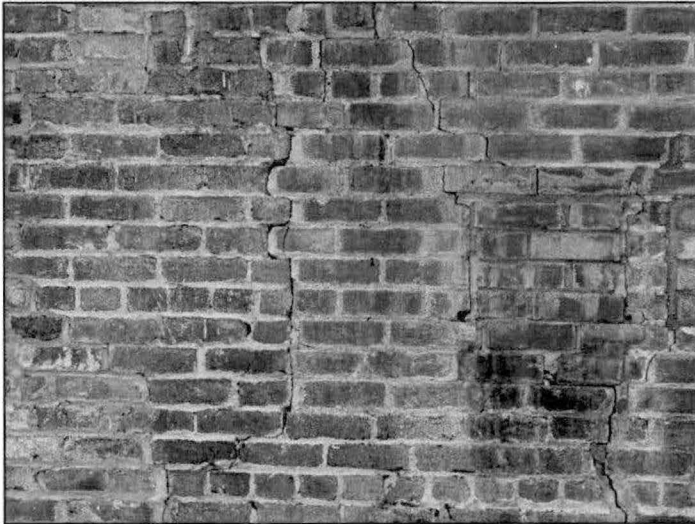
**Photograph A.155.** Severe cracking in brick wall, through both bricks and mortar.

The underlying cause to the severe cracking should be investigated immediately and thoroughly. The crack appears to be in a location that has been repaired with new masonry units and repointed. It is unknown at this time if the crack is a remnant of the extensive damage that had warranted the repair. Once the underlying issue is remediated, the crack should be immediately repaired, either through repointing if necessary, or patched to avoid any moisture infiltration. The cracked brick, on the other hand, should be replaced in the process if the crack extends to the rear of the brick. If the crack does not extend to the rear of the brick, the unit should be removed and reversed to retain the historic material.

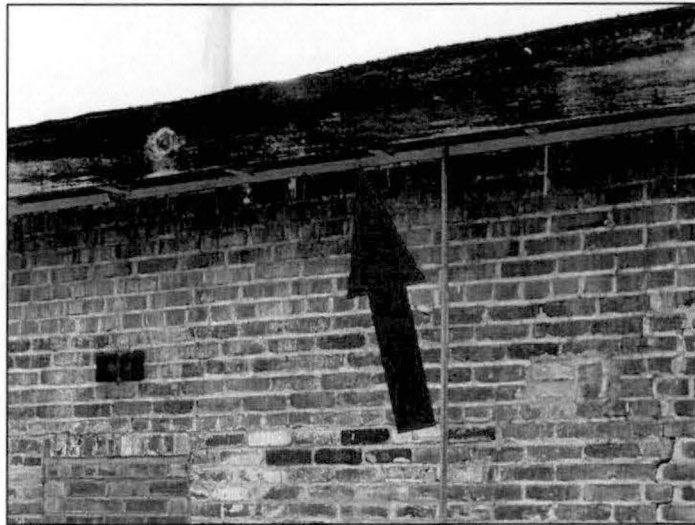
**Photograph A.157.** Moderate black rot on wood eaves.

Due to the lack of a gutters at the eaves (the roof drains to scuppers), there appears to be drainage off the roof that is infiltrating the wood eaves. There is extensive decay and black rot on visible on the wood eaves. The wood eaves appear to be irreparable, and should be replaced.

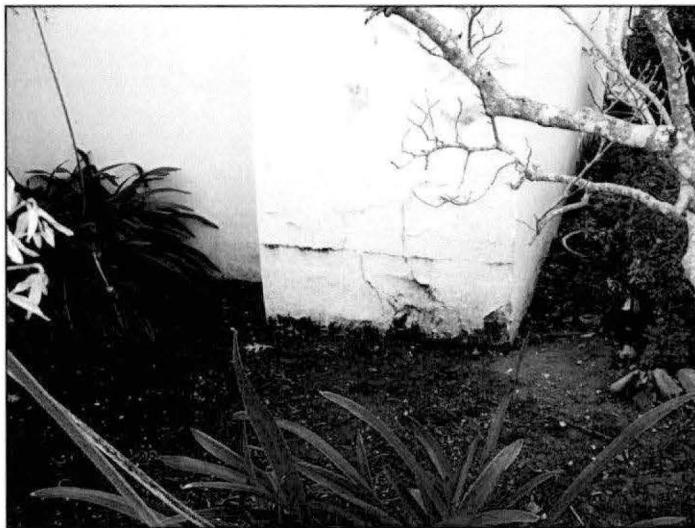
**Photograph A.162.** Minor rising damp on stucco exterior.

The rising damp on the stucco is likely caused by ponding at the base of the building. The ponding issue should be remediated as soon as possible, if it requires regrading, or channeling the downspouts further from the base of the building.

The affected stucco should be assessed as to the extent of the damage, to determine if the damage warrants treatment.

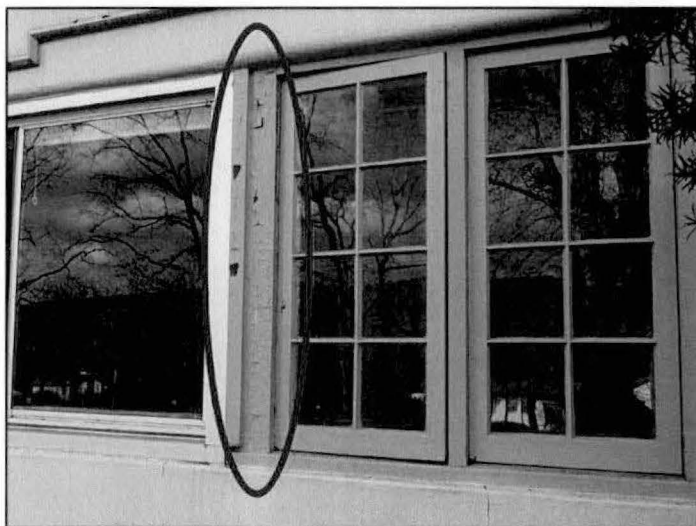
**Photograph A.164.** Minor paint peeling on wood window casing.

There does not appear to be severe enough damage to warrant stripping and repainting the affected wood elements. Given the impending vacancy of the building, it is not advised to treat the peeling paint at this time.

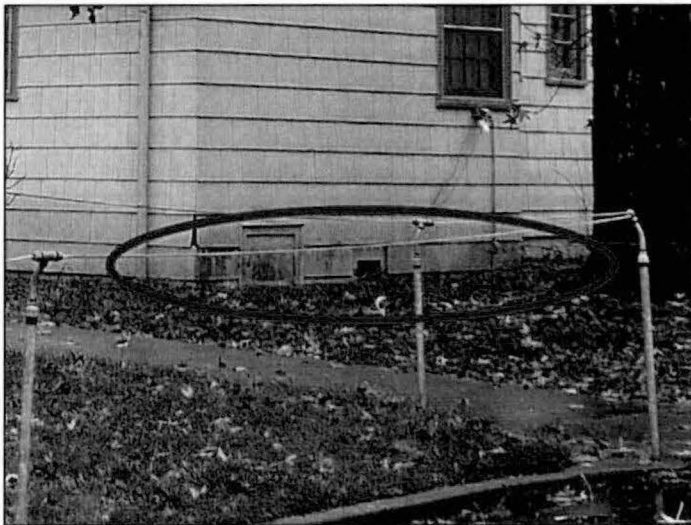
**Photograph A.188.** Minor moisture infiltration from ponding.

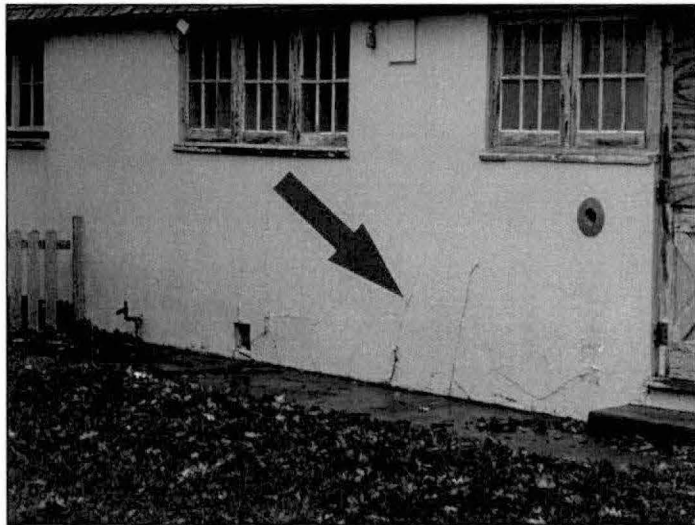
Photograph A.195. Severe cracking in stucco.

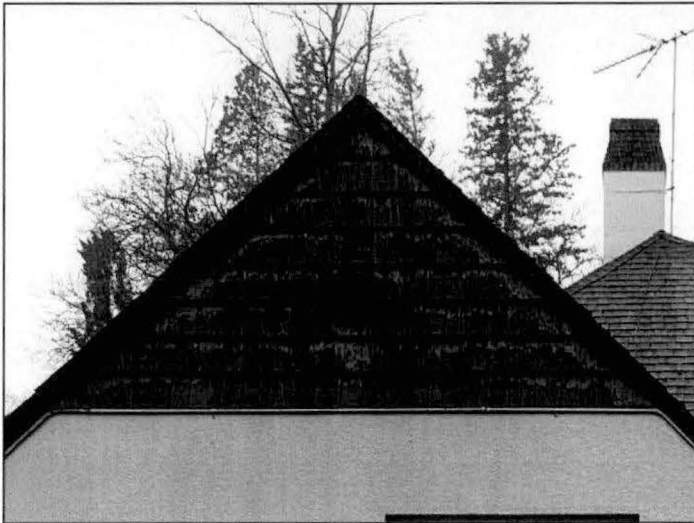
**Photograph A.196.** Minor deterioration of asbestos shingles.

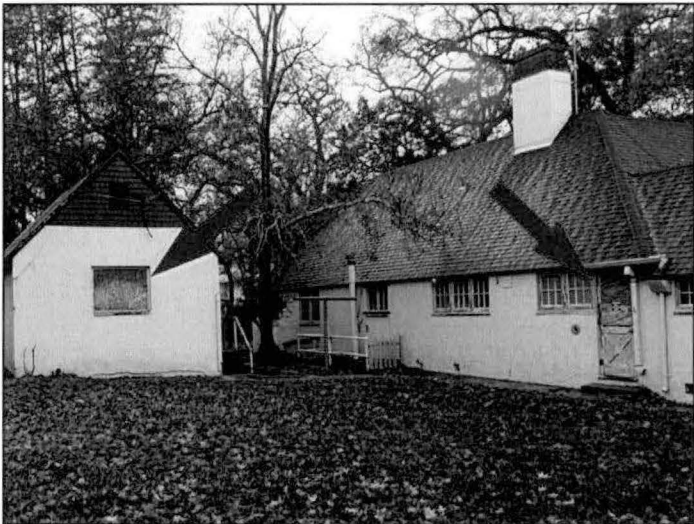
**Photograph A.197.** A few windows are covered in wood boards.

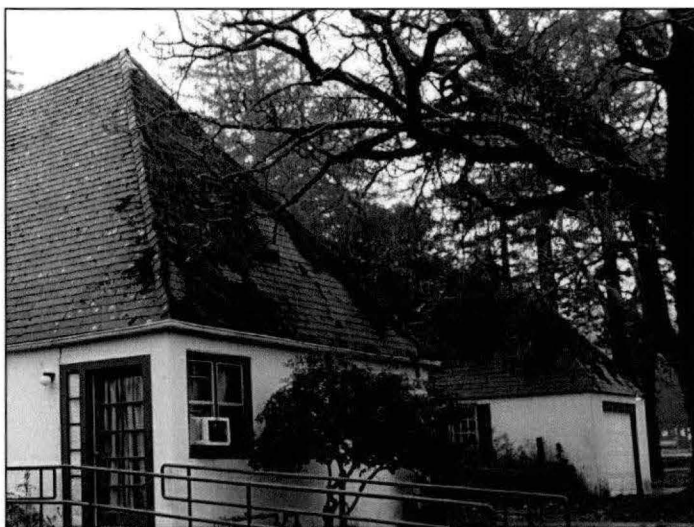
| Residence 149 - Condition Issues | | | | | | |
|---|---|---|---|---|---|---|
| Biological Growth | | | | | × | Roofing |

**Photograph A.200.** Severe biological growth on roofing.

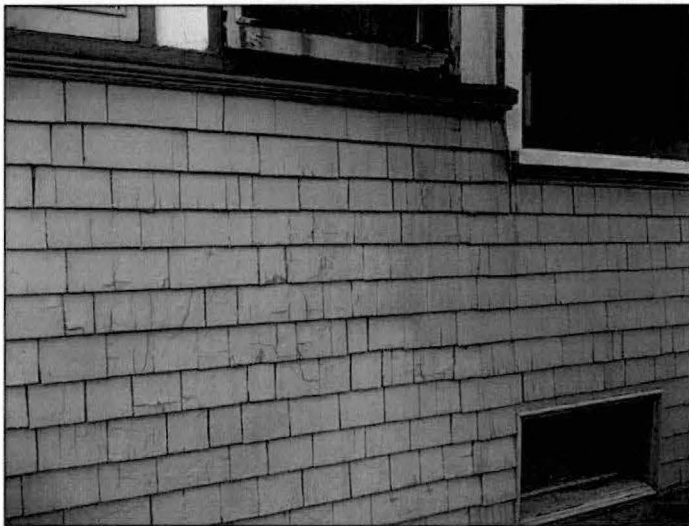
**Photograph A.204.** Moderate moisture infiltration on wood shingle siding.

### *Moderate moisture infiltration on shingle siding - Urgency Score 2*

The moisture infiltration in appears to be caused by water draining down the exterior, due to a faulty or leaking gutter system. The shingles should be assessed as to the extent of the damage, to determine if the damage warrants treatment. The faulty gutter system should be remediated before performing any treatment to the wood shingles.

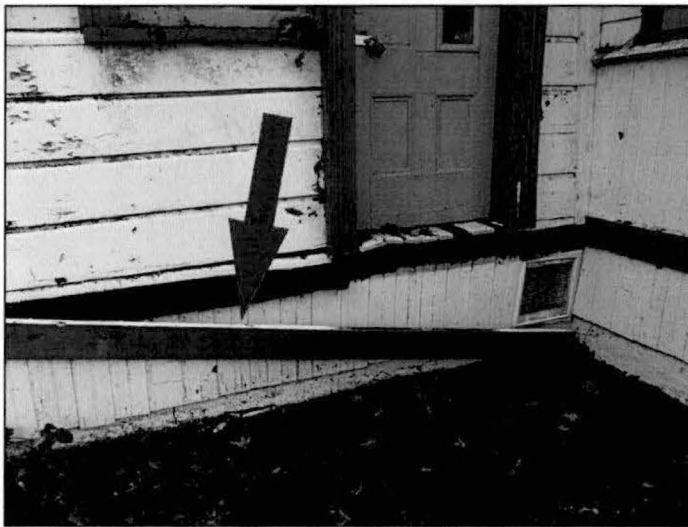
Photograph A.208. Severe siding separation.

The separated siding has revealed the crawlspace. If accessible, the crawlspace should be assessed for any excessive moisture infiltration, and treated if necessary before reattaching the wood siding.

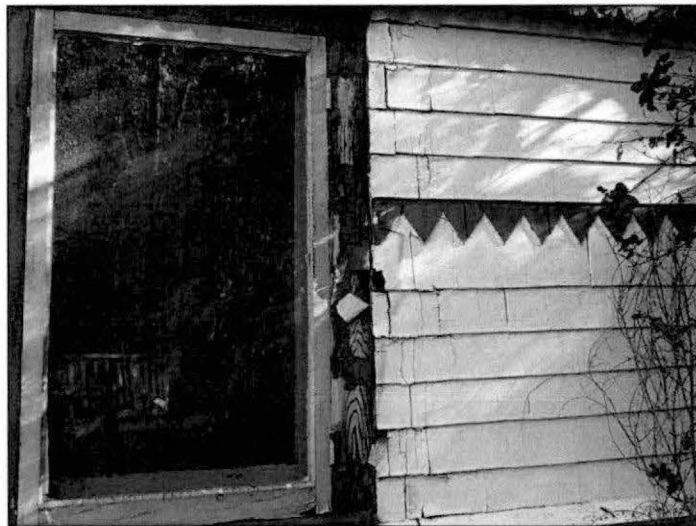
Photograph A.210. Severe exterior paint chipping on wood siding.

Due to the severity of the paint peeling, it is advised to strip the affected wood siding of the old paint, treat, and repaint to protect the windows from severe moisture infiltration and further damage during the vacancy period.

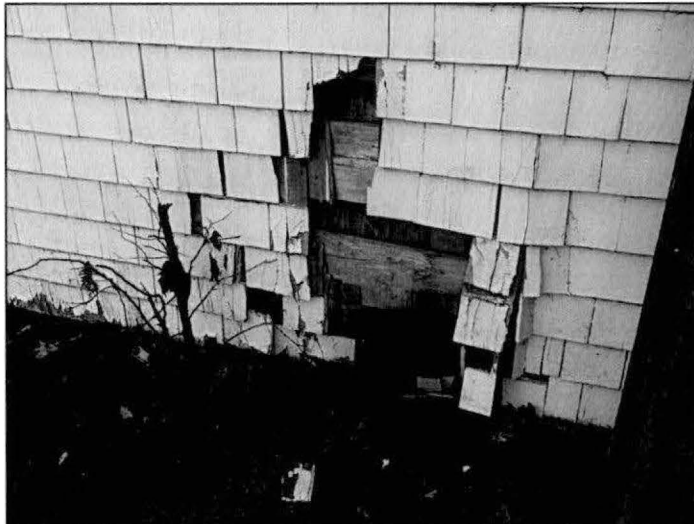
| Sonoma House Outbuilding 2 - Condition Issues | | | | | | |
|---|---|---|---|---|---|---|
| | Deterioration | | | | × | Heavy deterioration to wood siding that exposes structure's wood frame |

**Photograph A.212.** Severe deterioration of wood siding, exposing the structure's wood frame.

### *Severe deterioration of wood siding, exposing structure's wood frame - Urgency Score 3*

Due to the severity of the deterioration, and the exposure of the wood frame to moisture, it is advised to take action immediately. It is suggested to remove the damaged shingles surrounding the

exposed area, assess the underlying wood and wood frame for excessive moisture infiltration, and repair if necessary. Then, repair the exposed area's sheathing, and replace missing shingles in-kind. This will prevent further moisture infiltration during vacancy.

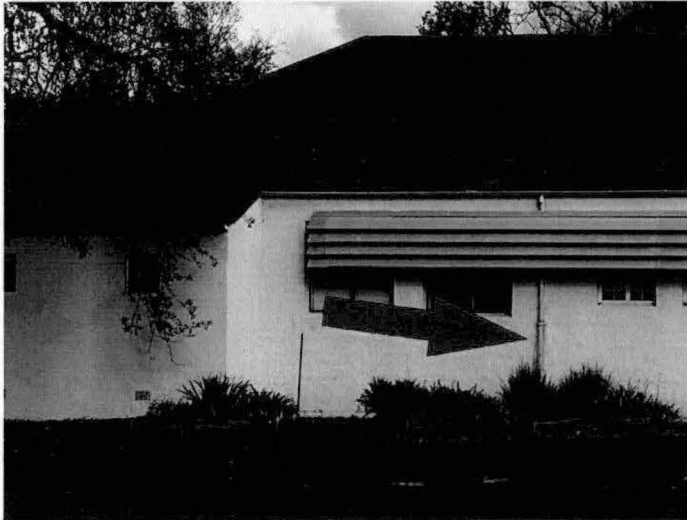
Photograph A.223. Minor corroding downspouts

#### *Minor corroding downspouts - Urgency Score 2*

Due to the minor severity of the corrosion, the downspouts appear to be repairable, and should be patched rather than replaced. This will prevent excessive drainage onto the concrete exterior.

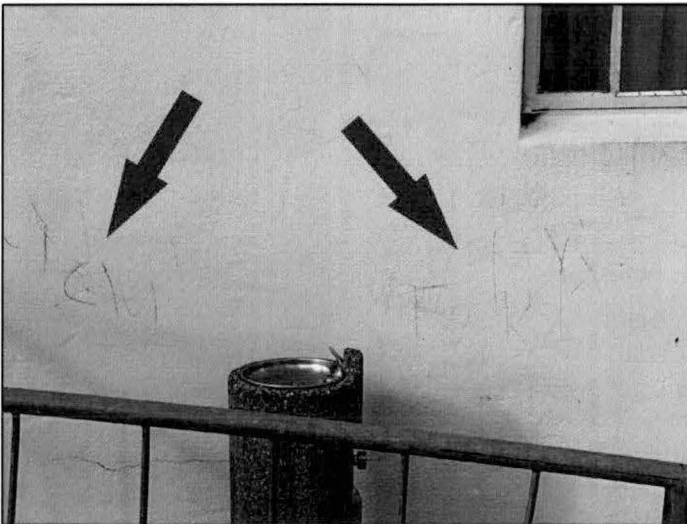
Photograph A.224. Minor scratching on concrete.

The scratching does not appear to be severe or causing enough damage to warrant treatment. Due to the vacancy status of the building, it is not advised to treat the vandalism at this time.

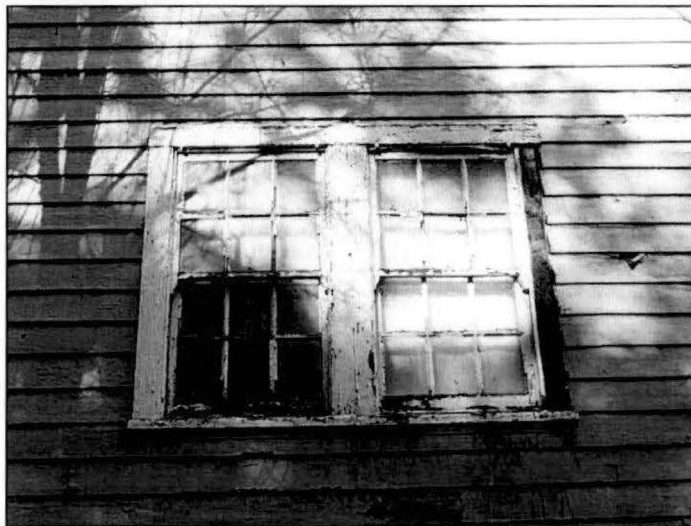
**Photograph A.232.** Severe paint chipping of wood windows and wood window casings.

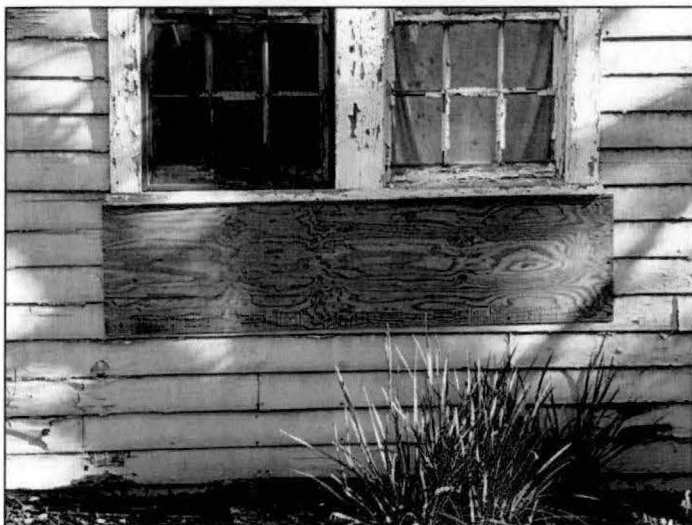
| Walnut - Condition Issues | | | | | | |
|---|---|---|---|---|---|---|
| | A few windows covered in wood boards | | | | | |

Photograph A.235. Wood board is affixed to the wood siding.

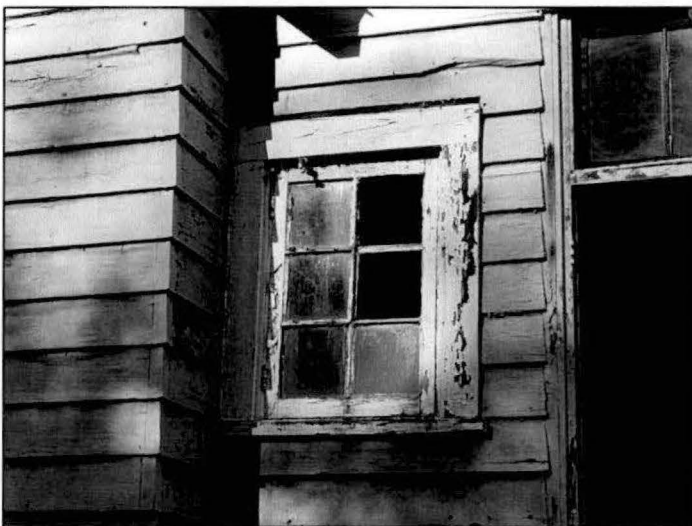
| Walnut - Condition Issues | | | | | | |
|---|---|---|---|---|---|---|
| | Several broken and missing window glazings | | | | | |

Photograph A.236. Missing window glazings.

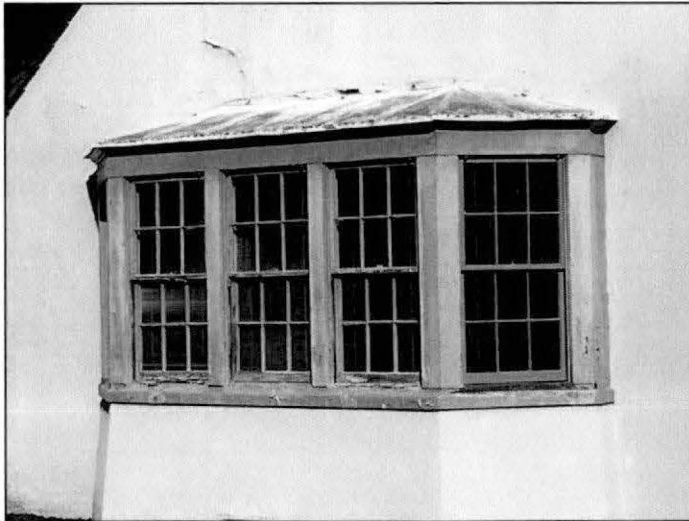
**Photograph A.239.** Detail of the 6/6 double-hung wood windows located in the projecting gable of the southwest elevation.
