HISTORIC STRUCTURES REPORT:

THE EDUCATION BUILDING AND COMMERCE HALL,
(THE WEST AND EAST WINGS OF THE GILBERT COMPLEX)
ON THE UNIVERSITY OF OREGON CAMPUS, EUGENE

A TERMINAL PROJECT
BY DAVID ADAM SINGER

UNIVERSITY OF OREGON
HISTORIC PRESERVATION DEPARTMENT
MARCH 2000

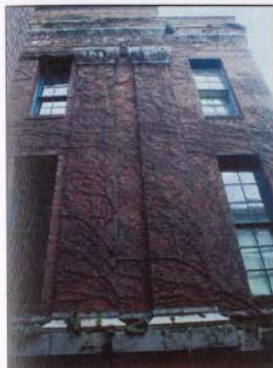
FIGURE 11: PILASTERS AT NORTH ELEVATION.
NOTE VINES AND GROWTH.

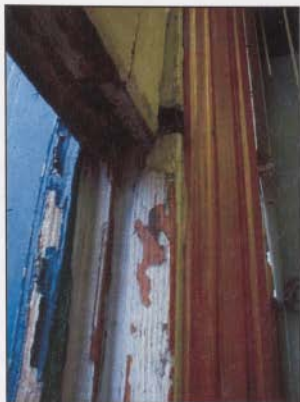
FIGURE 37: PAINT DETERIORATION AND DISICCATION OF WINDOW JAMB AND SASH.

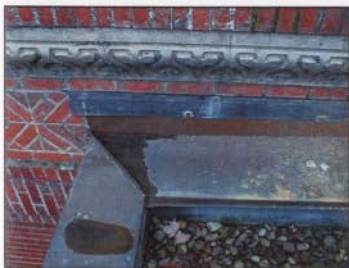
FIGURE 57: FLASHED CONNECTION AT THE TOP OF THE 1951 ADDITION.

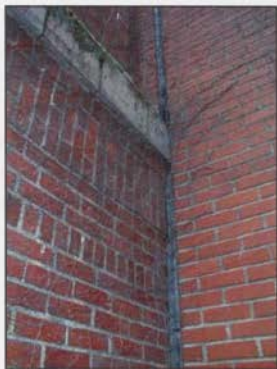
FIGURE 58: DETAIL OF THE EXPANSION JOINT SEAM BETWEEN COMMERCE HALL AND THE 1951 ADDITION

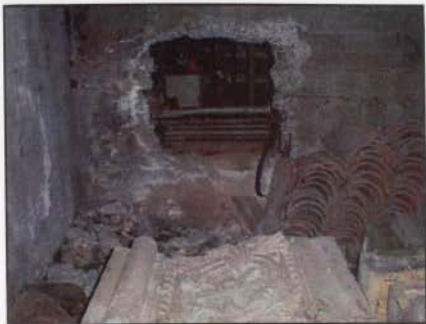
FIGURE 102: STAIR VAULT
 Hidden access to the stair vault of the Education Building was found off the mechanical room, 112. The terra cotta was found in this space. A pilaster capital and a stack of terra cotta roofing tiles are pictured in the foreground.

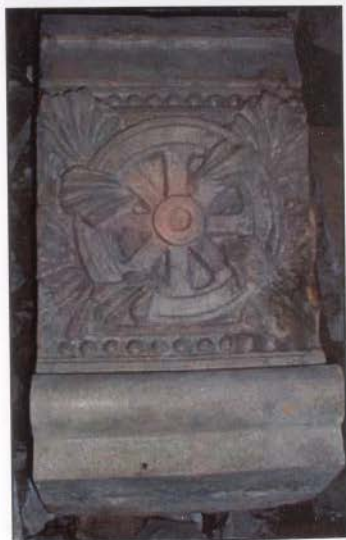
FIGURE 103: PILASTER CAPITAL
 Type: Pilaster capital
 Number: 1 each
 Glazing: Glazed buff clay body
 Size: 27"x15 1/2" x 14"
 Condition: Good condition
 Original Location: Extra piece
