Historic Structure Report New Mine Casemate Fort Columbia State Park

**Terminal Project
Historic Preservation Program
School of Architecture and Allied Arts
University of Oregon
November 2008**

Chapter 3: Physical Description and General Assessment

Conditions as of October 2008. Photo reference numbers correspond to images in Volume 2: Photographic Documentation.

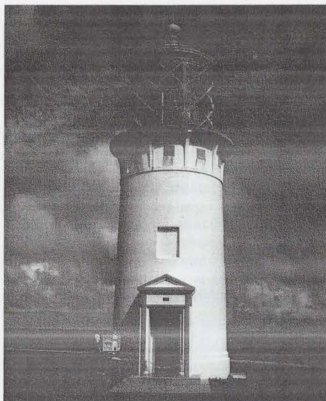
Figure 12. The concrete lighthouse at the Kilauea Point Light Station, Kilauea, Kauai, Hawaii, was constructed circa 1913. The concrete, which was a good quality, high strength mix for its day, is in good condition after almost one hundred years in service. Deterioration in the form of spalling related to corrosion of embedded reinforcing steel has occurred primarily in areas of higher ornamentation such as projecting bands and brackets (see close-up photo).

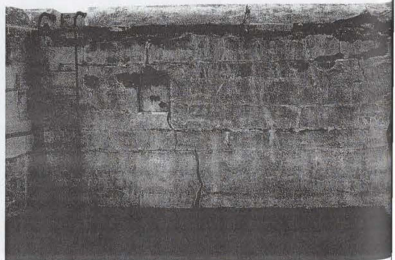
Figure 13. Fort Casey on Admiralty Head, Fort Casey, Washington, was constructed in 1898. The lift lines from placement of concrete are clearly visible on the exterior walls and characterize the finished appearance.

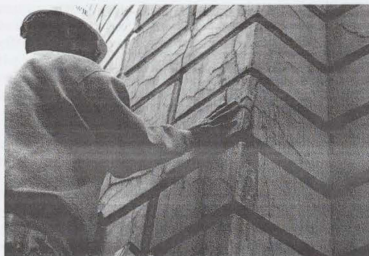
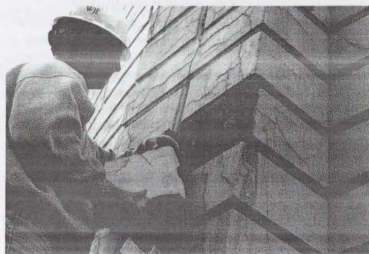
Figures 14. Layers of architectural concrete that have debonded (spalled) from the surface were removed from a historic water tank during the investigation performed to assess existing conditions. Photos: Anita Washko, Wiss, Janney, Elstner Associates, Inc.

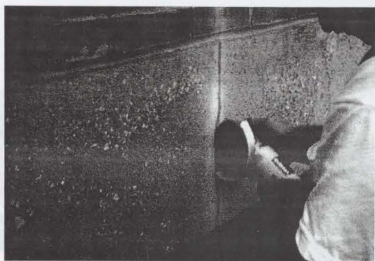
Figure 19. A high-speed grinder is used to widen a crack in preparation for installation of a sealant. This process is called "routing." After the crack is prepared, the sealant is installed to prevent moisture infiltration through the crack. Although sealant repairs can provide a durable, watertight repair for moving cracks, they tend to be very visible.

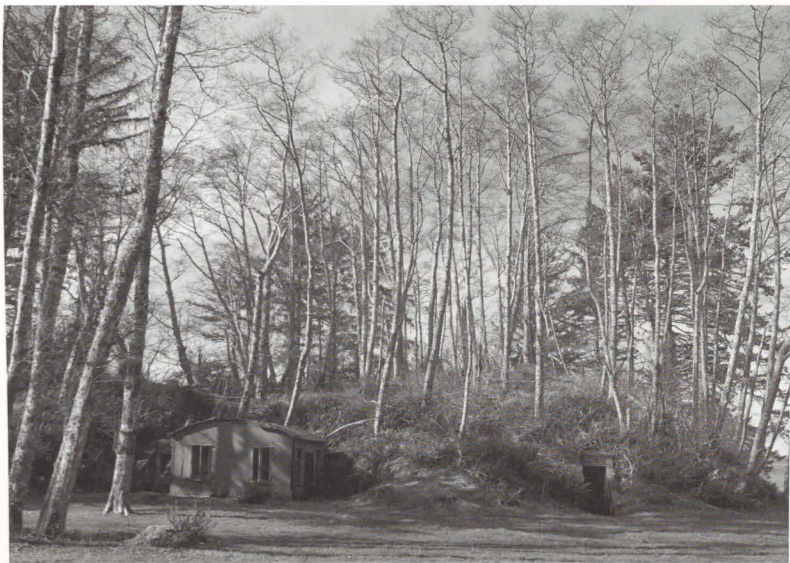
Photo 1. Looking south at Fort Columbia's new mine casemate. The west entry tunnel is seen on the right. On the left is the World War I era searchlight powerhouse, with the casemate's east gate just visible behind it to the left. The trees and native plants covering the earthwork were planted by the Army Corps of Engineers as part of the design of the fortification. The result is an intimate relationship between casemate and landscape. February 2008.

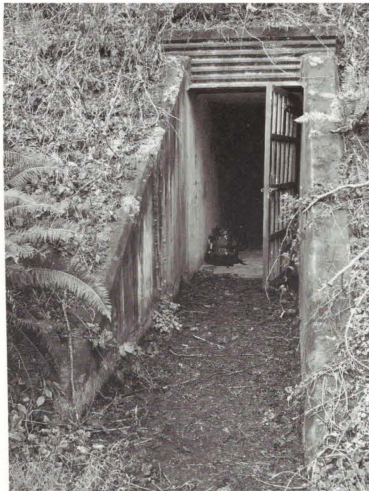
Photo 3. (Middle, bottom). View down west entry tunnel to the first ninety degree turn. The tunnel walls appear to have been finished with a skim coat of plaster.

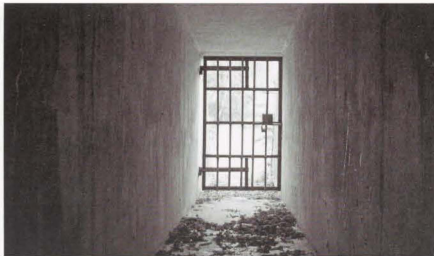
Photo 4. (Middle, top). Looking out from the west entry tunnel. The two-inch chamfer at the junction between wall and ceiling is visible in this photo.

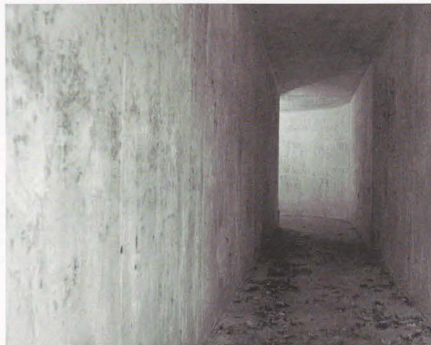
Photo 5. (Above). A number of different paint finishes were used on the casemate tunnel. The buff-orange color seen here was applied in a tapered chevron pattern running from ceiling to floor about eight feet inside the gate.

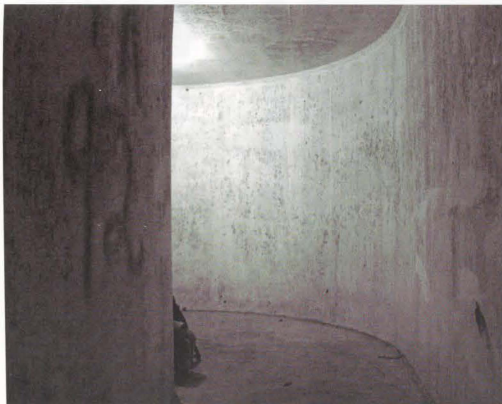
Photo 7. (Right). The second turn in the west entry tunnel. Note the very wet conditions at this point in the tunnel. Water was about 1/2" deep in February of 2008. Water infiltration seem to be predominantly from the significant crack system on the inside of the turn. This is one of the few structurally significant problem areas in the casemate. The concrete ceiling in this spot is about 1' thick, not as substantial as the rest of the structure.

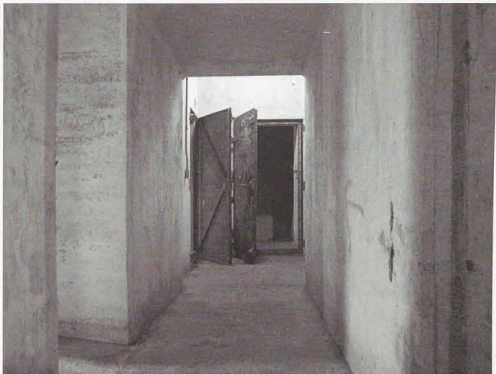
Photo 10. (Right). View of tunnel end at dormitory and airlock entrance.

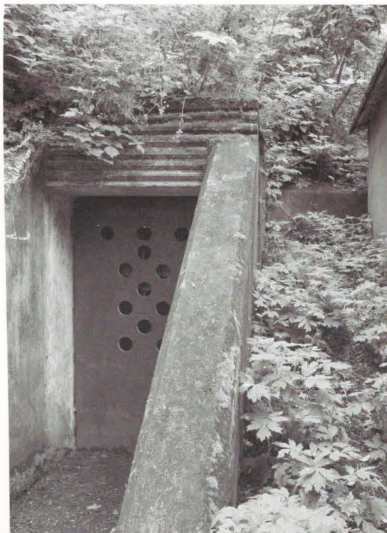
Photo 12. (Above). Looking out from east entry tunnel. The gate has been damaged and is sealed shut with plywood panel. Holes provide ventilation.

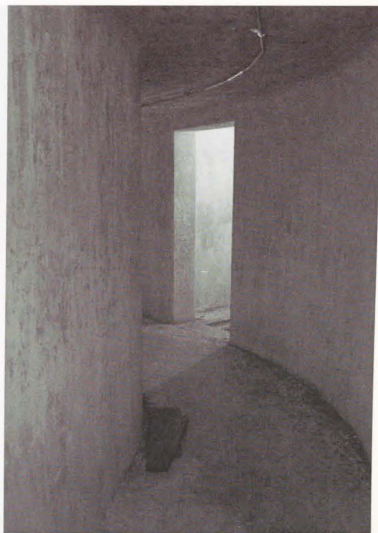
Photo 13. (Right). View down east tunnel toward oil storage room. Concrete in this section of the casemate is very sound.

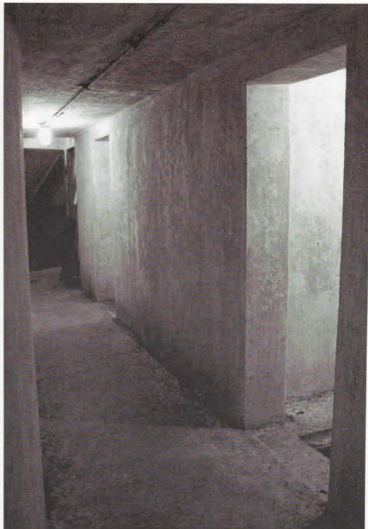
Photo 15. (Above). View from manhole room toward oil storage room and east airlock.

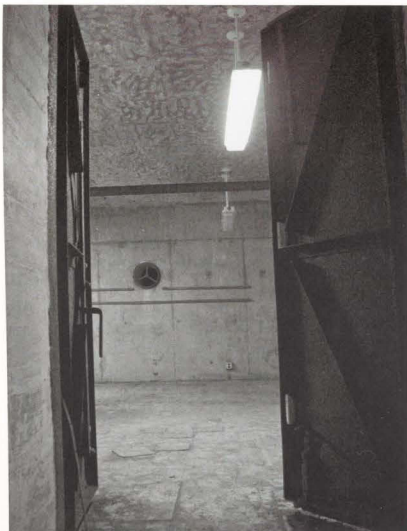
Photo 19. (Above). Steel plotting room door with frame cast in place. Form board impressions on wall. Door reveal is four feet thick in this spot. One foot abutting tunnel is original tunnel wall from 1941-43 building phase. Plotting room wall is three feet thick added in 1944-45. Construction joint where cap has been placed is visible at left of photo.

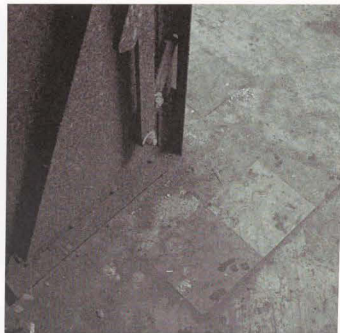
Photo 20. (Above). Remnants of red and black 8"x8" tile floor covering in plotting room.

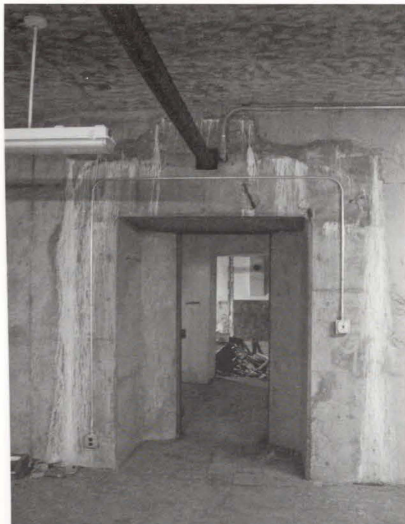
Photo 31. (Above). South doorway between plotting room and gas-proofing room. Note series of cold joints around the top of the door and severe efflorescence. Wall of plotting room is one foot thick here, added to three foot wall of gas-proofing room.

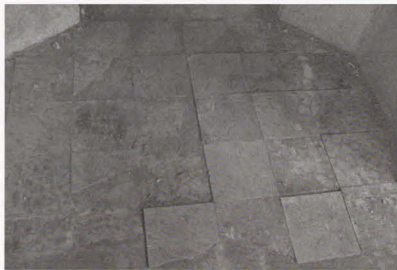
Photo 33. Remains of tile floor in doorway.

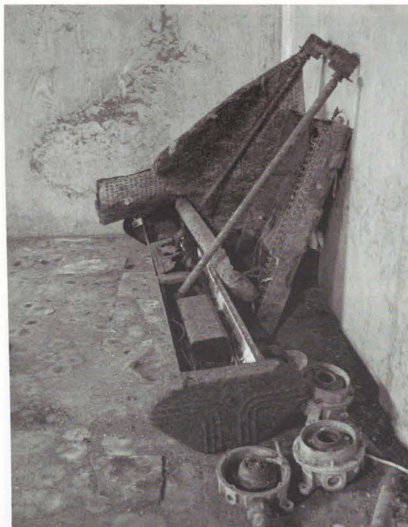
Photo 34. (Left). Light fixtures and acoustic ceiling tiles in corner of plotting room. Of main interest is the fluorescent tube fixture, an early example of this technology. This fixture should be retained and refurbished or used as a model to fabricate reproductions.

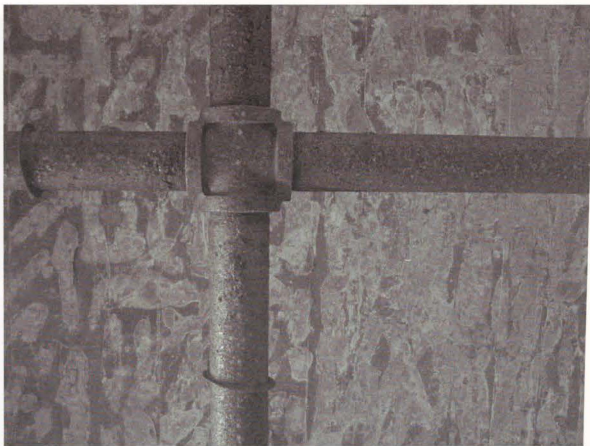
Photo 35. (Above). Intersection of gas-proofing pipes, plotting room ceiling. No identified traces of any original finish is found on the overhead gas-proofing pipes. Remains of mastic used to attach acoustic tiles to ceiling. There are none currently in place.

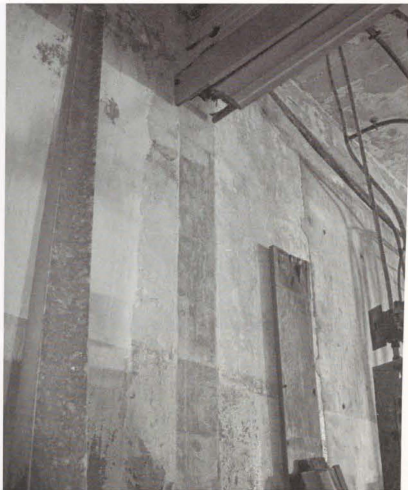
Photo 64. (Above). Connection of dormitory partition wall with north casemate wall is tenuous and should be repaired.

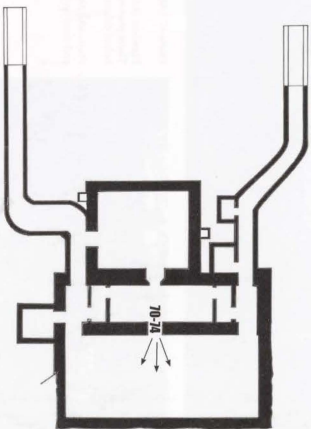
Photos 70,74. Five photo view south-west across operating room from central casemate door. The cable gallery is filled several feet deep with severely decayed building debris. Debris was removed September 2008.

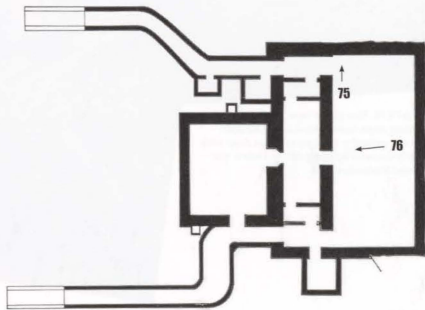
Photo 75. (Above). Battery room sink on east wall of casemate. Concrete infill above door from 1943 tunnel addition is shown. Repainting the casemate is not recommended based on the desire to preserve historic finishes. Although the interior of the 1921 casemate was painted, the 1941-43 addition appears to have received a plastered finish. Additional testing is necessary to determine the exact nature of the finishes.

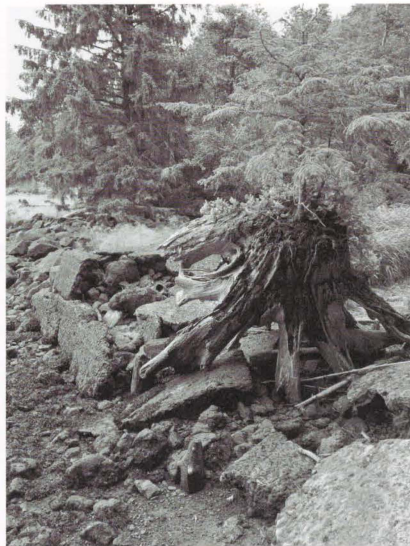
Photo 85. (Right). Cable gallery at low tide. The concrete is badly deteriorated.

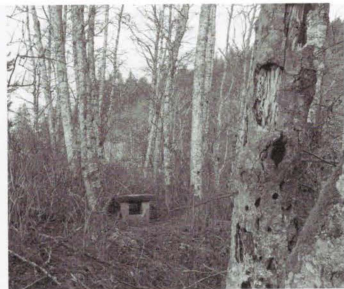
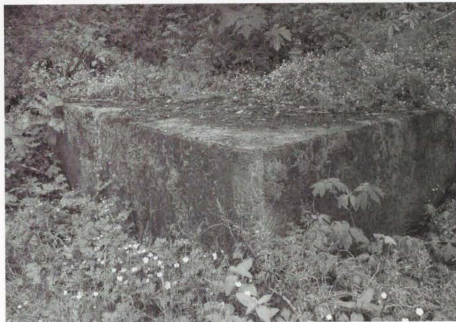
Photos 90-95. Due to the attempts to conceal the presence of the fortification and nearly seventy years of plant growth, the exterior of the casemate has few distinguishing features. A number of ventilator stacks rise up through the earthwork. The earthen covering of the burster course has slumped revealing its southeast corner.

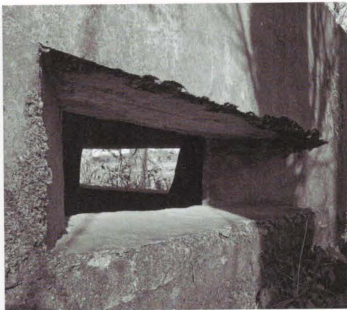
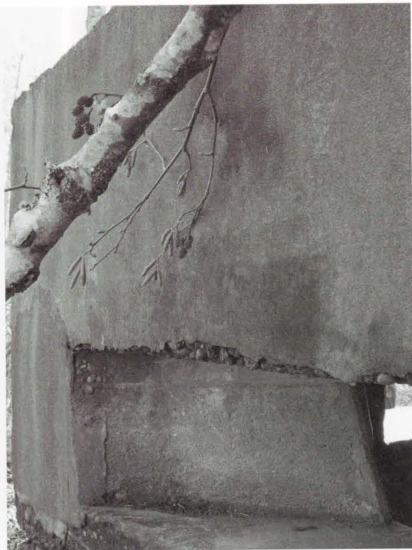
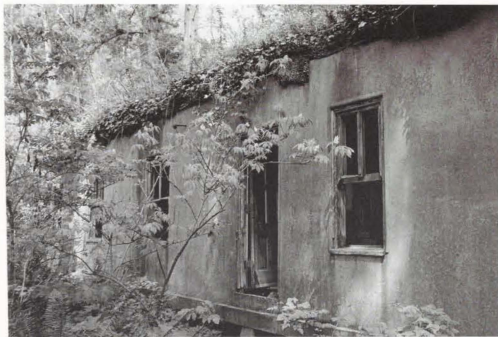
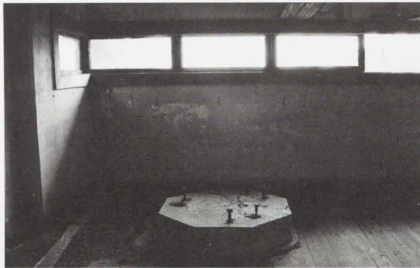
Photos 100 - 103. There is a pillbox located slightly southwest of the west casemate entrance. It provided cover to the landward entrance to the casemate. The structure approaches approximately 10'x10'. The earth has blocked the entrance.

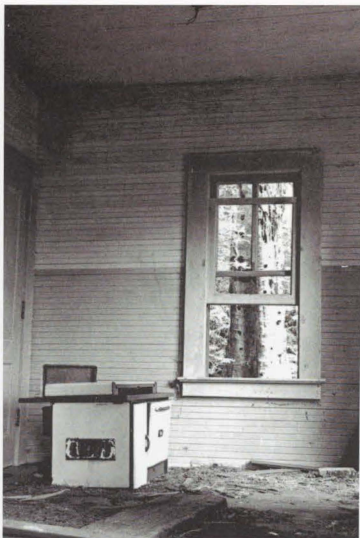
Photo 103. (Left). The mine command station is a two-story structure on Scarborough Hill. It housed the observation equipment for mine plotting and, until 1945, the mine plotting room. Photos 104-105. Above and Top left. The dormitory is a Sewell type building on Scarborough Hill. It was constructed around 1911.
