WILD NOTIONS:
PRESERVATION OF HISTORIC BUILDINGS IN OREGON WILDERNESS

A THESIS

Presented to the Historic Preservation Program,
and the Graduate School of the University of Oregon
in partial fulfillment of the requirements
for the degree of
Master of Science

March 2020

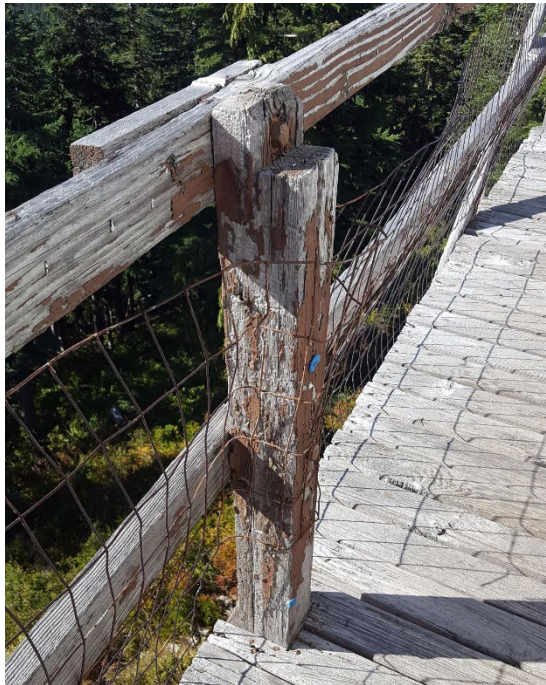
Catwalk - The catwalk surrounds the lookout cab on all four elevations and is in fair-to-poor condition. The joists are in excellent condition, but the deck and railings pose a safety hazard and will reduce the building's integrity if they deteriorate. Railings are constructed with posts, diagonal braces at each corner, and two horizontal rails reinforced with a continuous panel of wire fence. All pieces of the railing are in place but posts and rails are weathered and rotted; wire panels are rusted, bent, and torn; and the rickety railing has been reinforced with 2x4s. The catwalk deck has been repaired in the past with boards in several different sizes. The original deck boards appear to be 3½" x 1¼". They run east-west, so boards on the north and south elevations are long and boards on the east and west elevations are short. The south and east sides are the most deteriorated. *Recommended treatment:* repair the railing by replacing one central post on each elevation, all railings, and the wire panel that wraps across the exterior of the railings. The deck could be repaired by replacing all long deck boards and then reusing salvaged materials to replace short boards on the east and west sides as needed.

Railing condition

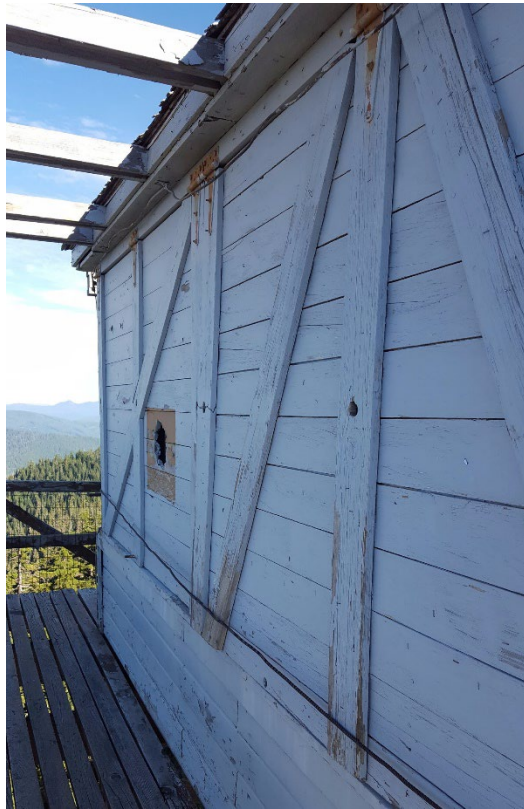
Shutters - The shutter system is in fair condition. Each elevation has two awning-style shutters constructed from a single layer of 1x6 horizontal tongue and groove boards reinforced with vertical and diagonal braces. The shutters are designed to hang suspended from rafters above. All shutters on the south and east sides are severely weathered and broken. Shutters on the north and west sides are slightly weathered and the boards are sporadically cracked or missing. Some have been replaced in the past with a slightly different design. The shutter hinges and pins are in good condition. At least four pins and six hinges are missing. *Recommended treatment:* reconstruct four shutters and repair four shutters; replace absent hardware.

Typical condition, north elevation

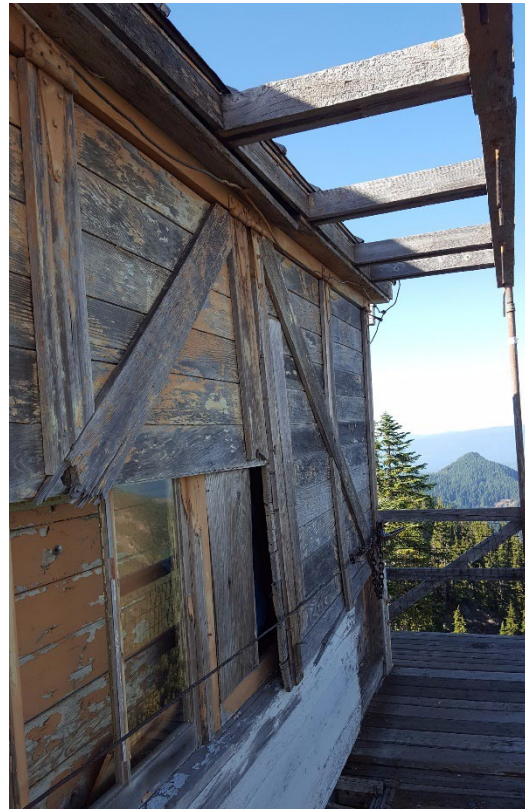
Typical condition, east elevation

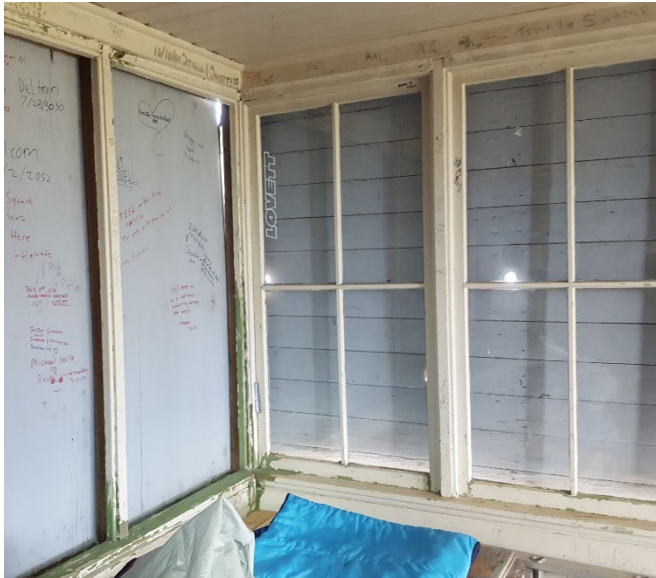
Windows - Overall, the window system is in poor condition. These elements are highly significant architectural features that define the lookout's historical character and function. They also serve a critical structural purpose by protecting the interior, walls, floor, and foundation from weather damage and keep the building secured. Bull of the Woods Lookout originally had 19 four-lite casement windows, but all sash on the south and west windows have been removed. They are not stored on site. These window openings are covered by sheets of plywood. A sash on the north elevation was replaced with a reconstruction that does not match the originals (although it bears a close resemblance). The remaining sash are missing 4 panes of glass. A substantial amount of glazing putty is damaged. All interior stops are in place. All exterior stops are in place or stored under the bed, ready for new windows to be installed. *Recommended treatment:* reinstall or rebuild ten absent sash, repair extant sash by replacing missing glass panes and reglazing with new putty.

Window condition

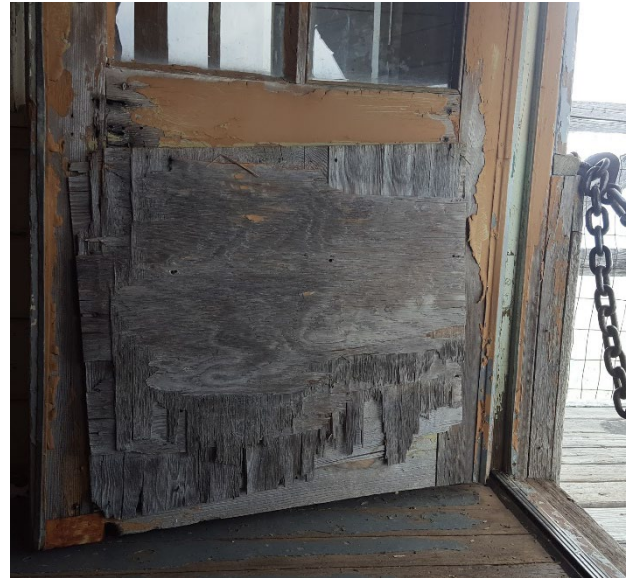
Door - The lookout's single door is on the east elevation, at the top of the stairs. It appears to be original and is in poor condition. The glass panes, muntin, and hardware are worn but intact, however, the bottom of the door is broken as if it has been kicked open and repaired numerous times. The door does not lock. *Recommended treatment:* repair or replace the door (this may require further, more detailed assessment).

Door condition

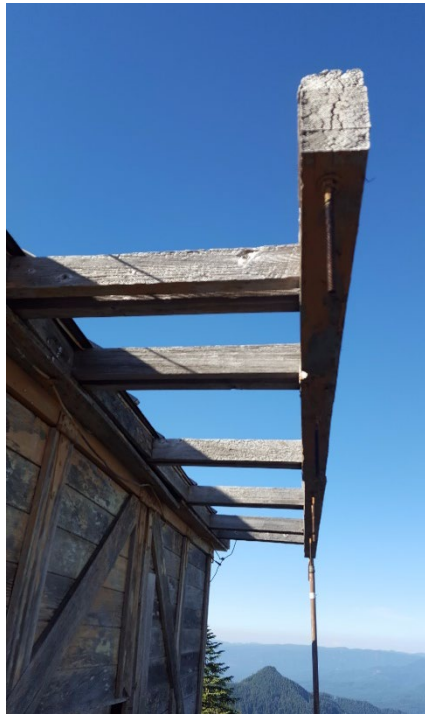
Outriggers - Shutters are held open in an awning position suspended from outriggers that protrude above the windows. All these outriggers appear to be in good condition, weathered but not cracked or broken. All hardware is in place.

Outriggers

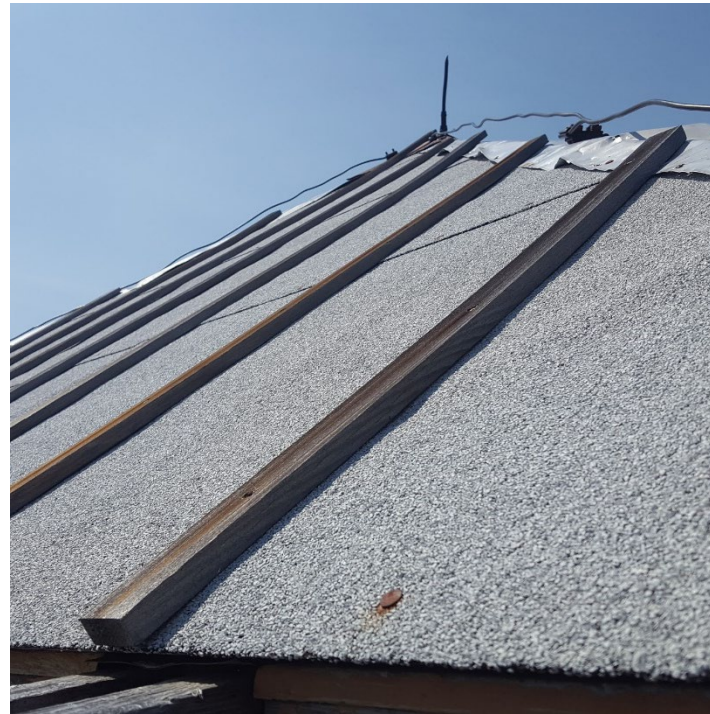
Roof cladding - The hipped roof was not fully accessible during this assessment but appears to be in fair condition. Internal rafters and sheathing were partly visible through the attic hatch, and they appear to be in good condition. The attic is uncluttered and well ventilated. Stove pipe hole has been closed up. Light is visible through the sheathing boards, which indicates that the roof has no moisture barrier, or the barrier is failing. Three sides are clad in cedar shingles that are weathering but in good condition. The east side of the roof has been redone in rolled asphalt with wooden battens, which is a functional alteration to the original design. The hips and peak are capped with metal which is in good condition, but a 1' long section is missing on the southwest corner. *Recommended treatment:* replace the east side of the roof with cedar shingles once the asphalt layer begins to fail, and replace flashing that is absent from the hip.

Asphalt roof

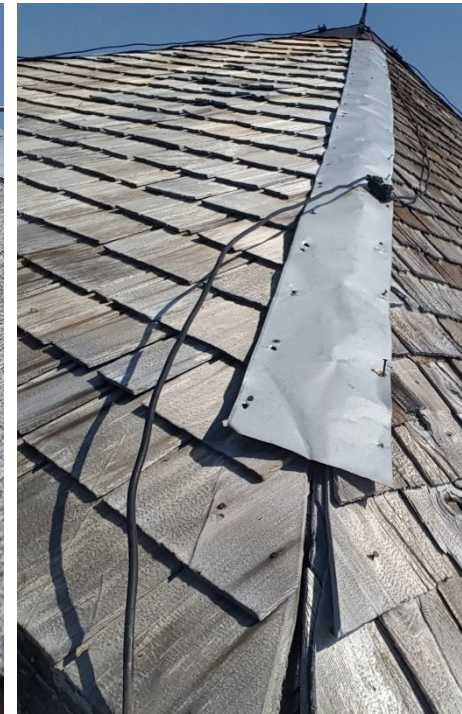
Shingled roof and flashed hip

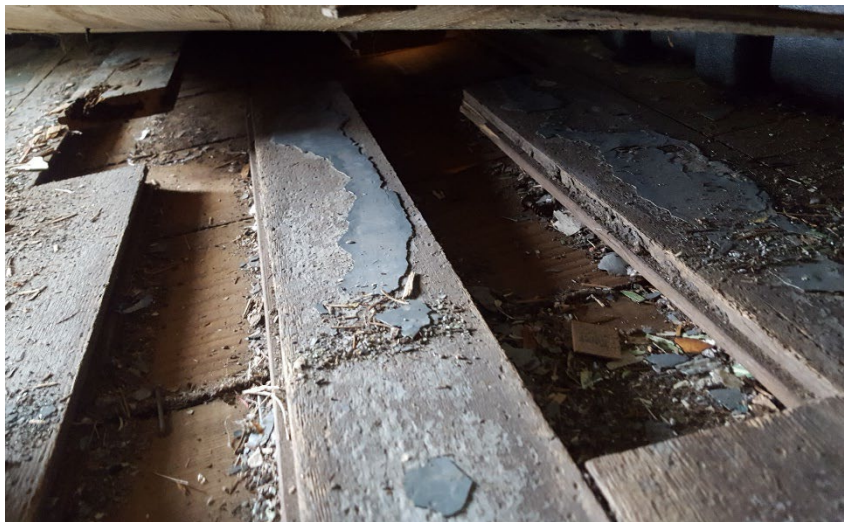
Interior finishes - The interior was previously treated with latex-based paint. The floor was finished with grey-over-white which is now in poor condition. The walls and ceiling were finished with white-over- green, which is in fair condition. *Recommended treatment:* test for lead content, scrape failing paint, and apply primer and paint.

Floor condition

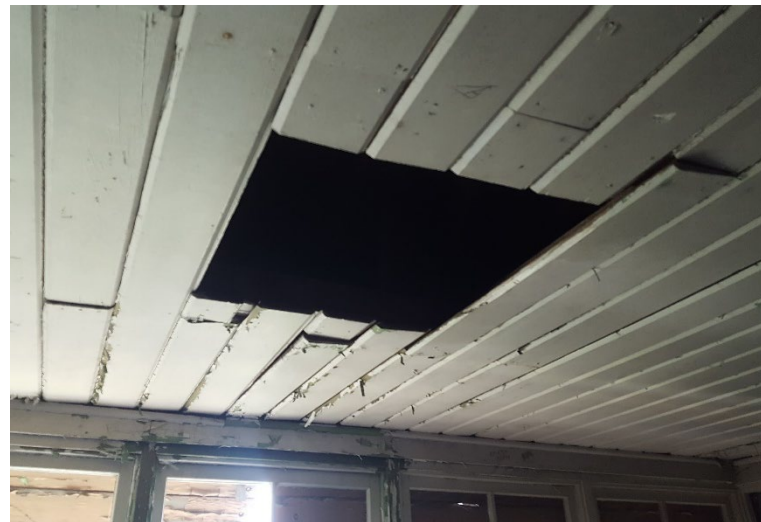
Ceiling - The ceiling is clad in the same lapped boards as the walls. All boards are in place.

Ceiling condition

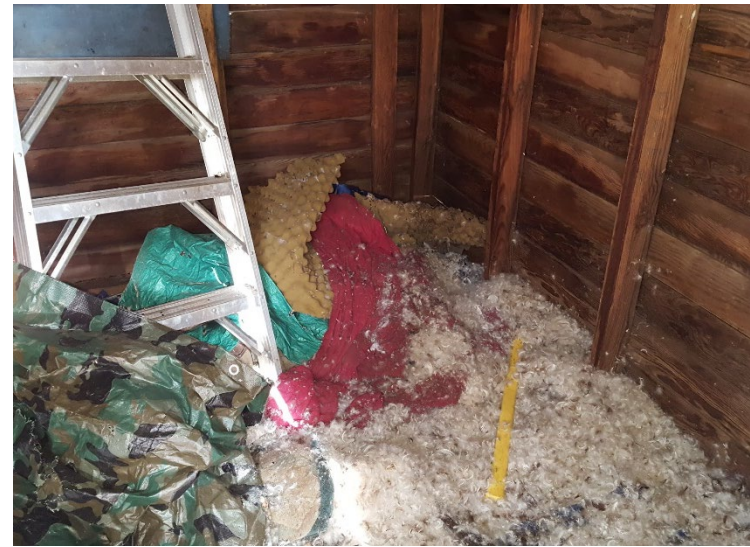
Shed interior, animal activity

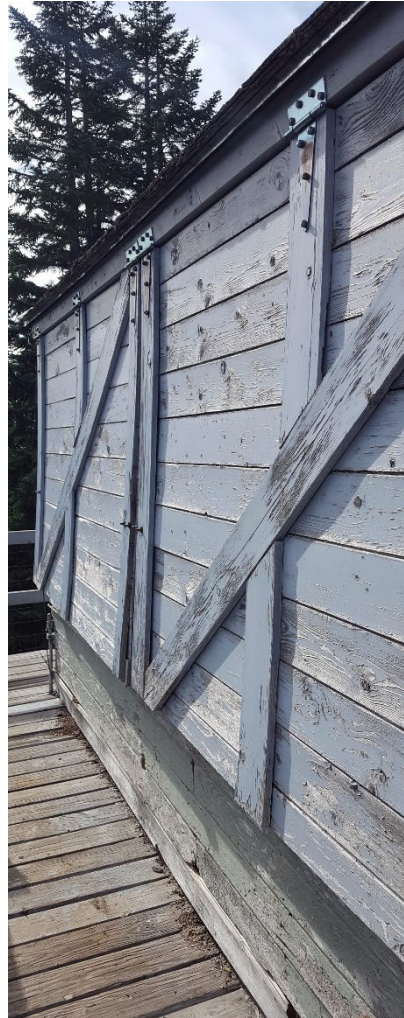
Shutters - The shutter system is in fair-to-poor condition. Each elevation has two awning-style shutters constructed from a single layer of 1" thick horizontal tongue and groove boards reinforced with vertical and diagonal braces. The shutter parts were originally nailed together and painted white. The shutters hang by long strap hinges and are held open by short struts that rest on the catwalk railing. All shutters are 4'-8" tall. Most are 7' wide, but two shutters that share the same elevation as the door are narrower, at 5'-5" wide. The door may have had its own 2'-10" wide shutter at one time. The shutters are built from horizontal 1x6 tongue-and-groove boards and are braced with vertical and diagonal 1x6 boards. Shutters on the south side of the building were previously reconstructed and are in good condition. Struts are in fair condition, worn but functional. *Recommended Treatment:* reconstruct two large shutters and both small shutters; use salvaged pieces to repair missing and damaged part of the other shutters. All the existing hinges (a mix of originals and replacements) can be reused.

Condition of south shutters

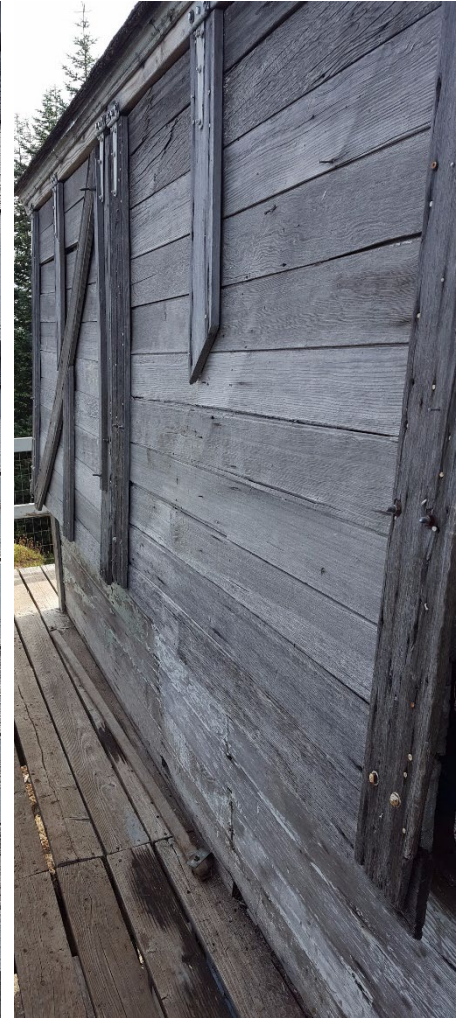
Condition of east shutters

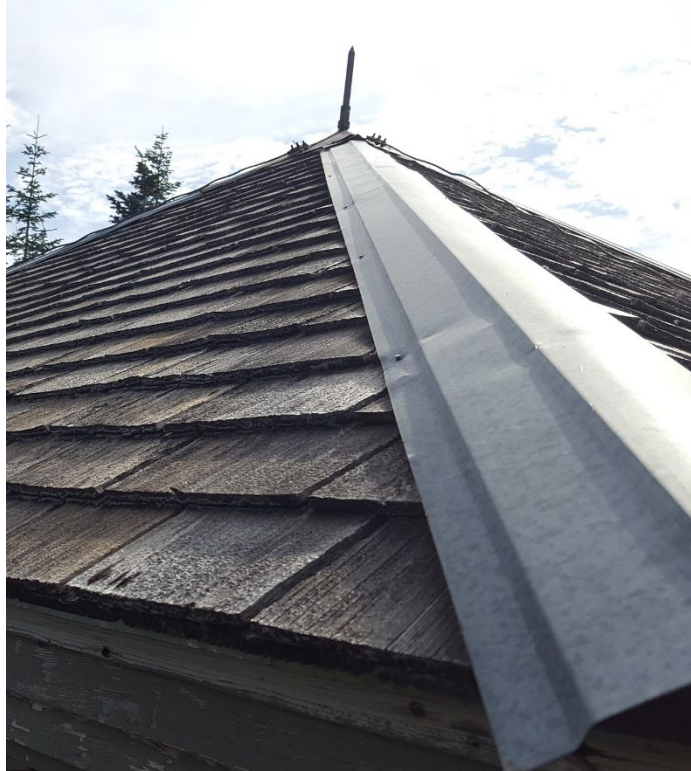
Roof - The hipped roof appears to be in good condition. It is clad in cedar shingles and capped with metal at the hips and peak. The attic was inaccessible during this trip but rafters and sheathing were partly visible through the attic hatch. The roof structure appears to be in good condition. The attic appears to be uncluttered (except for tools) and well ventilated. *Recommended Treatment:* tidy the attic and remove excess supplies and trash.

Typical condition, roof

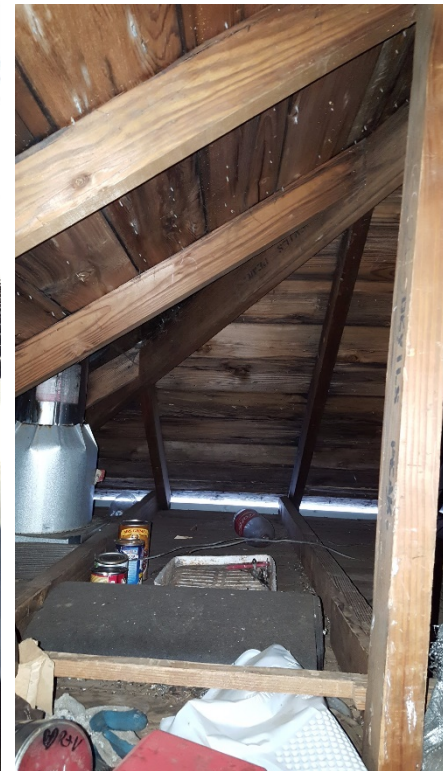
Typical condition, attic

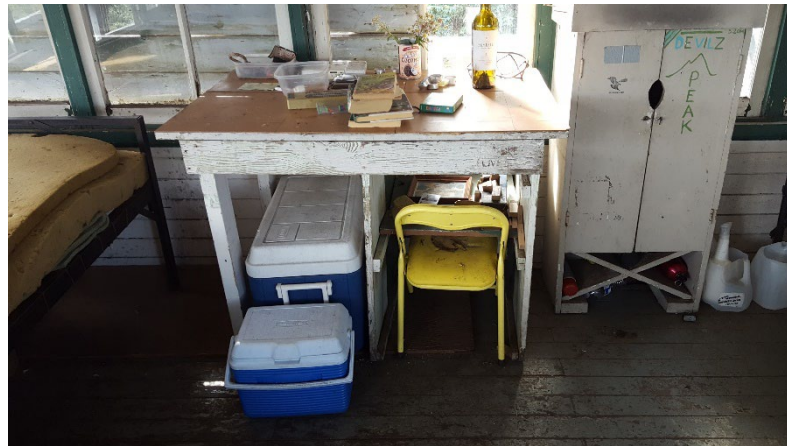
Furniture - The lookout contains two beds, folding chairs, a short cabinet, two desks, an upright cabinet, and a toolbox. Some of these items may be original, such as the desks and the upright cabinet which would have held an Osborn fire finder. *Recommended Treatment:* a substantial restoration of the lookout's interior could include repairing and repainting the furniture.

Furniture

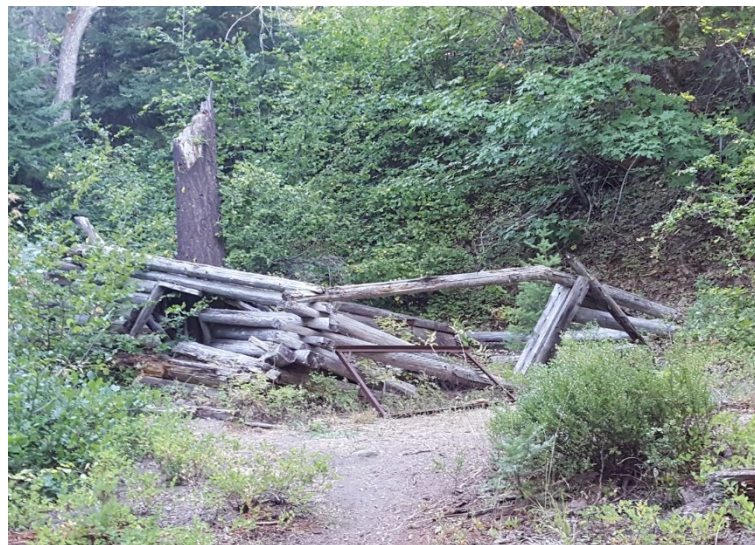
Today, the cabin is collapsed and deteriorated to such a degree that many of its architectural characteristics are obscured. The roof, which was broken by a fallen tree more than 40 years ago, is now entirely gone. The wall logs have rotted into the ground, but their dimensions and joinery are still partially evident. The north wall and its corners are less than 1' high. All log courses that comprise the south wall and its corners are still intact. The south wall's board-and-batten gable end has fallen into the center of the building. On the east elevation, the top plate log is still in place and indicates the original location of the cabin's only door. The plate is broken and suspended above the lower wall logs which have collapsed. Overall, the south end of the ruins still communicates useful information about how the cabin was constructed, but rest of the structure is unrecognizable.

South and east elevations, 2017.

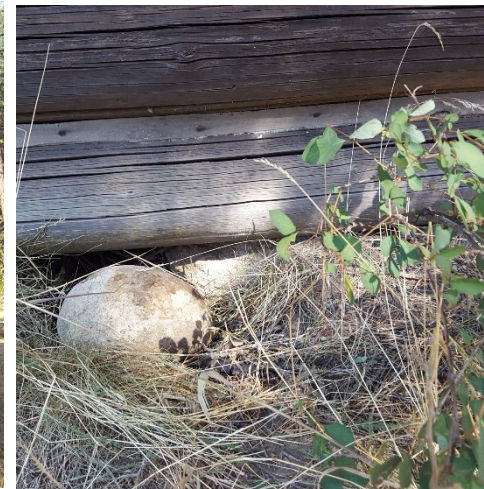
Plants against wall logs

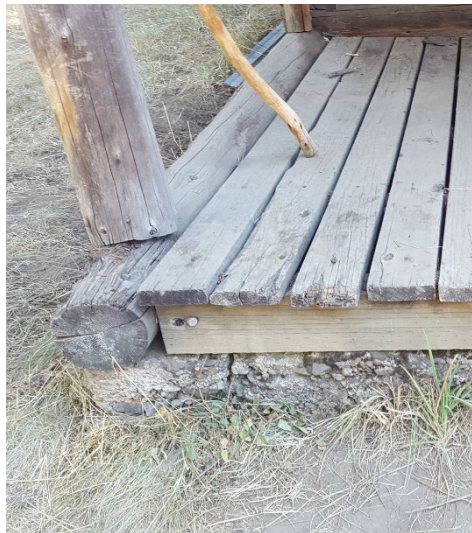
Porch - The porch has been repaired in the past and is in good condition. The porch could use a single stone or pressure-treated step. Five pressure-treated joists run north-south and are certainly not original. It is likely that the porch floor was rebuilt more than a decade ago, and that the repairs have held up well. It is decked in 2x6 boards that are weathering at the ends, where they protrude beyond the roof’s eave. Four posts with valley notches at the either end are wedged between sill logs and log top plates. Top plates are connected by two pole rafter ties that run north-south. The top plates extend beyond the roof’s eave and are rotting from exposure. The southwest corner of the porch has been repaired with a small piece of pressure treated wood that lifts a rafter tie off of the top plate to protect it from rot. These minor structural issues and surface rot do not need to be addressed but could be monitored in the future. *Recommended Treatment:* install a step.

Porch construction

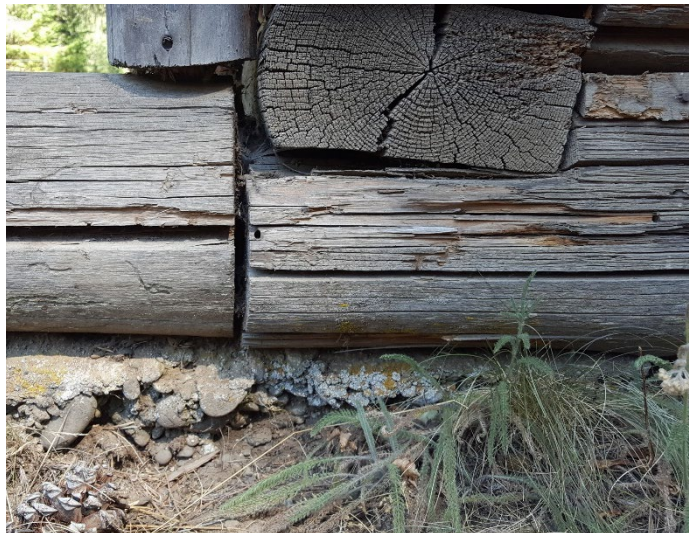
Foundation - The foundation is in fair condition. The building’s footprint is 12’6” x 23’4” (including the porch); The porch measures 12’6” x 7’4”. It is a 6” high wall built from concrete that has large aggregate and a rough texture. Moss indicates a moisture issue and could be removed from the foundation. An opening on the center of the south elevation provides limited access to the crawlspace underneath the building, and is filled with sticks and other debris. *Recommended Treatment:* clear out the crawlspace and secure it with a small wire panel to keep animals out.

Foundation and sill construction

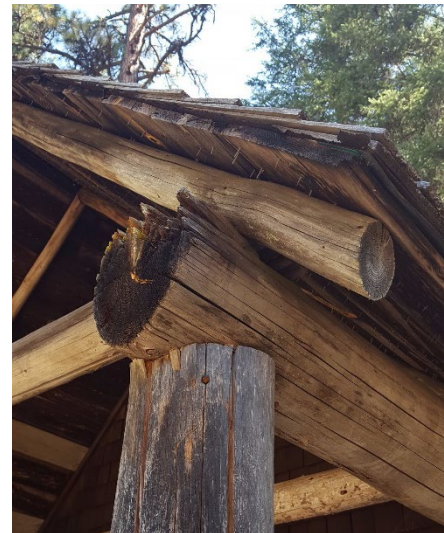
Condition at southwest corner

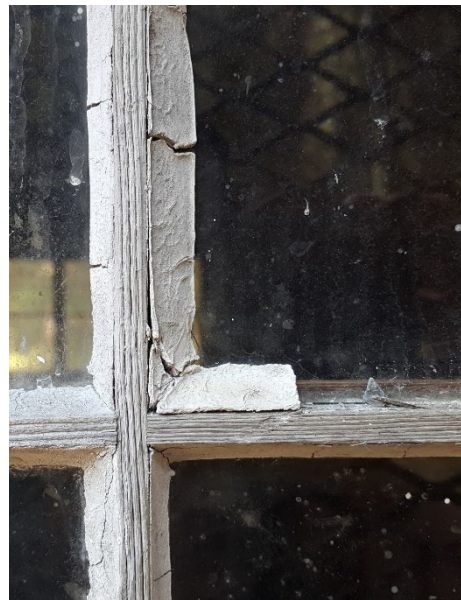
Windows - Overall, the window system is in fair condition. Millard Ranger Station has two horizontal windows with four-light sliding sashes behind metal security cages. These windows are located at the center of the north and south elevations and measure roughly 6' x 2'4" (including the trim). The north window has a loose header that could be nailed down. The south window sill is split on both ends and could be replaced with a new 4'7" long 1x2 board. The glazing is in fair condition. One pane is cracked and patched with tape. All the glazing putty is skillfully applied but in poor condition. Sash would ideally be treated with several coats of linseed oil to restore the wood and extend the lifetime of new putty. Both security cages trap dirt and make it difficult to clean the windows. The window cages are bolted through the wall logs and should be easy to remove from the interior. *Recommended Treatment:* treat sash with linseed oil, replace cracked pane, reglaze all sash, and clean behind the security cages.

Putty condition

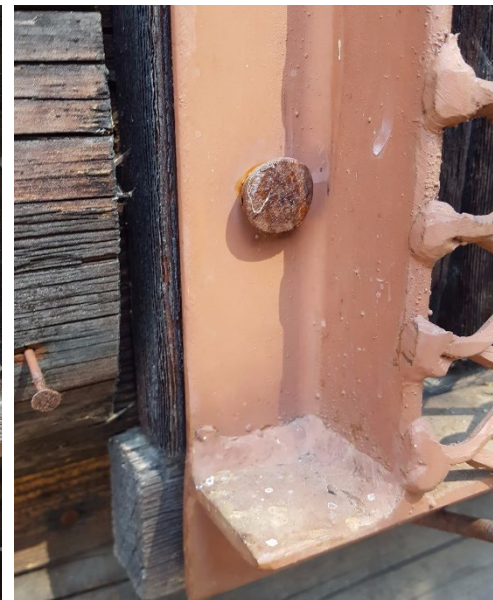
Security cage

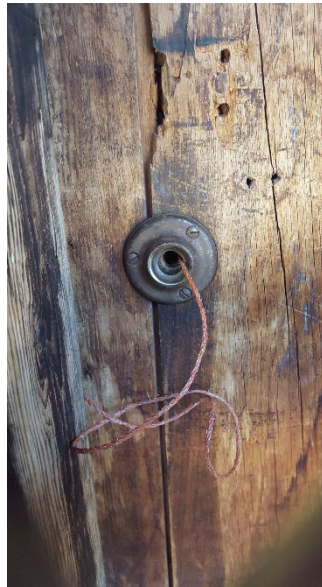
Door - The front door was largely inaccessible during this assessment because it is covered in a metal security cage installed through the log walls. However, it appears to be in good condition. The metal cage is padlocked. The original door is latched with a strap, chain, and twisted nail. The handle is missing and has been replaced with a length of string for latch. *Recommended Treatment:* replace the handle with an appropriate replicate and retain the unique nail-latch.

Door hardware

door	good	minor	Clean behind security cage. Replace door handle with appropriate replica.

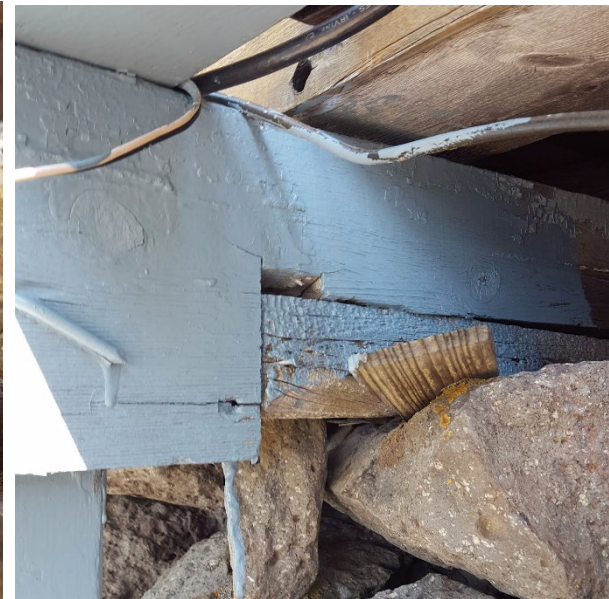
Typical rough construction of solar panel deck

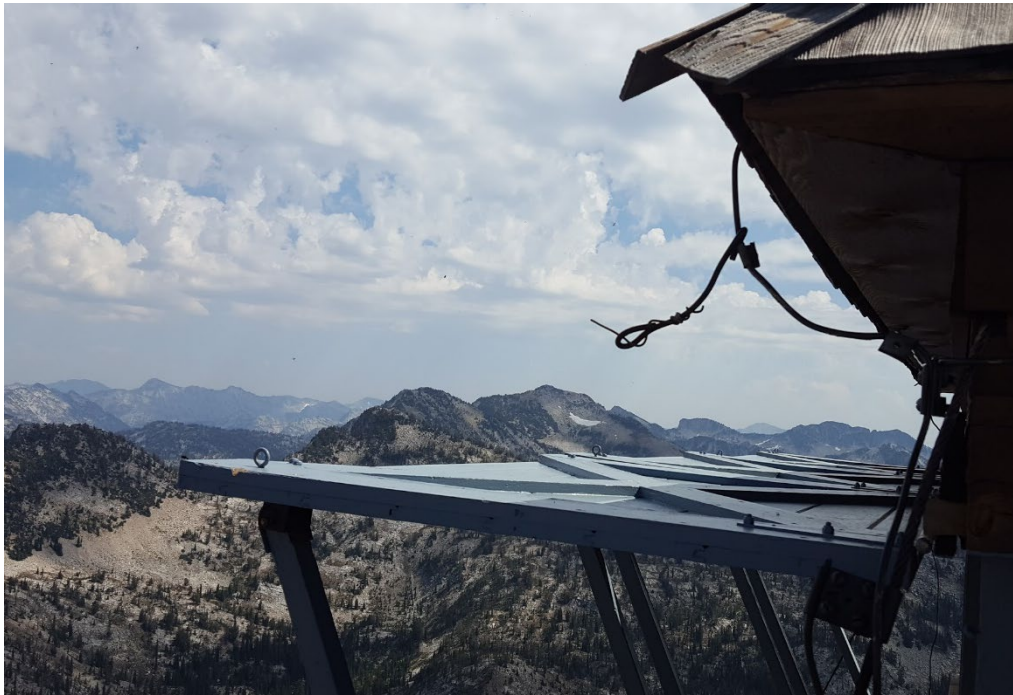
Shutters - The shutter system is in good condition. Each elevation has two or three awning-style shutters constructed from horizontal boards reinforced with vertical and diagonal braces. The door does not have a shutter, which is unusual for an L-4 lookout. All the shutters are designed to be held open with wood struts. Two rows of horizontal shiplap siding above the windows has been altered on each elevation to support the shutters below. The shutter hinges are fastened to two 1x5 horizontal boards that were installed on top of the siding. Radio equipment is also anchored to these added boards. They are probably not original but serve a useful purpose by reinforcing the shutters. The lookout resident reported that it is difficult (even unsafe) for a single person to open these shutters. *Recommended Treatment:* replace nuts and bolts with square wire lock pins to make the hardware easier for one person to manage. The shutters' weight, height, and hardware can more easily be managed with two people, so the Forest Service staff could ensure that two people are available to change the shutter system at the beginning and end of fire season.

Shutter system

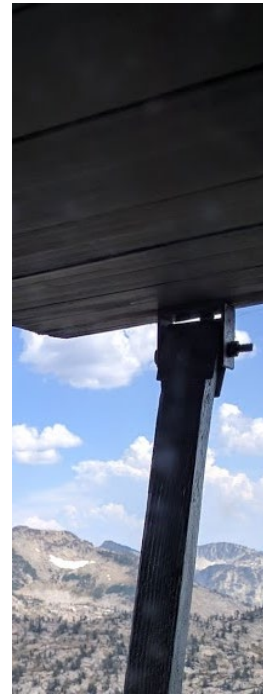
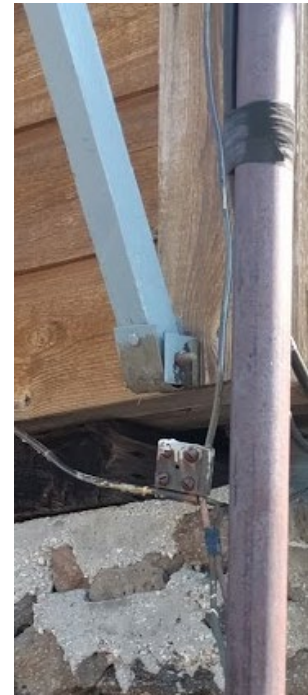
Shutter hardware

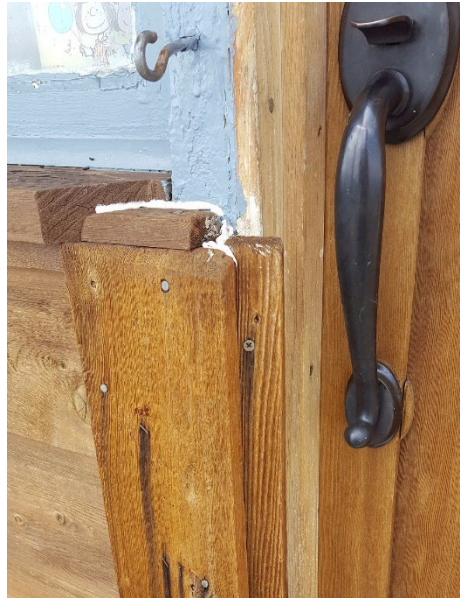
Hardware and trim

Door - The lookout's door is located on the southeast elevation. It is a prefabricated replacement and does not resemble the original door, which is still stored on site. The new door is in good condition with panes, muntins, panels, and hardware intact. It has an external lock. There are no function concerns associated with this feature, other than a need to keep snow flurries out. A signature suggests that it was installed ca. 2007. The original doorway was significantly altered to accommodate the new door. The hardware does not match the original hardware, nor does it fit the new door. Although the current door is in good condition, it detracts from the lookout's historical integrity. The lookout resident commented that even from a distance the new door looks "wrong." If the existing door remains in place it could at least be weatherized and painted. Ideally, the original door would be restored or reconstructed. It was not examined during this assessment but it is certainly salvageable. *Recommended Treatment:* consider restoring the original door.

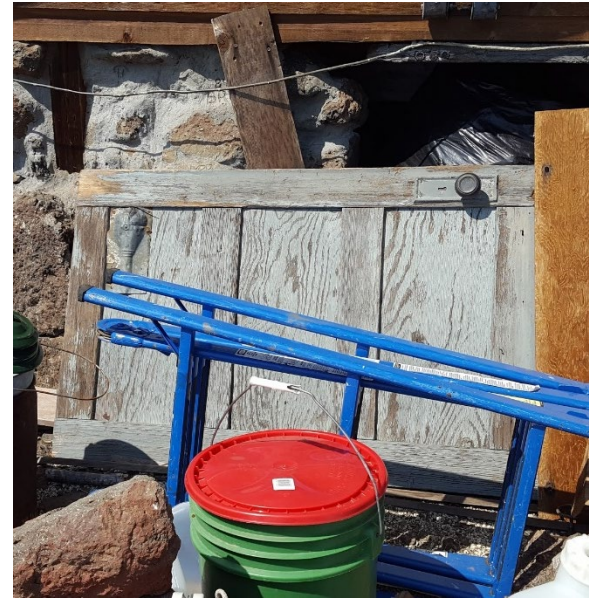
Original door

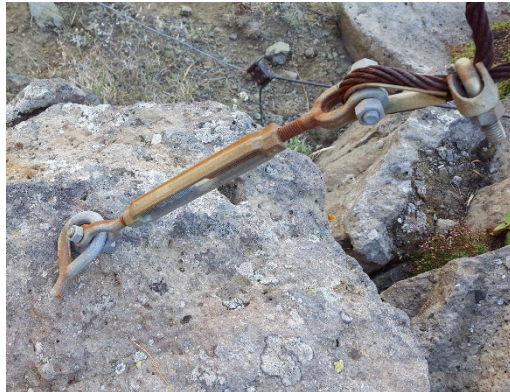
Safety - The lookout is safe for staff and visitors. In August of 2017 a guyline at the north corner of the lookout broke off, severed at its anchor in the basalt bedrock. *Recommended Treatment:* repair the guyline as soon as possible; it may be critically important.

Broken guyline

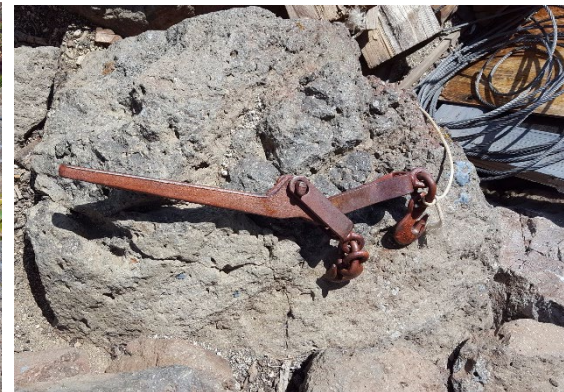
Security - A cable is run through the eye bolts and fastened with a griphoist to hold the shutters closed. This system is probably not original and the cable is scarring the lookout's corners. However, the system is effective and could be continued. *Recommended Treatment:* reinforce the corners with small pieces of aluminum flashing or a similar protective layer to prevent more damage.

Griphoist and cable

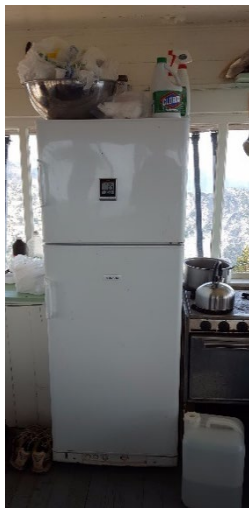
Refrigerator

Appliances - The lookout in residence reports that the refrigerator is substantially larger than needed and it blocks sight-lines and radio signals that are both essential for the lookout's work. It could be replaced with a smaller unit such as a mini-fridge. The wood stove, an Osborn box stove, is also over-large for the small interior space. The resident reports that this stove does not ventilate properly; There is an issue with the dampener and the stove will only operate if its door is open poses fire hazard. It is recommended that this stove be a) repaired by a capable technician or b) removed and replaced with a smaller stove. Although the lookout is also equipped with propane and solar power, a stove is probably the most reliable way to heat the building during winter when Mule Peak Lookout occasionally used for snow surveys. In all seasons it is used to burn trash and provide heat, but it is not often used for cooking. The resident reports that the stovepipe leaks and may not be flashed correctly. Furthermore, he has seen sparks fly out of the stovepipe's top and land on the ground outside the lookout. He has climbed up on the roof recently to adjust the stovepipe at its base, but it may need to be reflashed. On the south side of the lookout, a rough platform supports two solar panels. One is connected to new "Mule Peak" repeater. The other is connected to a battery and a defunct (or back-up) repeater. The lookout resident uses solar power to charge other electronic devices, such as a laptop and cell phone. One of the solar panels has displaced a strut that holds a shutter open. This may cause the shutter or remaining strut to fail over time, but it is not an immediate concern.

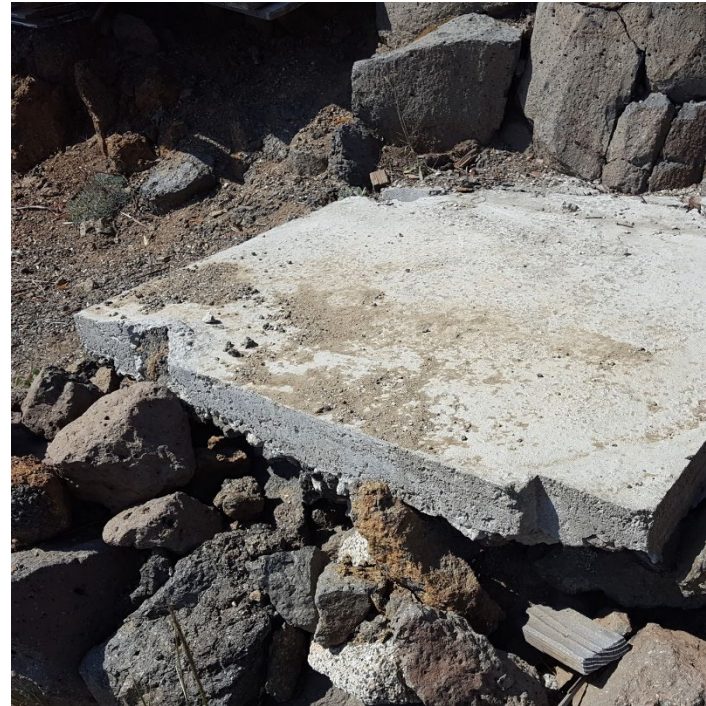
Fuel Storage - Propane and tools are stored on a flat spot adjacent to the building. A concrete slab further downhill on the east side used to provide a safe place for storing propane tanks inside a short wooden fence. Lookout staff relocated the propane supply because the concrete slab tipped. Propane tanks are connected to kitchen appliances and light fixtures inside the lookout via hoses that run through a gap in the foundation which allows access to the crawlspace. A large supply of firewood is also stored on the west side of the building.
Recommended Treatment: consider storing propane away from the lookout or phase out propane use in favor of solar power.

Concrete slab formerly used for propane storage

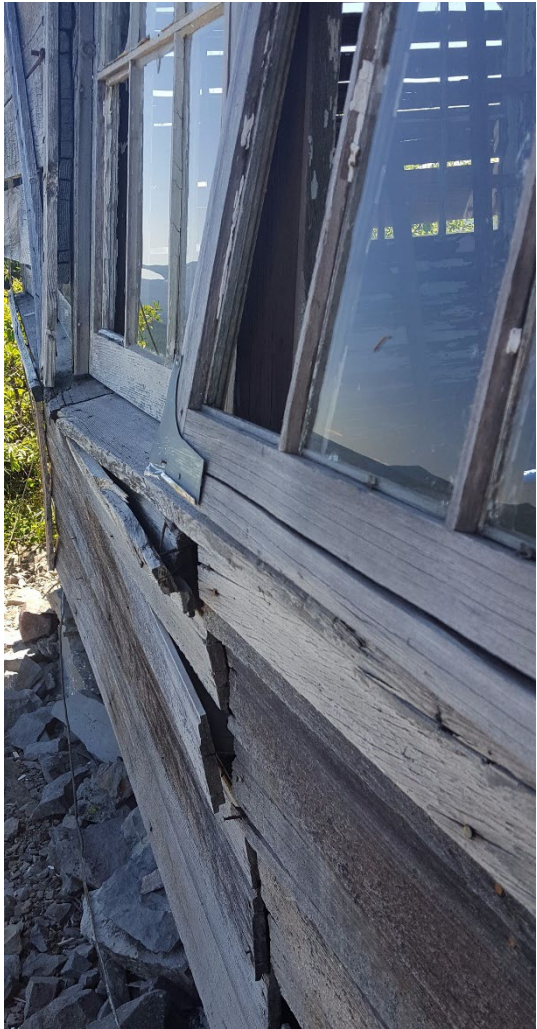
West wall exterior

Wall Structure - The lookout is framed in nominal 2" x 4" studs spaced 2' apart and reinforced with diagonal braces. A temporary wall across the interior reinforces the ceiling and walls. All materials are in good condition, but a structural failure in the roof has placed the east and west walls in critical condition. These walls have buckled out approximately 6" from plumb. Nevertheless, corner-to-corner measurements across the interior indicate that the lookout is still primarily still square, level, and plumb despite the structural failures at the center of two walls. The east and west sides have hinged along a vertical axis (unsupported by the foundation) and a horizontal axis (weakened by a row of windows). *Recommended Treatment:* reinforce studs with additional 2x4s which will be concealed behind the siding. This may not be necessary if other structural concerns in the roof are addressed and seem to be sufficient.

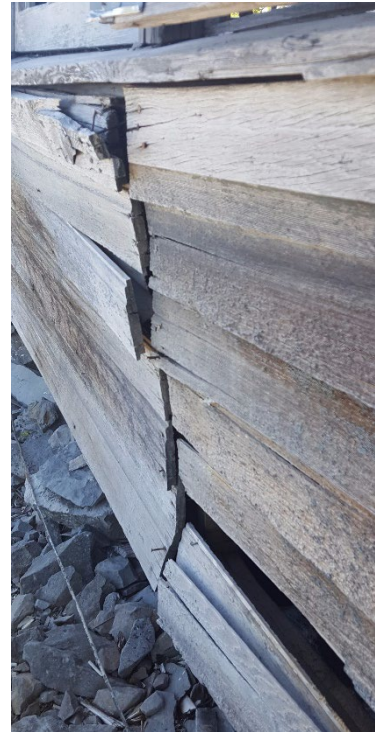
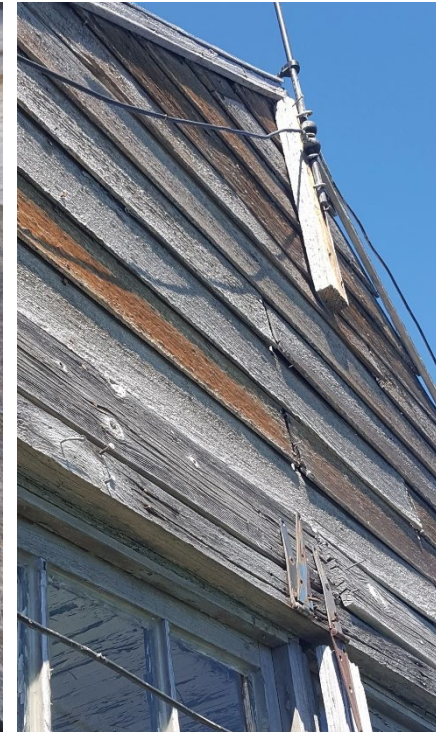
Exterior siding - Each elevation is clad in horizontal lap siding over tarpaper. The gable ends are 14' across and approximately 5'6" tall. Wall sections below the windows are approximately 14' across and 3' high. The siding is in poor condition due to weathering, UV damage, cracking, and cupping. Siding boards are 5-1/4" wide with 5" reveal and a beveled profile. Boards are cracked, cupped, and weathered to a mere 1/8 inch thick. The east and west walls were clad with 8' and 6' boards aligned so that their seams are continuous. This is not a significant characteristic and may be part of the problem that has caused these walls to buckle. When the roof structure and wall are repaired, new siding could be installed in an alternating pattern. Typically, all horizontal materials including siding, sills, trim, and headers are applied in both 8' and 6' lengths. *Recommended Treatment:* replace all siding on the east, south, and west elevations.

Typical condition below and above windows

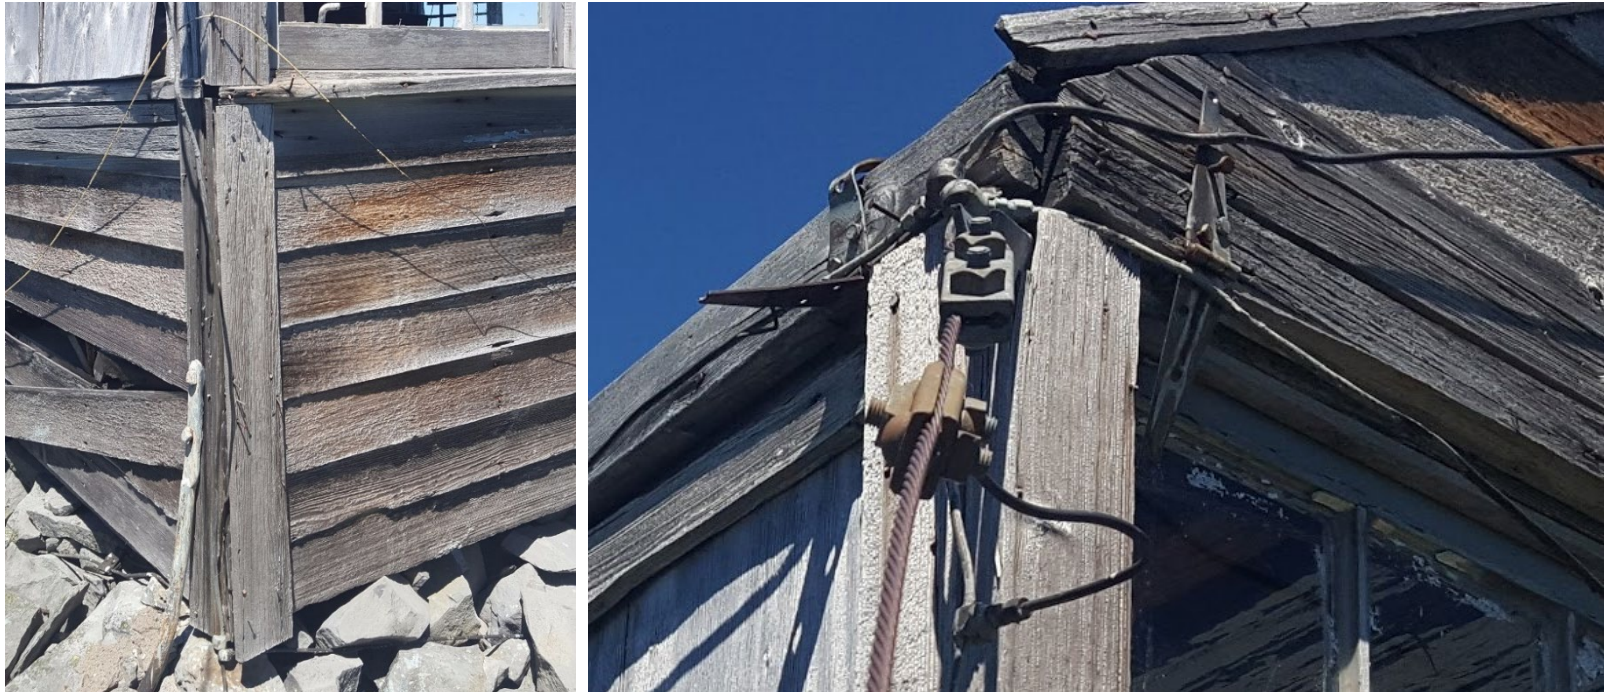
Exterior trim - Each elevation is trimmed with short corner boards below the windows, tall corner boards alongside the windows, window aprons, window sills, and headers that support the shutters from above the windows. Overall, the trim is in fair condition. Most of the damage is concentrated on the southeast side of the building where weathering and exposure are the most severe. *Recommended Treatment:* replace broken pieces of trim. Six short corner boards and two tall corner boards need to be replaced. They have a profile of 1-½" x 4-¼" (nominally 2" x 5") and are 3' and 4'3" long, respectively. One window apron needs to be replaced. It is 8' x 3-½" x ¾" (nominally 1 x 4). Three window headers need to be replaced on the north and south elevations. These boards have a 2" x 2-½" profile. Two headers need to be replaced on the west elevation, and have a slightly larger profile of 2" x 3-½". 3 window sills need to be replaced; they are 6" x 1-½" and beveled to 1".

Typical trim construction below and above

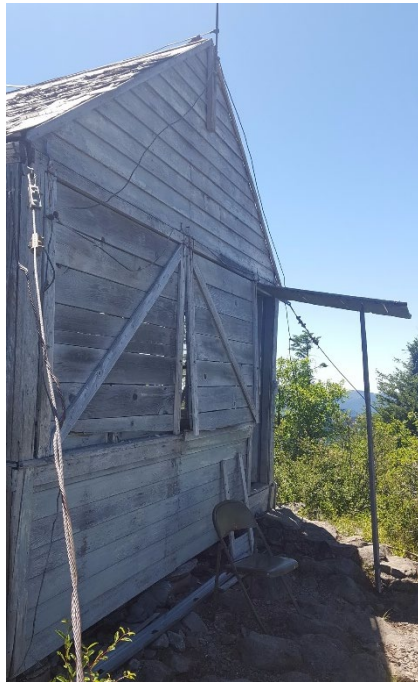
Typical construction

Shutters - The shutter system is in poor condition. Each elevation has two awning-style shutters constructed from a single layer of 1” thick horizontal boards reinforced with vertical and diagonal braces. Boards are fastened with 3” nails. The shutters are designed to hang suspended from the window headers above. Shutters come in three sizes. Small and medium-sized shutters have two vertical braces and one diagonal brace. Large shutters have three vertical braces and two diagonal braces. A small shutter hangs over the door and is in good condition. Several shutters have been replaced with plywood. The shutter hinges are in fair condition. Small and medium-sized shutters have two diamond-shaped hinges while large shutters have three. There are no latches to hold the shutters closed or open. 15 hinges can be reused. *Recommended Treatment:* reconstruct two medium-sized shutters and two large shutters. Repair three medium-sized shutters and one large shutter by replacing damaged boards. Replace six hinges.

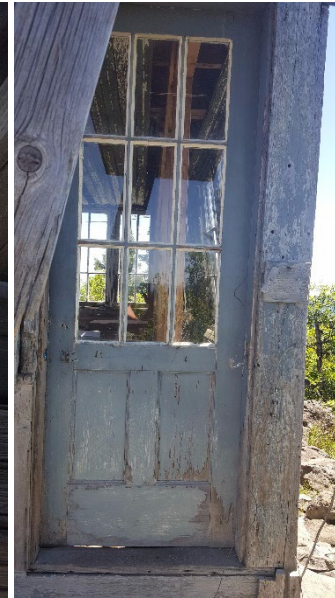
Door - The lookout's single door is on the north elevation. It is in good condition with panes, muntins, and panels intact. A small amount of damage to the woodwork could be patched with wood filler and the door could be repainted. The threshold dripline has broken off and could be repaired. The padlock and hasp have been removed. *Recommended Treatment:* repair the threshold and patch minor damage to the door's surfaces with woodfiller.

Door condition

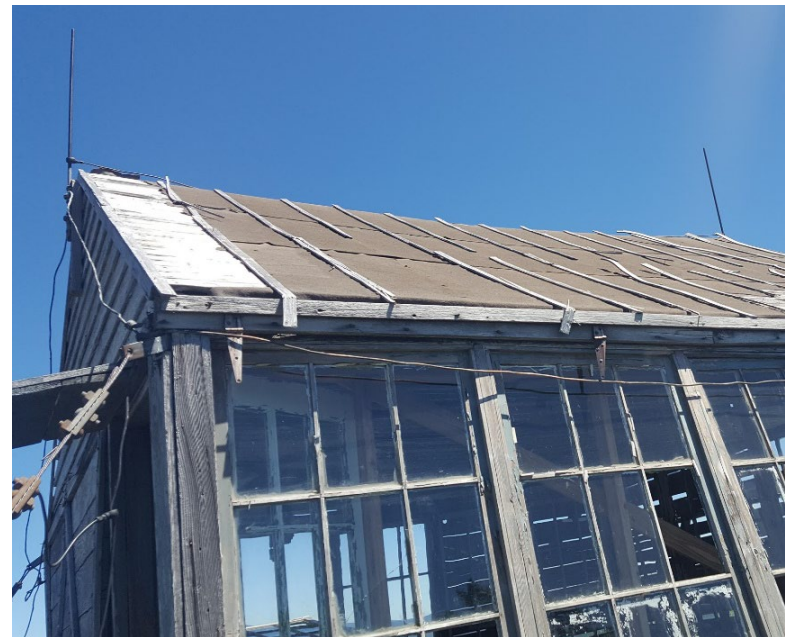
Roof cladding - The roof is typically clad in cedar shingles, but all are in critical condition. Shingles on the west side of the roof are extremely weathered and most are missing. The east side of the roof is stripped of shingles. Two 5' high stacks of cedar shingles are stored inside the lookout and appear to be in good condition. *Recommended Treatment:* replace all shingles.

East roof condition

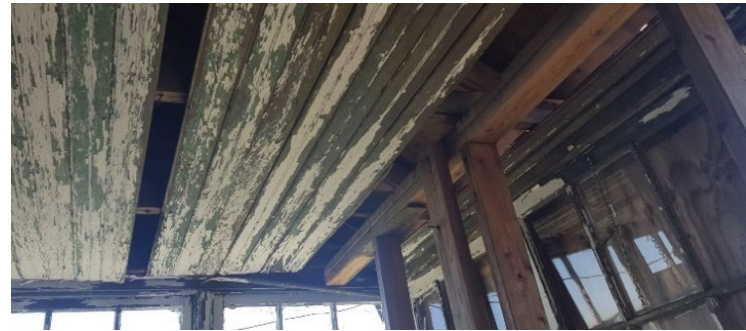
Ceiling -The ceiling joists were mostly inaccessible except where they can be seen through an attic hatch. They appear to be in excellent condition. Ceiling boards (the same beadboard as the walls) exhibit some sagging and need to be secured to the ceiling joists. This may be caused by the weight of trash in the attic, water infiltrating from the roof and causing boards to swell, or tension and expansion at various points in the buckling east and west walls. 10% of the ceiling boards are missing or broken. The beadboard has a profile of 3 ½" x ¾" and is in 8' or 5'7" lengths. *Recommended Treatment:* reinstall the ceiling once other structural concern have been addressed and the building is level, plumb, and square.

Ceiling condition

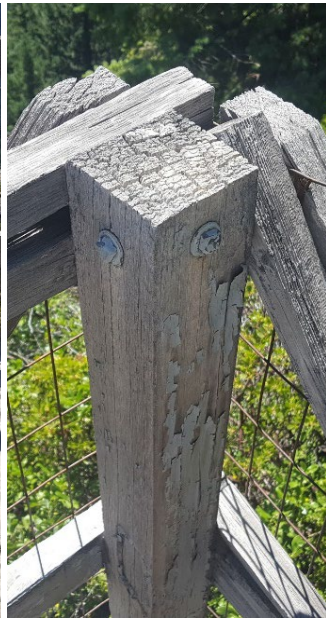
Erosion

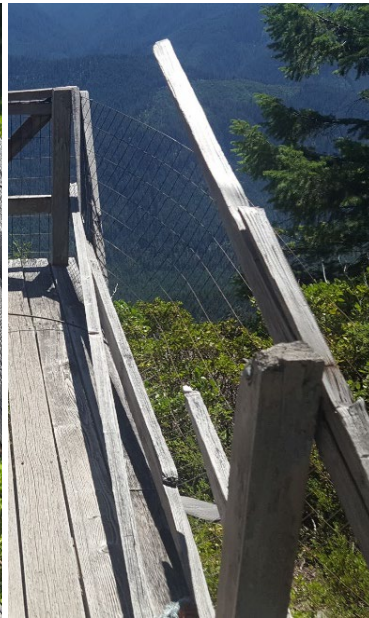
Broken northwest railing

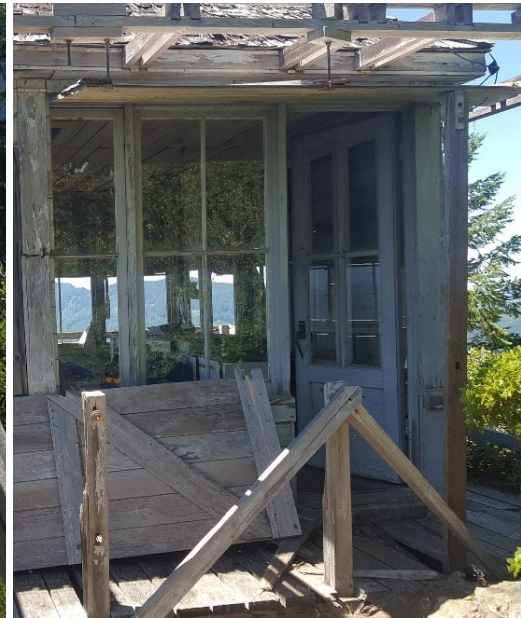
Altered northeast railing
