WILD NOTIONS:
PRESERVATION OF HISTORIC BUILDINGS IN OREGON WILDERNESS

A THESIS

Presented to the Historic Preservation Program,
and the Graduate School of the University of Oregon
in partial fulfillment of the requirements
for the degree of
Master of Science

March 2020

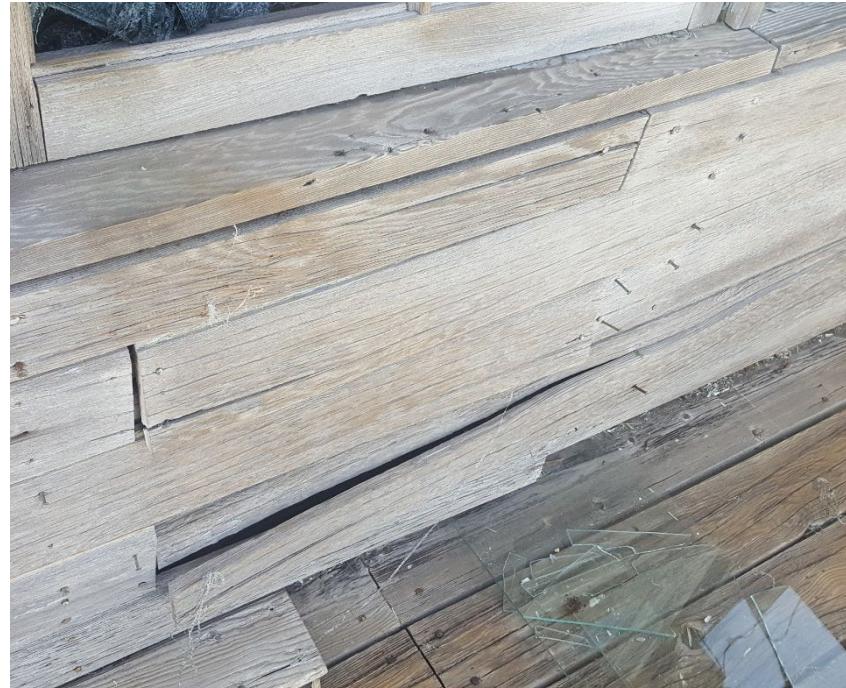
Typical condition

Exterior trim - Each elevation is trimmed with corner boards, baseboards, window aprons, window sills, and horizontal headers that support the shutters from above the windows. Overall, the trim is in fair condition. Most of the damage is concentrated on the south sides of the building where weathering and exposure are the most severe. The short corner boards are in poor condition, typically cracked, weathered, broken, or missing. These could be replaced throughout. One baseboard needs to be replaced. One window sill is cracked and needs to be replaced.

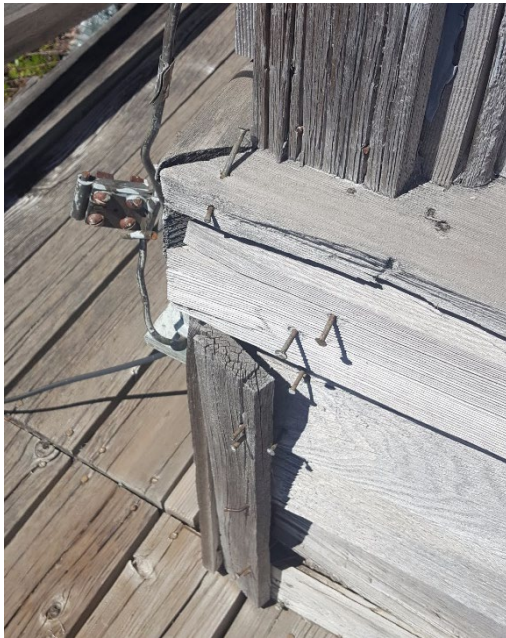
Corner boards

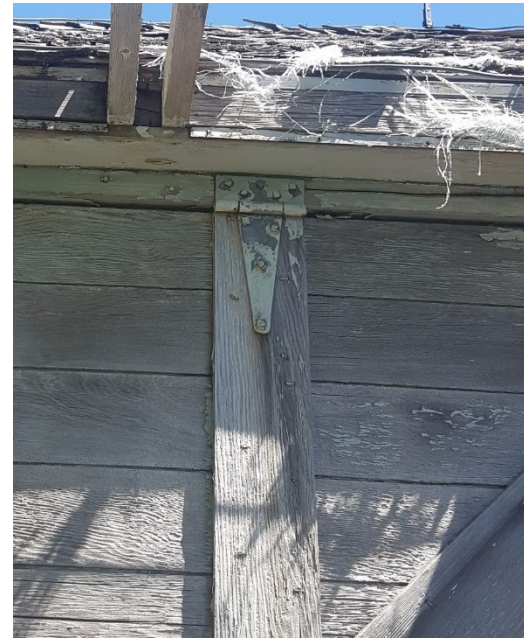
Shutter hinges

Shutters - The shutter system is in poor condition. Each elevation has two awning-style shutters constructed from a single layer of 1” thick horizontal tongue and groove boards reinforced with vertical and diagonal braces. The shutters are designed to hang suspended from rafters above. The shutters are screwed into exterior mullions with Philips-head screws. The screws render the shutters inoperable but likely have helped relieve weight and wear on the hinges. Most shutters are broken in half, and others are missing or otherwise damaged. Trail reports and public photographs indicate that the shutters have been broken in half for more than a decade. 75% of the shutters will need to be rebuilt. The remaining 25% need repairs. The shutter hinges and pins are in good condition. Pins are 5” long and have a square head (1” diameter) and a round shaft (½” diameter). At least four pins and six hinges could be replaced.

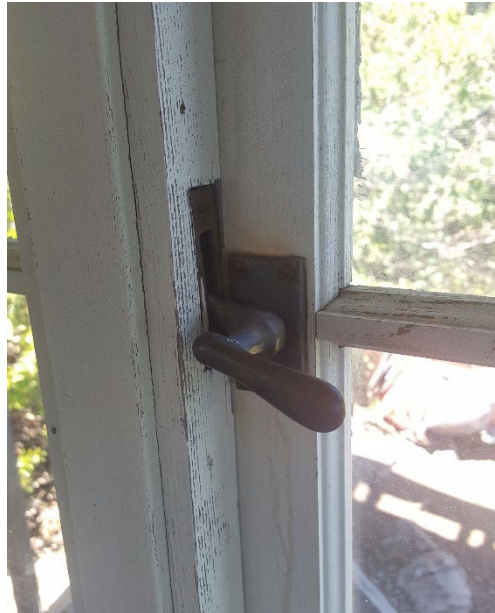
Interior sash and muntin profiles

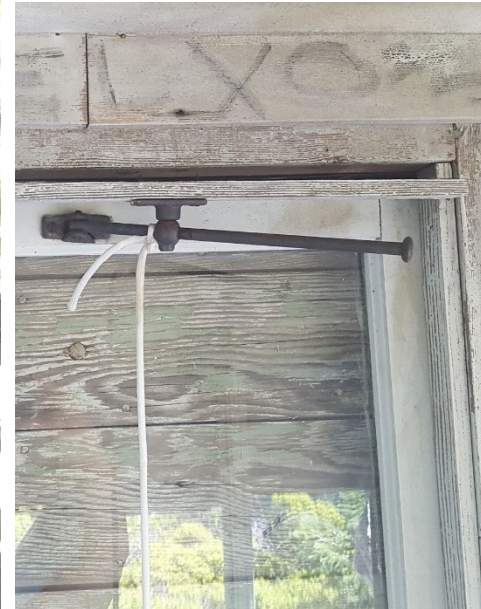
Hinge and detached header

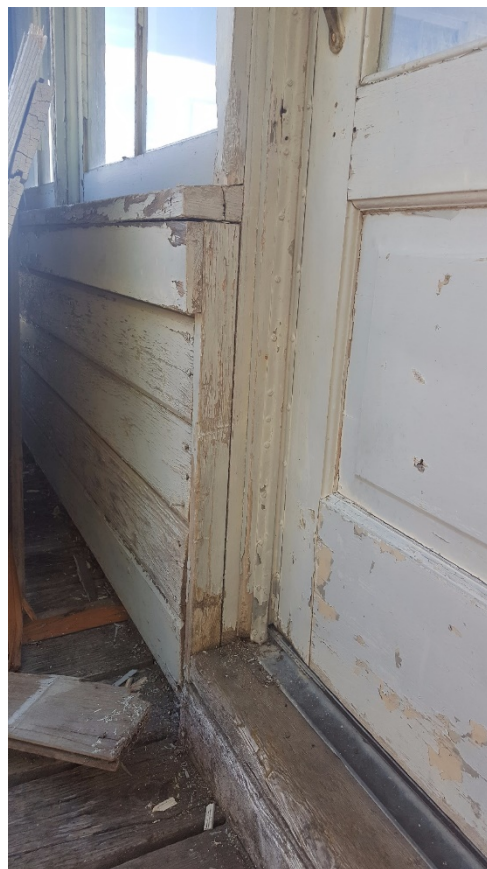
Door - The lookout's single door is on the northeast elevation. It appears to be original and is in good condition with panes, muntins, panels, and hardware intact. A small amount of damage to the woodwork could be patched with wood filler and the door could be repainted. It does not have an external lock.

Construction, hardware, and condition

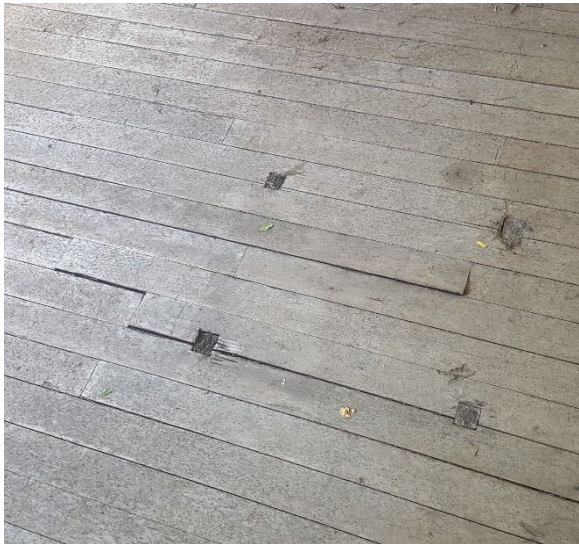
Floor - The floor and subfloor are in fair condition except for two sites where holes have been burned through the floor, subfloor, and joist from above. The floor and subfloor require repairs in two patches measuring 1' x 3' and 2' x 2'. Otherwise, the floorboards are worn and pitted by a pest infestation which has not affected the structural integrity of the floor. A piece of furniture, likely an Osborne Fire Finder, was formerly installed in the center of the room and has since been cut out. It appears that the floorboards were never painted. An application of varnish would protect the floor without significantly altering its original appearance and might be a worthwhile intervention.

Typical construction and condition, absent Fire Finder

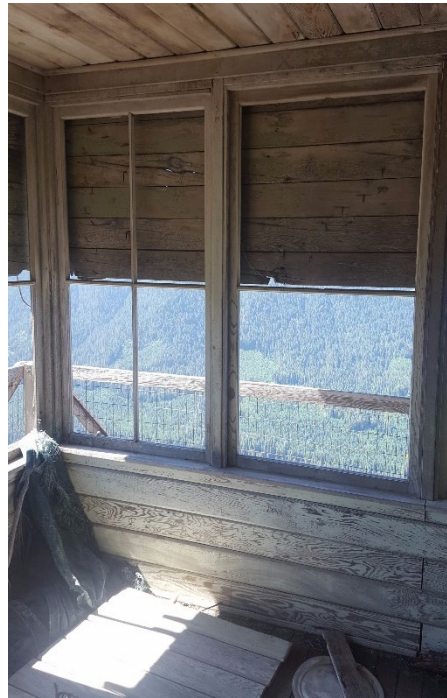
Typical condition

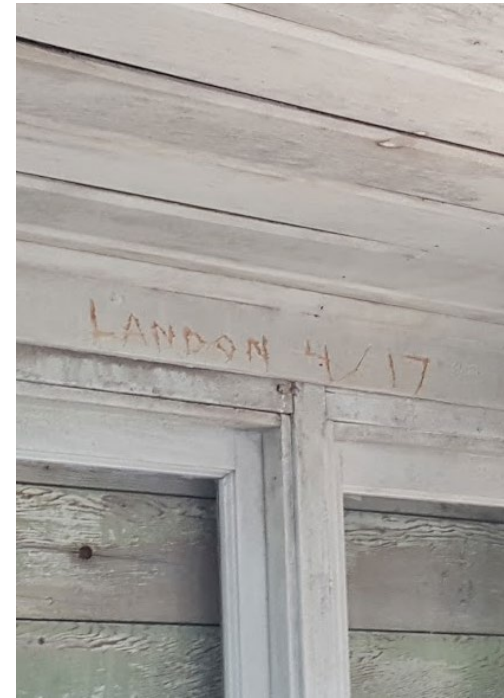
Walls - The wall structure, cladding, trim, and finishes are in good condition overall. The lookout is likely framed in studs aligned to the window mullions. The structure was not accessible but appears to be in excellent condition. Walls are clad in four rows of horizontal boards and formerly treated with a light grey latex-based paint. Lead content was not tested during this assessment. All boards are intact. Almost all paint has faded and weathered away, especially on the southwest end of the building where weather and UV exposure are the most severe. A new coat of primer and paint will be sufficient to protect these features. Quarter-round trim around the floor and ceiling; window sills, headers, and mullions are all in good condition. Window sills in the east corner have been roughly cut to fit around furniture. If furniture is removed it may be appropriate to replace the sills. Headers above the windows on each wall exhibit some graffiti in pencil and carving. These marks can be painted over and concealed with a small application of wood-filler. They do not necessitate replacing the damaged boards.

Carved graffiti damage

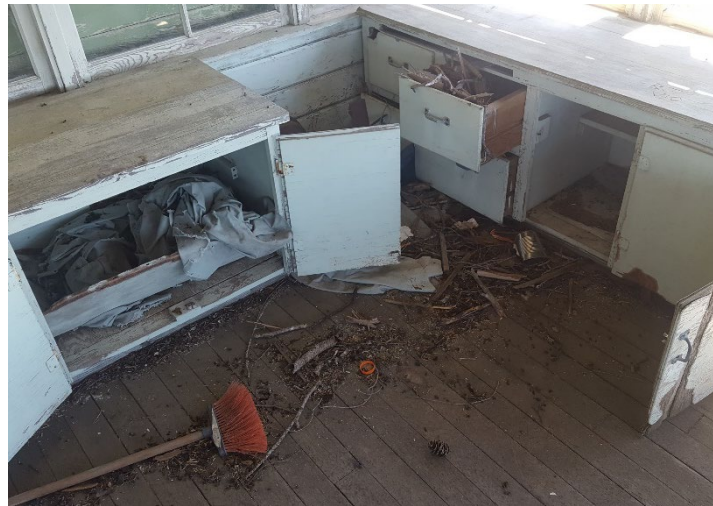
Trash - The site and interior are strewn with branches, broken glass, tarps, canvas sheets, a broom, a broken bow saw, a damaged tent, and other trash. This condition encourages other visitors to leave their trash behind and/or damage the interior. It also encourages animals and insects to occupy the building. Finally, this debris traps moisture, stains and scratches the interior. Trail reports and public photographs indicate that the interior was clean and tidy five years ago.

Furniture and debris

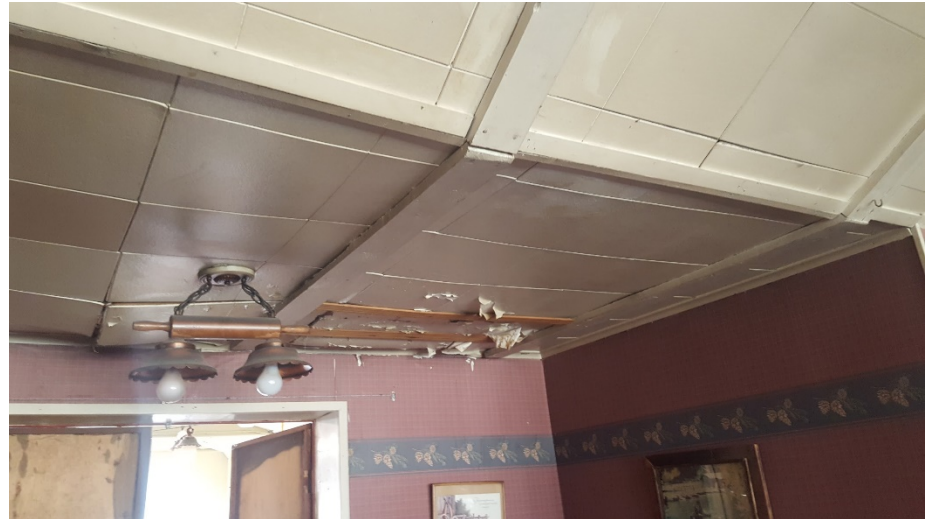
Dining hall ceiling condition

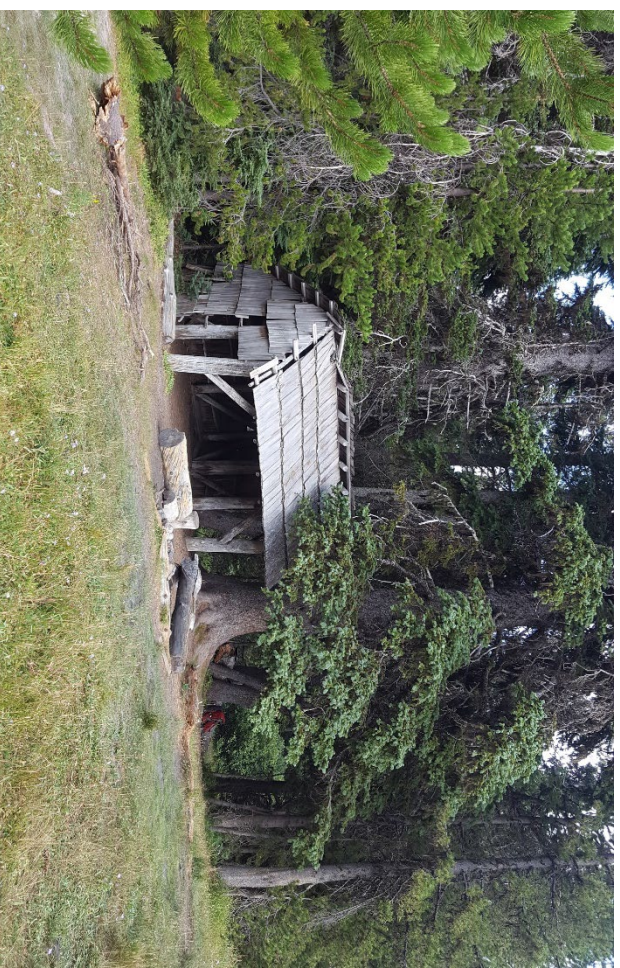
Site - Elk Meadows Shelter is sited at the edge of Elk Meadows and is tucked into the tree line where it faces west across the meadows, towards Mount Hood. Compared to the other extant shelters, Elk Meadows Shelter is at low elevation which protects it from severe weather conditions. However, the log-built shelter sits on soft soil that retains moisture and it is surrounded by trees and other plants that build up a thick layer of duff on the ground. All significant damage that this shelter has sustained originated from the site conditions. Moisture in the ground has rotted the sills and posts, and a fallen branch has cracked the roof structure. Once the building's critical structural issues have been repaired, site maintenance will be the key to retaining that progress in the future. Several hazard trees surround the shelter and pose a risk of damaging it. *Recommended Treatment:* rake plants and duff away from the shelter walls to keep the sills relatively clean and dry; remove hazard trees and overhanging branches, if it is feasible to do so.

Site conditions, north and west elevations

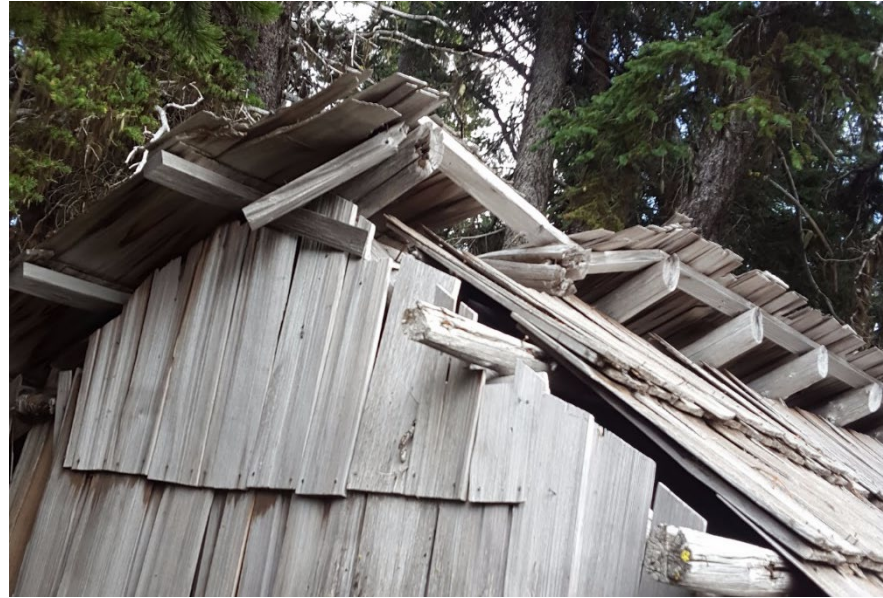
Roof structure - Elk Meadow Shelter has a modified gable roof, similar to a saltbox roof, but the east roof extends above the ridgeline by roughly 2'. The roof rises from 4'9" tall at the rear wall, to 10'10" at the peak, and drops to 7'6" at the entrance. The roof is built from pole rafters and nailers made from both poles and nominal 2x4 lumber. A fallen branch has damaged one rafter tail and one nailer on the east end of the ridge. 6' long 2x4s were used to reconstruct the east side of the roof and an unknown date, and are not historically accurate. This nominal lumber was not installed until sometime after 1978, because the original pole nailers are visible in USFS photos from that year. The north side of the roof retains its original pole structure to this day. Several of the 2x4 nailers are cracked along the nailing pattern that holds them to the rafters. The damage probably occurred when they were installed, and they can be retained for the time being. *Recommended Treatment:* repair the broken rafter tail with a scarf joint, and replace the broken 2x4 nailer. When the current roof begins to fail, it could be replaced with an accurate reconstruction of the original design. The north side of the roof, and maintenance records, can be used as a reference for that reconstruction.

Roof construction and condition

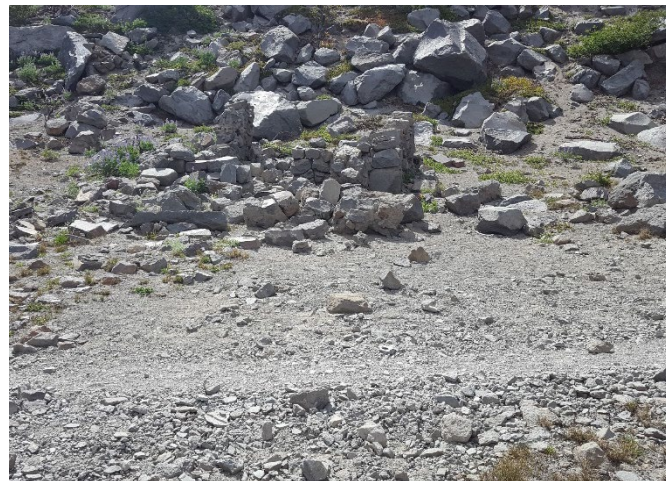
Gnarl Ridge Shelter has collapsed and is now a ruin of rough stone walls. The shelter originally faced north toward the Timberline Trail #600 which passes by within 20’ of the shelter. A steep rocky slope rises behind the ruin on its west side. Like the other shelters of this type, Gnarl Ridge Shelter has a 14’x14’ footprint with walls about 1’ thick built from uncoursed rubble. Today, the front and side wall are partially intact while the rear wall and its corners are entirely collapsed. The remaining walls achieve a maximum height of 41” at the northwest corner and 44” at the northeast corner. The side walls have collapsed to the east, meaning that the upper half of the west wall is now spread inside the building’s footprint while a large segment of the east wall is scattered outside the footprint. The front and rear walls have collapsed to the north in a similar manner. These walls are in poor-to-fair condition. Mortar is failing and masonry units are loose, particularly along the top of each wall. These loose rocks are unlikely to fall on their own but could easily be knocked down by visitors to a height of about 30”. If the ruin is stabilized these walls will require repointing. For interpretive purposes, fallen stones that fill the interior could be removed to essentially clean up the site and make the walls and footprint more apparent. The chimney and fireplace are essentially unrecognizable. They appear as a slightly thicker wall section at the northeast corner. The roof is also gone: no rafter pieces remain, but a piece of corrugated steel lies on the ground within 50’ of the east side.

Site condition

Recommended Treatment: Gnarl Ridge Shelter could be left as is, or at most repointed to preserve its current state. Reconstruction is not recommended under any circumstance.

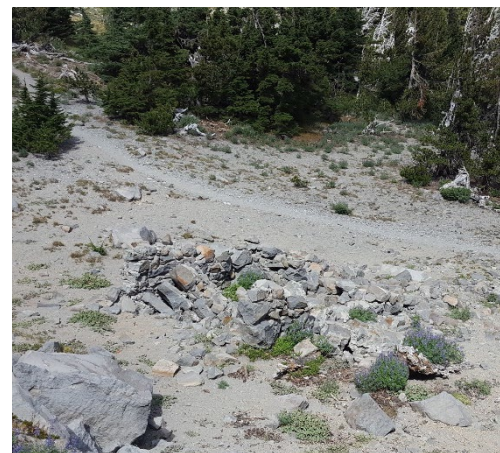
Gnarl Ridge Shelter, 2017

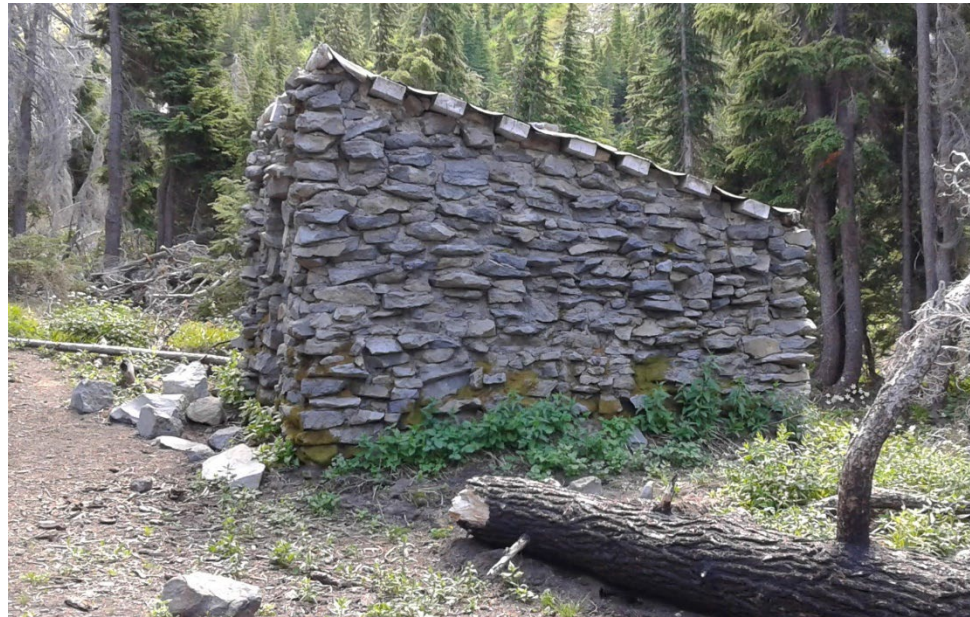
Site - Cairn Basin Shelter is sited below the timberline at the edge of a small clearing slightly east of the Timberline Trail. It is visible from the main trail and easily reached via a short spur trail. Overall, the site is in good condition. Dirt and duff have built up to a height of roughly 6” - 1’ on each elevation which will trap moisture against the masonry walls. Small plants are growing against the building. Large trees are close enough to fall on the building but they appear to be in good health. Otherwise there are no issues related to exposure, erosion, drainage, etc. The interior room is roughly square and measures approximately 10’ x 10’. The dirt floor has risen at least 6”. There is no evidence of floor below. *Recommended Treatment*: rake duff and vegetation away from walls to create a 2’ wide perimeter; rake out roughly 6” of dirt from inside the shelter.

Site, north elevation

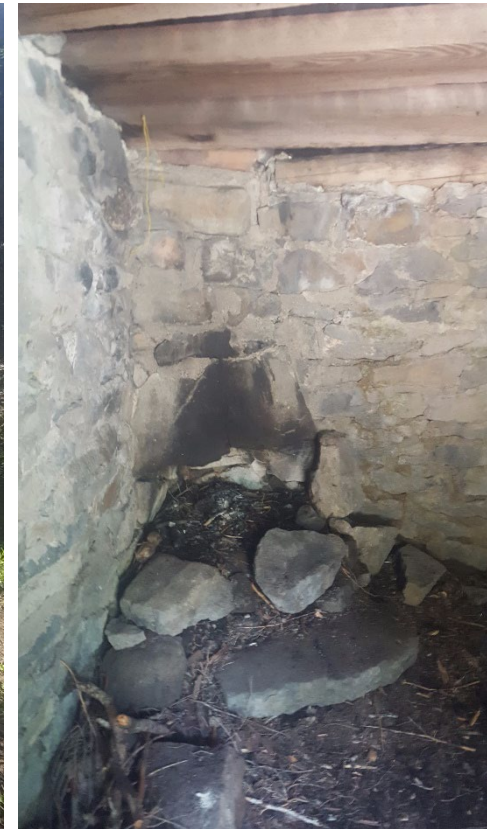
Chimney & Fireplace - A stone chimney located at the rear of the shelter creates a bulge in the exterior masonry wall at the southwest corner. It is in good condition. The chimney is uncapped and the flue is clear. The fireplace appears to be intact but is roughly built in comparison to the fireplace at McNeil Point Shelter. *Recommended Treatment:* if historical photographs or illustrations can be used to verify the original form of this fireplace at Cairn Basin Shelter, it could be repaired to match the original.

Fireplace

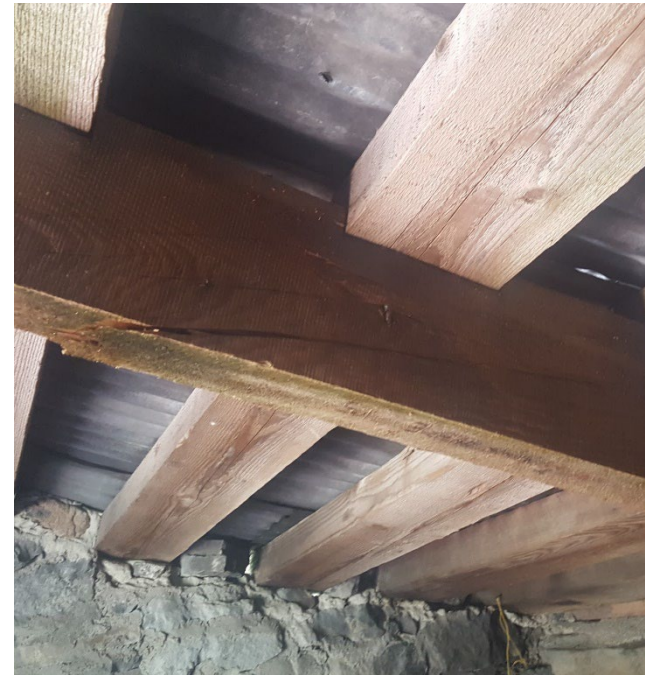
Roof Structure - This roof appears to be a replacement that alters the original peeled-pole design, although it is not clear when the roof was replaced. Forest Service photographs from the 1970's show the same roof in place. The roof is constructed from two peeled-poles and seven milled rafters that run north-south. The 12'3" rafters are supported by a single 14' 9" milled beam that runs east-west on center and is embedded in the masonry walls. The poles have a 5" diameter on average and the joists and beam have an 8' x 4' profile. Overall, the roof structure is in fair condition with one urgent failure that can be repaired in place. The beam may have failed under tension from snow loads overhead and a large knot that causes a weak point in the grain. Insect holes are visible in the pole rafters but they have not caused structural damage. The milled rafters are sound. *Recommended Treatment:* a 4' crack in the beam could be repaired by sistering a board on either side; In the long term, this beam may need to be replaced in full.

Cracked beam

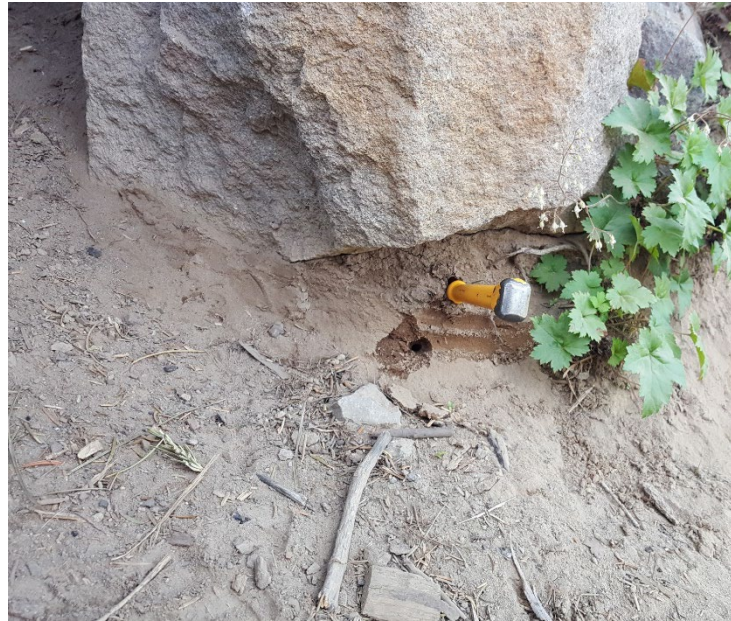
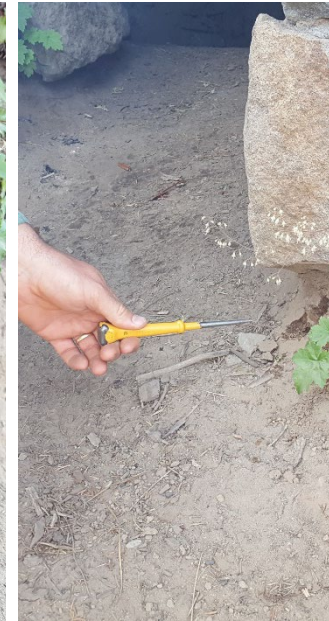
Awl inserted below wall

Awl depth

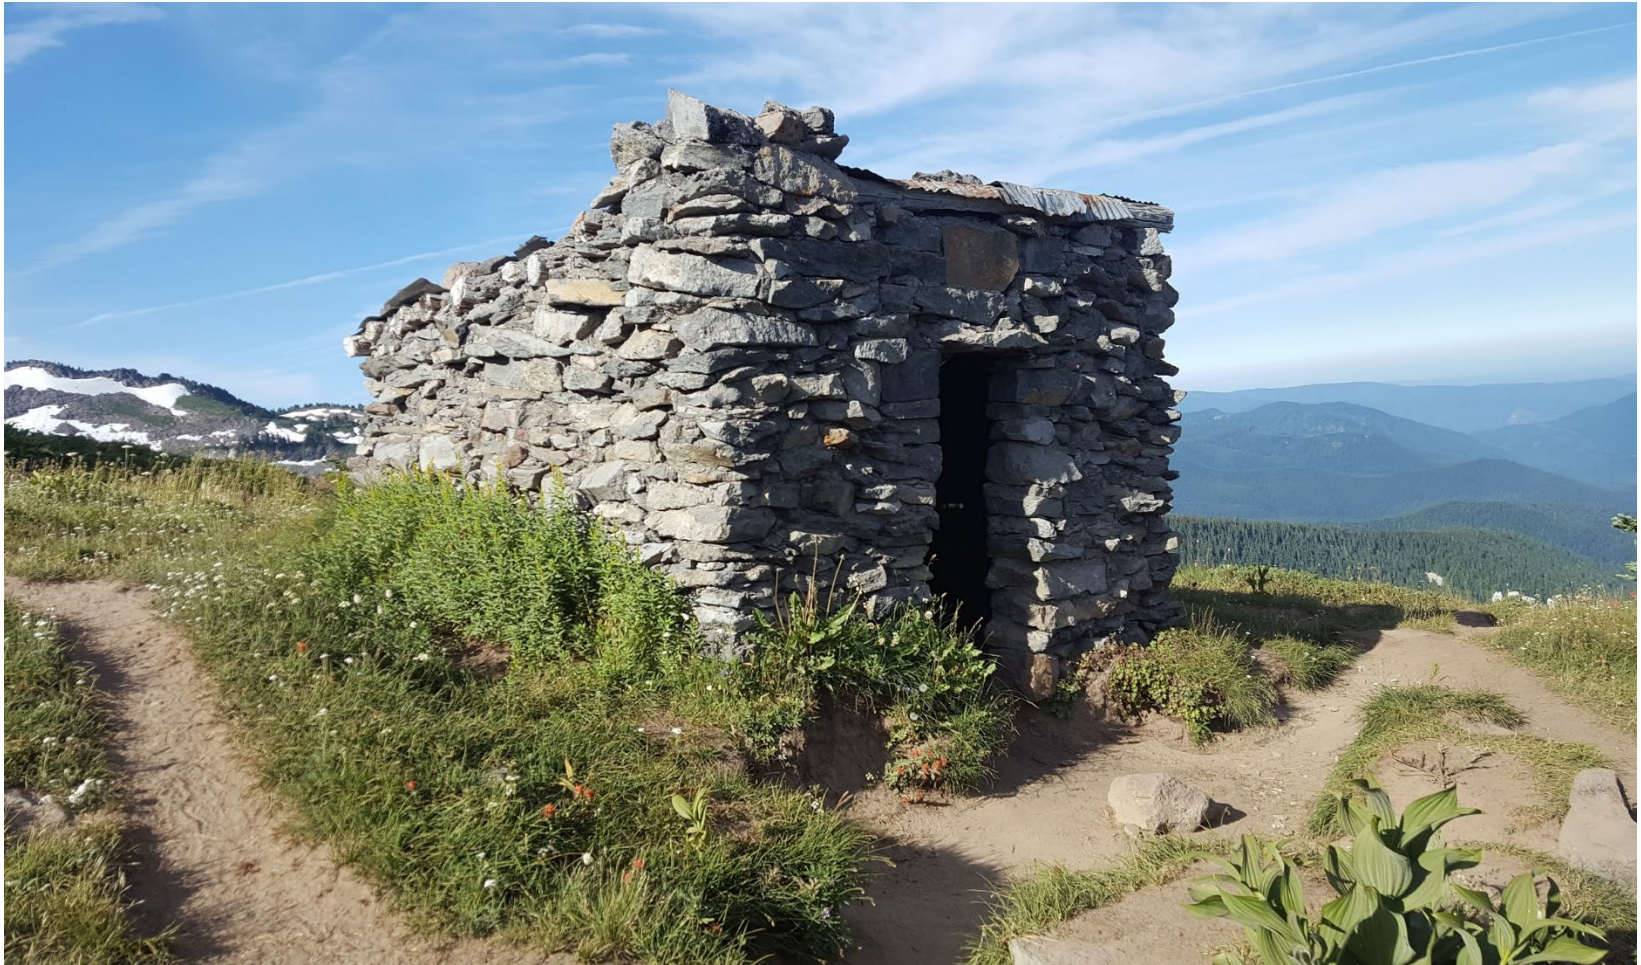
Site - McNeil Point Shelter is sited above the timberline on a prominent bluff with sweeping views of Mount Hood, the Muddy Fork River, and several peaks in the Cascade Range. Exposure and erosion have caused a critical issue in front of the north elevation where light, sandy soil has been eroded by visitors, water runoff, and wind. Small plants are growing against the building and could be retained as a strategy to prevent further erosion. The grade has dropped as much as 3' below the bottom of the walls. *Recommended Treatment:* reinforce the ground in front of the shelter with riprap. An area roughly 5' x 20' across and sloped from 3' to 6" deep could be filled with rock. The rock can be quarried from scree fields uphill within ¼ mile of the site. The riprap will compress over time and do not need to be topped with soil as this will erode quickly. Riprap installation is a critical work item that will stabilize the building and prevent severe damage in the near future. It could be done by a trail crew and does not require preservation expertise.

Site condition

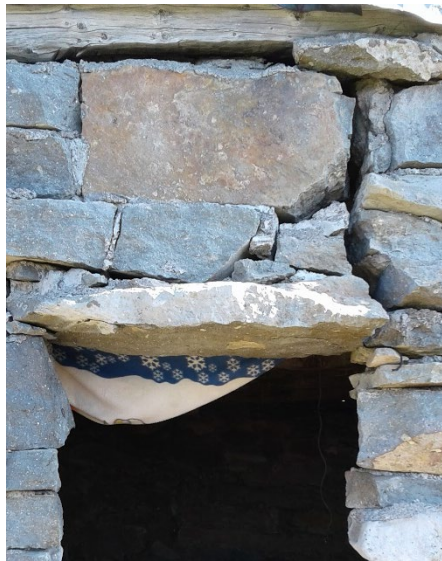
Walls - McNeil Point Shelter has a 12' x 12' square footprint and masonry walls rising to a height that ranges from 11' at the front to 6'6" at the rear. The walls are in direct contact with the ground. The random rubble walls are 1' thick, smooth to the interior and rough to the exterior with no recognizable coursing. Masonry units appear to be a local igneous rock. On average, mortar joints are 1"-2" thick and applied with a rough or rustic technique. The strong, light grey mortar appears to have a high degree of Portland cement. Overall, the masonry is in good condition and does not need to be repointed but a large section of the north elevation above the door is in critical condition. A wall segment comprised of half of the north elevation, the northwest corner, and the west wall has travelled away from its original location due to erosion below the north elevation. The lintel is in critical condition. There is a continuous 4" vertical crack through stones and mortar joints at the southwest corner. It penetrates the wall and is visible from both the outside and the interior. It appears to be mostly cosmetic and does not need to be repaired. Since this building has no long vertical mortar joints, a patch or mortar fill would be noticeable. *Recommended Treatment:* After riprap is installed, repair the north wall by repointing cracks with mortar. Alternatively, the damaged area can be removed and rebuilt when the roof is replaced, in which case most stones can be reused. The repaired section of wall will be roughly 2'4" tall, 6' wide, and 1' thick. Mortar can be mixed to match the original, but the local soil has a fine texture that would be a poor aggregate. The lintel could be replaced with a slightly larger stone.

Condition in north elevation

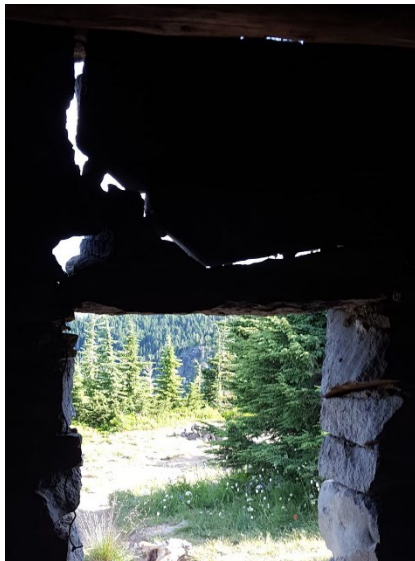
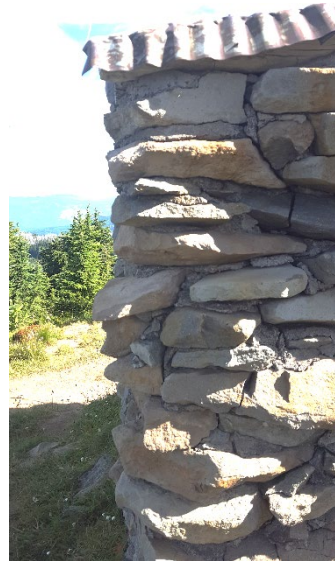
Condition at southwest corner

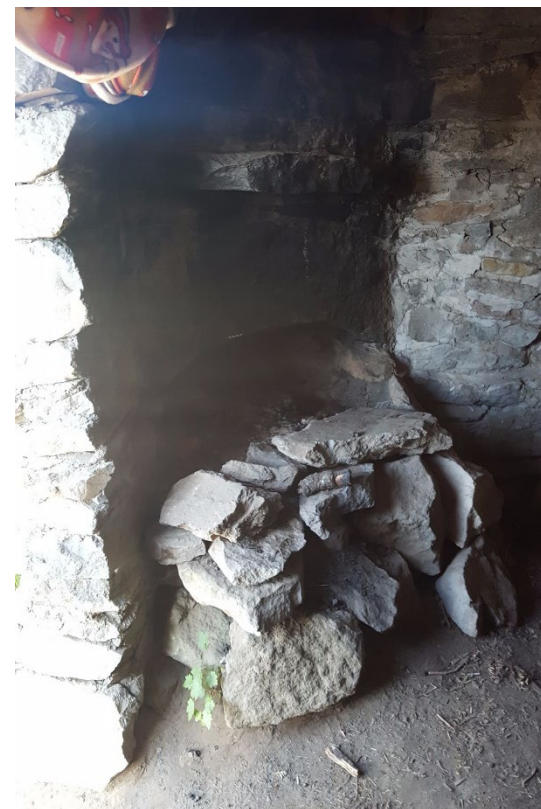
Chimney & Fireplace - A stone chimney located at the front of the shelter is flush with the exterior masonry wall at the northeast corner. It is in good condition. The chimney is uncapped and the flue is clear. The fireplace appears to be intact and its design is more formal than the fireplace at Cairn Basin Shelter.

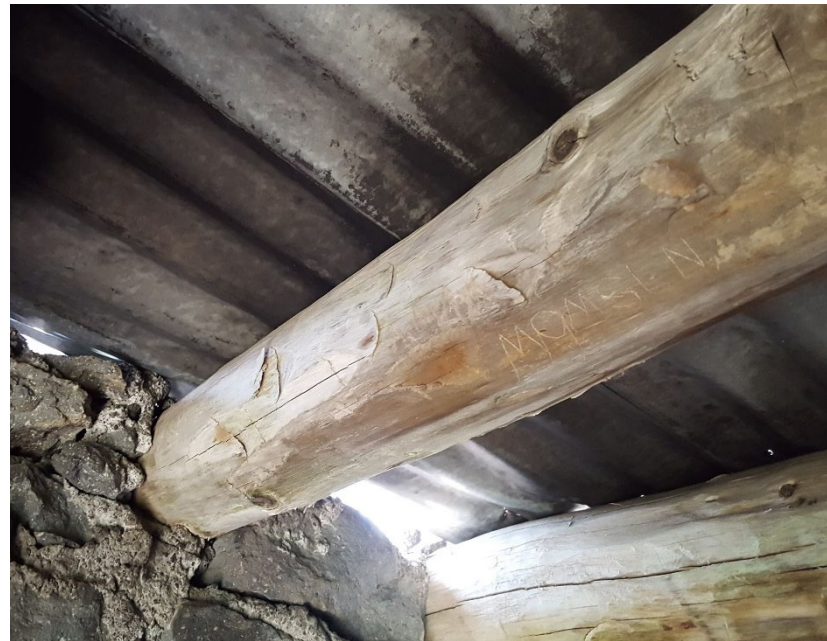
Roof construction

Roof Structure - The roof is constructed of 10 poles running east-west and is in poor condition. Several rafters have broken. These appear to be original logs. They have a steep taper, typically from 4" - 9" over a 12'6" length. They appear to have been collected onsite from slow-growth alpine trees with dense rings and steep tapers. Tool marks indicate that the poles were prepped with spuds and hatchets rather than draw-knives and bark was removed while they were green. The pole-ends rest on top of the masonry walls and are held in place with mortar. *Recommended Treatment:* replace rafters in full rather than repair in sections to ensure a strong roof. A crew may determine that some pieces can be reused but can expect to replace all the rafters. Some masonry repair will be needed when the rafters are replaced. Expect to repoint two sections approx. 12' x 1' x 1'.

Roof - The roof has a slope of 3/12 and is clad in 26" x 4'4" corrugated steel panels installed with a 3'10" x 4'2" reveal. The panels are in poor condition. *Recommended Treatment:* replaced all roof panels. A crew may determine that some pieces can be reused but may expect to replace 100% of the roof. New panels could be slightly larger, 28" x 4'6", to increase seams and extend drip lines. This is a very slight design change that will extend the roof's lifetime.

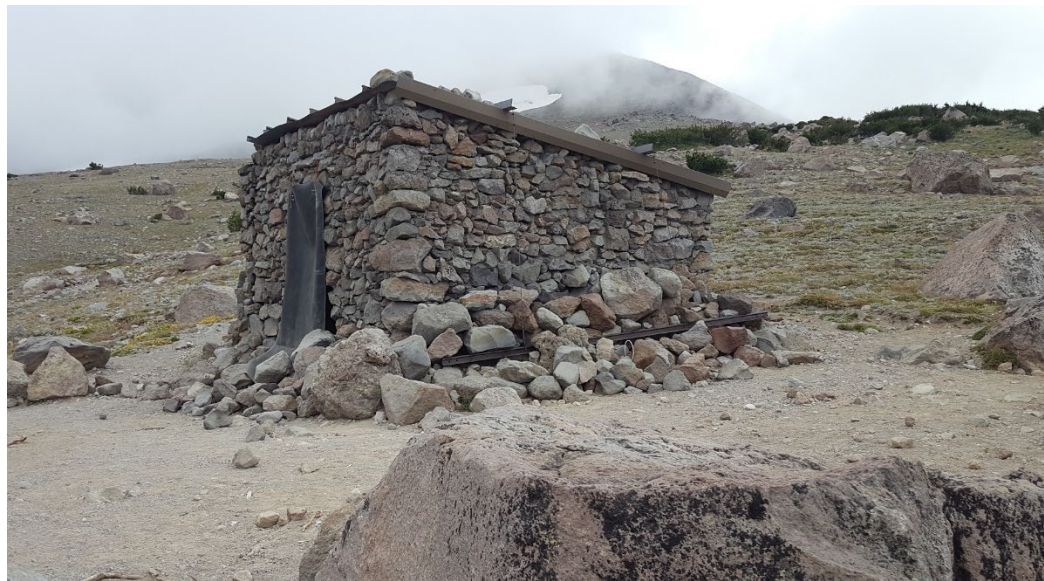
Site - Cooper Spur Shelter is sited well above the timberline on the shoulder of Cooper Spur with sweeping views of the Columbia River Gorge and Mount Adams to the north, Mount Hood to the west, and the Deschutes River to the east. Exposure and erosion have caused an issue in front of the north elevation where sandy soil has worn away on the downhill side of the building. Stones have been piled against the south, east, and north elevations to anchor I-beams cabled to the roof and prevent erosion at the base of the walls. A thick rubber mat hung in the doorway may also help prevent the floor from eroding, because it blocks wind and weather. *Recommended Treatment:* slight erosion could be addressed by installing a rough threshold of dry-laid stones in the doorway. This would reduce erosion that will otherwise undermine the walls. This work could be done by a trail crew.

Site condition

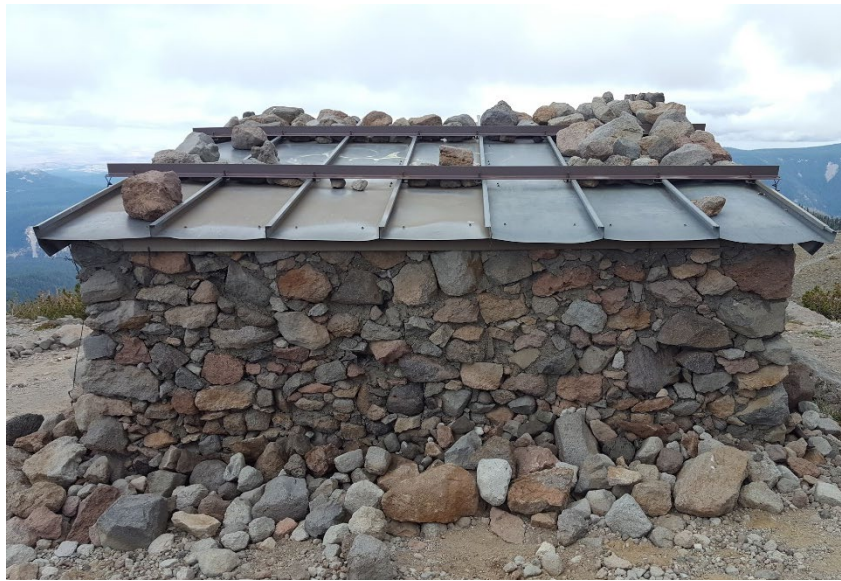
Some stones have fallen or been removed from the exterior side of the rear wall. The missing pieces are evident from the exterior, and even more so on the interior where shafts of light strike through small holes in the otherwise solid masonry wall. The missing stones do not presently create a structural concern but must at be monitored to ensure that they do not continue to expand. More stones are loose, either because mortar has worn away or because it was minimally applied. *Recommended Treatment:* As time allows, these missing patches could be refilled with stones that are spread across the site near the shelter. The three largest areas missing stones on the exterior of the rear wall measure roughly 1' x 6", 1' square, 1' square, but photography will be the most effective way to monitor this condition moving forward.

Rear wall condition and missing stones, 2017

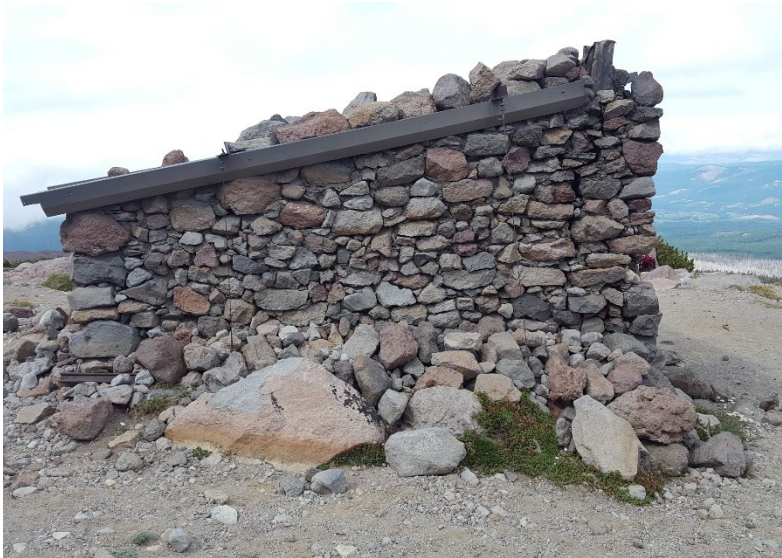
At the southeast corner, two large continuous vertical cracks are evident. One is located on the south wall, and one is located on the east wall. The cracks follow mortar joints and have not split through stones. They penetrate the wall and let light and weather into the chimney flue. Hikers' photos from the last decade indicate that these cracks are not new, and they are slightly visible in USFS photographs from August, 1978. If the cracks have stabilized they can be considered a cosmetic issue, but not a structural issue that needs to be repaired. Since this building has no long vertical mortar joints, a patch or mortar fill would be noticeable. *Recommended Treatment:* cracks do not need be patched with mortar unless they continue to expand and pose a structural concern.

South wall condition and vertical crack, 2017

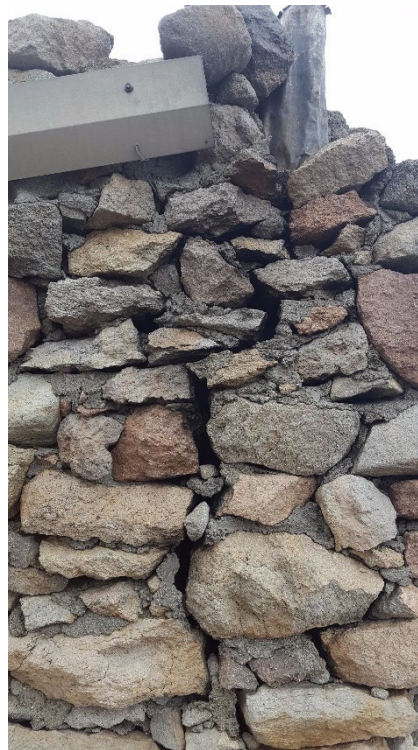
Chimney & Fireplace - A stone chimney located at the front of the shelter is flush with the exterior masonry wall at the northeast corner. It is in fair condition. The chimney is uncapped and the flue is clear. Unlike the other shelters, Cooper Spur Shelter's chimney is lined with a piece of corrugated steel rolled into cylinder. It forms a crude stovepipe that is 3' tall and has a 6" diameter. The fireplace appears to be intact. Its craftsmanship is more rough that at McNeil Point Shelter, and resembles the stone work at Cairn Basin Shelter. Large masonry units at the top of the chimney are loose. Two vertical cracks in the chimney walls presumably affect how it functions when there is a fire in the fireplace, but the shelter and its fireplace are not typically used so this is a minor concern. *Recommended Treatment:* repoint the top of the chimney to prevent damage to the shelter and to protect visitors who may otherwise be injured by falling stones.

Vertical crack

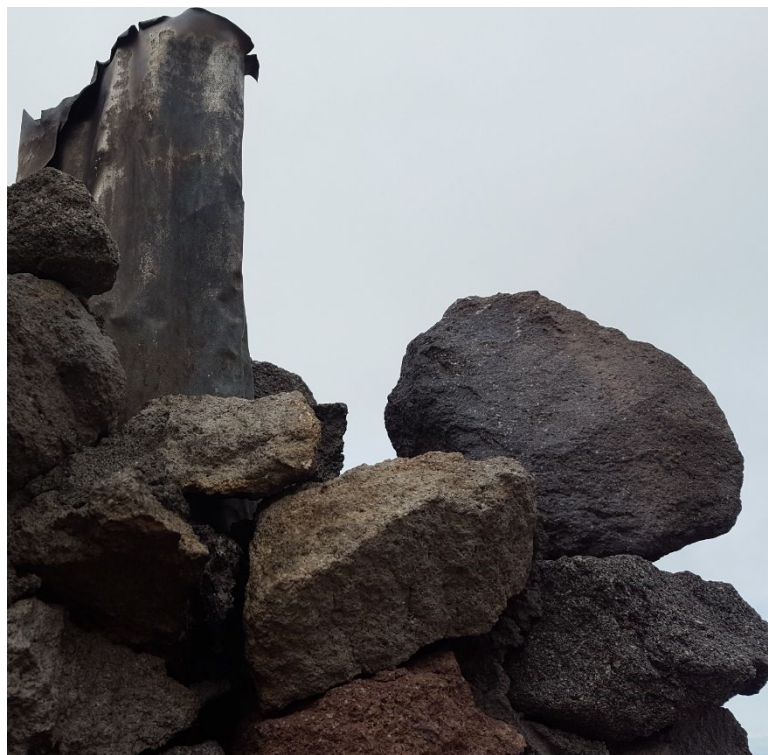
Corrugated steel stovepipe and loose stones

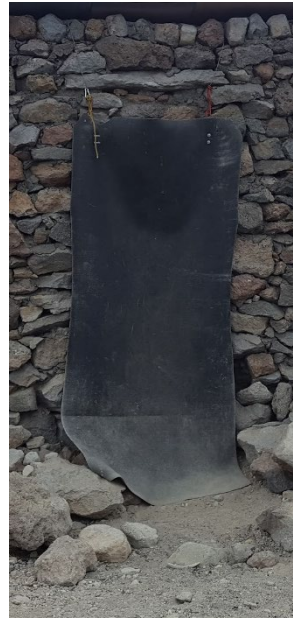
Doorway - The shelter doorway faces east, away from Mount Hood. The doorway has been altered with a metal lintel. Historical photos confirm that the original lintel was a continuous piece of stone which is still in place. The doorway was filled in and lowered, and the new lintel installed about 1' below the original. This alteration appears in a photograph from August 1978 and it may have been installed along with the new roof. A thick rubber mat hangs in the doorway, suspended on wire, carabineers, rope. The mat is clearly not original and was probably not installed by Forest Service staff so heritage resource managers will decide whether it serves a useful purpose and should be retained. Even though they are not original, the lintel and mat are reasonable, reversible alterations that can be retained. They do not appear to be damaging the building and may genuinely help hikers utilize the building as an emergency shelter.

Altered doorway

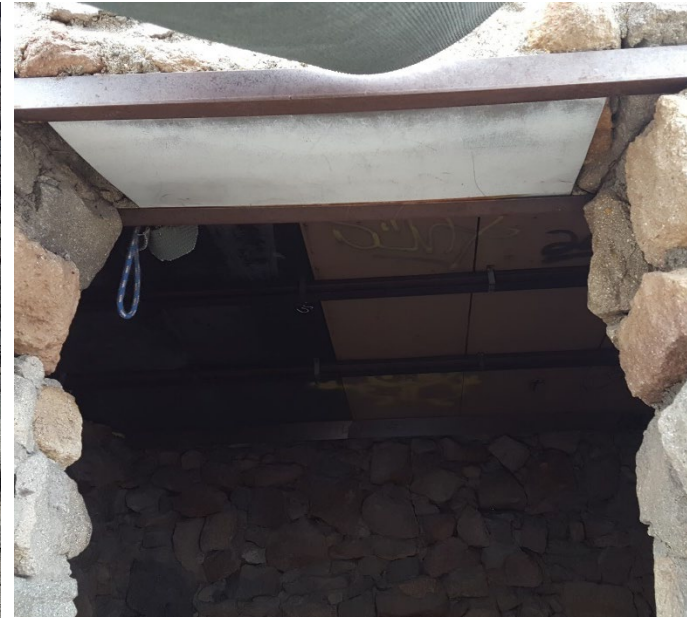
Metal lintel

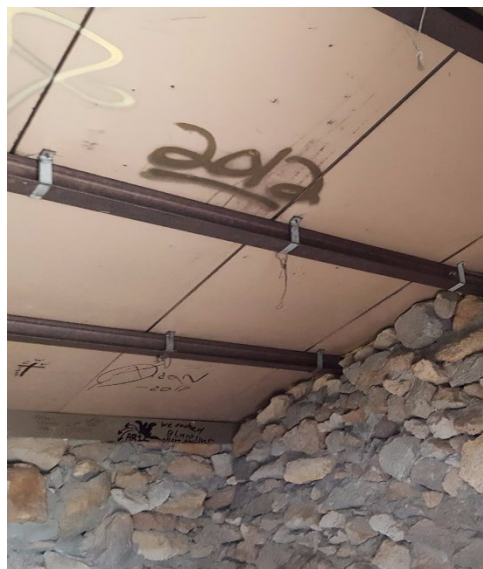
Five iron rafters run from east-to-west and are in good condition. The standing seam roof is comprised of seven panels, all in good condition except for graffiti scrawled on the undersides which are accessible from inside the shelter. All wires that anchor the roof are in good condition; three out of the four wires are under slight tension. Photos from 1978 show that the roof was once covered in a layer of stones; roughly half of these stones are still in place. Orange spray foam fills small gaps between the metal roof and the masonry walls. The foam probably makes the shelter more comfortable when it is used in emergencies. It can be retained if heritage resource managers believe that it serves a useful purpose. However, it is another intervention that has altered the integrity of this historic resource.

Graffiti

Cooper Spur Shelter			
walls	fair	urgent	Monitor loose stone at the rear wall and two cracks in the chimney. Repoint top of chimney and patches of rear wall using mortar, aggregate on site, and stone on site.
site	good	urgent	Reinforce ground at front elevation with dry-laid stone to prevent erosion
chimney	poor	minor	If fireplace should be operational, repoint cracks with mortar and aggregate on site
roof	good	minor	Remove or conceal graffiti

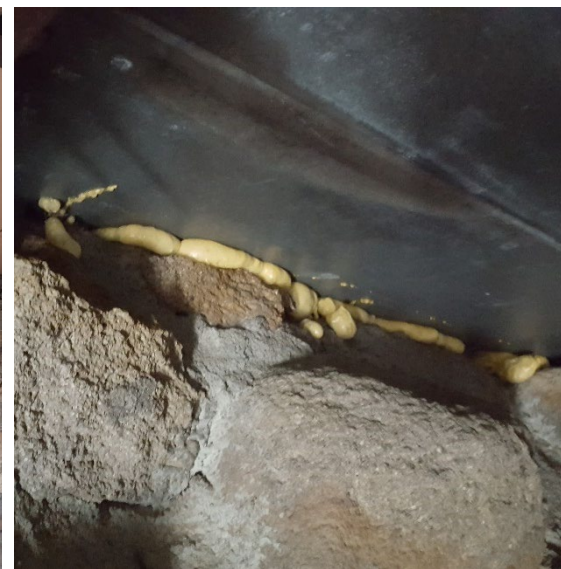
Spray foam

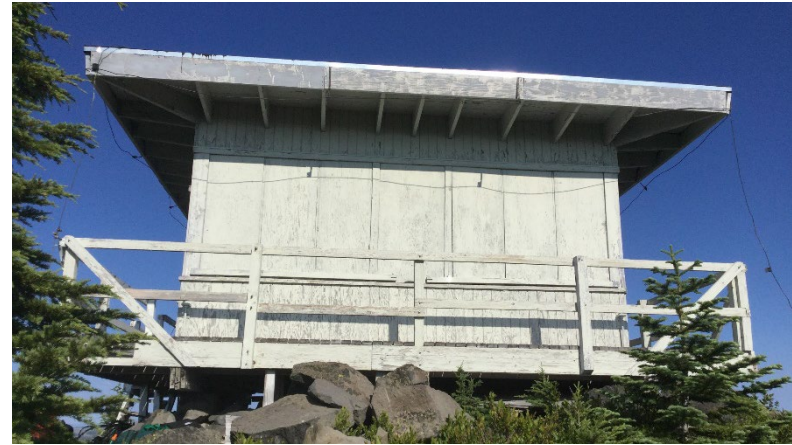
Catwalk railings - The railings are in fair-to-poor condition. They are typically constructed with five 4x4 posts on each side of the lookout, 2x4 diagonal braces at each corner, and 2x4 horizontal rails fastened with 3/16" thru bolts. Each of the four sides is built differently: posts are installed either in front of or behind the fascia, rails are misaligned or missing, posts extend to the ground or are just 4' long, and two railings accommodate a short flight of steps at the northeast corner. Before the railings are repaired it would be best to consult historic photos of the lookout and typical plans of the R6 lookout type in order to the original design of these railings. The north side railing is in poor condition. Two rails are missing and an original post was replaced with an 8' long pressure treated 4x4 that reaches all the way to the ground. The northeast corner is crudely reinforced with a post that reaches to the ground. A hiker's photo from 2002 shows that the northeast corner of the deck was cantilevered (not supported by a post) and the missing rails were intact. The east railing is broken in several places. The south and west railings are sound. *Recommended Treatment:* replace missing rails, posts, and one diagonal brace. Once the damaged joist and fascia are repaired, it might be possible to remove the northeast post.

West Elevation, railing design

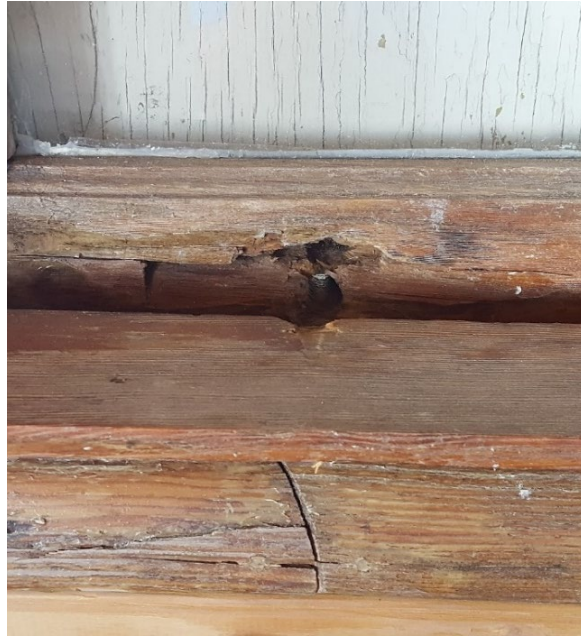
Condition caused by eyebolt installed through sash

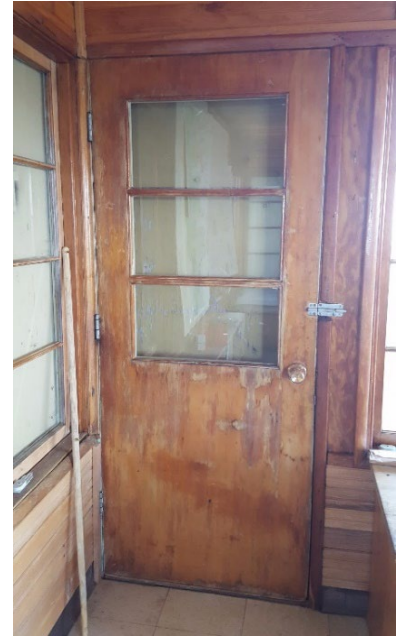
Door - The lookout's single door is on the north elevation. It was mostly inaccessible during this assessment but appears to have a hollow core filled with insulation and is in fair condition. The door and its shutter are locked with a Yale lock and a Master lock.

Door construction and condition
