WILD NOTIONS:
PRESERVATION OF HISTORIC BUILDINGS IN OREGON WILDERNESS

A THESIS

Presented to the Historic Preservation Program,
and the Graduate School of the University of Oregon
in partial fulfillment of the requirements
for the degree of
Master of Science

March 2020

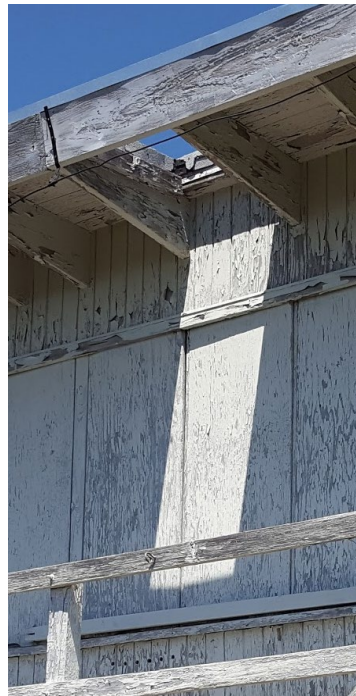
Roof access

Roof structure - The roof structure was mostly inaccessible during this assessment, but appears to be in excellent condition. A 2' x 2' section of the roof above the south catwalk is open to the sky, which allows easy roof access but also exposes the windows, siding, and deck to weather. It is probably impacting the condition of multiple systems; the missing deck board, separation of the south wall, damaged window putty, and scraped sash all occur immediately below this opening. *Recommended Treatment:* cover the opening with a simple plywood hatch.

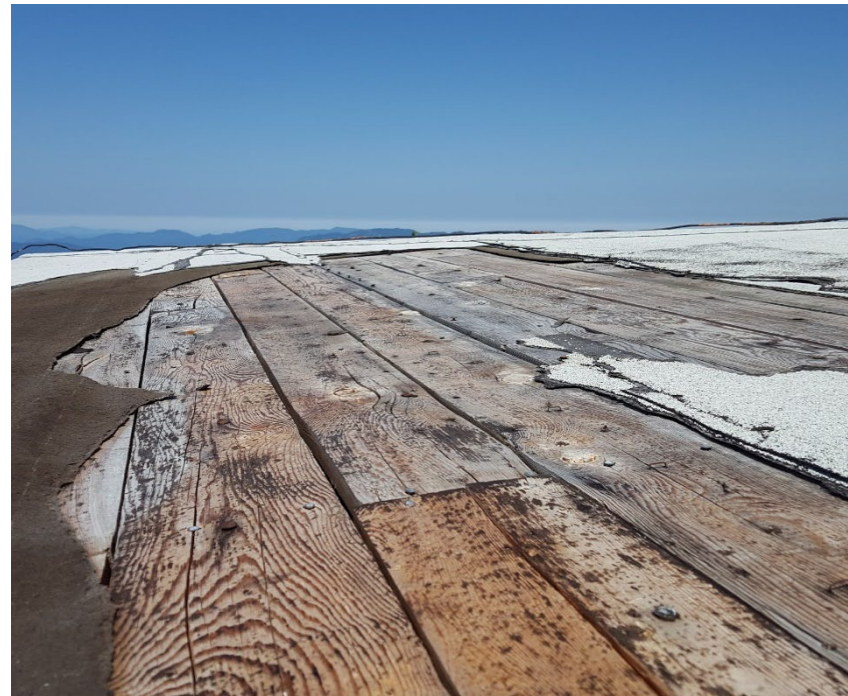
Roof - A section of rolled roofing on the south side is missing and has exposed the wood sheathing below. The patch measures approximately 8' x 10' and is a critical concern that has the potential to accelerate damage throughout the structure if it remains unrepaired through winter. Roofing nails are already on site inside the lookout. *Recommended Treatment:* replace roofing.

Roof condition

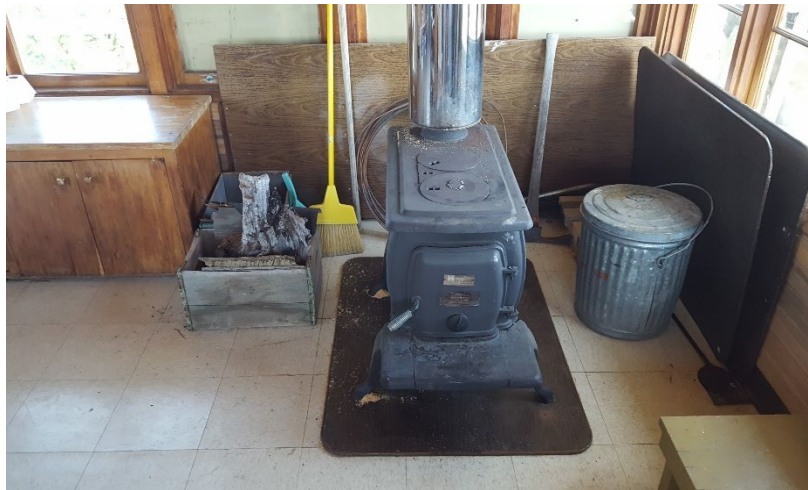
Floor - A linoleum floor and rubberized baseboard were recently installed and are in excellent condition. If linoleum was not originally used on the lookout's interior, it is still an appropriate alteration for an operable lookout.

Floor condition

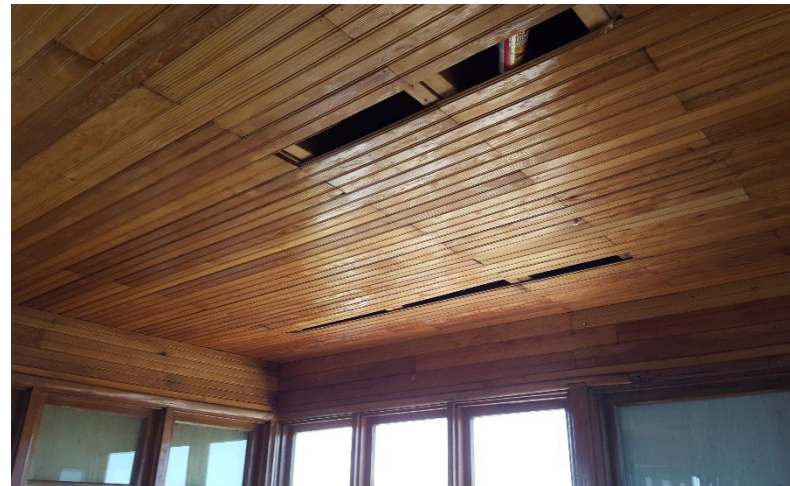
Ceiling - Carpenter ants are active near the stovepipe at the northeast corner and at the south side of the building. Chewing sounds, staining, and holes indicate an active infestation. Chemicals have been used in the rafters (and remain as trash). Approximately 10' of 0.3.2 x 5.6.0 x 0.0.2 beadboard is need to replace missing boards. The roof structure is largely inaccessible because the roof is flat. Missing sections of the ceiling expose some parts of the structure, which all appear to be in good condition. However, it is possible that carpenter ants have damaged the rafters and there may also be damage to the south side of the building where a large section of roofing is missing. Investigation is needed and would made when the ceiling is removed. *Recommended Treatment:* open up the ceiling mitigate the ant infestation, and investigate possible damage to the roof structure. Reinstall the extant ceiling and replace missing boards, anticipating some breakage in the process.

Ceiling condition
