STORIC STRUCTURES REPORT

STIMSON-GREEN MANSION AND CARRIAGE HOUSE

*TERMINAL PROJECT
TOWARDS PARTIAL FULFILLMENT
OF A MASTERS OF SCIENCE
IN HISTORIC PRESERVATION*

WINTER 2002-2003

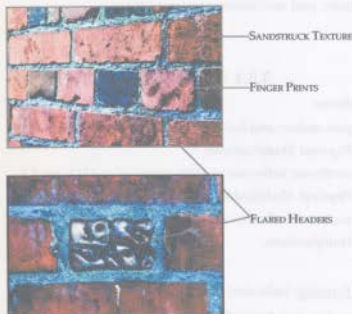
Fig. 3.3.1.1

This brick was power washed (at 110 psi) in the 1990s. There has been little to no brick replacement.

CONTEMPORARY VIEW OF BRICK. NOTE TEXTURE AND USE OF FLARED HEADERS.

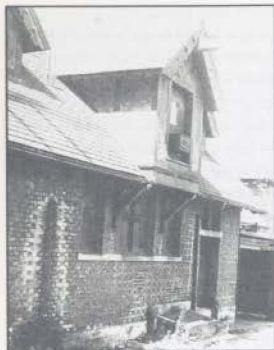
Fig. 3.3.2

CA 1958 VIEW OF NORTH END OF EAST FACADE, NOTE DARK BRICK AND EFFLORESCENCE. PHOTOGRAPH SOURCE: WEBER LANGENHAGGER COLLECTION, SEATTLE PUBLIC LIBRARY, SEATTLE WASHINGTON.

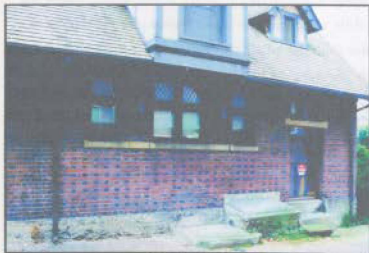
Fig. 3.3.2.1

CONTEMPORARY VIEW OF NORTH END OF EAST FACADE.

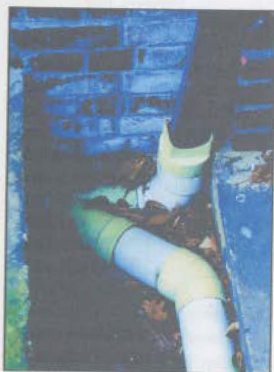
Fig. 3.4.1.11

CONTEMPORARY VIEW OF GUTTER DOWN ATTACHMENT NORTH OF EAST BASEMENT ENTRY TO PVC PIPE FOR STORM DRAINS. NOTE LEAVES AND EFFLORESCENCE.

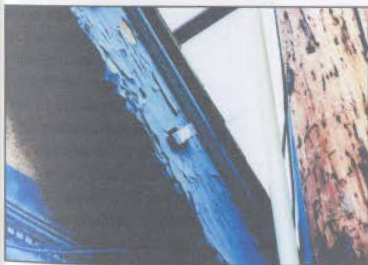
Fig. 3.4.2.6

CONTEMPORARY VIEW OF DETERIORATED PAINT ON BARGE BOARD ON SOUTHEAST CORNER OF BUILDING.

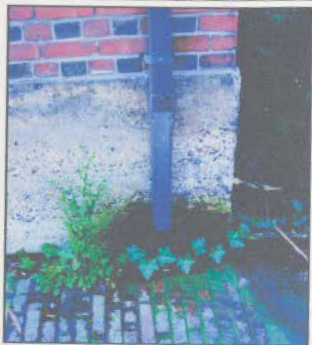
Fig. 3.4.2.7

CONTEMPORARY PHOTOGRAPH SHOWING THE GUTTER DOWNSPOUT OFF THE NORTHEAST CORNER OF THE CARRIAGE HOUSE. NOTE EXTENSIVE VEGETATION GROWTH AT BASE.

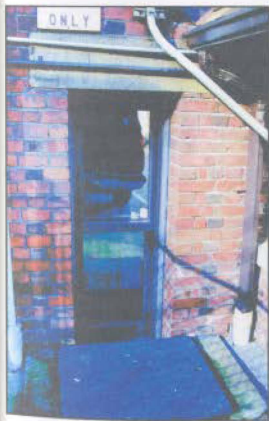
Fig. 3.5.3.1

CONTEMPORARY VIEW OF THE BASEMENT WINDOW SOUTH OF THE EAST BASEMENT ENTRY. TYPICAL OF TYPE "B" WINDOW.

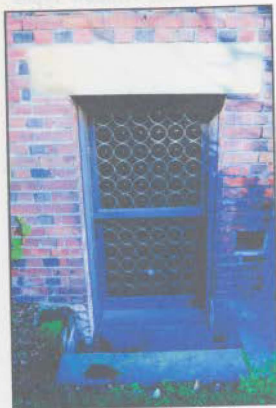
Fig. 3.5.3.2

CONTEMPORARY VIEW OF THE BASEMENT WINDOW SOUTH OF THE EAST CHIMNEY. TYPICAL OF TYPE "C" WINDOW.

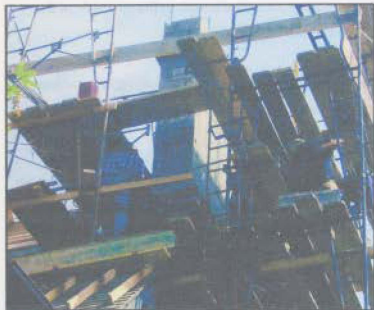
Fig. 3.6.2

2001 PHOTOGRAPH LOOKING UP AT WORK ON CHIMNEY. NOTE NEW CONCRETE BLOCK CORE. PHOTOGRAPH COURTESY OF THE STIMSON-GREEN MANSION.

In February of 2001 portions of the chimney above roofline were repaired and roof ties installed.

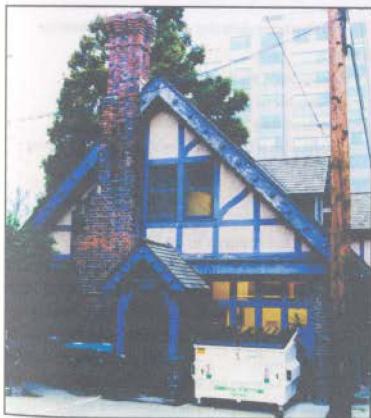
Fig. 3.6.5

Efflorescence, green growth, and dark brick are evident along the east and west sides of the chimney rising its full length. There is a blind valley without a cricket

CURRENT VIEW OF THE CARRIAGE HOUSE CHIMNEY LOOKING NORTHWEST FROM BEHIND THE STINSON-GREEN MANSION.

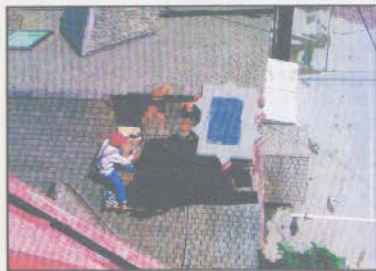
Fig. 3.6.5.2

2001 VIEW OF THE CARRIAGE HOUSE CHIMNEY LOOKING DOWN FROM THE THIRD FLOOR OF THE STIMSON-GREEN MANSION. NOTE THE CHIMNEY IS CAPPED AND BRACING ADDED. PHOTOGRAPH COURTESY OF STIMSON-GREEN MANSION.

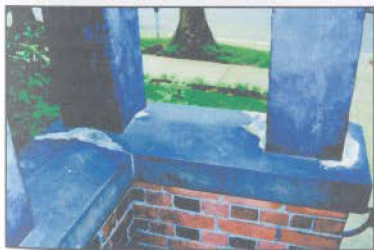
Fig. 3.7.1.1.2

CONTEMPORARY VIEW OF CEMENTITIOUS REPAIRS TO SANDSTONE CAPS ON SOUTH WALL OF MAIN ENTRY PORCH. NOTE HOW TIMBERS ARE CUT TO RECEIVE WASH.

There is light soiling of the stone on the north and south sides as well as deterioration of the corners. Crumbling and possible internal separation are evident on some stones.

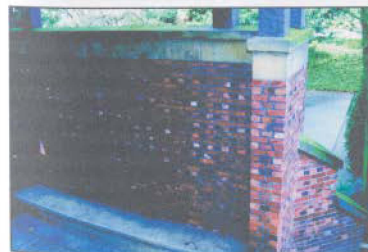
Fig. 3.7.1.3.3

Spalled brick are in the east end of the free standing wall adjacent the service drive as well as a dark coloring of the brick at grade suggesting high moisture content and mortar loss from the joints. To either side of the buttress are tree roots. Below the steps leading up to the veranda are deep gouges and spalled brick, as well as mortar loss near the downspout on the north end.

CONTEMPORARY VIEW OF FREE STANDING WALL AND BUTTRESS. NOTE GREEN GROWTH ON CAP STONES.

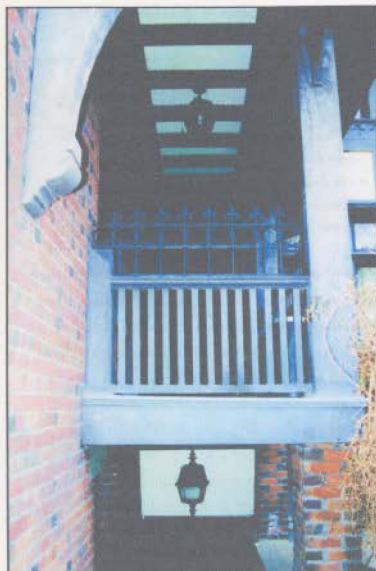
Fig. 3.7.1.5.2

CONTEMPORARY VIEW OF STOOP. NOTE SLOPE OF DECK VISIBLE BETWEEN DECKING AND BOTTOM OF WOOD RAILING.

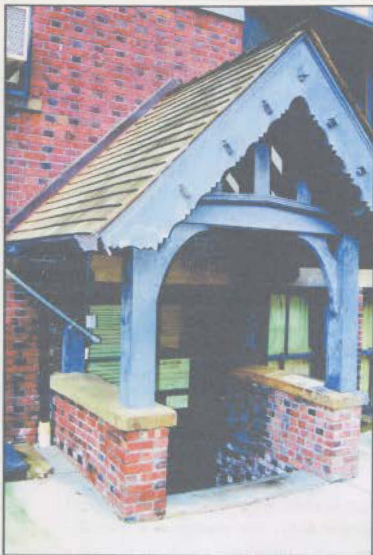
Fig. 3.7.3.1.1

CONTEMPORARY PHOTOGRAPH OF EAST BASEMENT ENTRY LOOKING NORTHWEST. NOTE EFFLORESCENCE ALONG INTERIOR BRICK WALLS AND PATCHING TO SANDSTONE CAPS.

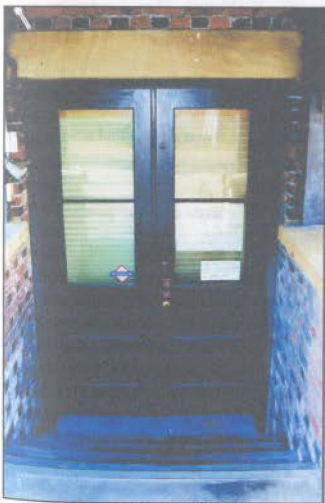
Fig. 3.7.3.1.4

CONTEMPORARY PHOTOGRAPH LOOKING DOWN STAIRS OF EAST BASEMENT ENTRY AT DOUBLE-DOORS. NOTE EFFLORESCENCE ALONG BRICK WALLS AND CONTEMPORARY DOOR HARDWARE.

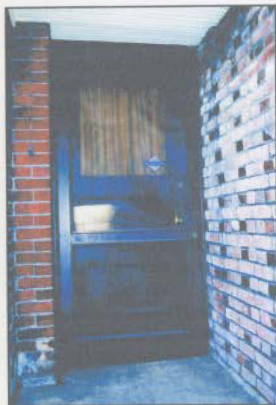
Fig. 3.7.3.2.1

CONTEMPORARY VIEW LOOKING NORTH FROM HALLWAY IN SOUTHEAST BASEMENT ENTRY AT DOORWAY INTO THE TURKISH DEN. NOTE EFFLORESCENCE ON BRICK.

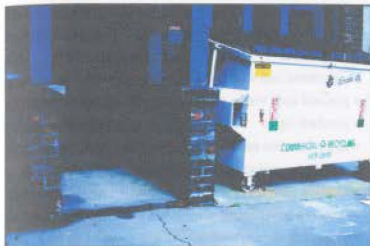
Fig. 3.7.4.2.2

CONTEMPORARY VIEW OF SOUTH ENTRY. NOTE CEMENTITIOUS REPAIRS TO STONE CAPS AND RE-POINTING OF BRICKWORK.

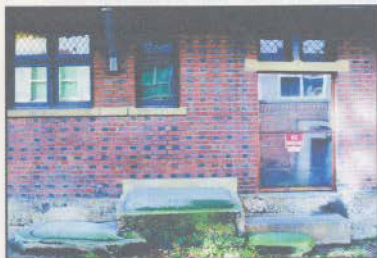
Fig. 3.7.4.4

CONTEMPORARY VIEW OF EAST ENTRY. NOTE PLASTIC COVERING OVER ENTRY.

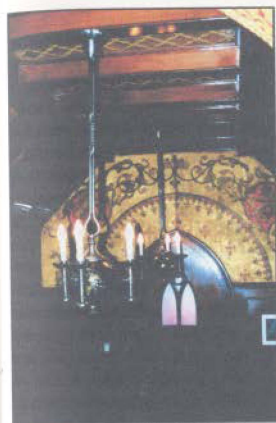
Fig. 3.8.1.1.3

CONTEMPORARY VIEW OF ENTRY HALL LOOKING WEST.

- the wood work was cleaned and re-oiled with Danish oil.
- the wall panels were repainted, according to Priscilla Collins they were deteriorated due to water entry (primarily from northwest corner), the remnants of the original designs were used to establish the existing design and colors.

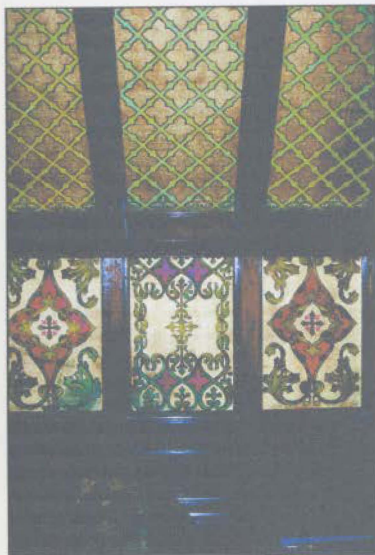
Fig. 3.8.1.1.6

CONTEMPORARY VIEW OF ENTRY HALL CEILING PANELS LOOKING SOUTH.

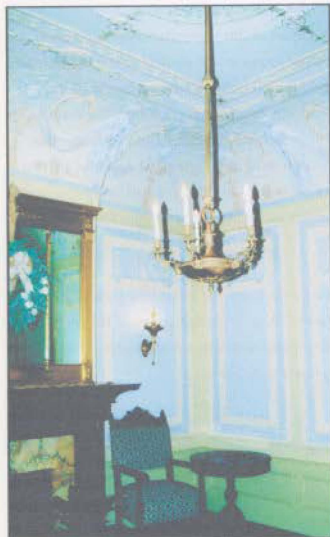
Fig. 3.8.1.2.4

CONTEMPORARY VIEW OF RECEPTION ROOM LOOKING NORTHEAST.

- sunken panels on the wainscot were replaced in the 1990s due to warping;
- they were repainted slightly darker at this time to accent the panels.

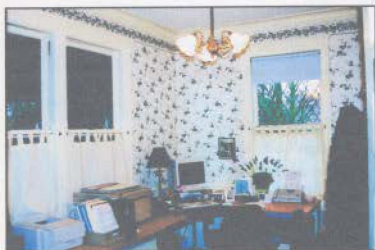
Fig. 3.8.1.7.1

- built-out area is located in south portion of ceiling (covered with plywood); this portion of ceiling cut out in 1990s to access leaking plumbing from second floor bathtub;

CONTEMPORARY VIEW LOOKING NORTHWEST OF THE BREAKFAST ROOM. NOTE THE THREE-LIGHT CEILING LIGHT.

- plaster was painted. The ceiling is approximately 120" high. Cracking in ceiling off south end of brick spine. Wall and ceiling separate slightly over doorway to staples pantry.

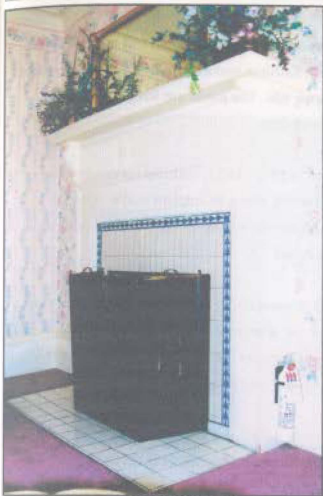
Fig. 3.8.2.1.2.3

CONTEMPORARY VIEW OF THE CHAMBER TWO FIREPLACE LOOKING SOUTHEAST.

Firebox, $34\frac{1}{2}$ " \times $29\frac{1}{4}$ " \times $18\frac{1}{2}$ ", features contemporary 9 " \times $4\frac{1}{4}$ " firebrick along its interior walls. The firebricks along the middle portion of the south wall are deteriorated.

The fireplace features a metal lintel behind the tiles. Cracking of the tiles is evident as well as a vertical crack over the mid point of the firebox opening.

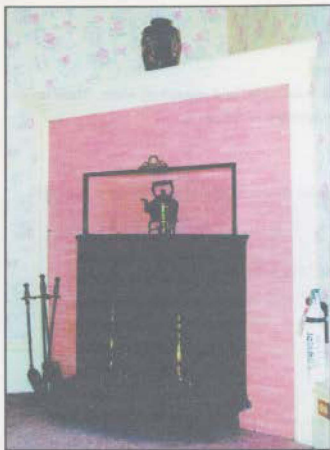
Fig. 3.8.2.1.3.6

The Franklin inset has rust on the back wall of its firebox otherwise it appeared in good condition.

CONTEMPORARY VIEW OF THE CHAMBER THREE FIREPLACE LOOKING SOUTHWEST.

Surround and mantel exhibit extensive cracking at the upper corners of the tile where the Franklin stove meets the cheek and mantel as well as at the bottom where the stove's hearth meets the tile. There is an overall crazing of the tiles and soiling of the grout lines.

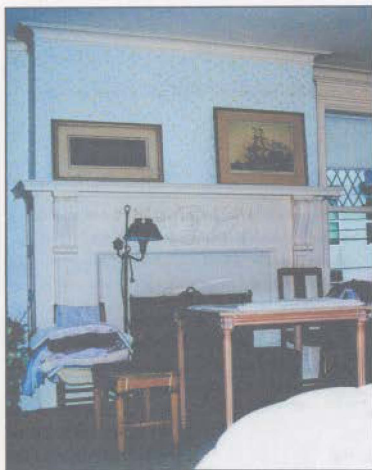
Fig. 3.8.2.1.4.4

CONTEMPORARY VIEW OF THE CHAMBER FOUR FIREPLACE LOOKING SOUTHEAST.

Hearth exhibits repairs done to the brick in the mid portion of the back hearth with cementitious material prior to 1986. The tiles were also painted prior to 1986. In the 1990s the flue was filled with fiberglass.

The (89 $\frac{3}{4}$ "x24 $\frac{1}{4}$ ") hearth of this 89 $\frac{3}{4}$ "x62 $\frac{5}{8}$ " fireplace is faced with 1"x6" tiles outlined with a band of $\frac{1}{2}$ " tiles. The back hearth is firebrick. There is cracking of the tiles on the hearth.

Firebox (35"x28 $\frac{3}{4}$ "x15") features firebrick along the sides, with some soot buildup in the flue.

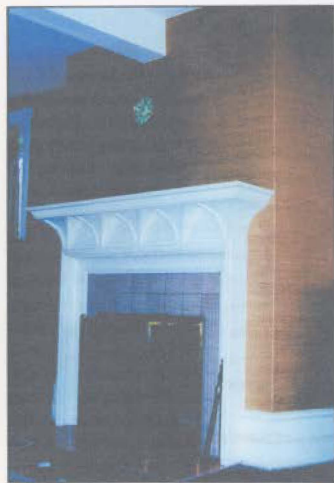
Fig. 3.8.2.1.5.7

CONTEMPORARY VIEW OF THE CHAMBER FIVE FIREPLACE LOOKING NORTHWEST.

Hearth is $60" \times 21\frac{3}{4}"$ with $4\frac{1}{4}"$ square contemporary pink-apricot glazed ceramic tiles with $\frac{1}{8}"$ grout lines filled with gray grout. Tiles on the hearth are missing, as well as the molding around the perimeter. There are two tile in the northeast corner under the chimney cheek that are different from those used on the hearth.

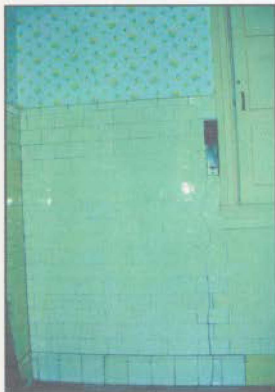
Fig. 3.8.2.3.3

CONTEMPORARY VIEW OF EAST BATHROOM LOOKING NORTHWEST. NOTE THE CRACK ALONG THE EDGE OF THE MEDICINE CABINET AND DIFFERENT COLORED BASE TILES IN THE WEST CORNER. THE ORIGINAL DRAWINGS INDICATED A DOORWAY IN THIS LOCATION.

- wainscot of 3" x 6" ivory white ceramic tiles, the base tiles on the west end of the north wall where a doorway originally led to the service hallway are whiter than the rest of the base tiles. There is also a faint difference between the wainscot tiles in this area and those adjacent on the north wall. The tiles overall exhibit extensive crazing with some hairline cracks. There is an 1/8" vertical crack west of the medicine cabinet from the floor to the bottom of the

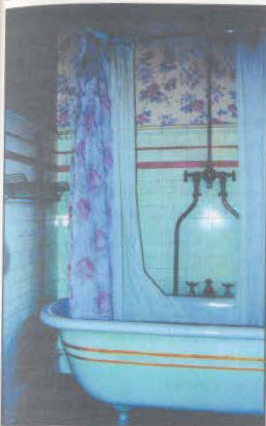
Fig. 3.8.2.3.4

CONTEMPORARY VIEW OF SOUTHEAST BATHROOM LOOKING NORTH. NOTE THE TILE FLOORING AND WAINSCOT AND ENAMELED CAST IRON BATHTUB WITH EXPOSED PLUMBING, AND TOWEL RACK (LEFT).

cabinet. The wall bows out in this area, separating the wall tiles from the floor tiles by approximately $\frac{1}{4}$ ". Along the west, north and east walls the top three to five rows of tiles are lighter in color than the tile below and exhibit wavy cracking rather than the crazing prevalent in the other tiles.

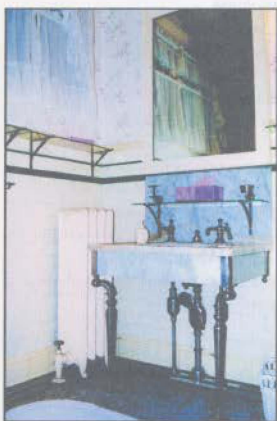
Fig. 3.8.2.3.5

- 61¼" wainscot (with 6" square base tiles and 2¼"x6" cap) of 3"x6" white tiles with a border of 1½" and ½"x6" pink tiles (similar in color to the tile used for the fireplace in chamber three) near the top with a band of similar ½" tiles above. There is some crazing and soiling of the grout lines as well as grout loss between the cap tiles. Cracking, in the form of a horizontal crack (tapering from ⅛" to a hairline) is evident in the lower west corner near the sill of the south window. At the east end of the room below the corner cabinet is another crack at the same height.

CONTEMPORARY VIEW OF WEST BATHROOM LOOKING NORTHWEST. NOTE THE SINK WITH EXPOSED PLUMBING, AND TILE FLOOR AND WAISNOCOT.

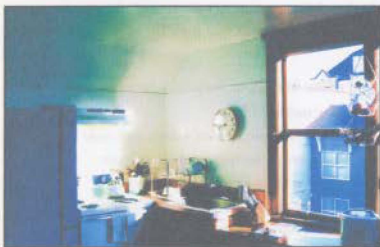
Fig. 3.8.3.2

CONTEMPORARY VIEW OF THE KITCHEN LOOKING NORTHEAST.

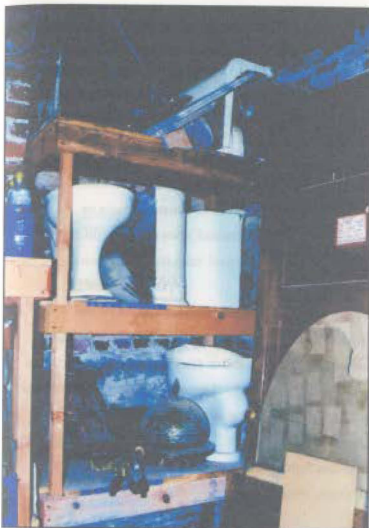
Fig. 3.8.4.10

Storeroom B remains mostly as it originally did with minor changes to the floor and ceiling. Located in the northwest corner below the veranda this room was originally not excavated. Accounts relate this area as having had a dirt floor and used as a storage area. See 2.2 *Physical Modifications*. During the 1970s, further excavation of the floor began in order to accommodate a concrete slab and convert the space into a bedroom. This remained unfinished up to the early 1990s, when it was determined the excavating had undercut the

CONTEMPORARY VIEW OF BUILDING ELEMENTS STORED IN SOUTHWEST CORNER OF STOREROOM B.

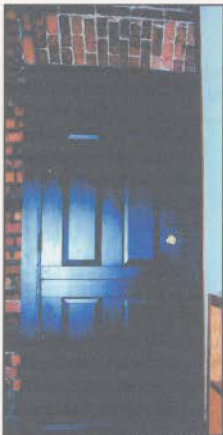
Fig. 3.8.5.1.2.1

- consist of brick similar to that of the southeast office. The brick is in a Common bond, with headers every sixth course. There are spot repairs with a hard dark-gray mortar along the south and west walls, particularly in the southwest corner. Efflorescence is present along the lower brick courses below the stairs in the north end. Wood trim runs along the perimeter of the room on line with the top of the window casings.

VIEW OF SOUTH ENTRY. NOTE JACK ARCH AND DUTCH DOOR.

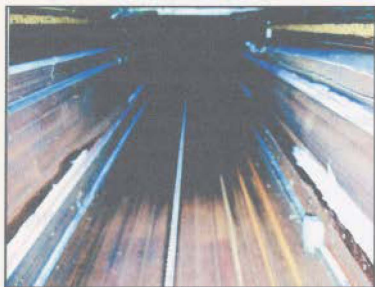
Fig. 3.11.6

CONTEMPORARY VIEW OF THE ELEVATOR SHAFT LOOKING DOWN FROM THE SECOND FLOOR SERVICE HALLWAY.

The shaft is approximately $32\frac{3}{8}$ " x 35" with $2\frac{3}{8}$ " bead board on walls. A $\frac{1}{2}$ " diameter metal cable—run through a large fly wheel at the top of the shaft and attached to a large flat weight on the east wall—carries the elevator. The weight runs in wood brackets. A 1" diameter rope, pulled by hand, raises and lowers the elevator.

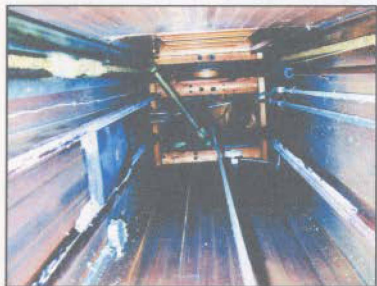
Fig. 3.11.6.1

CONTEMPORARY VIEW OF THE ELEVATOR SHAFT LOOKING UP FROM THE SECOND FLOOR SERVICE HALLWAY. NOTE THE WEIGHT ON THE LEFT HAND SIDE OF THE PHOTOGRAPH, AS WELL AS AN ELECTRICAL CONDUIT.
