HISTORIC STRUCTURES REPORT: LONE PINE INDIAN SHAKER VILLAGE,
A NINETEENTH CENTURY FISHING SETTLEMENT IN
THE DALLES, WASCOCOUNTY, OREGON

A THESIS

Presented to the Interdisciplinary Studies Program: Historic Preservation
and the Graduate School of the University of Oregon
in partial fulfillment of the requirements
for the degree of
Master of Science

December 1996

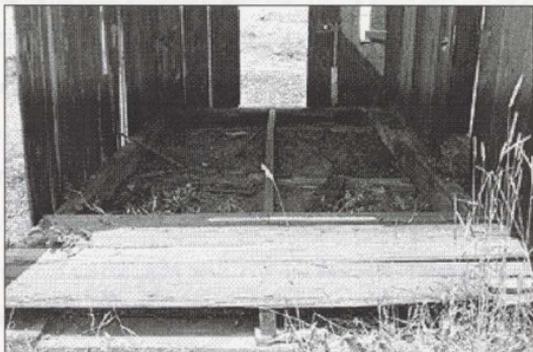
Figure 20. Visitor's House. South Elevation, Detail of the Floor Structure.

to weather with time. The Visitor's House has no foundation and the sills sit on the exposed ground and basalt rock. The sills vary in size and have end lap joints at the corners. There is no sill along the south elevation of the gable portion of the building (Figure 20). The floor structure in the gable portion consists of three sleepers, running east-west. A sleeper is placed at the north and south ends and in the center. A 3x6 joist running perpendicularly rests on the sleeper with 1x7 floor boards, running east-west, laid on top of the joist and nailed at the sills (Figure 21). In the lean-to, the sills have end lap joints at the corners, sitting on the exposed ground and covered with 3/4 inch tongue and groove boards (Figure 22). The walls of the entire building are constructed of simple, one inch thick boards and are continuous from ground line to eave. Each board is securely nailed to the sill, top plate, and trim board at the eave. The gable portion of the structure has four inch battens and the lean-to has horizontal one inch thick boards as

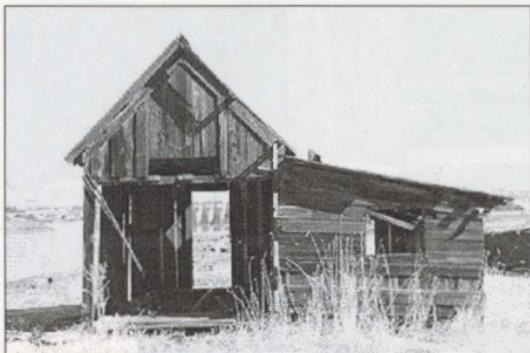
clapboarding on the south elevation (Figure 23). The top plates have end lap joints at the corners. The gable roof is constructed with 2x4 rafters, which rest on the top plate with 2x4 purlins which are underneath vertical one inch thick boards and exposed at the gable ends. The gables are finished with a bargeboard and rake. The roof in the lean-to consists of rafters that rest on a ledger, nailed to the east elevation of the gable portion, and on the top plate, which is nailed to the wall boards of the east exterior wall. The rafters are notched and rest on the beam, exposing their ends. The rafters are covered with vertical one inch thick boards and battens, not the typical double layer of vertical, overlapping boards. A ridge cap still remains on the roof peak (Figure 24).

Figure 23. Visitor's House, South Elevation, Overall.

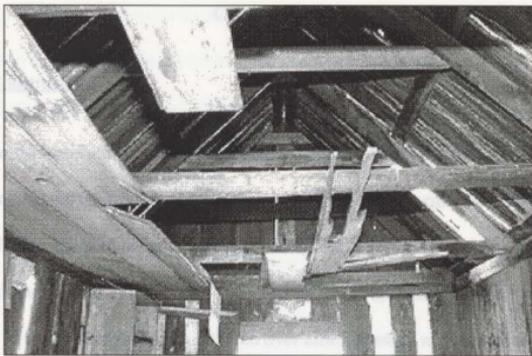
Figure 27. Visitor's House, Interior, Hung Ceiling in the Gable Portion.

(Figure 25). On the north elevation there are two single entries: one centered on the west half and the other on the eastern portion of the north elevation (Figure 26). No doors remain for these two openings. A framed opening exists on the east half of the south elevation. There is a wall cabinet in the northwest corner of the gable portion. A ceiling, made of 1x7 boards, has been suspended from the bottom of the collar ties (Figure 27).

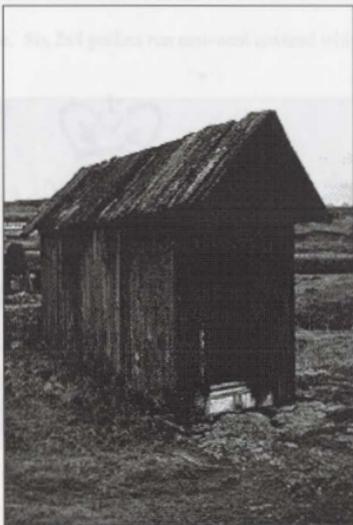
Figure 28. Chicken Coop from the Northwest.

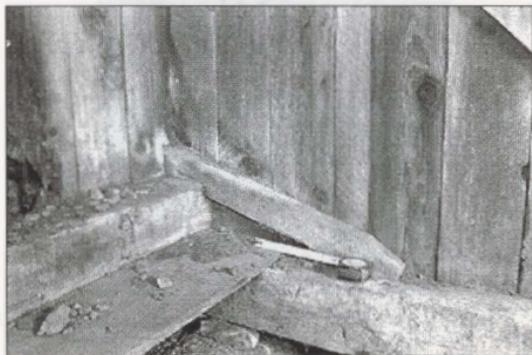
building. The heavy sills are set on the exposed ground and incline of a basalt rock outcrop. The sills are not lapped, but stacked and nailed (Figure 29). This was done to accommodate the slope of the site, demonstrating Gulick's ingenuity in building. There is no floor in this structure, only exposed earth. The chicken coop differs from the other buildings in the method of wall construction. Although still box-frame, the walls of this structure are made of a double layer of one inch thick boards and no battens. The wall boards run continuously from groundline to the trim board at the eave. They are nailed to the outer edge of the sill and top plate. The top plates have lap joints at the corners. The gable roof structure consists of four pairs of 2x4 rafters, three feet four inches on center, that sit on the top plate. Six 2x4 purlins run east-west covered with a double layer of

Figure 29. Chicken Coop, Interior, View of Stacked Sills in the Southeast Corner.

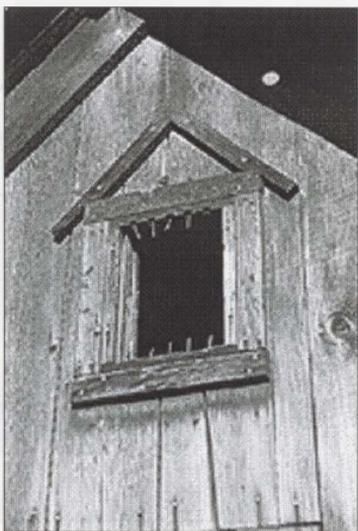
There is one entry, left of center, on the west elevation. Remnants and ghosted images of hardware exist, although there is no longer a door. A vent opening is located in the center of the west elevation gable (Figure 30). Originally the vent had a wooden

Figure 30. Chicken Coop, West Elevation, Detail of the Vent.

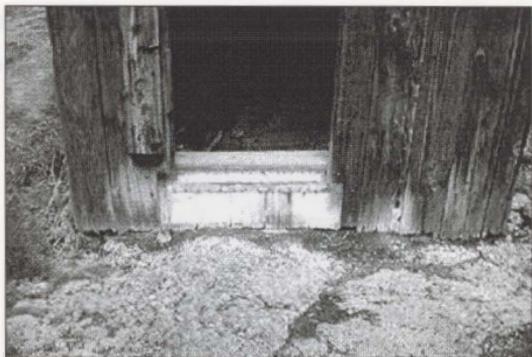
extending from the back sill, connect to the front of the Outhouse for support (Figure 31). The entry is raised and metal flashing has been used to cover the lip (Figure 32). The function of the building is expressed on the interior by the roosting pole stringers that still remain; two diagonal pieces that extend from the front of the sills to the back corners at the eave level.

Figure 32. Chicken Coop, Detail Showing the Raised Entry and Metal Flashing.

This building seems to have withstood the test of time, but it is beginning to show signs of neglect. The stain on the front is caused by the metal flashing but does not appear to be damaging the material. The graffiti is a result of vandalism by contemporary visitors to the site. The deterioration at the ends of the wall boards is caused by the proximity to the grass and the moisture that results. The deterioration of the roof is simply a result of weathering. The missing bargeboard may have been recycled for use in building fishing platforms.

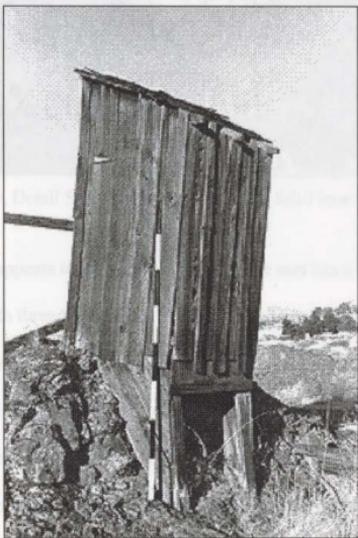
Figure 34. ● outhouse from the Southwest, Showing Siting on the Basalt Ledge.

The building is in fair condition. It is leaning significantly to the south and approximately half of the roof boards remain. The floor is not level. The wall boards on the west side of the door are pulling away from the floor, the southern corner boards are pulling apart (Figure 34). The exposed rafter tips are showing signs of rot on the north elevation. The toilet seat is made with three boards, of which the center board is missing.

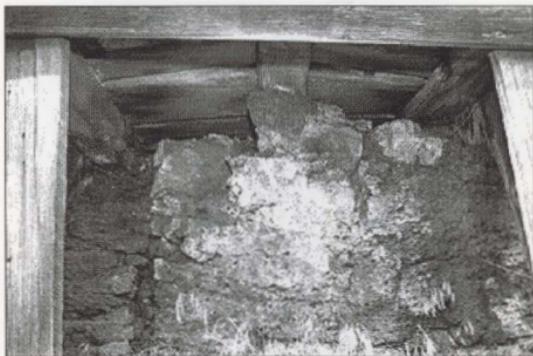
Figure 35 Outhouse. Detail Showing Underside of the Sill/Floor Structure.

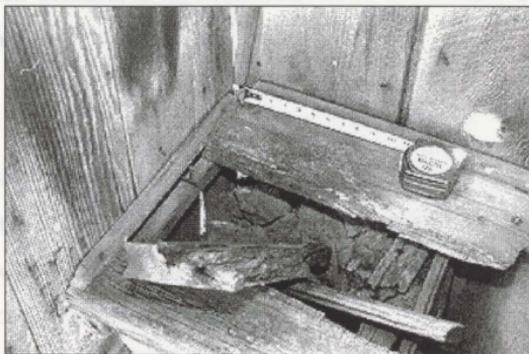
The interior appears to have been finished. The seat has a beveled hole, and the seatfront is made with three inch, beaded tongue and groove. Within the seat cabinet there are two side compartments which contain ballast, probably used as a counterbalance against the strong winds on the site (Figure 37). The entire inside is finished with quarter-round molding. Remnants of gypsum board remain on the walls.

Figure 37. Outhouse, Detail Showing the Toilet Seat and Ballast.

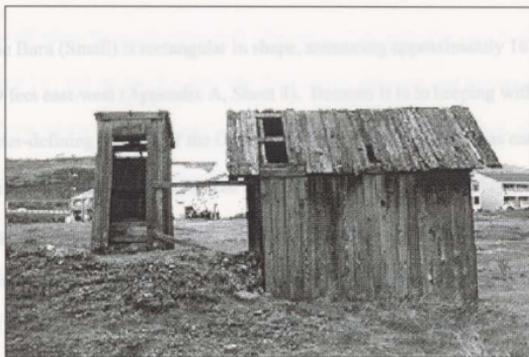
Figure 38. Outhouse, North Elevation Showing Connection to the Chicken Coop.

This structure has always been used as an outhouse. It is a simple and functionally unique resource for the site. It is tied into the Chicken Coop because the west side of the north elevation is attached to the top plate and a lower member of the Chicken Coop, for added support (Figure 38).

The Outhouse has been modified where the vent above the door has been boarded up (Figure 38).

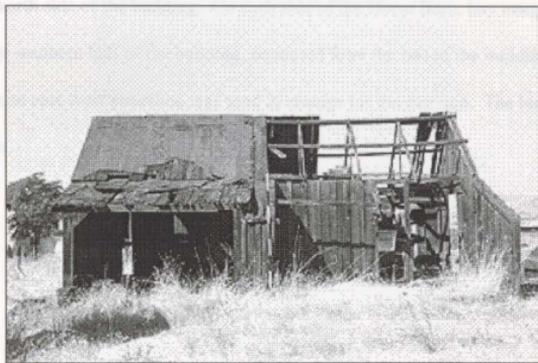
exposed at the gable ends. The gables are finished with a bargeboard and rake. Part of the roof still retains its metal covering (Figure 45).

Figure 45. Horse Barn, Detail Showing the Roof with Sheet Metal.

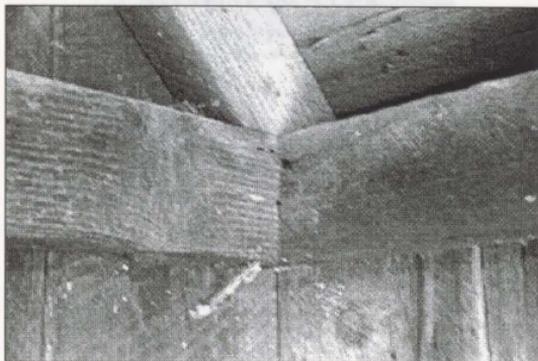
Figure 50. Storage Shed, Detail Showing End Lap Joint of the Top Plate.

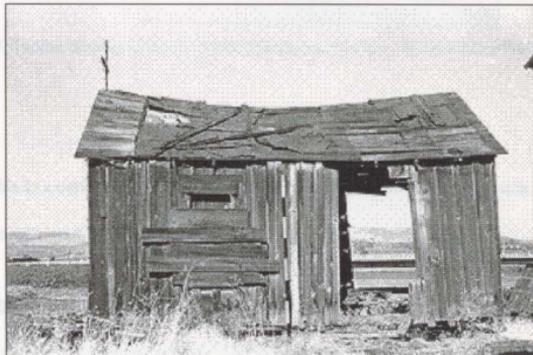
Figure 58. Indian Shaker Church, East Elevation.

The Church is in very poor condition. Currently, the sill is set on rocks and stacked lumber, causing warping of the structure. The floor structure is in stable condition but the floor surface is about 50 percent gone, leaving the structure exposed. The walls vary in their state of deterioration. The north elevation (formerly west) is in good condition. The east elevation (formerly north) is in poor condition with one large hole located where there was once a window. Most of the boards of this elevation have come loose at the sill and move as much as a half a foot with the wind. The other window opening on this elevation is boarded over (Figure 58). The altar bay on the south

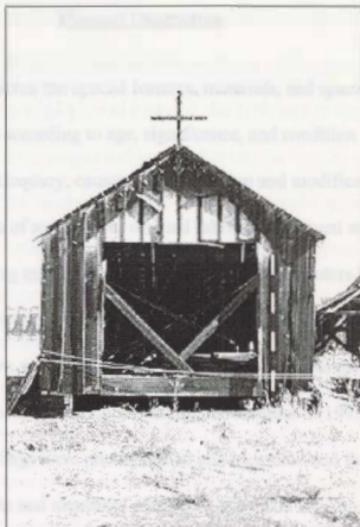
Figure 59. Indian Shaker Church, South Elevation, Opening for the Altar Bay.

elevation (formerly east) has fallen off, leaving 90 percent of the elevation open and the interior of the church exposed to the harsh climatic conditions. Temporary cross bracing has been placed in the opening (Figure 59). The west elevation (formerly south) has three holes: one at the door opening, one between the windows, and one at the south end. The wall boards on this side are also loose at the sill. The window sashes are 75 percent gone. The roof is deteriorated with most of the sheet metal gone and the ridge deflecting (Figure 55). The remaining roof boards are thin and deteriorating at the ends, and they do not adequately enclose the structure.

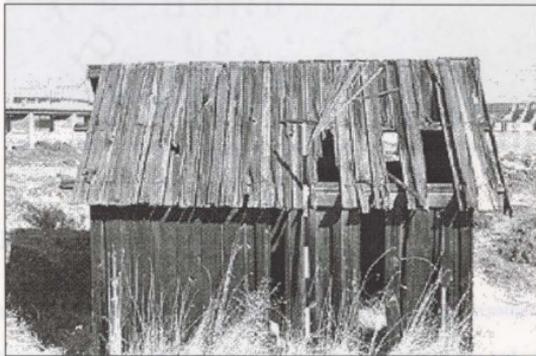
The Storage Shed is in fair condition with areas of deterioration. Overall, the building structure is intact, and the building remains fairly plumb. The boards of the south elevation have come loose at the ground and are in danger of falling off (Figure 68). There is lichen growth on the north wall boards, where the structure is built into the

Figure 68. Storage Shed, South Elevation.

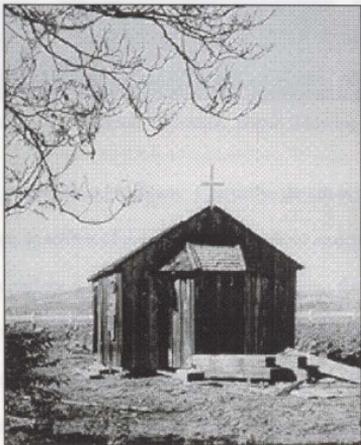
The Church was moved in 1974, when the Portage Inn was built on the property (Figure 70). At one time it was located adjacent to the parking lot, northwest of its current location, near Highway 197 (Figure 5). A patch in the flooring occurred near the

Figure 70. Indian Shaker Church as it Appeared in 1959, Having Been Moved from its Original Location (Oregon Historical Society).

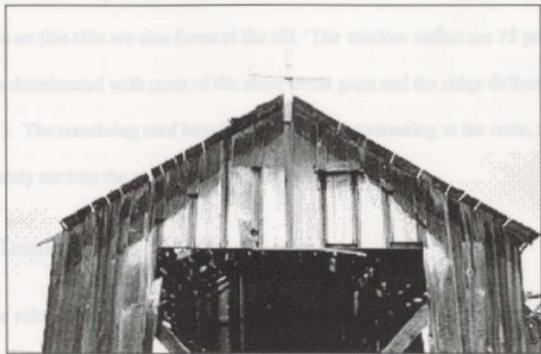
Figure 71. Indian Shaker Church, South Elevation, Detail Showing the Cross.

altar bay opening, replacing the lapped boards with narrower tongue and groove boards. The window on the east elevation has been boarded up. The cross is not original, having been replaced as recently as the winter of 1996 (Figure 71).
