THE GEORGE C. COOLEY COTTAGE  
BROWNSVILLE, OREGON  
A HISTORIC STRUCTURE REPORT

A TERMINAL PROJECT

June 1983

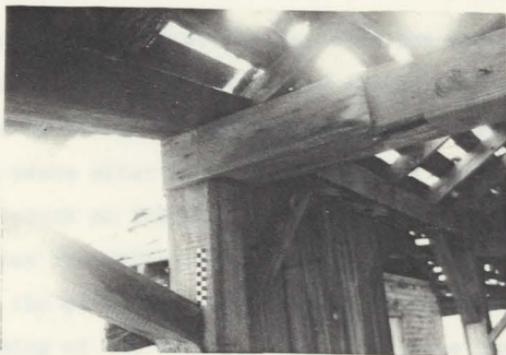
and reassembled. There are many indications in the construction of the woodshed which support this idea. One indication is that the majority of the braces used in the construction are made from 2 x 4 material, while the mortises in the posts and beams are cut to accept braces of a larger size. Another is that the 6 x 6 beam at the east end of the woodshed does not mortise into the 6 x 6 post at its southern end. There is simply no mortise in the post to accept the beam, instead the beam butts up against the post and is held in place by nails on its west side, and by a 1 x 6 board on the east side which spans both the post and the beam and is secured with nails. Also, the above mentioned beam has a mortise on its underside to accept a brace, but the post has no matching mortise on its north side (see Figure 5).

Fig. 5. Southeast end of woodshed. Note that beam only butts up to post.

As can be seen in Figures 5 and 33, the top plate on the south side of the woodshed has broken at its eastern end, directly over the post at that end. There is also a rotten area at the eastern tip of the top plate, and the brace from the top plate to the post at the east end has rotted and broken.

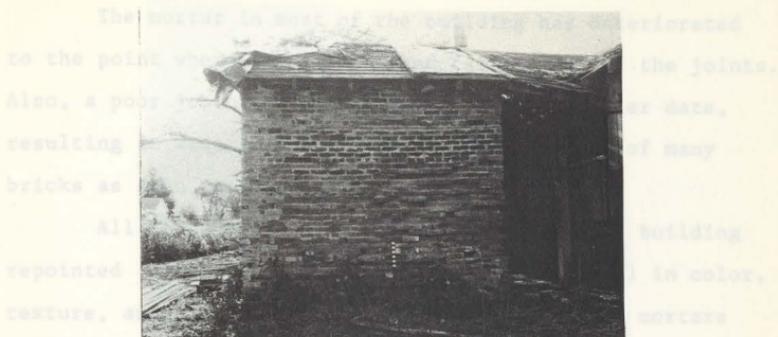
Many of the bricks in the building are spalling and have deteriorated severely. This problem is most serious on the northeast corner of the building as seen in Figures 36 and 37.

Fig. 36. East wall of fruit/milk house .

All deteriorated bricks should be replaced with sound bricks that match the original in size, color, and texture. It will be difficult to match the brick perfectly, but every effort should be made to produce as close a match as possible. When replacing bricks the so-called "bat" or "waxy" American look, where light and dark used bricks are interspersed in a wall, should be avoided. To the extent all the deterioration it may be necessary to dismantle the east wall of the building to carry out repairs.

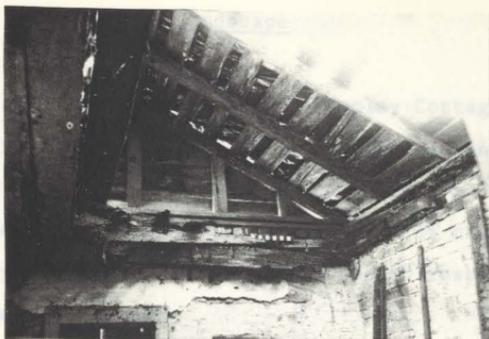
Fig. 38. Interior of fruit/milk house.

To help prevent future damage from rising damp, it is recommended that a damp-proof course of some type be installed

in the walls. Precautions should also be taken in areas where wood comes in contact with brick, such as the top plates, by adding barriers which prevent moisture from traveling into the wood, and details that help the wood to dry if it does become wet.
