WHIDBY ISLAND LODGE #15, F. & A.M., COUPEVILLE, WASHINGTON :

A HISTORIC STRUCTURES REPORT

by
KRISTIN GAYLE MONAHAN

A TERMINAL PROJECT

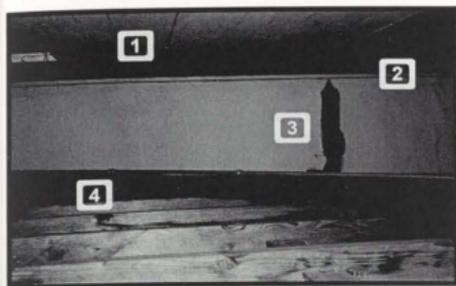
Figure 21: Space between the first and second floors as it appears today, showing (1) the original first floor ceiling, (2) the historic trim, (3) the calcimining, or historic wall finish, and (4) the ceiling joists for the current drop ceiling.

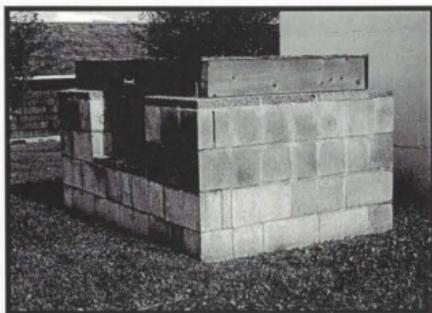
Figure 22: The cistern installed by L. Boyer in 1898 has since been surrounded by concrete blocks and had a new top installed. This is how it appears today.

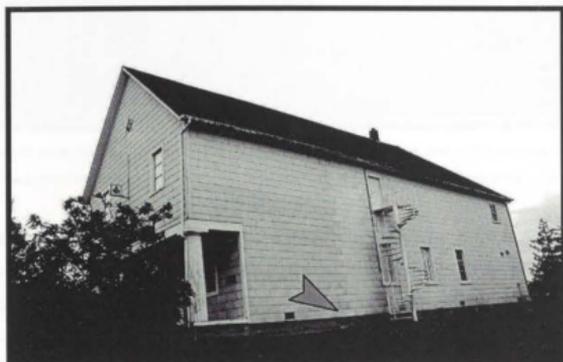
Figure 27: Northeastern elevation showing obvious difference in the color of cement-asbestos shingles (arrow), which line up directly with the foundations of the 1948 eastern addition.

During the mid to late 1940's the first discussions of another addition, this time to be installed on the eastern façade, took place, and the first mention of a steel fire escape occurred. In 1948, it was decided that twenty feet would be added to the eastern façade utilizing volunteer labor, with an estimated cost for materials of \$620. This decision followed a series of discussions which were first broached the previous year. It was also decided this year that asbestos shingles would be installed on the exterior surfaces of the Temple as soon as finances permitted.⁸⁰ While it is unclear when the installation occurred, irregularities in the installation of the asbestos shingles which become apparent approximately twenty feet from the eastern edge of both the north and south walls would indicate that they were originally installed *before* the addition was constructed, and that more shingles were added

to cover the addition at that time. If the shingles had been installed after the addition was completed then the visible anomaly in the tiles would likely not have occurred.

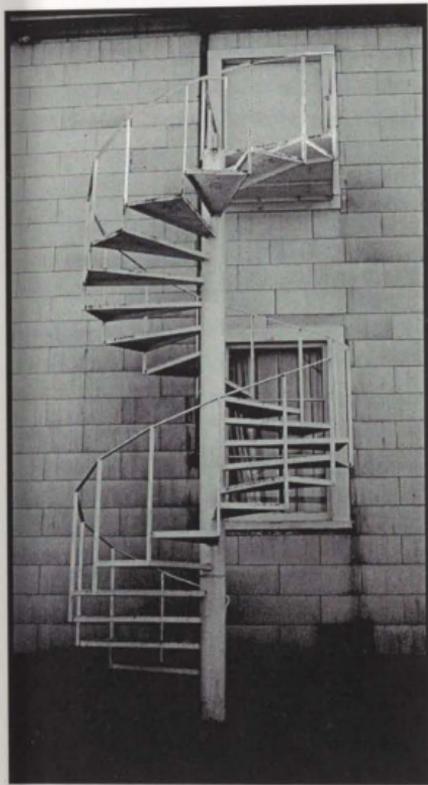
between 1960 and 1973. In February 1964, the steel spiral fire escape was installed on the northern elevation of the Temple. Access to the escape is granted from the interior via a door in the Lodge Hall room, which given its truncated height and the location of its threshold being two feet from the floor, appears to have been converted from a former

Figure 29: Steel spiraling fire escape on the north elevation of the Temple, which was installed in 1964. View Looking south.

window. The installation of the fire escape was first discussed in December of 1946, but at that time the addition to the eastern side of the building took precedence.⁸⁵ In 1973, after plans were presented for the construction of a detached storage building on the Temple lot, the concrete block structure currently located on the west side of the building was erected at a total cost of \$950.⁸⁶ Other than these two major projects, alterations to the Temple since the late 1950's have been relatively minor, and could most readily be classified as "improvements." Once again, modifications began to be made to the interior of the Temple, and mentions of furnishings and small scale repairs begin to re-occur. The most major of all these improvements occurred in the Temple's Kitchen, and they began taking place in the late 1950's.

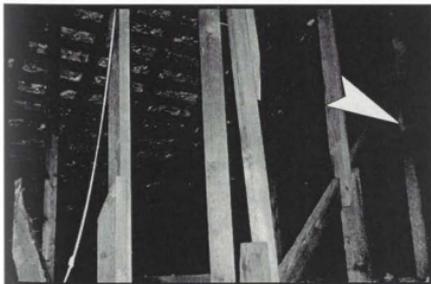
Exploration of the Temple attic and the crawlspace between the first and second floors do reveal a wealth of information about the ways in which the Temple has grown over its long life. Original floor joists visible in the attic were installed running east to west, and are made of nominal 2" x 6" rough-sawn boards spaced 16" on center. In the area of the crawlspace, the floor joists are not original, and these members are nominal 2" x 4"s, which are planed and spaced 16" on center. Historic wall studs which can be seen in the western portion of the attic in the area of the original gable end are also nominal 2" x 4" members. These are made of rough-sawn lumber, spaced 2' on center. The studs which formed the wall of the modified western gable end after the 1939 addition to the southern elevation were made of planed 2" x 4"s, and these were scabbed directly onto the historic wall studs of this elevation (see figure 2, below). The rafters and other framing members in the rest of

Figure 2: View of the historic wall studs on the western side of the Temple (arrow), and the scabbed on studs for the 1939 addition.

the Temple attic are also installed in a haphazard fashion. In the central section of the attic, the framing system is especially discordant.

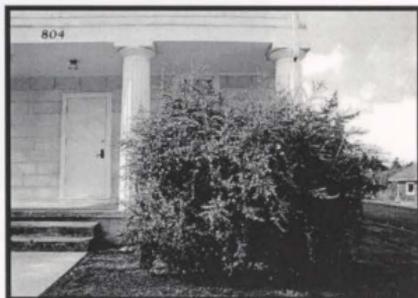
On the eastern elevation, formal landscaping is present along the sidewalk which runs parallel to Main Street. There are also two large bushes which have grown immediately adjacent to the exposed board-formed concrete foundations, which are located on the north and south sides of the centrally placed stair (see figure 6, next page).

Figure 6: Large bush north side east elevation.

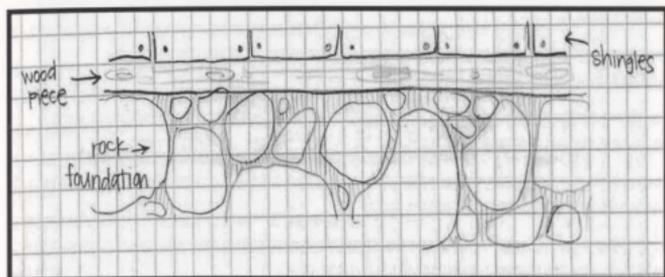
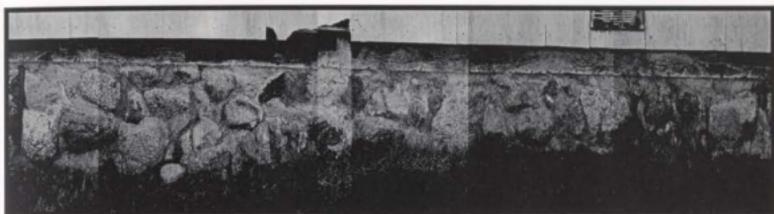
Structural Description: The Whidby Island Lodge #15, F. & A.M. Temple sits atop a composite foundation which is the result of numerous additions to the structure over its long history. The historic foundation is formed from large field stones, and this element is visible on the northern elevation (see figure 10, next page). The southern addition of 1939 and the eastern addition of 1948 both were installed with a board-formed concrete foundation (figure 12, next page), while the western addition of 1954 features a poured concrete foundation. The foundations are

Figures 10 (above) and 11 (below): Character sketch of historic field stone foundations, which are visible on the northern elevation of the Temple. Below: Composite photograph of this element.

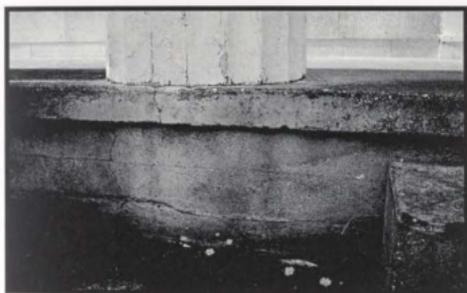
Figure 12: Board-formed concrete foundation, as seen on the 1948 addition to the eastern elevation.

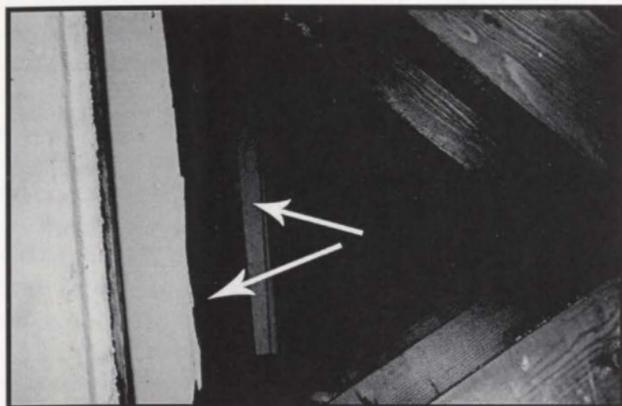
of the bracing members used in the Temple roof are made from recycled pieces of historic exterior siding (see figure 13, next page). On the interior, no historic wall, ceiling, or floor finishes are visible, except in the area between the first and second floors.

Figure 13: North side of the Temple attic, where recycled pieces of historic exterior siding have been used as vertical bracing elements. Siding has also been used throughout the attic for both diagonal and horizontal bracing members.

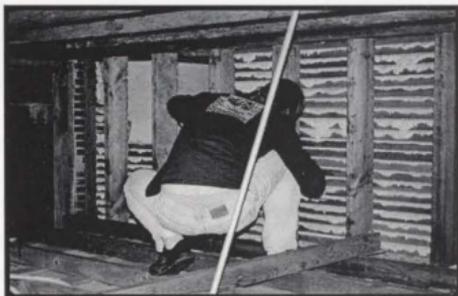
Figure 14: Zachary Dunlap measuring the historic lathe and plaster walls in the crawl space between the first and second floors. Note how large this space is.

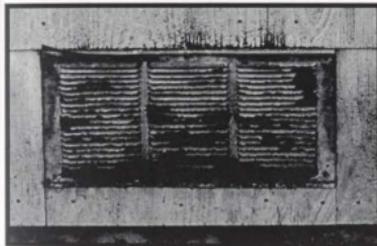
In addition to the windows and access door, a number of types of metal vents pierce the wall plane on this elevation. Four rectangular vents are located along the bottom shingle course, and two smaller units are present on the western side of this elevation, providing ventilation to the Temple's kitchen. All of the vents show evidence of corrosion, and the kitchen vents have an excess of glue on their lower edges.

Figure 15: Lower vent northern elevation.

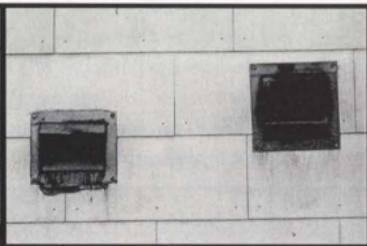
Figure 16: Kitchen vents. Note glue on lower edge left vent.

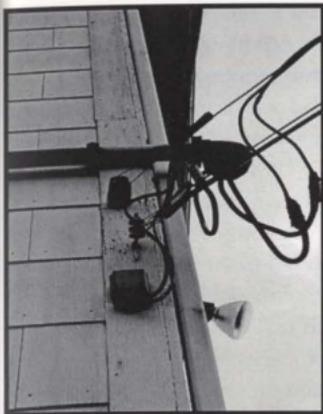
Figure 17: Plethora of wires which connect to the southwest corner of the western elevation.

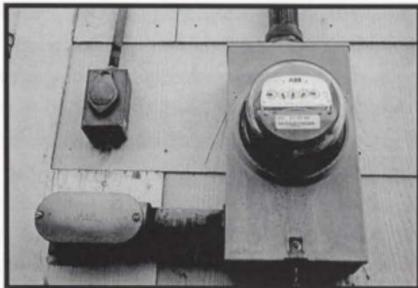
Figure 18: Just a few of the many electrical elements located on the western elevation.

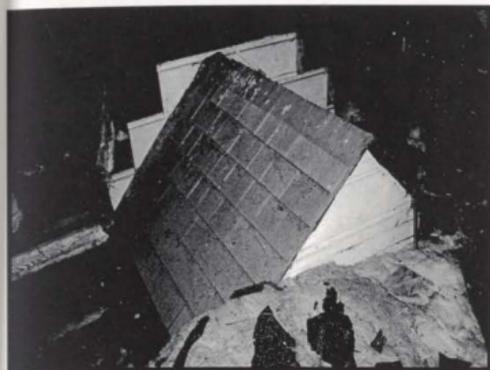
Figure 20: Remnants of a historic gable-roofed projection on the eastern elevation, which still has its original shingles. Note also the presence of the historic wood lap siding.

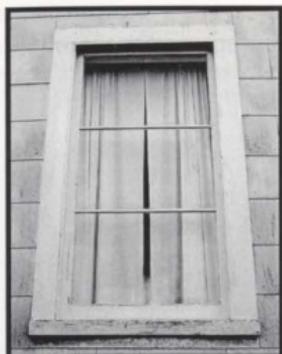
Figure 24: First story window, northern elevation.

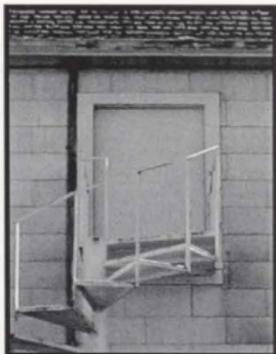
Figure 25: Former window, now exit door, north elevation.

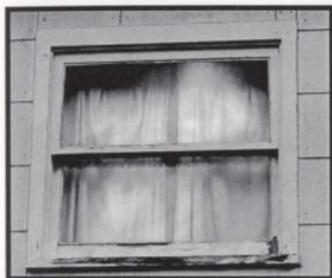
Figure 26: Second story window, northern elevation.

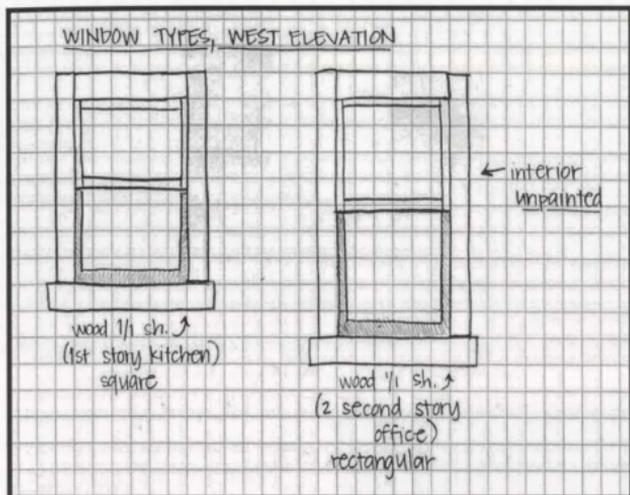
Figure 29: Sketch showing the various window configurations present on the western elevation. On the left, the first story window is pictured, and on the right, the second story units.

While all of the windows are in relatively good condition, some damage to the wooden elements was noted at the time of assessment. This damage is relatively minor, and is mostly related to chipped or cracked paint on the window sills. Details on the window condition will be discussed in length in the assessment portion of this document.

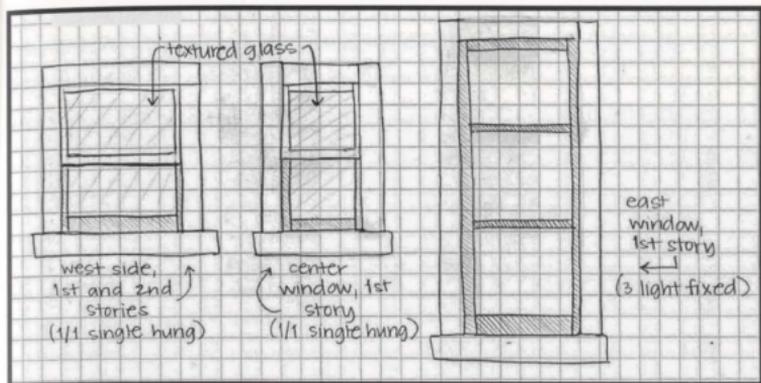
Figure 30: Sketch of the various window configurations present on the southern elevation.

The single hung windows on the first floor feature textured glass, as they both look into first floor restrooms. None of the other windows on the Temple have textured glass lights. All of the windows of the southern elevation are in good condition, all damage being either cosmetic or easily repairable. The worst of this damage is present on the large, first floor window, which has lost some of its glazing.

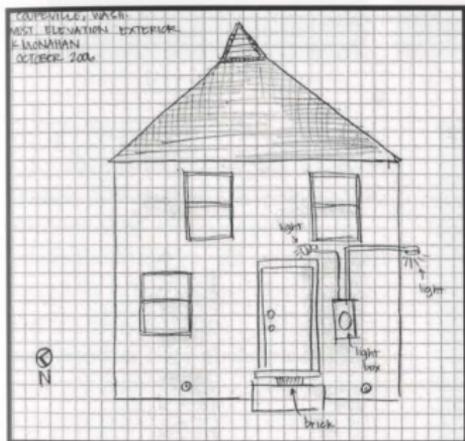
Figure 36: Character Sketch of the western elevation showing rough placement of door, windows, and electrical elements.

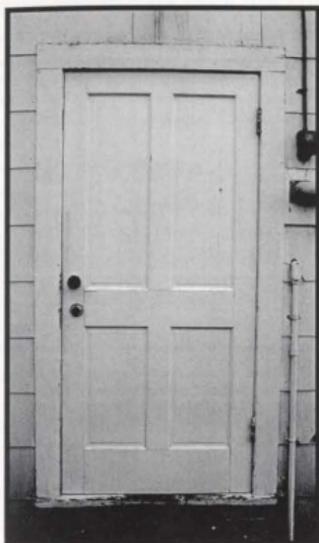
ing mechanisms have been recycled as the doors for two first floor storage closets. This fact gives credence to the theory that this is a historic element which has since been rehabilitated. The door on the western elevation is surrounded by wood trim pieces, and features a wood sill, all of which are painted white. The door sill sits 11" above the ground, and 4" above a concrete step. Due to this discrepancy in spacing, a standard brick has been installed to support the door sill on its underside (see

Figure 37: Western door, which is possibly a historic element.

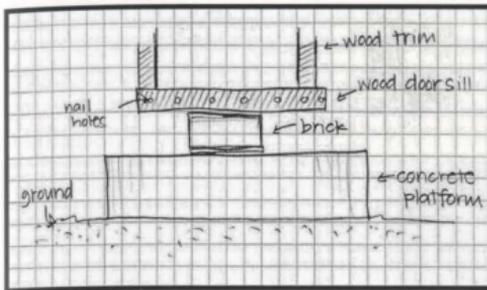
It is curious that the western Temple door sits so high above the concrete step which is placed underneath it that its sill must be supported by a brick. The door on the eastern elevation has a sill which sits atop another trim piece which, in turn sits directly atop the floor of the concrete porch. Thus, the step is only about 3" from the ground. Could this design once have been repeated on the western elevation? It is uncertain whether the current door configuration on the eastern elevation is the result of a miscalculation during construction planning, or whether it is the result of modification to the foundations of this elevation. As this entire facade is the result of an addition,

Figure 40: Sketch showing the configuration of the various elements which support the door sill on the western elevation.

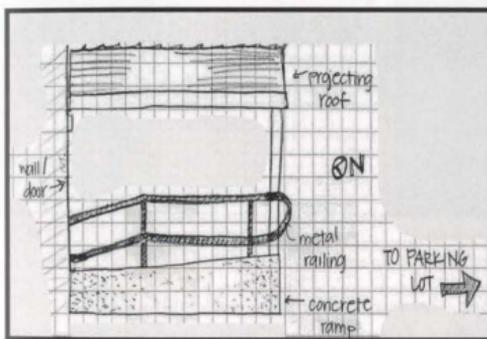
Figure 41: Sketch showing the configuration of the projecting covered access ramp on the south elevation.

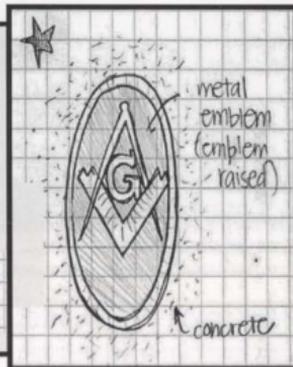
Figure 42: Sketch of Masonic Emblem which is embedded in the concrete ramp

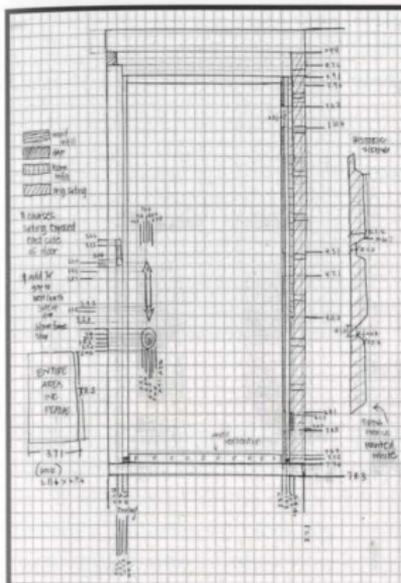
Surrounded by 4" trim pieces painted white, the door on the southern elevation of the Temple provides the best clues as to the historic appearance of the structure. Here, the trim piece on the eastern side of the door has been recently removed, exposing a section 3" wide and 11 courses tall of the historic wood drop siding; which remains in tact underneath the current cement-asbestos siding (see sketch and photograph

of these elements, below). It appears as though the siding was always painted white, as no evidence remains of any other color being used on this element, and historic photographs dating back almost to the time of construction show the Temple as a white structure. A gap exists between the door frame and this historic siding, and this space has been filled in with yellow insulating foam. In areas, this foam has expanded to cover sections of the historic siding.

Figure 43: Sketch for measured drawing of southern entrance door of the Temple.

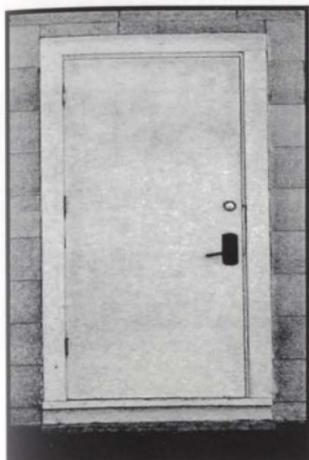
This door may also be accessed from the east via a concrete walkway which connects to the public sidewalk and two concrete stairs. The door is not original to the Temple, nor is it historic. Both the lock-

ing mechanisms and the interior hardware were replaced in the last 15 years.³

Figure 45: The front door of the Temple, eastern elevation. The door is not historic, but the frame may be.

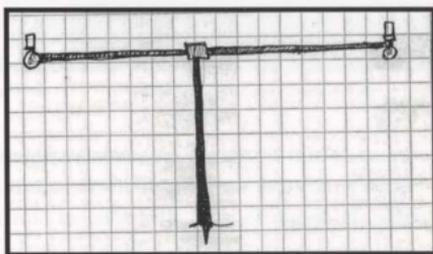
Figure 46: Sketch of the lighting elements on the northern elevation.

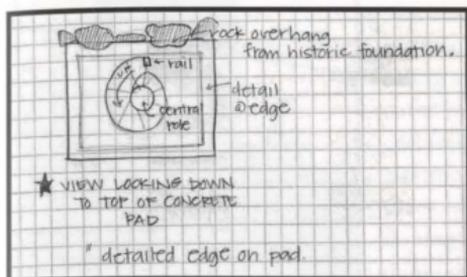
Figure 47: Sketch showing the raked edge detail of the concrete pad on the northern elevation, as well as the overhang of the historic rock foundation.

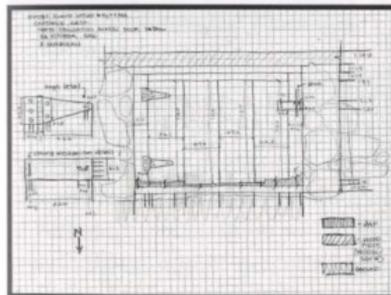
well as glimpses of the historic brick underpinnings and chimney base. Water has eroded the bottom edges of the individual planks which form the access door, but this has not reduced the element's charm, nor its functionality.

Figure 48: Measured drawing of the wood access door, north elevation, with hardware details.

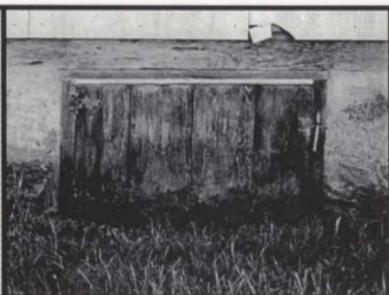
Figure 49: Photograph of the same element in situ.

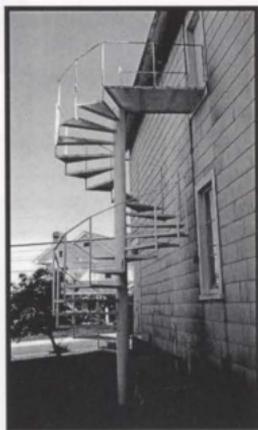
Figure 51: View of the steel fire escape looking east.

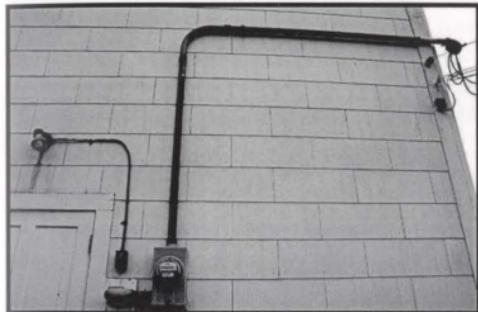
Figure 52: Photograph showing the various lighting elements on the western elevation.

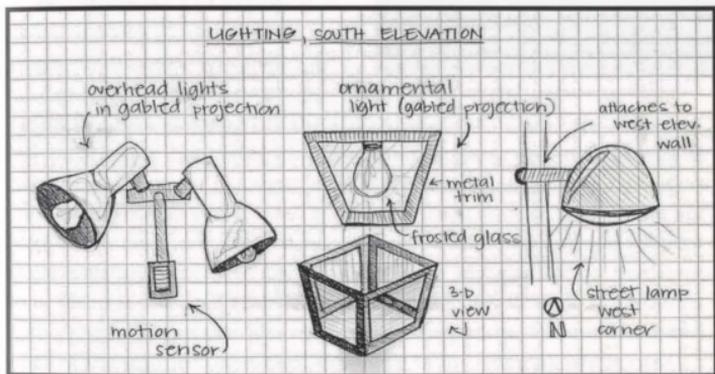
Figure 54: Sketch showing the configurations of the various lighting elements present on the southern elevation.

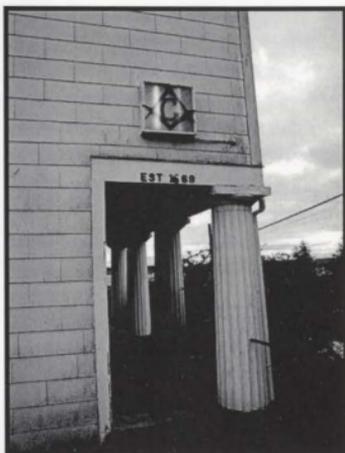
Figure 55: Lighted Masonic emblem on the southern elevation.

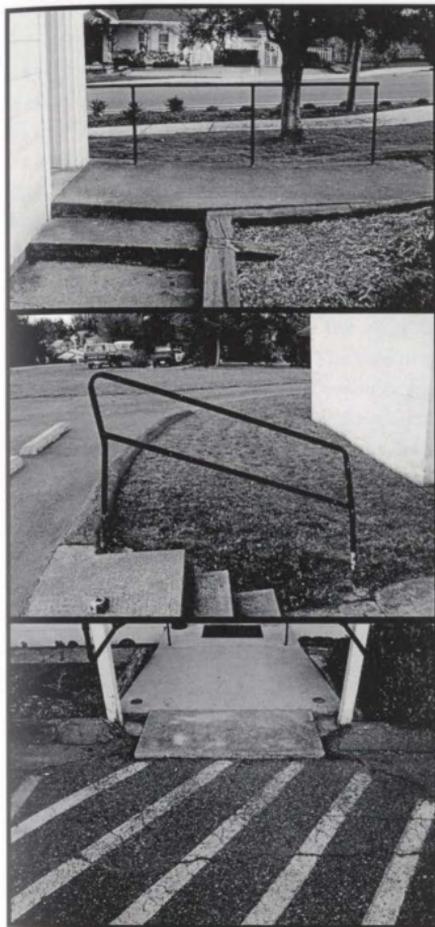
Figures 56 (Above), 57 (Center), and 58 (Below): Ramp and railing, east side, southern elevation, view looking east; stairs and railing, west side, southern elevation, view looking west; and central ADA accessible ramp to southern door, view looking north.

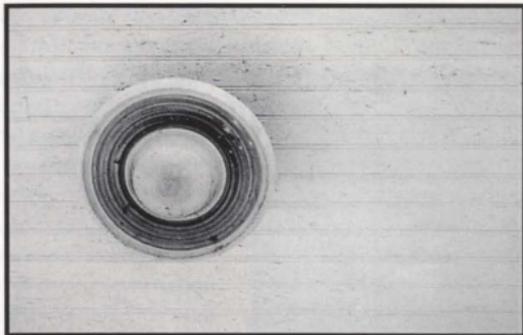
Figure 59: Light fixture on the eastern elevation. Notice the board board ceiling of the porch.

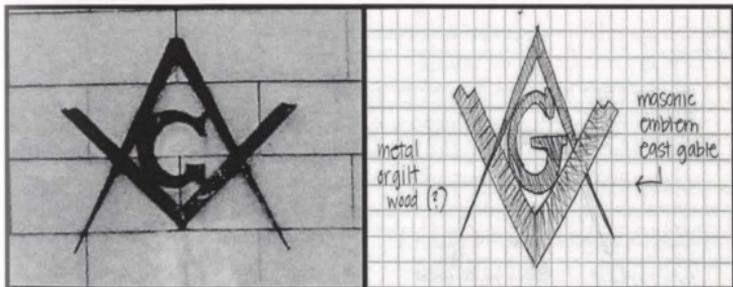
Decorative Elements: A number of Masonic emblems are located on this elevation, most notably the large Square and Compass emblem in the peak of the gabled roof. The age of this particular item is indeterminate. In his *History*, Frank Coates remarks that a similar emblem was donated to the Lodge in 1897 by Brother C.H. Stackpole and installed in this space, but that the possibility exists that the emblem was “carelessly thrown away” during the 1946 addition to this elevation.⁴ This remark likely means that the current emblem is a replica (see figures 60 and 61, below).

Figure 60: Masonic Emblem in gable peak on eastern elevation.

Figure 61: Sketch of the Emblem.

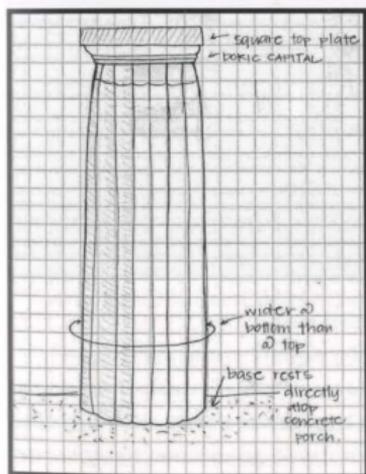
Figure 63: Overall character sketch of the fluted Doric columns, eastern elevation.

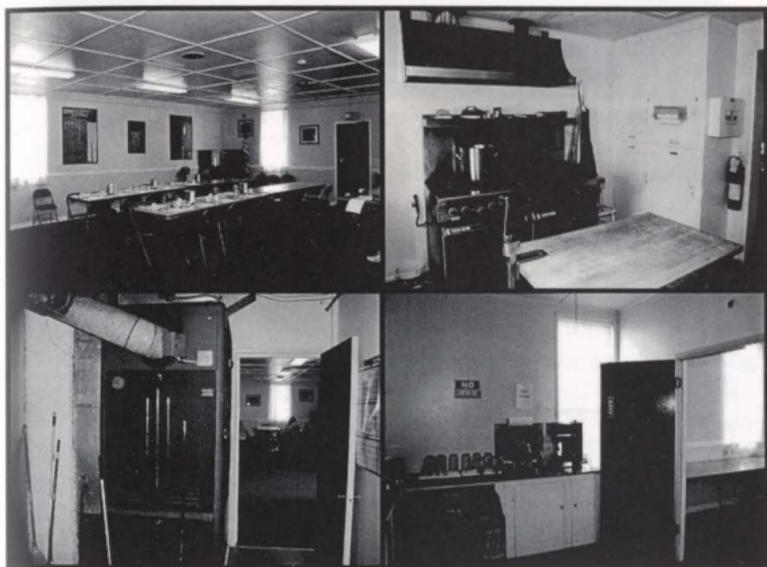
Figures 64 (Top Left), 65 (Top Right), 66 (Bottom Right), and 67 (Bottom Left): Lower Hall, Kitchen, Reception Area, and Furnace Room (note historic chimney to left of furnace, painted white).

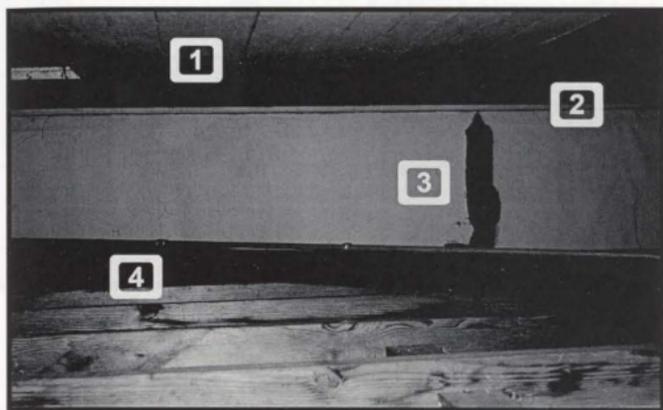
Figure 68: Original ceiling and wall finishes for the Lower Hall, first floor of Temple. (1) Historic Ceiling. (2) Wall trim. (3) Calcimining (historic wall finish). (4) Joists which support current Lower Hall ceiling.

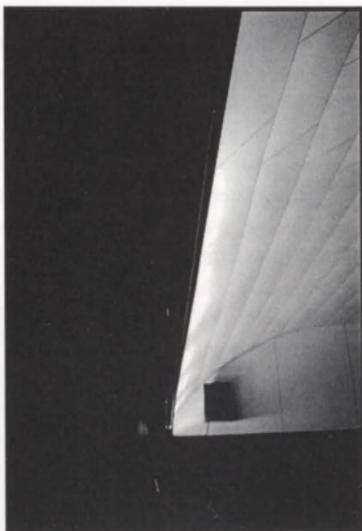
Figure 74: Northern and eastern walls of the Lodge Room interior. Both of these walls were modified to cover historic windows.

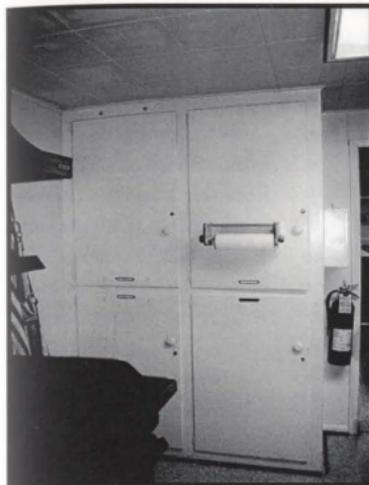
Figure 75: Built-in cabinets in the Temple Kitchen.

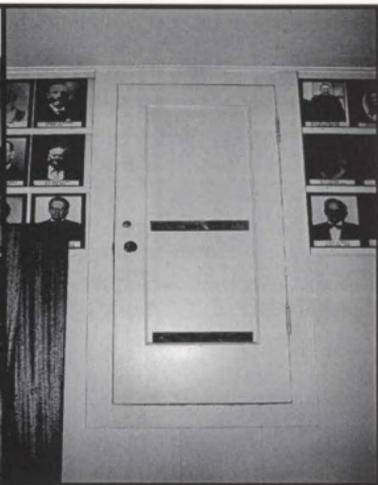
Figure 76: Built-in access door to the attic, Tyler Room, second floor.

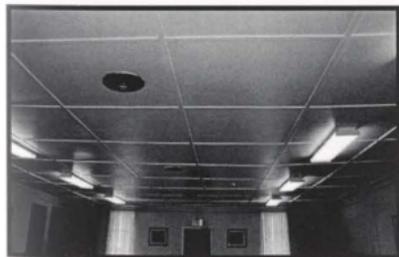
Figure 77: Batten ceiling detail in Temple's Lower Hall.

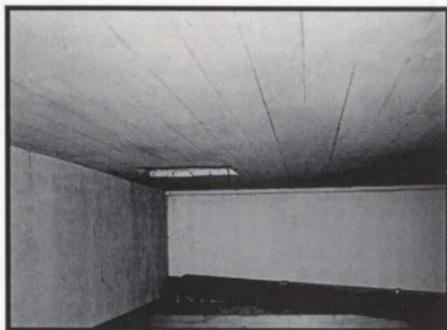
The ceiling heights on the first floor of the Temple are highly variable, owing partially to the many modifications which have been made to the interior of the structure. In the Lower Hall, the ceilings currently measure 9' in height, though evidence in the crawlspace between the floors suggests that these were originally 14' tall (see figure 78, below). The ceilings in the Kitchen and Reception Area are also 9' tall. Variability in the ceiling height does not follow any prescriptive system, as rooms immediately adjacent to one another, such as the Men's and Women's Restrooms have different ceiling heights (8' and 7 1/2', respectively). The hallway which runs outside the two restrooms and contains the storage closets on its north side also has a ceiling which

Figure 78: Crawlspace between the first and second floors over the Lower Hall reveals the original ceiling and wall finishes for this room.

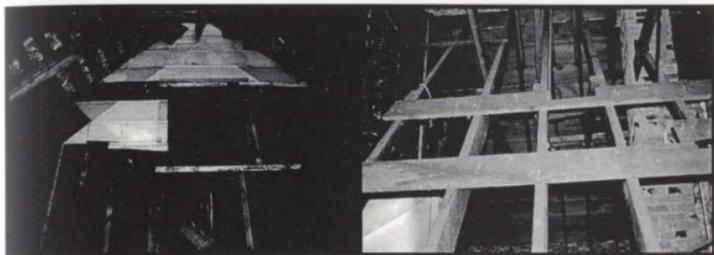
Figure 79: The original western gable end of the Temple roof is still visible in the framing of the attic rafters. Note the historic siding.

Figure 80: The nailer boards for the sub-sheathing of the original roof as still present in the attic.

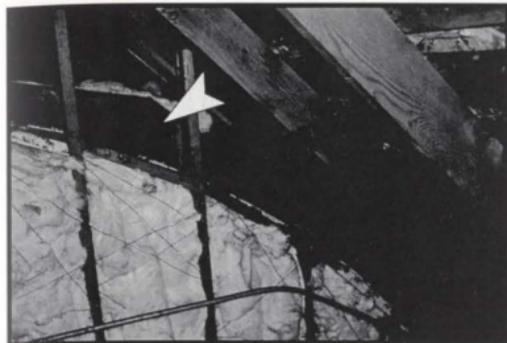
east of the modified historic chimney (see figure 83, below). The ceiling was framed in using 2" x 6" members, and it sits about 5' above the floor joists of the rest of the attic. The brick chimney which can be seen

Figure 83: Photograph showing the framing for the Lodge Room's barrel vaulted ceiling.

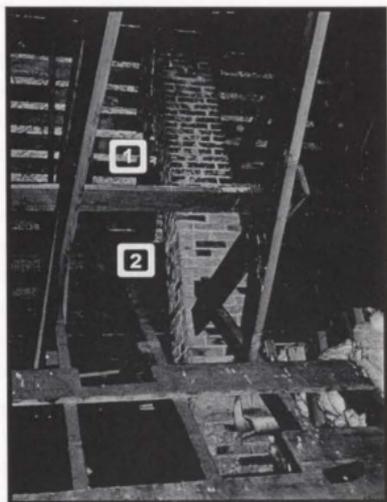
in historic photographs protruding from the south side of the western end of the gable roof is still intact, and can be seen both on the first floor of the Temple in the Furnace Room, as well as in the attic. Here, it is apparent that after the 1939 addition to the southern elevation, the historic chimney had to be expanded in order to remain usable. The bricks of the chimney addition are of a different color than the originals, as is the mortar used to bind them. This fact makes the modification easily readable.

Figure 84: Photograph showing (1) the addition to the chimney and (2), the original brick structure. Notice how the chimney originally protruded from the south side of the gabled roof. View looking north.

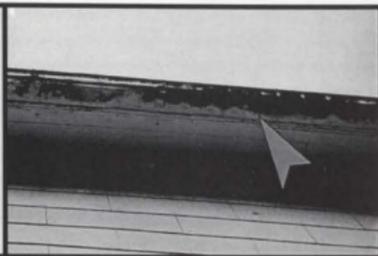
Eaves: The Temple eaves, especially on the northern and western elevations, have begun to show signs of rot and mold growth due to water infiltration. This condition has likely been caused by failings in the gutters and downspouts, as the degradation is mostly confined to areas which are immediately adjacent to these elements (see figures 18 and 19, below). Another cosmetic defect which has presented itself in the eaves

Figure 19: Mold growth and degradation to gutter and eaves on northern elevation.

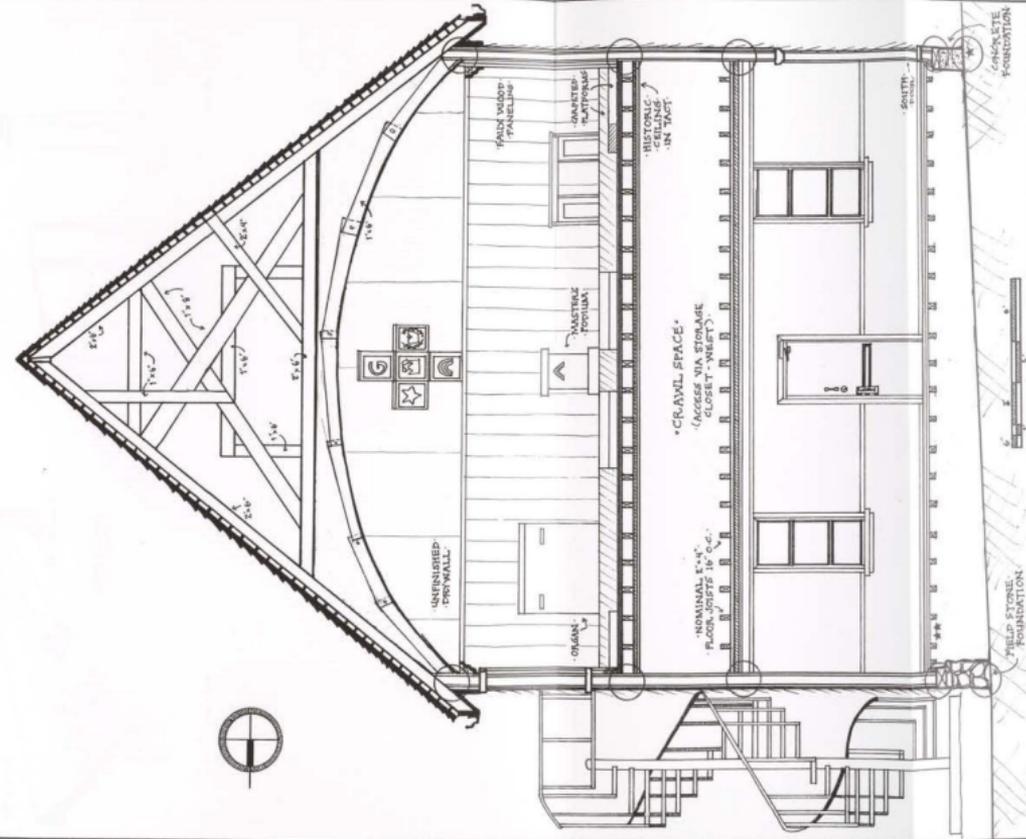
* CONNECTIONS IN CIRCLED AREAS
 * UNABLE TO BE DETERMINED CONCLUSIVELY
 * WITHOUT INTENSIVE INVESTIGATION
 ** DOTTED LINES REPRESENT
 ** INFERRED CONSTRUCTION
