A DOCUMENTATION AND RESTORATION PLAN FOR  
THE FIRST CHRISTIAN ADVENT CHURCH  
IN JOHN DAY, OREGON

A THESIS

Presented to the Interdisciplinary Studies Program:  
Historic Preservation  
and the Graduate School of the University of Oregon  
in partial fulfillment of the requirements  
for the degree of  
Master of Science

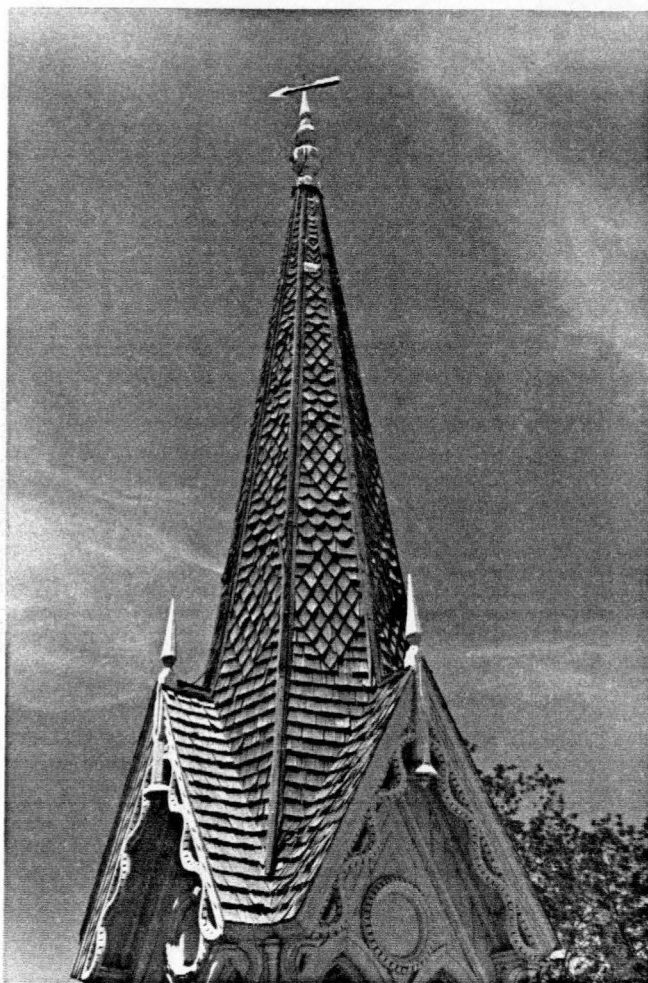
FIGURE 27. Spire, looking northwest.

The shingles on the north face of the steeple, and some of the more vertically inclined shingles on the intermediate roof, show less degradation. Decorative hip caps, all of which are very thin pieces of wood in the first place, also have eroded, split, and warped.

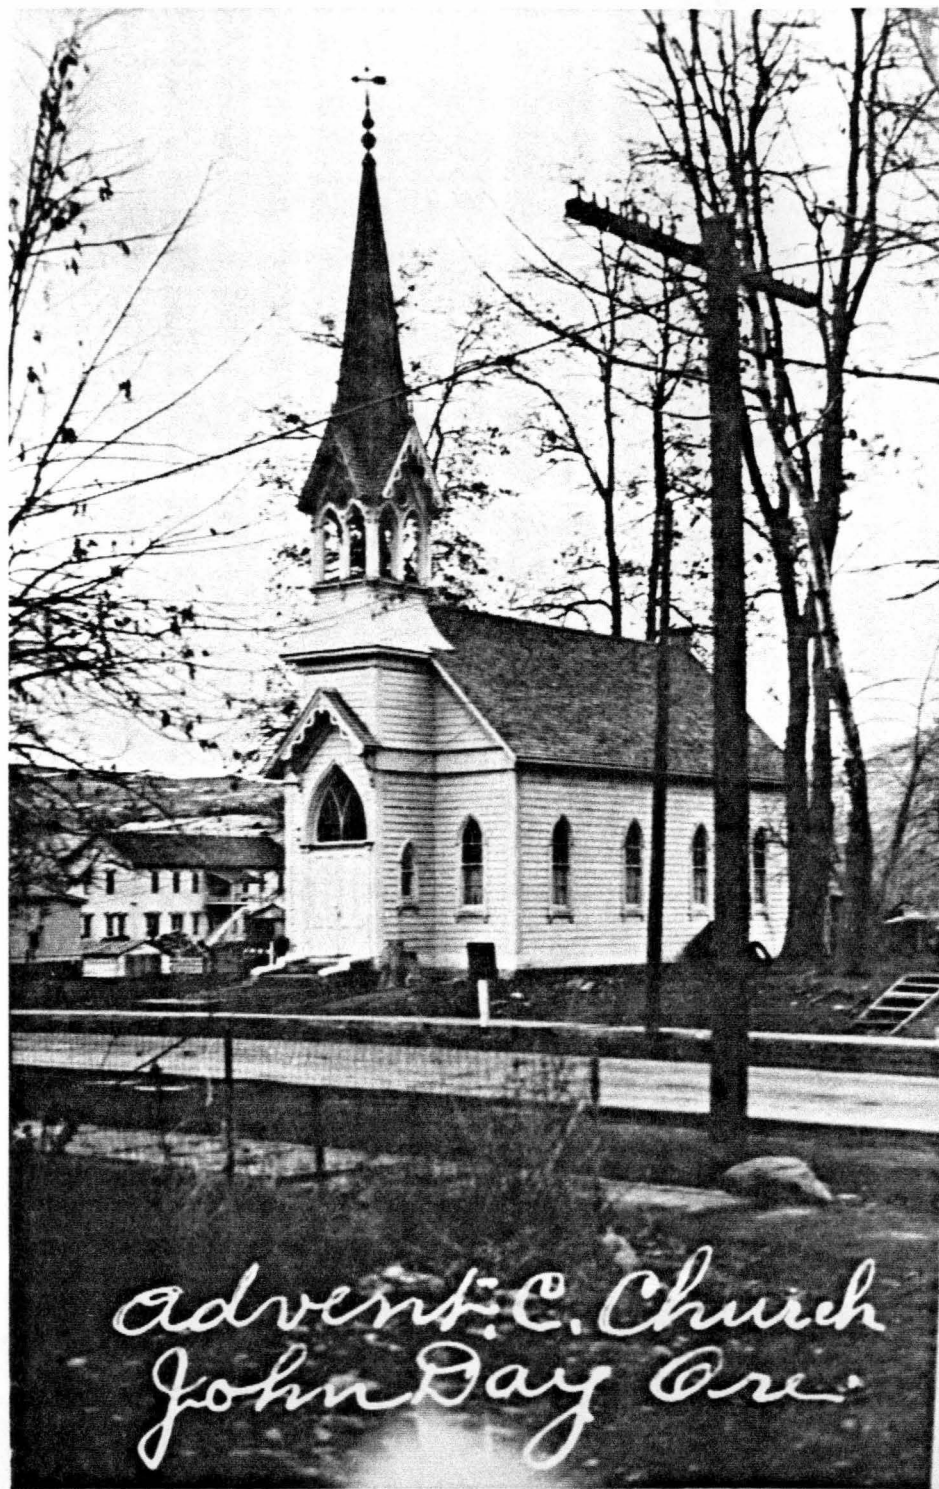
FIGURE 56. First Christian Advent Church. John Day, Oregon. 1933. Source: Murel Philips.

The current paint color is a light beige which approximates the original color. The belfry was originally polychromatic; besides the beige of the body, there was a deep red, a brown, and a black (see Restoration Plan for original paint colors). The original belfry colors remained until at least the early 1930s (Figure 56).

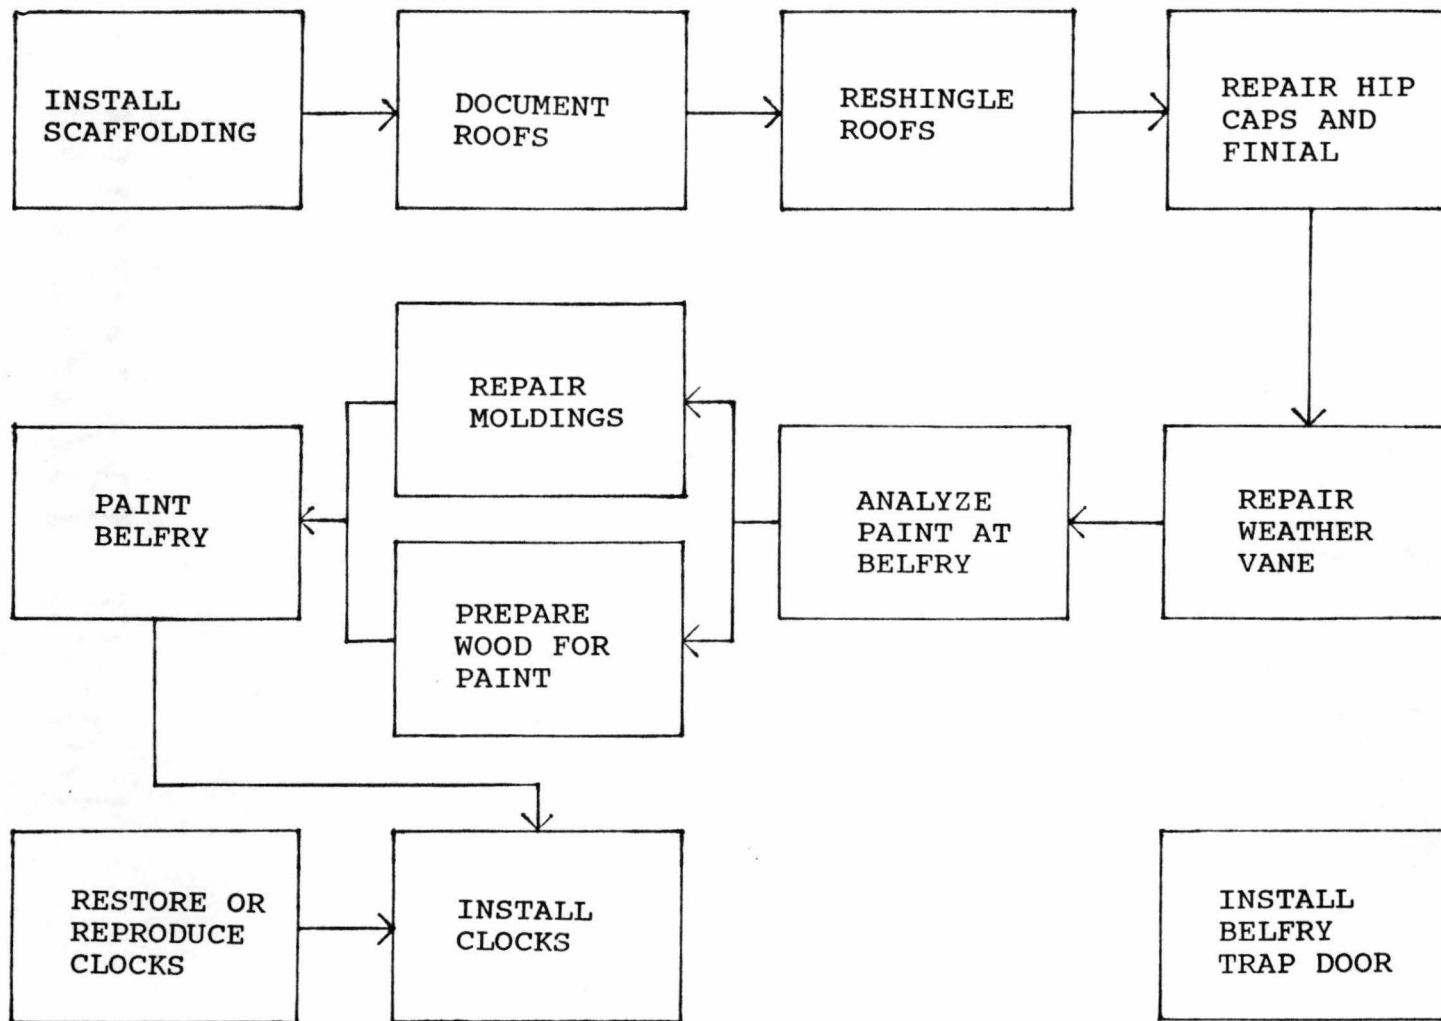
FIGURE 63. Flow chart: Phase one.

Phase One is the upper entrance tower restoration (Figure 63). Most shingles on the spire, intermediate roof, and entrance hood are in poor condition. These roofs are at once a critical part of the weather envelope and a very significant character-defining feature. In addition, such a visual first step in the restoration project will capture a great deal of community attention.

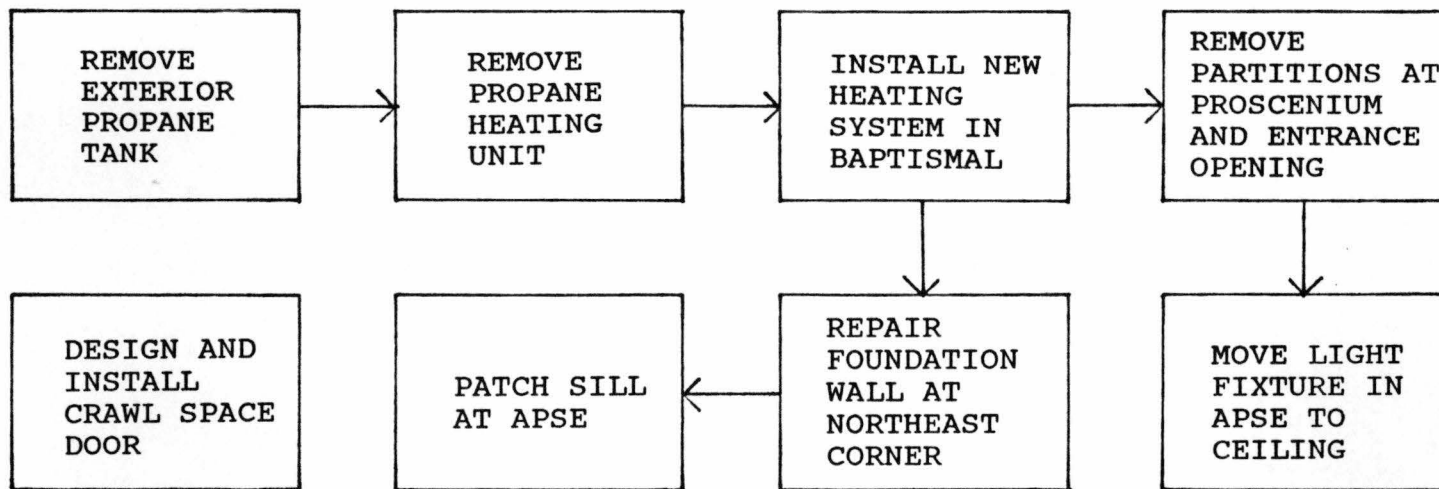
FIGURE 64. Flow chart: Phase two.

The installation of a propane heater in the apse in has caused more problems than any other alteration. Where it spans the apse in the crawl space, a 2'3" section sill was cut out to make room for duct work (Figure 55) (a hole was also cut in the floor of the apse for ducts). The sill break has exacerbated differential settlement at the northeast corner.

Phase Two involves the installation of a new heating unit, and subsequent repair of the foundation wall and sill (Figure 64). This phase will be less glamorous than the first, but it will make the building more useable and structurally stable. In addition, the removal of the propane heater means that the partition in the proscenium can be dismantled--a visual improvement on the interior.
