NEVADA FALL CORRIDOR:  
A CULTURAL LANDSCAPE  
REPORT

A THESIS

This study describes existing conditions, evaluates significance and historic integrity, and recommends treatment strategies to preserve historic elements of the Nevada Fall Corridor cultural landscape in Yosemite National Park.

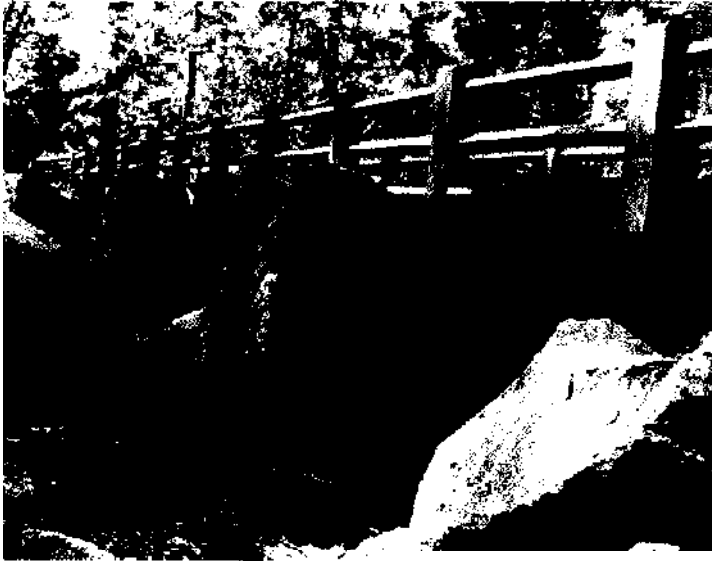
**Figure C1.8**—Vernal Fall Bridge demonstrates a scaled-down Rustic architecture design, with rubble masonry supports and timber posts and rail.

The bridge, eighty-five feet long, is Rustic in design with timber posts, deck, and rail over steel tnisses supported by mortared, rubble-masonry walls, two of which stand in the Merced River and two on the banks of the river (Figures C1.8 and C1.9). The posts and rails were replaced in 2003; the posts are twelve-inch by twelve-inch posts, the rails are five-and-a-half inch squaiv and two rails high, and stand forty-two inches above the decking. True two-inch by twelve-inch planks provide the decking. The passageway

is 122 inches wide. All the wood is treated and the bridge is in good condition. New posts and rails were installed in 2003; these feature chamfered posts, a method that invites in

moisture and accompanying rot<sup>8</sup> by exposing more wood surfaces, but which also serves to better reflect the Rustic style.

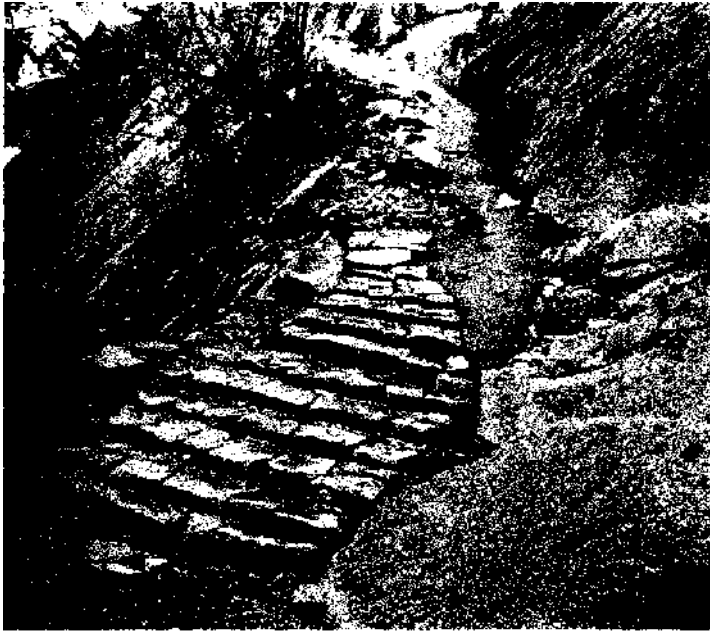
**Figure C2.6** — This riprap has weathered well since it was installed in 1997.

recently in 1997 when stone steps were installed to replace the bituminous surface that had given way. <sup>7</sup> This riprap appears to have weathered well (**Figure C2.6**), especially when compared to other sections just above this location that were not riprapped and

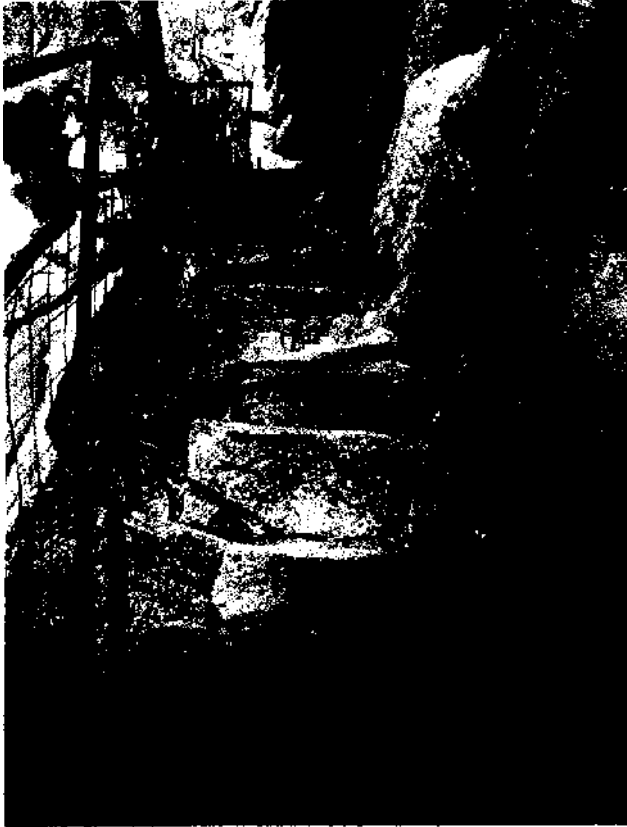
**Figure C2.11 – Railings protect hikers on the exposed section to the top of the fall from Fern Grotto.**

the top of the waterfall. This is the route used today. The final 200 feet up this exposed rock segment is protected by the 1929 iron railing that remains in fair to good condition. The railings are one-and-a-quarter-inch welded iron pipe two rails high on the exposed sections going up from Fern Grotto (**Figure C2.11**), and three rails high along the edge of the waterfall's bedrock apron. They are spaced on six-and-a-half-foot centers, sulphured in holes hand drilled into the rock, with all

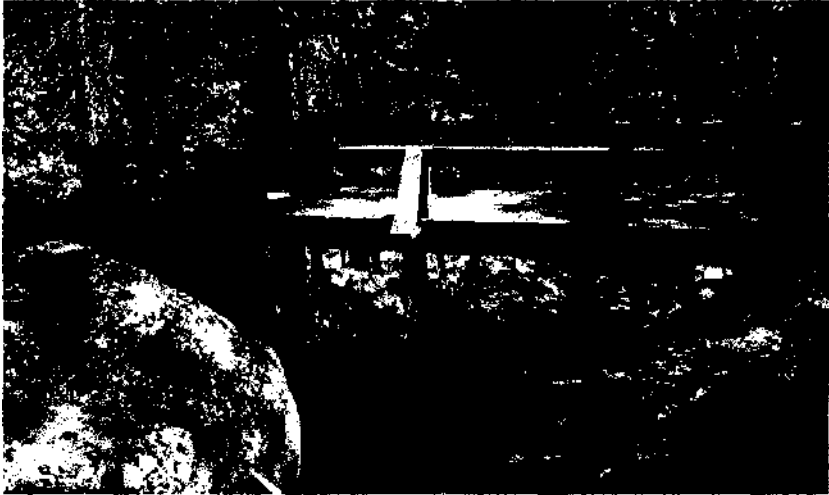
At about the 1,100-foot mark, the trail rises on a causeway supported by dry-laid stone retaining walls, then crosses a bridge (Figure C3.4). Of relatively recent construction, the bridge has steel stringers on cement piers supported by mortared rubble walls, with timber rails and posts. It is in good condition. This structure, which will be called Horse Bridge #1 in this report, is forty-two feet long with seven-and-five-eighth-inch rails and two-and-a-half-inch by eleven-and-a-half-inch plank decking. The posts are eight inch and the rails are cut diagonally at each end, where they extend three feet beyond the decking. Steel stringers run the length and are set on wood sills on a concrete base above random rubble dry-laid masonry abutments. The planks are of treated lumber in good condition with limited warping. The rails and posts are painted brown and the

Figure C3.4 – Horse Bridge #1 stands about a quarter-mile from the Happy Isles trailhead.

paint is peeling badly. One rail shows severe checking, however it appears

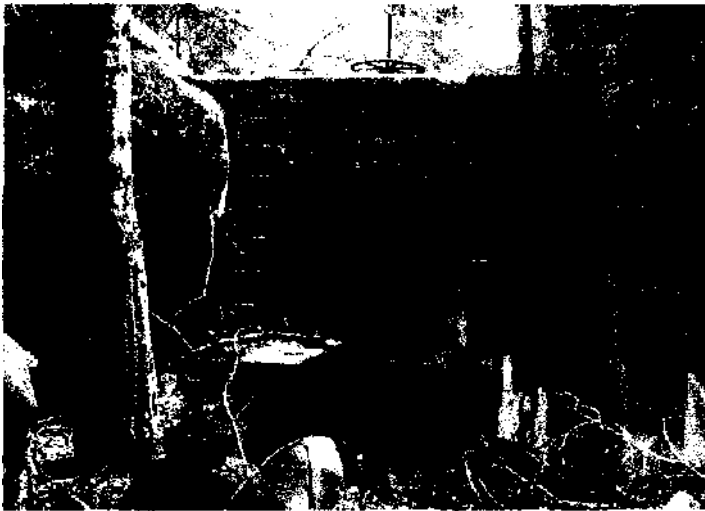
**Figure C3.9** — An abandoned trail terminates at this small dam at the Merced River.

Happy Isles connected by a pipeline extending upriver; the pipeline that terminates at this dam (**Figure C3.9**), however, is probably not part of the power plant but more likely part of the 1910 Valley water system.<sup>9</sup> These elements are in good condition.<sup>10</sup> The dam wall is two feet deep, fourteen-and-a-half wide, and nine feet tall. An iron valve wheelturning mechanism atop the dam is twenty-nine-and-a-half inches in diameter and in good condition.

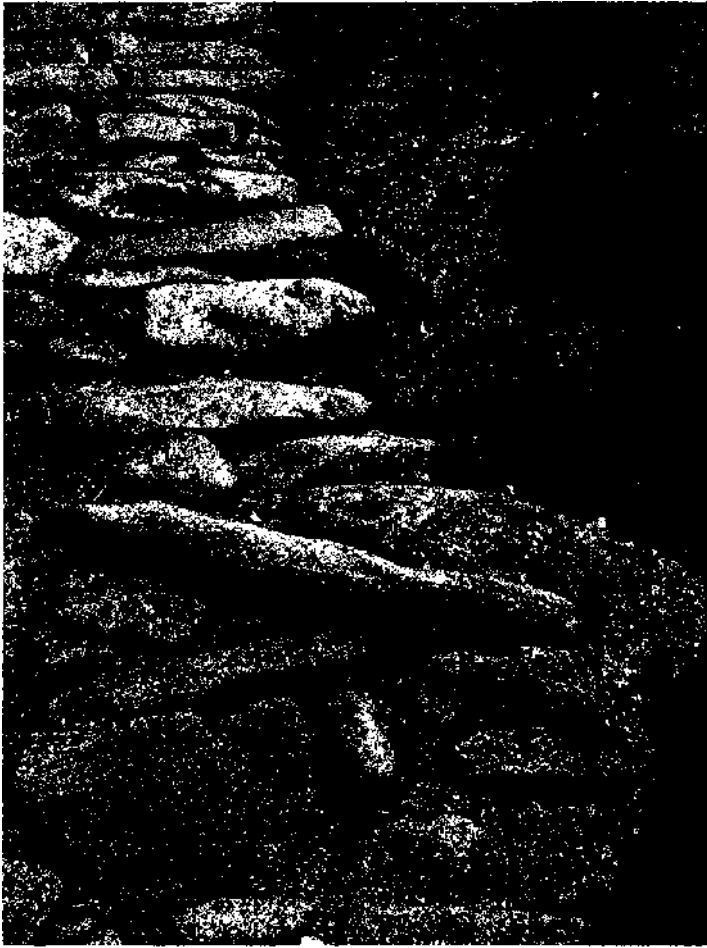
**Figure C7.4** - Original riprap by John Conway includes this section. The diagonal cobble directs water off the trail.

leaves on a southwest bearing for about 200 feet before turning west. It then begins climbing the switchbacks that lead down initially then up again toward Clark Point. The surface through here is the original work installed by John Conway in 1870-1871.<sup>7</sup> The tread is composed of native stone cobbles tucked tightly side-by-side deep into the soil for a firm hold that has lasted 135

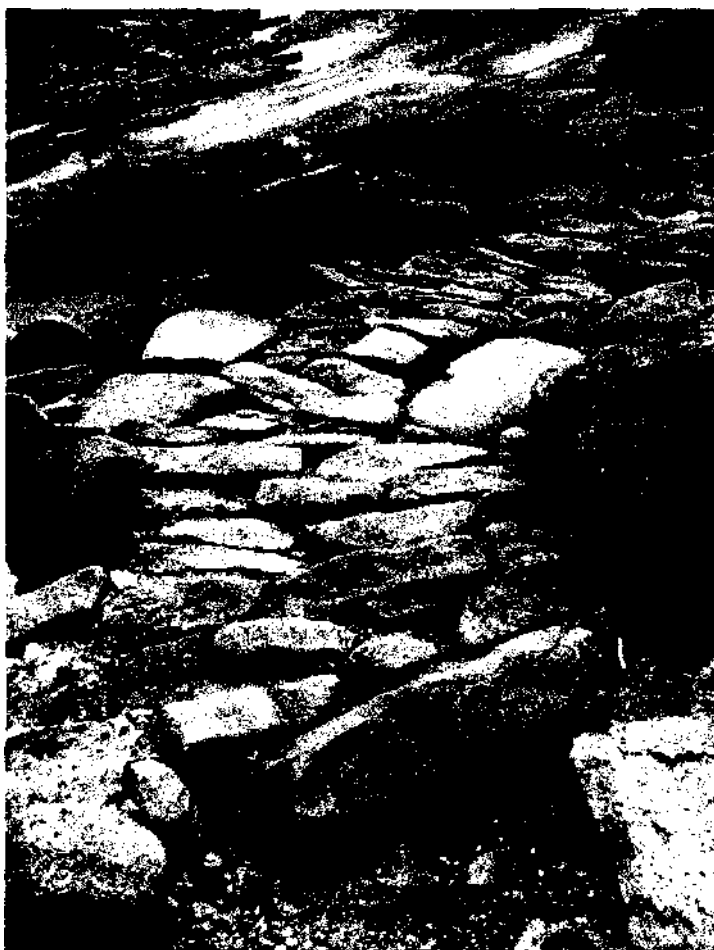
**Figure C7.6** — A switchback of solid riprap sweeps around a corner near Emerald Pool.

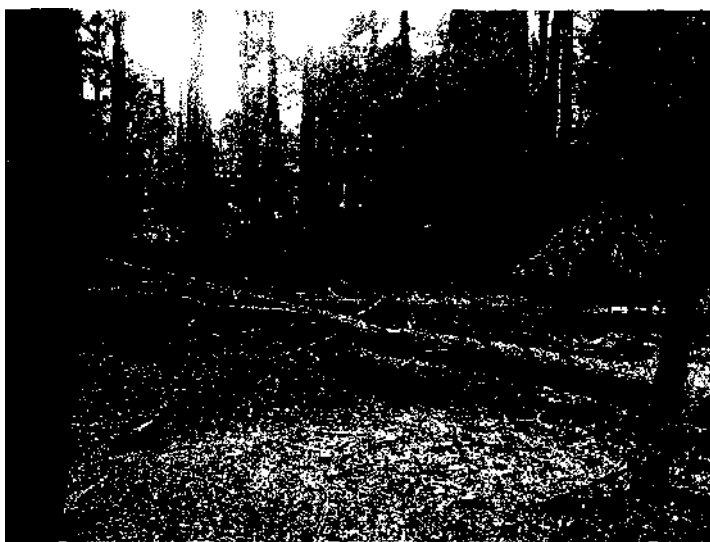
of the causeway to show the scene today - completely blocked by a dense band of young conifers that separates the causeway from the slickrock where the structures in **Figure L5.3** stood. Young cedars have also taken root on the fringes of the causeway itself and could eventually block that passageway if not thinned.

**Figure L5.4** – The view today, where Snow's reflection pool once stood as shown in **Flom L5.3**.

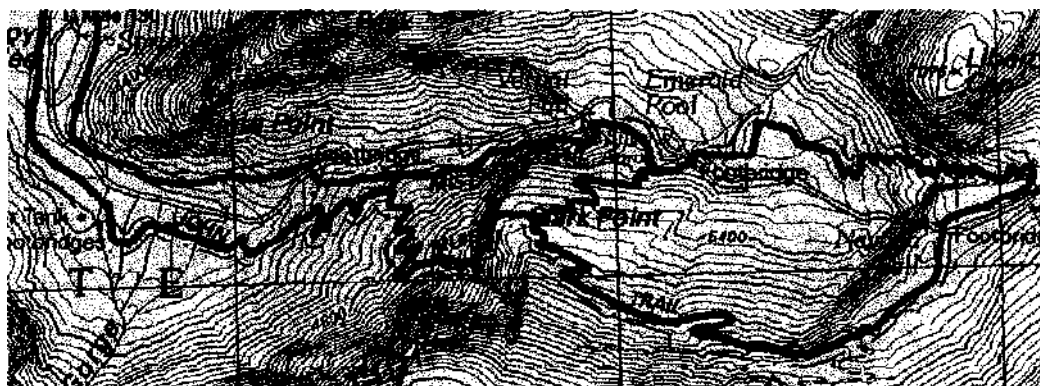
**Figure T.2** - All **current locations** of bituminous surfaces are shown on the corridor (USGS Half Dome Quadrangle, 1997).

The sections of tread surfaced with bitumen that need rehabilitation with compatible materials are detailed below. Lastly, the Bailey bridges and the current Nevada Fall Bridge are not compatible and replacements should be considered.
