**Dawson Park Gazebo
Assessment
2004**

May 6, 2004

**Subject: Visual Structural Site Observation of the Dawson Park Gazebo
MCE Project No.: 040208**

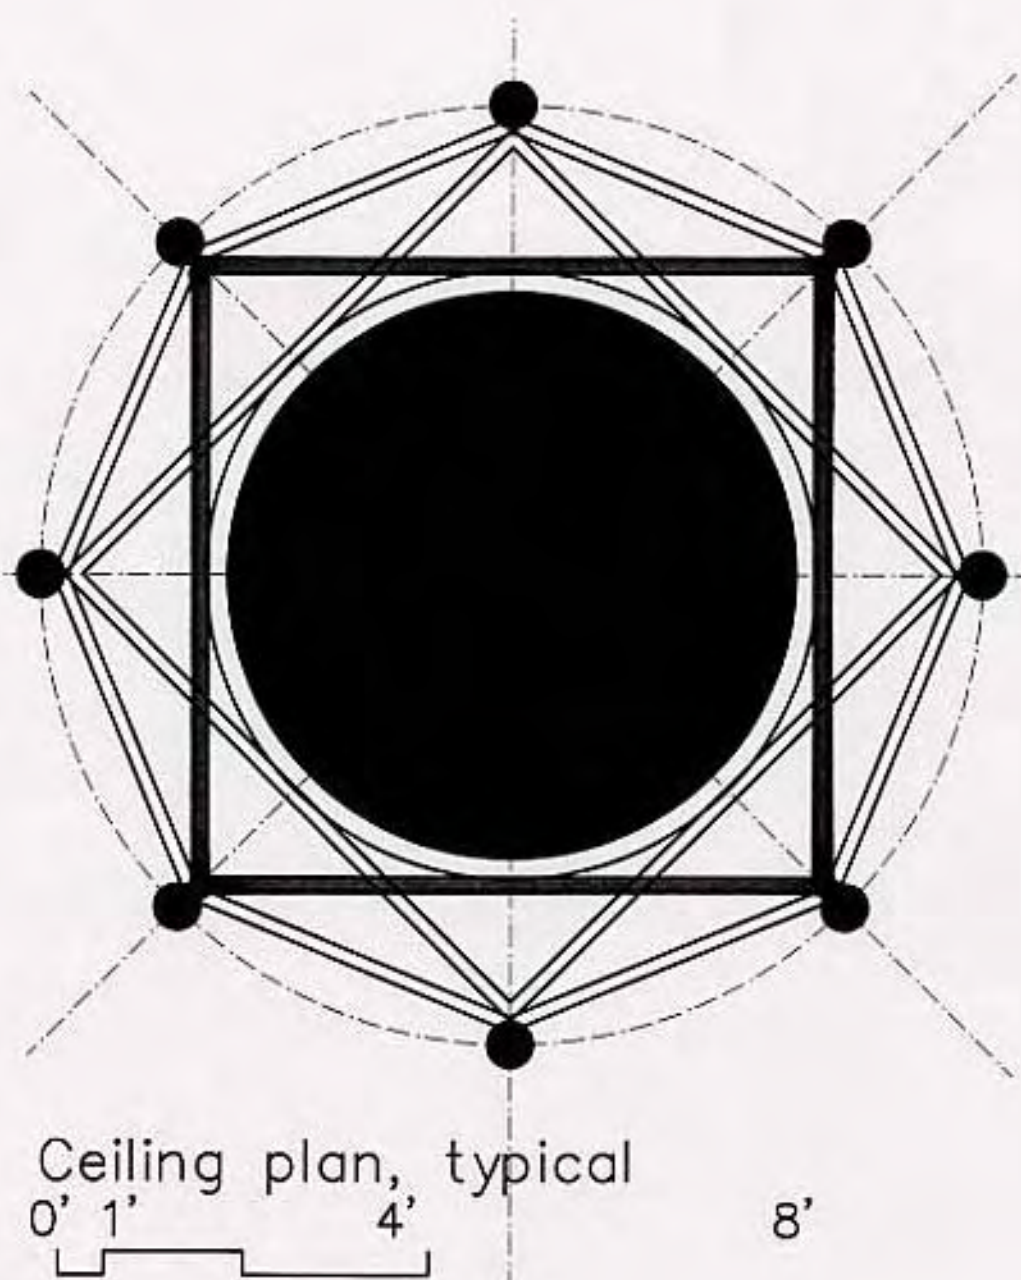
PHOTO #1: DAWSON PARK GAZBO

This structure is an open gazebo that combines eight (8) columns that are on a 20'-6" diameter circle which has internal beams carrying a round roof that is about 13 feet in diameter (photo #1). Both the vertical and lateral loads are carried by the 8 columns supporting the roof. The lateral loading (wind) is resisted by the way that the connection at the top of the column operates. These connections consist of a steel pipe section that is about 24-inches in length and has a snug, tight fit to the wood column. Between these column pipe collars there is a built-up steel member that uses a steel channel shape for the top and bottom flanges (photo #2).
