SUSTAINABLE HISTORIC PRESERVATION: A REHABILITATION PLAN FOR
THE JEFF. SMITH'S PARLOR MUSEUM IN SKAGWAY, ALASKA

Presented to the Interdisciplinary Studies Program:
Historic Preservation
and the Graduate School of the University of Oregon
in partial fulfillment of the requirements
for the degree of
Master of Science

June 2009

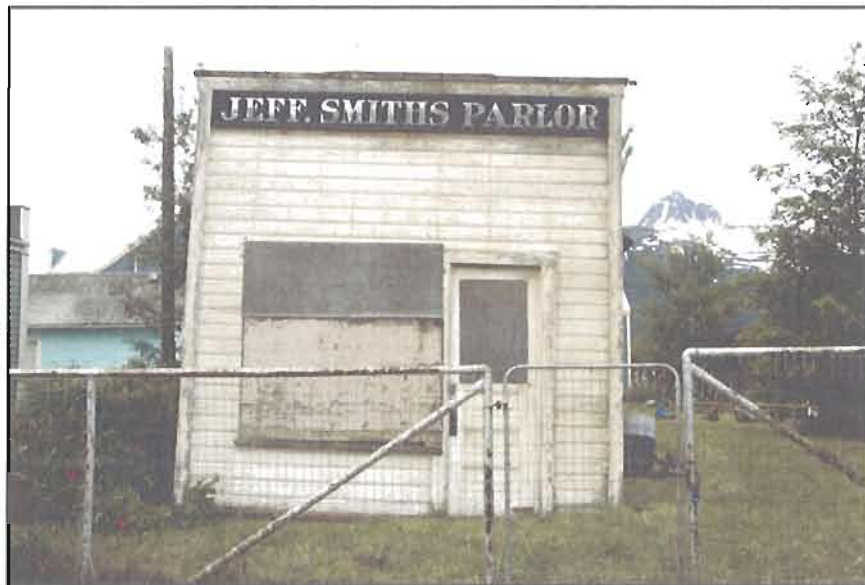
Following George's death in 1986, Edna Rapuzzi continued to open the museum to visitors, but by appointment only. When her health began to fail, the museum was closed, and the doors and windows were boarded over. Edna died in 1988 and having no children of their own, the Rapuzzi's estate passed to niece Phyllis Brown. In April 2007, Brown sold the Rapuzzi collection of artifacts (including one of Itjen's original street cars), memorabilia and historic buildings including the museum, to the Alaska-based Rasmuson Foundation. The Rasmuson Foundation donated the museum to the National Park Service Klondike Gold Rush National Historical Park in early 2009. The museum will undergo a rehabilitation to house the collection of Itjen and Rapuzzi and once again tell the colorful story of Skagway, her citizens and this time that of sustainable historic preservation (see Figure 11).

Figure 11. The Jeff. Smith's Parlor Museum, July 2008. *Source:* National Park Service/Alaska Regional Office, July 2008.

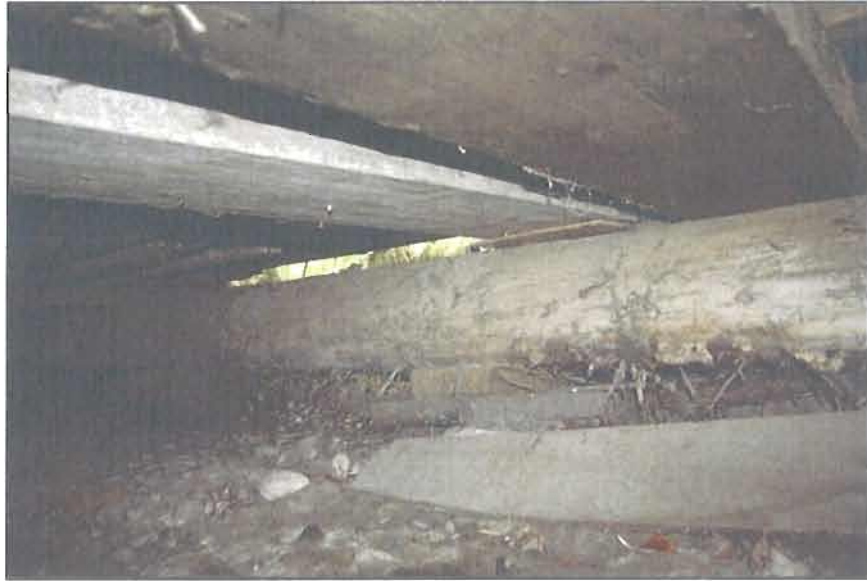
The single story building has at least three distinct foundation types. Beneath section A-1 the building sill rests on two logs running parallel to the length of the building (see Figure 16). These logs rest on stacked piers that consist of log cuts, stacked on stone and chunks of concrete. This foundation is visible from a small crawl space that is accessible by a trap door in the floor of room A-1.

Figure 15. Log foundation along east wall of section A-1. *Source:* National Park Service/Alaska Regional Office, The Jeff. Smith's Parlor Museum Historic Structures Report, 2008.

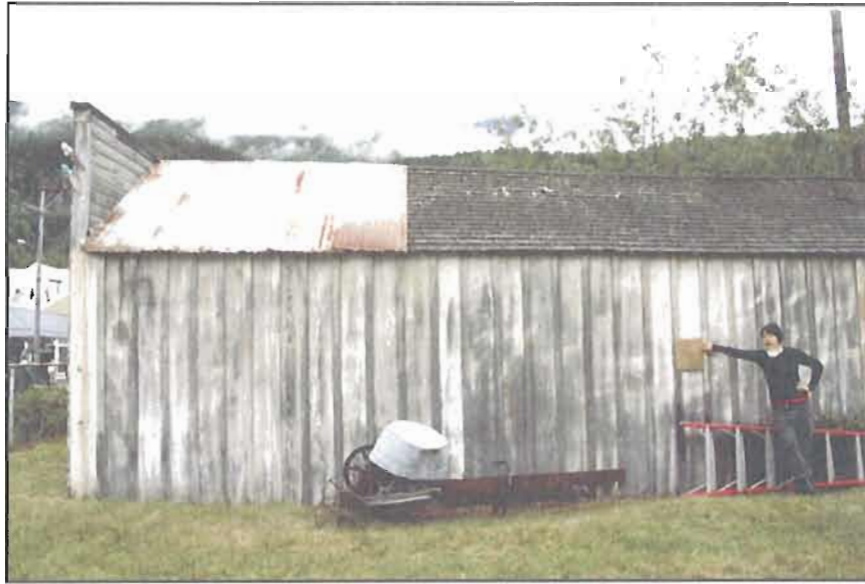
The 7'2" feet high walls are largely wood plank or box construction; a construction method that is common to many gold rush era buildings in Skagway. plank/box construction was quick and required few materials. Section B is stud wall construction and not plank but is sheathed with board and batten. In Section C the vertical supporting planks are not siding but battened structure of plank construction. The board and batten siding covers the east, south and west sides of the museum (see Figure 17). The batten widths on the south elevation are wider than those on the east and west elevations. The principle north false-fronted façade consists of horizontal shiplap siding. All of the walls show signs of weathering with graying wood and chipping/flaking white or light colored paint.

Figure 17. East elevation with board and batten siding. *Source:* National Park Service/Alaska Regional Office, July 2008.

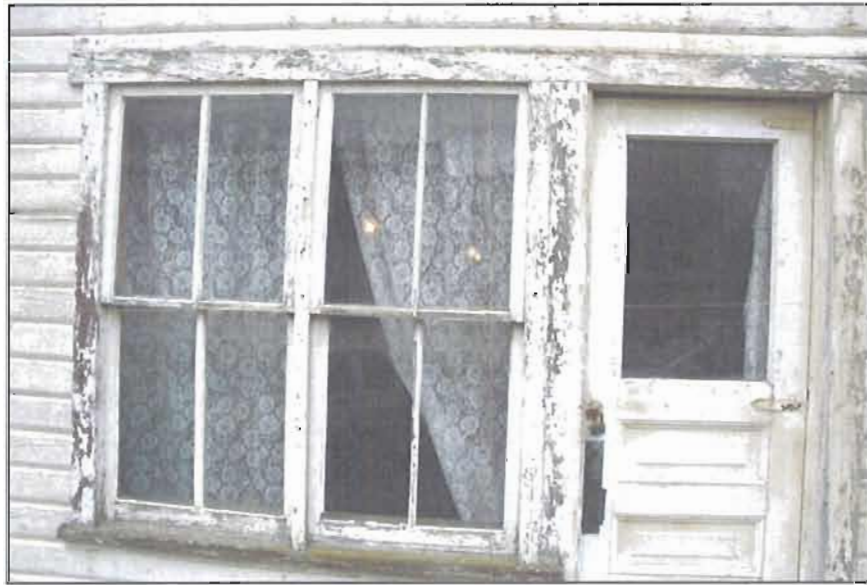
Only two doors and three windows provide egress and light to the museum. The main doorway on the north facade opens directly into original parlor/bar section of the building that dates to 1897 (see Figure 18). This doorway is framed with painted trim boards on the interior and exterior. The wooden door is three paneled on the bottom half and has a fixed window on top that is presently covered with plywood. Three strap hinges connect the door to what appears to be a rod fixed in the door frame. There are large gaps between the door and door frame.

The most prominent windows of the museum are adjacent to the front door. These 2'4" x 4' windows are double hung wooden sash windows. They are two over two with large vertical lights. Like the front door light, these windows are also presently covered by plywood. The sashes are nailed shut on the inside and are inoperable. The only other window in the building is located on the east elevation in section B. The light of this small 2'2" x 1'7" fixed sash window is covered with plywood on the inside of room B (see Figure 19). Externally the window is simply trimmed in wood with three horizontal iron bars protecting the light.

Figure 18. Windows and main doorway on north elevation. *Source:* National Park Service/Alaska Regional Office, July 2008.

- Remove windows and door for treatment and reinstallation following Phase 2. (Treatment of the window may include repair, re-glazing, or replacing missing elements in kind. It may also include the removal or encasement of lead paint.)
- Remove flooring where necessary to access crawl space and foundation and as required to reinforce floor structure.
- Remove or stabilize and protect all news clippings, signs, receipts and paper documents on walls.
- Remove historical wood bar and other artifacts still present.
- Abate lead paint, mold, dust and vermin droppings.

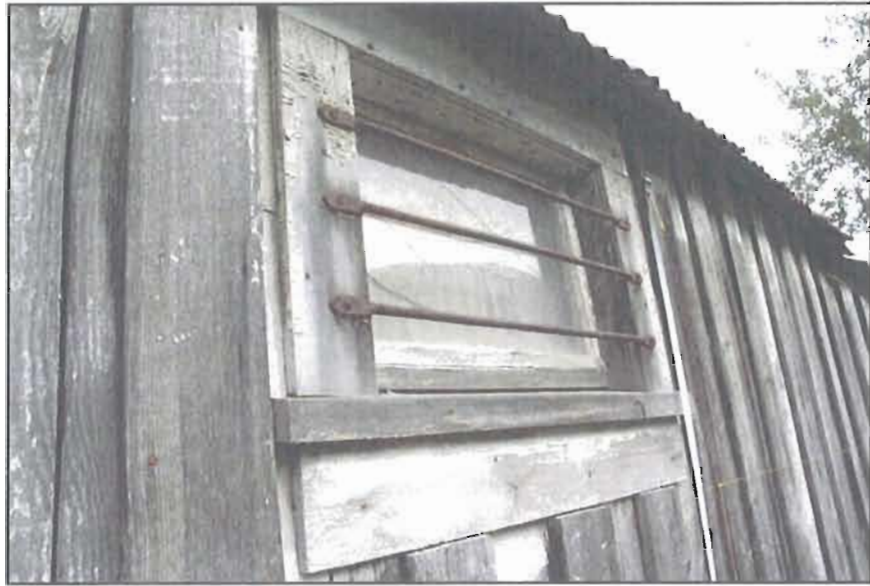
Figure 19. Window and metal bars on east elevation. *Source:* National Park Service/Alaska Regional Office, July 2008.

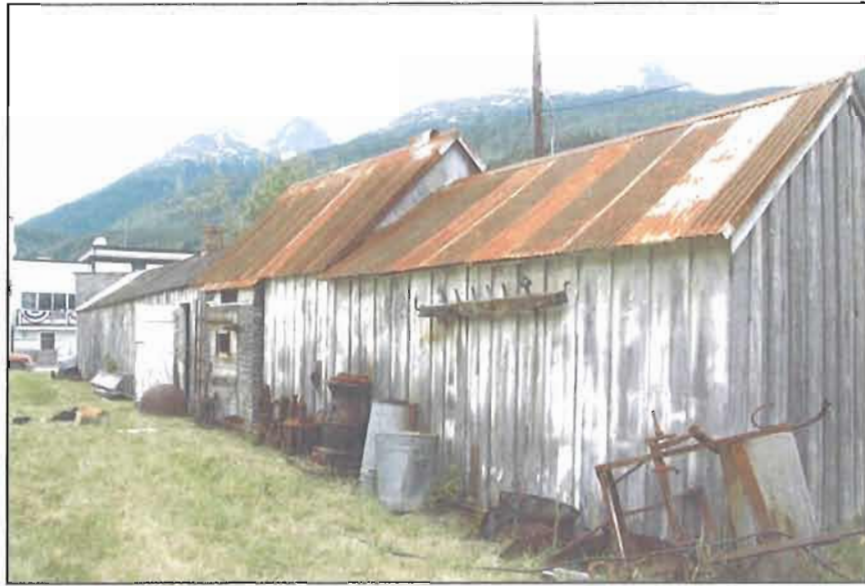
The most steeply pitched section of the museum roof is section B, where the pitch is 11:12. This section is covered entirely in corrugated and sheet metal. Here the gable faces extend above the ridges of roof sections A and B, and are faced with sheet metal. At the southern end of the building, roof section C has a pitch of 8:12 and is also clad in corrugated metal (see Figure 20). The false front of the museum is on the north end of roof section A and is clad in horizontal shiplap with a simple wood plank coping.

Figure 20. Metal gable roof of section B and C southwest elevation.
Source: National Park Service/Alaska Regional Office, July 2008.

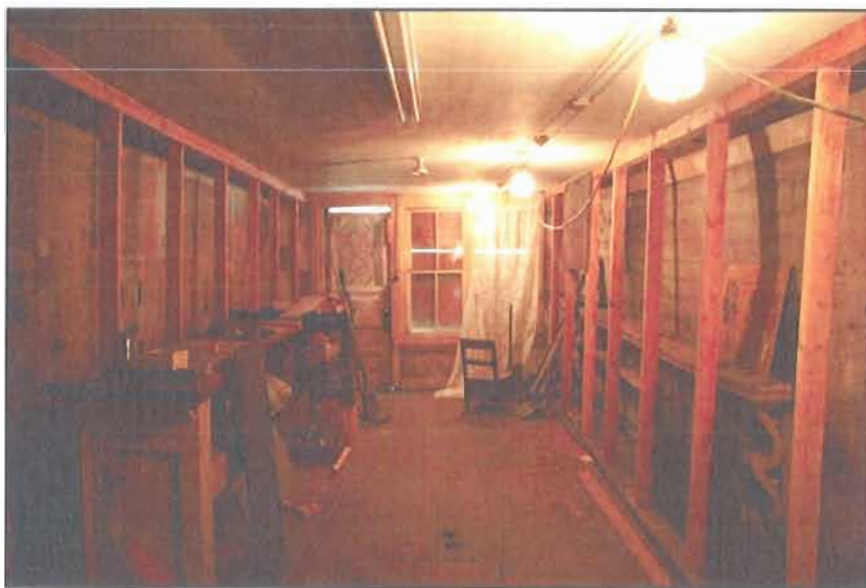
The museum is sparsely furnished and the furnishings that are present appear to be mostly remnants of the Itjen/Rapuzzi collection once housed in this building. There are wood chairs, and boxes of miscellaneous items in rooms A-1, A-2 and B. In room A-1 is a long bar that is similar to the one in historical photos from the Soapy Smith era; however, this bar is most likely not the 1897/98 bar. There is a desktop hung from the wall in the southwest corner of this room. Presently, there are two temporary 2" x 4" stud stabilizing walls in room A-1 that will be removed following the rehabilitation (see Figure 23).

Figure 23. Room A-1 looking north. *Source:* National Park Service/Alaska Regional Office, July 2008.

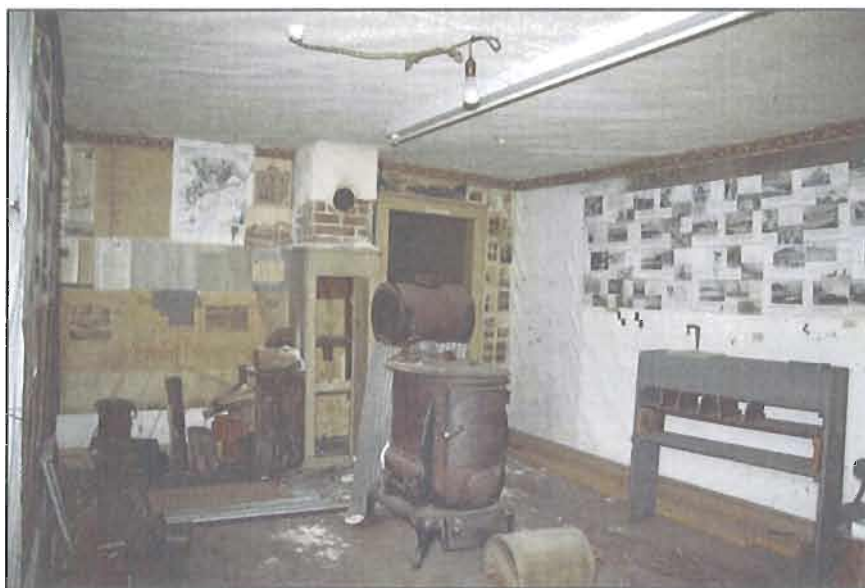
In room A-2 is a painted wood bench, a free standing wood shelf and a cast iron stove (see Figure 24). There are a variety of objects--small tanks, lamps, boxes, etc. on the floor around the periphery of both rooms A-1 and A-2. Many of the walls in room A-

Figure 24. Room A-2 looking toward northeast corner. *Source:* National Park Service/Alaska Regional Office, July 2008.

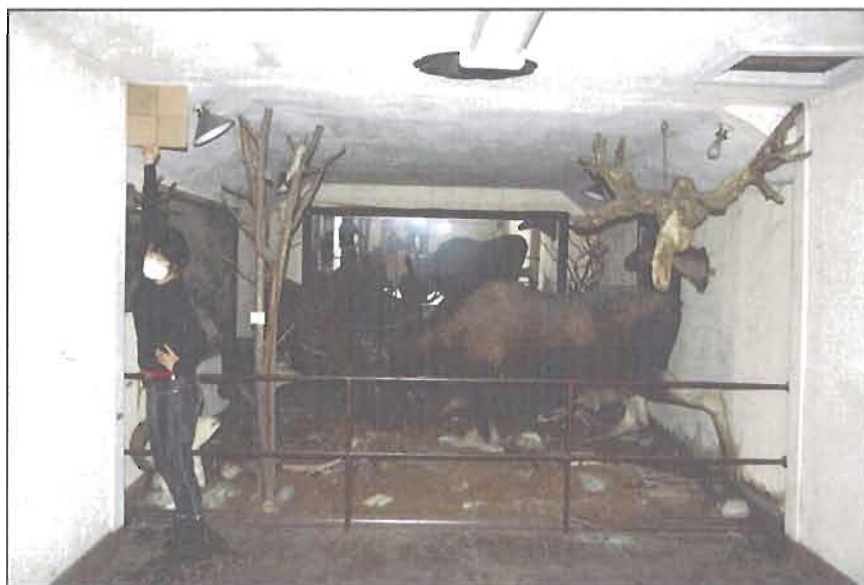
The most unusual furnishings in the museum are the preserved animals that are part of the life size diorama in the back of room C. This diorama is a grouping of animals collected by Martin Itjen as part of one of his museum exhibits. The animals were preserved with arsenic that was commonly used by taxidermists in the 1920/30s. The centerpiece of this life size diorama is two bull moose with interlocked antlers. According to local oral history, Mr. Itjen purchased the skeletons of these two bull moose that died of starvation after locking their antlers. Mr. Itjen then commissioned a hunter to shoot two moose for their hides that were then stretched around the skeletons restoring the moose to a more lifelike representation. Other mounted animals included in this diorama are a timber wolf, ram, deer, two white furred varmints situated in a branch, and a moose skull with deformed antlers (see Figure 25).

Figure 25. Room C wildlife diorama. *Source:* National Park Service/Alaska Regional Office, July 2008.

- Remove or stabilize and protect the wildlife diorama during rehabilitation. Abate the arsenic present in these preserved animals.
- Remove flooring where necessary to access crawl space and foundation and as required to reinforce floor structure.
- Remove picture, mirror and other artifacts still present.
- Inspect electrical system.
- Abate lead paint, mold, dust and vermin droppings.

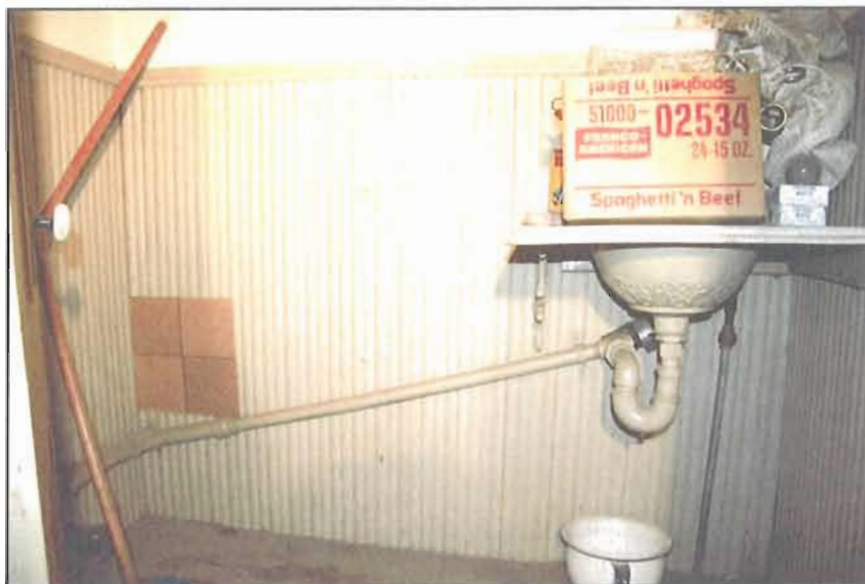
The mechanical systems in the museum represent the technology that was available in the decades that this building was used and occupied. While electricity to the building is currently not connected, there are remnants of knob and tube wiring in the attic and more contemporary overhead florescent and incandescent lighting in all of the rooms (see Figure 26). In the small bathroom (in the southwest corner of room A-1), is a corner sink and toilet flange, though there is no toilet (see Figure 27). There is no running water within the museum.

Figure 27. Sink and plumbing in bathroom. *Source:* National Park Service/Alaska Regional Office, July 2008.

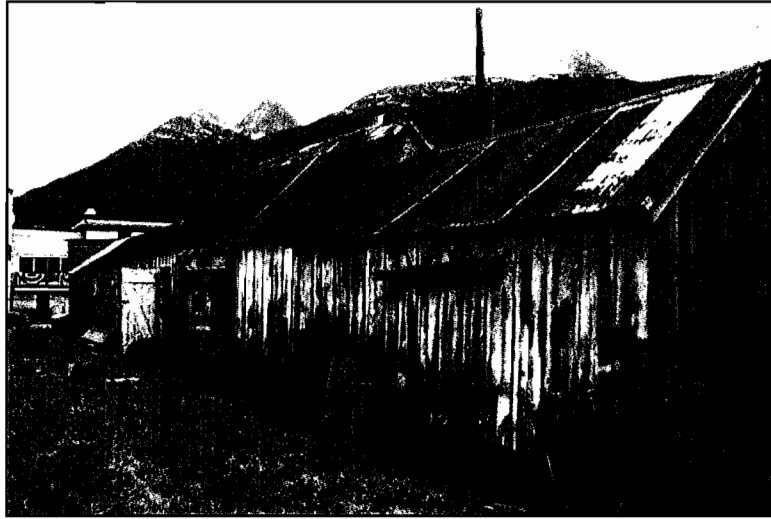
Figure 2. JSPM southwest corner. *Source:* National Park Service/Alaska Regional Office, July 2008.

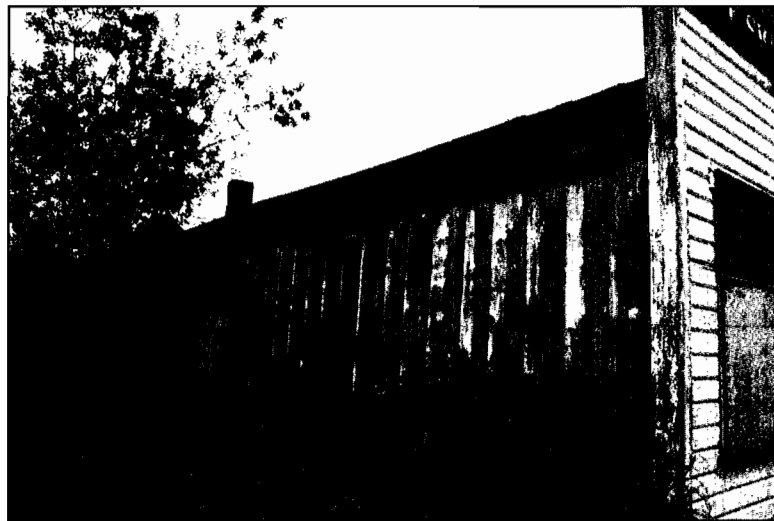
Overall the museum is in poor condition. The foundation has failed allowing the building to sink into grade on the west side and in the northwest corner. The east wall is bowing out and separating from the sill plate exposing the building interior and foundation to moisture. Foliage along the east elevation is infiltrating the building envelope. Additionally, moisture is entering the building holes in the roof allowing mold to anchor on the interior walls. To arrest further deterioration and listing to the building, the foundation needs urgent stabilization and roof moisture barrier reinforcement.

Figure 3. JSPM northeast corner. *Source:* National Park Service/Alaska Regional Office, July 2008.

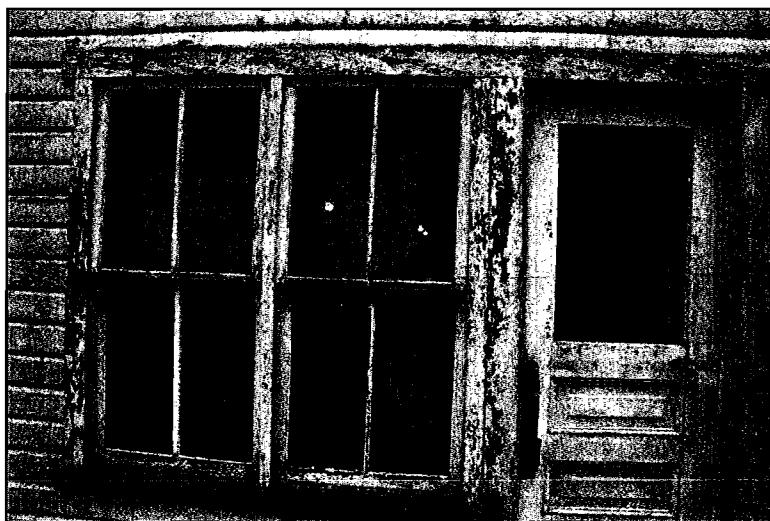
This is the principle elevation with a 3-panel wood door with window and two 2:2 double hung windows. The windows are presently inoperable, nailed shut and boarded over. The door is pad locked close and the window in the door is covered with plywood. The painted white on black "Jeff. Smiths Parlor" sign hangs just below the cornice board on

Figure 9. North elevation windows and door. *Source:* National Park Service/Alaska Regional Office, July 2008.

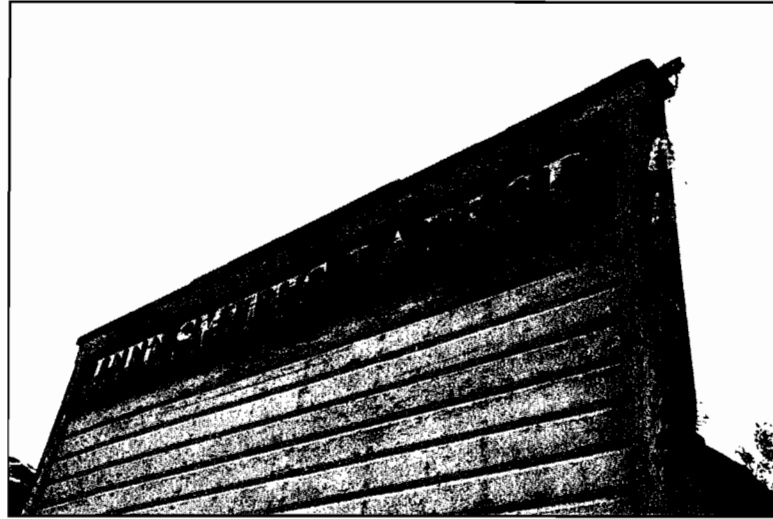
Figure 11. False front with painted sign - north elevation.
Source: National Park Service/Alaska Regional Office,
 July 2008.

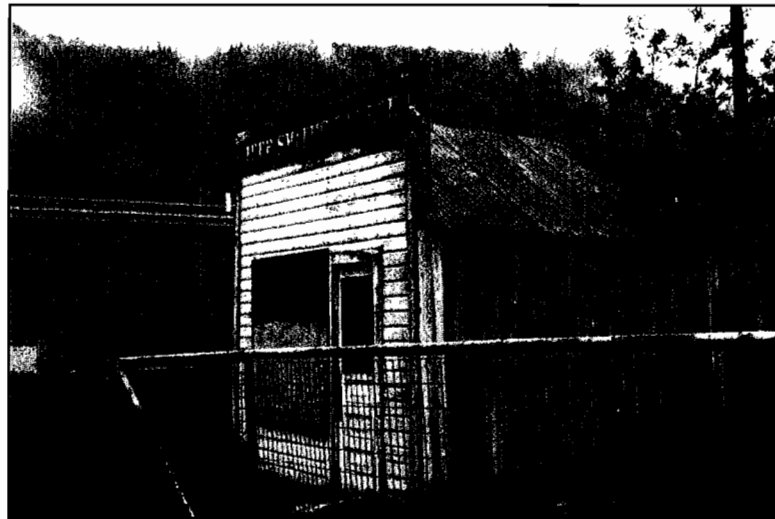
the roof parapet. This elevation is clad with shiplap siding that appears to have been painted with a whitish color paint that is now cracked and peeling. The water table is partially covered by grass and grade but is exposed in the northeast corner and appears to have been painted a red color. There is noticeable growth of moss between the base of the wall and the foundation.

Figure 12. Northwest elevation. *Source:* National Park
 Service/Alaska Regional Office, July 2008.

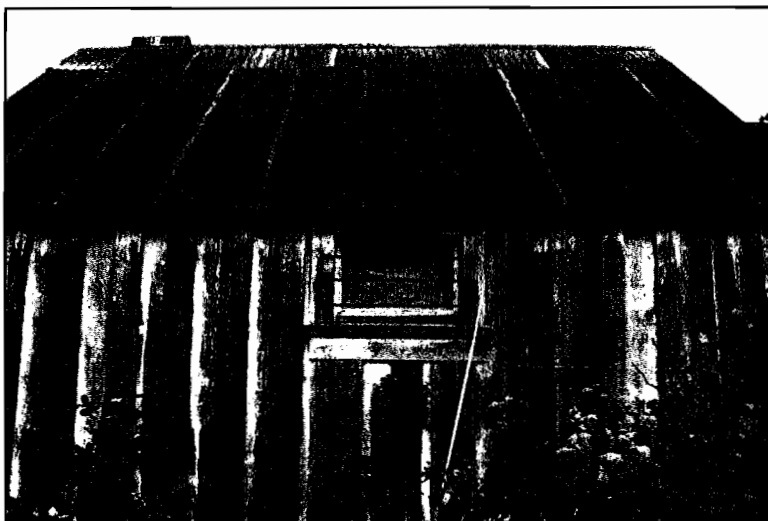
This elevation is clad with the board and batten siding. Here the battens vary in width and spacing. There is one fixed casement window midway down the length to this elevation in building section B. The window is boarded over with plywood from inside the building. The baseboard along this elevation is missing in some sections and in

Figure 13. East elevation window. *Source:* National Park Service/Alaska Regional Office, July 2008.

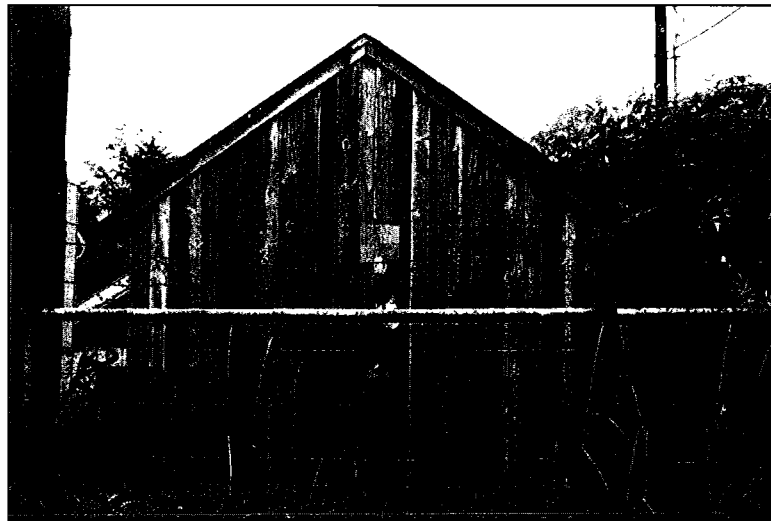
The board and batten siding on this elevation is wider than that of the east and west elevations measuring approximately 6" wide. The gable bargeboard is clad partially covered with a rusted metal flashing. There is very little paint on this elevation.

Figure 15. South elevation. *Source:* National Park Service/Alaska Regional Office, July 2008.

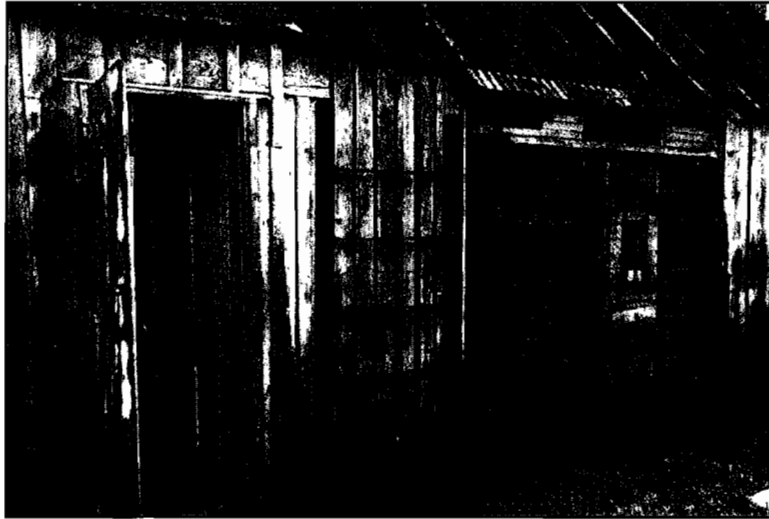
On this elevation the board and batten changes in width from north to south and the only accessible doorway midway in section A of this side of the building. Adjacent to this doorway is a reconstructed jail-like false façade and vertical metal bars attached to main body of the building. A variety of car jacks, pumps, pieces of metal and a wood and metal ladder rest against the side on this elevation.

Figure 16. West elevation entrance and jail-like false facade. *Source:* National Park Service/Alaska Regional Office, July 2008.

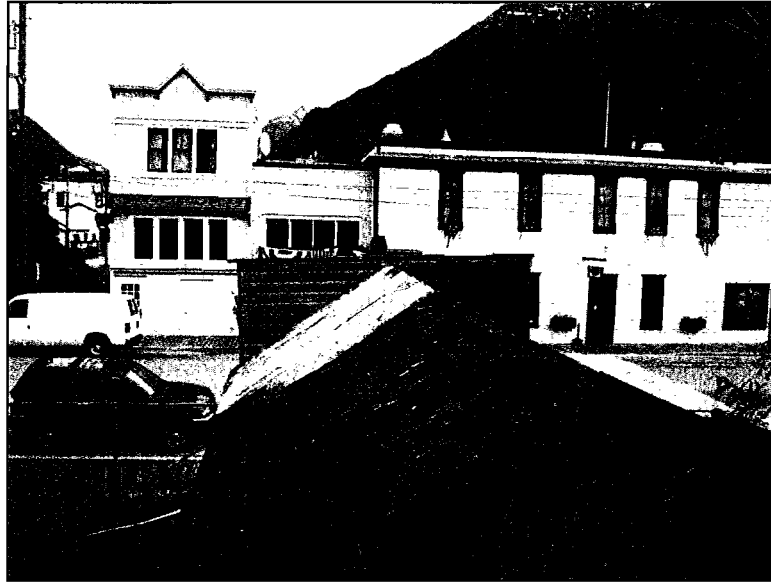
The Museum has three distinct gable roofs (see diagram). Roof A consists of cedar shingles and corrugated metal sheeting on the northwest end. Shingles are missing or damaged in this section created holes and gaps allowing moisture inside the building. Roof B is the steepest pitch gable and covered entirely in sheet and corrugated metal that has rusted. Roof C on the southern end of the building is also covered in corrugated metal.

Figure 17. View of roof looking north toward the back of the false front. *Source:* National Park Service/Alaska Regional Office, July 2008.

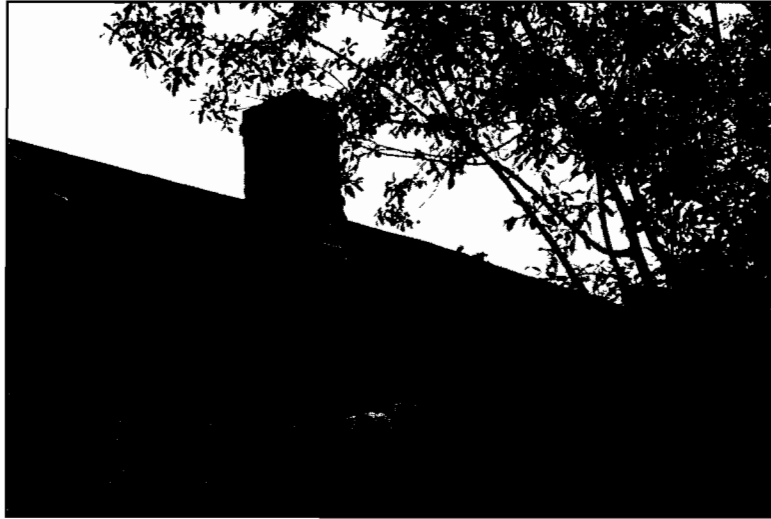
others is detached from the building at a 30 to 45 degree angle allowing duff and moss to collect near the foundation line. The chimney pipe that was once attached is now dangling from the roof along this side. Overgrown rose bushes, grass and a lilac bush are growing against this elevation.

Figure 19. East slope of roof section A, masonry chimney and detached chimney pipe. *Source:* National Park Service/Alaska Regional Office, July 2008.

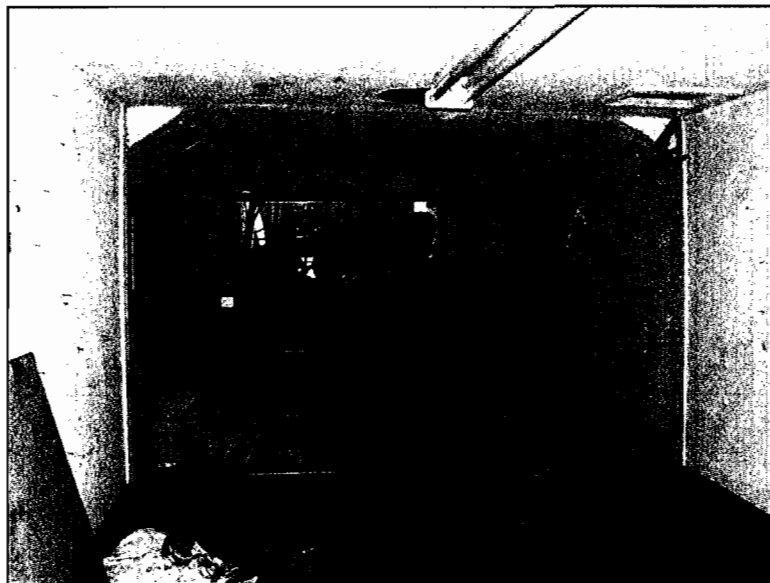
A small change in wall thickness distinguishes Room C from Room B, however, where Room B was mostly empty; a life size diorama occupies most of Room C. This diorama consists of animals collected by Martin Itjen as part of his Alaskana museum exhibit. The animals were preserved with arsenic and due to this contact hazard the interior of this room was not measured. The centerpiece of this life size diorama is two bull moose with antlers interlocked. According to local oral history, Mr. Itjen purchased the skeleton of these two bull moose that had died of starvation after locking antlers. Mr. Itjen commissioned a hunter to shoot two moose for their hides that were then stretched around the skeletons restoring the moose to more lifelike representations. Other mounted animals included in this diorama are a timber wolf, ram, deer, two white furred animals situated in a branch, and a moose skull with deformed antlers. On the walls behind this diorama is a large mirror on the south wall, a painting of mountain scene on the east wall and a photograph of a ship on the west wall. A mixture of wood shavings, rocks and branches are spread on the floor beneath the diorama.

Figure 33. Room C. *Source:* National Park Service/Alaska Regional Office, July 2008.
