THE PRESERVATION OF PRE-WORLD WAR TWO
COAST GUARD ARCHITECTURE IN OREGON

A THESIS

Presented to the Interdisciplinary Studies Program:
Historic Preservation
and the Graduate School of the University of Oregon
in partial fulfillment of the requirements
for the degree of
Master of Science

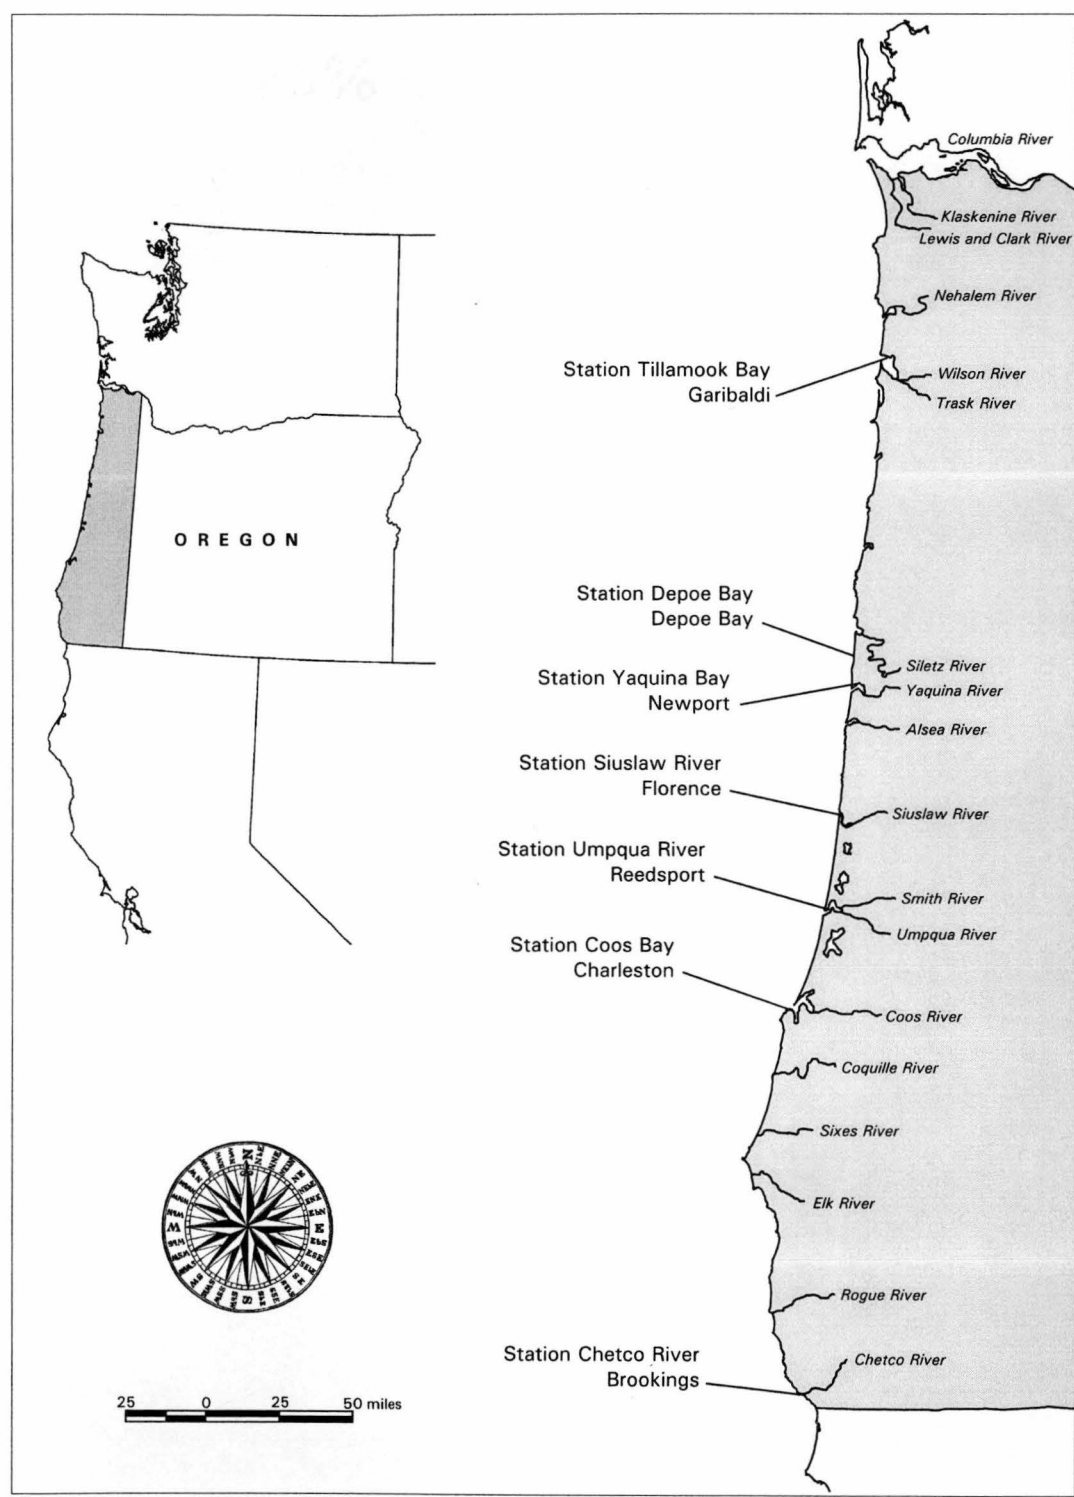
Figure 1. Current Coast Guard Lifeboat Stations on the Oregon Coast with Location.

Starting out as the U.S. Life-Saving Service in 1871, the forerunner to the Coast Guard arrived in Oregon in 1878. From the humble beginnings of a one-man station near Coos Bay, the Life-Saving Service expanded to protect six of the major waterways along Oregon's Coast. In 1915, the Life-Saving Service joined the Revenue Cutter Service to become the U.S. Coast Guard and added two more stations prior to WWII. Today, the Coast Guard operates seven lifeboat stations on the Oregon Coast (Figure 1).

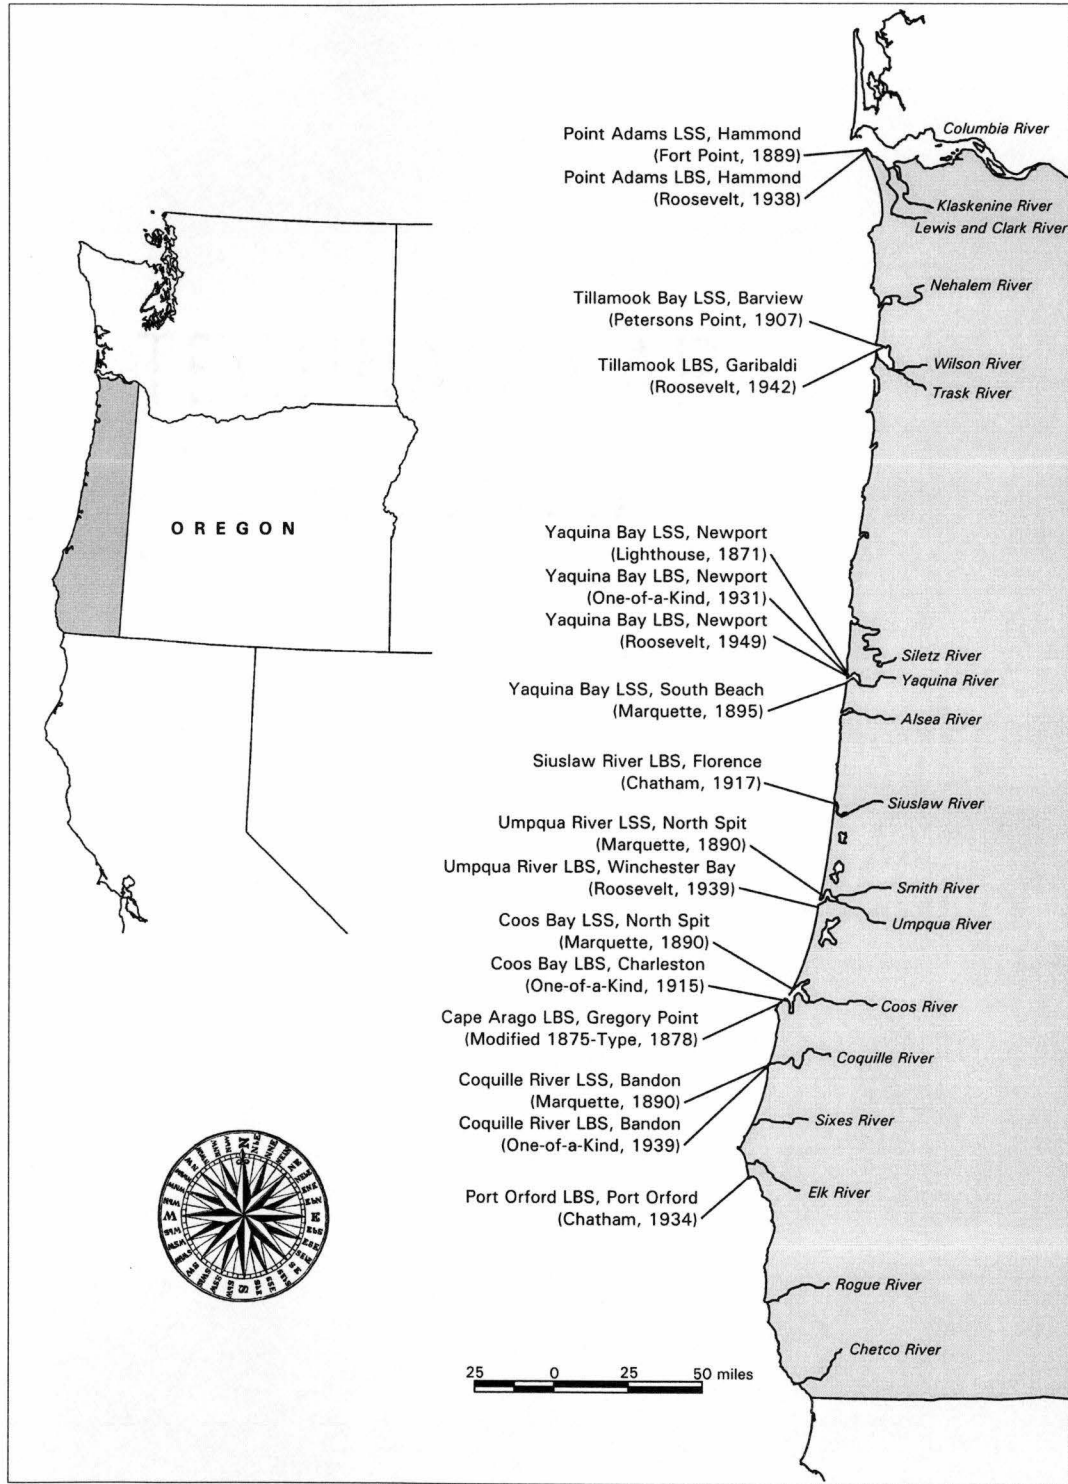
Figure 2. Pre-1950 Life-Saving Service and Coast Guard Stations on the Oregon Coast with Station Type and Year Construction Started.

The Life-Saving Service and Coast Guard built 13 stations along the Oregon Coast prior to 7 December 1941 (Figure 2). Two more stations were built after WWII began using pre-WWII plans. These stations were placed at the following major waterways to protect shipping: Columbia River, Tillamook Bay, Yaquina Bay, Siuslaw River, Umpqua River, Coos Bay, Coquille River, and Port Orford. All but two of the pre-World War II buildings at the thirteen stations have been deactivated by the Coast Guard. Fortunately, other parties are using the deactivated buildings at these locations: Point Adams, Tillamook Bay, Yaquina Bay, Umpqua River, Coos Bay, Coquille River, and Port Orford. Unfortunately, only three locations have any structures left from the Life-Saving Service era: Point Adams, Tillamook Bay, and Yaquina Bay.

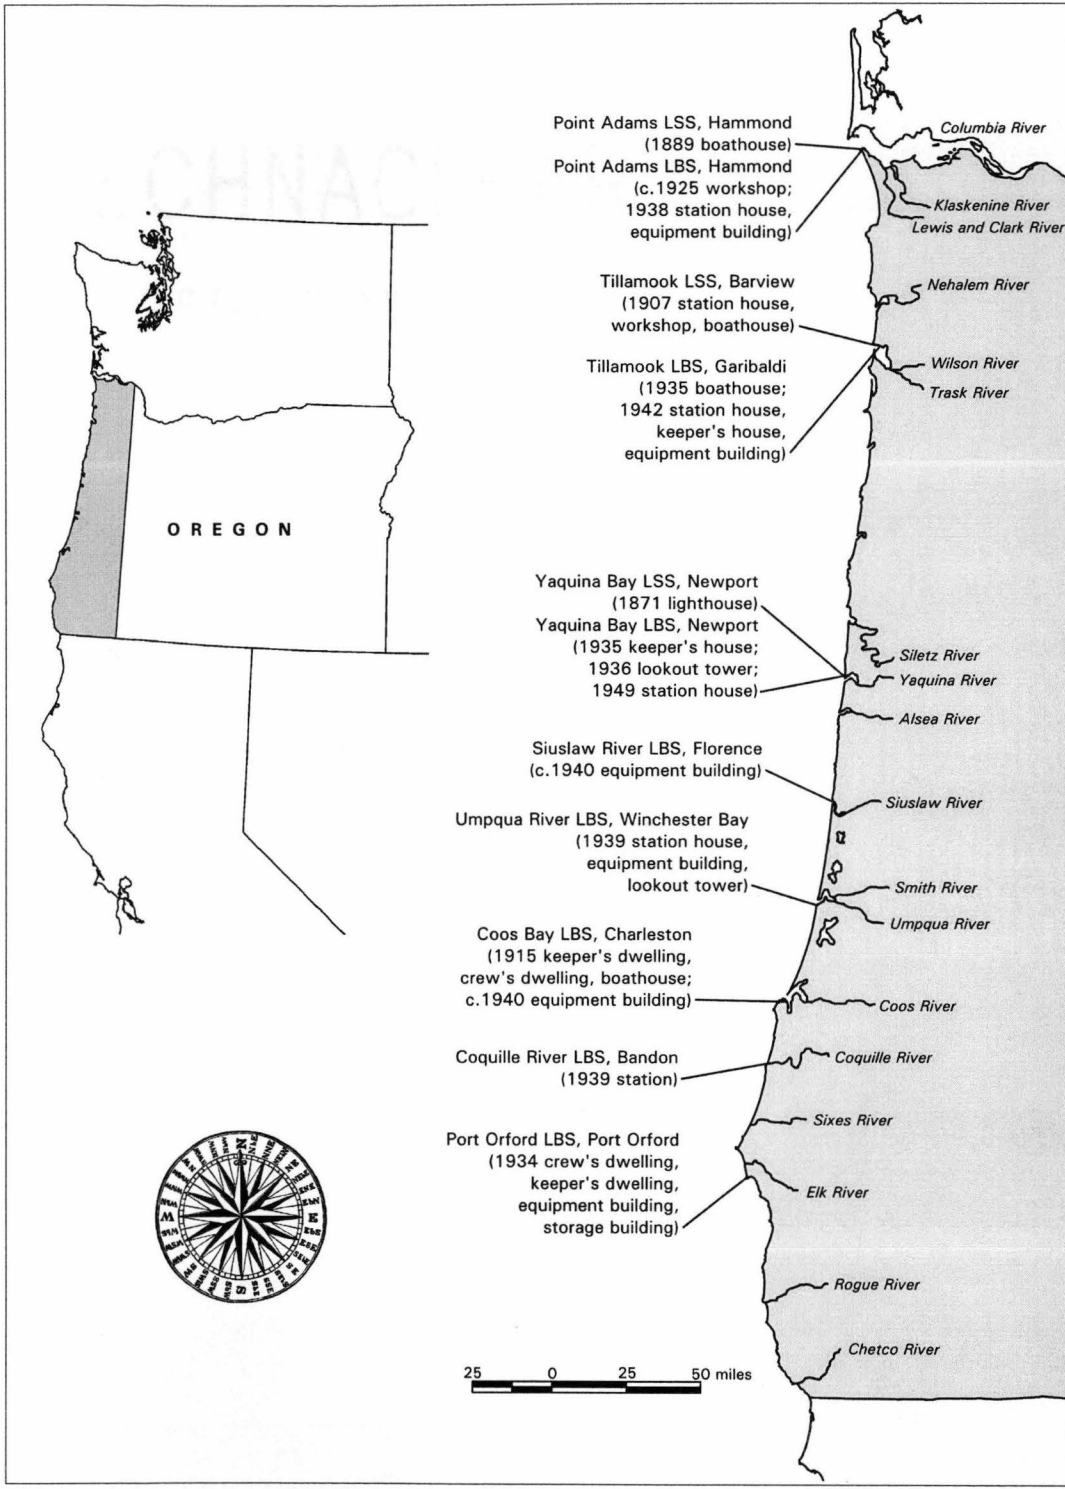
Figure 3. Principal Buildings Still Standing at the Pre-1950 Life-Saving Service and Coast Guard Stations on the Oregon Coast.

About half (i.e., 24 out of 50) of the primary buildings built before WWII have survived to the year 2000 (Figure 3). These “primary” buildings are defined as station houses, keeper’s dwellings, boathouses, equipment buildings, and lookouts. Very few ancillary structures, such as antennas, fencing, water towers, and boardwalks, survive at any of the stations. Selected buildings at five of the thirteen stations have been placed on the National Register of Historic Places: Tillamook Bay, Yaquina Bay, Umpqua River, Coquille River, and Port Orford.

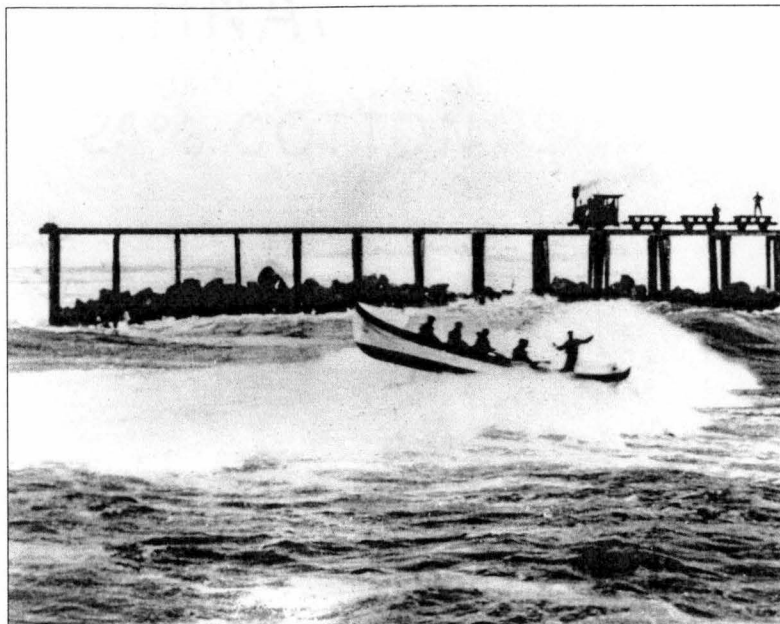
Figure 6. Dobbins Lifeboat During Training at Coquille River Bar. Source: U.S. Coast Guard Headquarters (Life-Saving Service: Surfboats File).

The size of the crew was determined by the number of oars required to pull the largest boat at the station. Since lifeboats with eight oars were typical in Oregon, stations had a crew of eight (Figure 6). On the Atlantic, crews as small as six were needed to row the surfboats. The crew was chosen personally by the keeper from local members of the populace. This demonstrates the autonomy and responsibility given to the keepers by Kimball. Kimball wrote of the “. . . necessity for mutual confidence between a leader and his followers in hazardous enterprises involving their own lives and the lives of others.”²¹ Early in the history of the Life-Saving Service, it was found that this policy created a situation where crew members were often selected based on political, social, and family lines. However, in 1882, Congress straightened out this situation and made “fitness” the sole requirement and extended the selection process to include a review by

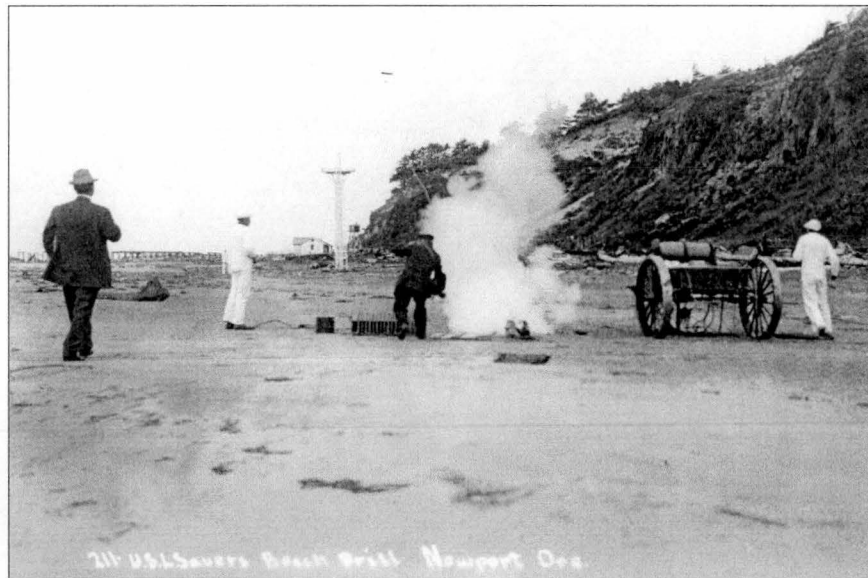
Figure 10. Crewmen Drilling with the Beach Apparatus, Yaquina Bay Life-Saving Station, Circa 1910. Source: Author's Collection.

The beach apparatus drill, performed on Mondays and Thursdays, was meant to get the crew so used to erecting a breeches buoy that they could do it in the dark. The breeches buoy was a device by which a person could be moved from ship to shore on an aerial line. All the equipment for the breeches buoy was stored on a beach apparatus cart. This cart would be “hitched” to the crewmen and dragged to the drill field (Figure 9). At the end of the drill field 75 yards away would be a wreck pole, representing a mast on a stranded vessel. The keeper would fire a small cannon called a “Lyle gun” which would send a 17-pound projectile trailing a shot line over the wreck pole (Figure 10). Various mortars, cannons, and rockets had been experimented with over the years, and the Lyle gun was the final solution. It could fire the projectile over a distressed ship with accuracy up to an extreme range of 695 yards.³²

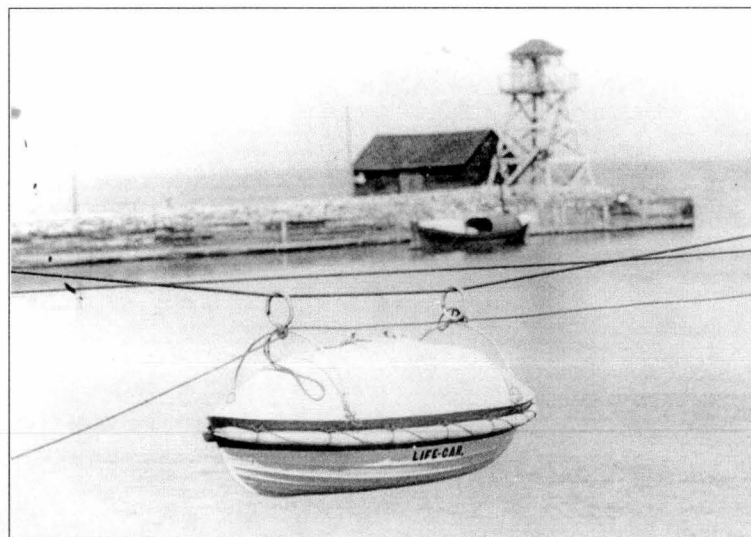
Figure 12. Lifecar Rigged from Ship to Shore. Source: U.S. Coast Guard Headquarters (Life-Saving Service: Surfboats File).

On occasion, a lifecar would be substituted for a breeches buoy. A lifecar was basically a metal torpedo with a hatch (Figure 12). When the hawser could not be raised high enough above the water or if a shipwreck victim was injured, a lifecar could be pulled out to the wreck on the same rigging as the breeches buoy. Several people could squeeze into a lifecar, seal the hatch, and then get dragged through the surf to shore. Only a few rescues were performed each year using the lifecar, though it was a piece of equipment issued to every station.

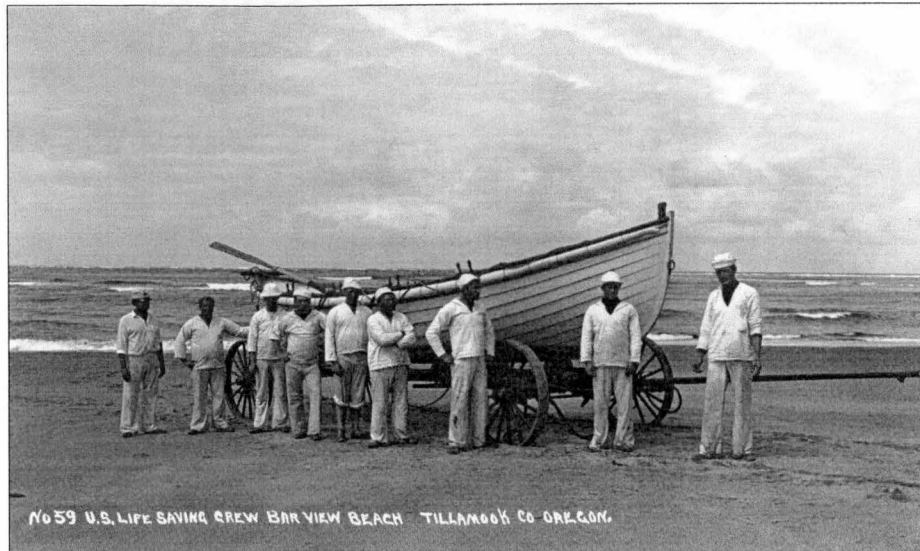
Figure 13. Tillamook Bay Life-Saving Station Crew with Surfboat, Circa 1910. Source: Author's Collection.

There were three principal types of surfboats used in Oregon: the Beebe, the Beebe-McLellan, and the Monomoy. They measured 25' to 27' long and weighed 700 to 1,100 pounds. Surfboats were relatively light-weight so that they could be pulled along the beach on a carriage (Figure 13) and then launched directly into the surf (Figure 14). Six crewmen were needed to row the surfboats with the keeper manning a long steering oar at the stern. They were highly maneuverable and excellent for short distances when only a few people were imperiled. Surfboats were ideal for work on the Eastern Seaboard. None of the surfboats were self-righting, but the Beebe-McLellan was self-bailing.

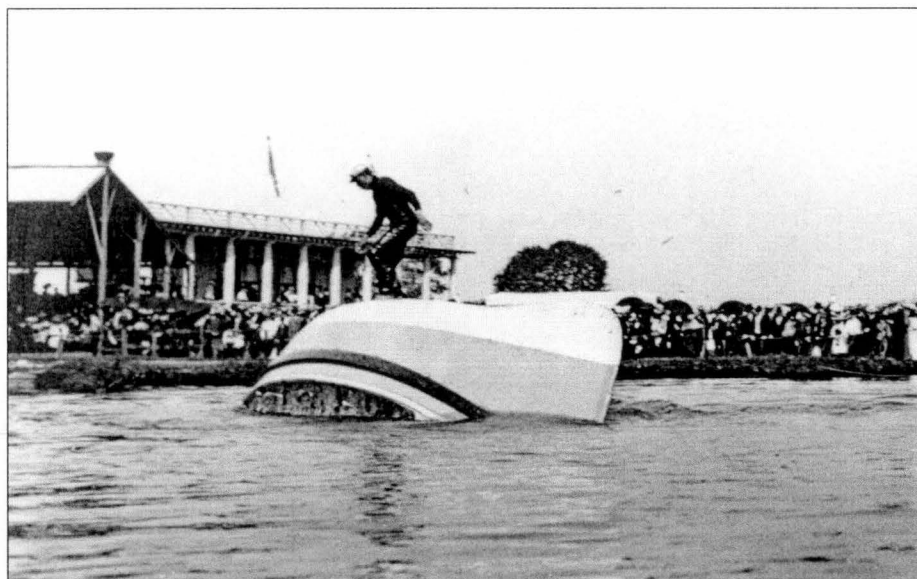
Figure 16. Keeper Walking Around Stern During Capsize Drill at Lewis and Clark Exposition, 1905. Source: Oregon Historical Society (OrHi #9999Y387-79857).

return to their seats on the thwarts. The fastest time ever recorded to capsize a surfboat and returned to the seated position was 13 seconds.³⁵ The righting procedure was so quick that a keeper could actually step over the stern and not get wet (Figure 16).

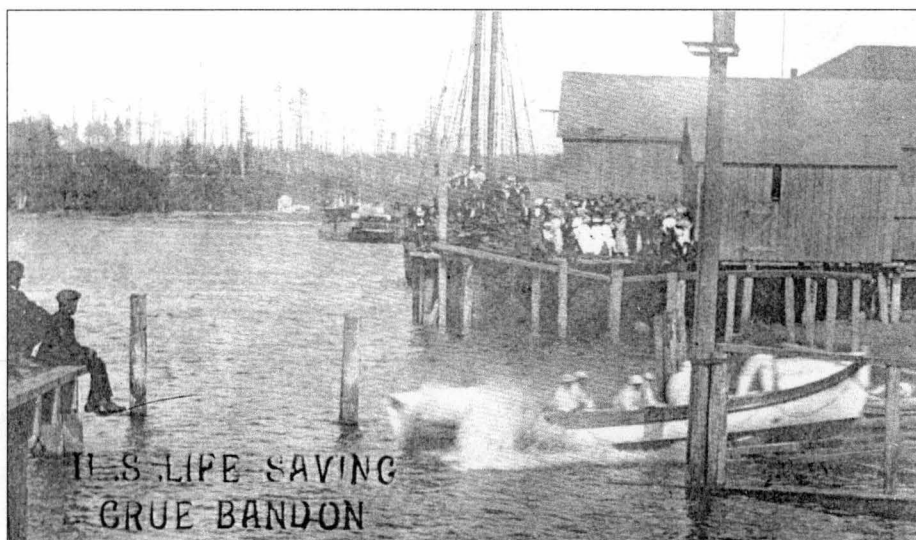
Figure 18. Dobbins Lifeboat Hurtling Down Launchway at Coquille River Life-Saving Station. Source: Bandon Historical Society (BHS #1104).

The Dobbins lifeboat, on the other hand, was a compromise between the surfboat and lifeboat. It was developed by David P. Dobbins, Superintendent of the Ninth District, in 1881. The Dobbins lifeboat was roughly the same length as the English lifeboat at 24', but more than half as light, weighing from 1,600 to 2,000 pounds. It was cheaper to build, was self-righting and self-bailing, and could still carry 33 people safely.³⁷ Because of its light weight, the lifeboat could be launched like a surfboat directly from the beach (Figure 17) or from a marine railway (Figure 18). It was rowed by eight and steered by the keeper with a tiller (Figure 19). A Dobbins lifeboat appears

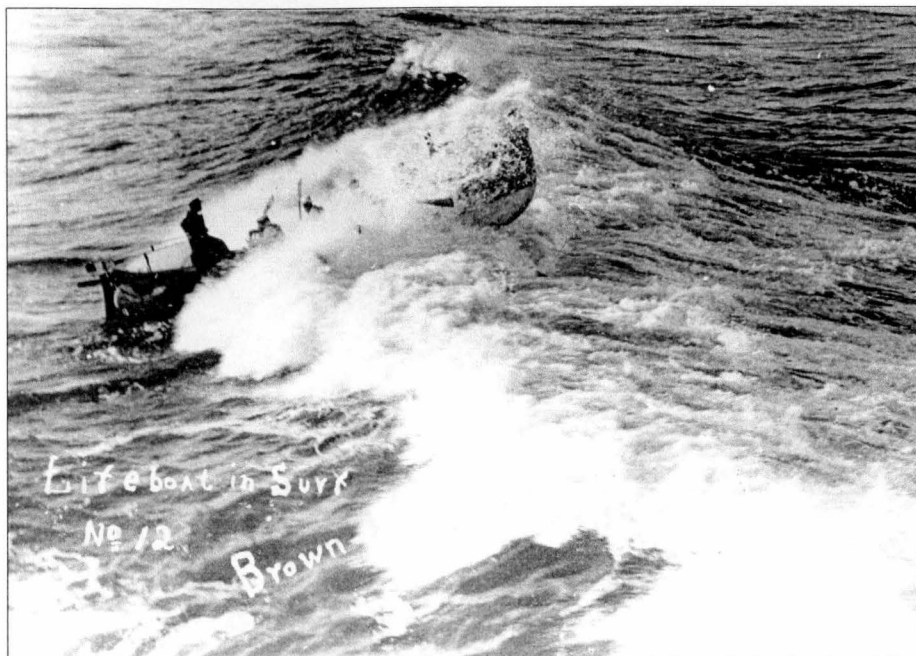
Figure 19. Dobbins Lifeboat at the Coos Bay Bar, 1910. Source: U.S. Coast Guard Headquarters (Life-Saving Service: Surfboats File).

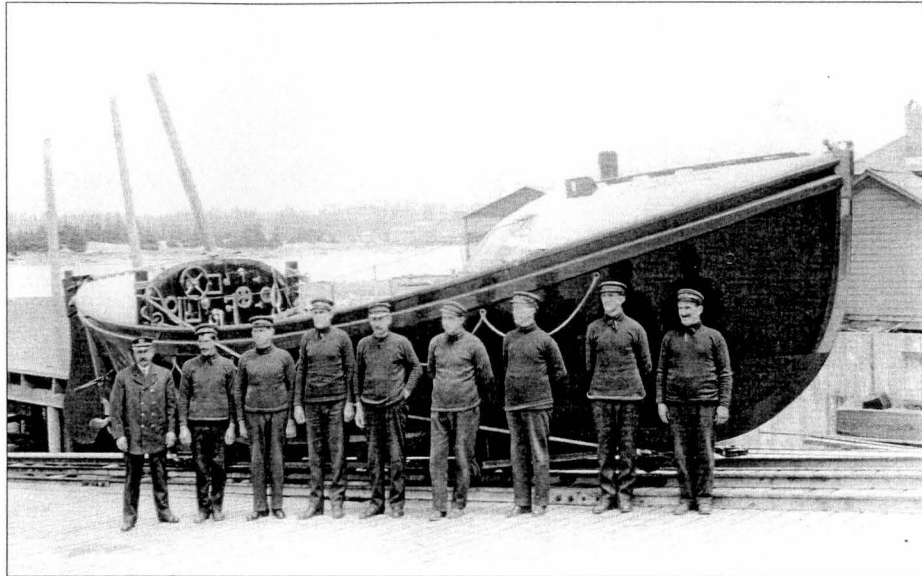
Figure 20. New 36' Motor Lifeboat at Coquille River Lifeboat Station, Circa 1915. Source: Bandon Historical Society.

scene.³⁸ Soon, the 13th district had a higher percentage of motor lifeboats in use than any other district in the country (Figure 20). By 1914, there were 147 motor lifeboats and surfboats in service.³⁹

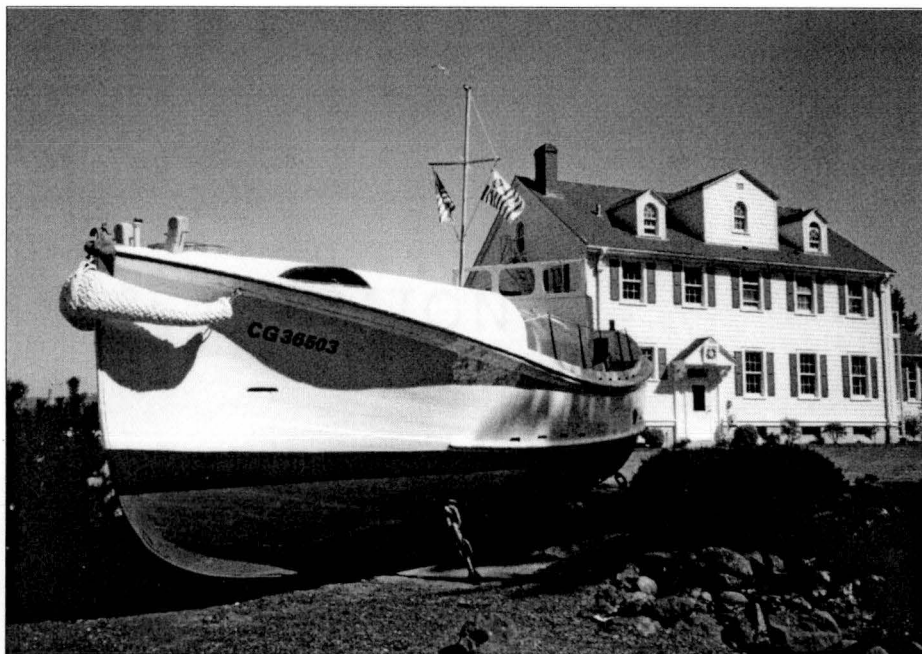
Figure 21. Motor Lifeboat Display at the Yaquina Bay Lifeboat Station, 1999. Source: Author.

The 36' motor lifeboats went through many incarnations throughout their long history. The boat was an extremely successful design that continued to be produced as late as 1956. The last active 36-footer in America was retired from Depoe Bay, Oregon, in 1987. The boat is now on display in Newport News, Virginia, at the Mariner's Museum.⁴⁰ Tillamook Bay, Yaquina Bay, Umpqua River, and Port Orford all have their 36' motor lifeboats on display near their respective Coast Guard stations (Figure 21).

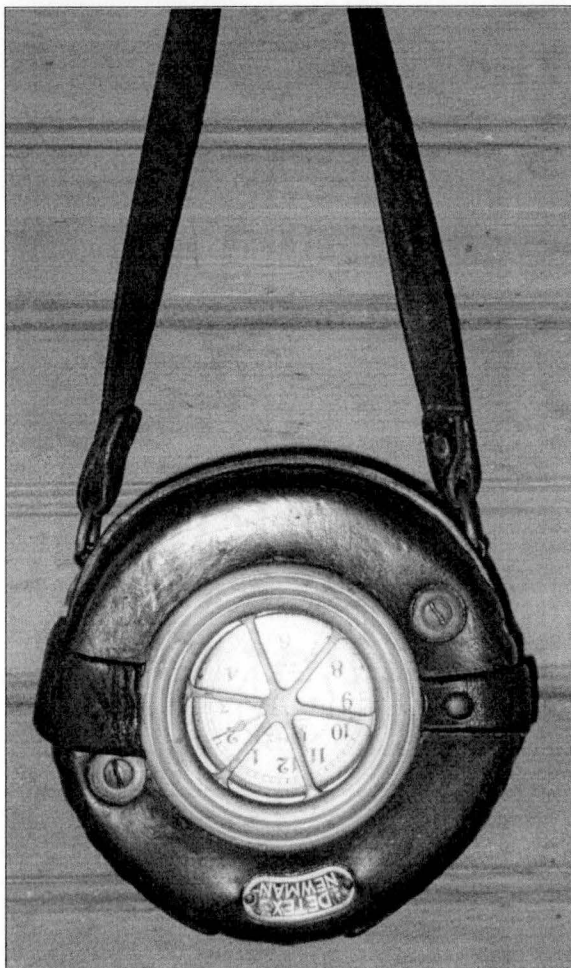
Figure 22. Patrol Clock, Point Allerton, Massachusetts. Source: Author.

patrol and exchange tokens to show that they had completed their assigned “beat.”⁴¹ On the Oregon Coast, since the stations were so isolated, a life-saver would walk until he reached the end of his beat where there would be a post with a key attached. He would insert the key into a patrol clock that he carried (Figure 22), marking the time in which he reached the end of his patrol. If a crewman spotted a ship either too close to shore or aground, he would burn a red Coston flare to either ward off the ship or to signal the ship that help was on the way.

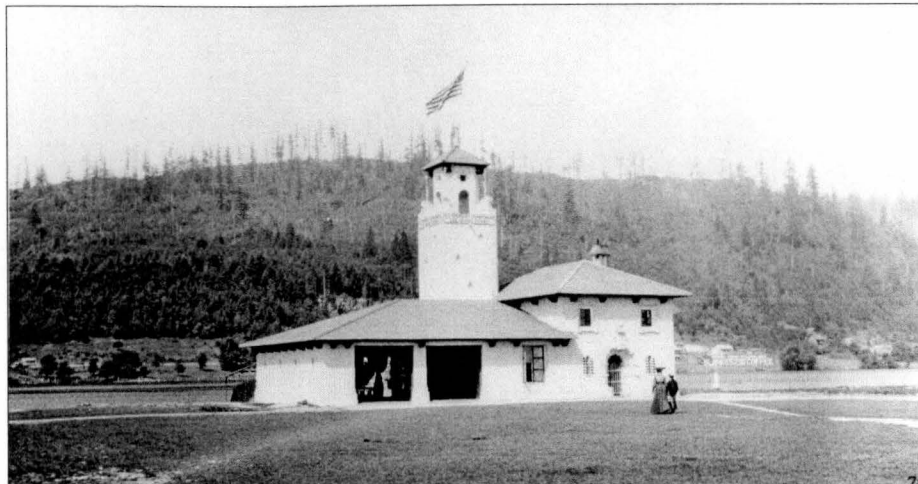
Figure 25. Life-Saving Station at the Lewis and Clark Exposition, 1905. Source: Oregon Historical Society (OrHi #9999Y397-79867).

At Oregon’s Lewis and Clark Centennial Exposition held in Portland in 1905, there was a life-saving station (Figure 25). A keeper and a crew of eight manned the station from May through October and mounted daily exhibitions (Figure 26). Located on an island in the middle of Guild Lake, sharing space with the U.S. Government Building, the Life-Saving Station continued the Spanish Colonial architectural theme of the island. During its 4-1/2 month run, more than 2.5 million people attended the

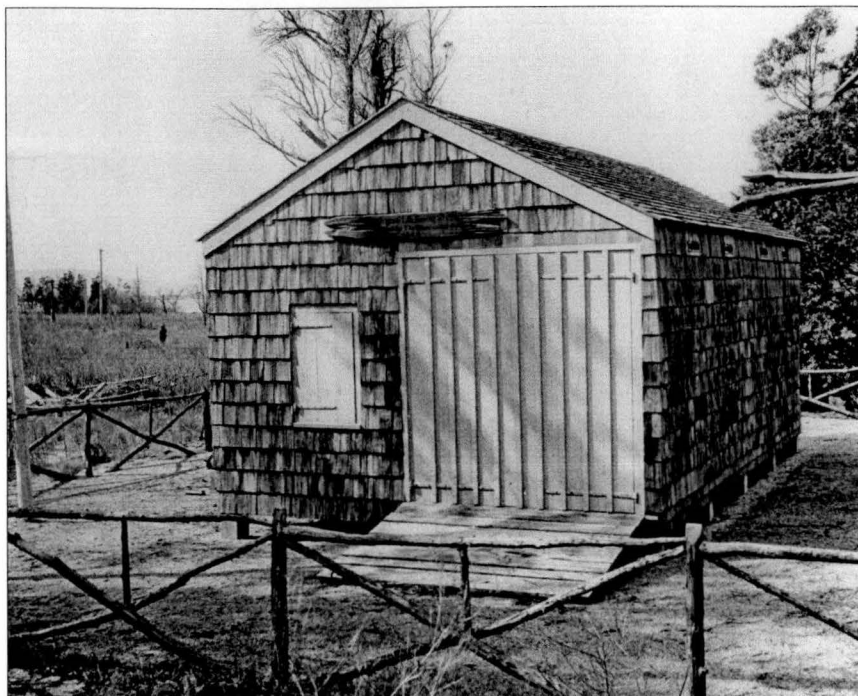
Figure 32. Spermaceti Cove, New Jersey, Boathouse (1848) in 1926. Source: U.S. Coast Guard Headquarters (Life-Saving Service: Stations and Architecture File).

The first federally-funded stations were constructed in 1848 when Congress appropriated \$10,000 for eight boathouses along the New Jersey shore. These unmanned and unkept stations were simple, one-story, gabled boathouses, 16' wide by 28' deep (Figure 32). They were surfaced in shingles and were probably very similar to the lifeboat stations built by the Massachusetts Humane Society.

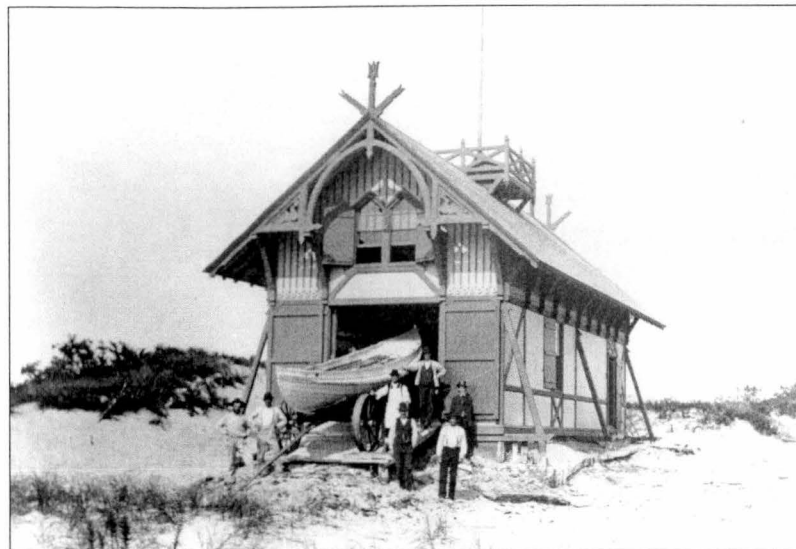
Figure 33. Plum Island Life-Saving Station (Chandler, 1873-74), Massachusetts, an 1874-Type Station. Source: U.S. Coast Guard Headquarters (Life-Saving Service: Stations and Architecture File).

With the Congressional appropriation of \$100,000 in 1873, a new design was developed for the stations. Twenty-three of what have become known as 1874-type stations were built. These were the first stations to employ a recognizable architectural style (Figure 33). The stations were designed in the mode of the Carpenter Gothic and

the Stick Style. Influences from the outdated Carpenter Gothic can be seen in the beaded vertical siding and intricate scroll work in the gable. From the Stick Style came the station's gable stick work, brackets and half-timbering to represent the structural elements of the building. Disregarding the detailing, the station design was much the same as the Red House stations from 1871 in size and layout. A lookout platform was added to the roof with an internal ladder to reach it.

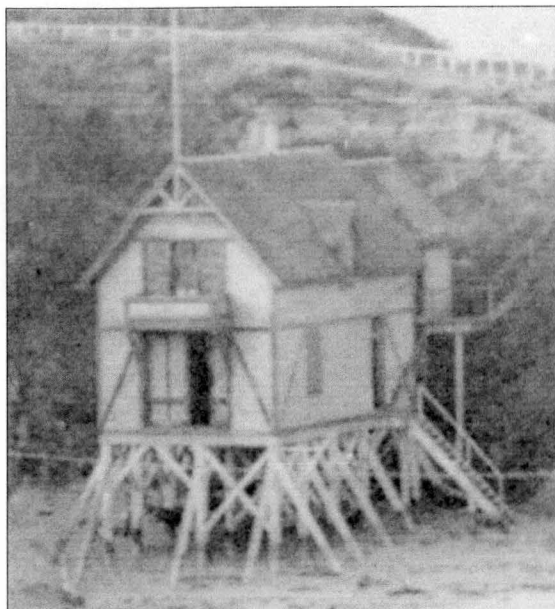
Figure 34. Cape Arago Life-Saving Station (Chandler, 1878), a Modified 1875-Type Station. Source: U.S. Coast Guard Headquarters (Life-Saving Service Photos: Personnel File).

second floor was divided into a large room at the front, a store room at the middle, and two bedrooms in the back. At least 16 of the 1875-type stations were built on the Atlantic and Great Lake coasts. For Oregon, Washington, and California, a modified version was drawn which altered some of the detailing, eliminated the lookout tower, and added dormers. This is the version that was built at Coos Bay, Oregon, for the Cape Arago Life-Saving Station (Figure 34).⁷⁰

Arago station did not have a lookout tower or platform on its roof but instead substituted a balcony above the boatroom doors. This balcony can be found on the 1875-type clipped gable stations, but the Cape Arago Station did not have a clipped gable. The Cape Arago Life-Saving Station is discussed in detail in Chapter IV.

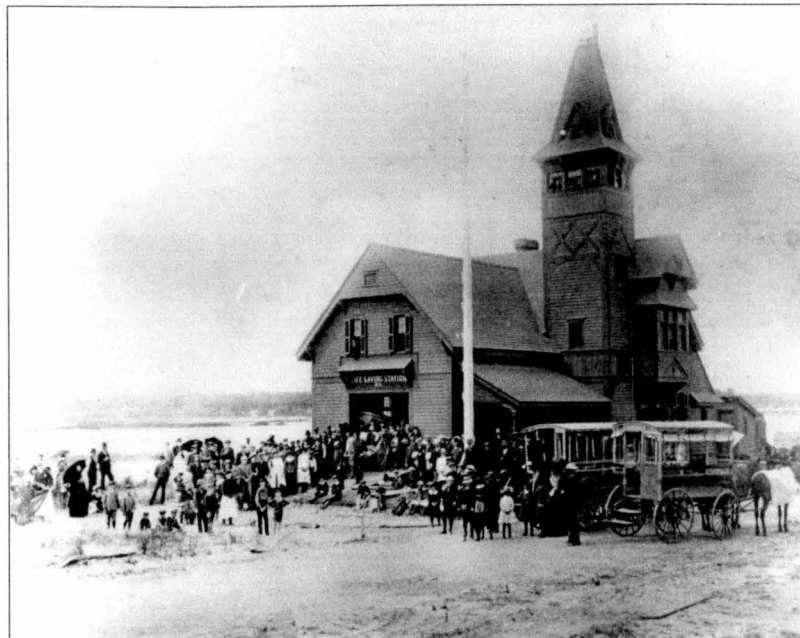
Figure 35. Deal Life-Saving Station (Pelz, 1882-83) in New Jersey. Source: U.S. Coast Guard Headquarters (Life-Saving Service: Stations and Architecture File).

Several high-style stations were designed on commission after the 1882-type station by prominent, independent architects. Paul J. Pelz designed what in 1885 can be only described as passé High Victorian Gothic meets Queen Anne at Deal, New Jersey (Figure 35). This design can be considered the pinnacle of ornateness in Life-Saving Service architecture. Its sister station at Bay Head was featured in the 15 September 1885 issue of *American Architecture and Building News*.⁷⁵

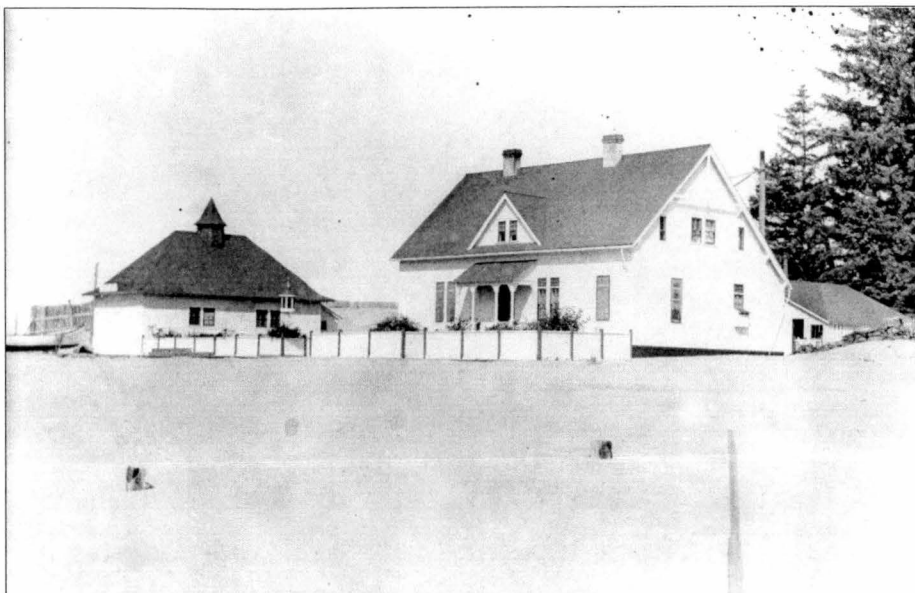
Figure 36. Marquette-Type Dwelling and Fort Point-Type Boathouse at Umpqua River Life-Saving Station (Bibb, 1890) in 1923. Source: U.S. Coast Guard Headquarters (Umpqua River File).

Bibb's last design was the Marquette-type station of which 13 were known to be built. Four of these were built in Oregon, making it the most common Life-Saving Service station type on the Oregon Coast (Figure 36). The Marquette-type was also the first foray into a standard, nationwide architecture, as it was used on the Pacific, Atlantic, and the Great Lakes. Like the Fort Point-type station, the Marquette-type station plan separated the rescue equipment from the living quarters. This type was particularly well-suited for the Oregon Coast where lifeboats were launched directly into the water. The dwelling or station house was symmetrical and rectangular in plan, 50' wide by 30' deep. It was 1-1/2 stories tall and built on wooden piles. The dwelling was clad in horizontal drop siding with wood shingles in the gables. Two large, gabled dormers marked the

front and rear porches. The roof was surfaced with wood shingles. A simple king post in the gable ends was the only elaboration.

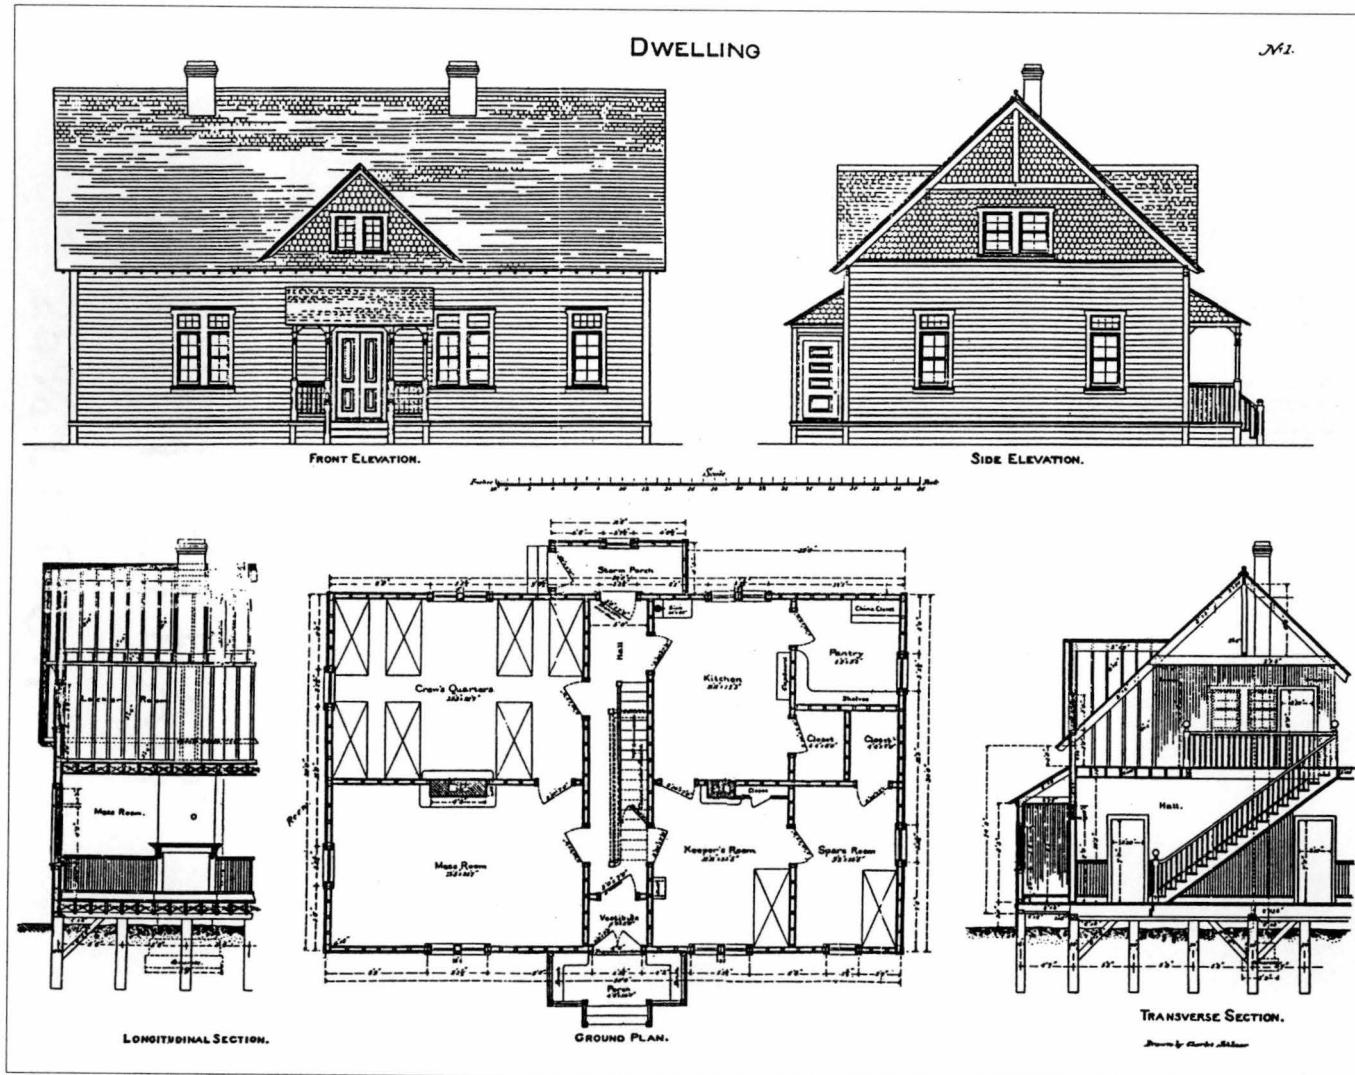
Figure 37. Marquette-Type Dwelling Plans. Source: Wick York.

The Marquette-type station house was divided by a central hallway and stair with the right half reserved for the keeper and the left half for the crew (Figure 37). On the main floor, the keeper's living room, office, kitchen and pantry were to the right. On the left were the crew's quarters and mess room. Upstairs, the right half contained the bedrooms for the keeper and his family. On the left was the crew's locker room. There was no bathroom within the station house, though there was a bath house included on the grounds. At the Yaquina Bay Life-Saving Station, the crew's quarters became the crew's kitchen, and the crew's locker room became their quarters. It must be kept in mind that

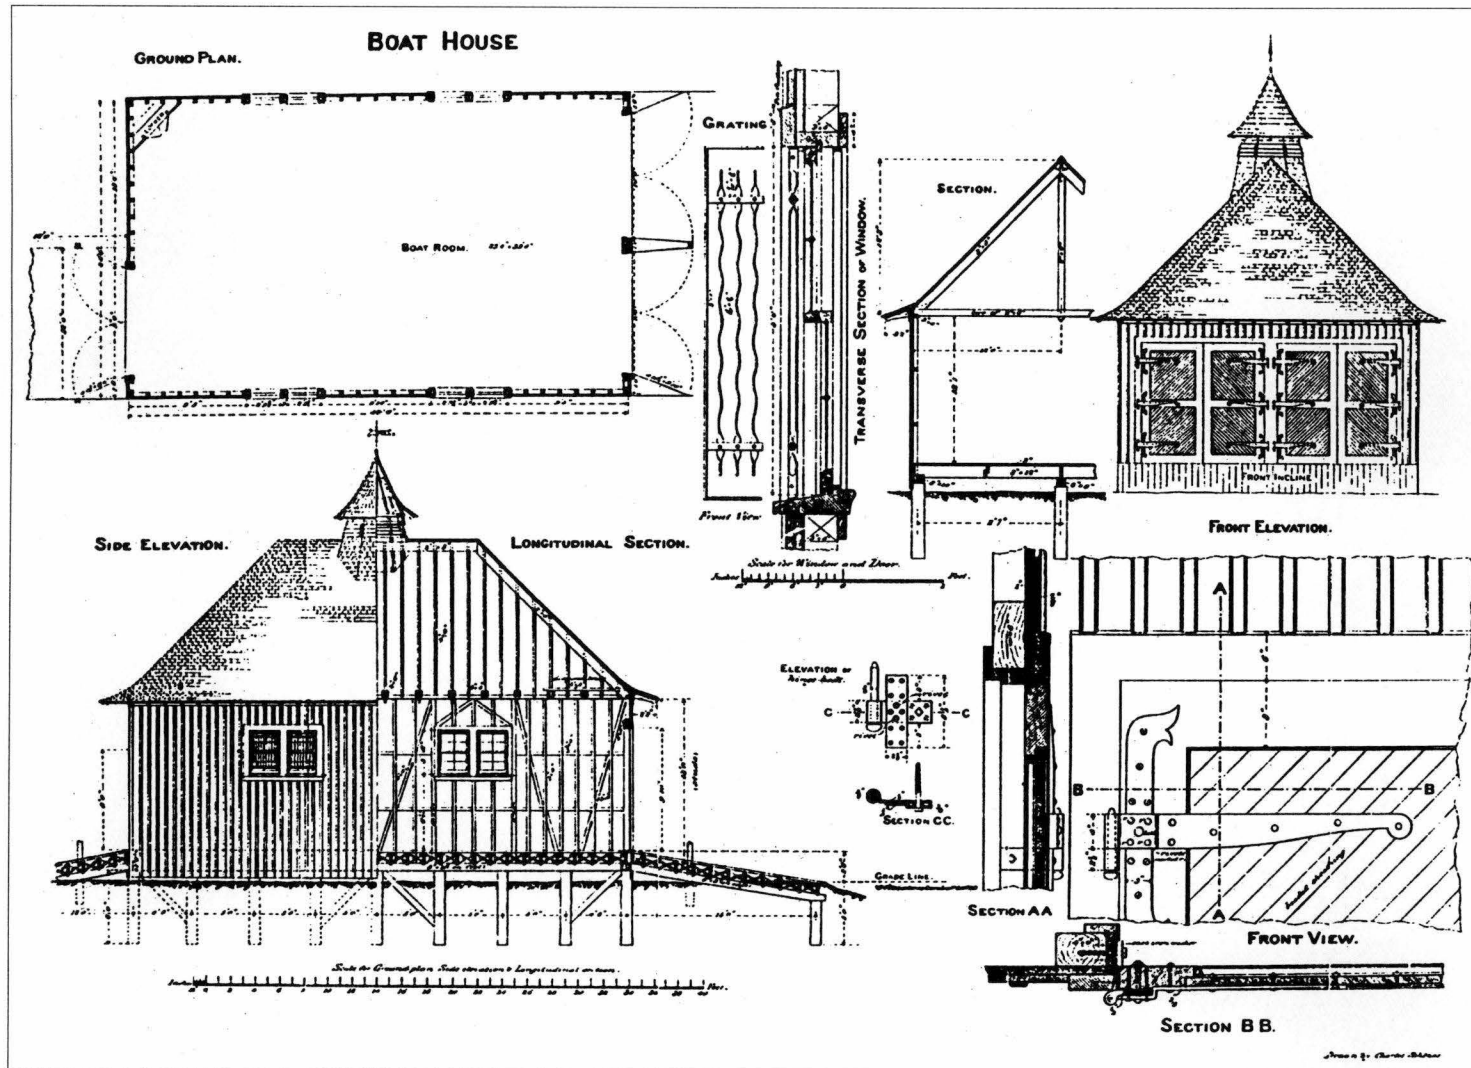
Figure 38. Fort Point-Type Boathouse Plans. Source: Nautical Research Centre (#3-451).

The Marquette-type station continued the new concept of separating the boathouse from the living quarters. All but two of the Marquette stations were built on the Great Lakes and Pacific Coast, suggesting that an integrated boathouse was preferred only on the East Coast. The standard Fort Point-type boathouse plan was recycled and used at all of the Marquette-type stations in Oregon. The boathouse was one story and rectangular in plan, 24' wide by 40' deep (Figure 38). The structure was built on piles and capped by a hip roof. The distinctive feature of a Fort Point boathouse was its "witch's hat" ventilator named for its trademark shape. Allowing in light and increasing the ventilation of the area were two sets of paired, double-hung windows on either side of the boathouse. Paired double doors on the front each led to a bay on the inside, one bay containing a surfboat and the other a lifeboat. The rafters were used to hang equipment such as the lifecar and breeches buoy. A small workbench was situated at the back next to the rear doors. With the beach apparatus cart parked in the bay with the surfboat, the space was fairly cramped (Figure 39).

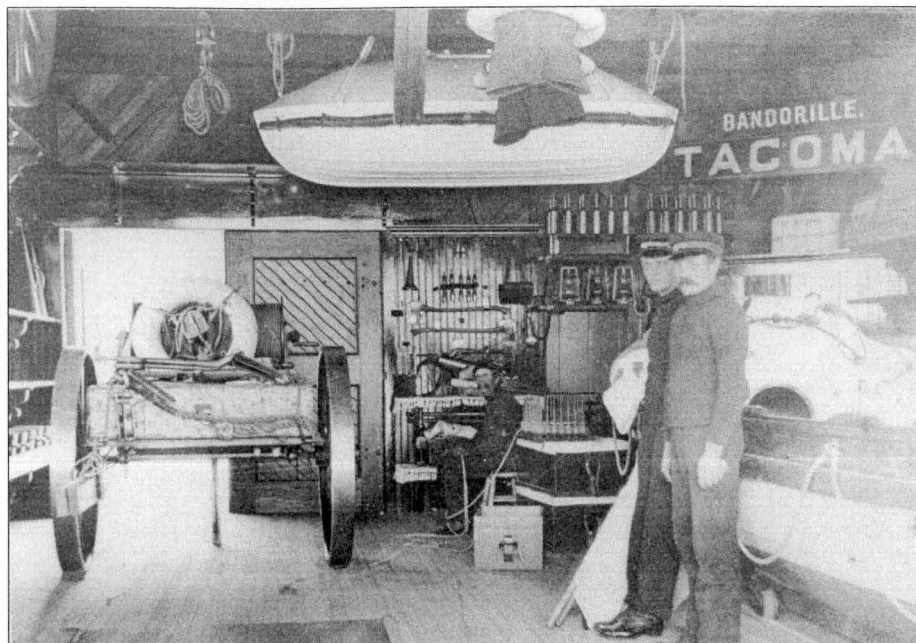
Figure 39. Boathouse Interior, Umpqua River Life-Saving Station, Circa 1900. Source: Lincoln County Historical Society (LCHS #355).

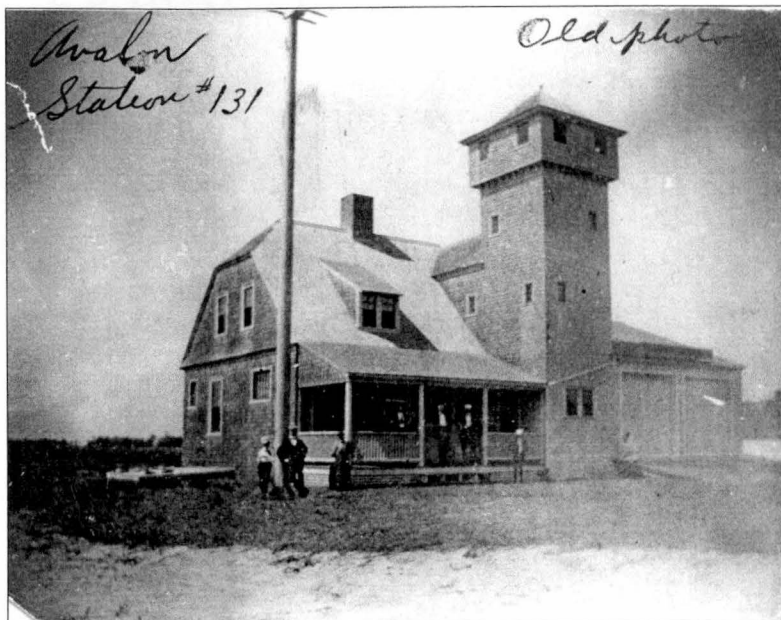
Figure 40. Avalon Life-Saving Station (Tolman, 1894) in New Jersey. Source: U.S. Coast Guard Headquarters (Life-Saving Service: Stations and Architecture File).

Tolman continued to design in the Shingle style, producing two more designs, the Niagara-type and the Duluth-type, and a sole one-of-a-kind station. The Niagara was similar to the Quonochontaug, but the Duluth departed from the norm and provided a large lookout tower (Figure 40). At least 54 of Tolman's station designs were built, plus a modified version of his Quonochontaug plan was constructed for the World's Columbian Exposition at Chicago in 1893.

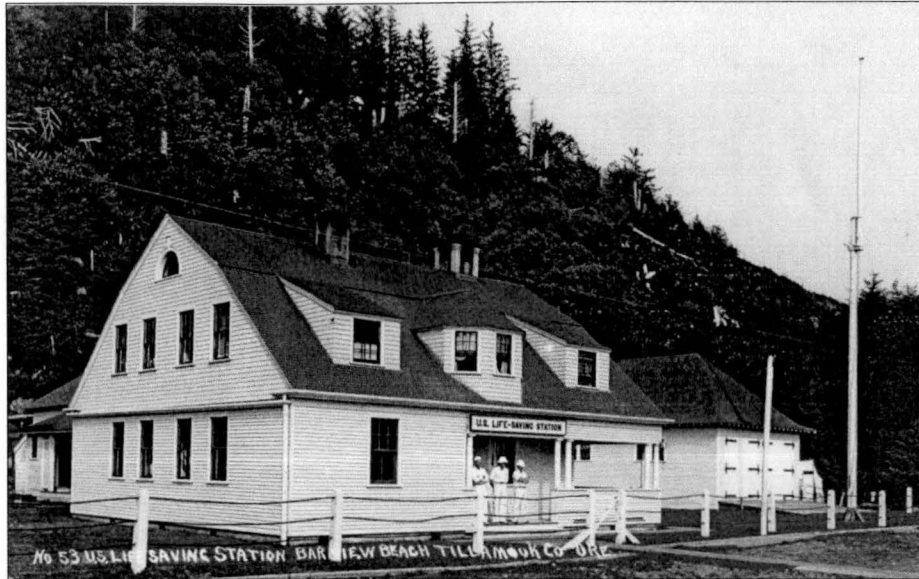
Figure 41. Tillamook Bay Life-Saving Station (Mendleheff, 1908) at Barview, Oregon, Circa 1913. Source: Author's Collection.

for the Service the longest.⁷⁷ Mendleheff started out by designing the Petersons Point-type station, one of which was built on Tillamook Bay, Oregon, at Barview. The station was a gambrel-roof structure, like the Fort Point-type station, but it was much squatter and less symmetrical with an integral porch (Figure 41). It had three dormers, again like the Fort Point-type, but the center one was three-sided to form a diminutive lookout tower. The 1-1/2 story station was sheathed in shingles. Detailing was Colonial Revival with Tuscan columns and lunette windows in the gables. The boathouse was detached. Chapter IX describes the Tillamook Bay Life-Saving Station in detail.
