THE PRESERVATION OF PRE-WORLD WAR TWO
COAST GUARD ARCHITECTURE IN OREGON

A THESIS

Presented to the Interdisciplinary Studies Program:
Historic Preservation
and the Graduate School of the University of Oregon
in partial fulfillment of the requirements
for the degree of
Master of Science

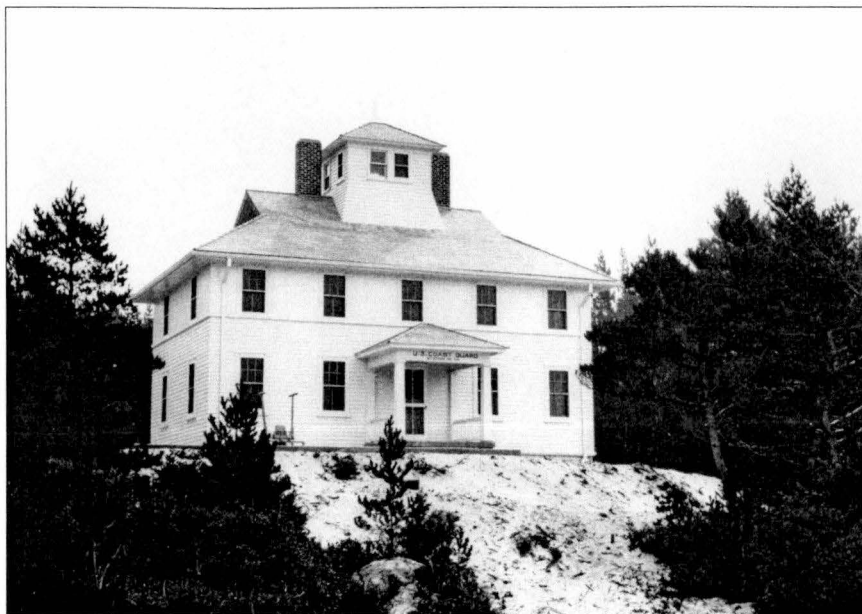
Figure 42. Siuslaw River Lifeboat Station (Mendleheff, 1917) at Florence, Oregon. Source: U.S. Coast Guard Headquarters (Siuslaw River File).

At least 30 of the Chatham-type stations were built, one of which was the Siuslaw River Lifeboat Station (1917) at Florence, Oregon. The station house was symmetrical, 44' wide and 24' deep, clad in shingles, with a hipped gable roof (Figure 42). The roof was frequently surmounted by an integrated lookout tower harkening back to the designs of Chandler in the mid-1870s. The boathouse was detached and enlarged to accommodate the evolution to the larger motor lifeboats and their associated equipment. The Siuslaw River Lifeboat Station is described thoroughly in Chapter X.

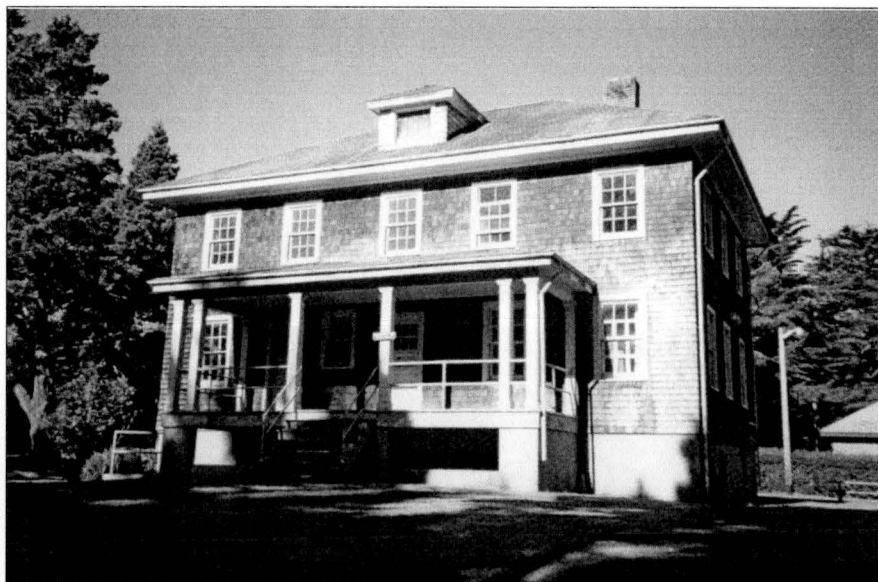
Figure 43. Port Orford Lifeboat Station (1934), Station House, in 1996. Source: Author.

On 28 January 1915, the Life-Saving Service merged with the Revenue Cutter Service to form the Coast Guard. An all-time high of 279 stations were active at the changeover. It is believed that Mendleheff continued on as architect through the transition period to the Coast Guard.⁷⁸ Variations on the Chatham-type station continued to be built through the 1930s.⁷⁹ In 1936, the Port Orford Lifeboat Station was built on a variant of the Chatham plans (Figure 43). The station featured a simpler hipped roof, no cupola, and a dormer on the front and back of the building. It also featured a wider front porch. The Port Orford Lifeboat Station is described in detail in Chapter XI.

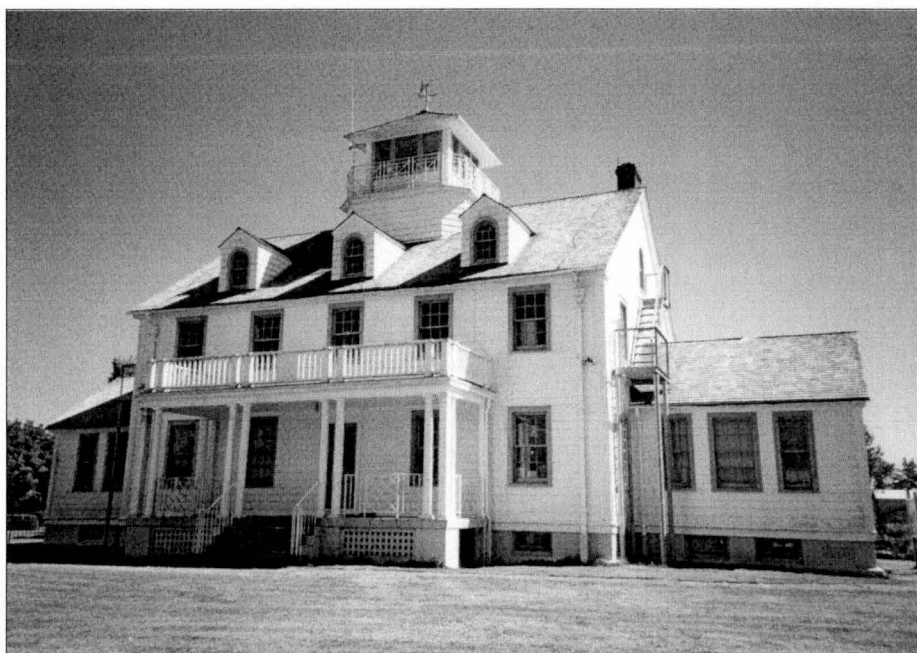
Figure 44. Point Adams Lifeboat Station (1939), Station House, in 1997. Source: Author.

A total of four Roosevelt-type stations were built in Oregon, making it as prolific in Oregon as the Marquette-type of the Life-Saving Service era. At Point Adams, Oregon, there is an early Roosevelt-type station from 1938 (Figure 44). Generally, the construction dates for the Roosevelt-type stations fall within the Franklin Roosevelt's presidency (1933-45). However, at Yaquina Bay, Oregon, the station was built in 1949. The Yaquina Bay Lifeboat Station is considered one of the last Roosevelt-type stations in the nation.⁸¹

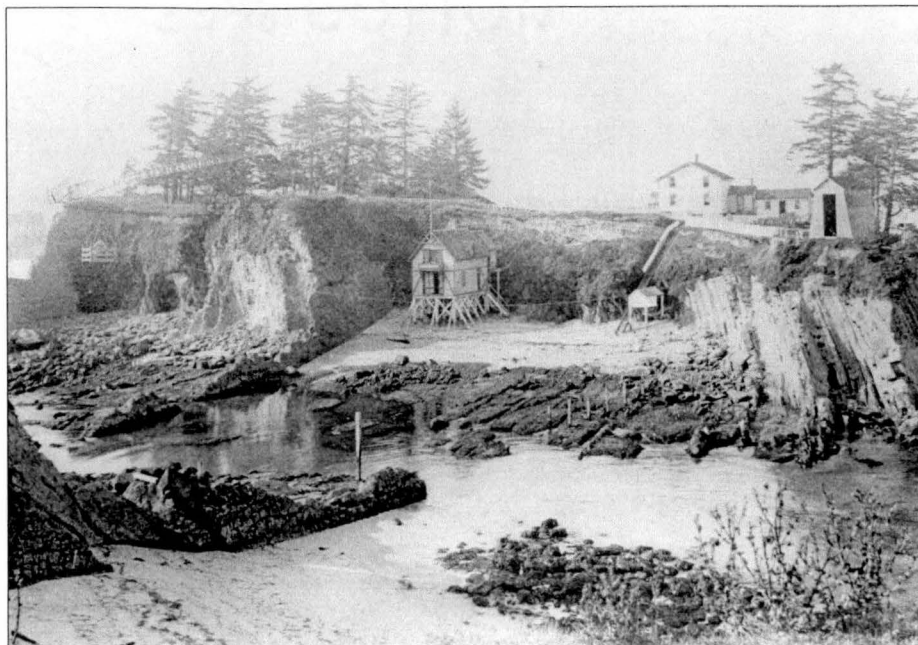
Figure 47. Cape Arago Station, 1885. Source: U.S. Coast Guard Headquarters (Life-Saving Service Photos: Personnel File).

Note the aerial car faintly visible on the left edge of the photo in Figure 47. The car ran out from the mainland to Lighthouse Island where the lighthouse and life-saving

There is a notation on 26 November that Keeper Abbott “effected communication with mainland by means of rigging the Beach Apparatus. . . .” This is likely the aerial car visible in the photo as the photo dates to 1885. A new bridge was built, but it was carried away by “heavy surf” in November 1888.⁹⁴ Maintenance on the structure was such a headache, keepers referred to it as the “Bridge of Sighs.”⁹⁵ The bridge that stands today (Figure 49) linking the mainland to Lighthouse Island is similar but not identical in appearance to the one in the circa 1910 photo (Figure 50). Undoubtedly, the bridge across the channel has been reconstructed several times.

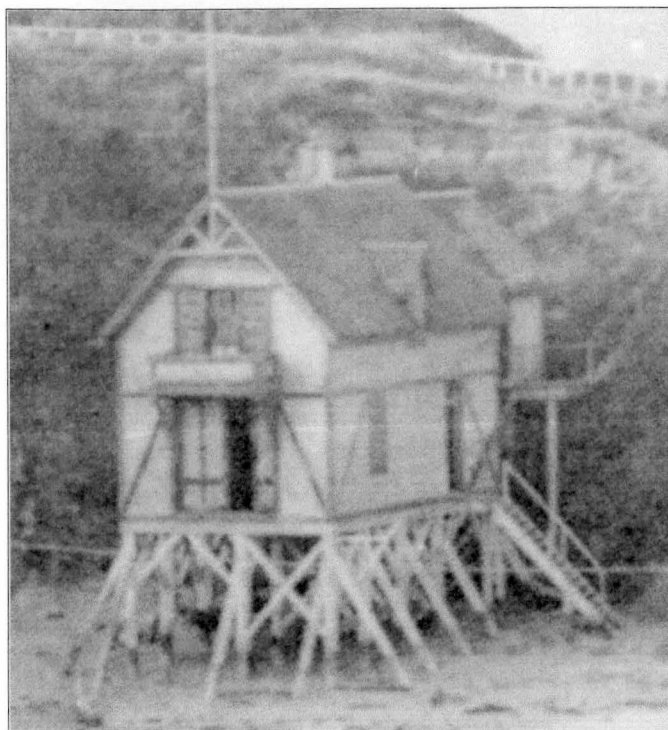
Figure 48. Detail of Cape Arago Station, 1885.
Source: U.S. Coast Guard Headquarters (Life-Saving Service Photos: Personnel File).

As mentioned previously, the Cape Arago Station was a modified version of the 1875-type. In fact it had modifications unseen at any other life-saving station (Figure 48). The Life-Saving Service did build from a standard set of plans, but it was not unusual for builders to make alterations to suit the local materials and conditions. Cape Arago did not have a lookout tower or platform on its roof but instead substituted a

balcony above the boatroom doors. This balcony can be found on the 1875-type clipped gable stations, but the Cape Arago Station did not have a clipped gable. To access the balcony, there was a door flanked by two windows. The 1875-type stations had the window but no door; the 1875-type clipped gable had the door but no windows; the Cape Arago Station had both the windows and the door.

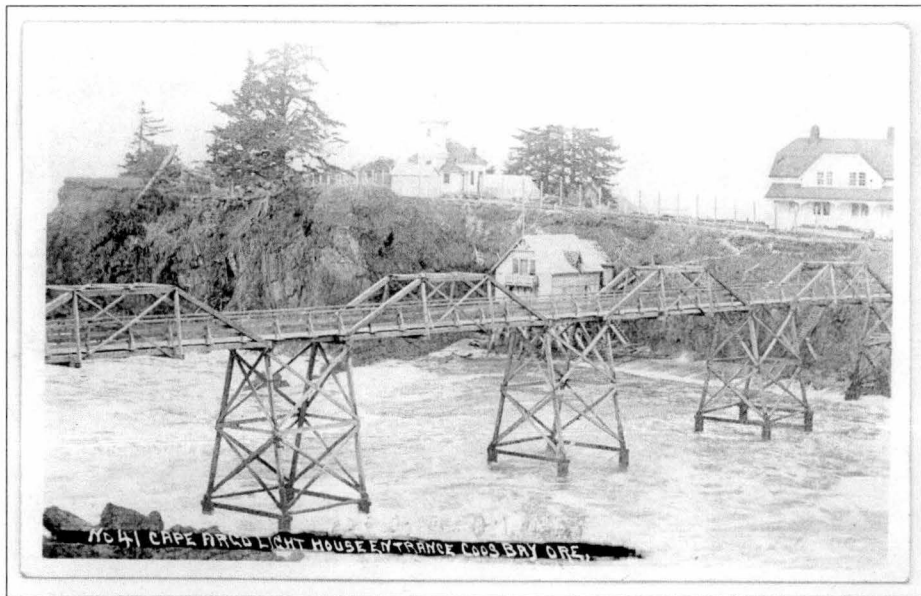
Figure 50. Bridge to Lighthouse Island, Circa 1910. Source: Author's Collection.

The Cape Arago Life-Saving Station was too small to house a crew and it was poorly sited; therefore, the location was abandoned in 1891. The station building continued to show up in the foreground of pictures of the Cape Arago Lighthouse. In the circa 1910 photo (Figure 50), the Cape Arago Life-Saving Station is still there; however, it is badly deteriorated and surrounded by logs. Without maintenance to the structure, the station was doomed to the elements (Figure 51).

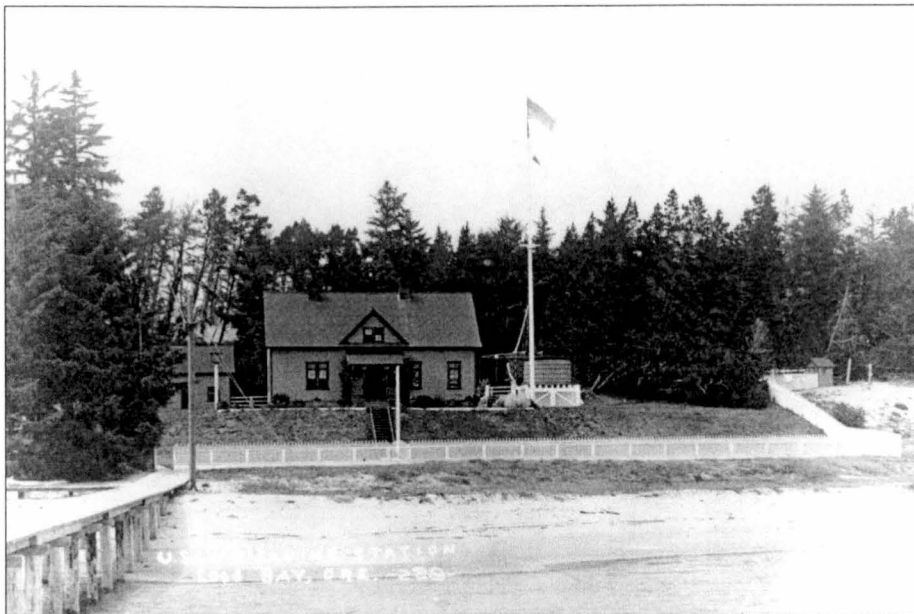
Figure 54. Coos Bay Life-Saving Station at North Spit, circa 1910.
Source: Oregon Historical Society (OrHi #0028P207-006940).

Even though the new station at North Spit was even further away from the land form known as Cape Arago (Figure 52), the station retained the original Cape Arago name and continued to be documented as the Cape Arago Life-Saving Station until mid-1902 when it became known as the Coos Bay Life-Saving Station.⁹⁸ Keeper Hodgson helped in siting the station approximately two miles from the entrance to Coos Bay on the north edge of the bay (Figure 53). The station house was placed on a small rise just off Hungryman Cove (Figure 54).

A pair of water towers were built adjacent to the station house to capture runoff from the roof of the station house. In Figure 54, a washhouse can be seen to the left of the station house. A washhouse was necessary since the station house had no plumbing other than the hand pump to the kitchen sink. In 1892, the crew built a wharf in front of the station constructed of planks found on the beach.¹⁰⁴ During September 1893, the crew built a woodshed.¹⁰⁵ The wreck pole is visible to the left of the group in Figure 55. A tall flag pole rises over the station yard. A post topped by a bell box appears to the left of the station house. During June 1892, the crew built a handsome picket fence around the property.¹⁰⁶

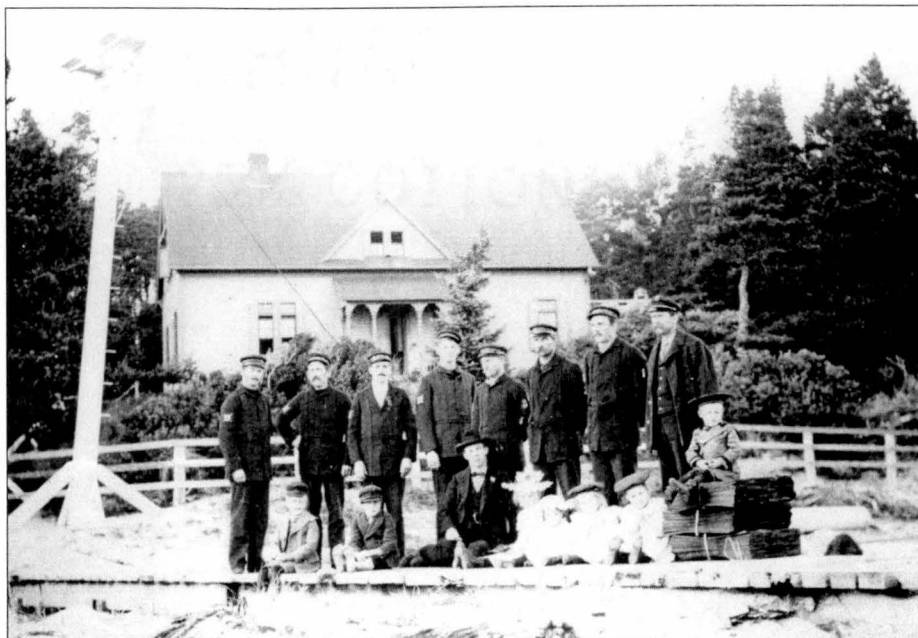
Figure 55. Cape Arago Life-Saving Station at North Spit, 1898.
Source: U.S. Coast Guard Headquarters (Life-Saving Service Photos:
Personnel File).

The station house at North Spit (Figure 55) was built from the standard Marquette plans as described in Chapter III. In general, the house was divided by a central hallway and stair with the right half reserved for the keeper and the left half for the crew. On the main floor, the keeper's living room, office, kitchen, and pantry were to the right. On the left was the crew's living room and quarters. Upstairs, the right half contained bedrooms for the keeper and his family. On the left was the crew's locker room.

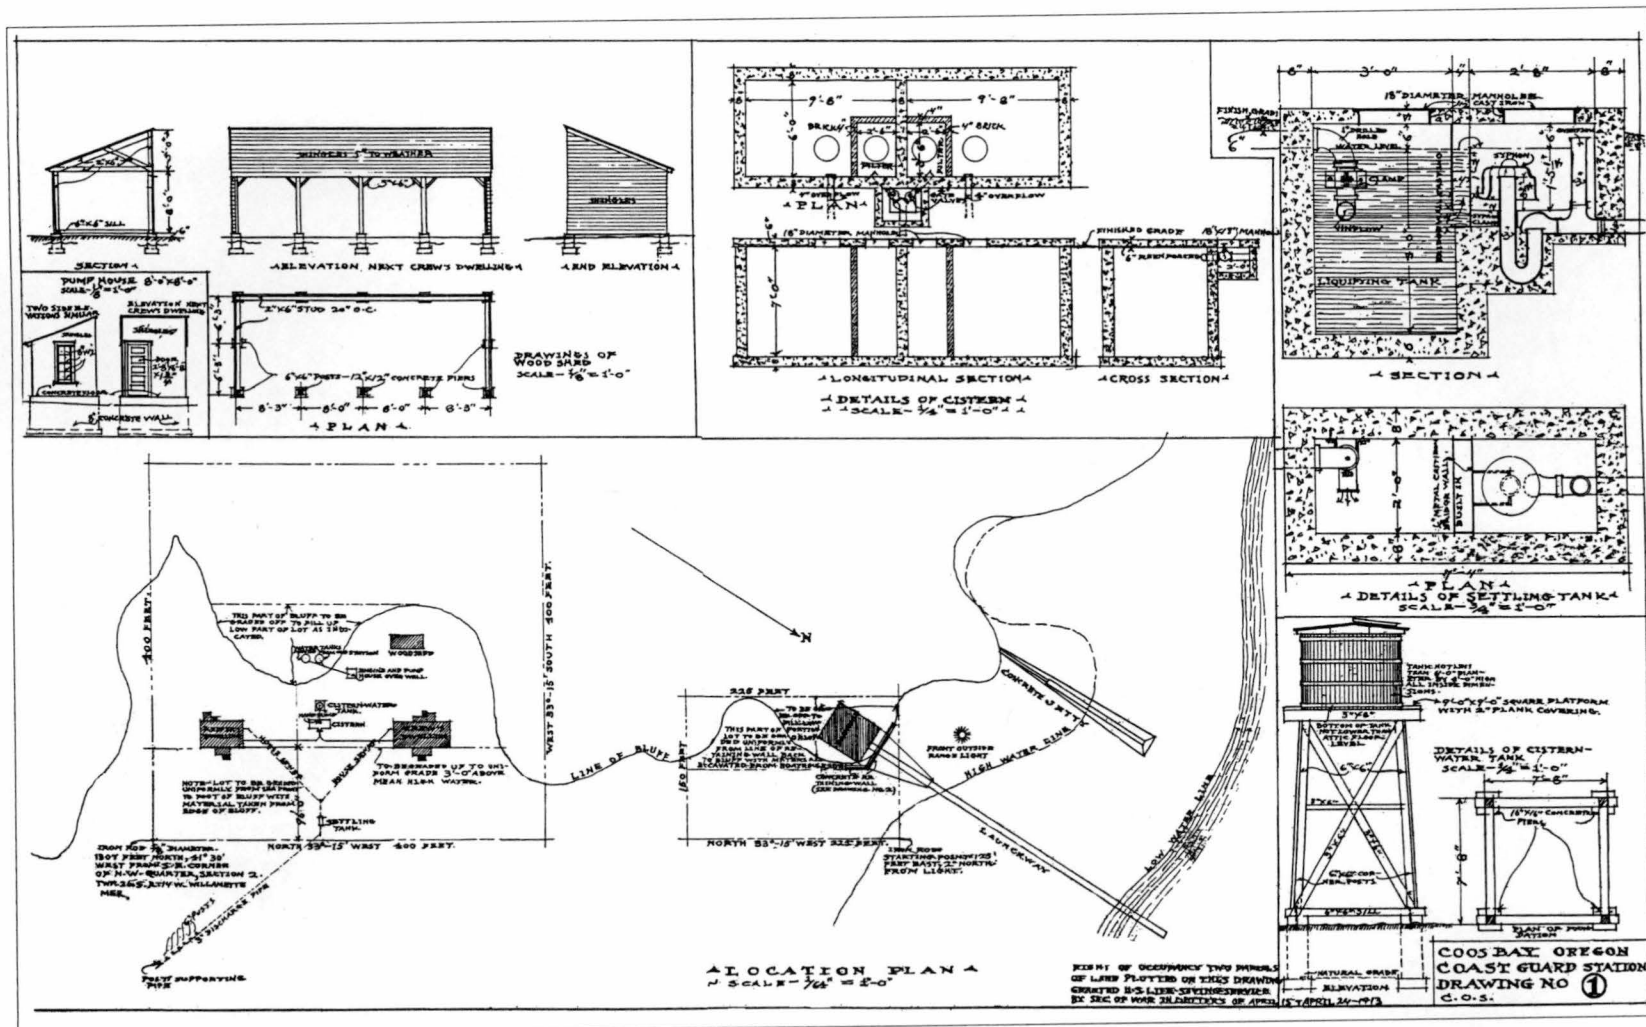
Figure 58. Coos Bay Lifeboat Station, Site Plan, 1915. Source: Oregon Institute of Marine Biology.

It appears structures were built and placed exactly as planned on the site drawing (Figure 58). When compared to period photographs, there appears to be not one variation by the builder (Figure 59). Part of the bluff behind the station was removed to enlarge and level the site. The keeper's dwelling was placed toward the south and the crew's dwelling to the north (left and right, respectively, in Figure 59). A woodshed was placed behind the crew's dwelling (Figure 60). The cistern water tank was positioned between the keeper's dwelling and the crew's dwelling. The tank was served by a pump house between the tank and the woodshed. A sewage settling tank was placed between and forward of the two dwellings. Its discharge pipe led into the bay and is visible in Figure 60 to the upper left. Wooden boardwalks connected the buildings. Sometime between 1917 and 1923, the two water tanks were moved from the old station on North Spit and placed on the carved out shelf on the bluff. By 1923 the entire compound was surrounded by a white picket fence.

The woodshed was a simple building 24' 6" wide by 12' 6" deep with a structure of 6" by 6" posts and sills and 2" by 6" studs. It was placed on 12" by 12" concrete piers and clad in shingles 5" to weather. It survived until at least 1954, but it is gone today. The pump house was 8' by 8' with a shed roof, two windows, and a door. It had a concrete floor and full foundation. The cistern water tank was 6' in diameter and 4' tall and was placed on a structure of 6" by 6" with 3" by 6" bracing, 12' in the air. The structure was 7' 8" square and rested on 16" by 16" concrete piers. The cistern water tank disappeared by 1951, and by 1954, a gabled roof building was built over the cistern, which has also been demolished.

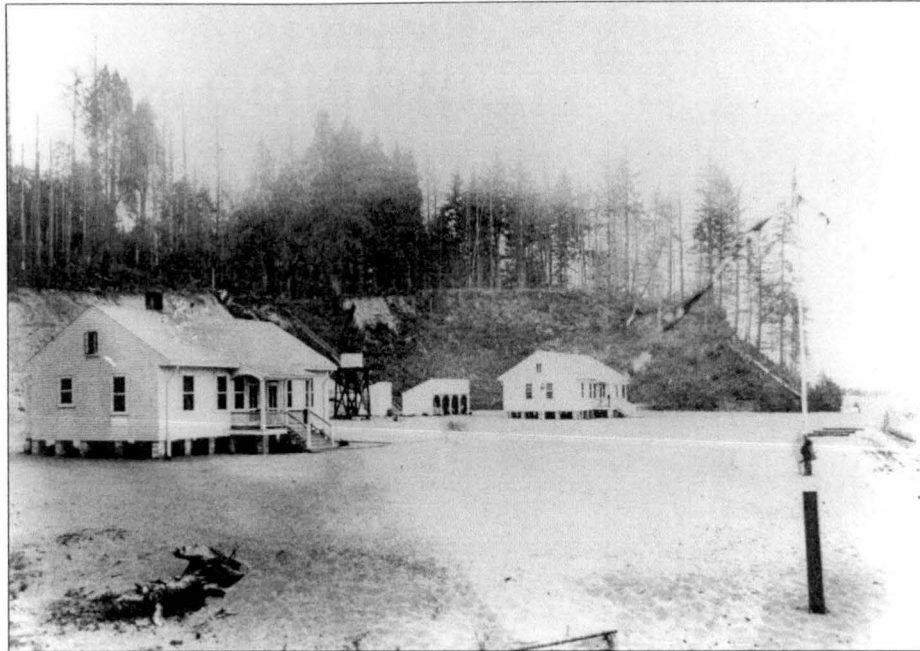
Figure 59. Coos Bay Lifeboat Station, circa 1916. Source: Oregon Historical Society (OrHi #654-A 98320).

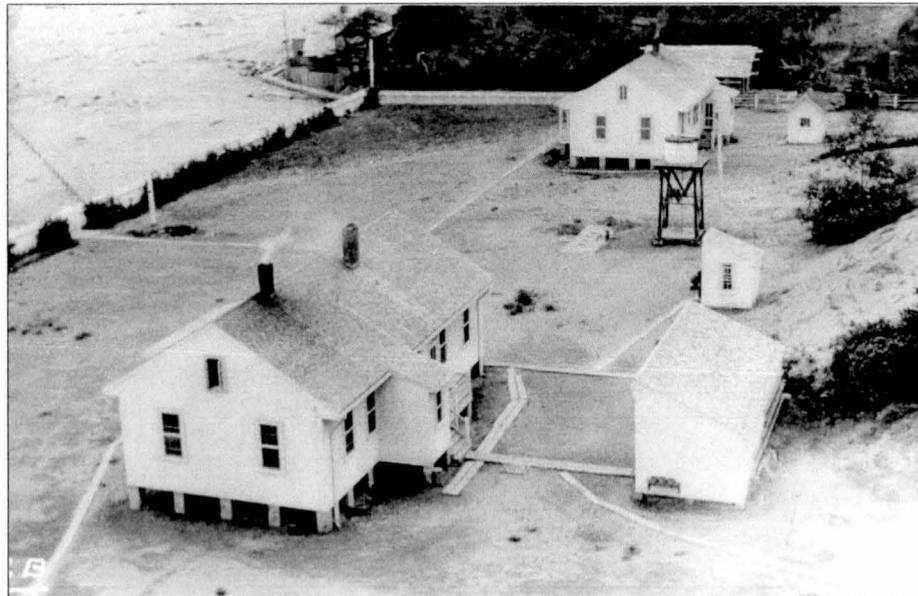
Figure 60. Coos Bay Lifeboat Station, 1923. Source: U.S. Coast Guard Headquarters (Coos Bay File).

left, and one is visible under construction in 1923 in Figure 60. These dwellings have been lost over time, though they may have been moved and recycled elsewhere.

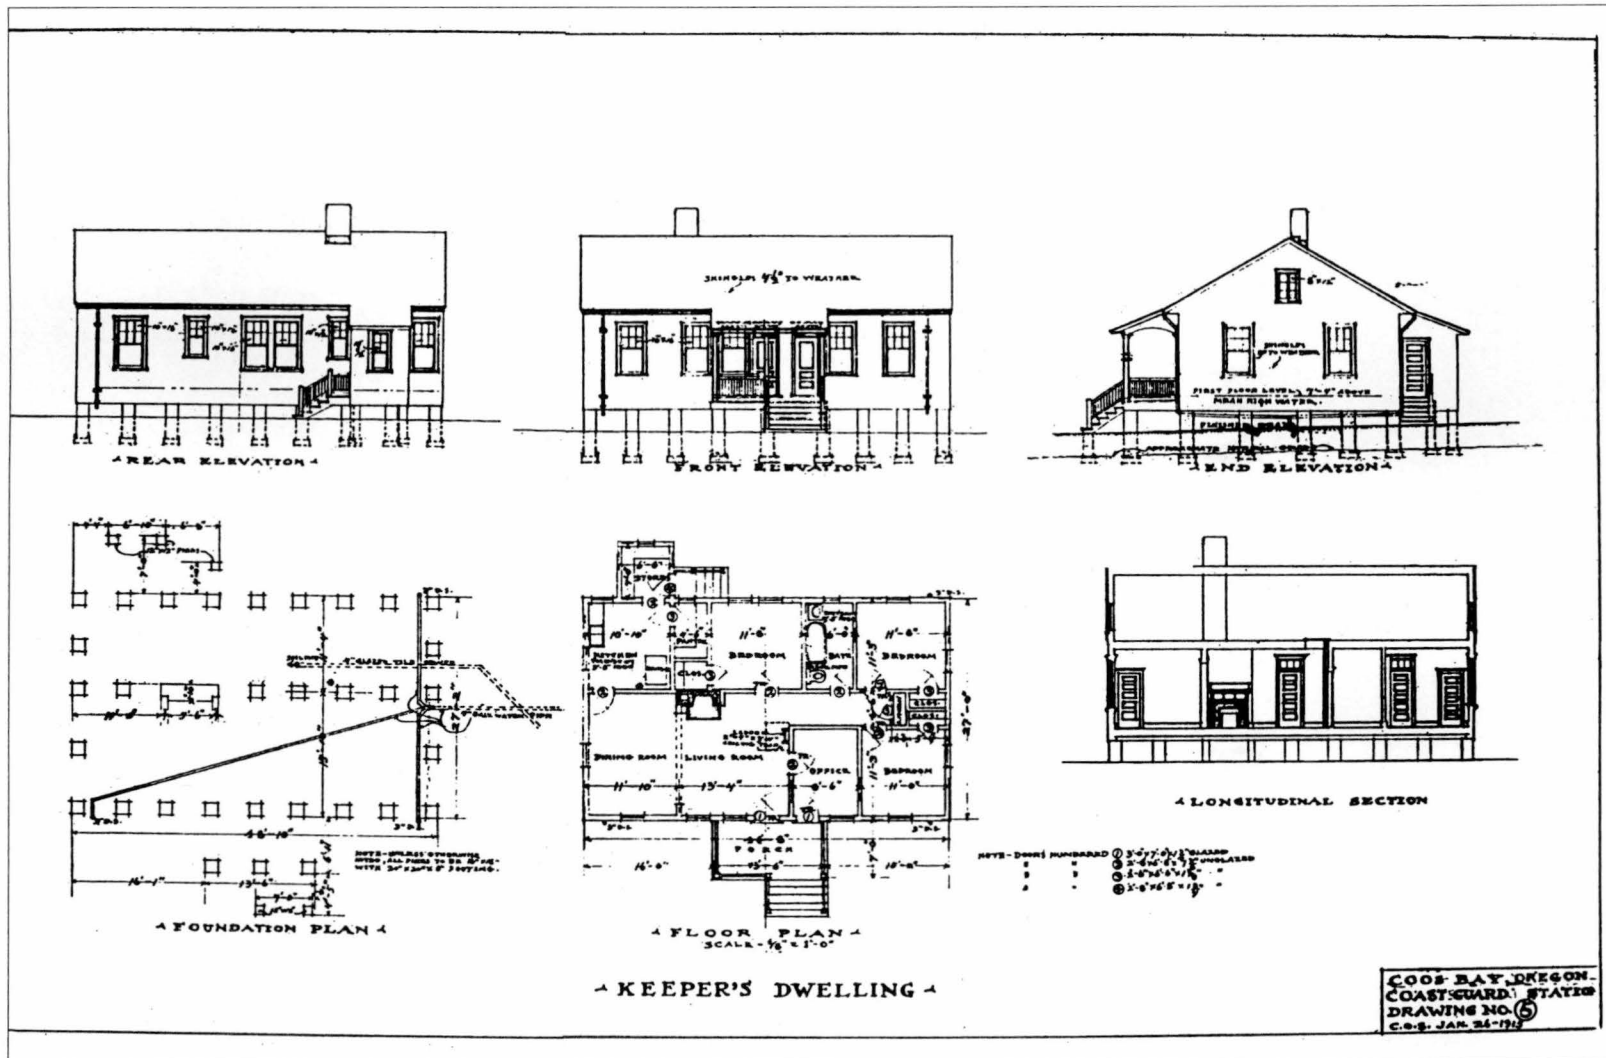
Figure 61. Coos Bay Lifeboat Station, Keeper's Dwelling, 1915. Source: Nautical Research Centre (#3-412).

Fortunately, the keeper's dwelling, the crew's dwelling, and the boathouse have not suffered the same fate as the auxiliary buildings. The keeper's dwelling was a simple gable-roof structure, built on concrete piers. It was 46' 8" wide by 27' 0" deep and had a living room, dining room, kitchen, bathroom, and an office (Figure 61). Windows were double-hung, six-over-one, and the roof and walls were sheathed in shingles. The vestibule on the rear of the keeper's dwelling was enlarged sometime between 1923 and 1939, according to historic photographs.

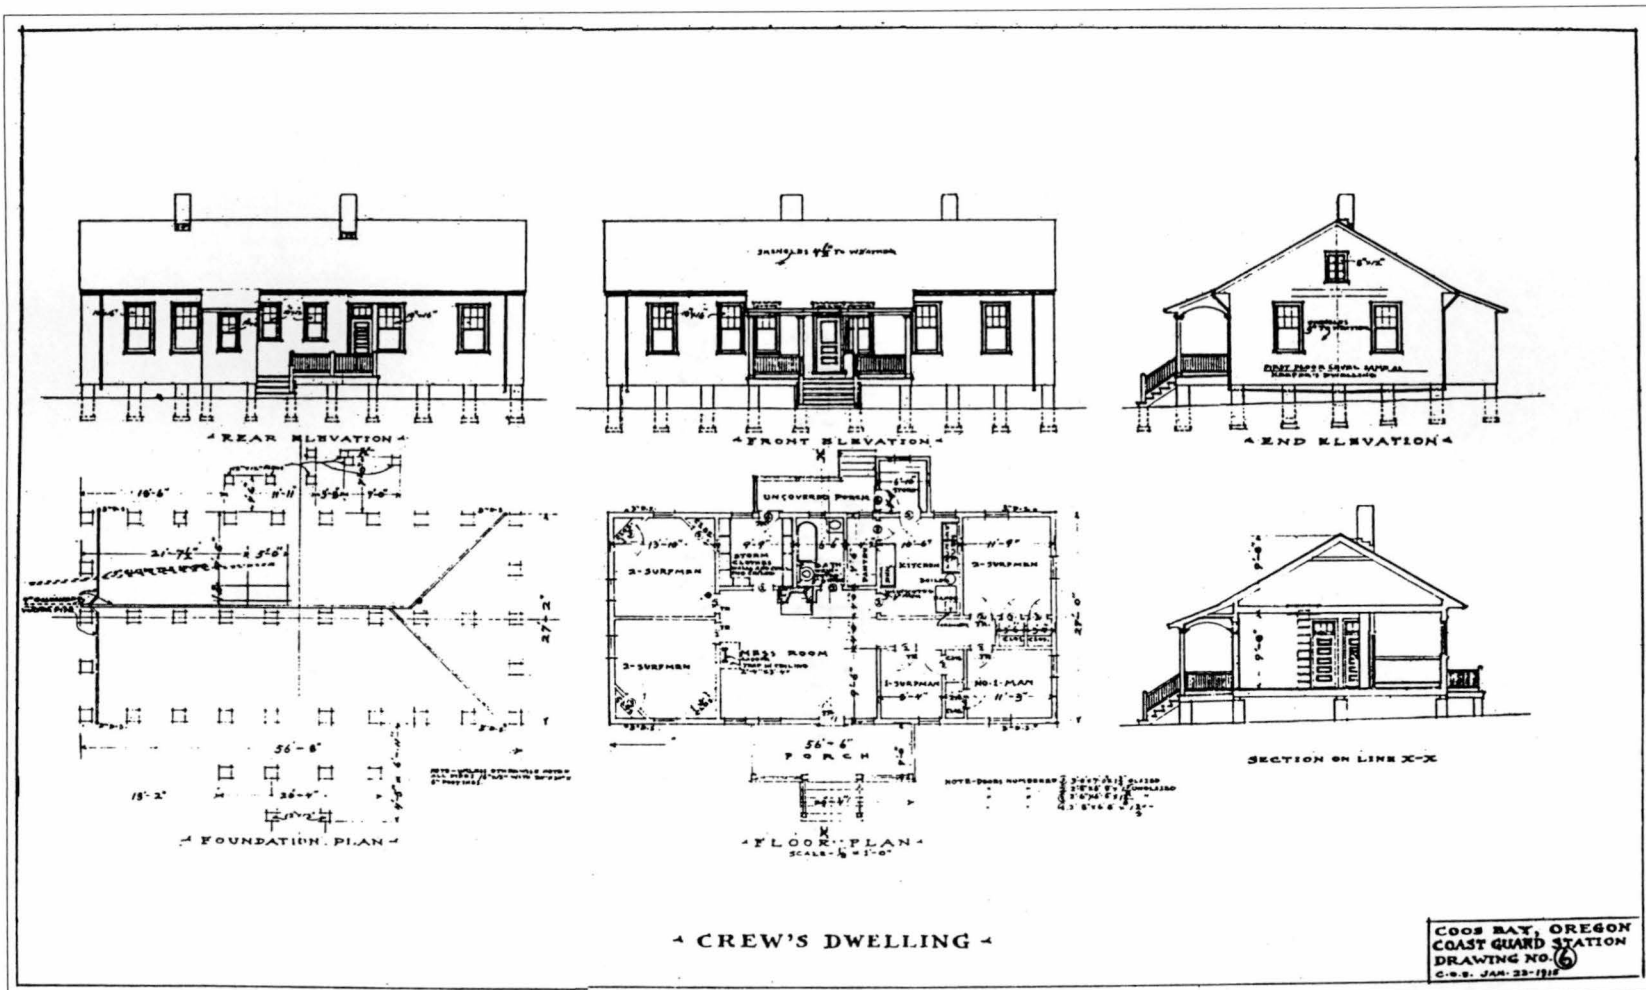
Figure 62. Coos Bay Lifeboat Station, Crew's Dwelling, 1915. Source: Nautical Research Centre (#3-413).

The crew's dwelling was designed in the same simple style as the keeper's dwelling, but was wider across the front at 56' 6" wide by 27' 0" deep (Figure 62). It had three bedrooms for six of the crew members, a single bedroom each for the top two crewmen, a mess room, kitchen, bathroom, and a storm clothes room. Minimal detailing was the same as on the keeper's dwelling.

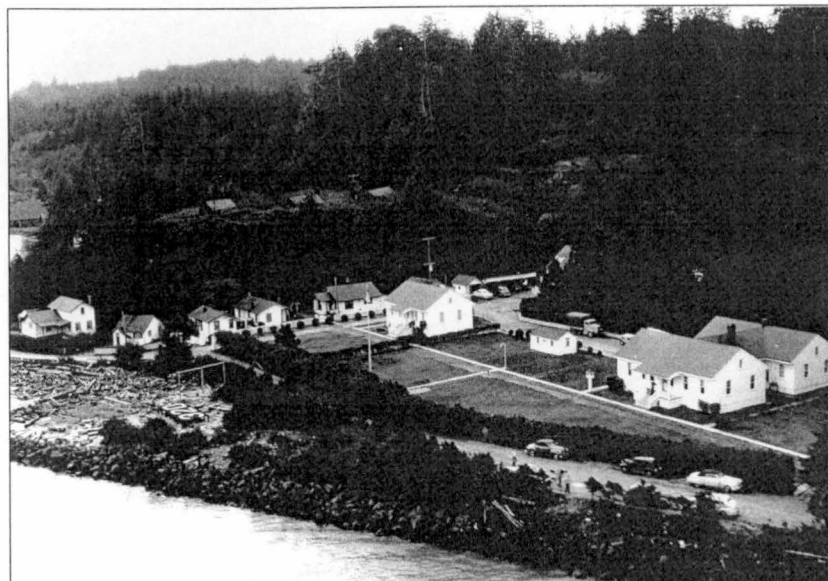
Figure 63. Coos Bay Lifeboat Station, 1954. Source: National Archives (RG 26-CGS, Box 2, Folder Coos Bay).

The crew's dwelling received a substantial addition sometime between 1923 and 1939, according to photographs. During that period, a building approximately identical to the crew's dwelling was built behind and parallel to the crew's dwelling and then connected at the center by a hyphen to create a H-shaped plan (Figure 63). This new "addition" became "the dorm" and the old crew's dwelling became "the office."¹¹¹

It was common practice at stations for married crew members to build houses close to the stations. These small, one-story, gable roof structures are purely vernacular, built with local materials by local carpenters. Five are recognizable in Figure 63 to the

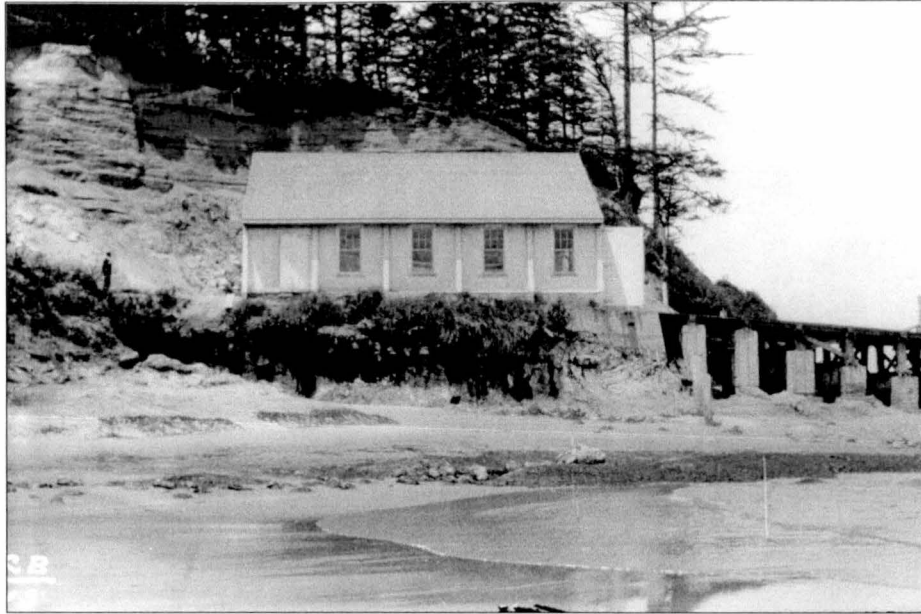
Figure 64. Coos Bay Lifeboat Station, Boathouse, 1923. Source: U.S. Coast Guard Headquarters (Coos Bay File).

The boathouse was as unique as the dwellings for the keeper and crew (Figure 64). The Coos Bay Lifeboat Station boathouse is believed to be the only one built from the plans drawn. The building measured 40' wide by 50' deep and was three-bays wide and five-bays deep (Figure 65). In 1915, the bays stored one 34' motor lifeboat, one Dobbins lifeboat, one Monomoy surfboat, and one Beebe-McLellan surfboat.¹¹² Its distinctive features are the six buttresses on each side of the building, recalling the 1874-type stations with their side buttresses. Like the dwellings for the keeper and crew, the roof and walls of the boathouse were covered in shingles, 4-1/2" to

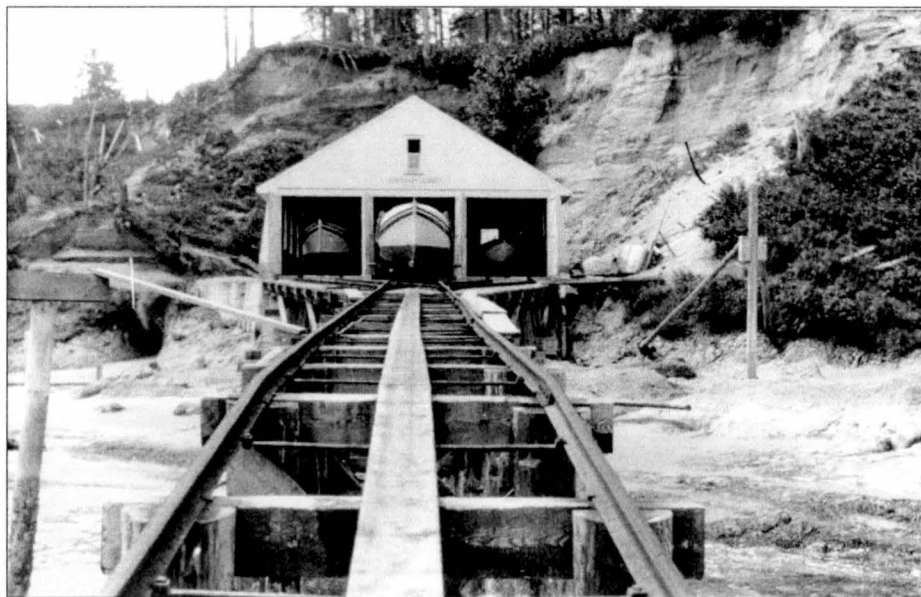
Figure 65. Coos Bay Lifeboat Station, Boathouse Ramp, 1923. Source: U.S. Coast Guard Headquarters (Coos Bay File).

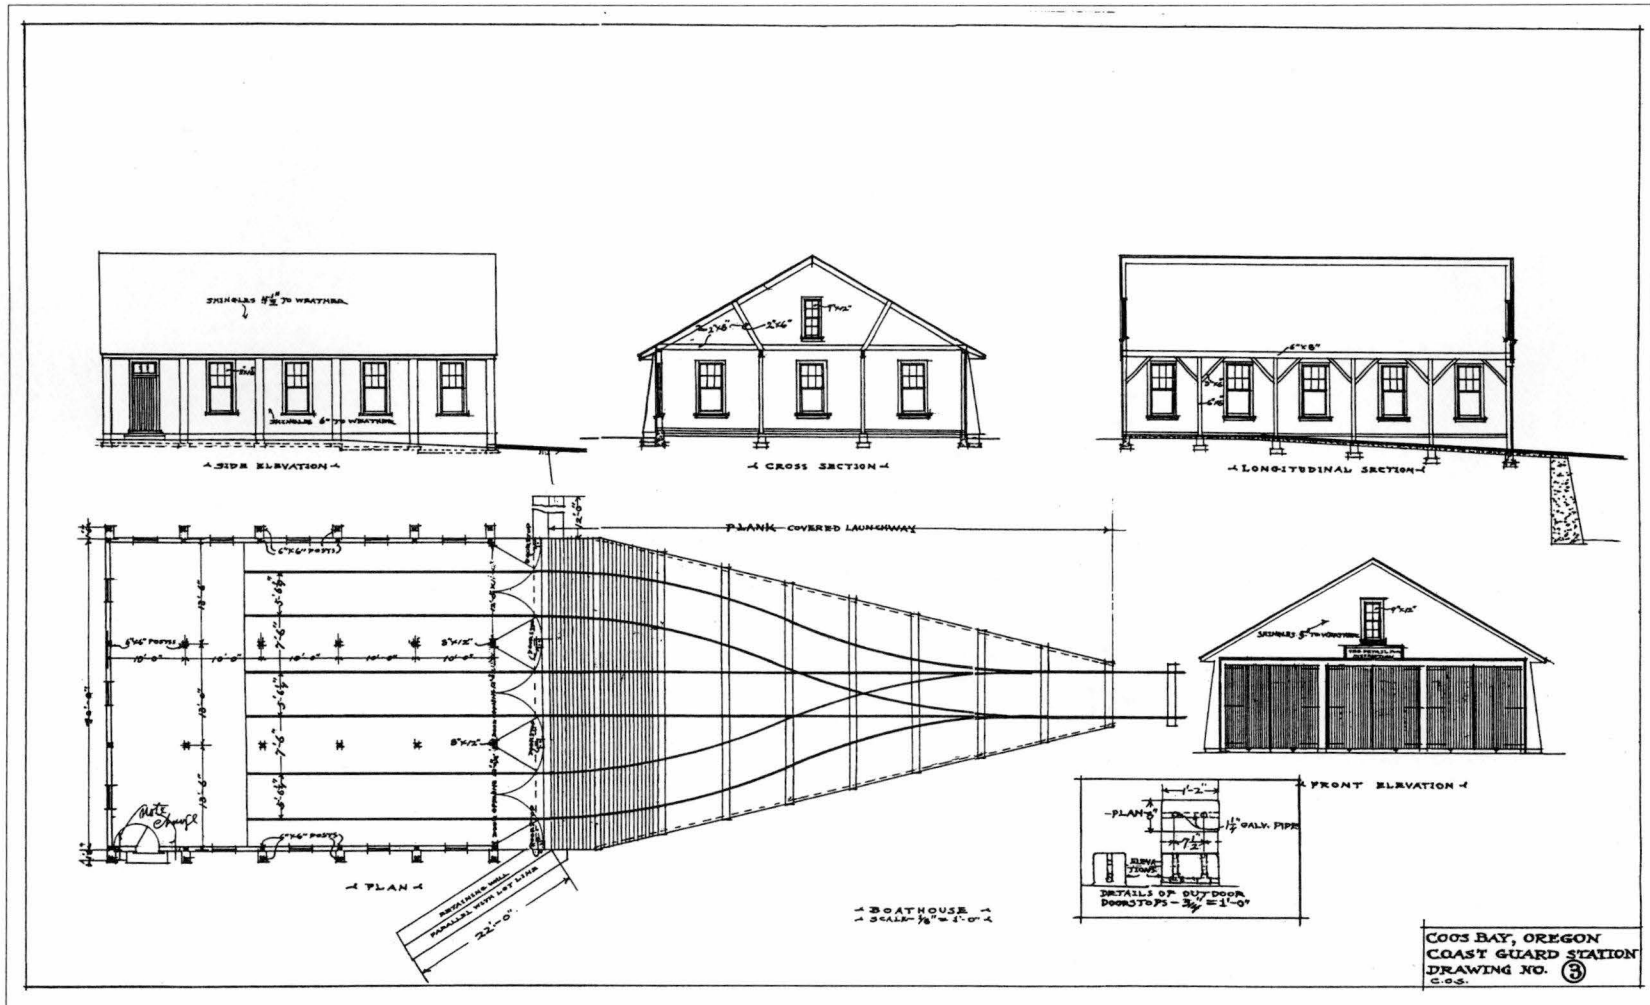
Figure 66. Coos Bay Lifeboat Station, Boathouse Plan, 1915. Source: Oregon Institute of Marine Biology.

weather on the roof, 5" to weather in the gable, and 6" to weather on the walls (Figure 66). Posts were 6" by 6", beams were 6" by 8", and rafters were 2" by 8".

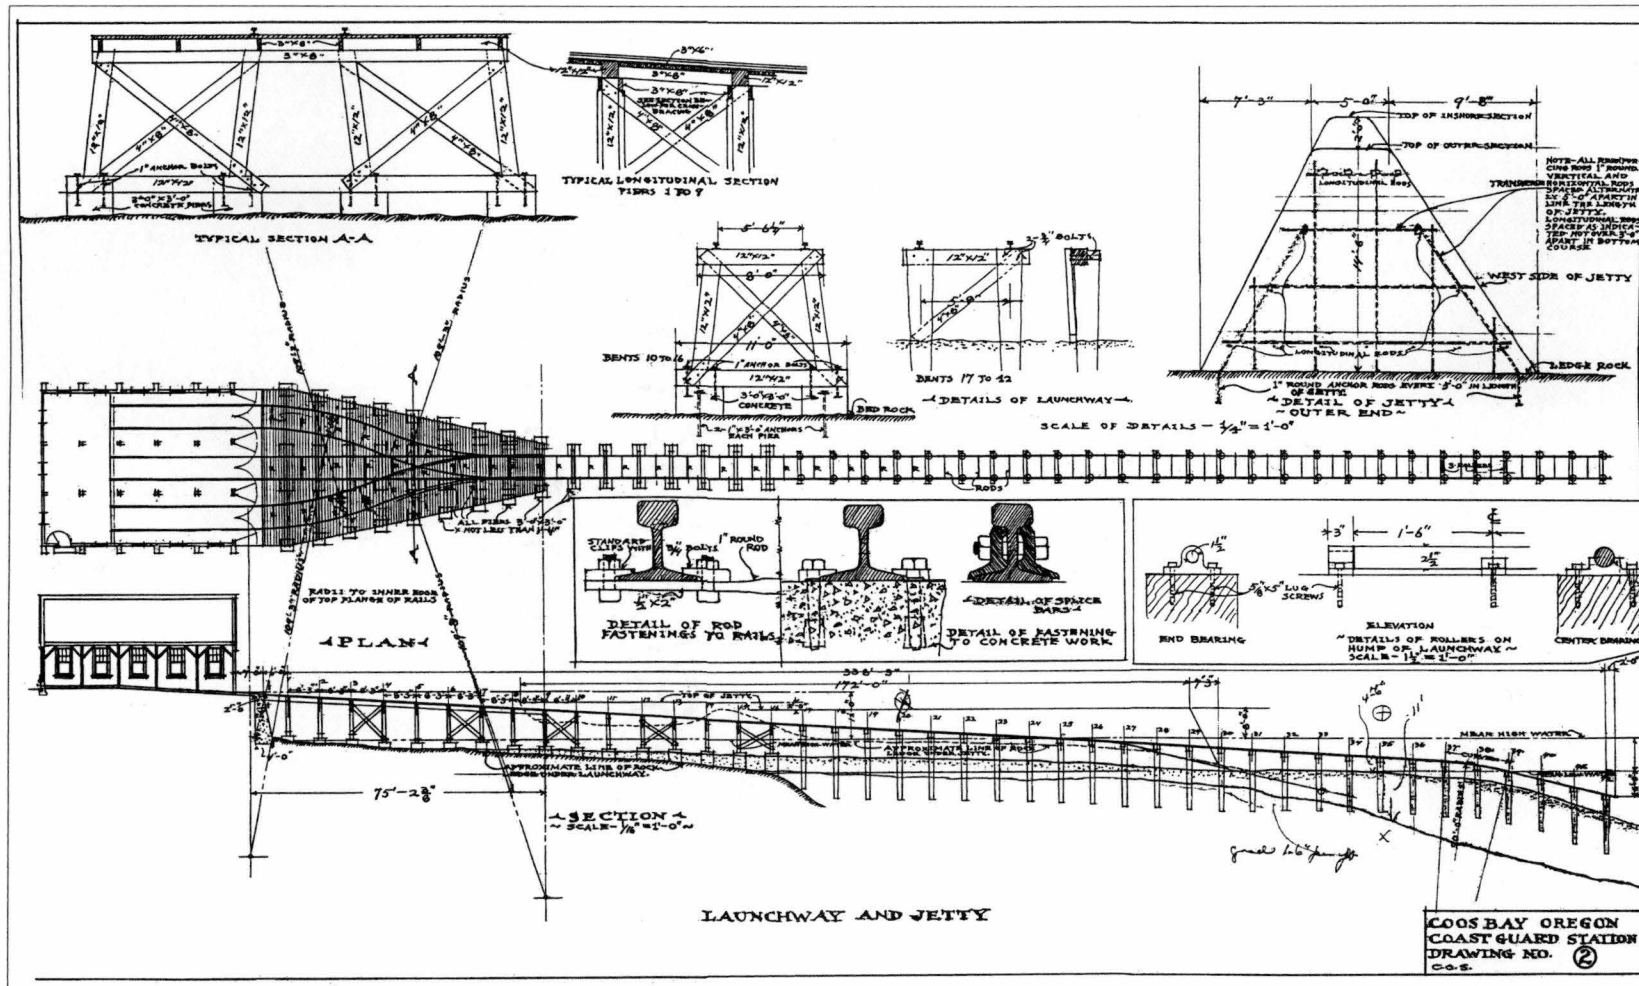
Figure 67. Coos Bay Lifeboat Station, Launchway Plan, 1915. Source: Oregon Institute of Marine Biology.

Extending from the front of the boathouse was the 338' launchway (Figure 67). Only the upper portion of the launchway, where there were three sets of railroad tracks, was covered in planks. This portion was supported by a wooden framework of 12" by 12" members bolted to concrete piers. Once the three tracks merged, the remaining four-fifths of launchway was simply rails on wooden pilings. These wooden piles were replaced in 1940 with concrete piers when the boathouse underwent a general upgrade to the approaches around the boathouse. A large concrete jetty was built in 1916 to the west of the boathouse and launchway to protect them from the onslaught of storms and surf.

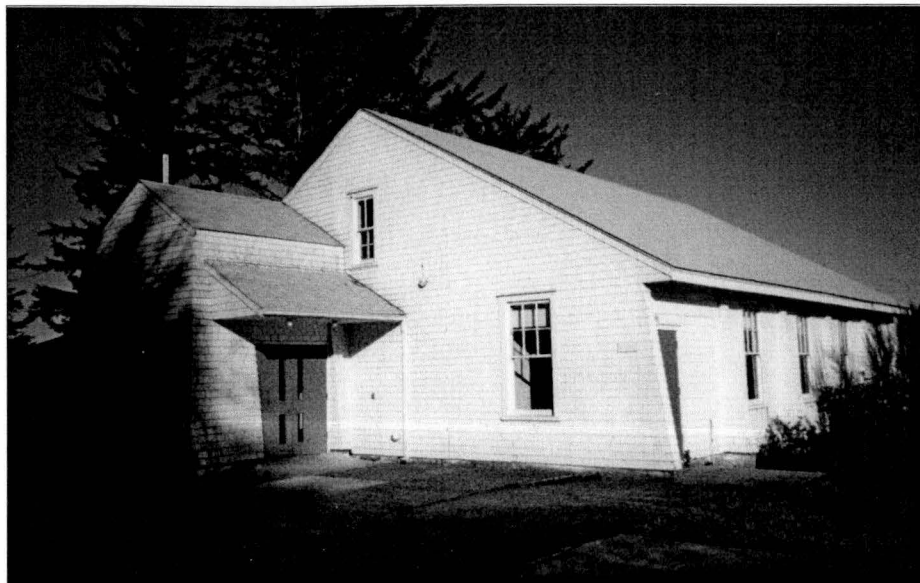
Figure 68. Former Boathouse (1915), Coos Bay Lifeboat Station, 1999. Source: Author.

The boathouse is the most intact of the three buildings. The building is in its original location. In 1975, the University of Oregon rehabilitated the boathouse and turned it into a lecture hall for OIMB. As designed by the University of Oregon Physical Plant, there were plans to build a two-story, lighthouse-like tower on the rear of the building to serve as an entrance. Instead, a much more modest projection was built on the back of the boathouse to serve as a lobby and to create an area for a men's restroom and a women's restroom (Figure 68). On the front of the boathouse, the doors were removed and replaced with multi-light inoperable windows (Figure 69). The eastmost bay received a three-sided bay window and the westmost bay has a door next to its fixed window. Inside, the sloped floor of the boatroom was terraced with a new floor over the old to accommodate level seating. A projection booth was added to the rear of the boatroom. There were plans to renovate the attic space; however, this was never performed, and the attic space remains as originally built.

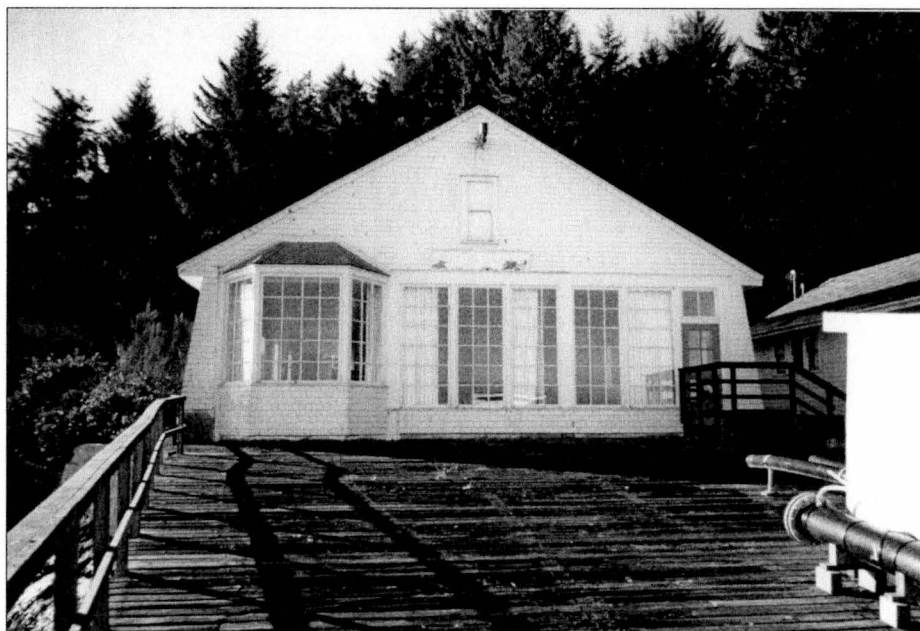
Figure 69. Former Boathouse and Launchway (1915), Coos Bay Lifeboat Station, 1999. Source: Author.

Both the boathouse and the remains of the launchway should be maintained in their current configuration. Future adaptations of the boathouse should not be performed if they disturb the Coast Guard-era elements.

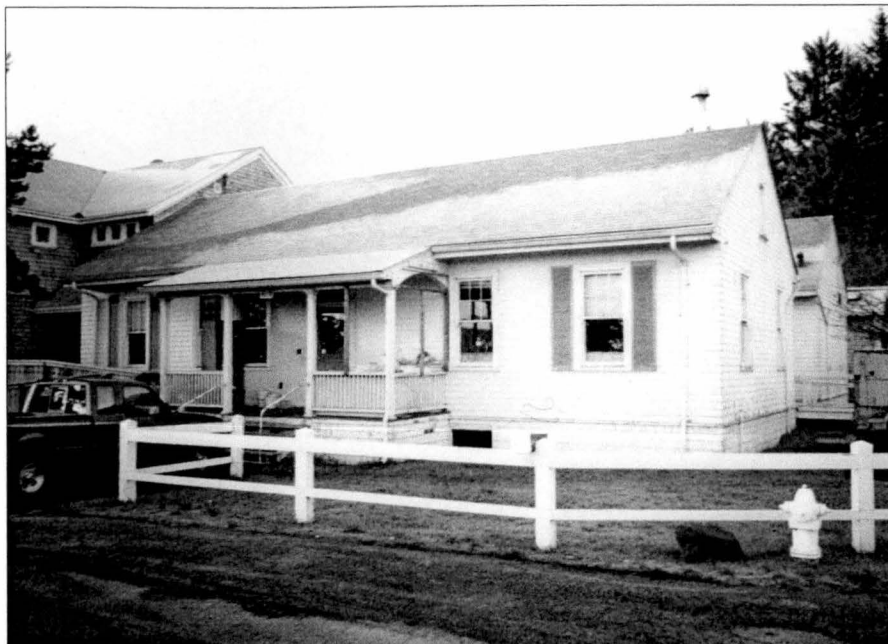
Figure 70. Former Crew's Dwelling (1915), Coos Bay Lifeboat Station, 1999. Source: Author.

The crew’s dwelling underwent a dramatic rehabilitation from dwelling to neurobiology research lab. The design came out of the office of Kruse & Fitch Architects of Seattle in 1968.¹¹³ Several more alterations have occurred since, the latest being a large, just-completed, two-story addition to its south elevation. However, the crew’s dwelling is still unmistakable from the exterior and should remain as such (Figure 70). At a minimum, the wood shingle siding, windows, and porch should be retained. The interior has been too heavily altered to offer any interpretive value.

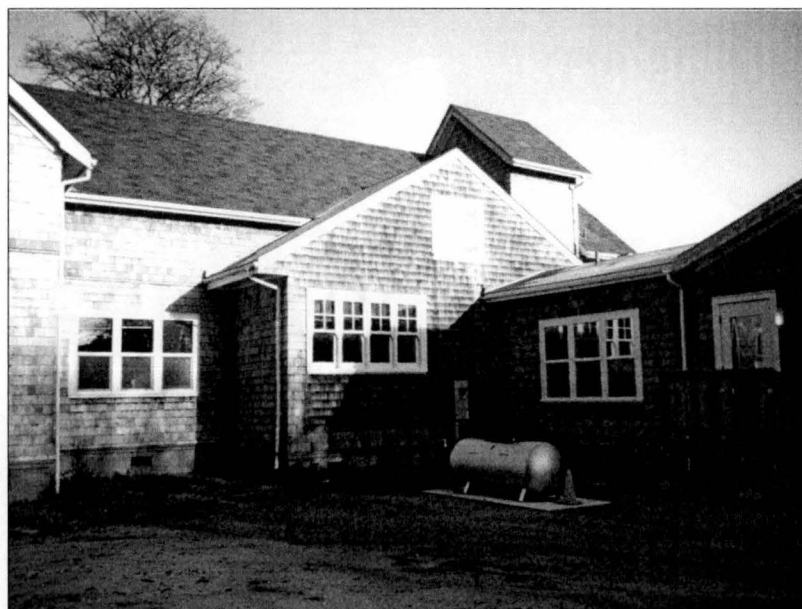
Figure 71. Former Keeper's Dwelling (1915), Coos Bay Lifeboat Station, 1999. Source: Author.

The keeper’s dwelling has been served an even worse life sentence than the crew’s dwelling. It has been enveloped by a just-completed, two-story library complex (Figure 71). Only through photo comparison can the exterior of the former keeper’s dwelling be distinguished. The new building does not differentiate the keeper’s dwelling in any way on the interior. A plaque on the interior denoting what the building once was is the only means left to present the history of the former Coast Guard building.

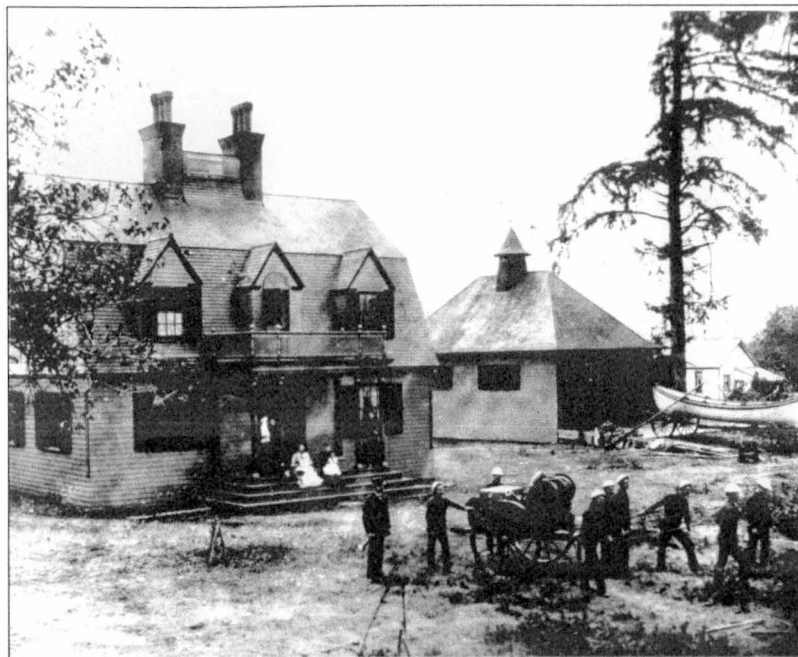
Figure 74. Point Adams Life-Saving Station, Circa 1900. Source: U.S. Coast Guard Headquarters (Point Adams File).

first station to emphasize the living quarters over the boatroom. For Point Adams two years later, he went one step further and detached the boatroom entirely from the dwelling (Figure 74). The evolution allowed the boathouse to be placed in a location convenient to launching a boat while the living quarters could be placed in a more protected location. Having the rescue apparatus in its own building also allowed for increased ventilation to dry out the equipment. Only three of what has become known as the Fort Point-type stations were built, but all were constructed on the Pacific Coast.
