THE PRESERVATION OF PRE-WORLD WAR TWO
COAST GUARD ARCHITECTURE IN OREGON

A THESIS

Presented to the Interdisciplinary Studies Program:
Historic Preservation
and the Graduate School of the University of Oregon
in partial fulfillment of the requirements
for the degree of
Master of Science

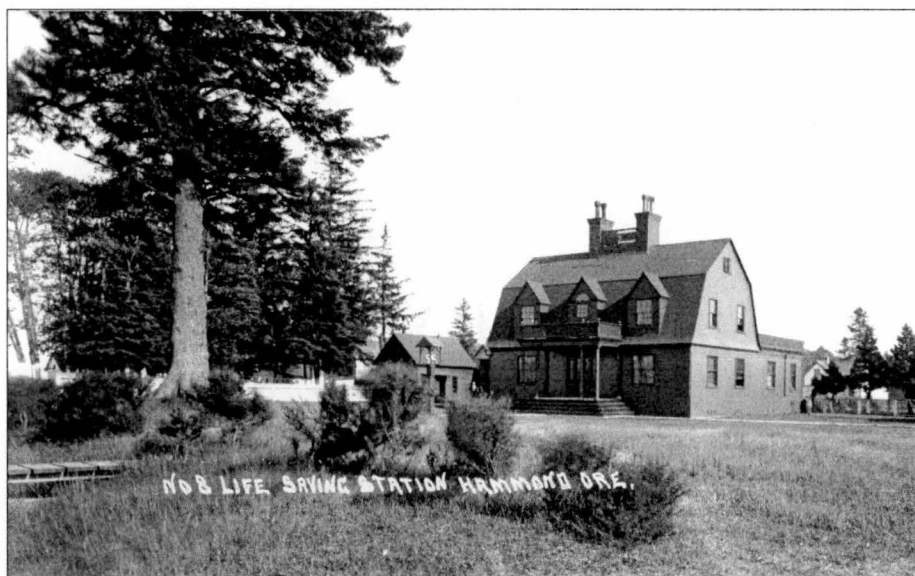
Figure 75. Point Adams Life-Saving Station, Circa 1910. Source: Oregon Historical Society (OrHi #654-A 10541).

The Point Adams station house was a symmetrically-planned, gambrel-roofed structure with three prominent dormers (Figure 75). In its symmetry, gambrel roof and front door detailing, the style is nodding to the Colonial Revival. The one sheet shown in Figure 76 is the only drawing that could be found for the three stations built. The design was short-lived, as all three stations were built in 1889, and no more would come from the plans. The Fort Point Life-Saving Station on San Francisco Bay was the prototype, followed by the Point Reyes Life-Saving Station just north of San Francisco Bay, and finally the Point Adams Life-Saving Station. The Fort Point Life-Saving Station is the only one that still stands, and it was the last U.S. Life-Saving Service station still in use in the nation when it was decommissioned in 1990. Today, it is part of the Golden Gate National Recreation Area.

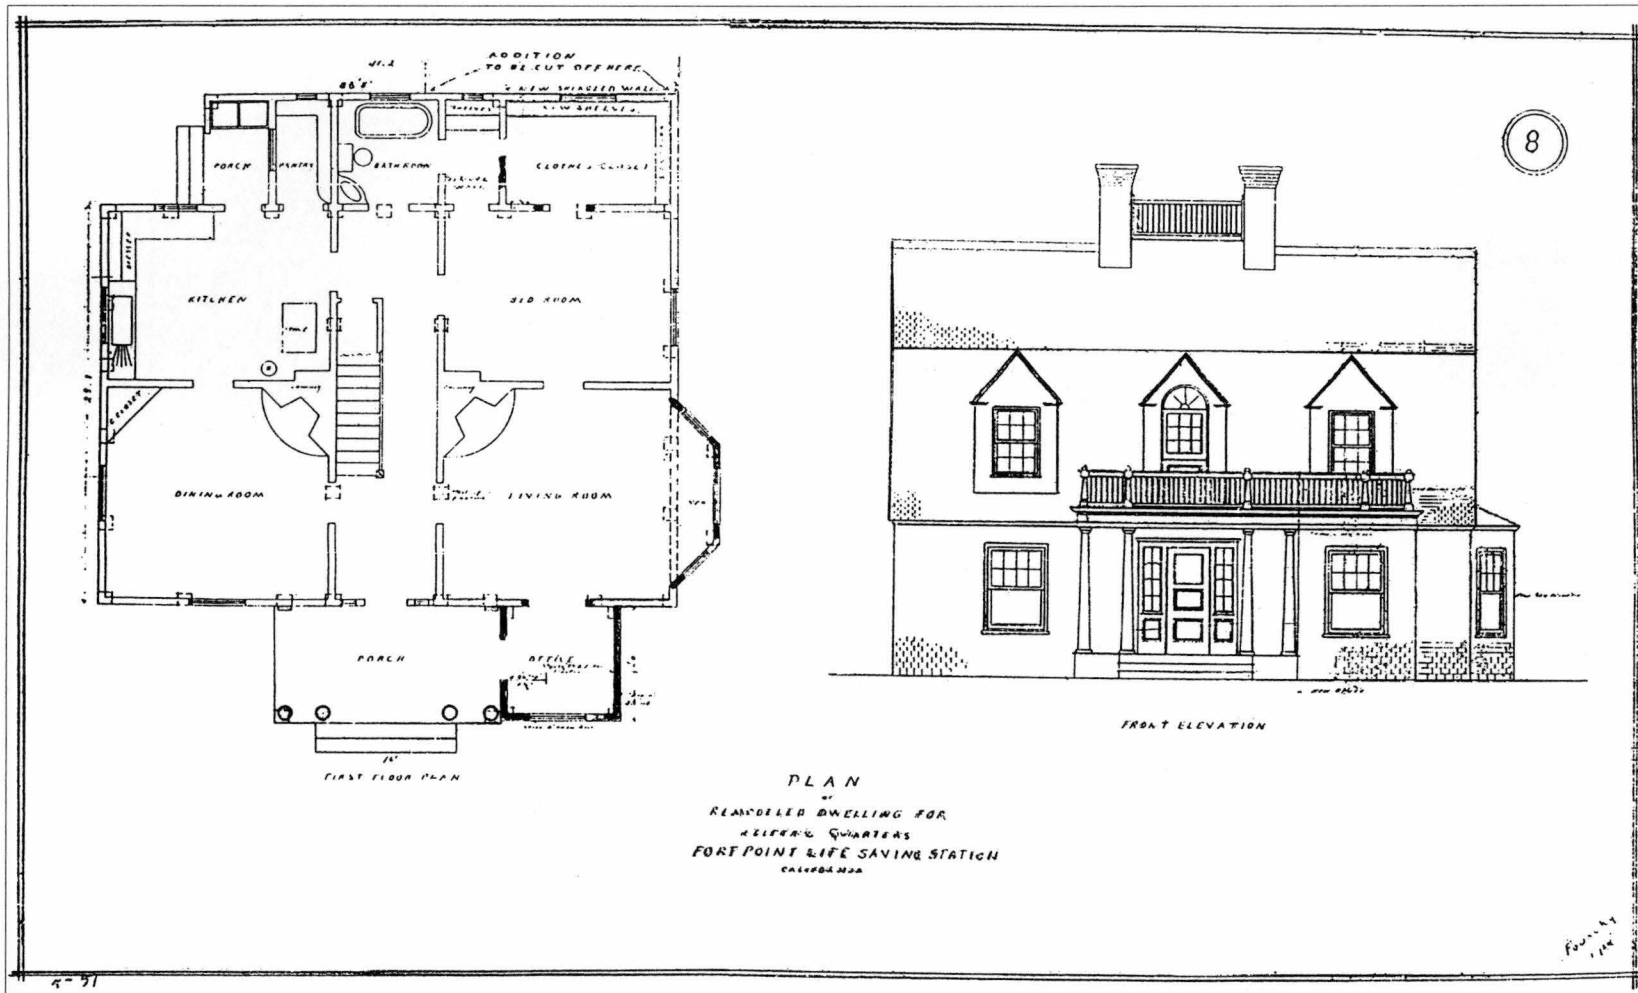
Figure 76. Fort Point-Type Station Plan. Source: Nautical Research Centre (#5-51).

The plan for the Fort Point Station in Figure 76 shows two additions using the original plan as a base drawing. There is a tiny office to the right of the entry and a three-sided bay on the right-side elevation. These modifications were not made to the Point Adams Life-Saving Station. Variances from the plans made at Point Adams were

operable shutters, eight-over-eight windows at the first floor, and an entry porch with steps off of all sides. As was typical among Oregon life-saving stations, the plan is symmetrical with a central entry and stair hall. Colonial detailing abounds, such as multi-pane windows with shutters, sidelights at the entry, classical porch columns, a lunette in the central dormer, and eave returns on the dormers. The entire building was sheathed in shingles.

The plans show the central stair hall with dining room and kitchen to the left and living room and bedroom to the right. At the end of the stair hall was a bathroom containing a bathtub, toilet, and sink. This was the first and only life-saving station in Oregon to include a bathroom inside the station house. The second floor would have had a central stair hall leading to four bedrooms for housing the crew, two to a room. The attic space was ventilated at the end walls and would have been used for storage. The roof was surmounted with a lookout between brick chimneys with corbeled caps. Undoubtedly, there was access through the attic to reach the lookout position. There was no basement. Heat was provided by fireplaces in the dining room and living room, and based on the fact there were six flues, there was a fireplace in each of the four crew rooms.

From the Fort Point plans, there was apparently an ell projecting from the rear of the station. A one-story ell is visible in one of the earliest photos of the Point Adams Station and was probably the keeper's bedroom, most likely accessible only from the

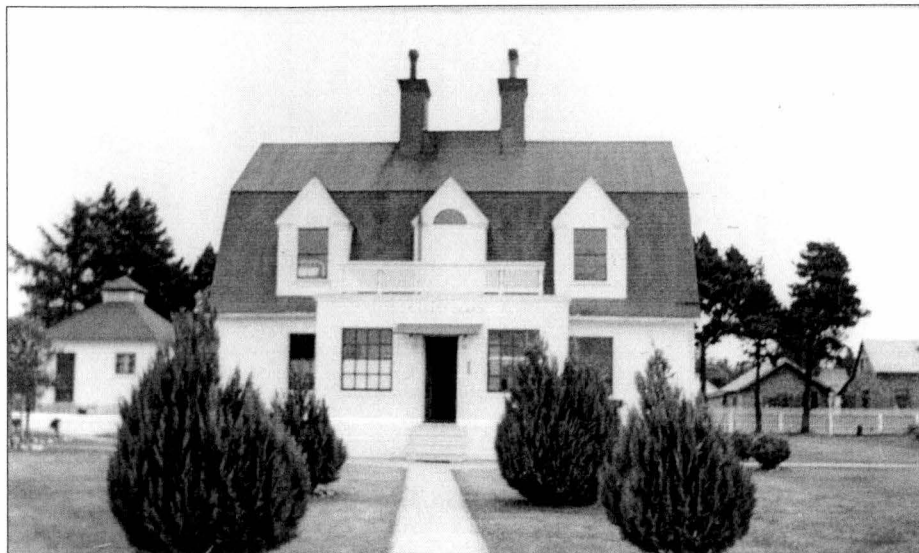
Figure 77. Point Adams Coast Guard Station, 1938. Source: Oregon Historical Society (OrHi #0020P364-000364-A).

outside. Sometime between 1923 and 1931, the front porch was filled-in (Figure 77). Apparently the door in the middle dormer was sealed off at about the same time, possibly to house a bathroom for the second floor.

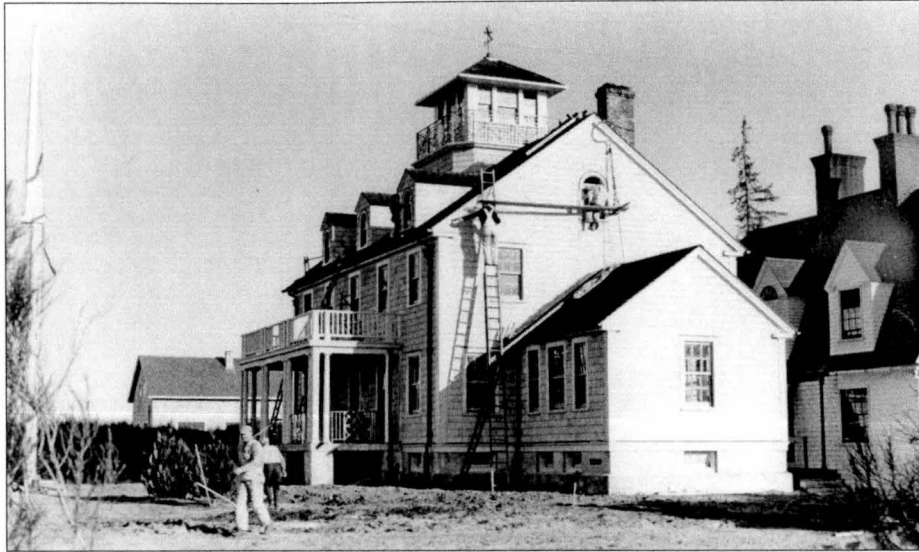
Figure 78. New Point Adams Coast Guard Station, 1939. Source: U.S. Coast Guard Headquarters (Point Adams File).

represented by multi-pane windows flanked by operable shutters, large Classical corner boards, Tuscan columns, eave returns, a water table with cap, and metal railings in Classical motifs. Even the restricted roof of the entry porch was rimmed with a balustrade. On the rear elevation was an entrance door sheltered by a small gable hood supported by distinguished brackets.

The Point Adams Lifeboat Station was erected to replace the inadequate life-saving station house built 50 years earlier in 1889. The new station was the first of the four Roosevelt-type stations to be built on the Oregon Coast. These stations followed a standard plan developed by the Coast Guard and were for the most part built during Franklin Roosevelt's administration (1933-45), hence the designation, Roosevelt-type. The new Point Adams station was begun in October 1938, and built as a Public Works Administration Project (PWA). George Buckler of Portland was the general contractor and it cost \$44,000 to build.¹²⁹ What was unusual about the construction process at Point Adams was the proximity of the old and new buildings (Figure 78). The Coast Guard designers wanted to site the new station as close as possible to the site of the old station; however, they also wanted to continue to use the old station until the new station was ready in April 1939. Therefore, the new station was built just a few feet in front of the old station.

Like the former Fort Point-type life-saving station house, the new Roosevelt-type station house was completely symmetrical across the front. However, the new station's Colonial Revival roots were much more apparent. Colonial Revival detailing was

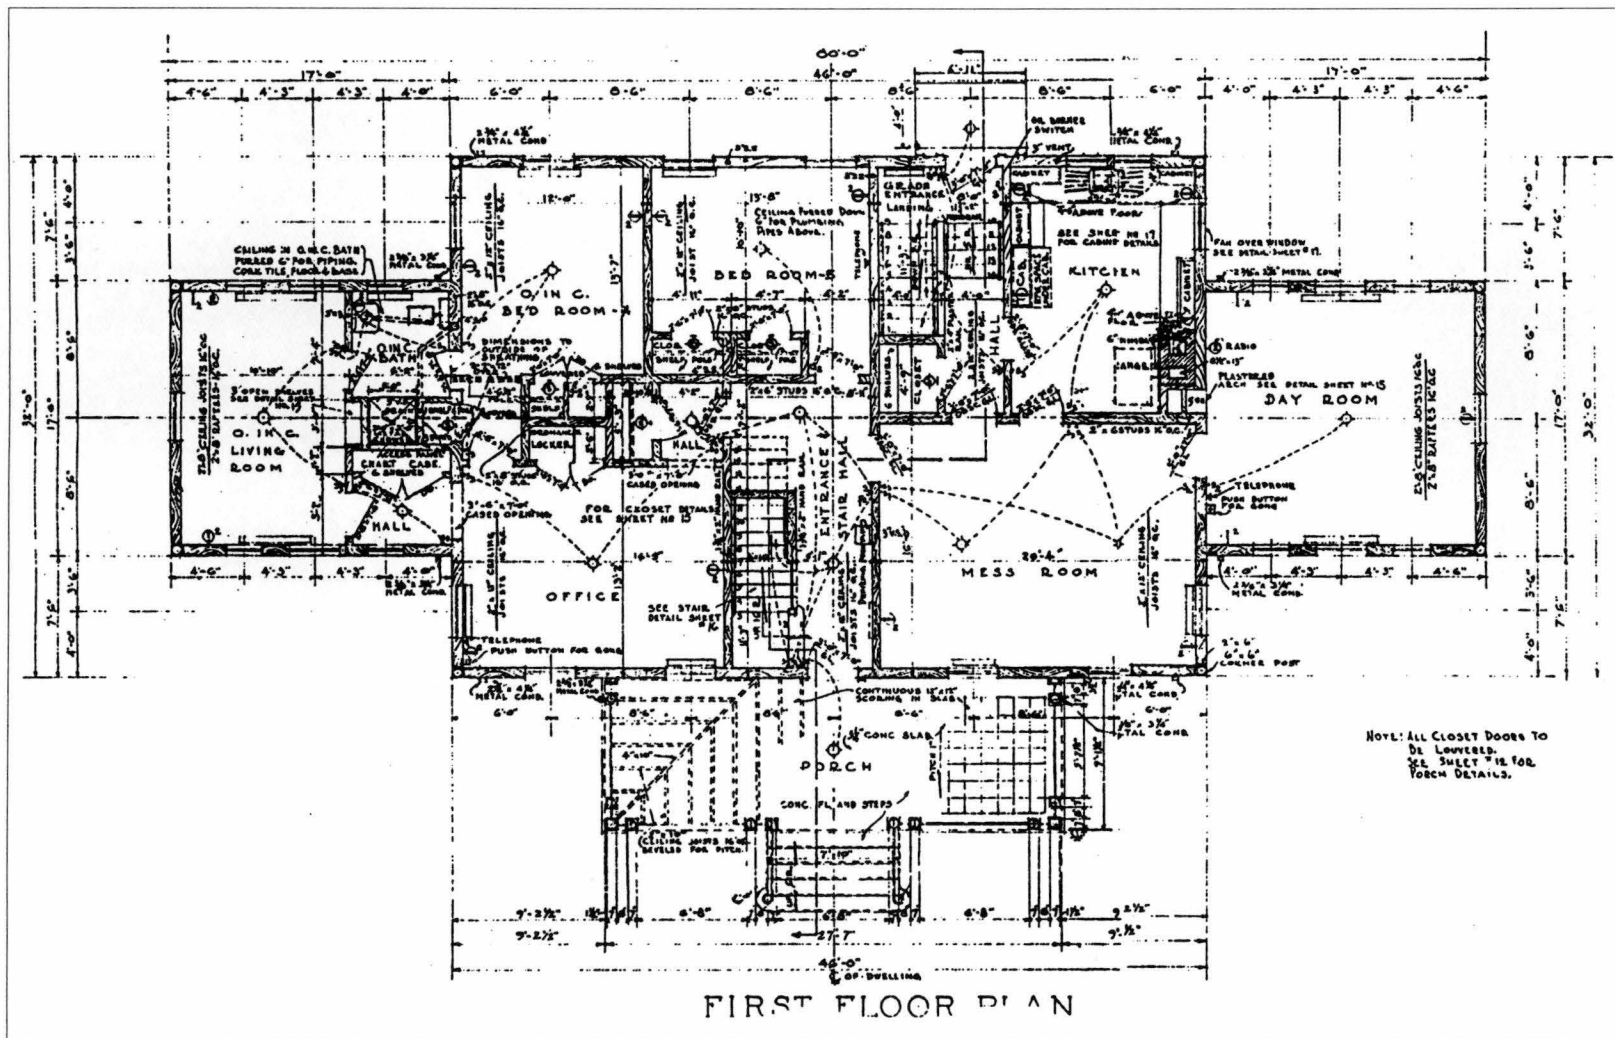
Figure 79. First Floor Plan, Umpqua River Lifeboat Station, Drawn October 1938. Source: Umpqua River Coast Guard Station National Register Nomination.

The building was a commodious 80' wide and 32' deep, designed to sleep 17 but could easily handle more people. On the first floor was a central stair hall, dividing officer's quarters to the left from the crew's living space on the right (Figure 79). On the left was the Officer in Charge's (OIC) office, living room, bathroom, and bedroom. On the right was the crew's mess, kitchen, and day room. At the end of the stair hall was a spare bedroom. The second floor was divided symmetrically into four bedrooms for the crew (Figure 80). Each room was setup to sleep four with four beds and four built-in

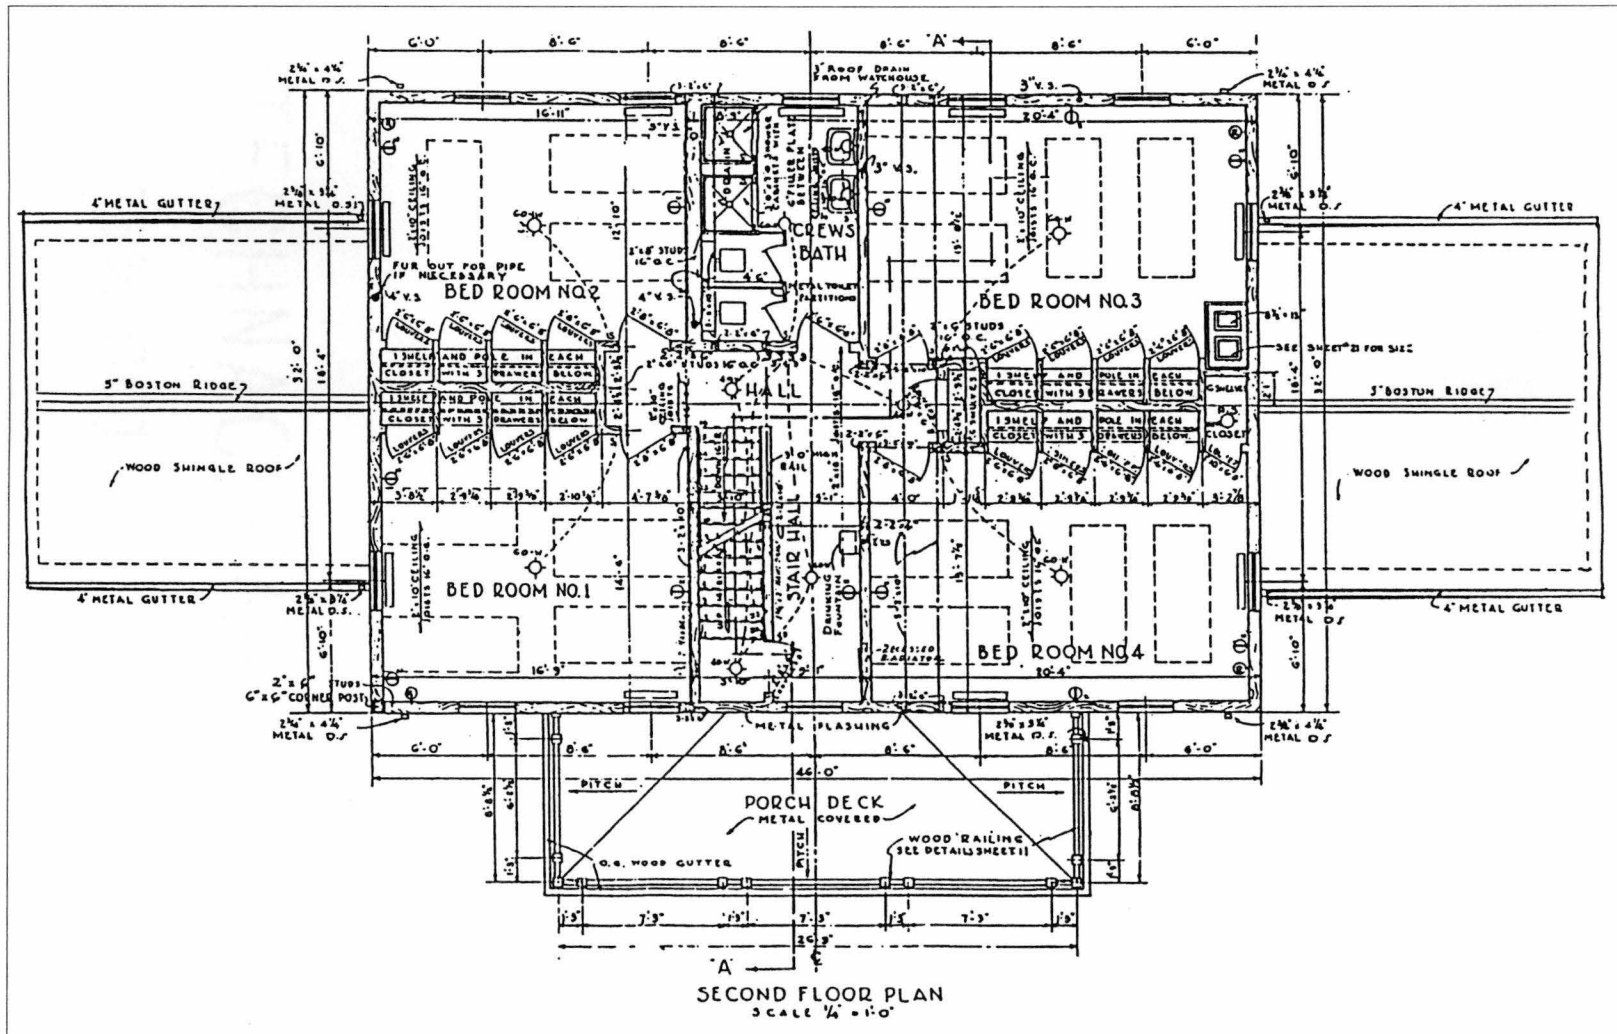
Figure 80. Second Floor Plan, Tillamook Bay Lifeboat Station, Revised Drawing May 1940. Source: Tillamook Bay Coast Guard Station National Register Nomination.

lockers. At the end of the stair hall was the crew's bathroom with two toilets, two sinks, and two showers. In the stair hall, the staircase continued on to the attic which was divided into two large bunk rooms with lockers on the end walls. A fold-down stair in the stair hall provided access to the 9' by 9', continuously manned, lookout.¹³⁰ Six dormers, with arched windows, pierced the attic. Under the building was a full basement with a drill room, boiler room, storm clothes room, provision room, and laundry room. The entire building was surrounded by a concrete sidewalk in the form of a large oval.

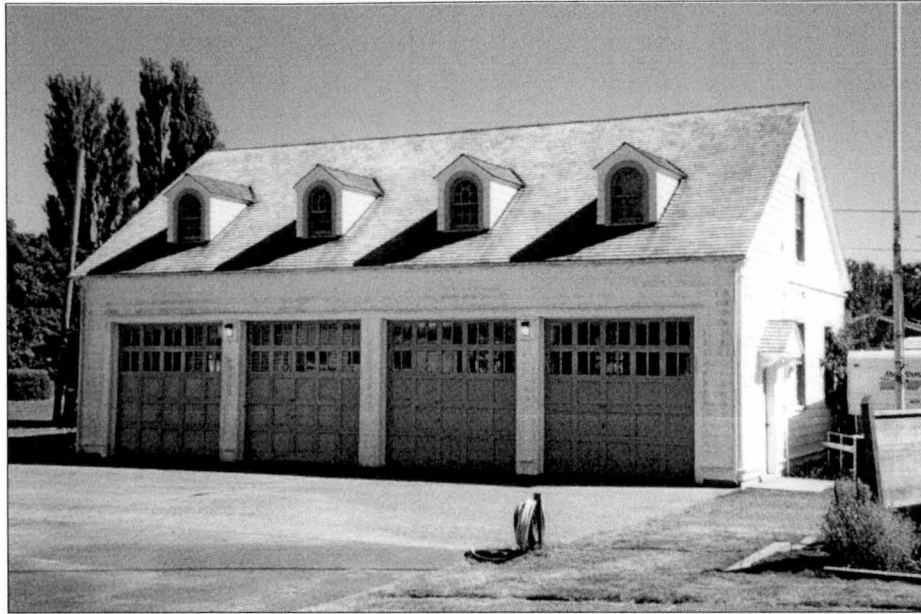
Figure 81. Equipment Building (1939) at Point Adams Lifeboat Station, 1997. Source: Author.

Revival theme of the station house with its arched, multi-light windows in the dormers, eave returns at the gable ends, a lunette over the gable windows, and water table with cap. Each dormer was centered over a garage door that contained 10 lights over 15 panels. On the back side, there were four more dormers. On the west elevation was an entrance door sheltered by a small gable hood supported by elegant brackets. The building was clad in shingles and finished with classical corner boards.

A standard, four-bay equipment building was built in 1939 to the south of the station (Figure 81). Stations starting in the 1930s all had what were called equipment buildings, which served as garages for vehicles and small boats, plus had storage space for equipment in the attic. The plan of the building was approximately 50' wide by 30' deep and built on a concrete foundation. The equipment building continued the Colonial

The exterior of the equipment building (1939) is in excellent shape. The attic space has been adapted into a meeting space. The other four-bay, Roosevelt-type equipment buildings in Oregon are at Siuslaw River and Coos Bay and are identical to the one at Point Adams. The Coast Guard still uses the Siuslaw River and Coos Bay equipment buildings and have altered their exteriors significantly to meet their current needs. In contrast, the Point Adams equipment building has excellent integrity. The National Marine Fisheries Service should continue to maintain the building in its current state, its exterior should not be altered, and its interior not be changed any further. The

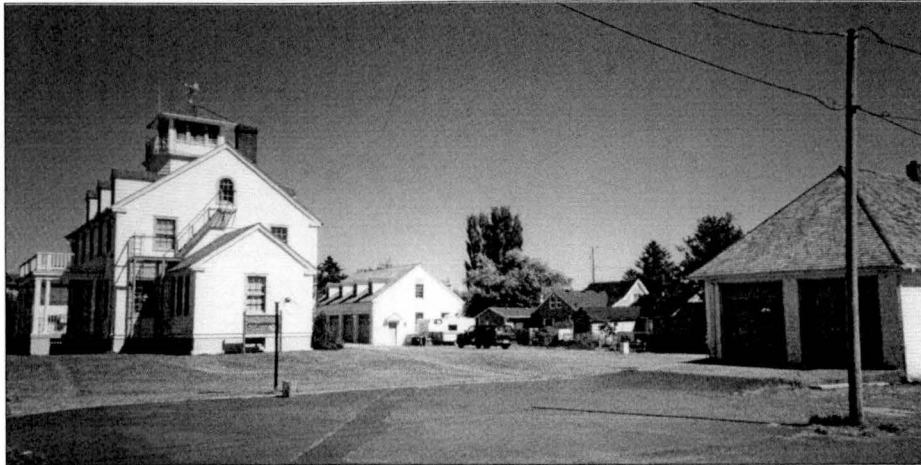
Figure 82. Decommissioned Point Adams Lifeboat Station Complex, 1997. Source: Author.

The Point Adams station complex is remarkably intact (Figure 82). The station was decommissioned c.1963 and was used for a brief time by the Clatsop Community College. In 1969, the National Marine Fisheries Service bought the station complex and its 5.8 acres from the Coast Guard to use as a research station. At the time, the National Marine Fisheries Service was well aware of the historic importance of the station and have done their best to preserve what remains over the past 30 years.¹³³ The Point Adams 1889 station house, the c.1915 boathouse, and the 1939 boathouse are all gone, but the 1889 boathouse, c.1925 shop building, and the 1939 station house and equipment building all survive.

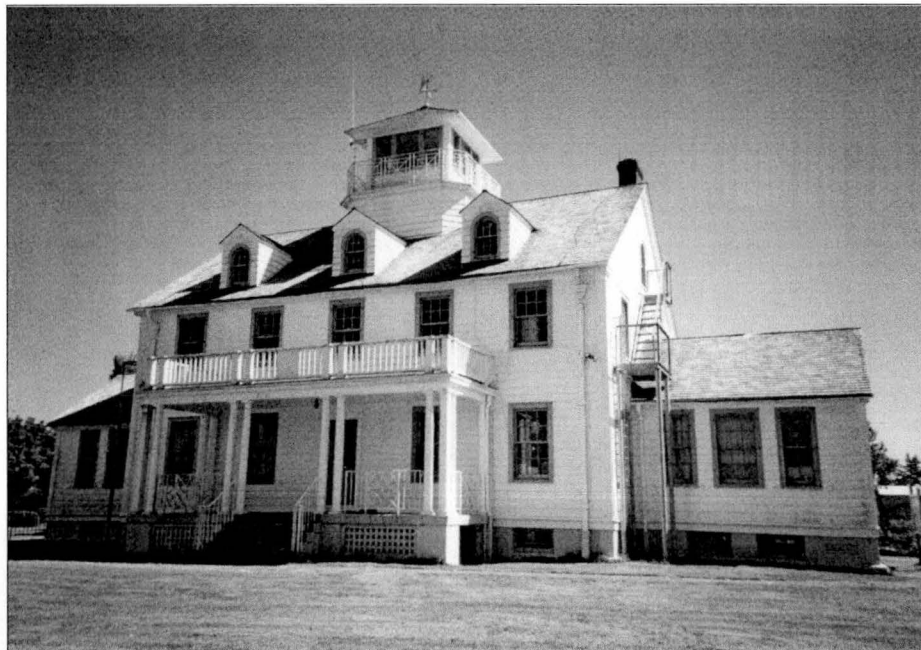
Figure 83. Station House (1939) at Point Adams Lifeboat Station, 1997. Source: Author.

escape on either side of the building to serve the second floor and attic. The shutters have been removed, but they are in on-site storage. On the interior, the National Marine Fisheries Service has not altered the spatial arrangement, only the use of the rooms. All decorative features have been retained. Much of the original signage, cabinetry, closets, and hardware remains. Unfortunately, most of the light fixtures have been replaced over the years; however, in the entry hall there is an original 1939 light fixture. The National Marine Fisheries Service has even continued to use the same shades of paint, such as pale yellow and pale gray, on the interior. The station house is a good model of adaptive reuse.

The 1939 station house is the most intact building on the site (Figure 83). It retains its original exterior appearance with only the addition of a non-integral, metal fire

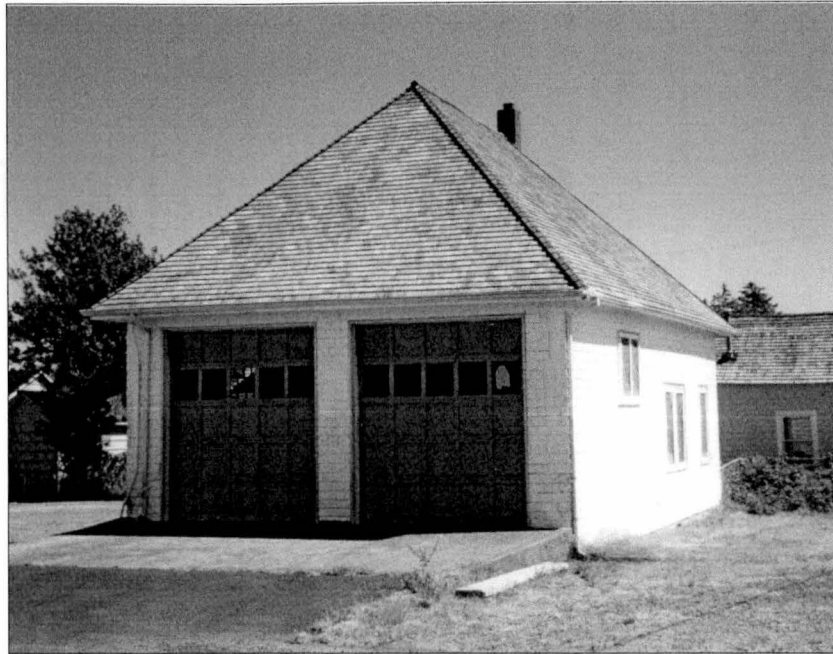
Figure 84. Boathouse (1889) from Point Adams Life-Saving Station, 1997. Source: Author.

The original boathouse from the 1889 station is a rare artifact (Figure 84). The only other boathouse remaining in Oregon from the Life-Saving Service era is at Barview on Tillamook Bay. Of the five Fort Point-type boathouses built in Oregon, Point Adams has the only one remaining. Unfortunately, the boathouse lost its most character-defining feature, the witch's hat ventilator, sometime after 1939. It has also lost its two, paired boatroom doors, its flared eave, and some of its windows. During the Coast Guard era, an entry door was inserted along with several newer windows. However, the boathouse is structurally sound and well maintained. As with all of the buildings on the site, a new cedar shingle roof was installed in 1990. If there was a strong desire, coupled with financial support, this would be a prime building for restoration back to its 1889 appearance. At the very least, National Marine Fisheries Service should continue to maintain the structure and not alter it further.

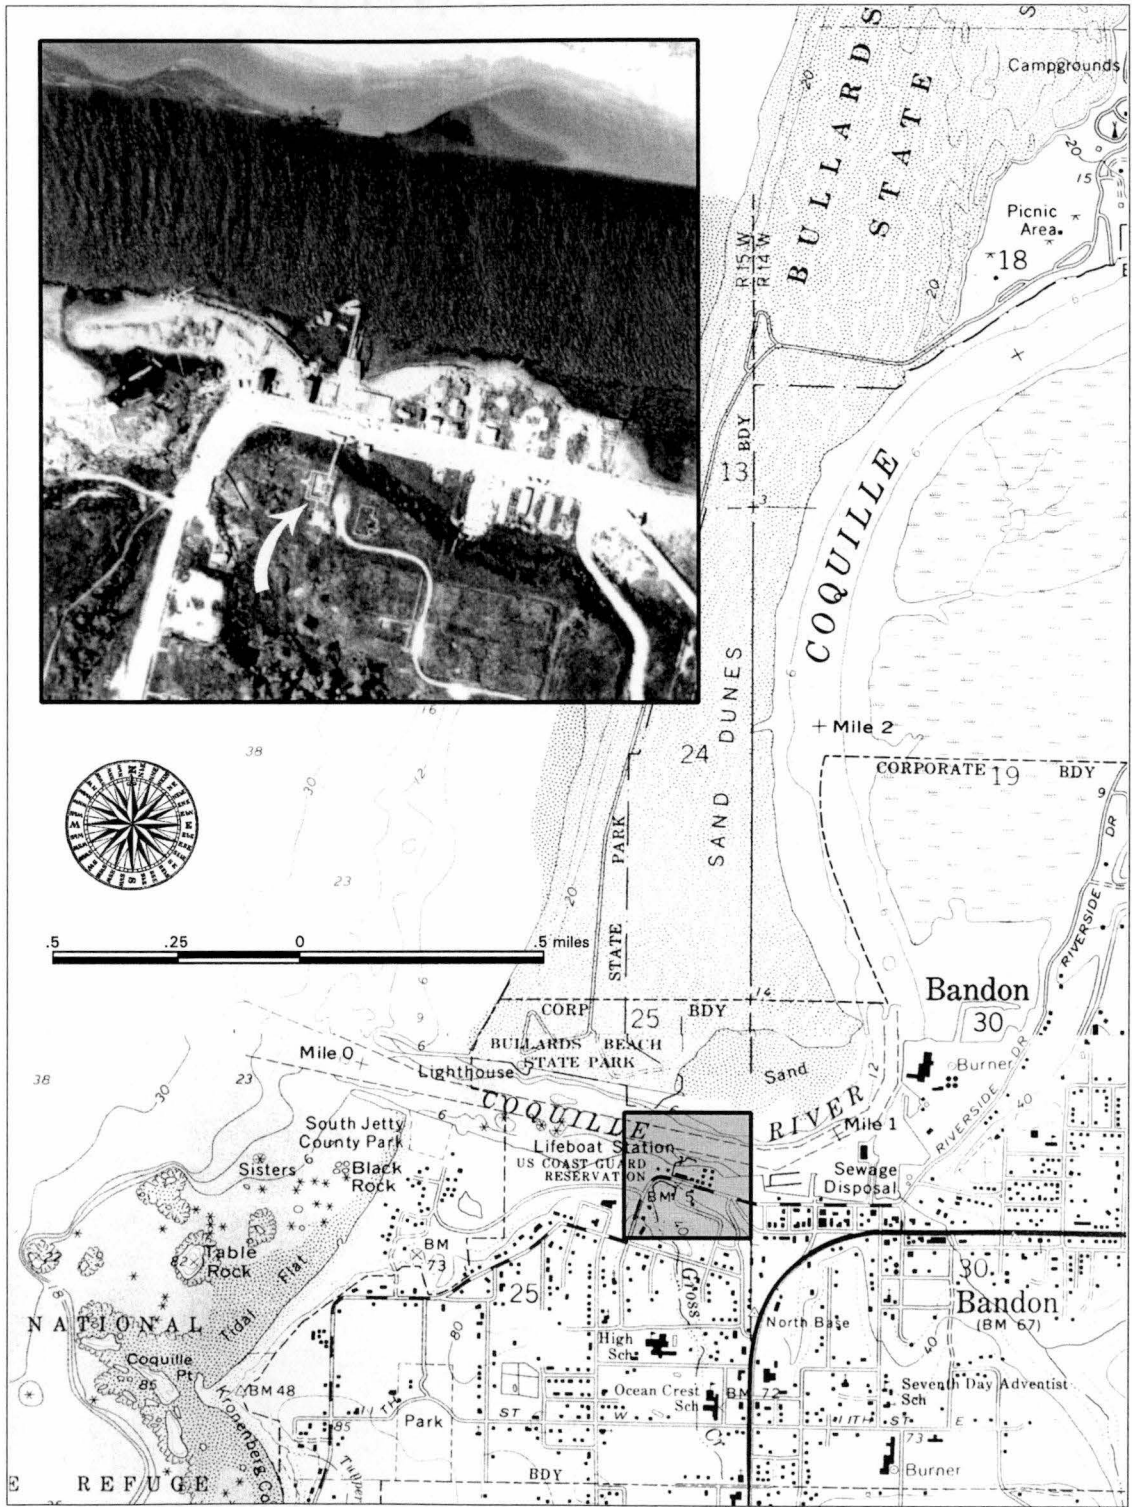
Figure 87. Aerial Photo of the Coquille River Station Area in 1939 Superimposed Over the Bandon, Oregon, USGS Map (1973 Revision).

The station was built on the standard Marquette plan with a Fort Point-type boathouse, as described in Chapter III. The station complex was situated on the west end of the Bandon waterfront on First Street (Figure 87). The boathouse was located on the river's edge with a launchway descending directly into the water (Figure 88). The station house was located on the bluff above the boathouse at the end of an 81-step staircase (Figure 89). In general, the 50' by 30' house was divided by a central hallway and stair with the right half reserved for the keeper and the left half for the crew (Figure 90). On the main floor, the keeper's living room, office, kitchen and pantry were to the right. On the left was the crew's living room and quarters. Upstairs, the right half contained the bedrooms for the keeper and his family. On the left was the crew's locker room.

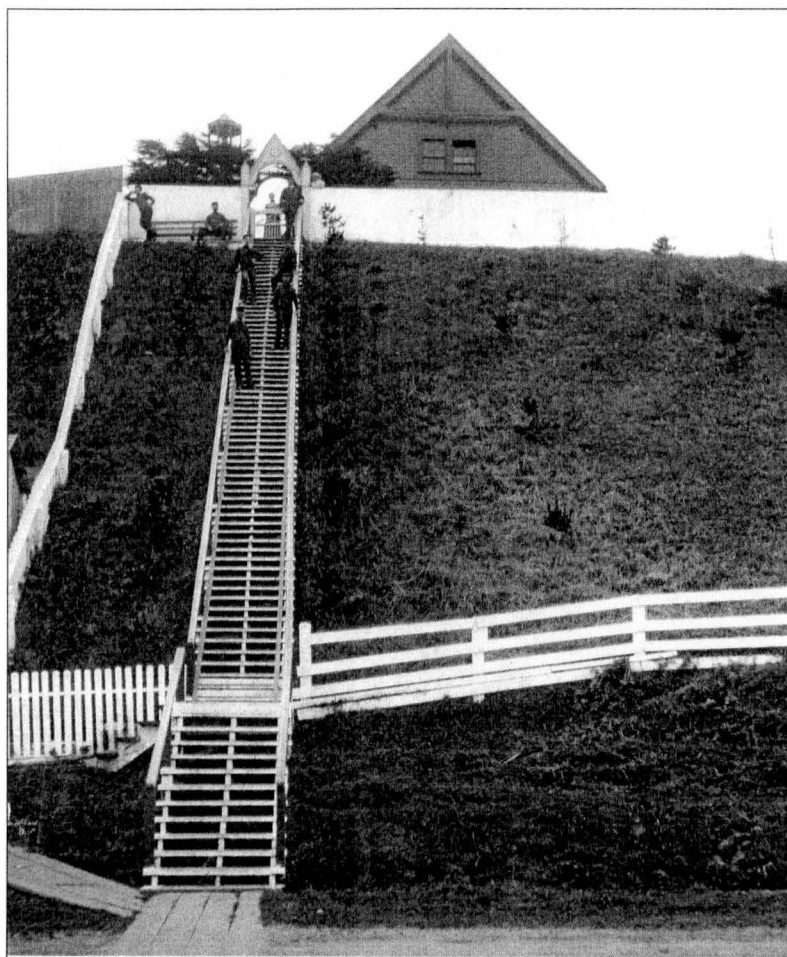
Figure 89. Coquille River Life-Saving Station Staircase to Station House, Circa 1910. Source: Bandon Historical Society (BHS #1559).

In late-1916, a concrete sidewalk and retaining wall were poured at the base of the station bluff. At the stair to the station, the retaining wall opened in two places to create two, eight-step flights that rejoined into one before going up the hill. Between 1923 and 1936, the upper portion of the launchway was replaced with a concrete ramp and bulkhead.

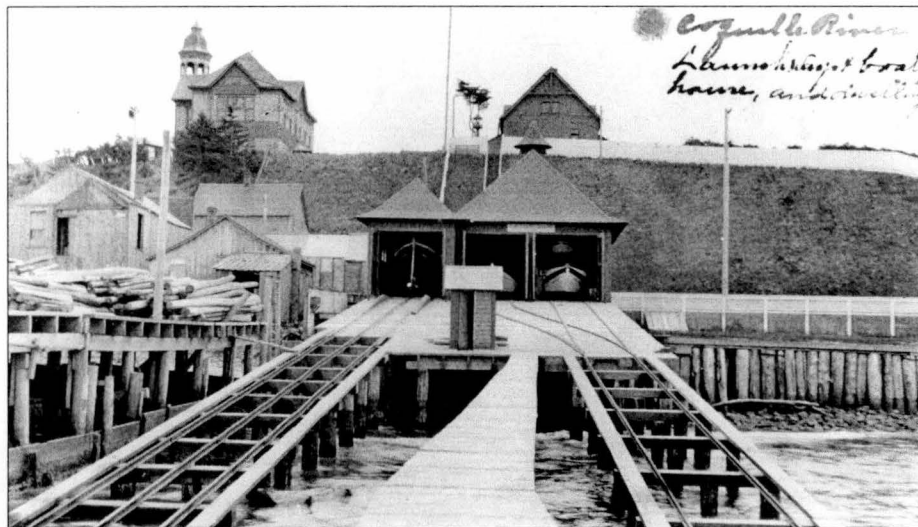
Figure 91. Coquille River Life-Saving Station Boathouse with Station House Directly Behind on Hill, 1916. Source: U.S. Coast Guard Headquarters (Coquille River File).

The boathouse was a Fort Point-type boathouse. The standard Fort Point boathouse is thoroughly described in Chapter III. The Coquille River boathouse was located on the waterfront approximately 70' below the station complex. The building was one-story with two bays and measured 24' wide by 40' deep. One bay held a surfboat and the other bay a lifeboat. A launchway led from the building directly into the Coquille River. Around 1915, a diminutive boathouse was appended onto the original boathouse to store the crew's new 36' motor lifeboat (Figure 91). A new launchway was built adjacent to the old one to give the new motor lifeboat a direct run into the river.

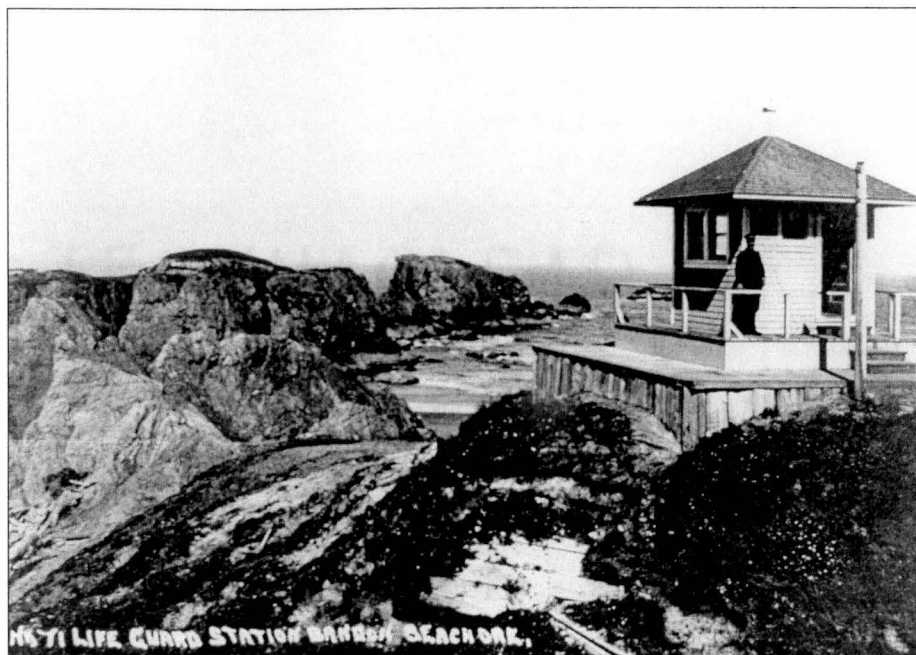
Figure 92. Lookout at Coquille Point, Circa 1900. Source: U.S. Coast Guard Headquarters (Life-Saving Service: Stations File).

About a mile southwest of the station there was a lookout station to watch the river mouth (Figure 92). The watch house was similar to those mounted at other stations on a tower. This one, however, was elevated by its location on Coquille Point and had no need for additional height. The watch house was an 8' cube with windows on each side, capped by a hipped roof, and built on a wooden platform. Below the lookout on the beach was an auxiliary boathouse where a surfboat and equipment were kept just in case the boats from the station could not get across the bar in an emergency (Figure 93).¹³⁹

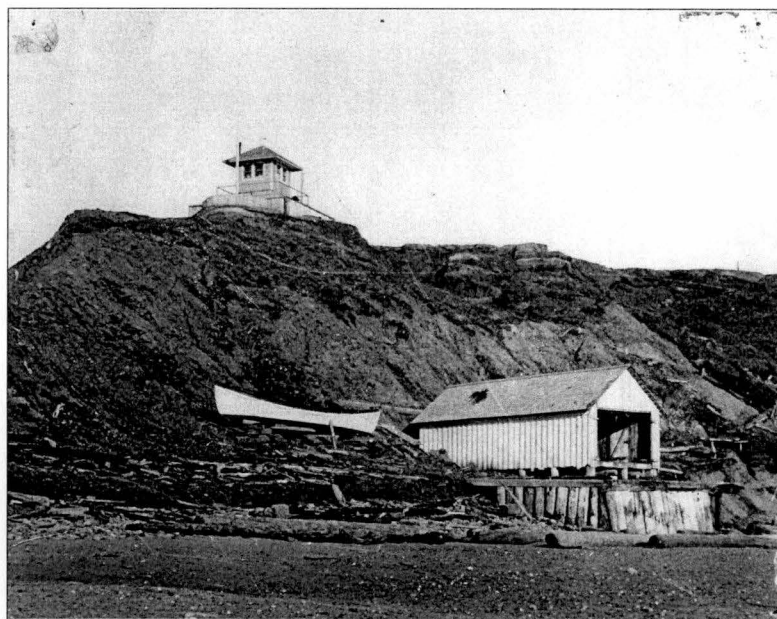
Figure 93. Lookout and Abandoned Boathouse at Coquille Point, Circa 1910. Source: Bandon Historical Society (BHS #178).

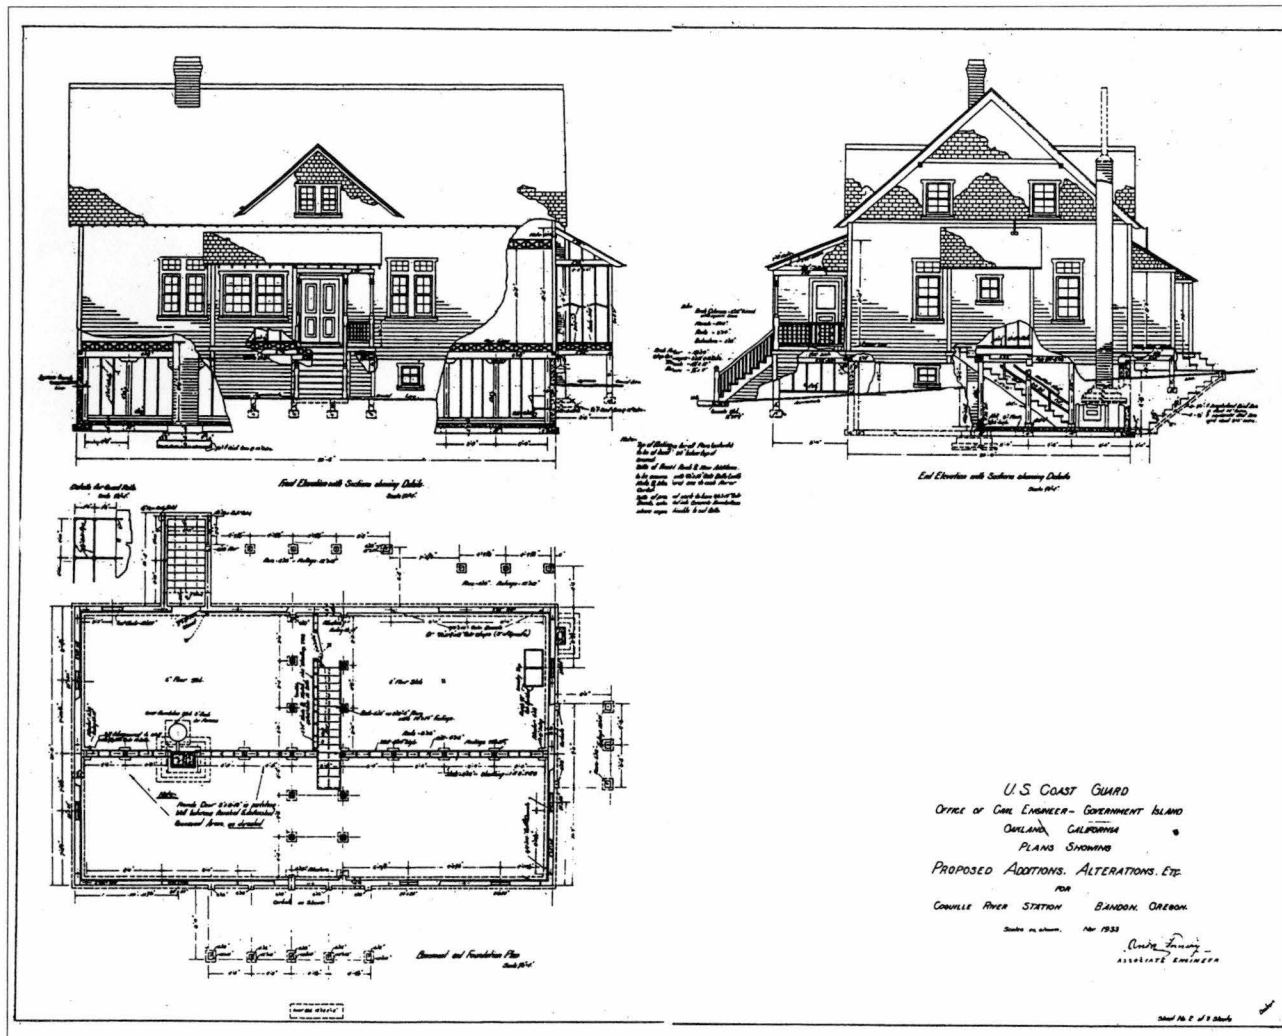
Figure 94. Coquille River Life-Saving Station Remodel Plan, 1933. Source: Nautical Research Centre (#3-439).

Plans were drawn in November 1933 to insert a basement under the station house. Final drawings were made in February 1934 and the basement was built soon after (Figure 94). An exterior entrance to the basement from the rear was provided, as well as an interior stair from the central hall. A furnace and hot water tank were installed. A small lean-to was erected on the south end of the building to house the first toilet for the station house. A new garage building was also built at the same time. It was a 1-1/2 story structure, 22' wide by 27' deep, with a gable roof penetrated by two dormers. Inside were a bedroom and bathroom over a two-bay garage. Unfortunately, most of the town of Bandon burned down soon after in 1936. Only 16 out of approximately 500 buildings survived the blaze on 26 September 1936. The station complex did not outlive the firestorm (Figure 95). All that did survive were the boats, the concrete launchway, and the bell stand on the hill.

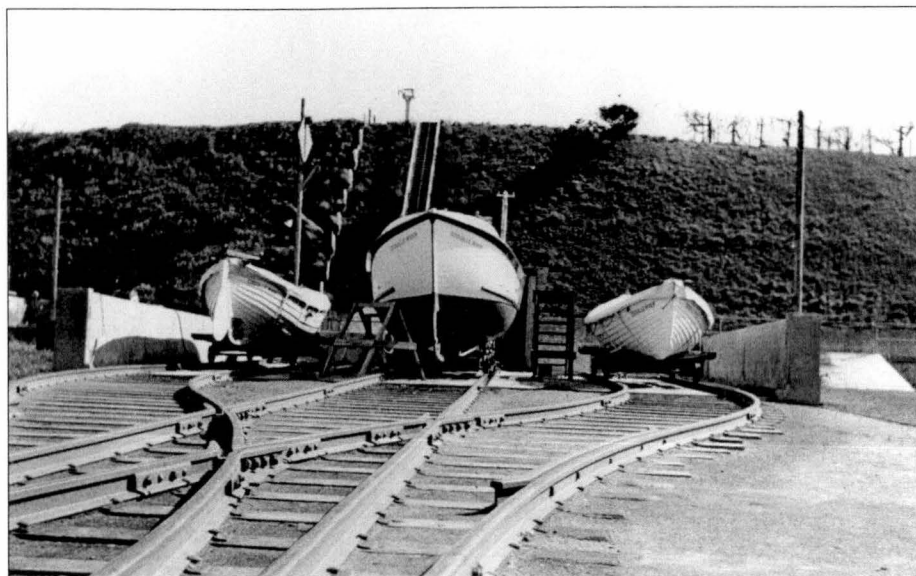
Figure 95. Remains of the Coquille River Life-Saving Station Boathouse After Bandon Fire, 1938. Source: U.S. Coast Guard Headquarters (Coquille River File).

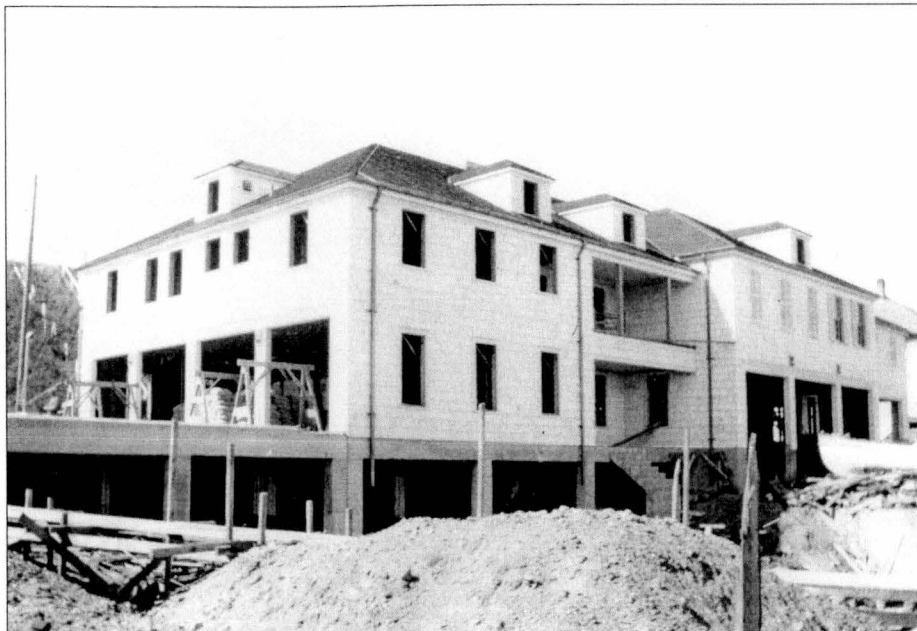
Figure 96. Coquille River Lifeboat Station Under Construction, 1939. Source: U.S. Coast Guard Headquarters (Coquille River File).

World newspaper in 1940.¹⁴⁰ Quinn Construction Company of Portland was the general contractor for the building; however, local subcontractors were used on the job. Working drawings were completed by the Coast Guard on 23 December 1938, and construction started in February 1939 (Figure 96). It was decided to consolidate all of the Coast Guard operations into one building on the waterfront, similar to the one on Yaquina Bay's waterfront, though larger. The structure cost approximately \$80,000, but equipping the station drove the cost up to \$125,000. This was by far the most expensive of the pre-WWII stations built in Oregon. The station was built on the site of the old

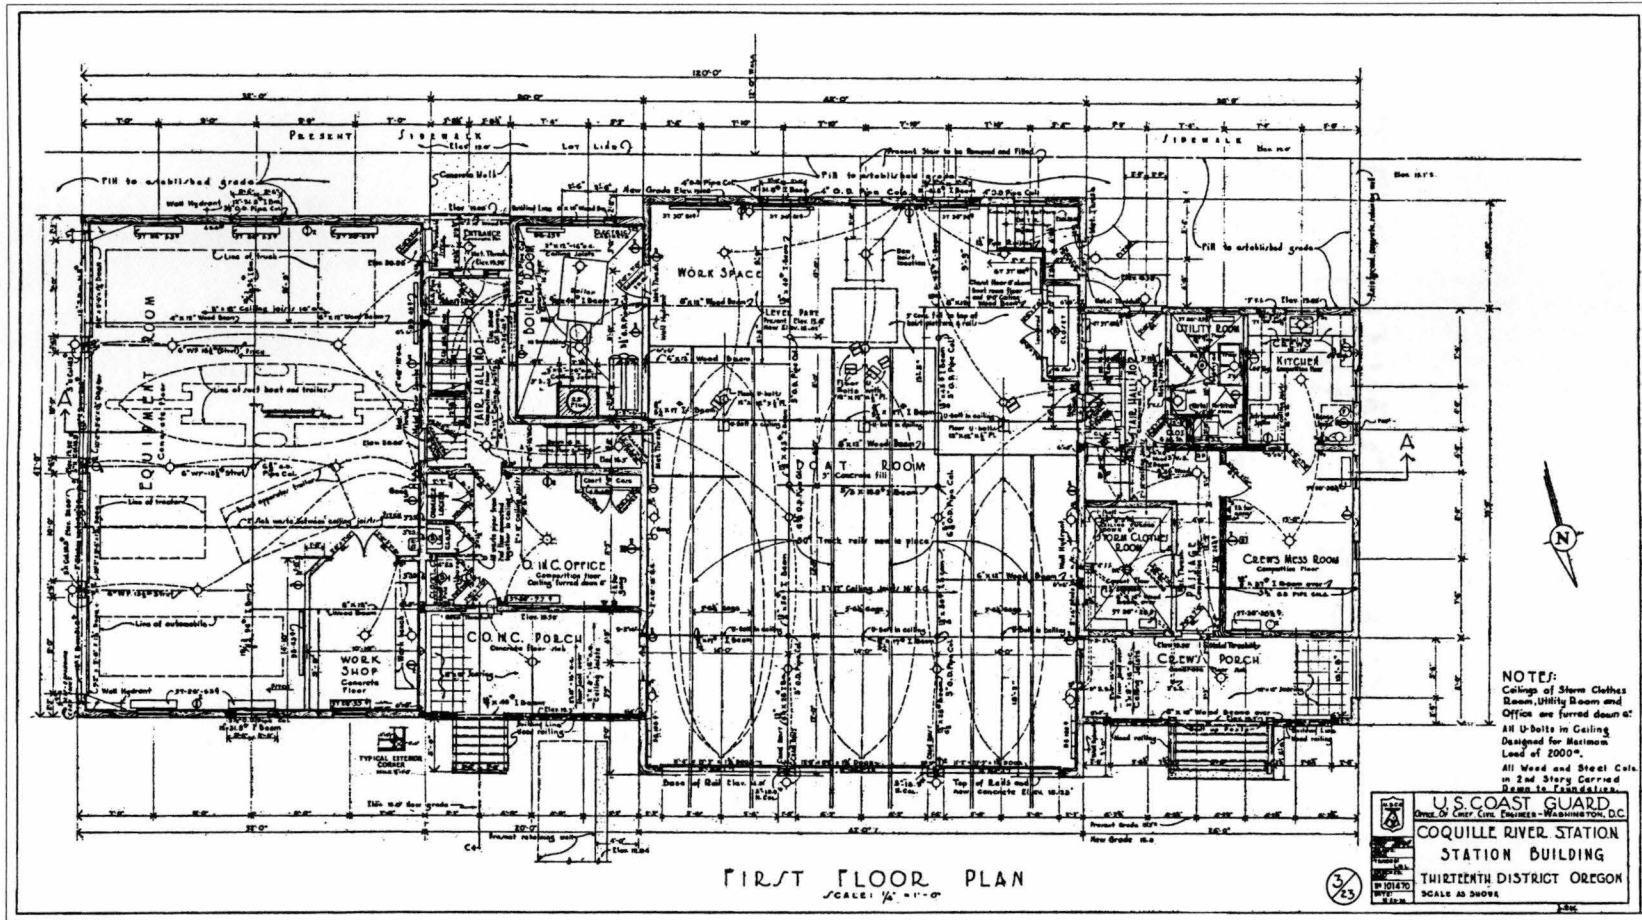
Figure 98. Coquille River Lifeboat Station, First Floor Plan, 1938. Source: U.S. Coast Guard Civil Engineering Unit, Oakland, CA.

The new, two-story station was 120' wide by 54' deep, making it easily the largest station constructed on the Oregon Coast. It was built on a reinforced concrete foundation with a concrete bulkhead along the river to protect the property. The station's exterior walls and subfloor were constructed entirely out of wolmanized Douglas fir lumber to help prevent dryrot and insect damage.¹⁴³ The first floor had a 54' by 42' boatroom built over the former launchway not destroyed by the fire (Figure 98). To the left of the boatroom was the crew's kitchen, mess room, utility room, storm clothes locker, and porch. To the right were the three-bay equipment room and workshop, and the office of the Officer in Charge. The equipment room housed a surfboat, a lifeboat, a tractor, truck, and automobile. On the left side of the second floor, there was a bathroom and three bedrooms for two surfmen each (Figure 99). The center section of the second floor
