THE PRESERVATION OF PRE-WORLD WAR TWO
COAST GUARD ARCHITECTURE IN OREGON

A THESIS

Presented to the Interdisciplinary Studies Program:
Historic Preservation
and the Graduate School of the University of Oregon
in partial fulfillment of the requirements
for the degree of
Master of Science

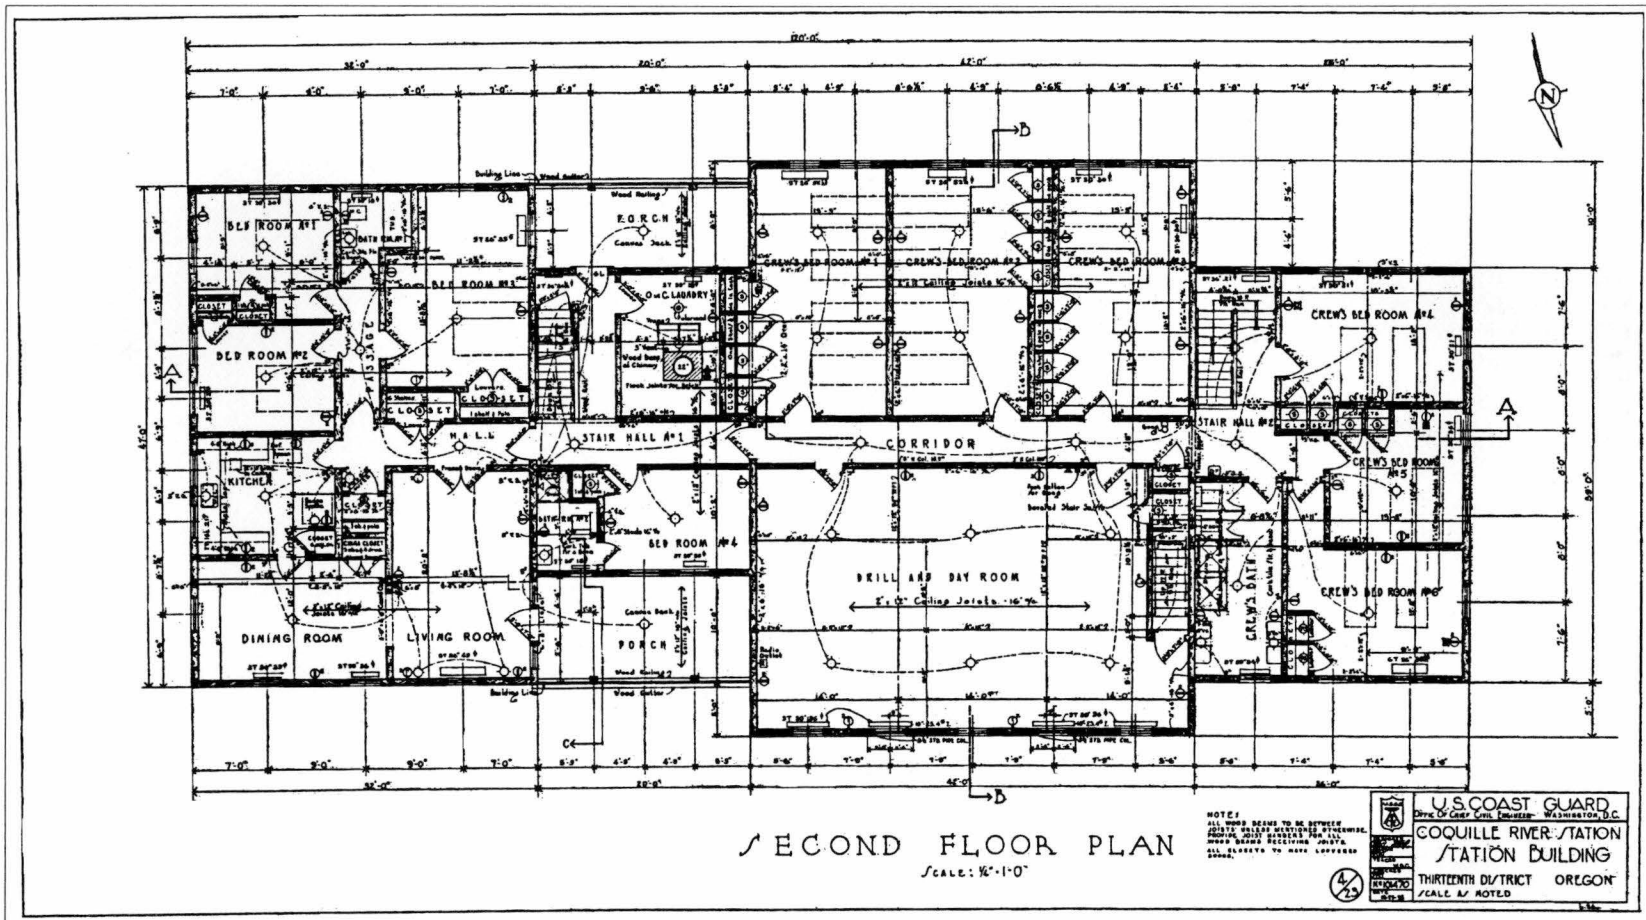
Figure 99. Coquille River Lifeboat Station, Second Floor Plan, 1938. Source: U.S. Coast Guard Civil Engineering Unit, Oakland, CA.

The new, two-story station was 120' wide by 54' deep, making it easily the largest station constructed on the Oregon Coast. It was built on a reinforced concrete foundation with a concrete bulkhead along the river to protect the property. The station's exterior walls and subfloor were constructed entirely out of wolmanized Douglas fir lumber to help prevent dryrot and insect damage.¹⁴³ The first floor had a 54' by 42' boatroom built over the former launchway not destroyed by the fire (Figure 98). To the left of the boatroom was the crew's kitchen, mess room, utility room, storm clothes locker, and porch. To the right were the three-bay equipment room and workshop, and the office of the Officer in Charge. The equipment room housed a surfboat, a lifeboat, a tractor, truck, and automobile. On the left side of the second floor, there was a bathroom and three bedrooms for two surfmen each (Figure 99). The center section of the second floor

contained a large day room and three more bedrooms large enough for four crewmen each. The right side of the second floor had four more bedrooms, and a kitchen, dining room, living room, and laundry room. The third floor was used for storage space, but during WWII, the area was converted into additional living quarters for the patrolmen (Figure 100).¹⁴⁴ Windows and doors were all weather-stripped with copper. The building was completely electrified with “. . . electric ranges, refrigerators, etc.” An oil-burning heating system serviced the entire building. The station also boasted the “latest style” of one-piece, stainless steel sinks.¹⁴⁵ The old Life-Saving Service bell was removed from its stand on the top of the hill and put into a new stand east of the building.¹⁴⁶

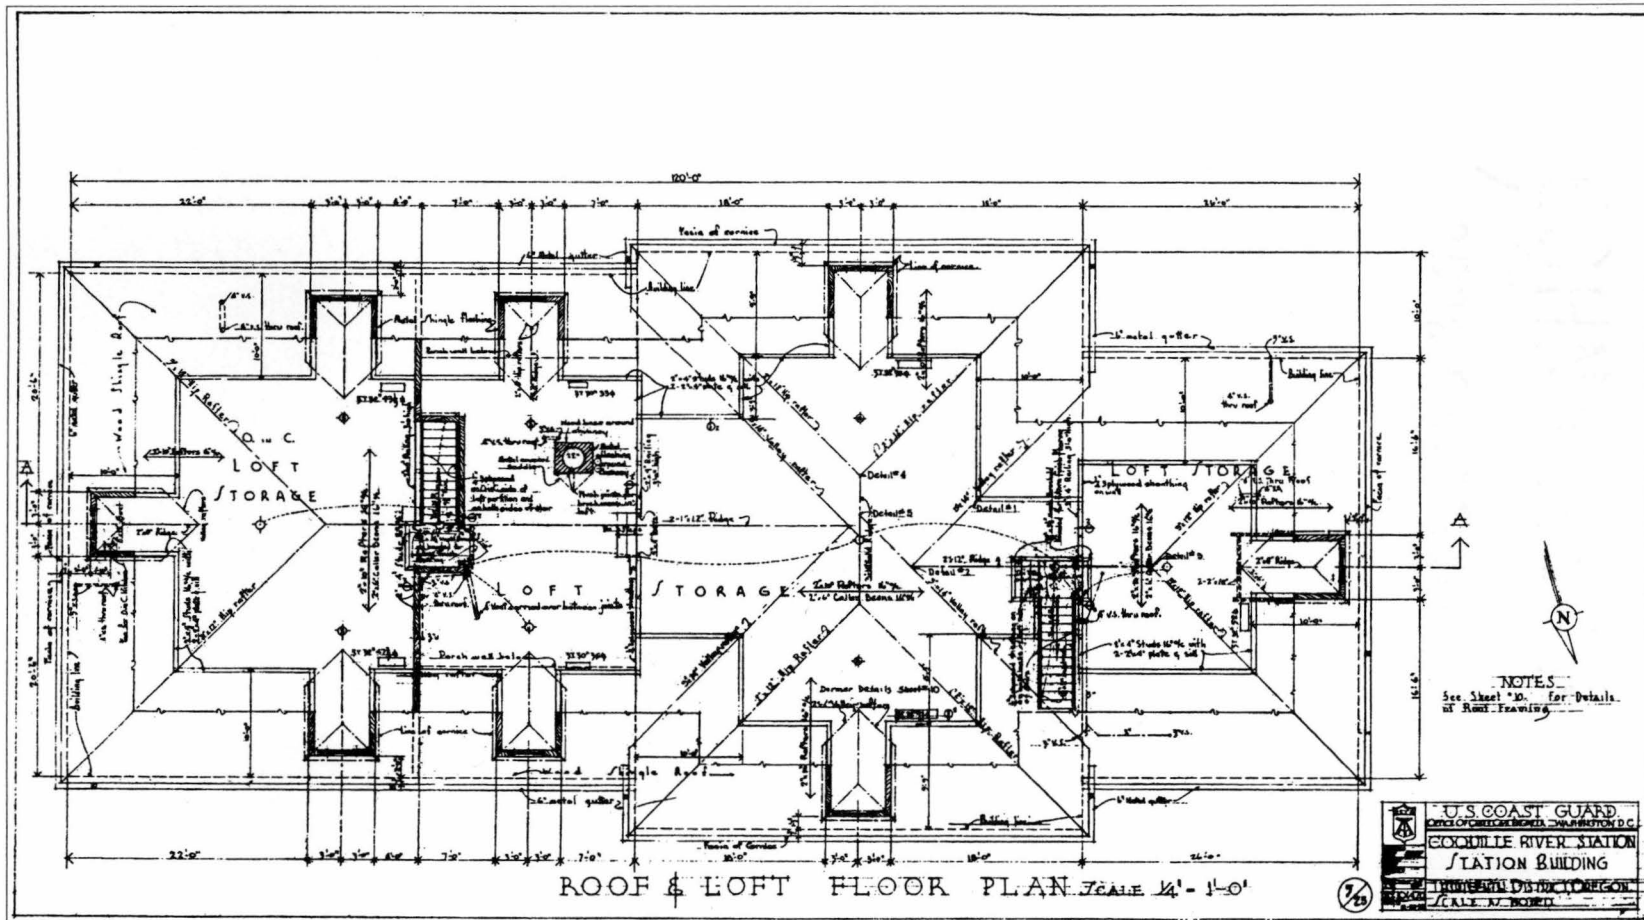
Figure 100. Coquille River Lifeboat Station, Attic Plan, 1938. Source: U.S. Coast Guard Civil Engineering Unit, Oakland, CA.

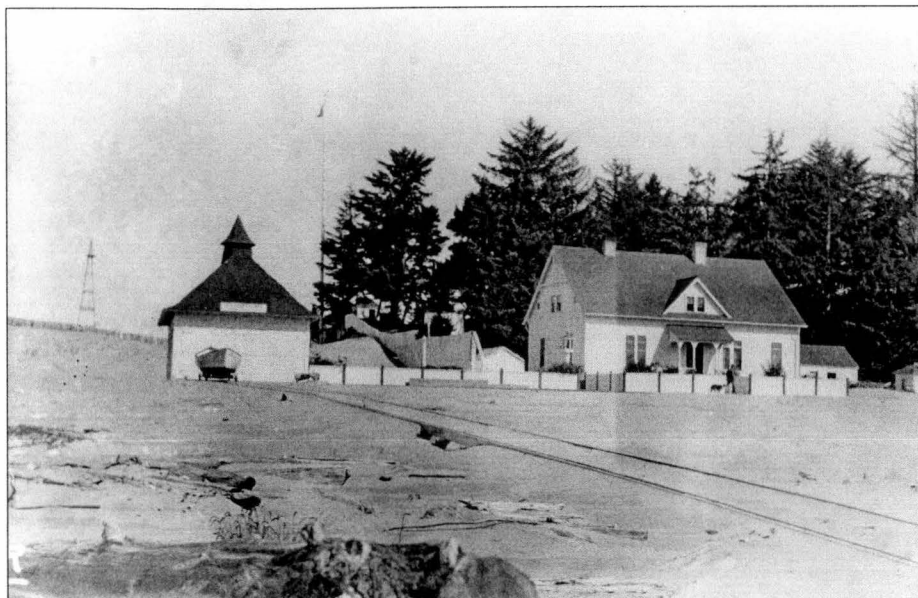
Figure 105. Umpqua River Life-Saving Station, 1923. Source: U.S. Coast Guard Headquarters (Umpqua River File).

the standard Marquette plan with a Fort Point-type boathouse (Figure 105) as described in Chapter III. The station complex was located on a small area of stable soil, 1800' southwest of the base of Army Hill, adjacent to the river beach. In general, the 50' by 30' house was divided by a central hallway and stair with the right half reserved for the keeper and the left half for the crew. On the main floor, the keeper's living room, office, kitchen and pantry were to the right. On the left was the crew's living room and quarters. Upstairs, the right half contained bedrooms for the keeper and his family. On the left was the crew's locker room.

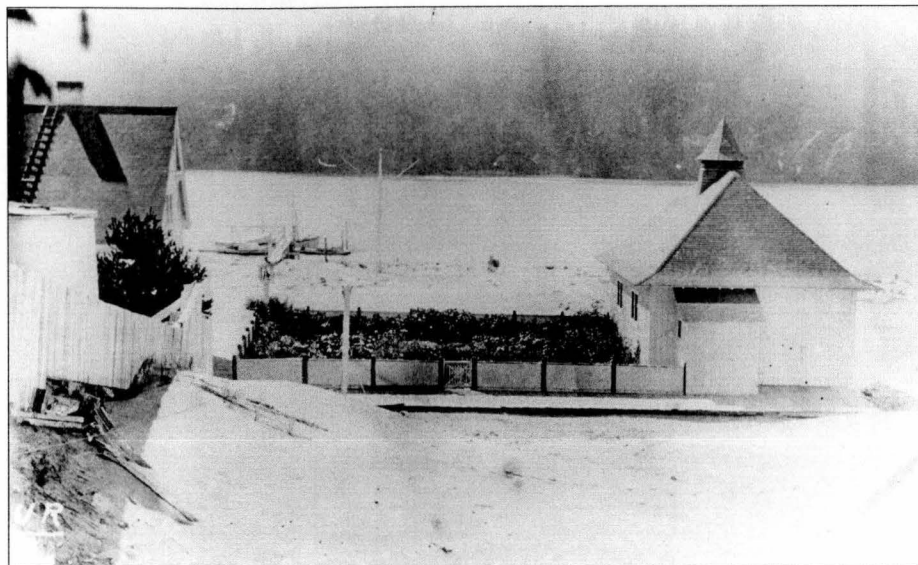
Figure 106. Behind Umpqua River Life-Saving Station, 1923. Source: U.S. Coast Guard Headquarters (Umpqua River File).

There were many auxiliary structures on the station grounds. At the water's edge, there was a small wharf. The wreck pole stood next to the landing. In the area between the boathouse and station house was a garden surrounded by a solid board fence (Figure 106). At the corner of the garden closest to the front of the station house was an elaborate bell stand. The bell was used to summon the crew in an emergency. The front yard of the station house was also surrounded by a solid board fence. No other station in Oregon appears to have had a solid fence suggesting that drifting sands were especially a

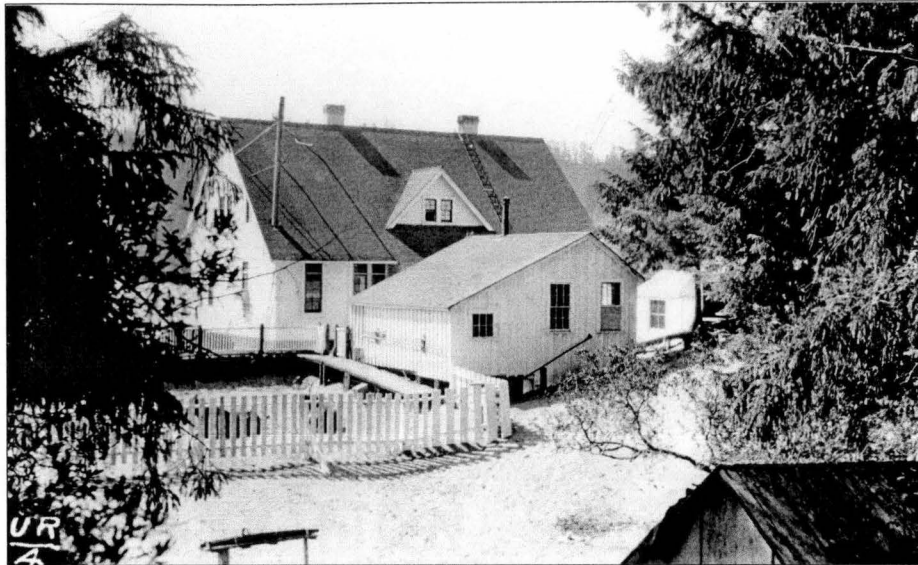
Figure 107. Shop Building Behind Umpqua River Life-Saving Station, 1923. Source: U.S. Coast Guard Headquarters (Umpqua River File).

problem at Umpqua. A solid fence also extends from the back of the station house toward the hill connecting up to the station's flag pole and a structure with a pyramidal roof. Directly behind the station house was a gable roof structure with lean-to, most likely the shop building (Figure 107). Attached to the shop building on its northeast side was a paddock area enclosed by a picket fence. According to Figure 107, there were two horses contained within this corral, the earliest sign (1923) of station horses found in Oregon. Another gable roof structure stood northeast of the corral, probably a small barn for the horses. A small pyramidal roof building was next to the barn. Southwest of the shop building was a small gable roof building. Behind that was the ubiquitous water storage tank. Wooden boardwalks connected the buildings. The lookout tower was

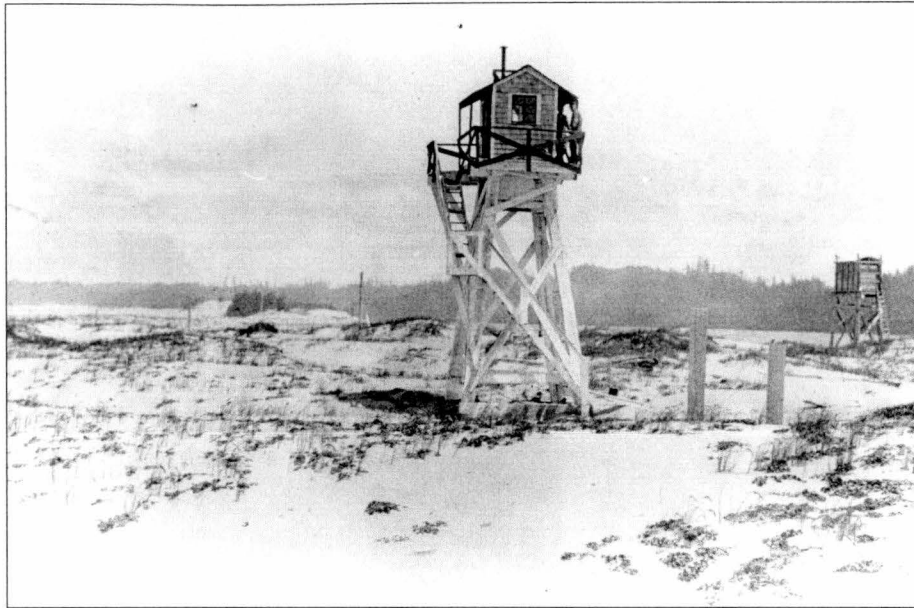
Figure 108. Lookout at Umpqua River Life-Saving Station, 1923.
Source: U.S. Coast Guard Headquarters (Umpqua River File).

located closer to the mouth of the Umpqua River about a mile away from the station house (Figure 108).

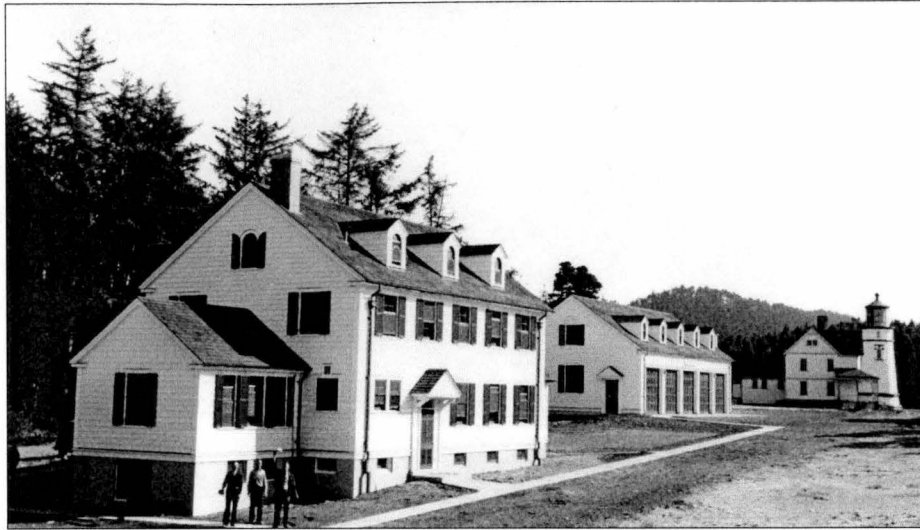
Figure 110. Umpqua River Lifeboat Station, 1939. Source: U.S. Coast Guard Headquarters (Umpqua River File).

rear elevation was an entrance door sheltered by a gable hood supported by distinguished brackets. The building was painted white with green shutters and a red roof.

The building was a commodious 80' wide and 32' deep, designed to sleep 17 but could easily handle more. In fact, 18 men were stationed there in 1956 and many more during WWII.¹⁶¹ On the first floor was a central stair hall, dividing officer's quarters to the left from the crew's living space on the right (Figure 111). On the left was the Officer in Charge's (OIC) office, living room, bathroom, and bedroom. On the right was the crew's mess, kitchen, and day room. At the end of the stair hall was a spare bedroom. The second floor was divided symmetrically into four bedrooms for the crew (Figure 112). Each room was setup to sleep four with four beds and four built-in lockers. At the end of the stair hall was the crew's bathroom with two toilets, two sinks, and two

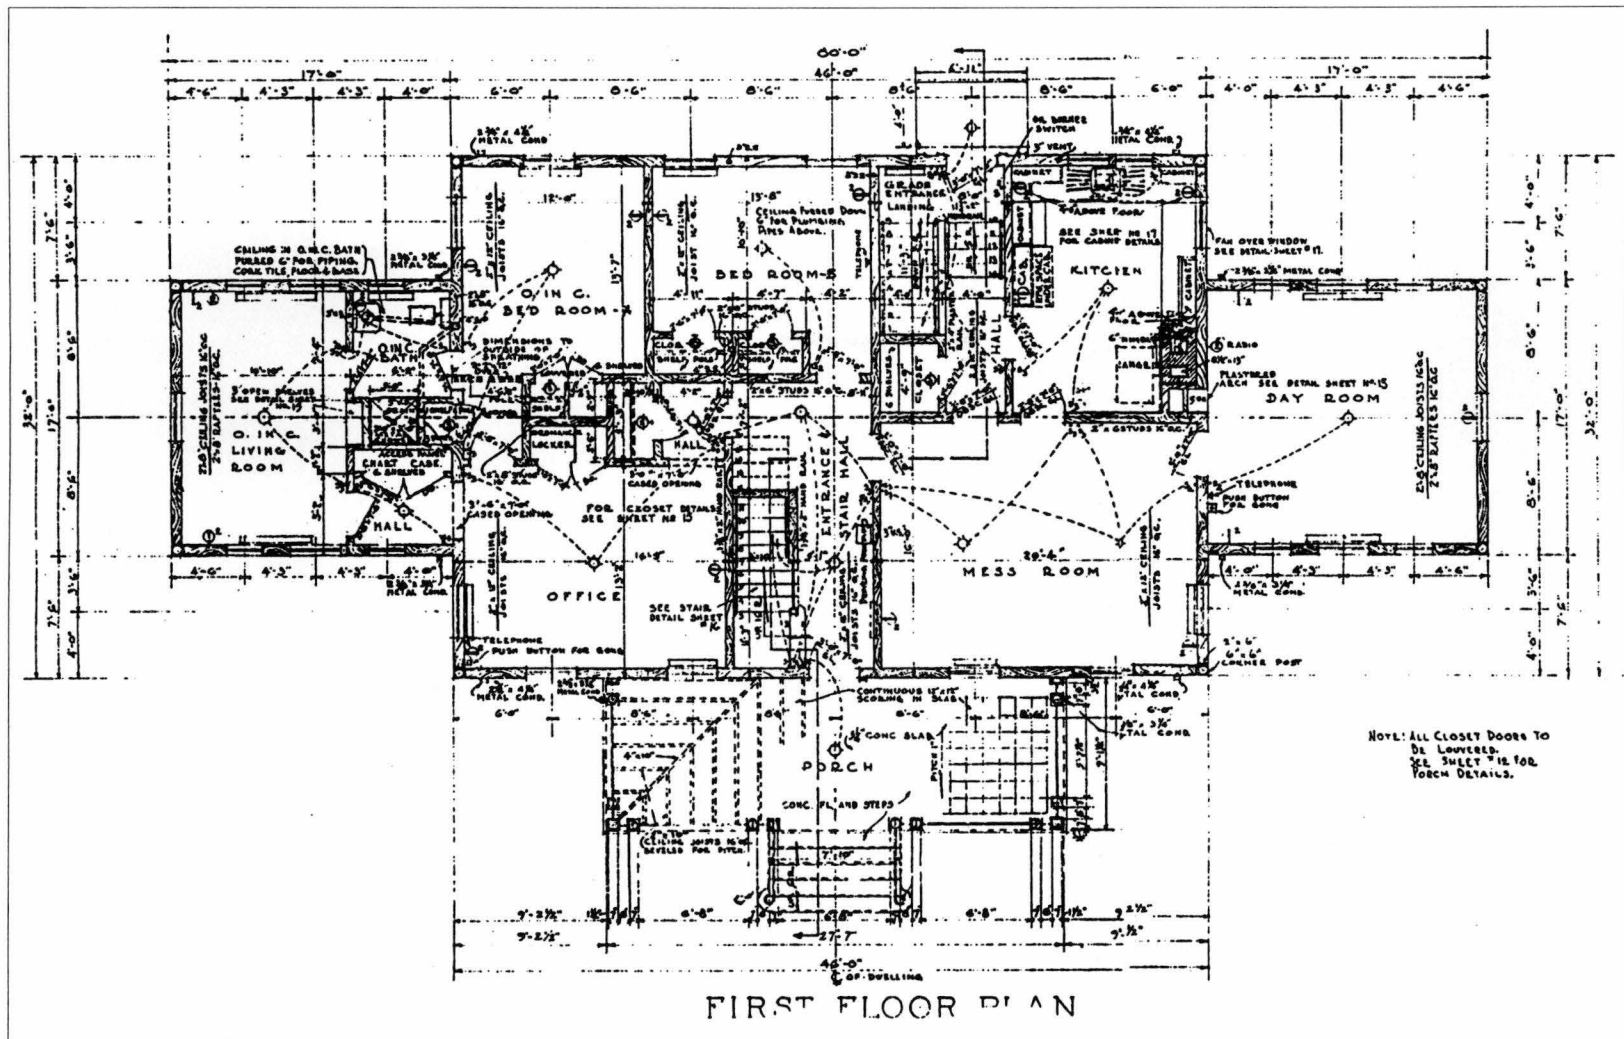
Figure 111. First Floor Plan, Umpqua River Lifeboat Station, Drawn October 1938. Source: Umpqua River Coast Guard Station National Register Nomination.

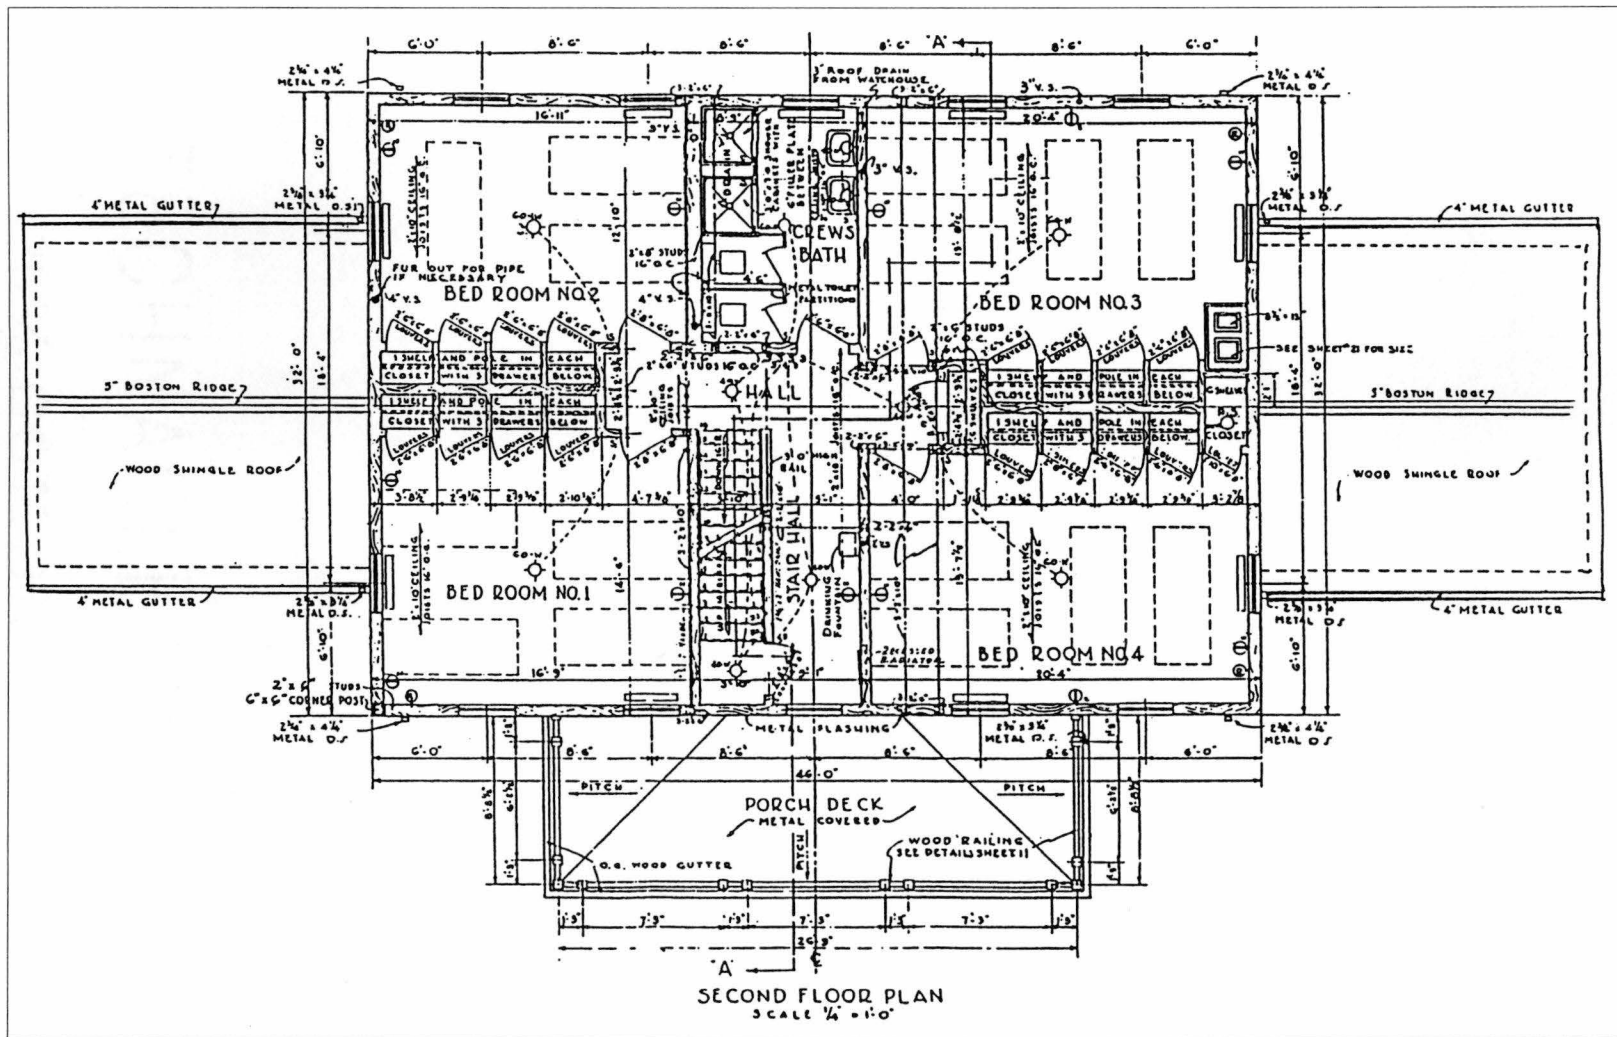
Figure 112. Second Floor Plan, Tillamook Bay Lifeboat Station, Revised Drawing May 1940. Source: Tillamook Bay Coast Guard Station National Register Nomination.

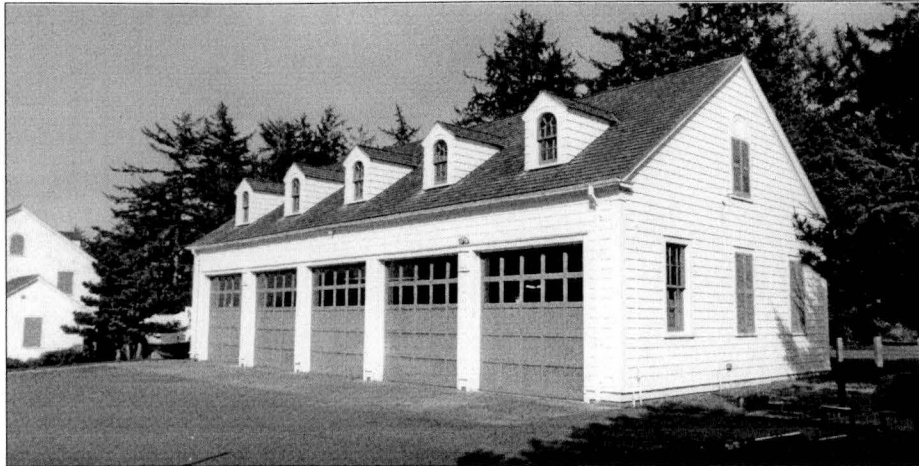
Figure 113. Equipment Building at Umpqua River Lifeboat Station, 1991. Source: Oregon State Historic Preservation Office (Umpqua River Coast Guard Station File).

A standard, five-bay equipment building was also built in 1939 to the north of the station (Figure 113). Stations starting in the 1930s all had what were called equipment buildings, which served as garages for vehicles and small boats, plus had storage space for equipment in the attic. The plan of the building was approximately 62' wide by 30' deep and built on a concrete foundation. The equipment building continued the Colonial Revival theme of the station house with its arched, multi-light windows in the dormers, eave returns at the gable ends, a lunette over the gable windows, and water table with cap. Each dormer was centered over a garage door that contained 10 lights over 15

panels. On the back side, there were five more dormers. The attic was divided into two dormitory rooms and a bathroom during WWII to house beach patrolmen.¹⁶² On the south elevation was an entrance door sheltered by a small gable hood supported by elegant brackets. The building was clad in shingles and finished with classical corner boards. It was painted in the same color scheme as the station house.

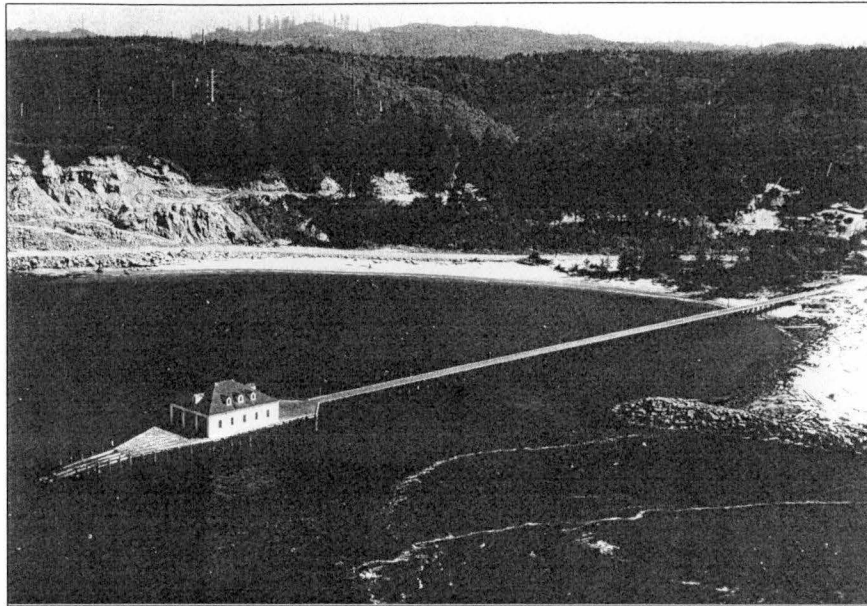
Figure 114. Boathouse at Umpqua River Lifeboat Station, 1962.
Source: U.S. Coast Guard Headquarters (Umpqua River File).

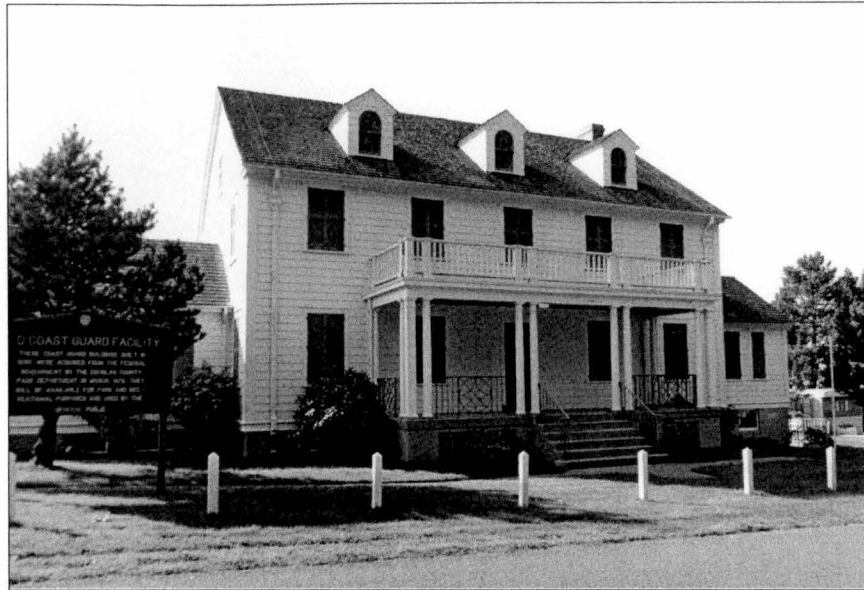
Figure 116. Station House at Umpqua River Lifeboat Station, 1991. Source: Oregon State Historic Preservation Office (Umpqua River Coast Guard Station File).

Fortunately, the Umpqua River Lifeboat Station is still quite intact when compared to the life-saving station (Figure 116). The boathouse was lost in 1966, but the 1939 station house and equipment building still stand thanks to Douglas County Parks. After Douglas County acquired it in 1976, they began the work of turning the station house into a local history museum. They retained all of the exterior features, right down to the operable shutters (Figure 117). Inside the station house, the mess room, OIC office, and day room were converted into exhibit rooms without harming the finishes. The histories of the Life-Saving Service and Coast Guard on the Umpqua River are on

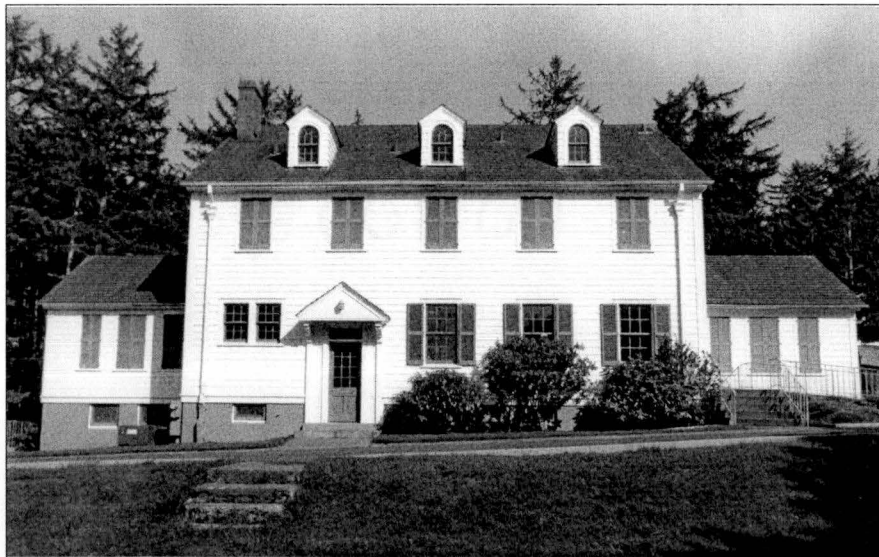
Figure 117. Rear Elevation of the Station House at Umpqua River, 1991. Source: Oregon State Historic Preservation Office (Umpqua River Coast Guard Station File).

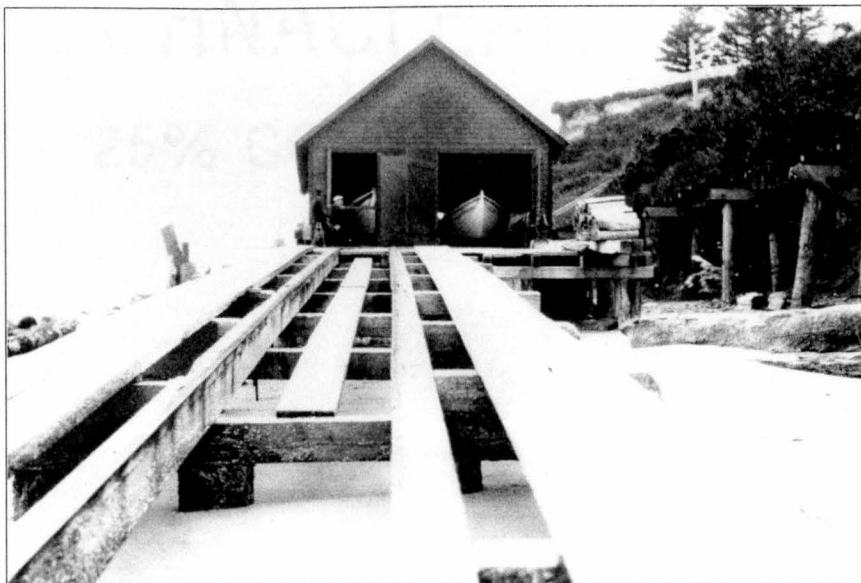
Figure 124. Yaquina Bay Station Boathouse After Move, 1923.
Source: U.S. Coast Guard Headquarters (Yaquina Bay File).

Lifeboats, as opposed to surfboats, were a more practical type of rescue boat on the Oregon Coast. Lifeboats were considerably larger and heavier than surfboats so they could not be easily hauled by hand to a launch site. Instead they were usually launched directly into the water from their boathouse down a long ramp. The lifeboats were cradled in carriages fitted with railway wheels correlating to rails on the launchway. This provided a quick launch and easy recovery of the boat. The station at South Beach had such a boathouse on the south shore of Yaquina Bay. It was a two-bay, gable roof boathouse built to hold two rescue boats (Figure 124). A switch was provided partway down the ramp so that only one set of rails went into the water.

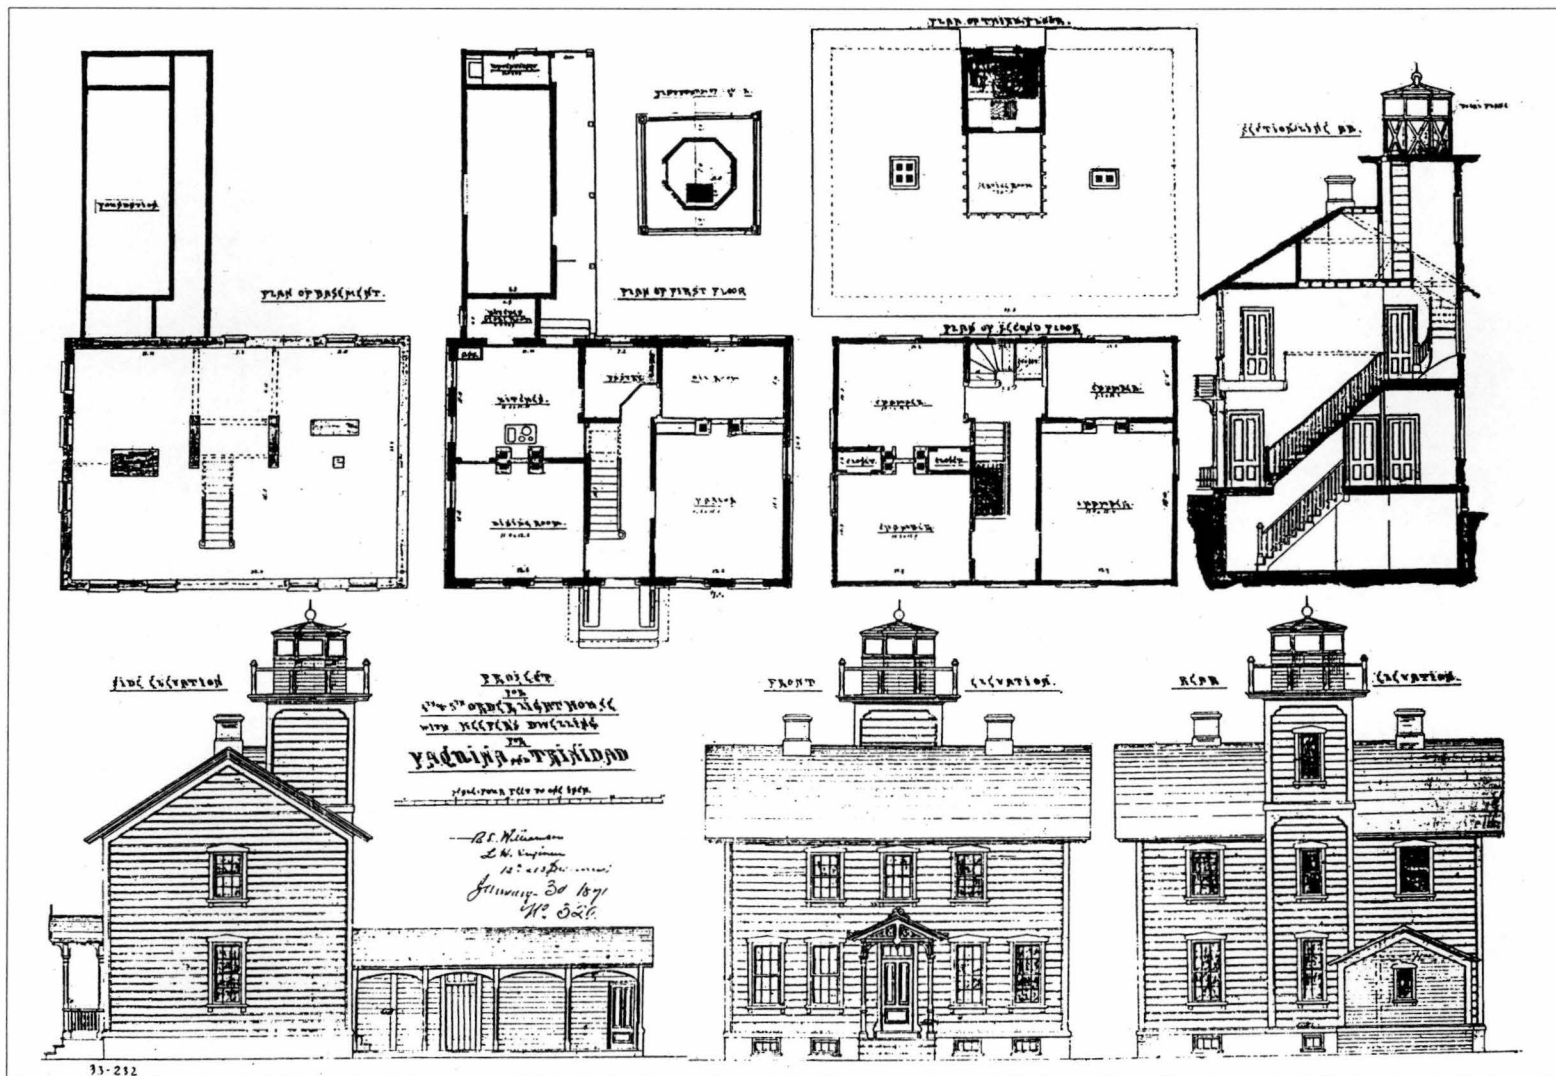
Figure 128. Williamson's 1871 Plans for the Yaquina Bay Lighthouse. Source: Nautical Research Centre (#33-232).

It is unknown how the life-savers adapted to the space in the lighthouse. Since it was a dwelling for a lighthouse keeper and his large family, the building most likely was used in the same manner. The life-saving keeper had his own house down the hill, so the crew had the run of the house. The main floor had a central hall plan, with the dining room and kitchen to the left, and the parlor and work room to the right (Figure 128). Upstairs were four bedrooms divided up among the crew. An eighth surfman was finally added to the crew on 1 May 1913, so the rooms would have divvied up evenly after then.¹⁸⁹ Storm clothes were probably kept in the basement.

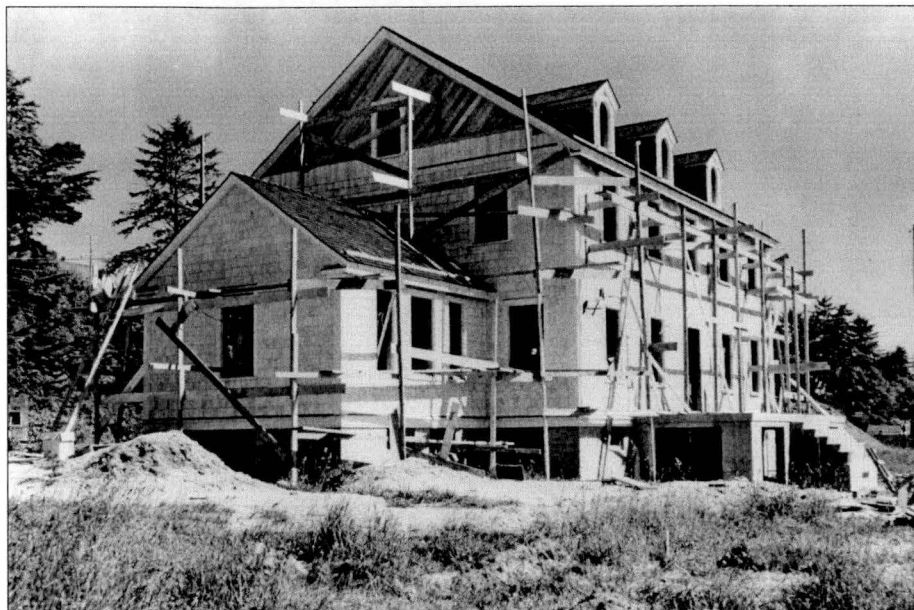
Figure 137. Yaquina Bay Station Under Construction, 1949. Source: U.S. Coast Guard Headquarters (Yaquina Bay File).

The crew lived at the Abbey Hotel after the fire for several months. Fortunately, beach patrol activities were scaling back with the war. The crew then moved into six temporary barracks moved to a site above the waterfront owned by the American Legion. However, due to postwar construction material shortages, it was not until 1948 that bids went out for the construction of two new Coast Guard buildings on a shelf of land east of the Yaquina Bay Bridge. The land had been purchased from the Port Commission in 1945 and had been used by the Coast Guard as a drill field. One building was to be a 2-1/2 story frame structure to contain the headquarters of the local Coast Guard and provide accommodations for a crew of 22 men, consisting of a bunk room, recreation room, galley, and mess hall (Figure 137). The other building was to be 1-1/2 stories on a

concrete slab and used to house motor equipment.²⁰⁴ Both buildings were built using Minalith fire-retardant treated fir.²⁰⁵

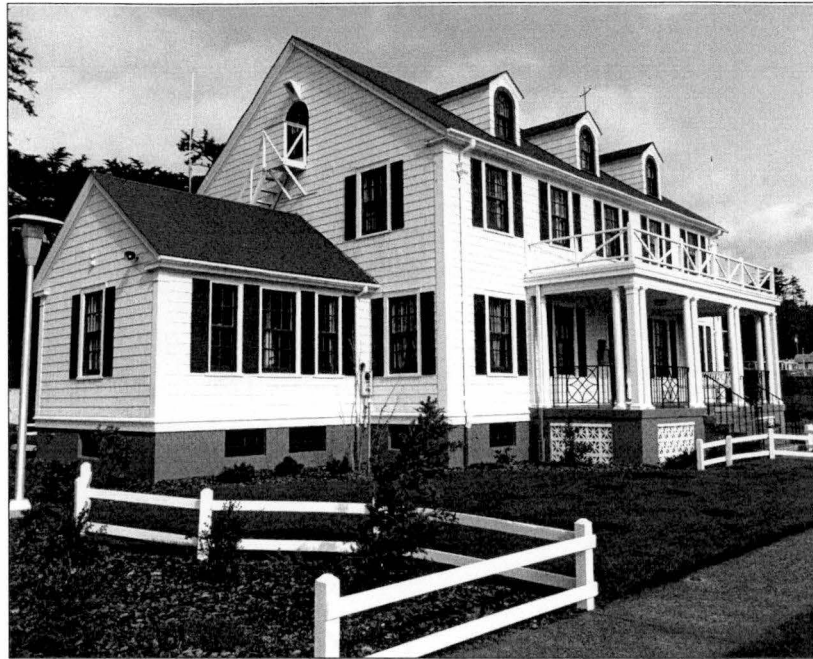
Figure 138. Yaquina Bay Station House, 1983. Source: U.S. Coast Guard Headquarters (13-CGD-0924830306).

The Coast Guard moved into their new station on 14 December 1949 (Figure 138). The day following, the six temporary buildings on American Legion land were transferred to the Legion in lieu of “restoration of the property and rent.”²⁰⁶ The buildings were located on Harbor Drive between 10th and 11th Streets and were eventually demolished to make way for Pacific Communities Hospital.²⁰⁷

The Yaquina Bay Coast Guard station built in 1949 on Naterlin Drive has turned out to be one of the last of the Roosevelt-type stations to be built in the United States. The station house has good integrity and is in excellent condition (Figure 139). The most glaring modification is an enlarged central dormer on its street-side elevation (Figure 140); however, its waterside (i.e., front) elevation is intact. The station is a great example of a late Roosevelt-type station, joining the ranks of the older Roosevelt-type stations at Point Adams (1938), Tillamook Bay (1942), and Umpqua River (1939). Continued use and maintenance of this station is the most practical option for the station house.

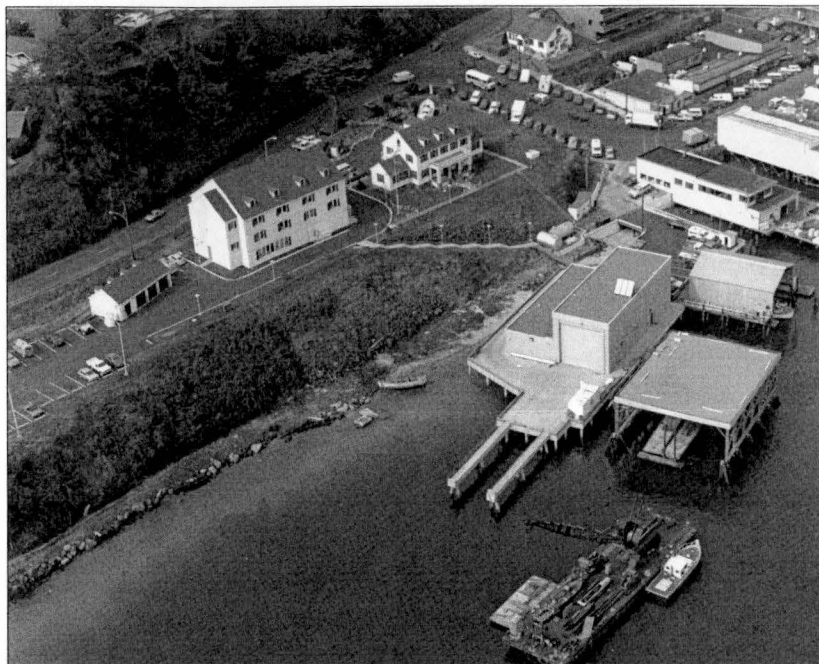
Figure 139. Yaquina Bay Station, 1983. Source: U.S. Coast Guard Headquarters (13-CGD-092283-07-06).

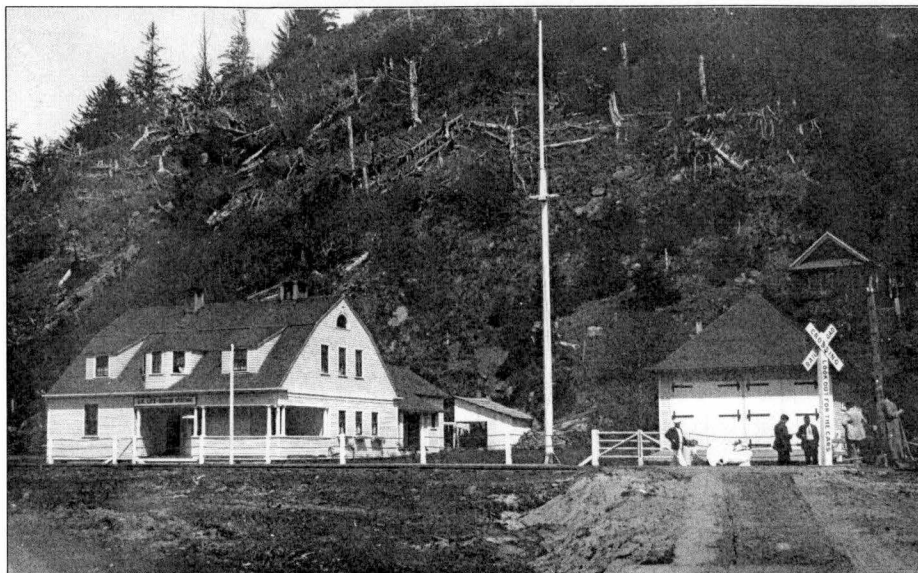
Figure 143. Tillamook Bay Life-Saving Station, Circa 1910. Source: Author's Collection.

designed by Bibb, but it was much squatter and less symmetrical with an integral porch (Figure 143). It had three dormers, again like the Fort Point-type, but the center one was three-sided to form a diminutive lookout tower. The 1-1/2 story station was sheathed in shingles. Detailing was Colonial Revival with Tuscan columns and lunette windows in the gables.

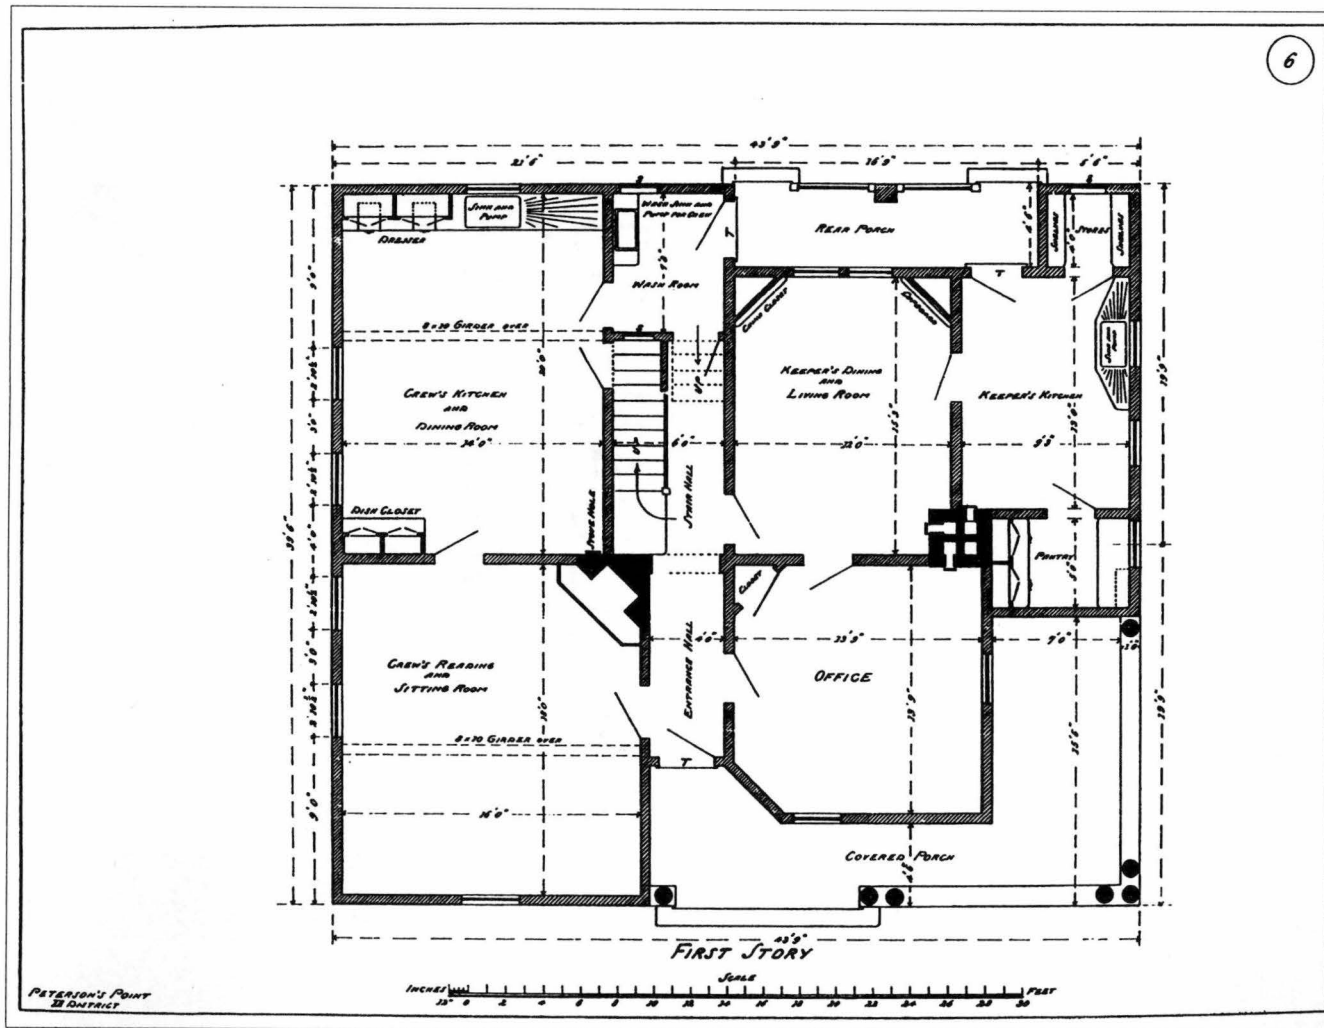
Unlike the earlier symmetrical plan at Point Adams, the Tillamook Bay station was simply balanced. The building was nearly square at 43' 9" wide by 39' 6" deep. It had a central hall plan, but an integrated porch wrapped around the right corner to counter the symmetry (Figure 144). The central hall divided the keeper's office, living/dining room, and kitchen on the right, from the crew's sitting room and kitchen/dining room on the left. At the end of the stair hall was a wash room. Upstairs,

Figure 144. First Floor Plan, Tillamook Bay Life-Saving Station. Source: Nautical Research Centre (#424).

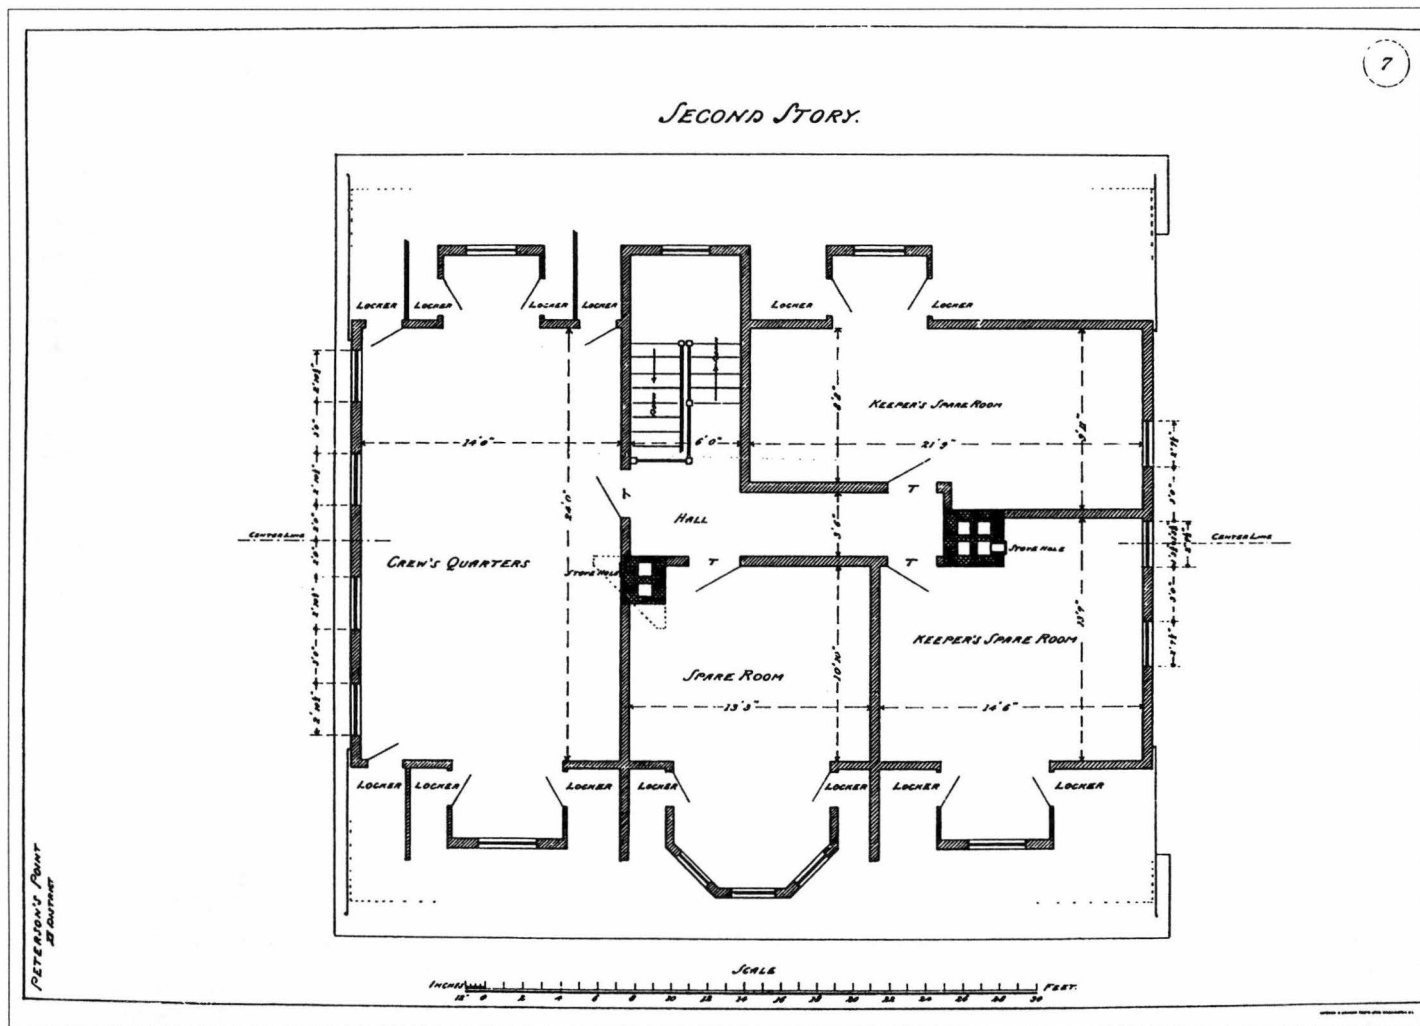
the right half contained two rooms for the keeper and his family, and the left half was the crew's quarters (Figure 145). In the center was a spare room for guests.

Figure 145. Second Floor Plan, Tillamook Bay Life-Saving Station. Source: Nautical Research Centre (#425).
