THE PRESERVATION OF PRE-WORLD WAR TWO
COAST GUARD ARCHITECTURE IN OREGON

A THESIS

Presented to the Interdisciplinary Studies Program:
Historic Preservation
and the Graduate School of the University of Oregon
in partial fulfillment of the requirements
for the degree of
Master of Science

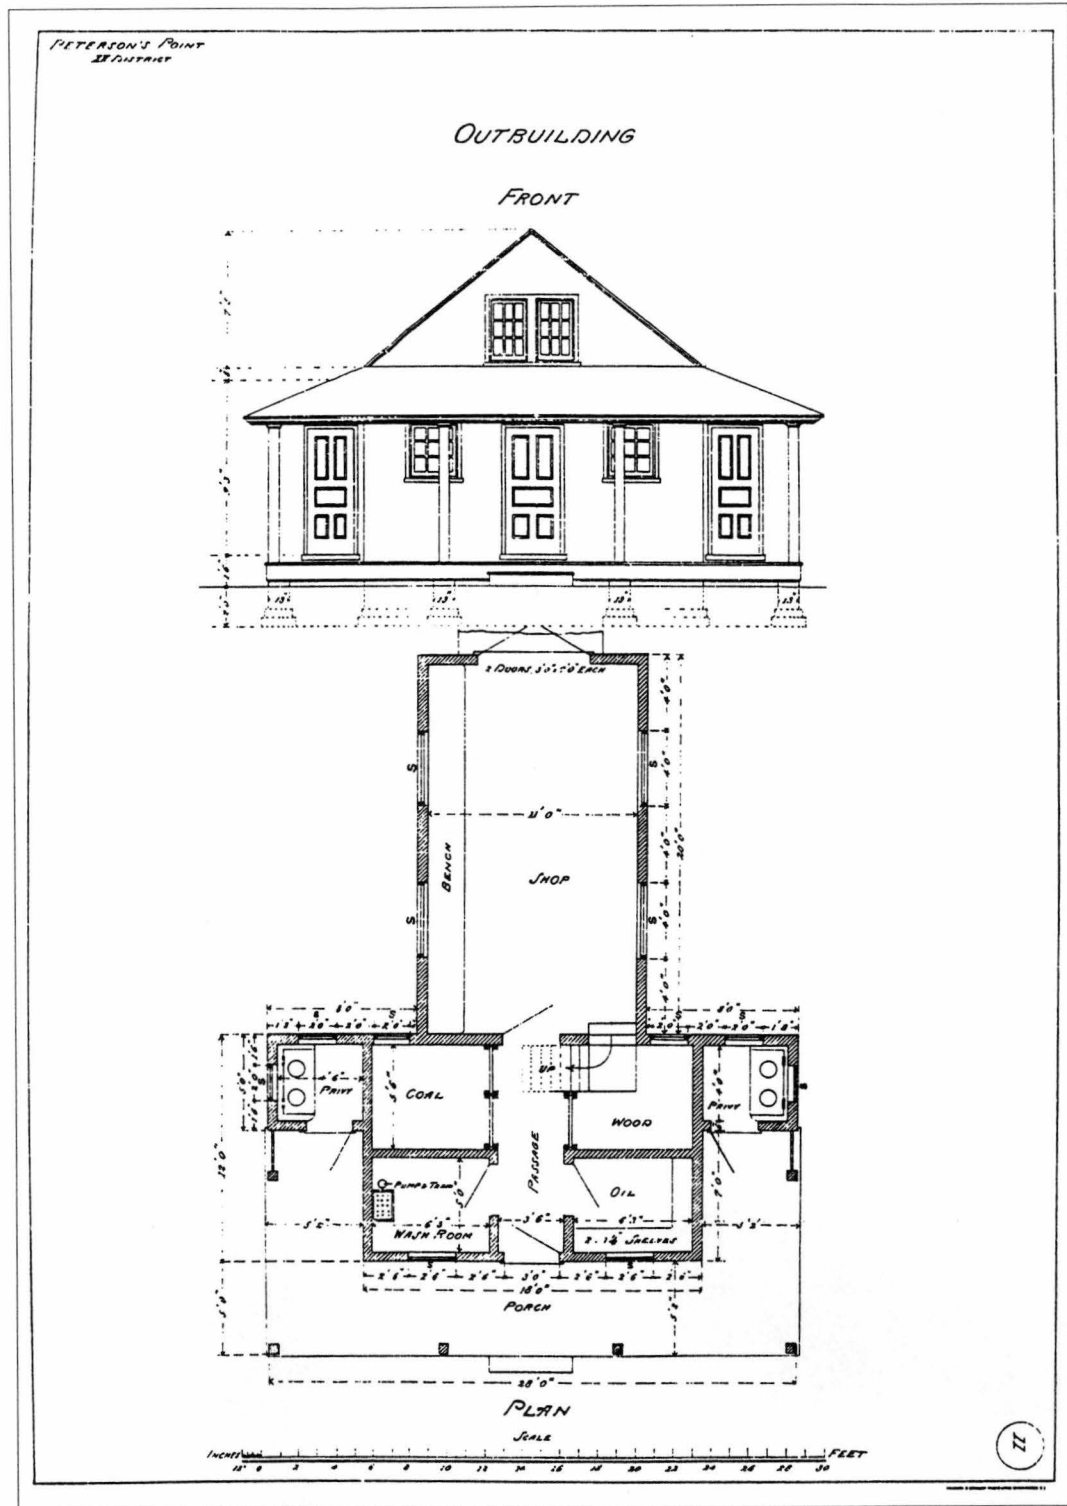
Unlike the Point Adams station that had an interior bathroom, Tillamook Bay had a washroom in the station house and two privies in a symmetrical shop building behind the station house (Figure 146). This building was quite unusual in that it is thought to be the only Life-Saving Service building to combine privy and shop into one structure. The building was one story in a T-shaped plan. It was 28' wide by 37' deep and had a wraparound porch on the front leading to the privies. A central hall plan led past coal, wood, and oil storage rooms, and back to the shop area. Upstairs was a loft space.

Figure 146. Floor Plan and Elevation, Shop Building, Tillamook Bay Life-Saving Station. Source: Nautical Research Centre (#429).

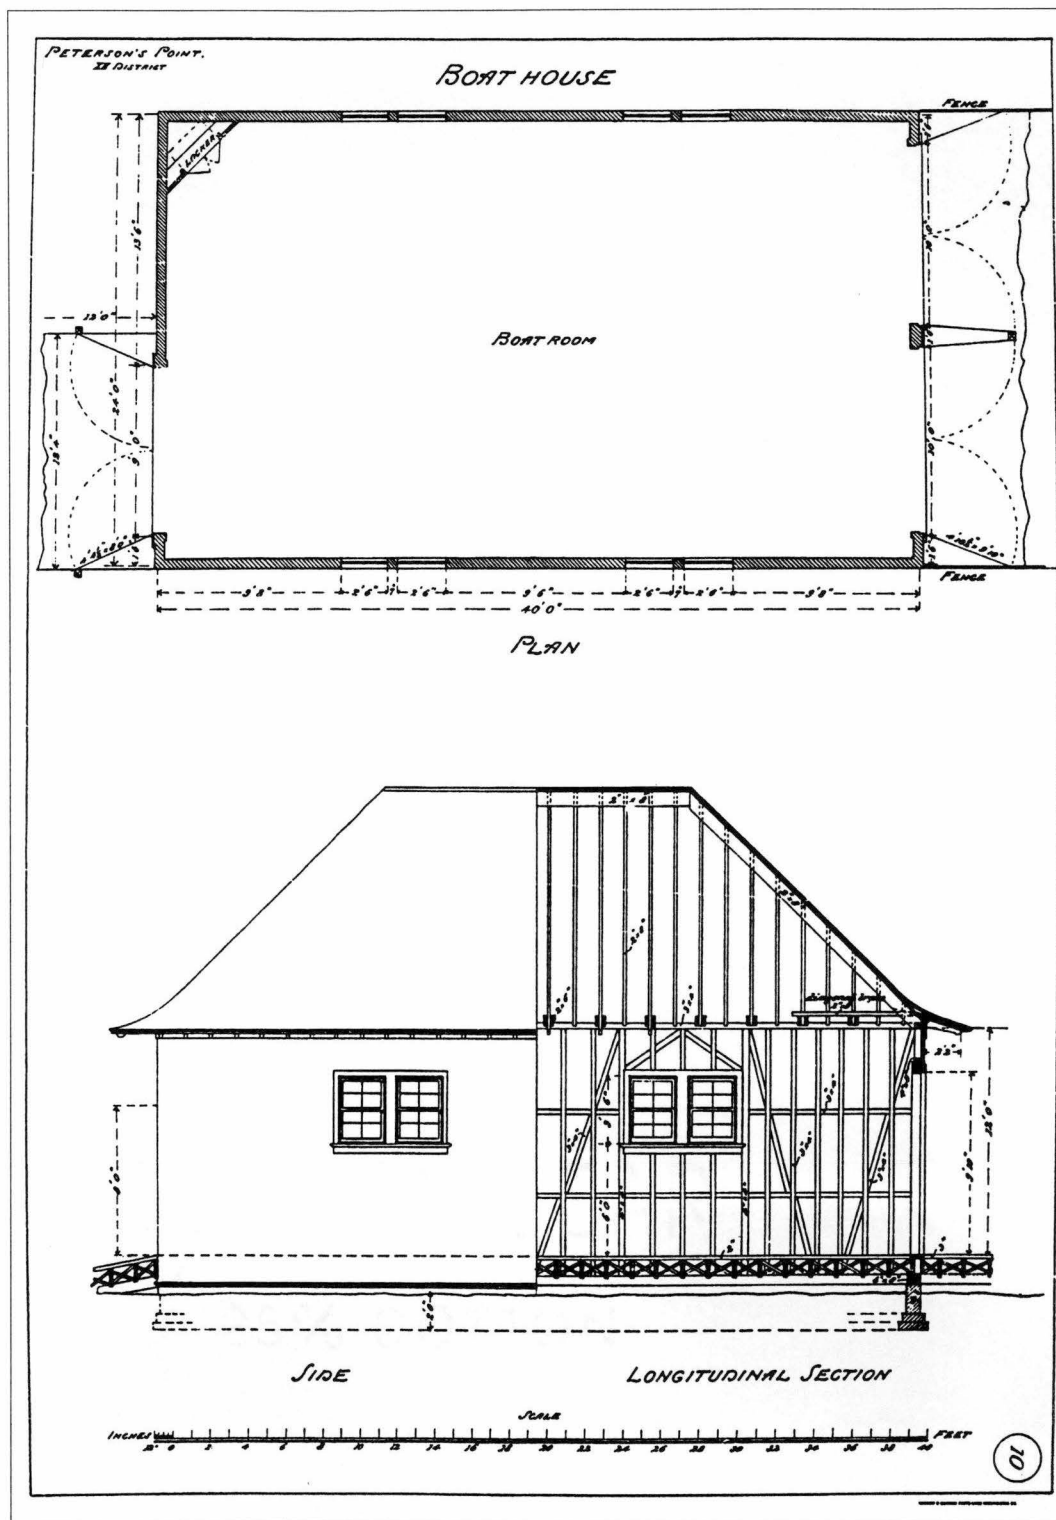
The boathouse was almost a direct copy of the Fort Point-type boathouse designed by Bibb, only simplified. It had the identical framing, it was one story, and it was rectangular in plan with the same overall dimensions, 24' wide by 40' deep (Figure 147). The structure was built on a concrete foundation, unlike the pilings of the Fort Point-type, and capped by a hip roof. One simplification was the elimination of the "witch's hat" ventilator. Admitting in light and ventilating the area were two sets of paired, double-hung windows on either side of the boathouse. Paired double doors on the front each led to a bay on the inside, one bay containing a surfboat and the other a lifeboat. Hinge details were simplified from the Fort Point-type (Figure 148). The rafters were used to hang equipment, such as the lifecar and breeches buoy. A small tool locker was situated at the back corner. A pair of doors led out the back.

Figure 147. Plan and Section, Boathouse, Tillamook Bay Life-Saving Station.
Source: Nautical Research Centre (#428).

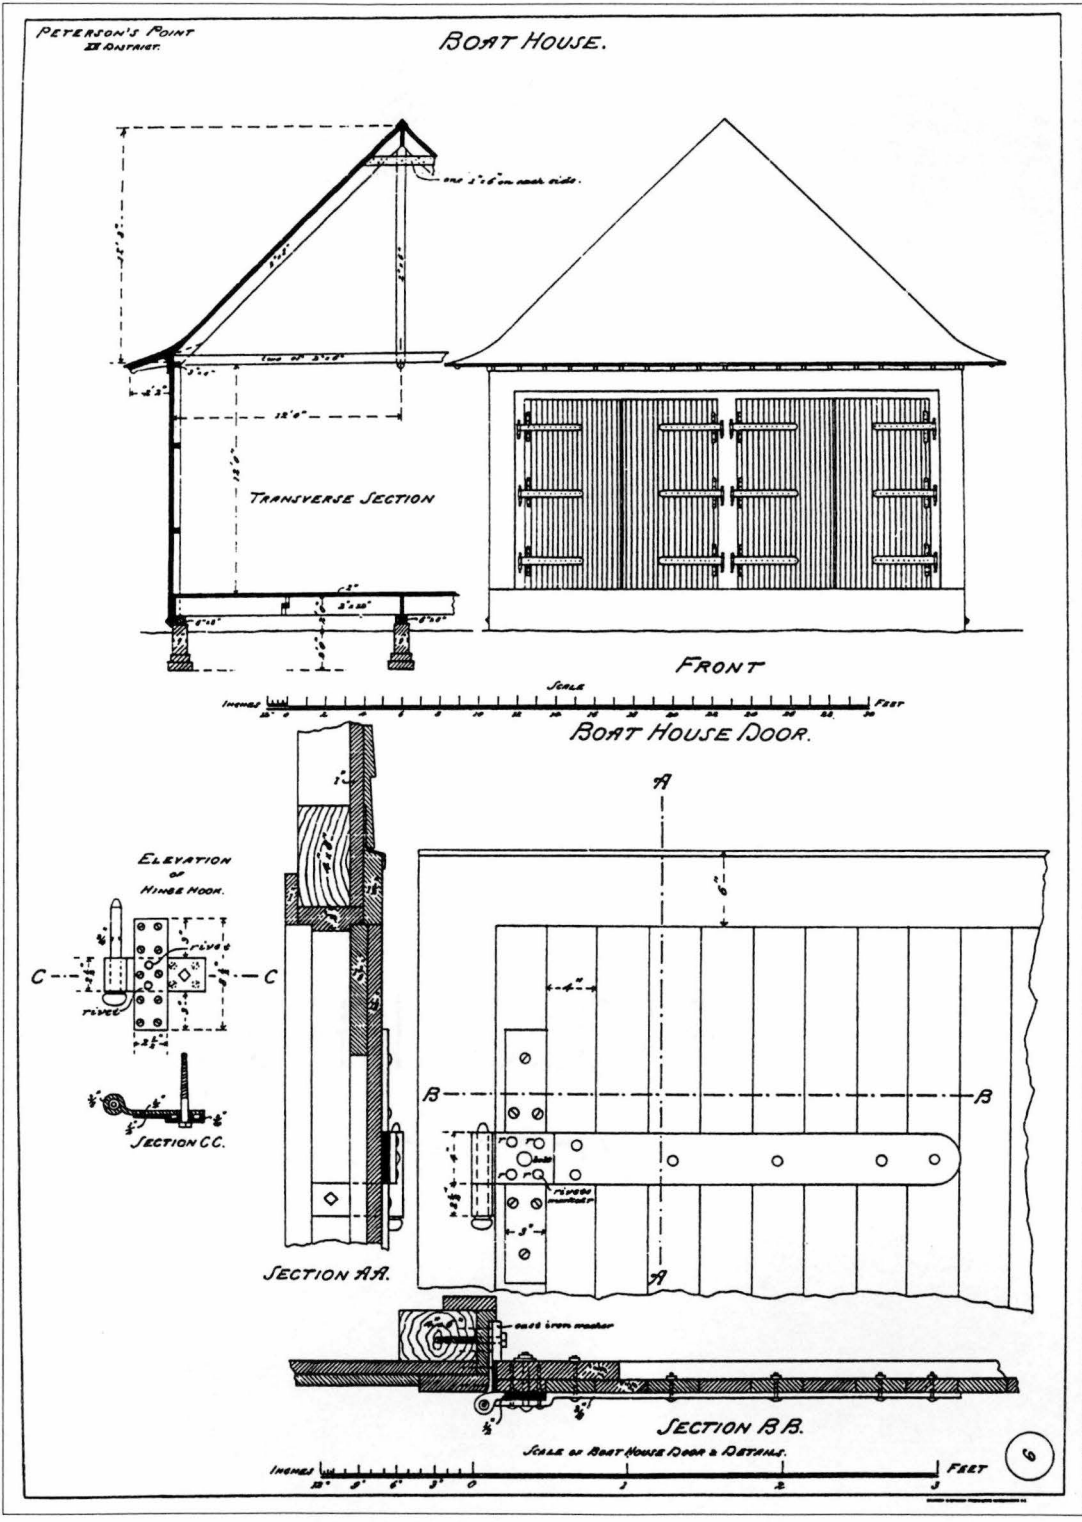
Figure 148. Boathouse Details, Tillamook Bay Life-Saving Station. Source: Nautical Research Centre (#427).

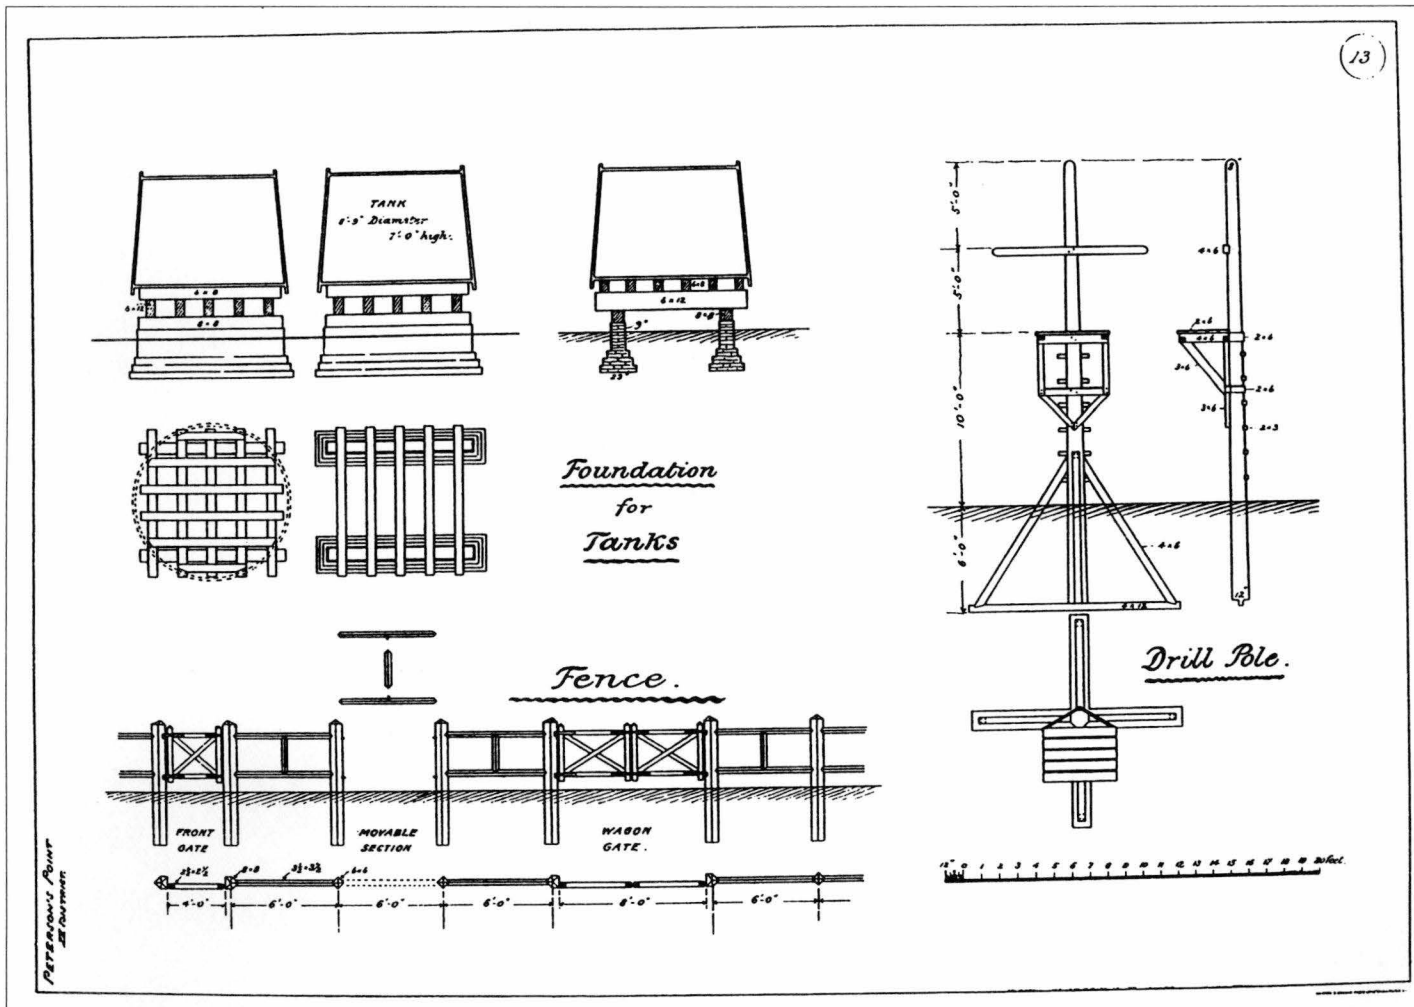
This was the only Oregon station plan found with drawings for ancillary structures (Figure 149). The water tank was placed up on the hillside to store water from

Figure 149. Auxiliary Structures, Tillamook Bay Life-Saving Station. Source: Nautical Research Centre (#431).

Lifesaving Creek. The rail fence, as designed, was first built as a series of posts connected by three hawser “rails.” A wooden gate was fashioned in front of the boathouse. Around 1923, the crewmen built the fence according to Mendleheff’s design. It is unclear where the wreck pole was set up. The area northwest of the station appears too small for a drill field. Most likely the wreck pole was located down on the beach. A flagpole between the station house and boathouse was replaced by a standard, 50' metal signal flag tower prior to 1923.

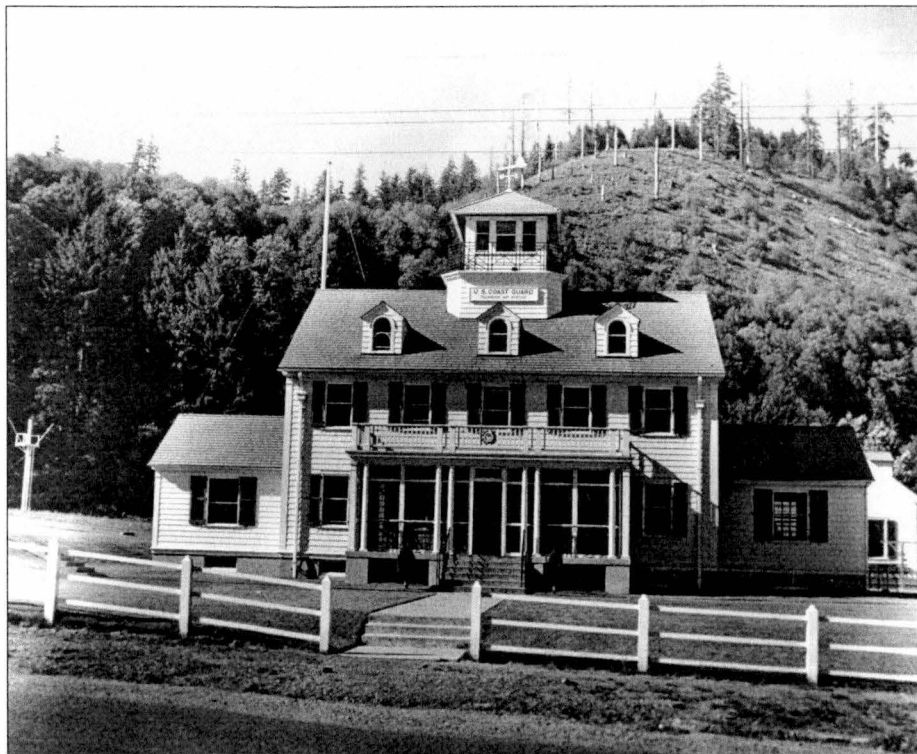
The new station was the third of the four Roosevelt-type stations to be built on the Oregon Coast (Figure 154). These stations followed a standard plan developed by the Coast Guard. Colonial Revival detailing was represented by multi-pane windows flanked

Figure 154. Tillamook Bay Lifeboat Station at Garibaldi, 1945.
Source: U.S. Coast Guard Headquarters (Tillamook Bay File).

by operable shutters, large Classical corner boards, Tuscan columns, eave returns, a water table with cap, and metal railings in Classical motifs. Even the restricted roof of the entry porch was rimmed with a balustrade. On the rear elevation was an entrance door sheltered by a gable hood supported by distinguished brackets. The building was painted white with green shutters and a red roof.

The Roosevelt-type station built at Garibaldi differed slightly from the stations at Point Adams (1938) and Umpqua River (1939). On the wings, the three windows on the front facade were replaced with a single, larger window. The arched windows on the end walls became simpler, wooden fan details over rectangular windows. Otherwise, from the exterior, all of Oregon's Roosevelt-type stations look the same. On the interior, the kitchen layout appears to have been the only change to the first floor plans between 1938 and 1940. The other floor plans did not change. The lifeboat station built at Yaquina Bay in 1949 followed the same plans as the Garibaldi station; however, like Umpqua River, Yaquina Bay was built without a lookout monitor.

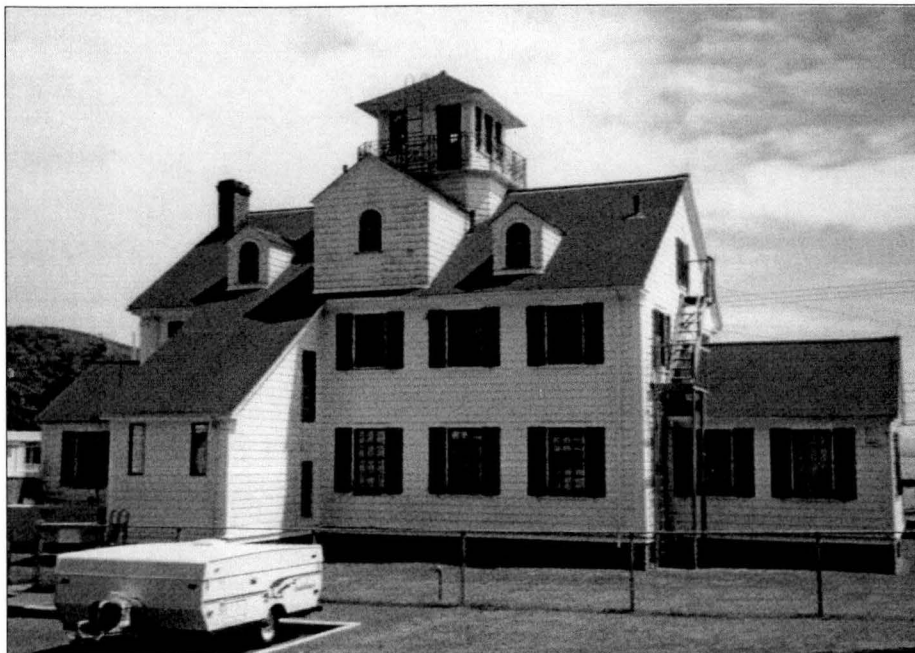
In 1986, the interior of the station house was rehabilitated into a duplex, with one family's quarters on the first floor and another family's quarters on the second floor. An obtrusive, shed-roofed stair tower was attached to the rear of the building to provide access to the second floor (Figure 155). The center dormer on the rear elevation was also

Figure 155. Rear Elevation, Tillamook Bay Lifeboat Station, 1997.
Source: Author.

enlarged. A metal fire escape has been attached to the exterior to provide an alternate exit from the attic and second floor. Other than a kitchen and bathroom rehabilitation, the first floor layout changed little. On the second floor, the interior stair was sealed off and a kitchen built over it. A dining room and living room were created out of two of the original bedrooms. Washer and dryer alcoves were built and several room entries reoriented. However, six of the original lockers are still present.²²³

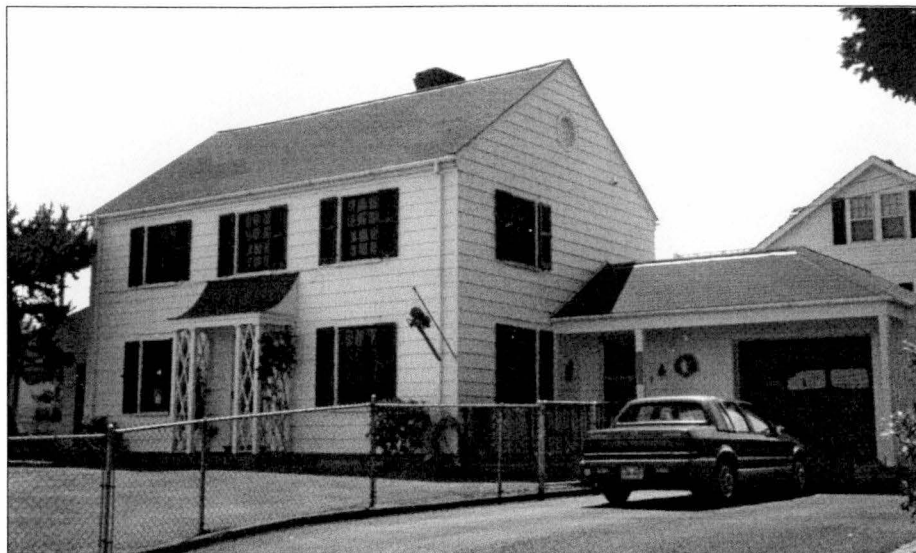
To the west of the station house is the Officer in Charge's (OIC) house. Built for an estimated \$25,000, it is a two-story, gable-roofed structure that continues the Colonial Revival theme of the station house (Figure 156). It has double-hung, nine-over-nine

Figure 156. Officer-in-Charge's House (1942), Tillamook Bay Lifeboat Station, 1997. Source: Author.

windows with operable shutters. Bull's-eye windows light the attic. The front porch is covered by a flared, shed roof supported by slender columns connected by thin, diagonal spacers. Like the station house, the OIC house has flanking, one-story wings. The south wing was originally an open porch and has since been glazed in. The north wing was an attached garage, which has now been converted into living space.²²⁴

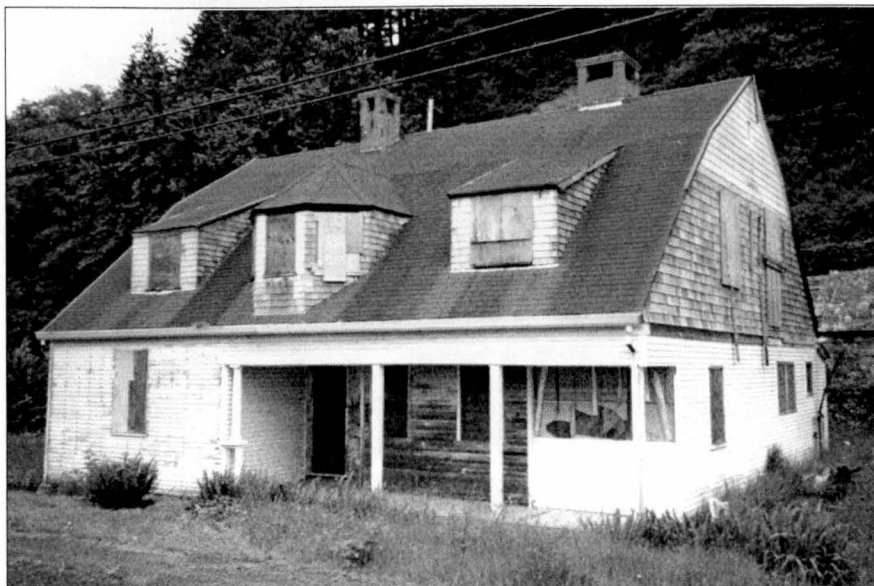
The station is the only remaining example of a Petersons Point-type station in the nation (Figure 157). The Tillamook Bay Life-Saving Station is a prime candidate for restoration (Figure 158). The original plans still exist, and there are many historic photos of the buildings. This is the only privately held station on the Oregon Coast. Unfortunately, an undersized sewer line for the town of Barview was installed through the property. The line occasionally backs up onto the property and into the station buildings. As a consequence, the buildings are condemned for human habitation. The owner, Gary Newkirk, has been in a legal entanglement with the sewer district over the issue for a decade. It is vital that the deterioration of these buildings be arrested.

Figure 157. Station House (1907), Tillamook Bay Life-Saving Station, 1997. Source: Author.

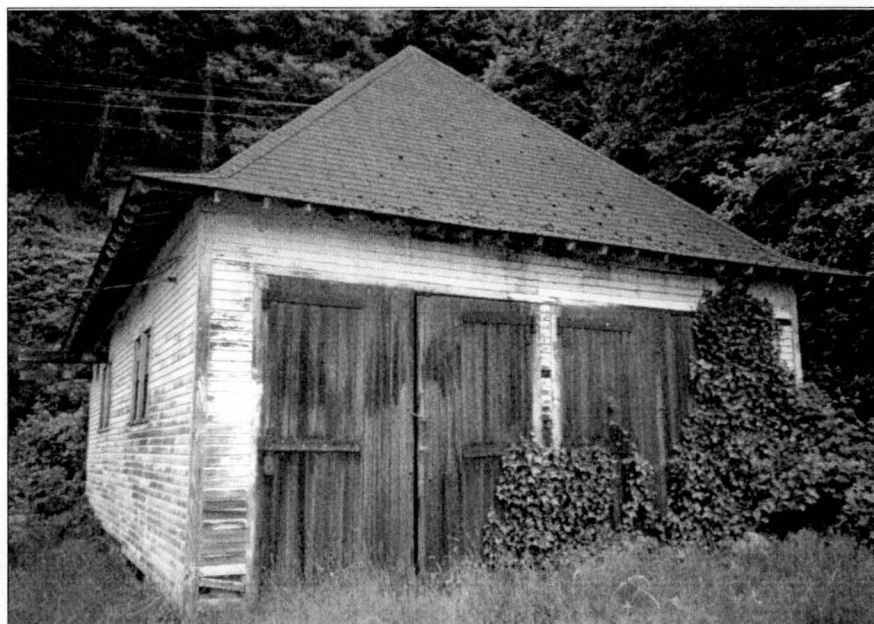
Figure 158. Boathouse (1907), Tillamook Bay Life-Saving Station, 1997. Source: Author.

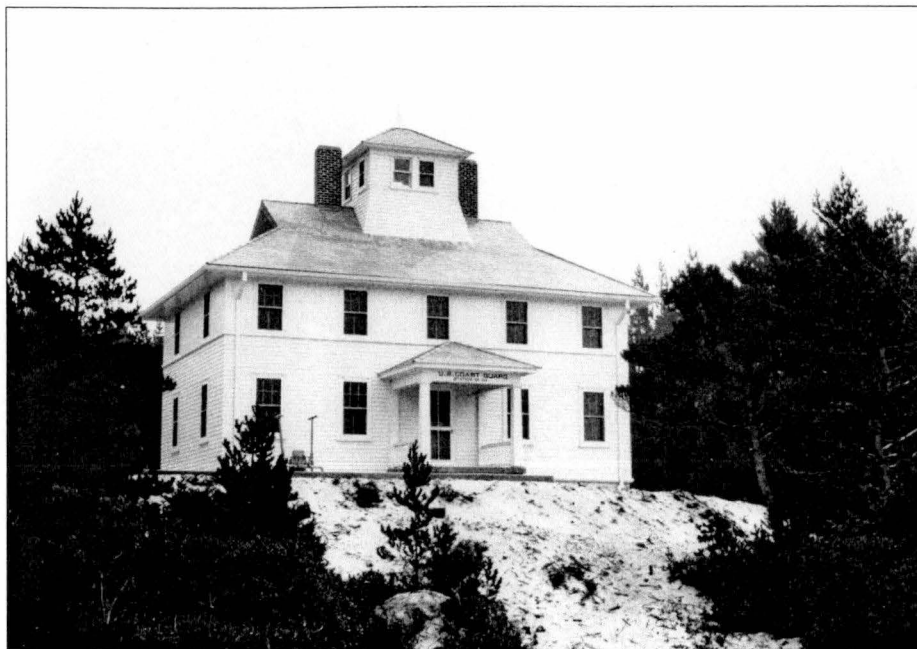
Figure 162. Siuslaw River Lifeboat Station, 1917. Source: U.S. Coast Guard Headquarters (Siuslaw River File).

The station built at the Siuslaw River is known as an early Chatham-type station (Figure 162). It was designed by Victor Mendleheff who had been designing stations for the Life-Saving Service, and then the Coast Guard, for 18 years prior to this station's design. Starting with the original Petersons Point design (1898) used at Tillamook Bay Life-Saving Station (1907), he had continued with Colonial Revival detailing and shingle surfaces through all of his 13 designs, including the Chatham-type. However, the Chatham station marked a sudden departure from the 1-1/2 story stations that had been the hallmark of the Life-Saving Service and brought the station to a full two stories in height. This aligned with the decade by decade trend of giving the crew more living space. At least 30 Chatham-type stations were built on both East and West Coasts marking the first time since the Marquette-type stations of a standard, nationwide architecture. Variations on the Chatham-type station continued to be constructed through the 1930s.²⁴² In fact, the 1934 station built at Port Orford is representative of the tail end of development of the Chatham-type in the United States. From that point on, the Coast Guard transitioned to the Roosevelt-type stations.

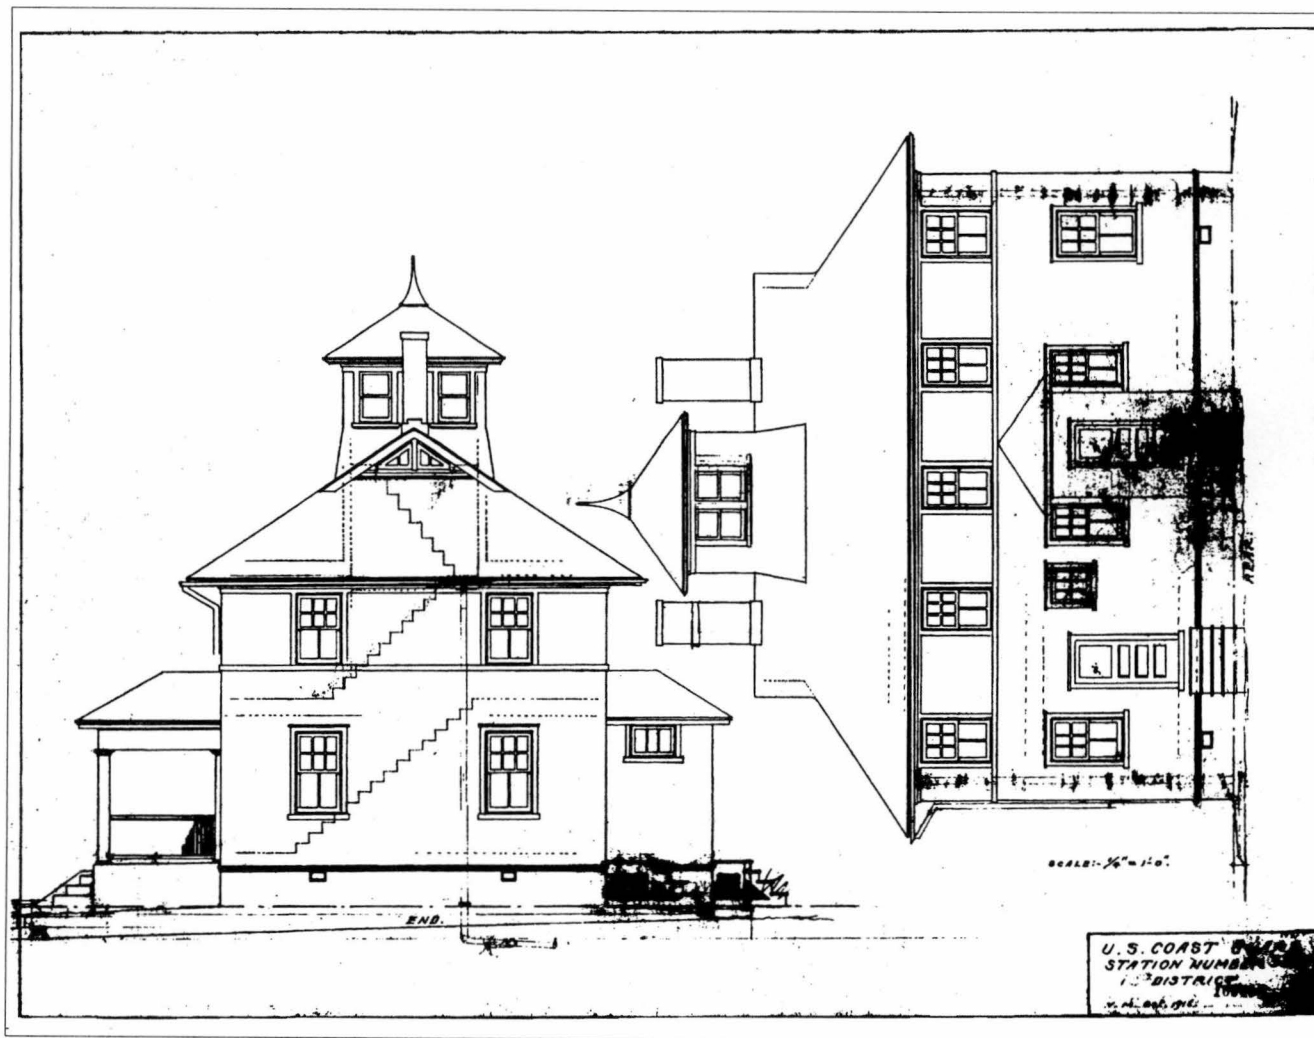
The station house was symmetrical, 39' 8" wide and 24' 6" deep, clad in shingles, with a hipped gable roof (Figure 163). The roof was surmounted by an integrated lookout tower nestled between two brick chimneys. Windows were double-hung, six-over-two, though in the tower, the windows were one-over-one for increased visibility (Figure 164). The hipped roof of the entry porch was supported by square, battered columns and connected to the building by a balustered rail. Mendleheff had gradually

Figure 163. Siuslaw River Lifeboat Station, Side and Rear Elevation Drawings, October 1916.
Source: U.S. Coast Guard Civil Engineering Unit, Oakland, CA.

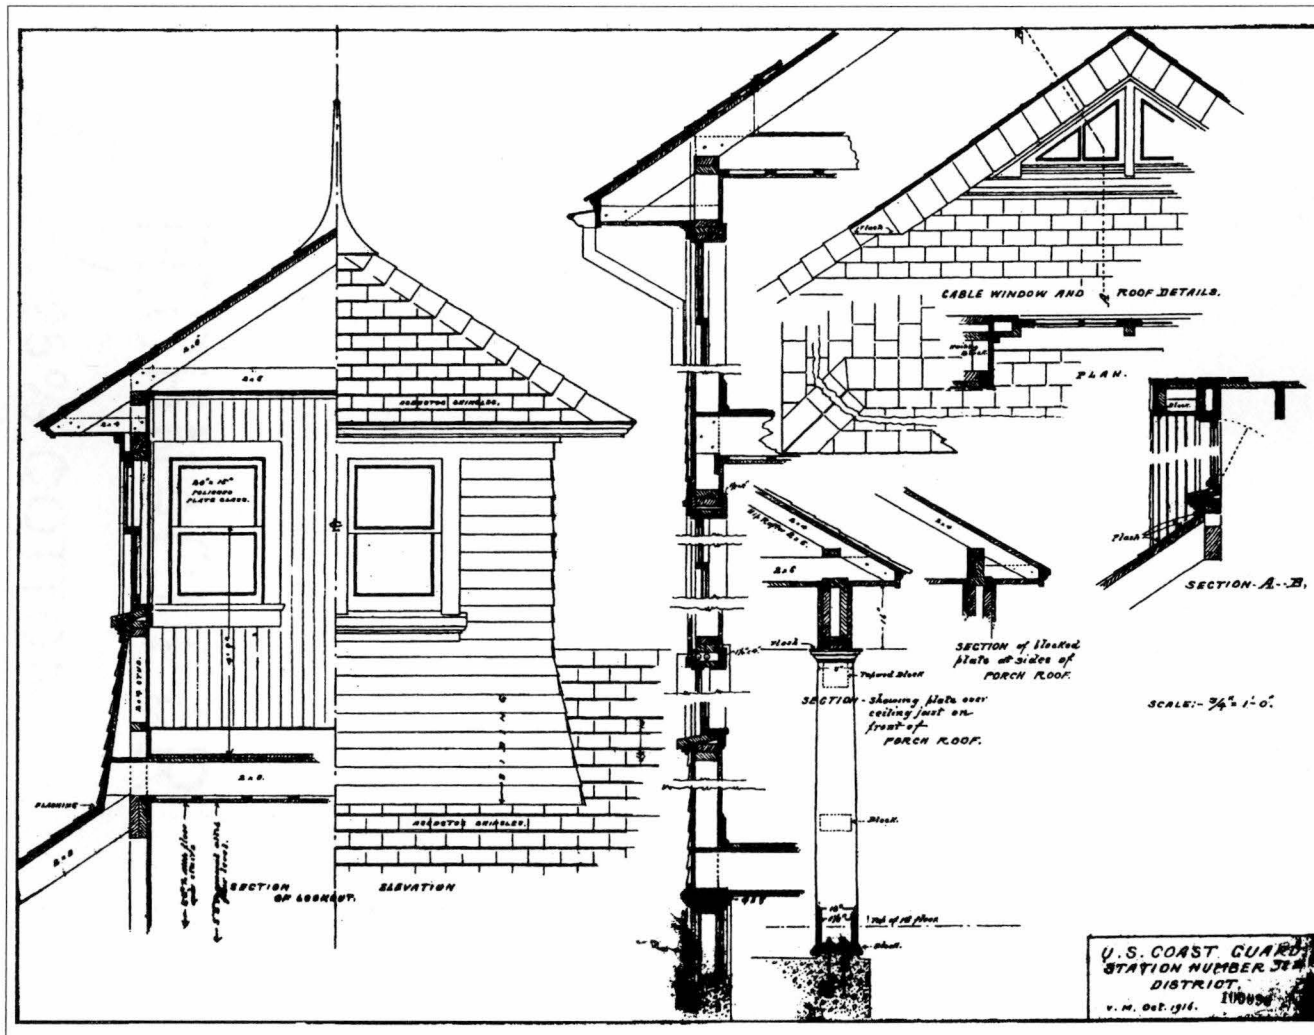
Figure 164. Siuslaw River Lifeboat Station, Monitor and Wall Section, October 1916. Source: U.S. Coast Guard Civil Engineering Unit, Oakland, CA.

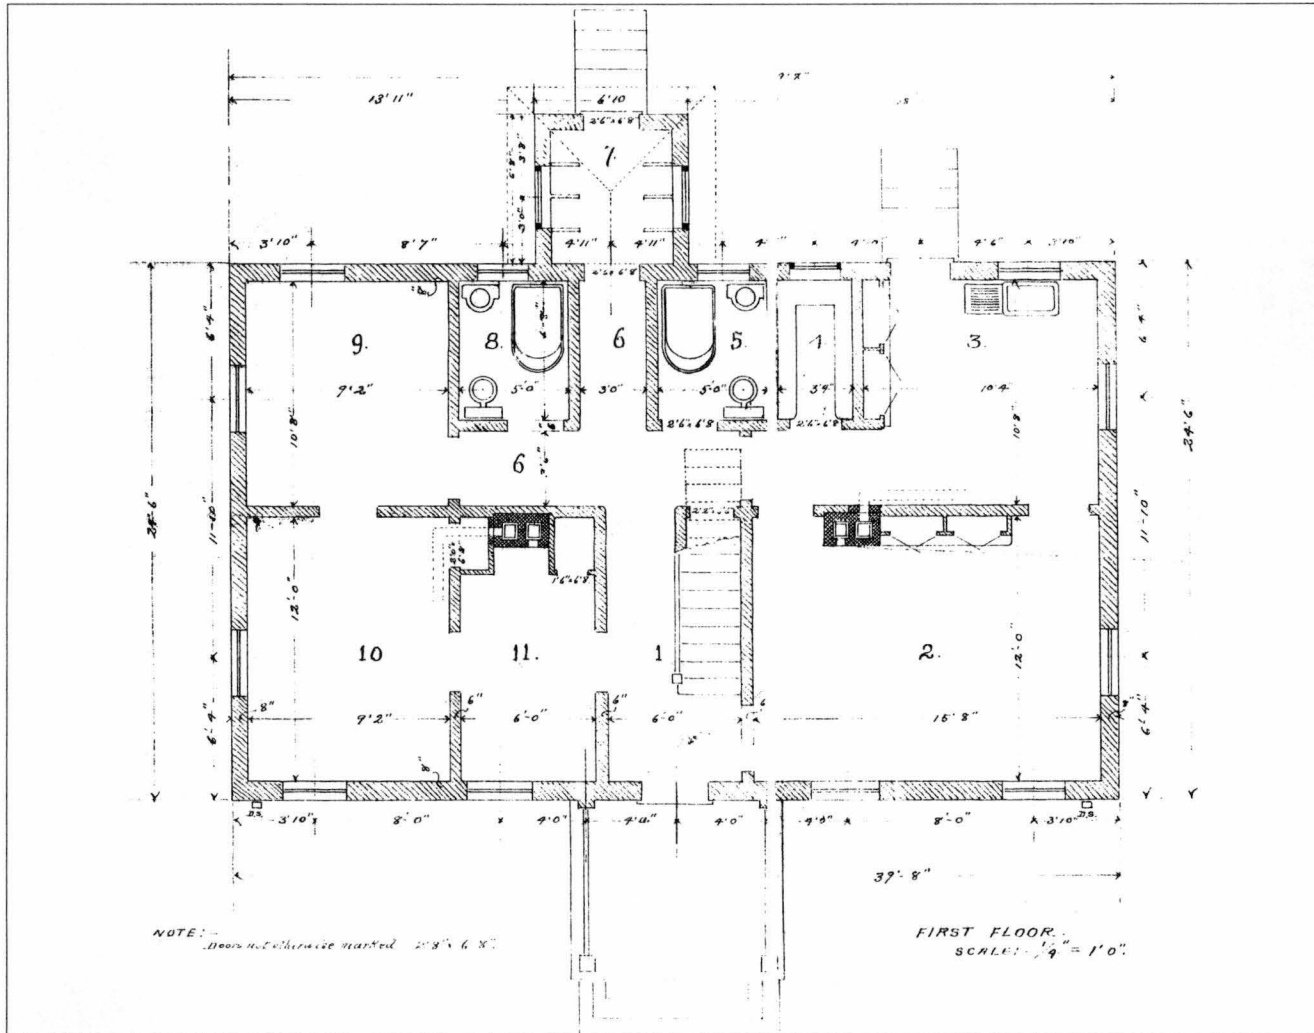
Inside the station, the storm clothes room of Hatteras was replaced with a second bathroom at Siuslaw (Figure 165). A spare bedroom at Hatteras was replaced by a kitchen and pantry at Siuslaw. The office at Hatteras was divided into two rooms at Siuslaw. Mendleheff seemed willing to reconfigure the station house in a multitude of ways, customizing it for the needs of different locales. Only in size and window placement did the two stations have a common first floor plan. Upstairs, the two plans

Figure 165. Siuslaw River Lifeboat Station, First Floor Plan, October 1916. Source: U.S. Coast Guard Civil Engineering Unit, Oakland, CA.

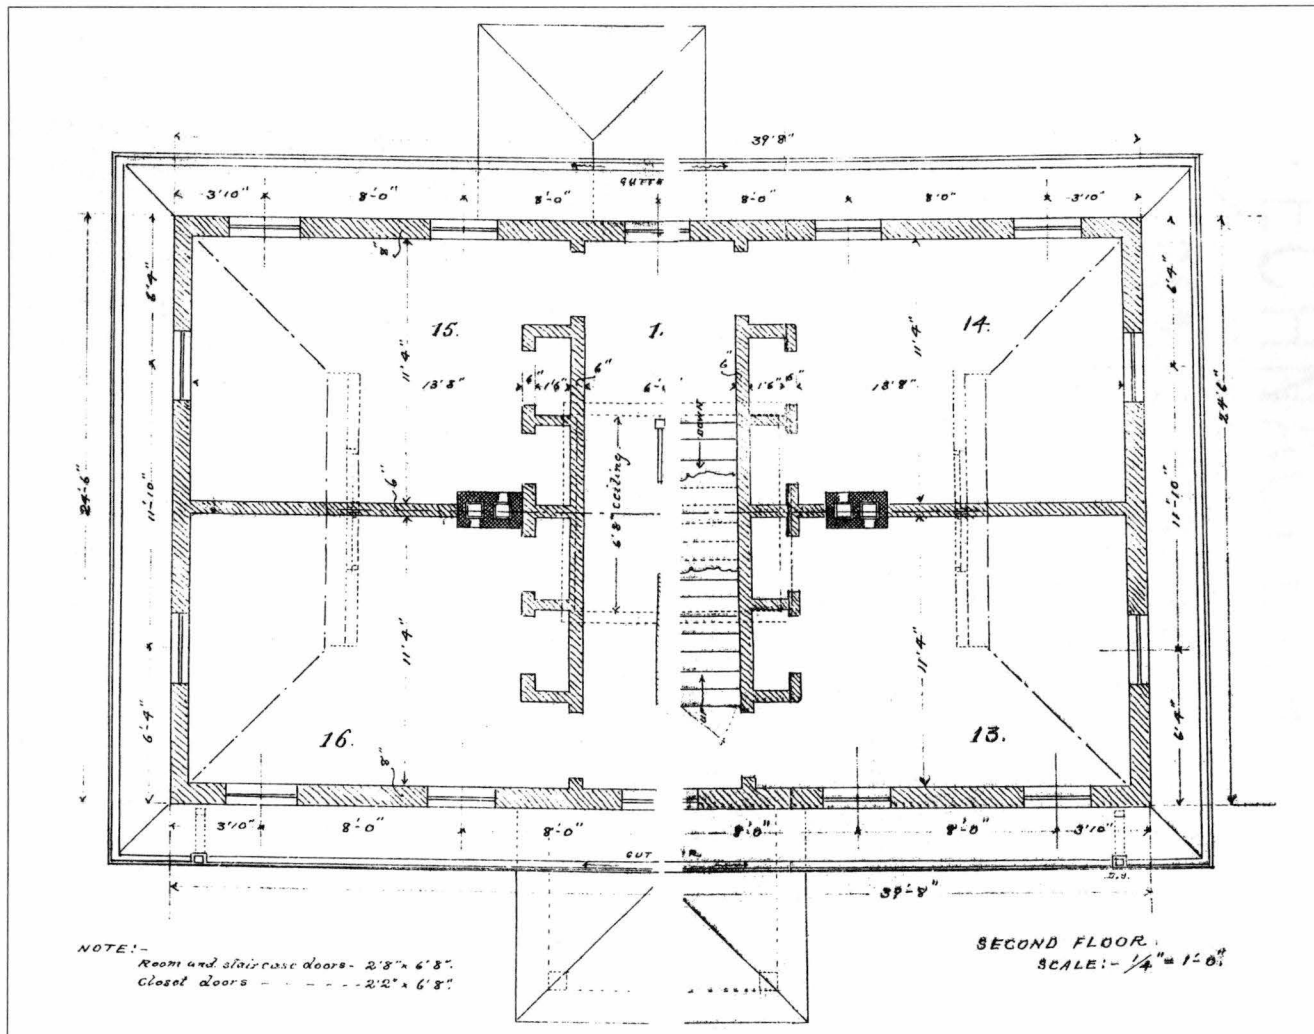
Figure 166. Siuslaw River Lifeboat Station, Second Floor Plan, October 1916. Source: U.S. Coast Guard Civil Engineering Unit, Oakland, CA.

become more similar (Figure 166). The floor was divided evenly into four bedrooms, two crewmen per room. The attic was used for storage, and in an emergency, bunk space. A steep staircase led from the attic to the lookout monitor. The entire structure was supported by a concrete foundation.

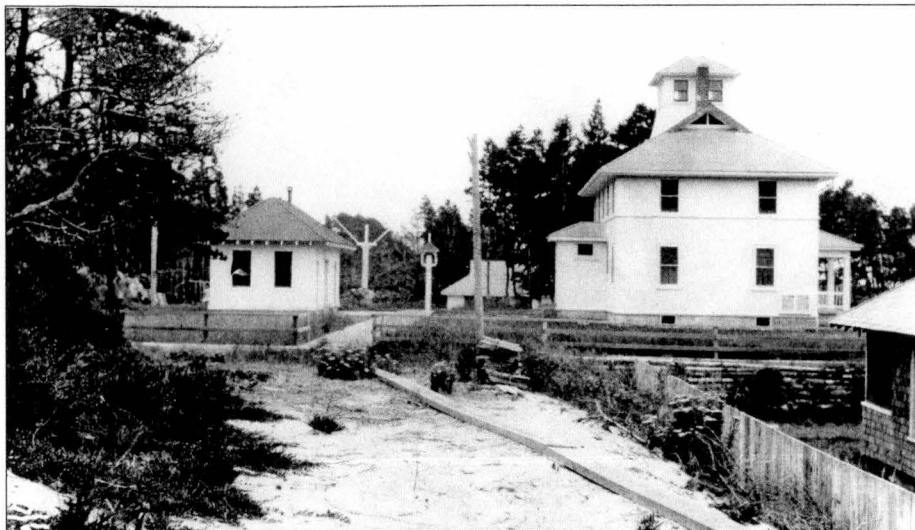
Figure 167. Siuslaw River Lifeboat Station From North, 1923.
Source: U.S. Coast Guard Headquarters (Siuslaw River File).

Figure 167 shows several of the outbuildings constructed at the station. Directly behind the station to the east was a one-story, hipped roof, shingle-covered shop building. Like the station house, the shop building still stood in 1967, but was gone by 1983, replaced by asphalt. Further to the east on a small hill was a wood frame water tower, ubiquitous at all Oregon stations. It was also still standing in 1967, but gone by 1983. Between the station house and the shop building was the bell stand. To the southeast of

To the north of the station house, and just visible at the right corner of Figure 167, was the home of one of the crew members. Reported *The West* in 1918, "Most of the men are married and will soon erect cottages near the station for homes for their families. They will make quite a little community in that part of the city limits of Florence."²⁴³ This community was Siuslaw's "Little America," a development that cropped up at most stations in Oregon to house the families of the crew. There appears to have been at least

Due south of the station house, and just visible in the background of Figure 167, was the first boathouse. Also built in 1917, the boathouse continued the features of the station house with a hipped gable roof, six-over-two windows, and triangular window in the gable (Figure 168). The structure was 23' wide by 39' 6" deep, two-bays wide, and was built on a concrete foundation. Unfortunately, the boathouse was built to accommodate a surfboat and lifeboat only and was located inconveniently high above the river. The 1921 *Annual Report* mentions that a wharf and approach were constructed on the river to the west of the station house. A small surfboat house, pitched to the angle of the shore, was built next to the wharf. In 1924, plans were drawn for a replacement boathouse with launchway at the river's edge (Figure 169). The boathouse was similar to the older boathouse with two bays and a hipped gable roof. It was larger at 26' wide by 49' deep to accommodate motor lifeboats. All of the boathouses were gone by 1967, though soon after, a large, utilitarian boathouse was erected on the water.

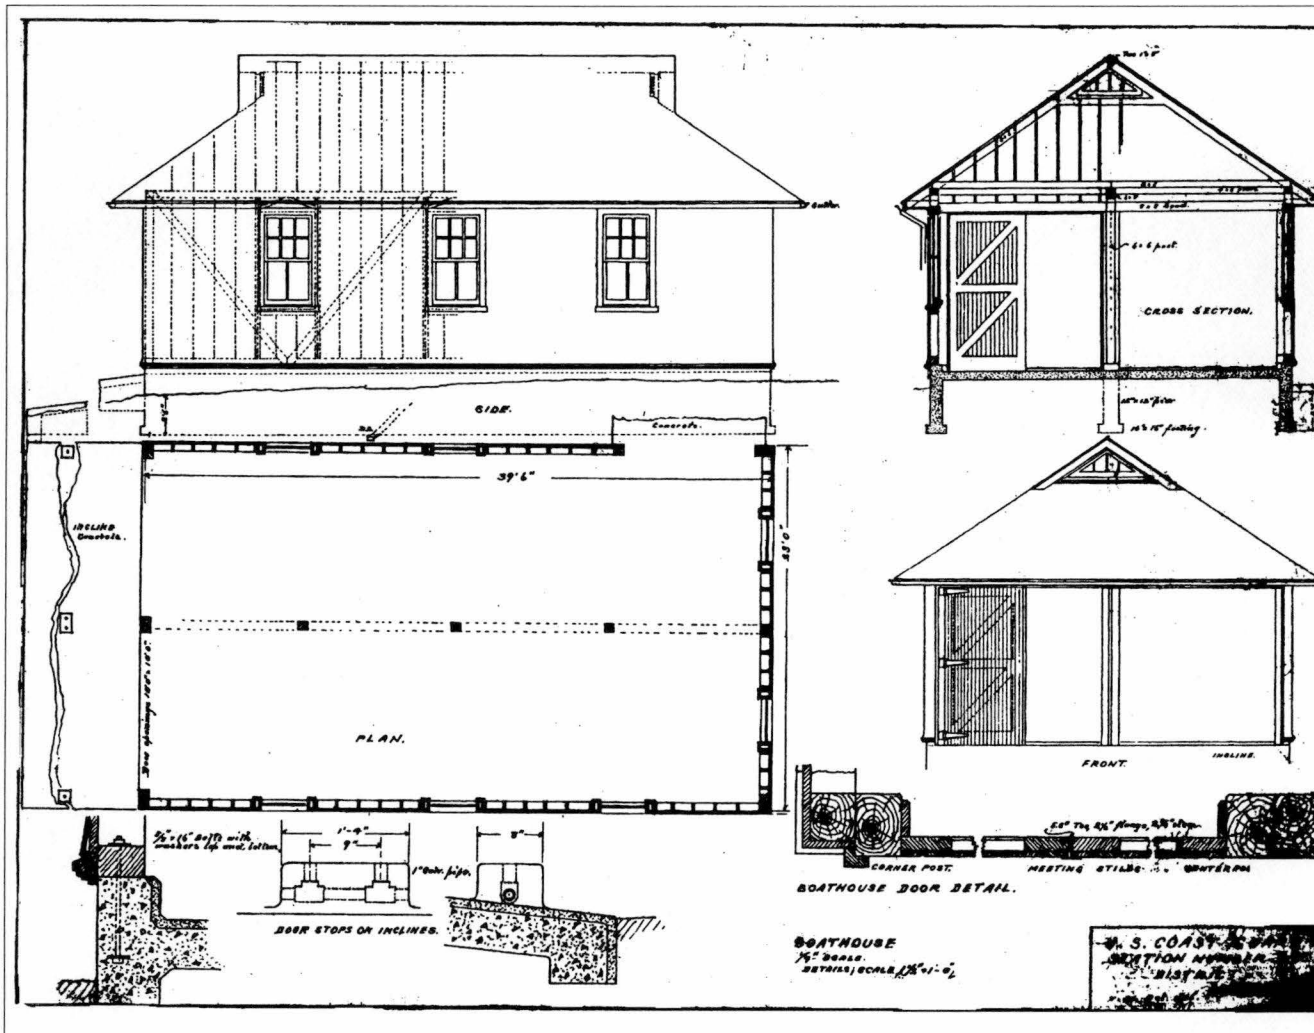
Figure 168. Siuslaw River Lifeboat Station, Boathouse Plan, October 1916. Source: U.S. Coast Guard Civil Engineering Unit, Oakland, CA.

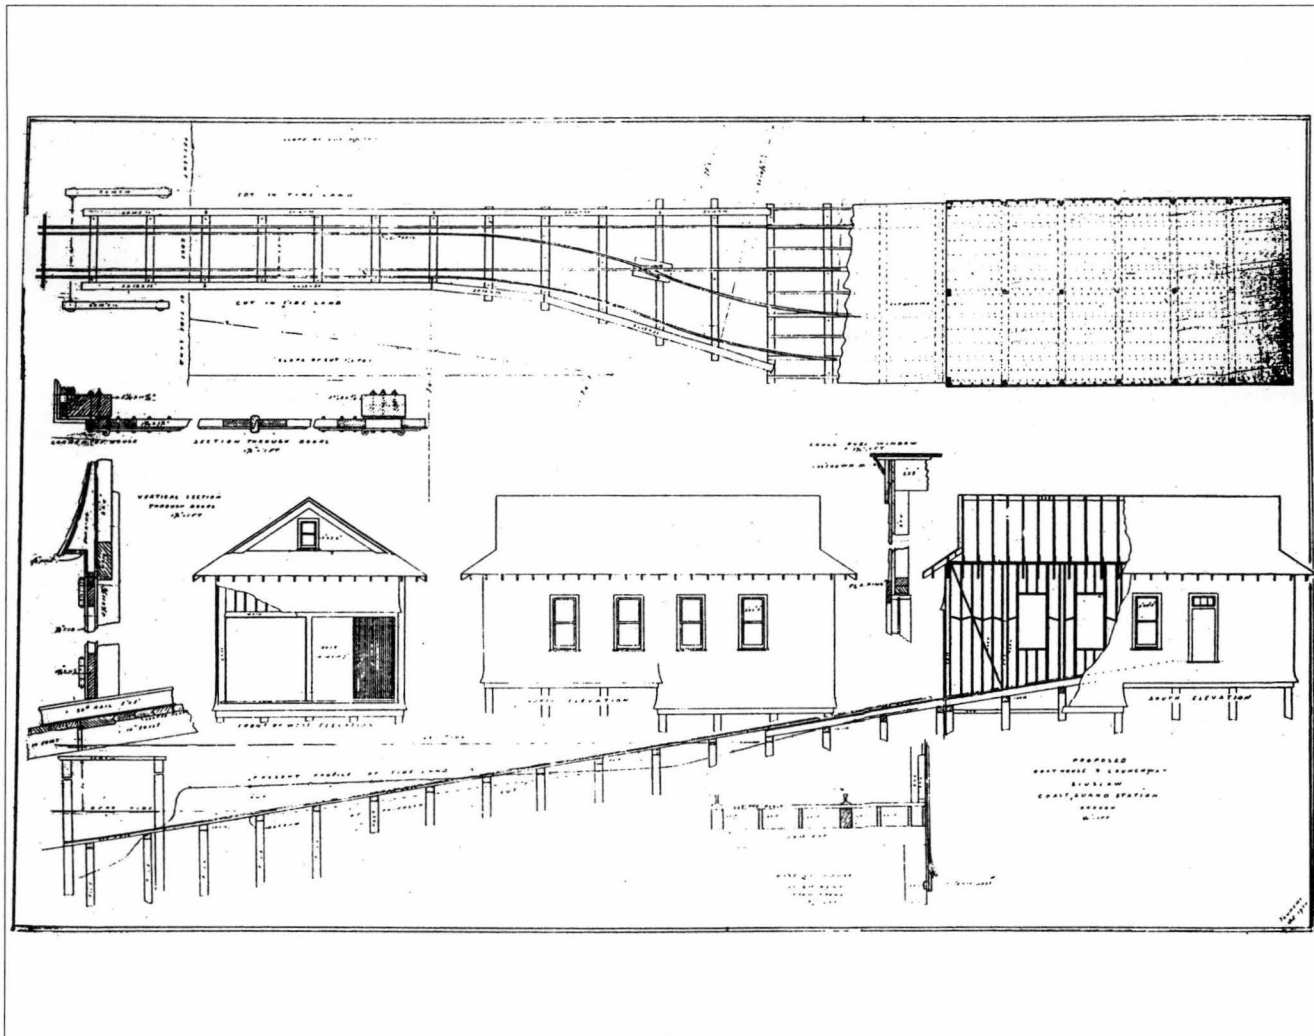
Figure 169. Siuslaw River Lifeboat Station, Second Boathouse Plan, October 1924. Source: Nautical Research Centre (#12-229).

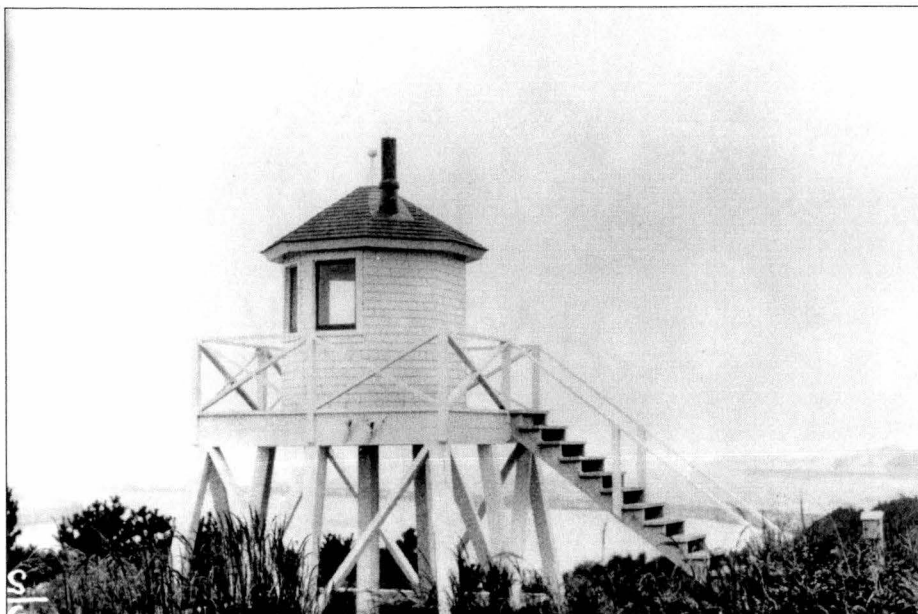
Figure 170. Lookout at Cannery Hill, Siuslaw River Lifeboat Station, 1923. Source: U.S. Coast Guard Headquarters (Siuslaw River File).

Northwest of the station house was a lookout tower on Cannery Hill (Figure 170). The eight-sided tower was raised only about 8' above the ground, as Cannery Hill offered sufficient elevation. Shingle-clad with an eight-sided roof, it is the earliest lookout in Oregon known to have a stove for heat. The diminutive tower has disappeared over time, made obsolete by a metal-framed lookout tower on the north jetty to the northwest.
