THE PRESERVATION OF PRE-WORLD WAR TWO
COAST GUARD ARCHITECTURE IN OREGON

A THESIS

Presented to the Interdisciplinary Studies Program:
Historic Preservation
and the Graduate School of the University of Oregon
in partial fulfillment of the requirements
for the degree of
Master of Science

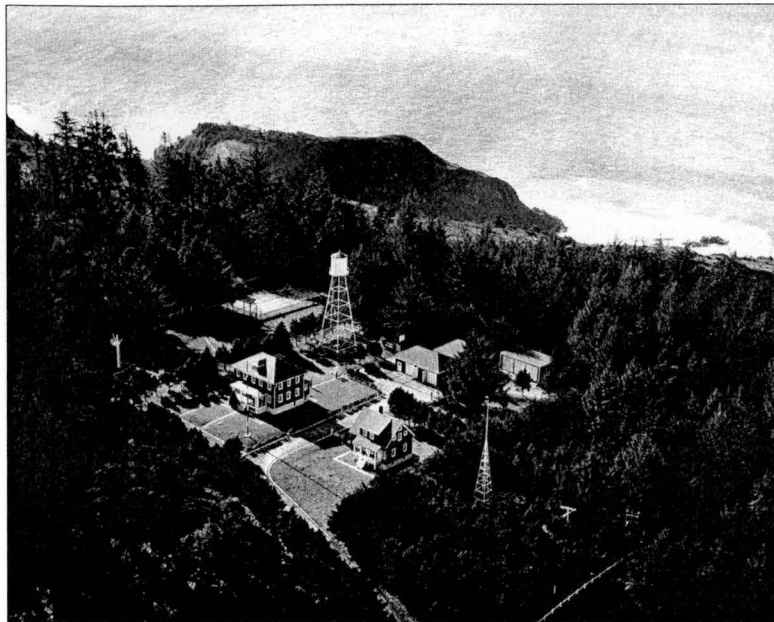
Figure 173. Port Orford Lifeboat Station, 1954. Source: National Archives (RG 26-DS Box 21 Folder 437).

In July 1933, the *Curry County Reporter* gossiped about construction at the site and noted that the keeper’s dwelling and boathouse were well underway.²⁵⁷ The site chosen was a geographical feature known as “The Heads” (Figure 172) on the western edge of Port Orford. The prominent headland offered a wide view of the ocean and harbor at a vantage point 280' above the water. On 1 July 1934, the station was commissioned and put into service (Figure 173).²⁵⁸

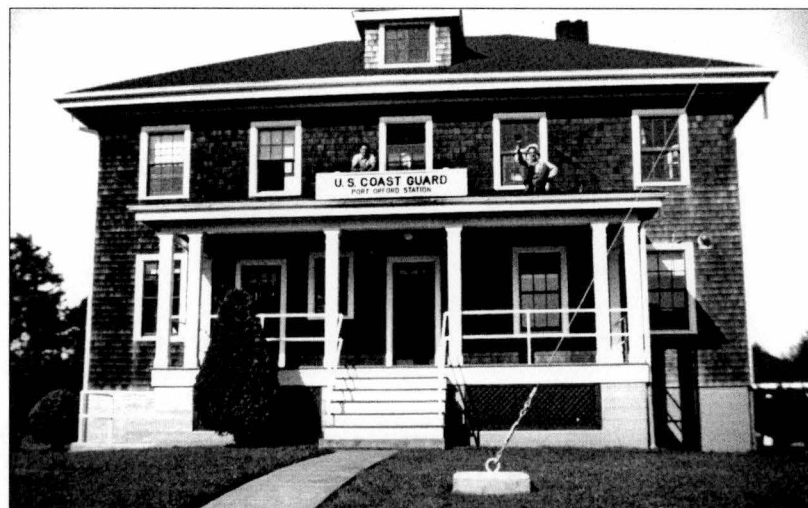
Figure 174. Station House, Port Orford Lifeboat Station, Circa 1940. Source: Oregon State Historic Preservation Office (Port Orford File).

The station house built at Port Orford is known as a late Chatham-type (Figure 174). The original Chatham was designed by Victor Mendleheff in 1914 for the

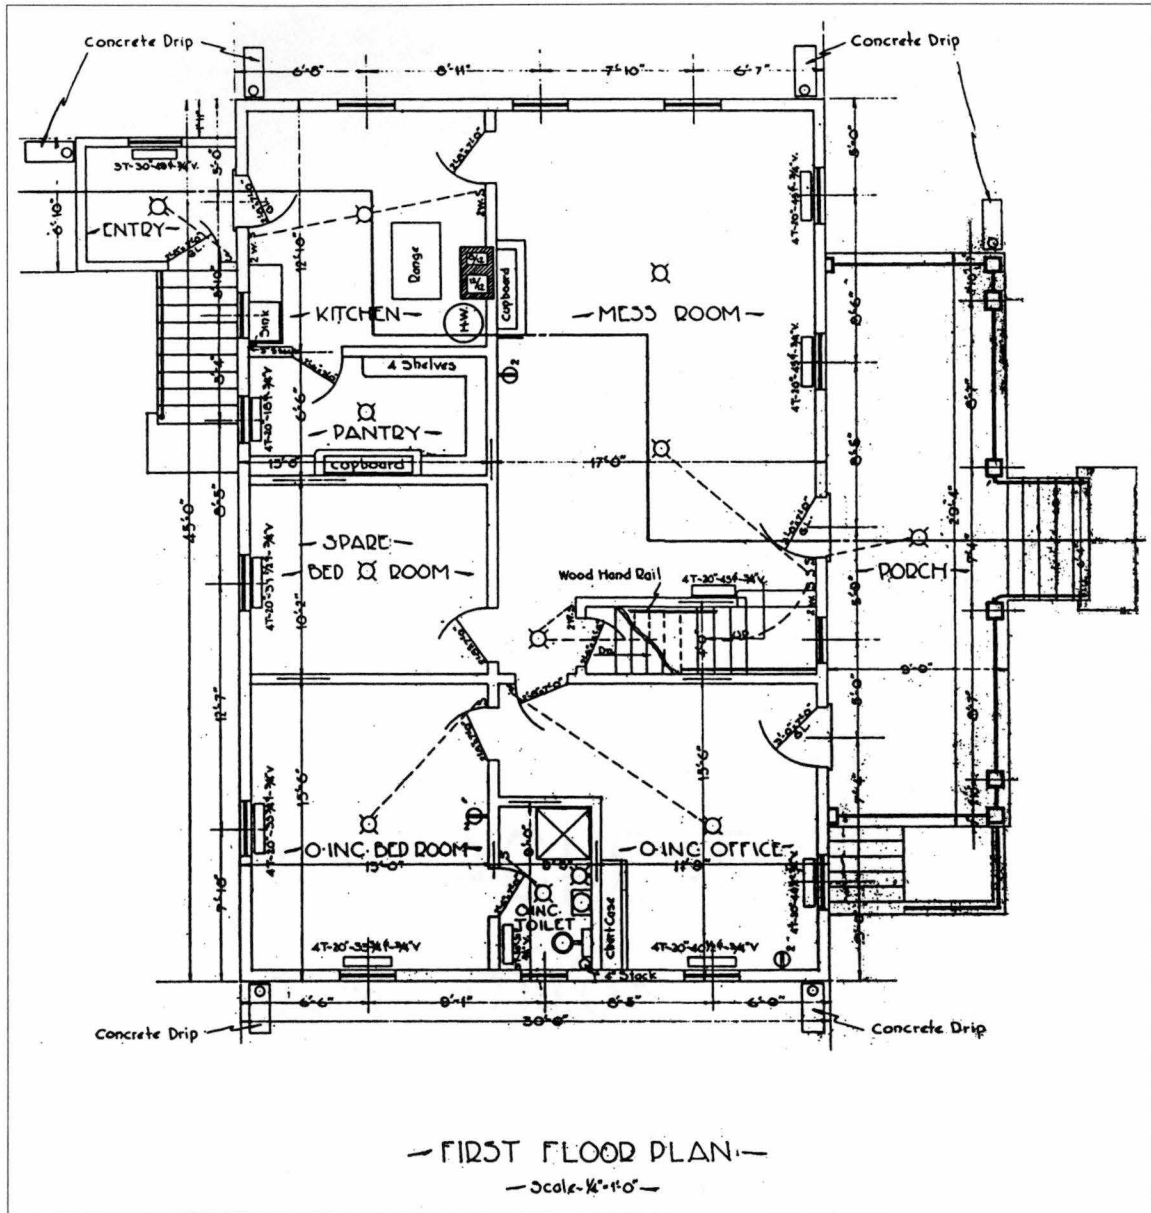
Figure 175. First Floor Plan, Port Orford Lifeboat Station. Source: State Historic Preservation Office (Port Orford File).

The Port Orford station house is elevated on a high concrete basement. The two-story building is capped with a hipped roof sporting two dormers. The front porch is nearly full-width with a concrete floor and metal pipe railing. The porch roof is hipped and supported by Classical, square posts. From the front porch there are two entries. One goes into the mess room and the other directly into the Officer in Charge's (OIC) office. Across the back of the building is the kitchen, spare bedroom, and OIC bedroom and bath (Figure 175). There is a back door in a vestibule off the kitchen. On the second

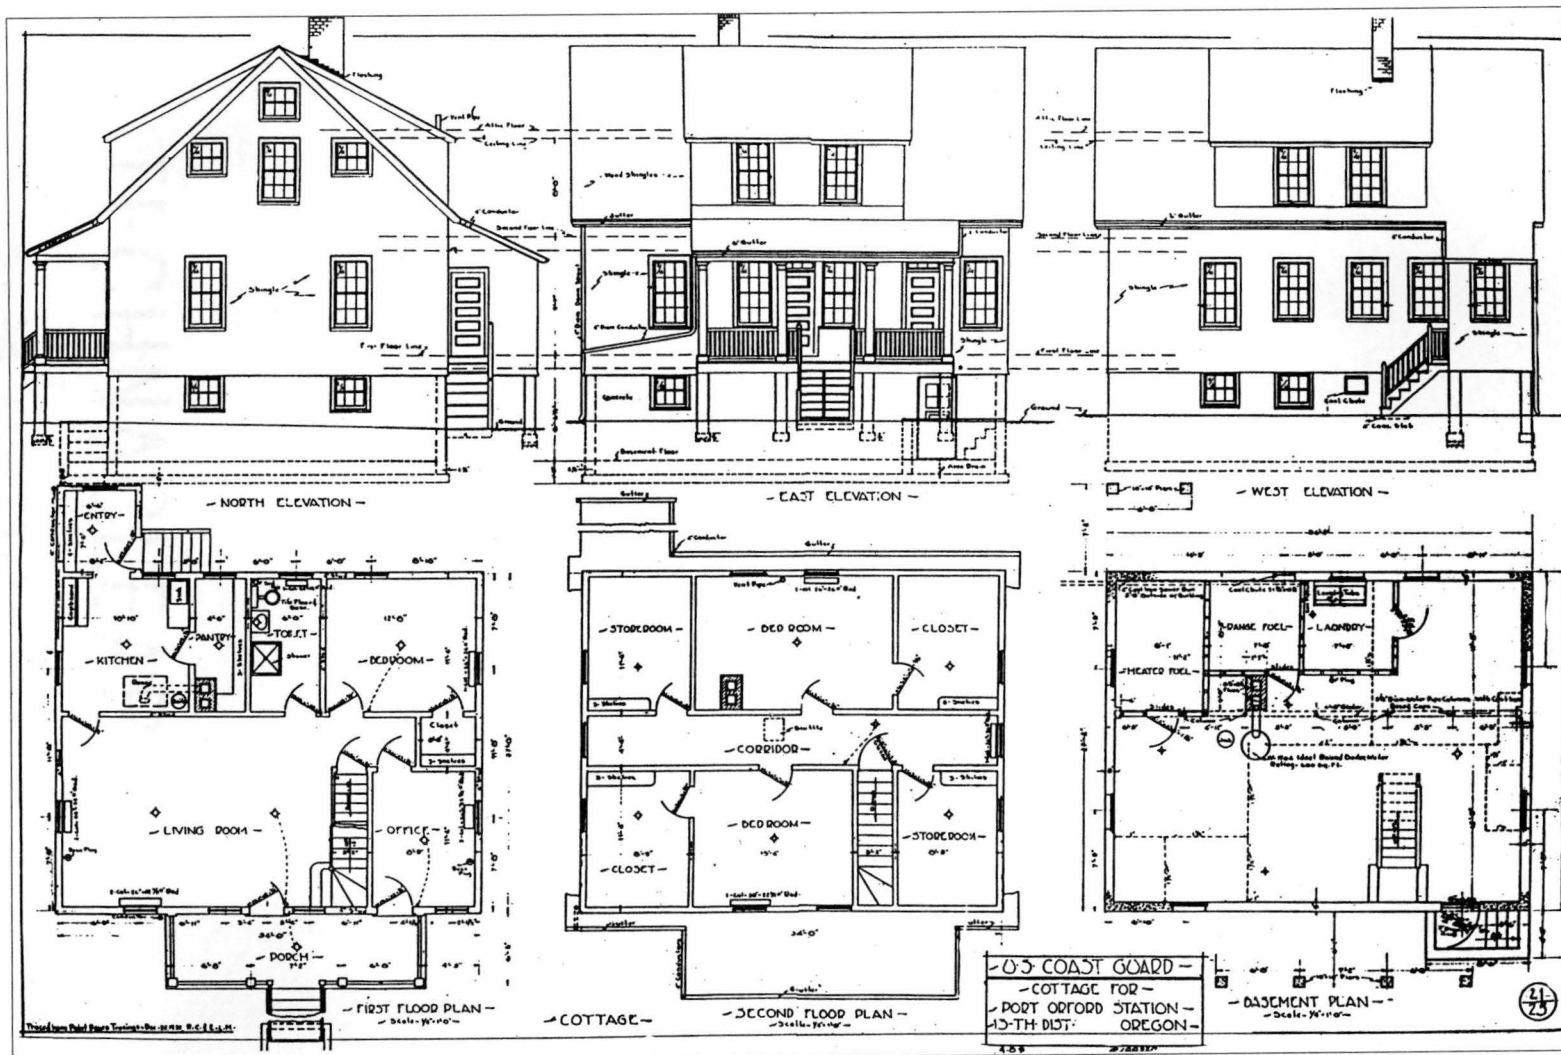
Figure 177. Keeper's Cottage, Port Orford Lifeboat Station. Source: Nautical Research Centre (#11-53).

The keeper's house was built north of the station house. The building is 1-1/2 stories, topped with a gable roof and two large shed dormers (Figure 177). Like the station house, the structure is clad in shingles, pierced by six-over-six, double-hung windows. The plan is 34' wide by 27' deep with a living room, office, bedroom, kitchen, and toilet on the first floor. The second floor had two bedrooms, two large walk-in closets, and two store rooms. The basement has two fuel rooms and a laundry room.

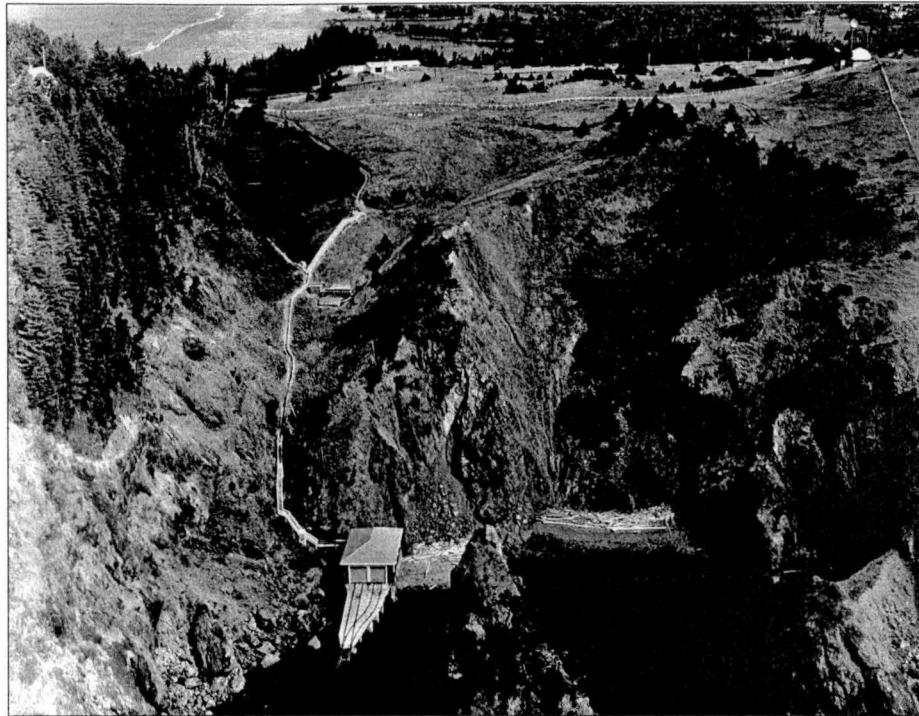
Figure 178. Boathouse in Nellies Cove, Port Orford Lifeboat Station, 1959. Source: National Archives (13CGD-081659-8).

The boathouse had the most unusual siting of any Coast Guard boathouse in Oregon. Since the station was located high on the headland, the boathouse was 280' below on the water at Nellies Cove (Figure 178). The 532-step staircase used to reach the boathouse was known as "The Stairs of a Thousand Tears." The boathouse was 36' wide by 60' deep, two-bays, with a hipped roof. The building was clad in shingles and

punctuated by four, six-over-six, double-hung windows on either side and one on the rear of the building. The boathouse was entered from a door on the back. The boatroom doors were metal roll-ups. Rails left each boat bay and joined together in a single set leading down the launchway and into the water. Apparently a storm damaged the boathouse and launchway extensively in 1939. As a consequence, enormous concrete breakwaters were built to divide Nellies Cove in two and give more protection to the boathouse (Figure 179). The launchway was also rebuilt at this time using concrete caissons for pilings. Unfortunately, the boathouse burned down in the 1970s and all that remains are the concrete caissons and remnants of the launchway.

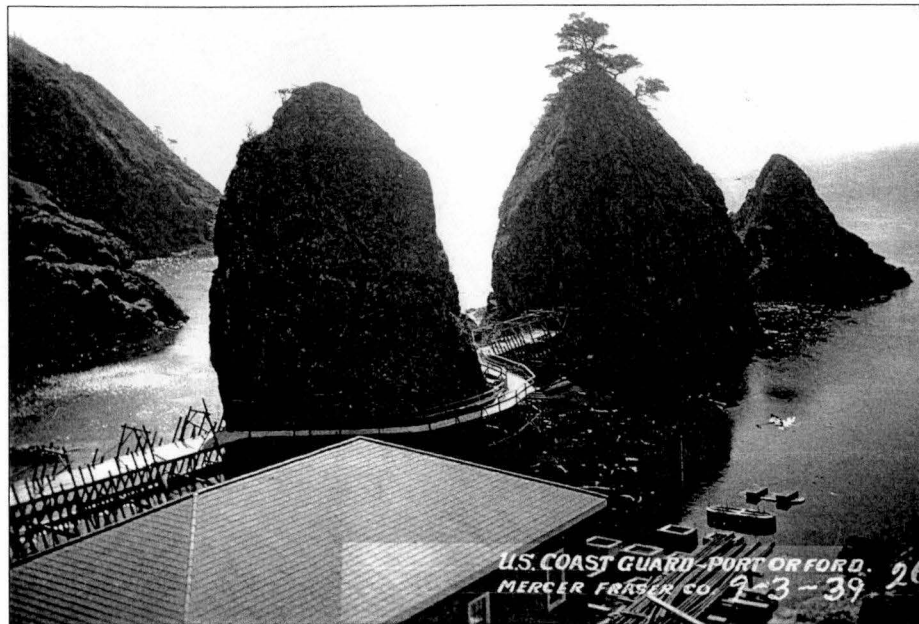
Figure 179. Boathouse Launchway and Breakwater Under Construction, 1939. Source: National Archives (RG 26-DS Box 21 Folder 437).

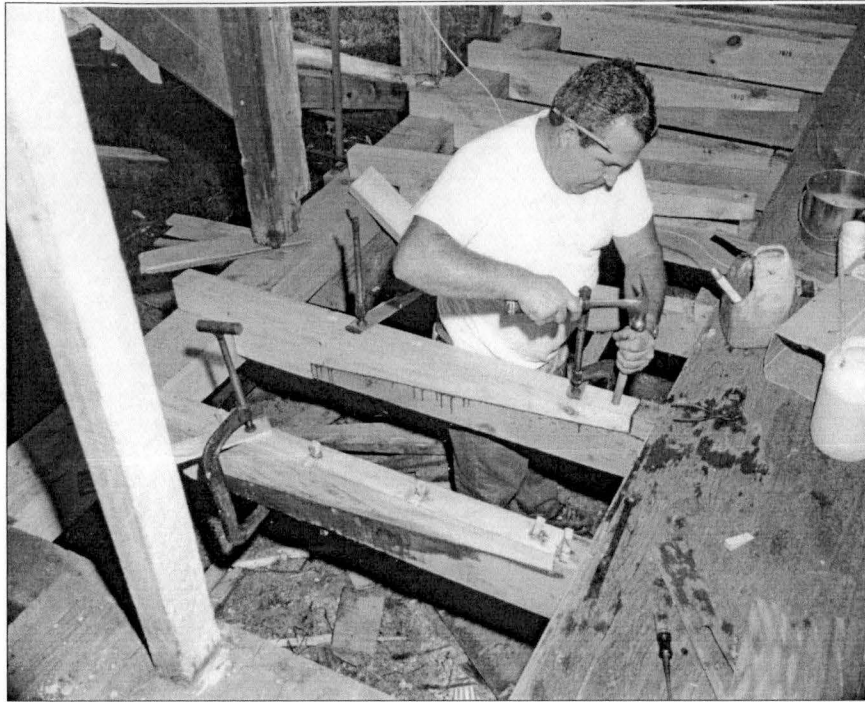
Figure 182. Splicing Floor Joists at Block Island Life-Saving Station, Rhode Island, 1970. Source: Mystic Seaport (#70-8-364).

entire floor joist. Instead, splice on a new end with an in-kind material and save as much of the original fabric as possible (Figure 182).

The most important part of a restoration is not to remove more original material than is absolutely necessary. If a floor joist is rotten only at the sill, do not replace the

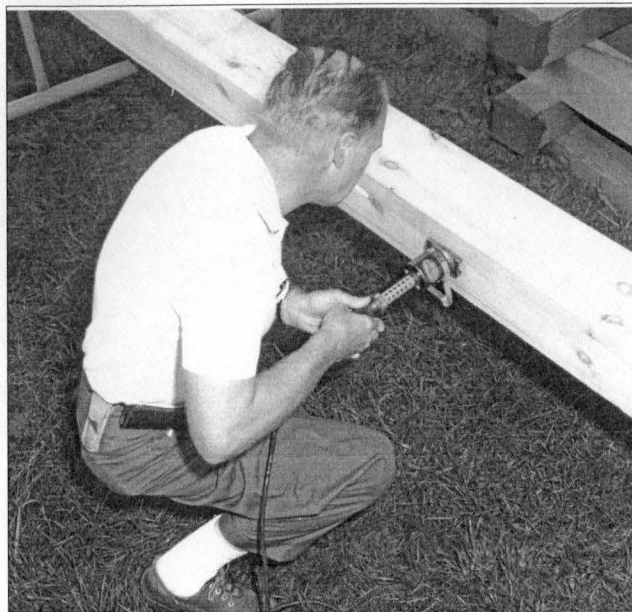
Figure 183. Marking New Material, Block Island Life-Saving Station, Rhode Island, 1970.
Source: Mystic Seaport (#70-9-213).

be lost forever and that there is no time like the present to record what is being done. Newly installed material should also be recorded with equal care so that later researchers can understand what was done. Any new construction material should be date stamped (Figure 183), and a written and visual record made.

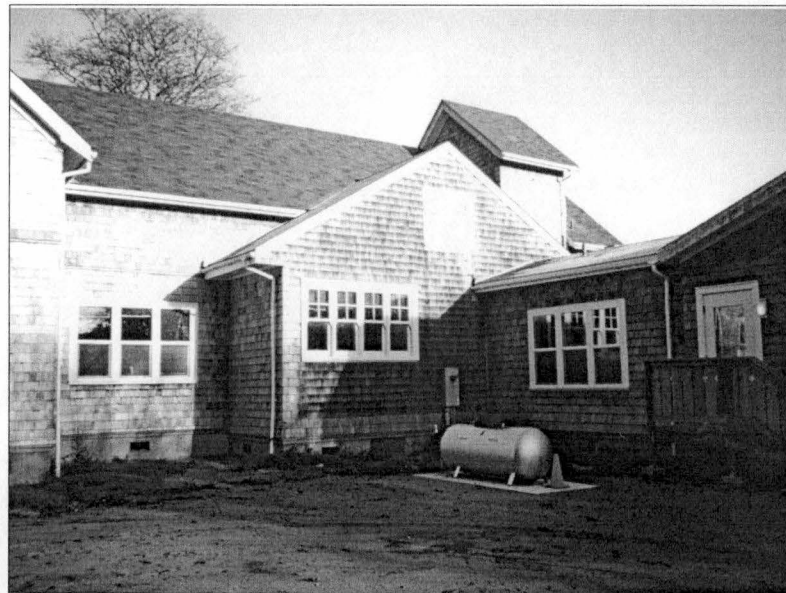
Figure 190. Keeper's Dwelling (1915) Enveloped, Coos Bay
Lifeboat Station, 1999. Source: Author.

Recycling is not accepted as a preservation treatment by the Secretary's *Standards*. Recycling involves demolishing a building and reusing its parts. Old automobile restorationists have used this method for years, sacrificing one car for parts to keep another running. Altering a building to the point of unrecognizability would also be considered recycling (Figure 189). The Oregon Institute of Marine Biology (OIMB) has chosen an aggressive way of reusing two of their historic Coast Guard buildings. The former keeper's dwelling has been fully incorporated into the library on the OIMB campus (Figure 190). While this does not conform to the Secretary's *Standards*, it is a way of making use of an old building. By not demolishing the building, the owners of the building have left some room for physical interpretation of the structure. The remains of the building can serve as a jumping off point from which to interpret the early Coast Guard. For example, a plaque within the new OIMB library telling viewers what purpose the building formerly served could inspire people to delve deeper into learning more

about the Coast Guard's story at Coos Bay. While not condoned by any preservationist, recycling cannot be ignored and should be confronted.

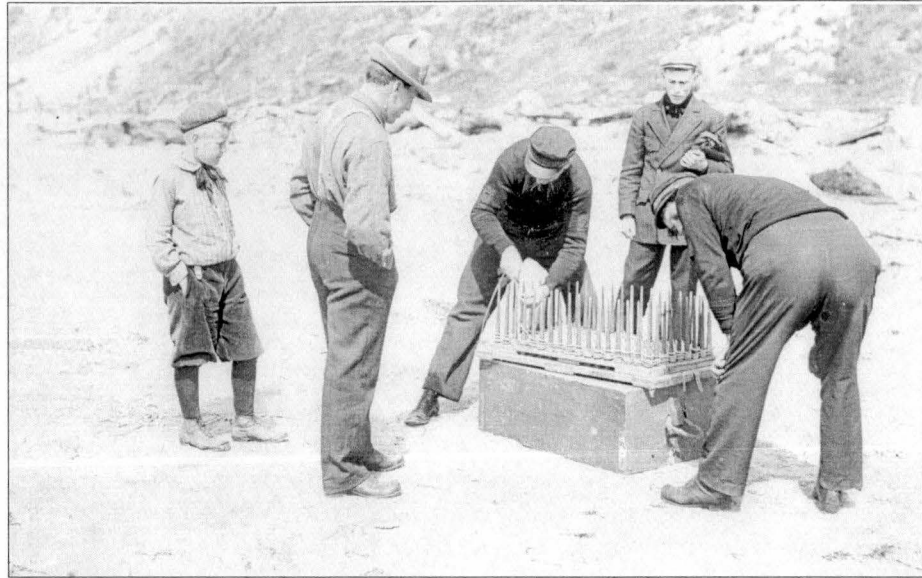
Figure 191. Faking Shot Line at Yaquina Bay, Circa 1910. Source: Lincoln County Historical Society (LCHS #2265).

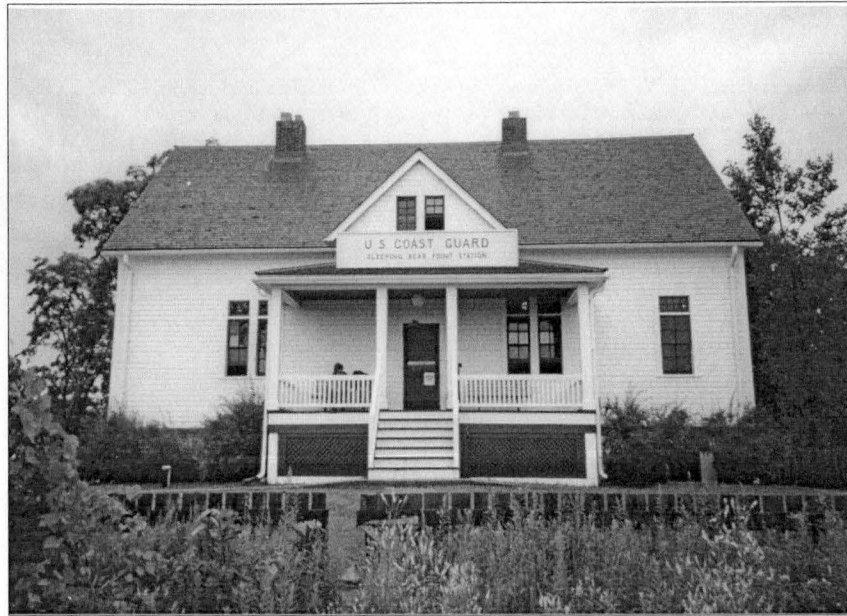
Figure 192. Sleeping Bear Point Life-Saving Station (1901), 1997. Source: Author.

Considered one of the best examples of interpretation of the Life-Saving Service is the Sleeping Bear Point Life-Saving Station (1901) at Sleeping Bear Dunes National Lakeshore near Empire, Michigan. The former station has been restored by the National Park Service. It is a model for the proper restoration and interpretation of a life-saving station or lifeboat station. The station is a Marquette-type similar to the four Marquette-

type Life-Saving Service stations built in Oregon that are no longer standing (Figure 192). The station house is set up with non-permanent, interpretive displays on the first floor (Figure 193). Existing cabinetry is used to display life-saving items (Figure 194). The second floor is set up as a house museum to give the visitor an idea of what it was like to be a surfman (Figure 195). The Fort Point-type boathouse stands nearby (Figure 196). The station has been moved to its present location though it still retains its original orientation and relationship with Lake Michigan. Inside the boathouse are a surfboat, lifeboat, lifecar, and beach apparatus cart just as they would have been housed 100 years earlier (Figure 197). Items are displayed in proper fashion, though not in quantities that would have originally occupied the boathouse. The displays are interpreted by trained docents rather than signage.

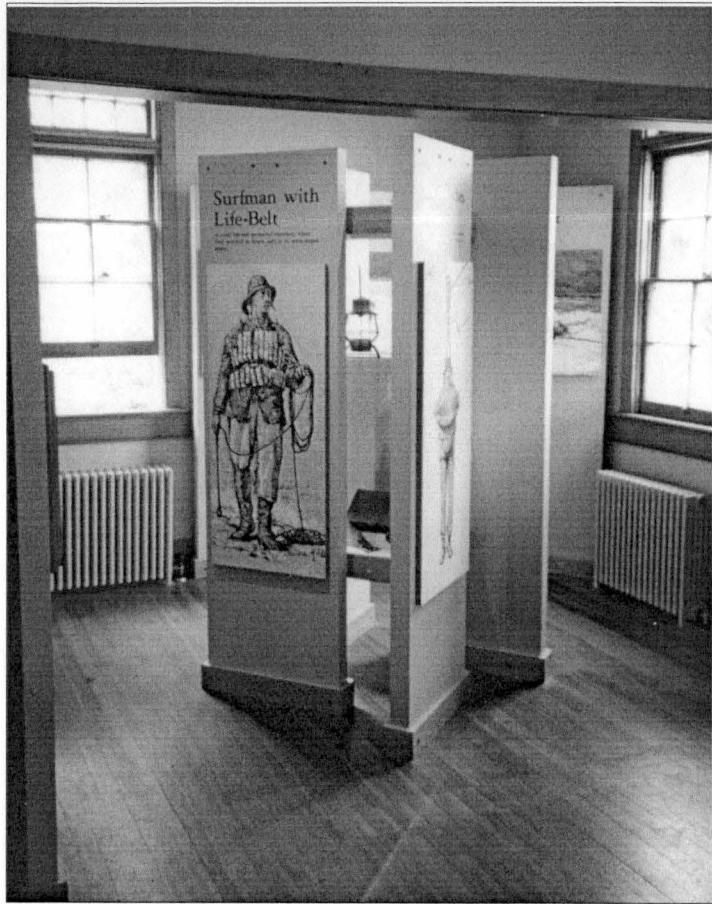
Figure 193. Keeper's Office Interpretation, Sleeping Bear Point Life-Saving Station, 1997. Source: Author.

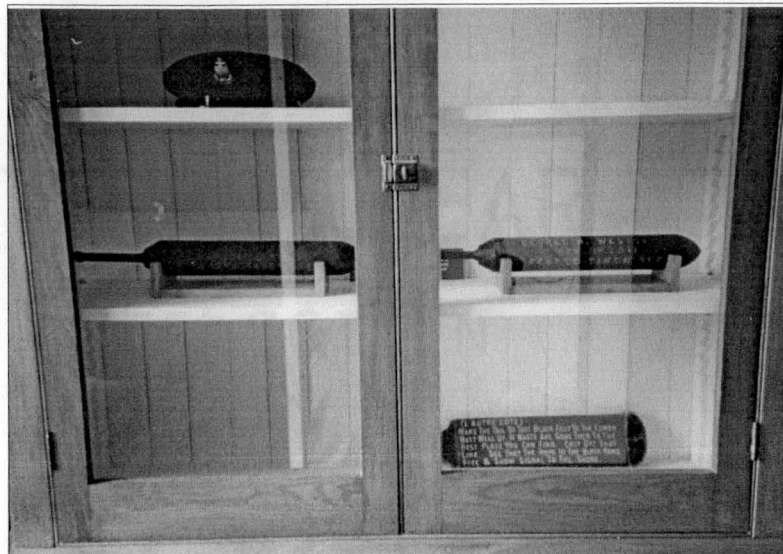
Figure 194. Kitchen Cabinet Interpretation, Sleeping Bear Point Life-Saving Station, 1997. Source: Author.

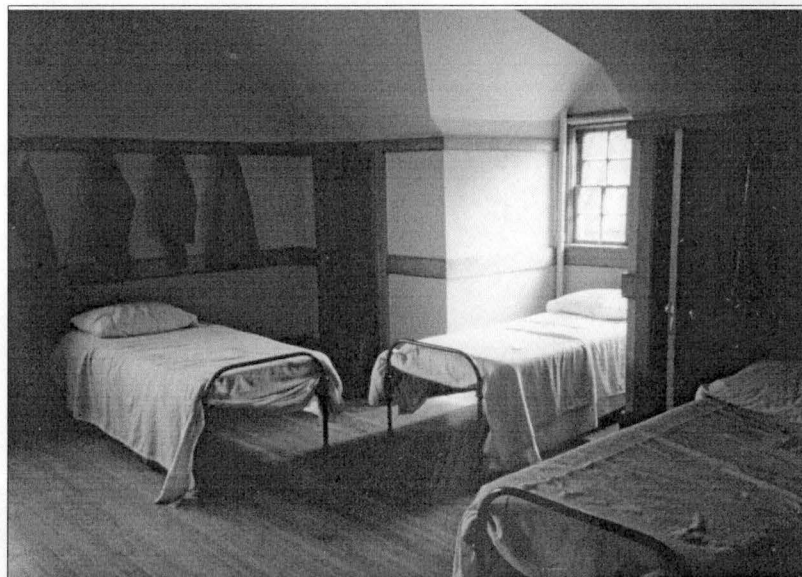
Figure 195. Crew's Quarters Interpretation, Sleeping Bear Point Life-Saving Station, 1997. Source: Author.

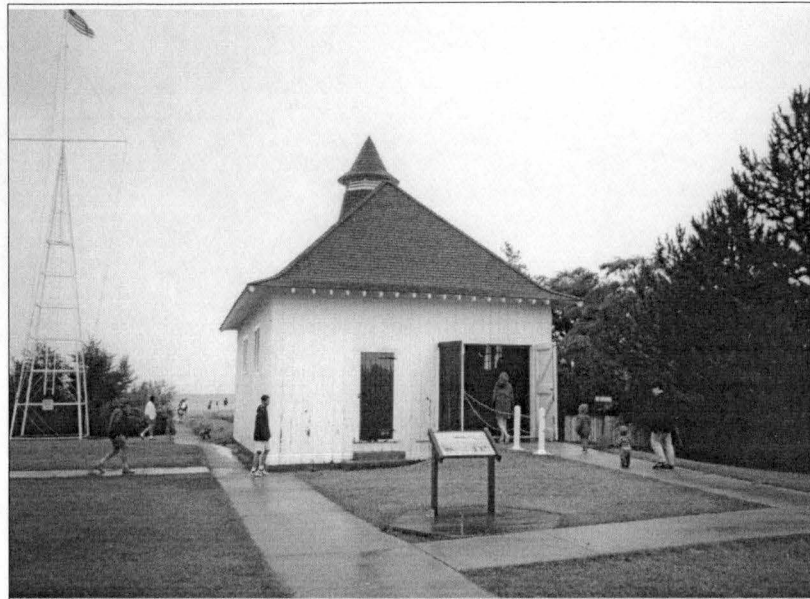
Figure 196. Boathouse (1901), Sleeping Bear Point Life-Saving Station, 1997. Source: Author.

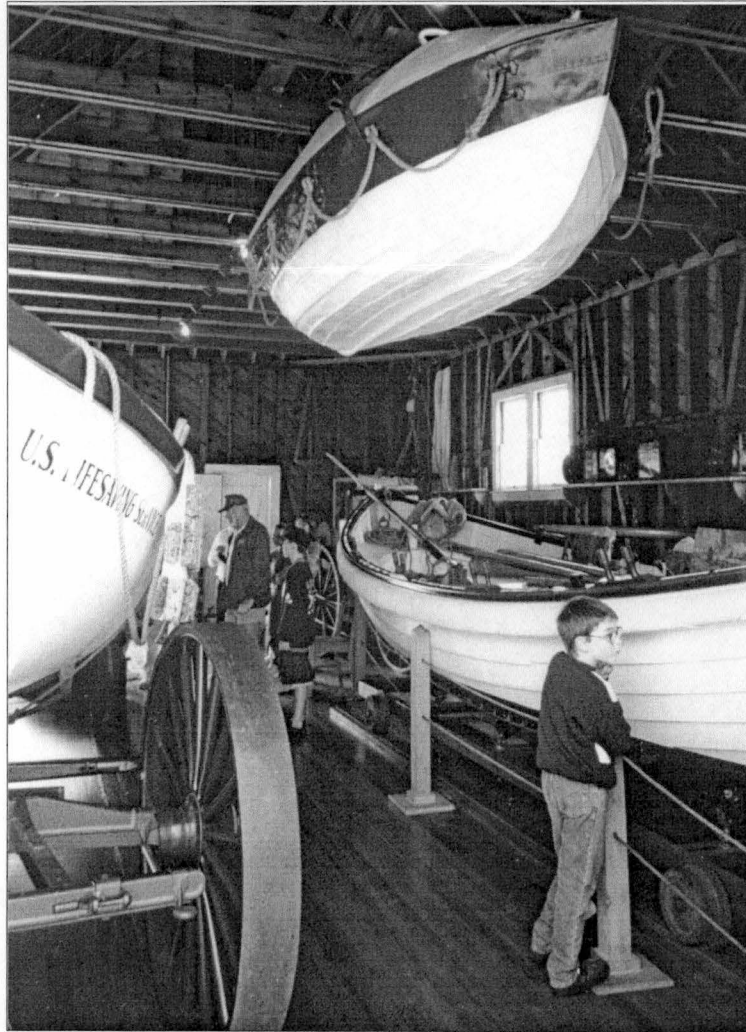
Figure 197. Boatroom Interpretation, Sleeping Bear Point Life-Saving Station, 1997. Source: Author.
