Mapping Rockfall Susceptibility in the Steep Rocky Slopes of Skagway, Alaska

A thesis accepted and approved in partial fulfillment of the

Master of Science

in Earth Sciences

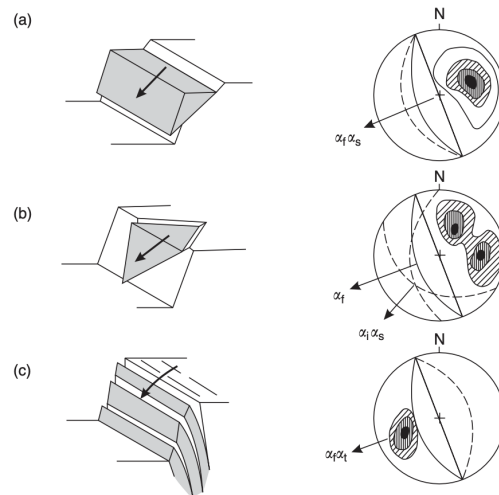
Figure 1: Diagrams representing common failure modes: (a) planar sliding, (b) wedge, and (c) toppling. On the right of each diagram are stereonet, where the rock slope face is represented by a solid black line, and poles to planar discontinuities that meet conditions for failure are contoured. Dashed lines represent general orientations of these discontinuities as planes. From Wyllie and Mah, 2004.

Common modes of rock slope failure (**Figure 1**) include planar sliding, wedge, and toppling are summarized below from Wyllie and Mah 2004. Planar slides occur when a block of rock slides on a single planar discontinuity from the slope face. Wedge failures occur when two or more planar discontinuities intersect, forming a wedge of rock, which then slides from the slope face. Toppling failures occur when discontinuities steeply dipping into the rock slope face form slabs or columns of rock that rotate forward along a fixed base. Two types of toppling failures can occur that are influenced by the strength of the rock mass and the nature of discontinuities. Flexural toppling, where slabs of rock bend forward until they break in flexure, is typical in shale and slate where orthogonal jointing is not well developed. Block toppling is common in hard rock with three well developed orthogonal joint sets, where two steeply dipping joint sets form the sides of blocks, and a third set of low angle, widely spaced joints form a basal failure plane.

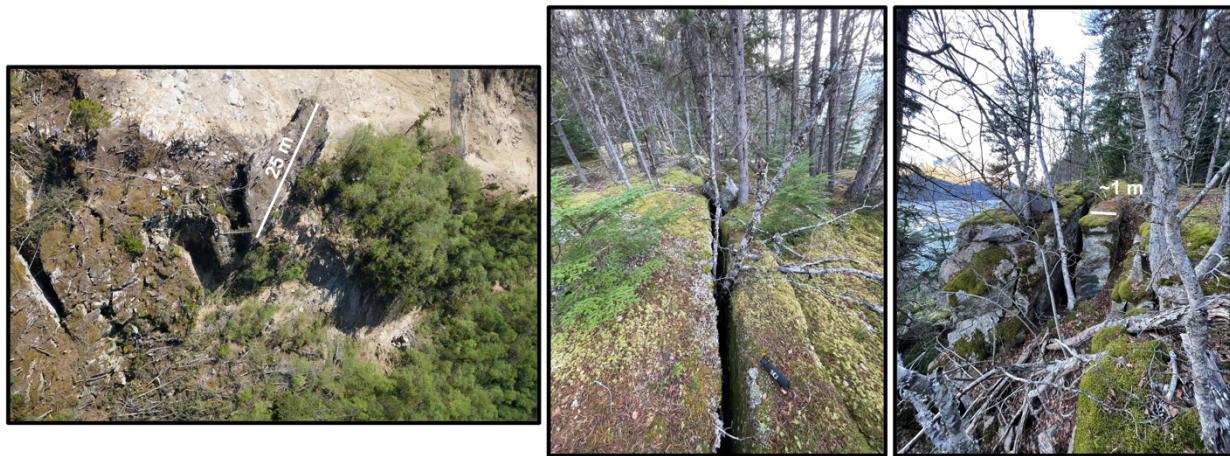
Figure 2: Rock slopes on the east side of Skagway valley with tension cracks and tall slabs of rock, consistent with the block toppling mode of failure.

In a public geotechnical site assessment, the active rockfall source area situated at the top of the slope above Skagway's cruise ship dock has been described as a progressive toppling failure with a stair-stepped basal feature (Brennan & Whistler, 2022). Topple failures observed in the field were consistent with this description, which closely aligns with block toppling failure. Since block toppling is the failure mode commonly observed in the study site (**Figure 2**), block toppling was chosen as one of the failure modes modeled with kinematic analysis in this study. Planar slide failures were observed in the field but were much less abundant, these were also included in the kinematic analysis. Wedge failures were not observed in the field and therefore were not included in the kinematic analysis.

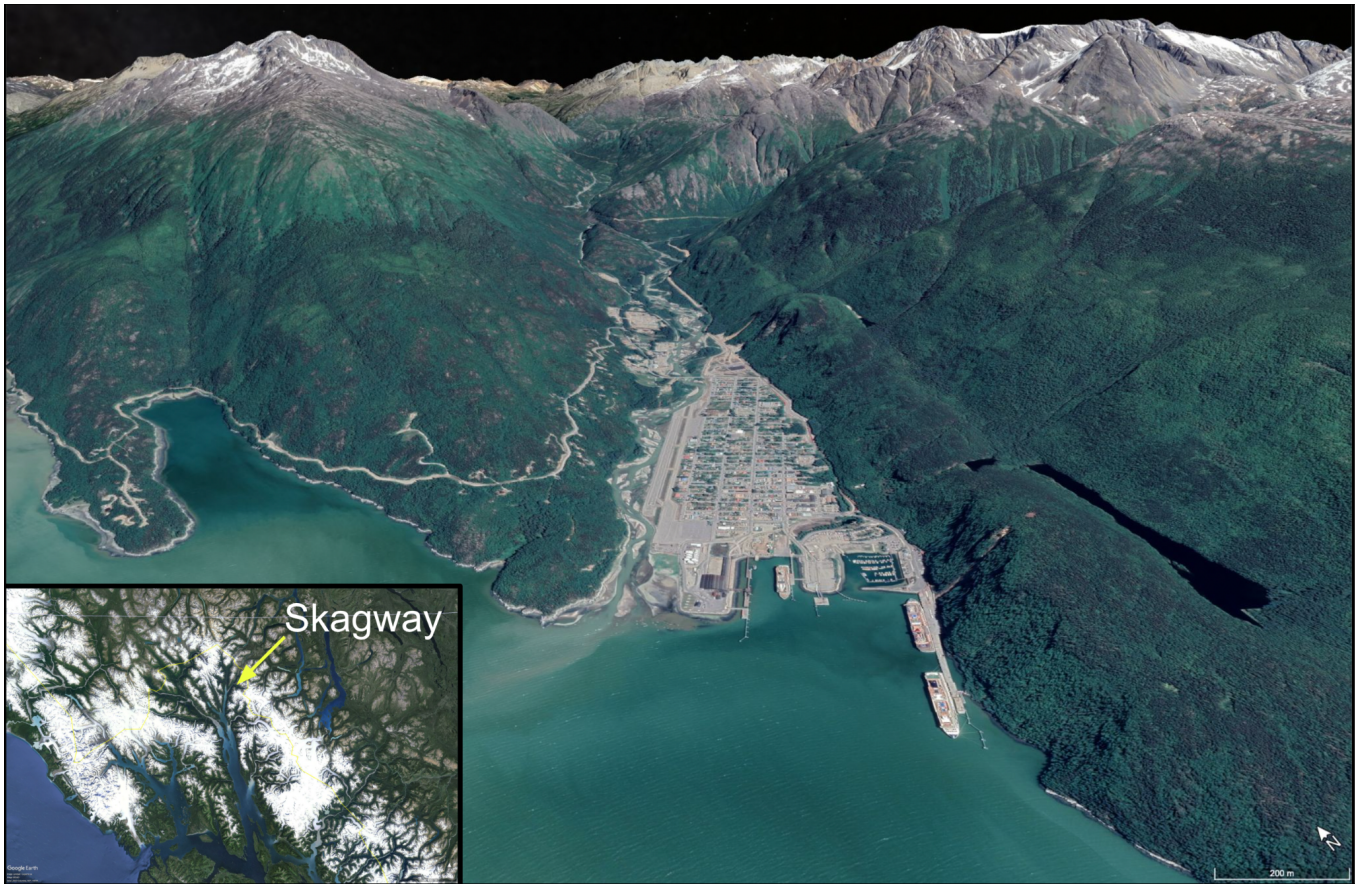
Figure 3: Oblique view of Skagway, Alaska and its steep valley walls.

At the head of the Taiya inlet, Skagway is situated in a U-shaped valley carved by glaciers (**Figure 3**) in the northern extent of the Alaskan panhandle. The surrounding terrain is steep and rugged, composed of Tertiary granodiorite bedrock of the Coast Range Batholith (Yehle and Lemke, 1972), a belt of plutonic and metamorphic rocks that extends to northern Washington. The Eastern Denali Fault and the Chatham strait fault lineaments meet just south of Skagway, which are both strike-slip fault systems (Choi et al., 2021).

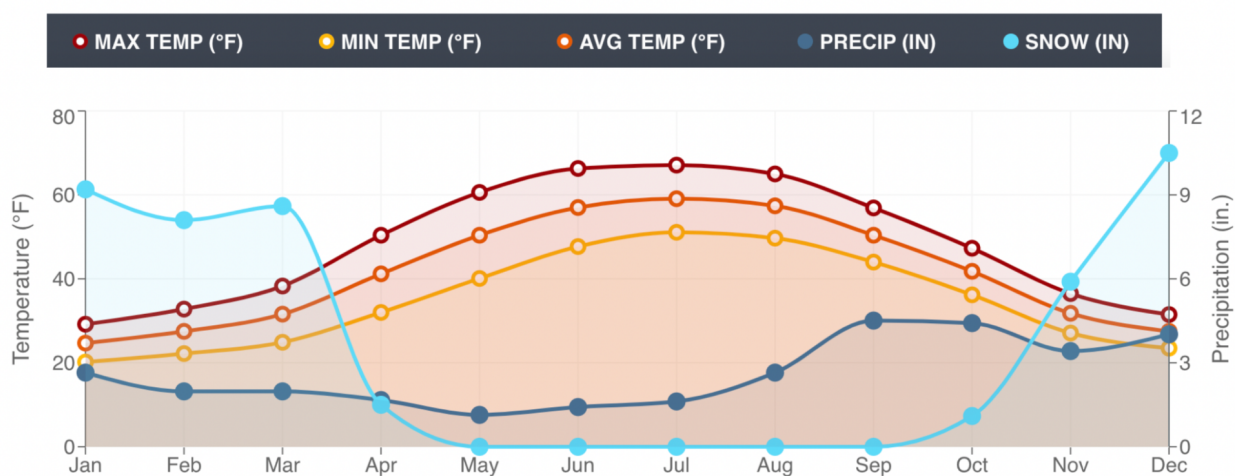
Figure 6: Climate normals in Skagway, Alaska from 1991-2020, from the NOAA climate normals database.

Skagway's climate is characterized by cold winters and cool, wet autumns (**Figure 6**). Peak precipitation generally occurs in the fall (Palecki et al., 2021), however it receives relatively low precipitation compared to other areas in southeast Alaska, due to the rain shadow effect of the coast range. Vegetation in Skagway is typically composed of spruce-birch forests, with a layer of spongy moss and spruce needles lining the forest floor.

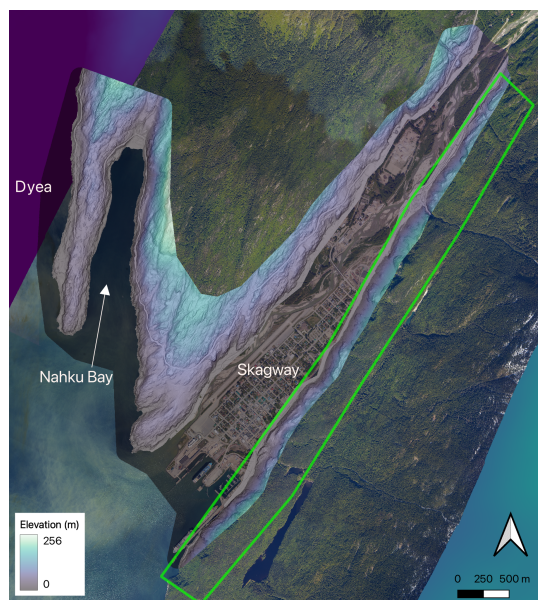
Figure 7: Coverage area a 2014 Lidar survey which includes Skagway valley, Nahku Bay, and one side of Dyea valley. The area of interest for the 2023 UAV Lidar survey is outlined in green.

Two Lidar DEMs were used in this study to map talus deposits and for the slope orientation inputs for GIS-based kinematic analysis. One Lidar DEM surveyed in 2014 (**Figure 7**) was available on the DGGs elevation portal, with 3x3 ft. cell size, which includes rock slopes in Skagway Valley, Nahku Bay and part of Dyea valley (Macpherson et al., 2014).

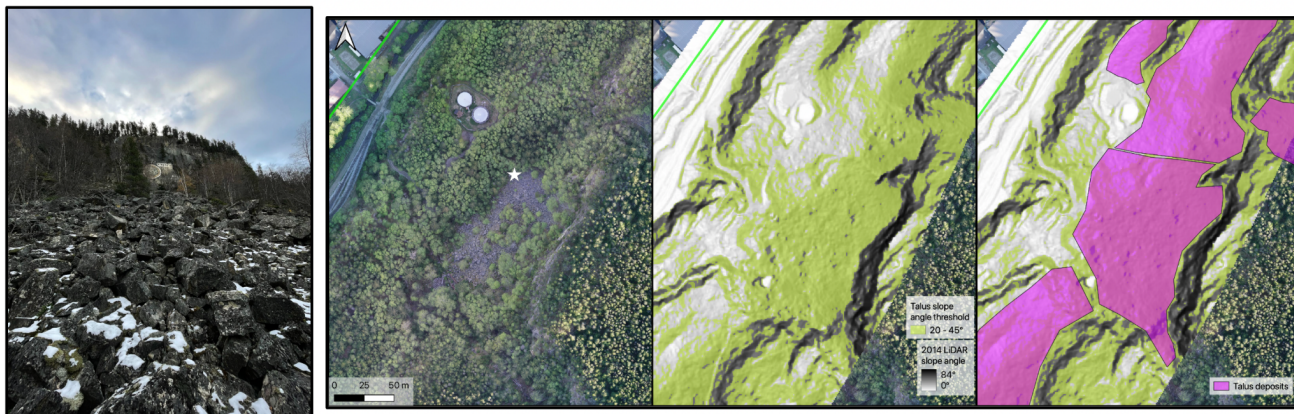
Figure 8: Photo taken from an exposed talus deposit with boulder sized clasts at the base of a 40 m cliff known as Kirmse’s Cliff (far left). Aerial imagery from 2023 of the talus deposit and cliff (center left), white star represents photograph location. Terrain within the slope angle threshold of 20° - 45° colored in yellow (center right), which are used to identify talus deposits (far right).

Slope angle thresholds have been used to identify rockfall source areas and talus deposits in mountainous terrain (Loye et al., 2009). Slope angle rasters were derived in QGIS from the 2014 and 2023 DEMs. A talus deposit at the base of a prominent vertical cliff, which includes both forested and exposed talus, (**Figure 8**) was used to define the threshold of slope angles that represent talus deposits in Skagway, which is typically 20°-45°. Talus deposits apparent at 1:1000 map scale, typically on the order of 1000's of m² but not smaller than 100's of m², were identified

On the east side of Skagway valley, rockfall susceptibility is not distributed homogeneously across the landscape. On Kirmse's Cliff, talus deposits extend from the valley bottom to the base of a uniform vertical cliff face that terminates at the bench at the top of the slope (**Figure 8**). In this area, rockfall susceptibility is high, but concentrated to a relatively small area of vertical rock slope, and a partially forested talus deposit sits between the cliff and structures in Skagway. Above the cruise ship dock, rockfall susceptible slopes are not concentrated to a single area (**Figure 11**). Instead, rock slopes susceptible to block toppling failure are continuous from the topographic

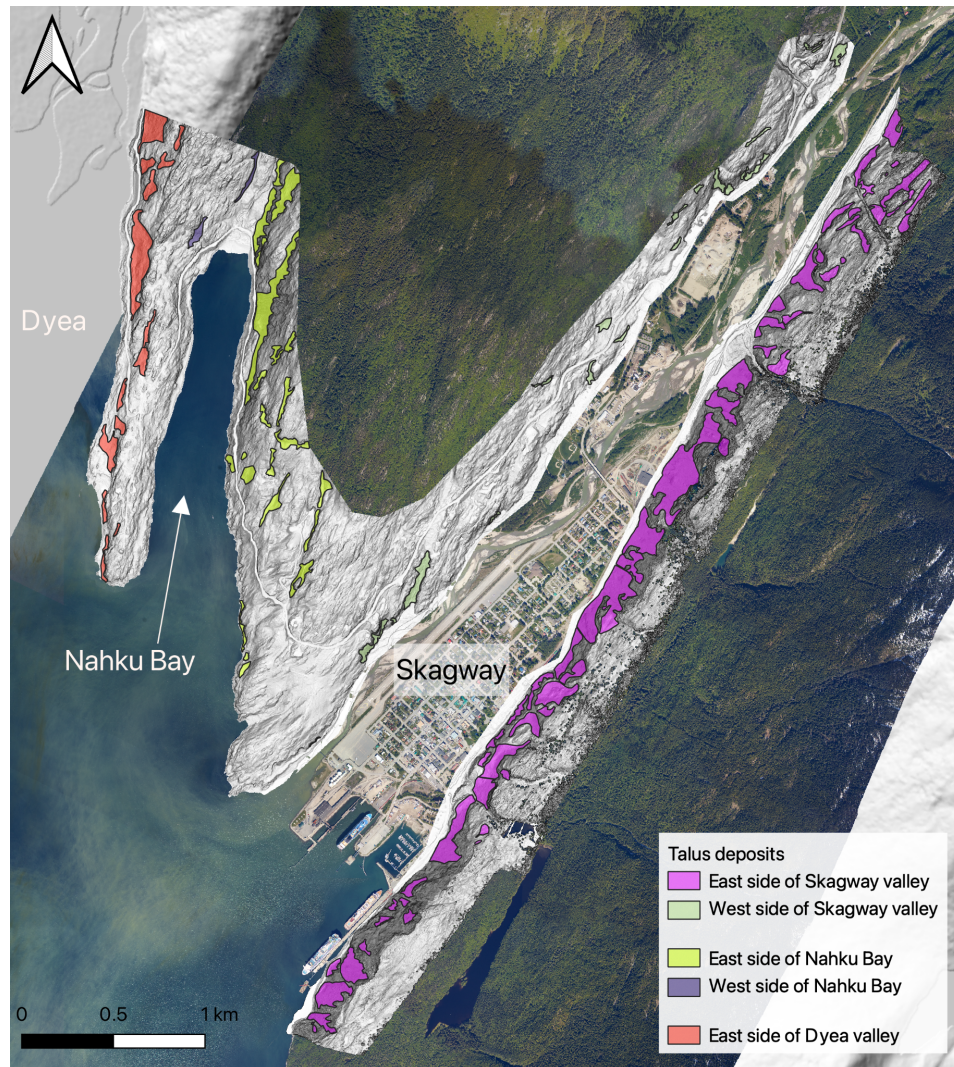
Figure 9: Manually mapped talus deposits colored by their location within Skagway valley, Nahku Bay, and Dyea valley. Slope angle base maps from 2014 and 2023 lidar datasets.

On the east side of Skagway valley, there is a sharp inflection point at the top of the slope, which is particularly distinct above the cruise ship dock, where a flat topographic bench abruptly contacts steep, rugged terrain that continues downslope (**Figure 9**). Below this inflection point, talus deposits are located at the base of steep slopes. The bench has retained much of its glacially smoothed texture, therefore the sharp inflection point marks the extent of post-glacial rock slope failure. The west side of Skagway valley has considerably different morphology, in that it lacks a distinct topographic bench and is overall more consistent and gradual than the east side. Some vertical cliffs are present along the Skagway River, otherwise, the topography on the west side of Skagway valley mainly consists of rock slopes that form prominent ridges that parallel the strike of the valley.

Talus deposits compose 12% of the 7.2 km² total mapped area (**Figure 9**). On the east side of Skagway valley, 56 talus piles were mapped, with an average area of 9,288 m², which make up 20% of the 2.62 km² mapped area. On the west side of Skagway valley the 20 talus deposits were on average smaller in area than those on the east side of the valley (**Table 1**), and only constituted 3% of the 1.67 km² mapped area.

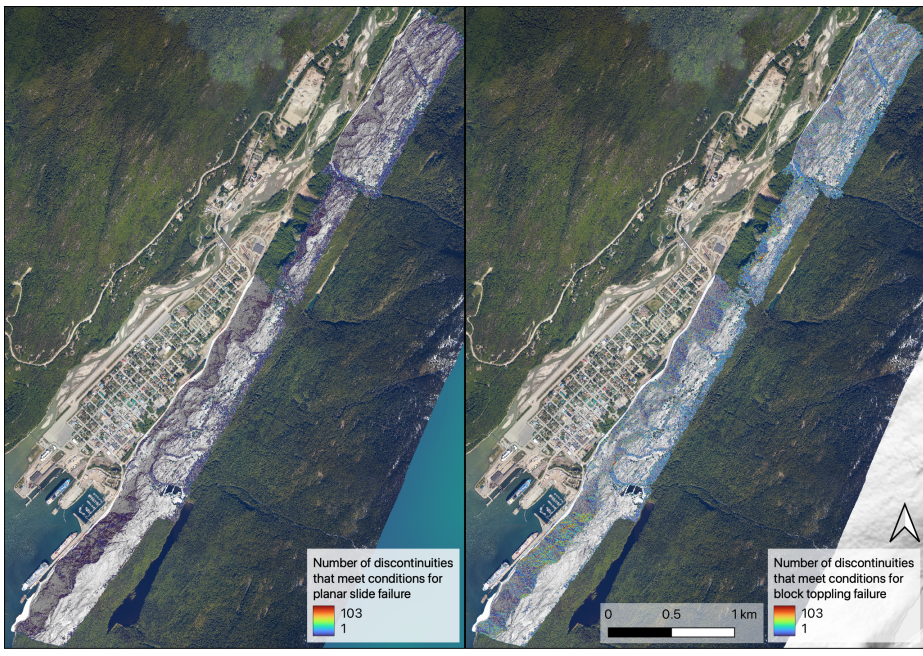
Figure 12: Susceptibility of rock slopes to planar slide failure (left), and block topple failure (right) within the 2023 lidar coverage area. Areas with no potential failure planes are not colored.

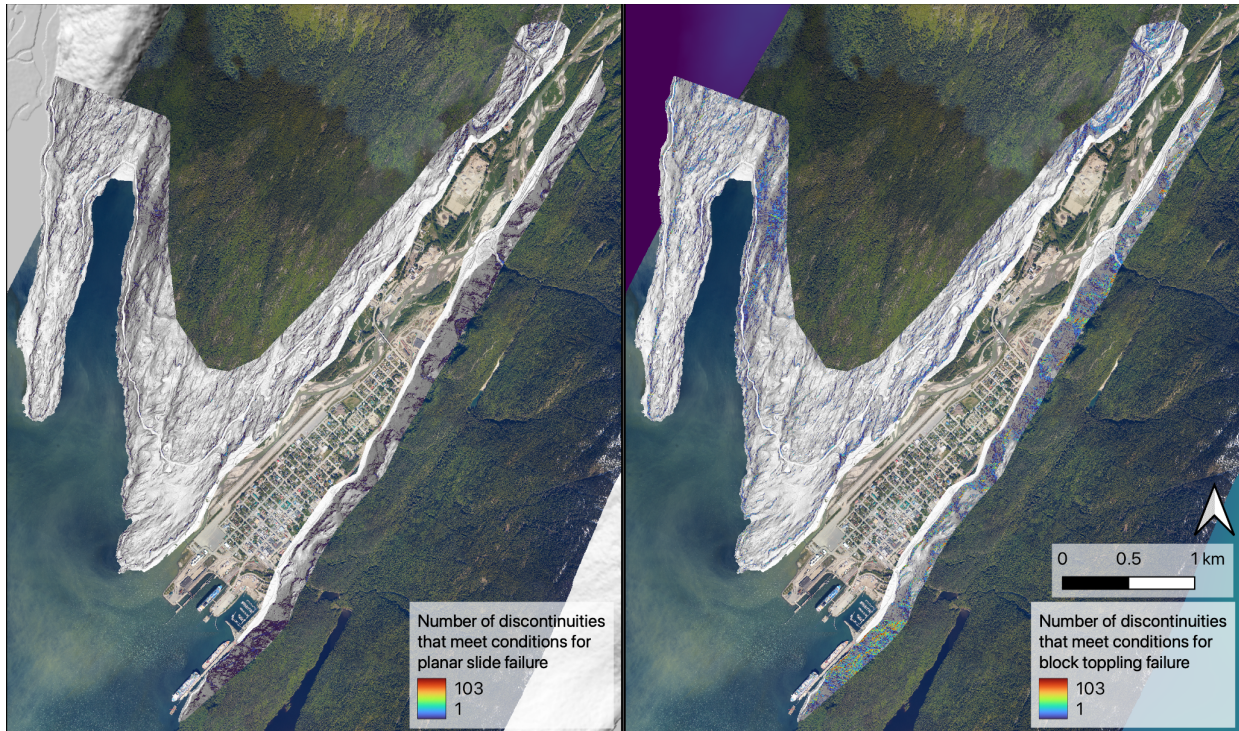
Figure 13: Susceptibility of rock slopes to planar slide failure (left) and topple failure (right) within the 2014 lidar coverage area. Areas with no potential failure planes are not colored.

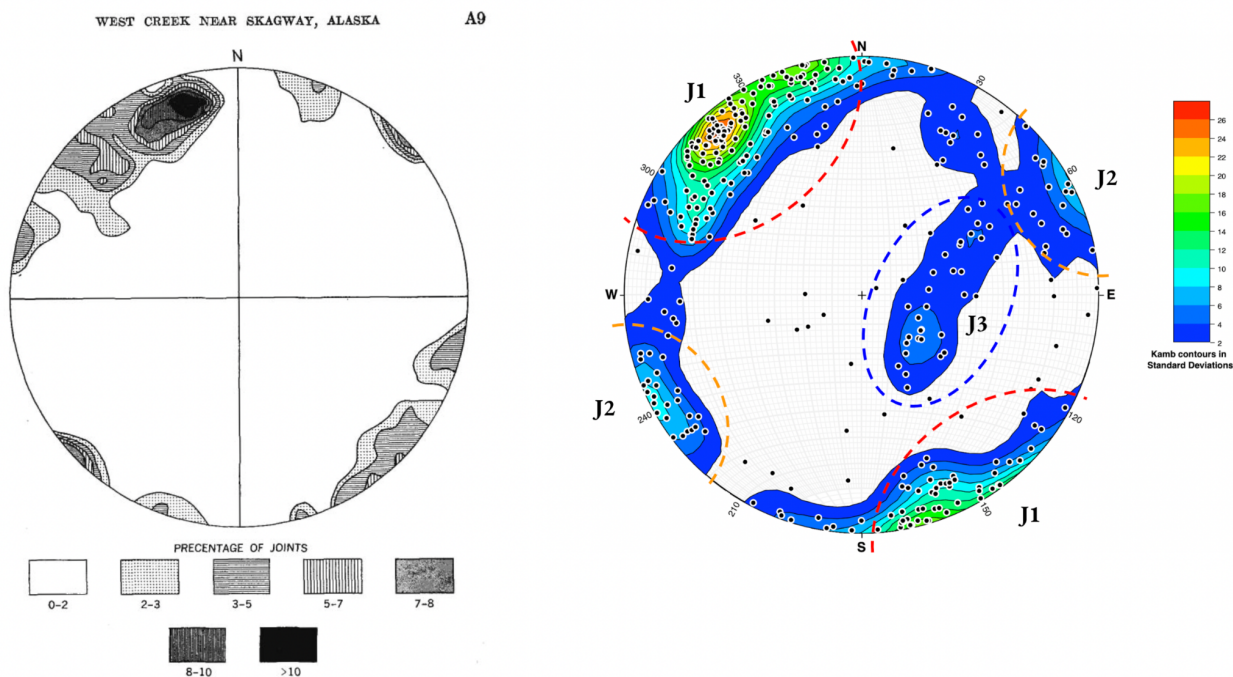
Figure 14: Lower hemisphere equal area stereonet where joints are plotted as poles, from joints measured in West Creek (n=60) (left), and in Skagway (n=337) (right), which are grouped into two orthogonal joint sets (J1 & J2) and one set of low angle sheeting joints (J3).

The joints measured in this study (**Figure 14**) are consistent with the steeply dipping, orthogonal joint sets measured in a nearby structural survey in West Creek (Callahan & Wayland, 1965), and described in a geotechnical assessment of the rock slopes above Skagway's cruise ship dock (Brennan & Whistler, 2022). High angle joints are likely formed by the tensile component of shear stress from the nearby Chatham Strait fault and Eastern Denali fault systems, while sheeting joints are formed by releasing overburden pressure.

Rock slopes with orthogonal jointing are predisposed to block toppling failure, where steep orthogonal joints form the sides of toppling blocks and low angle joints, like the sheeting joints observed in this study, act as the basal failure plane (Wyllie & Mah 2004). Given the densest cluster of joints (**Figure 14**) dips steeply to the southeast, rock slopes facing northwest would generally form anti-dip slopes which are conducive to toppling failure. This is supported by larger and more abundant talus deposits on the east sides of Skagway valley and Nahku bay, indicating the rockfall occurs preferentially on northwest facing slopes.

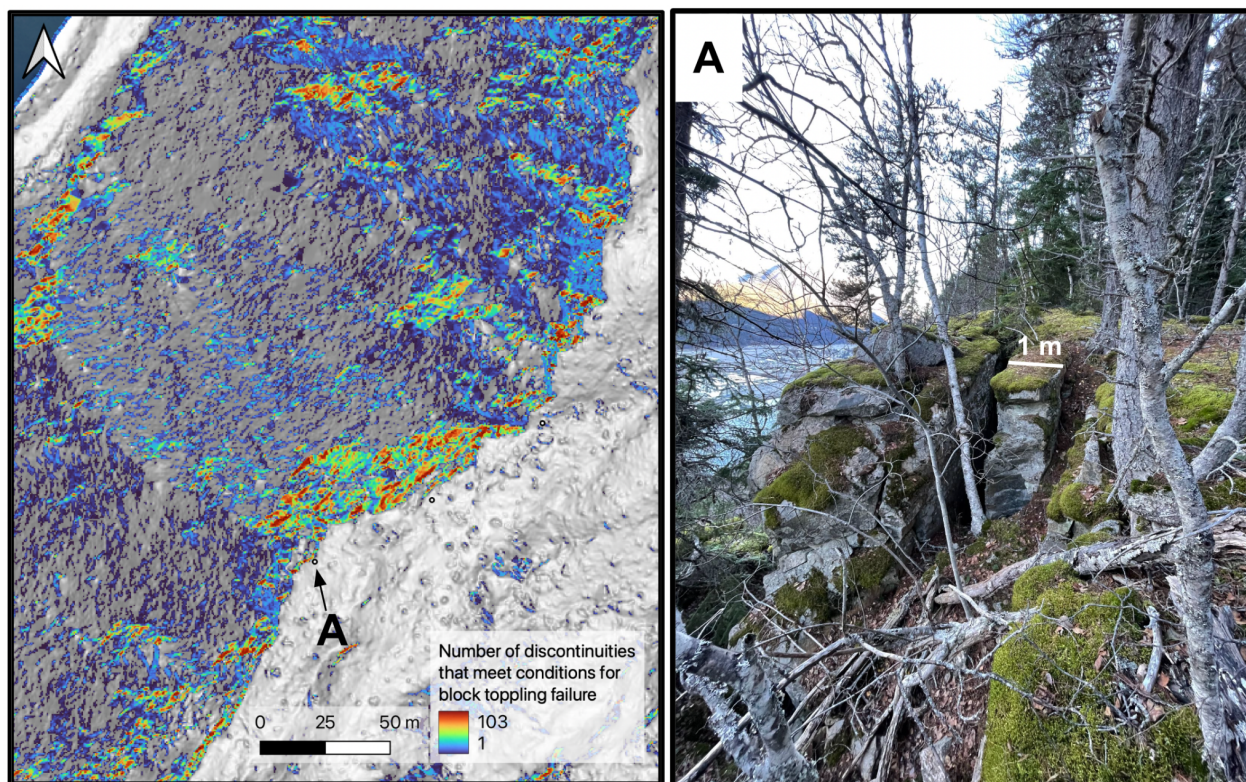
Figure 15: Tension cracks developing in a rock slope that will likely topple in the future (right), which is consistent with the high rockfall susceptibility in the same area for block topple failure.

Rockfall susceptibility maps are consistent with the failure mode and location of rock slope failures observed in the field. At the edge of the glacially flattened bench above the cruise ship dock, parallel slabs of rock are formed by tension cracks, which are likely to experience toppling failure as

vegetation and other processes widen these cracks (**Figure 15**). This is consistent with the results of the kinematic analysis for block toppling; cells proximal to this feature contain >70 potential failure planes for block toppling failure, which is a relatively high susceptibility. The same cells are also susceptible to planar sliding failure to a much lesser degree, which contain <10 potential failure planes.

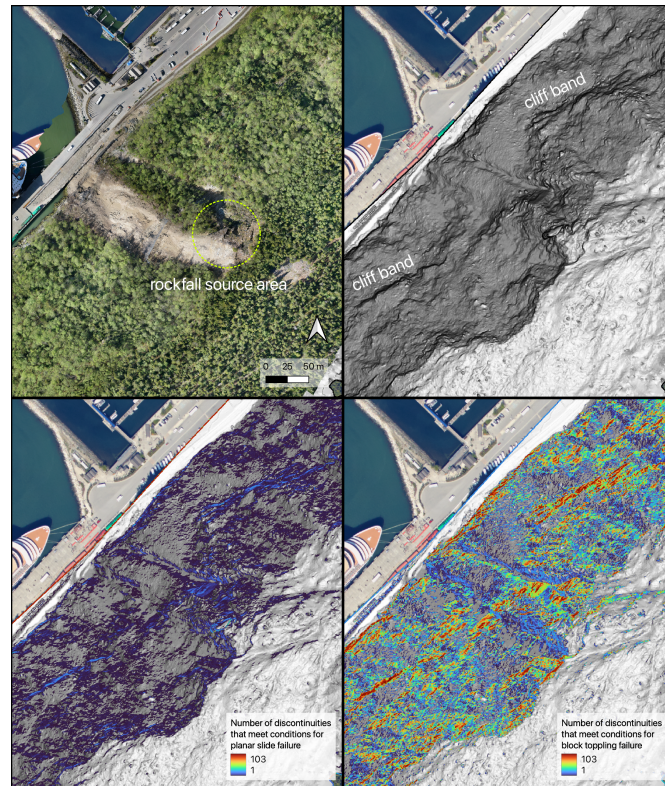
Figure 17: The steep slopes above the cruise ship dock. Aerial imagery taken in 2023, which shows the rockfall source area of the North Slide. Attenuator nets are located midslope and at the base of the slope (top left). Slope angle map with labeled cliff bands (top right). Rockfall susceptibility for planar slide (bottom left) and block topple failure (bottom right).

| Figure 17: The steep slopes above the cruise ship dock. Aerial imagery taken in 2023, which shows the rockfall source area of the North Slide. Rockfall susceptibility for planar slide and block topple failure. | 37 |

bench down to the base of the slope, resulting in a large area of high rockfall susceptibility in very close proximity to Skagway's infrastructure.

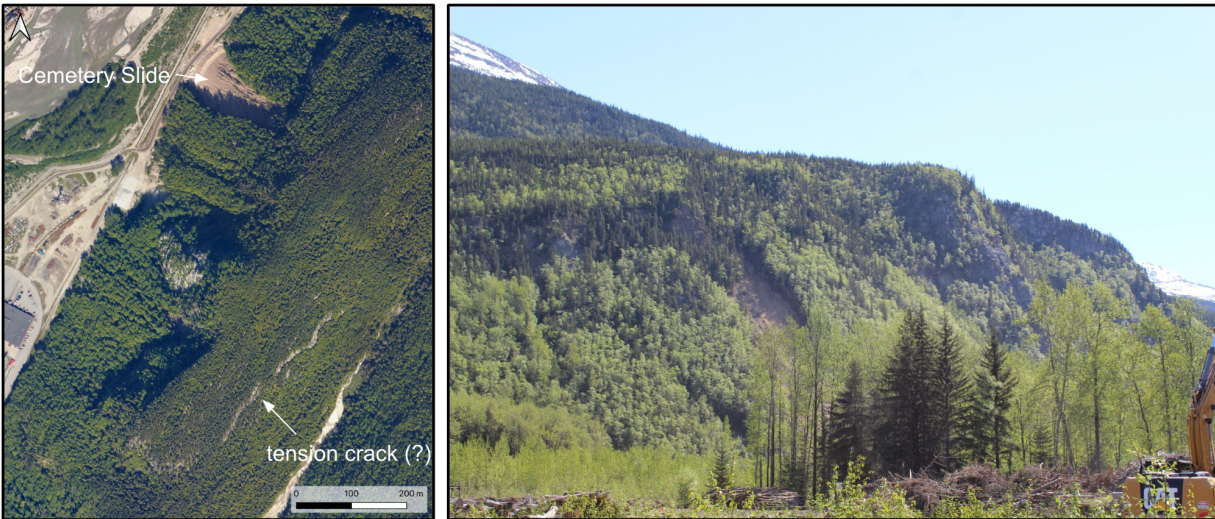
Figure 18: The Cemetery Slide area at the north end of Skagway valley, with a runout path stripped of vegetation. Lineament striking NE/SW, potentially a tension crack opening to the north (left). Photo of the slope face taken from Skagway valley (right).

| Figure 18: The Cemetery Slide area at the north end of Skagway valley, with a runout path stripped of vegetation. Lineament striking NE/SW, potentially a tension crack opening to the north. Photo of the slope face taken from Skagway valley. | 38 |

An area with similar slope characteristics can be found 3 km north of the harbor, where the slopes reach 320 m above the valley floor. A prominent rock slope is continuous from the topographic bench down to the valley floor; vertical cliffs are also present at the top of the slope (**Figure 18**). The source area for the Cemetery Slide, which is comparable to the active rockfall area above the cruise ship dock, is located at the inflection point at the top of the slope along this prominent topographic rise. No rockfall records from this area were examined in this study, but the runout

zone of the Cemetery Slide is consistent with other active rockfall source areas in Skagway. A lineament runs along the back of this topographic rise, which is potentially formed by a tension crack extending to the north. The lineament strikes parallel to the valley, consistent with other tension cracks observed in the field, but this location was not visited in the field, and thus the presence of a tension crack could not be verified.

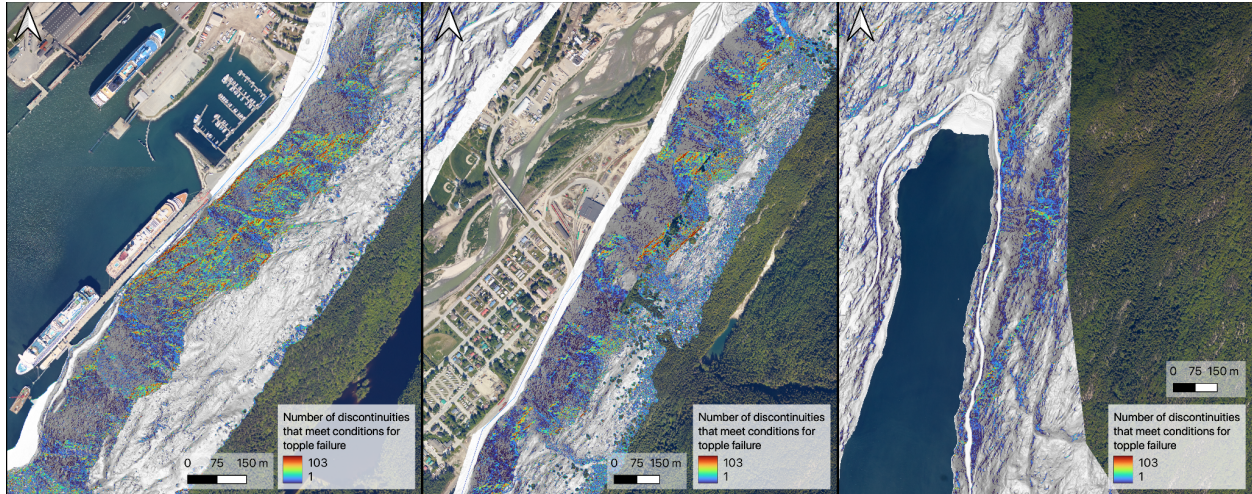
Figure 19: Three areas that are characterized by large continuous areas of rockfall susceptible slopes that are present continuously from the base of slopes to high elevations (>200m), which are found above the cruise ship dock (left), along the topographic rise near the Cemetery Slide (center), and on the east side of Nahku Bay (right).

| Figure 19: Three areas that are characterized by large continuous areas of rockfall susceptible slopes that are present continuously from the base of slopes to high elevations (>200m), which are found above the cruise ship dock, along the topographic rise near the Cemetery Slide, and on the east side of Nahku Bay..... | 39 |

In the northeast part of Nahku Bay, another zone of high rockfall susceptibility is also present (**Figure 19**). Steep rocky slopes rise to an elevation of 250 m within 200 m horizontal distance from Dyea road. This area lacks a distinct runout path like those apparent at the Cemetery Slide and above the cruise ship dock, but does encompass source areas for two events in the rockfall inventory that impacted Dyea road.
