# Coos Bay Lowland Assessment and Restoration Plan

2006

Coos Watershed Association  
P.O. Box 5860  
Charleston, OR 97420

## Chapter 2: North Slough Sub-basin Assessment

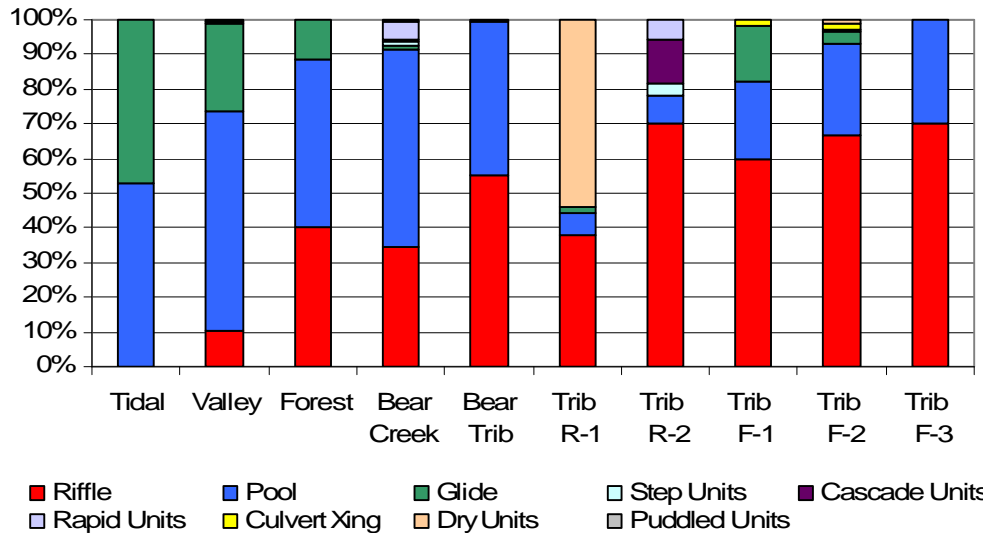
Figure NS-5  
Unit Types

Figure NS-5, unit types, shows the percentage of unit types within each reach surveyed. A moderate portion of North Slough is considered tidal slough or tidal glide (green). Tidal glides are very similar to small estuarine channels, as described by the Oregon Watershed Assessment Manual. Riffles increase in the tributary reaches and higher on the mainstem. Trib R-1 has a large amount of dry units.

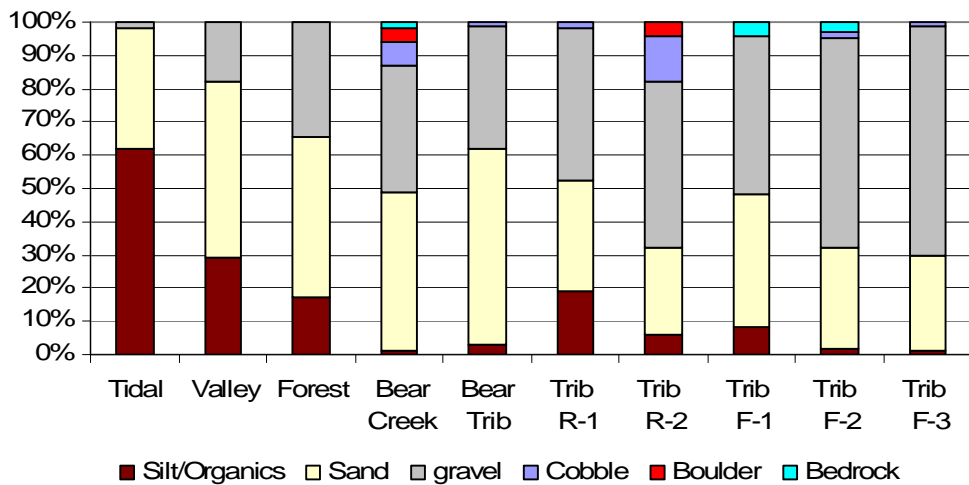
Figure NS-6  
Substrate Types

Figure NS-6, substrate types, shows the percentage of each substrate within the reaches. These typically correspond with the unit types. This sub-basin contains high percentages of silt and sand, especially in the mainstem reaches and increasing to more than 60% in the Tidal reach. Conversely, the proportion of gravel increases in the tributary reaches.

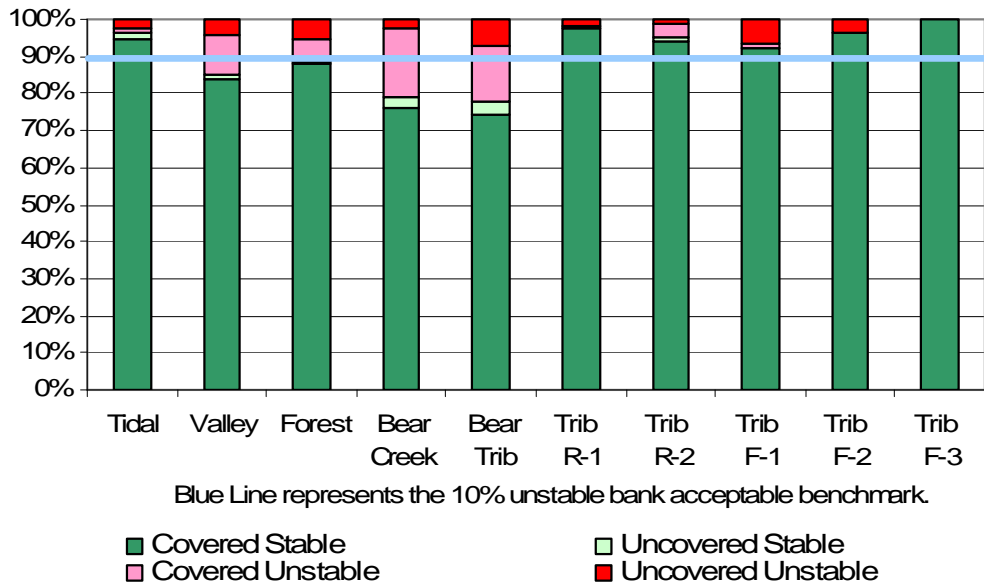
Figure NS-11  
Bank Stability

Bank stability surveys are conducted as part of the aquatic habitat surveys. Figure NS-11 shows the bank stability ratings for each aquatic habitat reach. The North Slough bank stability survey indicates that most of the stream system has fair bank stability, however, Bear creek and its main tributary both have over 20% unstable banks. Most covered unstable banks are dominated by Reed canarygrass (*Phalaris arundinacea*).

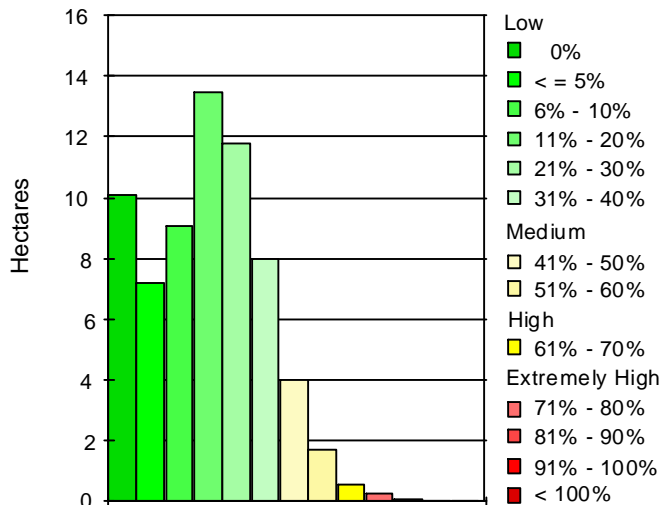
Figure NS-12  
Slope Stability

The slope analysis, shown in Figure NS-12, determined that 89.9% of the area in the sub-basin is in the low risk category for landslide potential, 8.7% is at moderate risk, 0.8% is at high risk, and 0.6% is at

extremely high risk. The most unstable slopes are located in the headwaters of North Slough Creek, in the highest elevations at the eastern end of the sub-basin. The highest slopes are found in areas of Tye silt/sandstone, which means that there is high potential for slope failure in these areas.

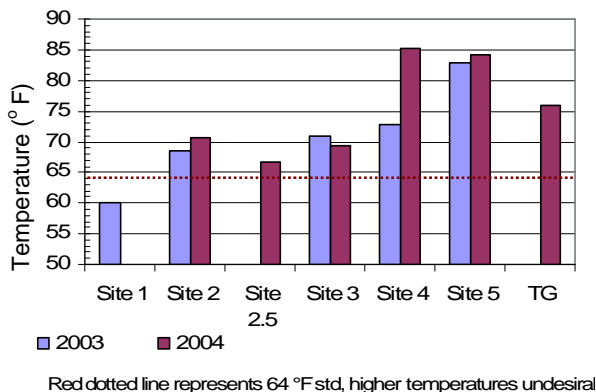
**Figure NS-13  
7-Day Moving  
Averages of  
Daily Maximum  
Temperatures**

Figure NS-13 illustrates the temperature trends within the sub-basin using 7-day average maximums, and colors them according to salmonid suitability. The map shows the temperature trends over the length of the stream, displaying the

temperature increases from 55°F at the headwaters to 76.7°F near the mouth in 2003. The Bear Creek Tributary data is from 2004. On North Slough Creek in 2003, the average daily high water temperature downstream from the Upper site to the mouth increased 0.52°F per 1000 ft. This represents the difference between the average daily highs at the uppermost mainstem site (Site 1), and Site 6, near the tide gate. The change in temperature between the individual sites for 2003 was less than 1°F per 1000 ft for all segments except between Sites 3 and 4, where the stream temperature changed -13.35 °F per 1000 ft, meaning temperatures actually decreased in this segment. Based on the data, the tributary would appear to be a cooling influence, but the temperature logging site is over 2 miles up the tributary. Without a temperature unit measuring the tributary shortly before it meets the mainstem, as well as a site just upstream of the confluence on the mainstem, it is not possible to draw exact conclusions on the influence of the tributary on mainstem water temperature. Unit placement was largely dictated by landowner permissions for access.

Table NS-9, above, shows the 7-day average maximum and minimum temperatures, and the number of days and hours spent exceeding 64 and 70°F for each temperature logging site in the North Slough sub-basin. Exceedance of standards is shown in Figure NS-13, below. The data indicate that during the hottest 7-day period of the season, the average minimum temperature never dropped below 64°F. All sites on North Slough in 2003 and 2004 exceeded the state standard for 7-day maximum temperatures of 64°F.

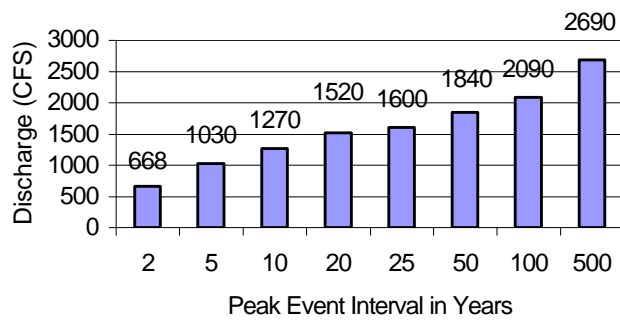
**Figure P-3**  
Peak Event Interval in Years

Annual peak stream flow for Palouse Creek was obtained using the Peak Flow Estimation Program (OWRD, 2005). They use hydrologic prediction equations and physical watershed characteristics to estimate peak flows. Figure P-3 shows the estimated discharge at the mouth of Palouse creek for storm events at two to five hundred year recurrence intervals. The bankfull storm event is estimated to be 668 cfs. On the other extreme, a maximum discharge of 2,690 cfs is estimated for a 500-year storm event in Palouse Creek.

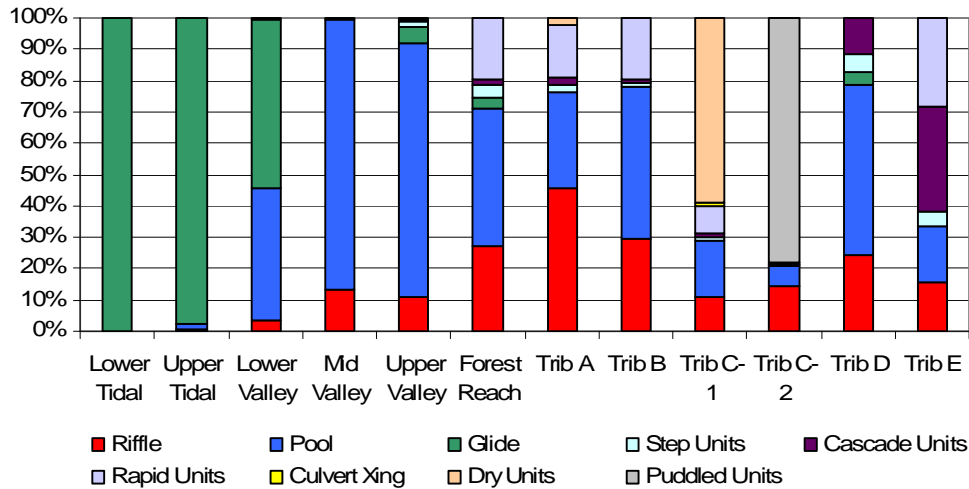
Figure P-5 Unit Types

Figure P-5 shows the percentage of unit types in each reach. Both Tidal reaches are almost all (99.5%) tidal glides. The Lower Valley reach has a high number of glides, but is less tidally influenced. The remaining mainstem reaches contain a high number of pools. Tributary C was mostly dry during the summer habitat survey..

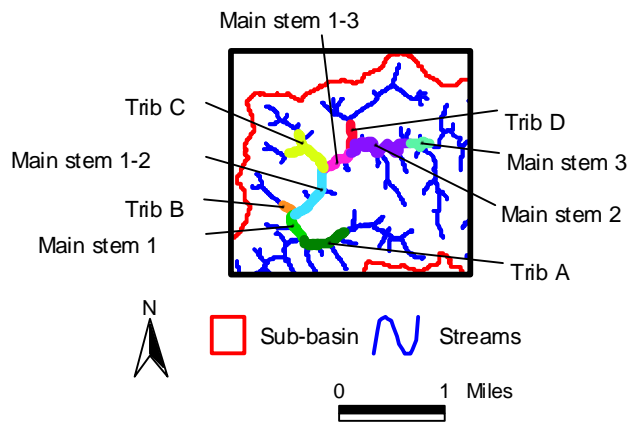
**Figure P-15**  
**Coho Spawning**  
**Survey**  
**Reaches**

During the winter of 2003 and 2004, the Coos WA and ODFW partnered to survey all major coho spawning reaches in the Palouse basin in order to assess the total coho escapement population. Reach locations are shown in Figure P-15. The Coos WA surveyed mainstem reaches 1-1, 1-2, 1-3, and all tributary reaches (see Figure P-15 below). The ODFW surveyed the mainstem reaches 2 and 3.

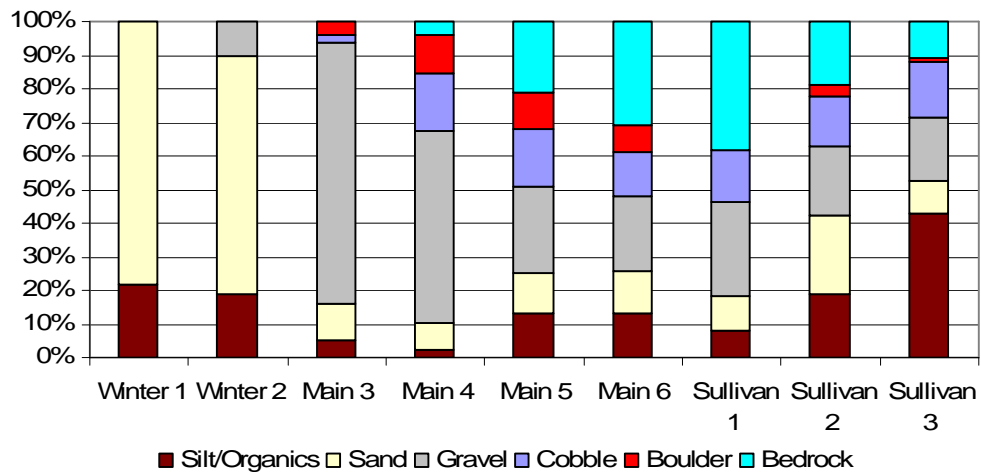
Figure L-6  
Substrate Types

Figure L-6, substrate types, shows the percent of substrate types found in each reach. The upper mainstem and Sullivan reaches have more cobble, boulders, and bedrock. Sullivan 3 has a high amount of silt/organics likely being caught in the large pool area shown in Figure L-5. The lower reaches, less varied in substrate types, are dominated by sand, gravel and relatively smaller amounts of silt/organics.

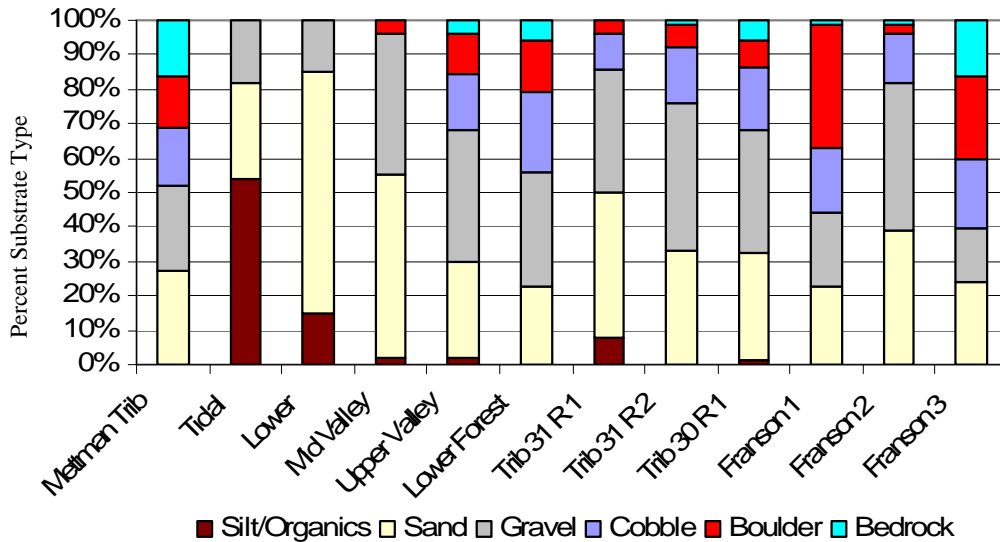
**Figure K-6  
Substrate Types**

Figure K-6 illustrates the substrate type for each reach. The substrate types correspond with the unit types. Higher gradient reaches tend to have more cobble, boulders, and bedrock; lower tidal areas tend to have higher sand/silt/organic substrates.

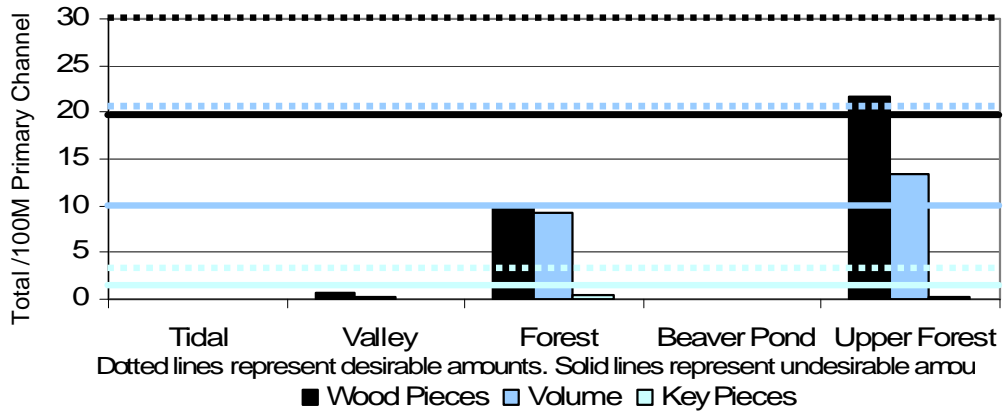
**Figure E-9  
Large Wood**

Figure E-9 describes the large wood analysis. The Tidal and Valley reaches had little to no large wood, and the Forest and Upper Forest reaches, had some wood but below desirable levels. Large wood was not visible in the Beaver Pond reach, but approximately one third of its surface is covered with live trees growing in the pond.

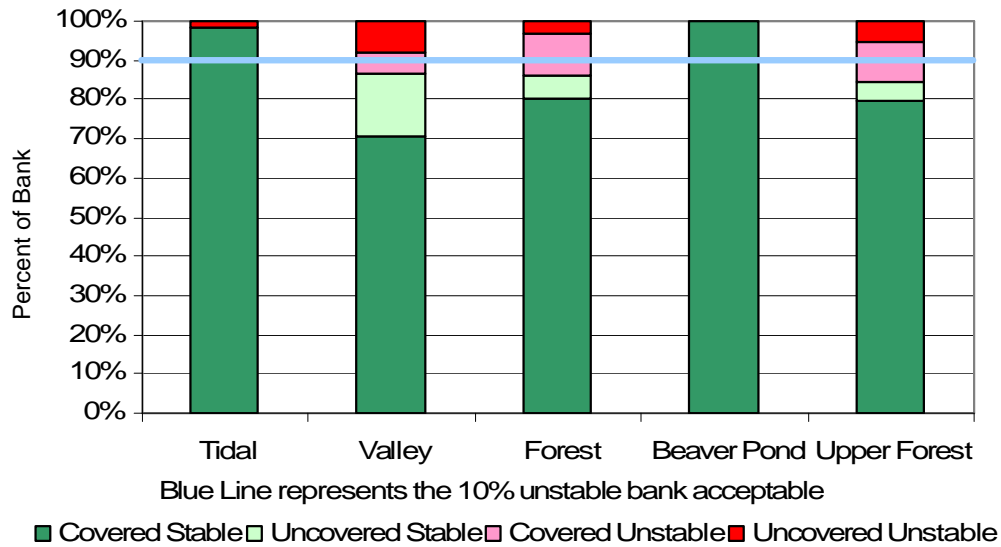
Figure E-11 Bank Stability

Bank stability surveys are conducted as part of the aquatic habitat surveys. Figure E-11 shows the bank stability ratings for each aquatic habitat reach. The Valley, Forest and Upper Forest reaches have more than the acceptable amount of unstable banks, while the Beaver Pond reach has all covered, stable banks.

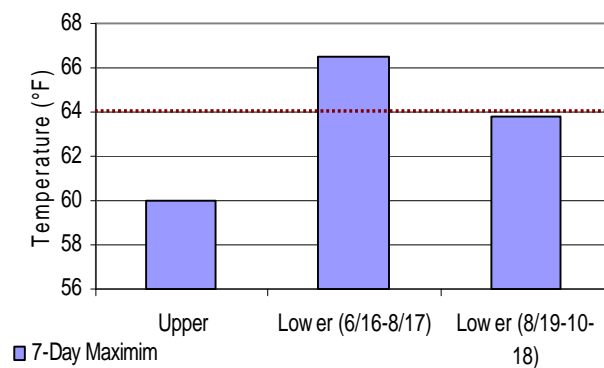
**Figure E-13**  
7-Day Moving  
Averages  
of Daily  
Maximum  
Temperatures

Table E-7 shows the 7-day average maximum and minimum temperatures, and the number of days and hours spent exceeding 64 and 70 °F for each temperature logging site on Echo Creek. Exceedance of the 64 °F standard is shown in Figure E-13, below. The data indicate that the lower site on Echo Creek did exceed the 64 °F standard during the first half of the summer. Both lower units combined recorded a total of 33 days exceeding the standard.

Red dotted line represents 64 °F std, higher temperatures undesirable

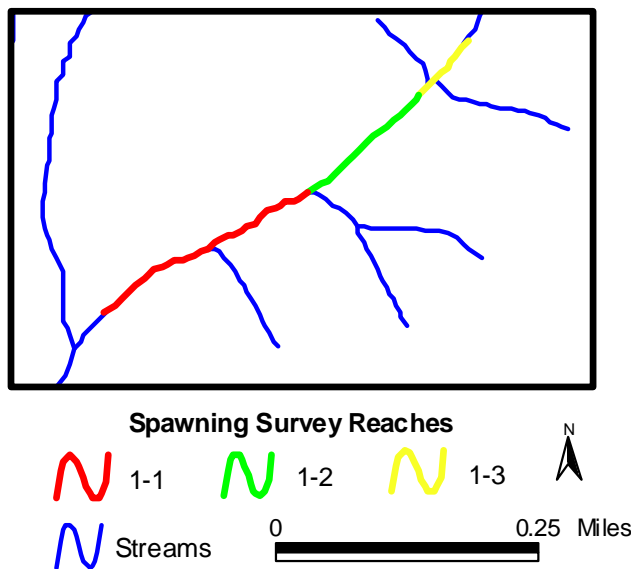
Figure E-16  
Spawning Survey

The Coos Watershed Association conducted its first Echo Creek spawning surveys in the 2003 season. (see Figure E-16). The start of the first segment of the reach begins at a beaver pond that is a wetland marsh. The first segment enters a forest canopy which provides a lot of shade from shrubs, conifers, and firs. There is a large amount of gravel in the first segment, though no fish were seen during the

spawning season. There are several small tributaries that branch from the creek throughout the reach. The dense canopy continues throughout the second and third segments of the reach. The third segment ends at a large pool with a waterfall which is a fish barrier. The upper part of the third segment has much more bedrock and less gravel is visible.

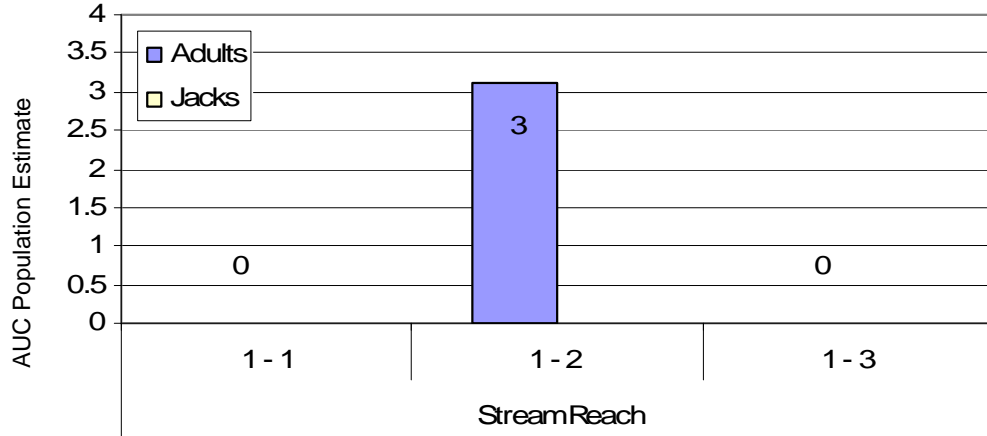
**Figure E-17**  
**Spawning**  
**Survey**  
**AUC**  
**Population**  
**Estimate,**  
**2003**

The amount of gravel found in reach 1-3 was significantly lower than in the other two reaches (see Table E-8). No fish were observed in reaches 1-1 or 1-3 (see Figure E-17), however, one redd was observed in segment 1-3. Segment 1-3 showed the highest redds/km, only because one redd was found and it was a short reach (.12 km). Reach 1-2 had 12 adult coho/km with a peak redd/km count of four. There were no other fish observed on the other reaches, and no other species of salmon were observed during the spawning survey season.
