A CASE STUDY OF A FLOODPLAIN CHANNEL RESTORATION PROJECT IN  
THE SOUTHERN WILLAMETTE VALLEY OF OREGON

A THESIS

March 2007

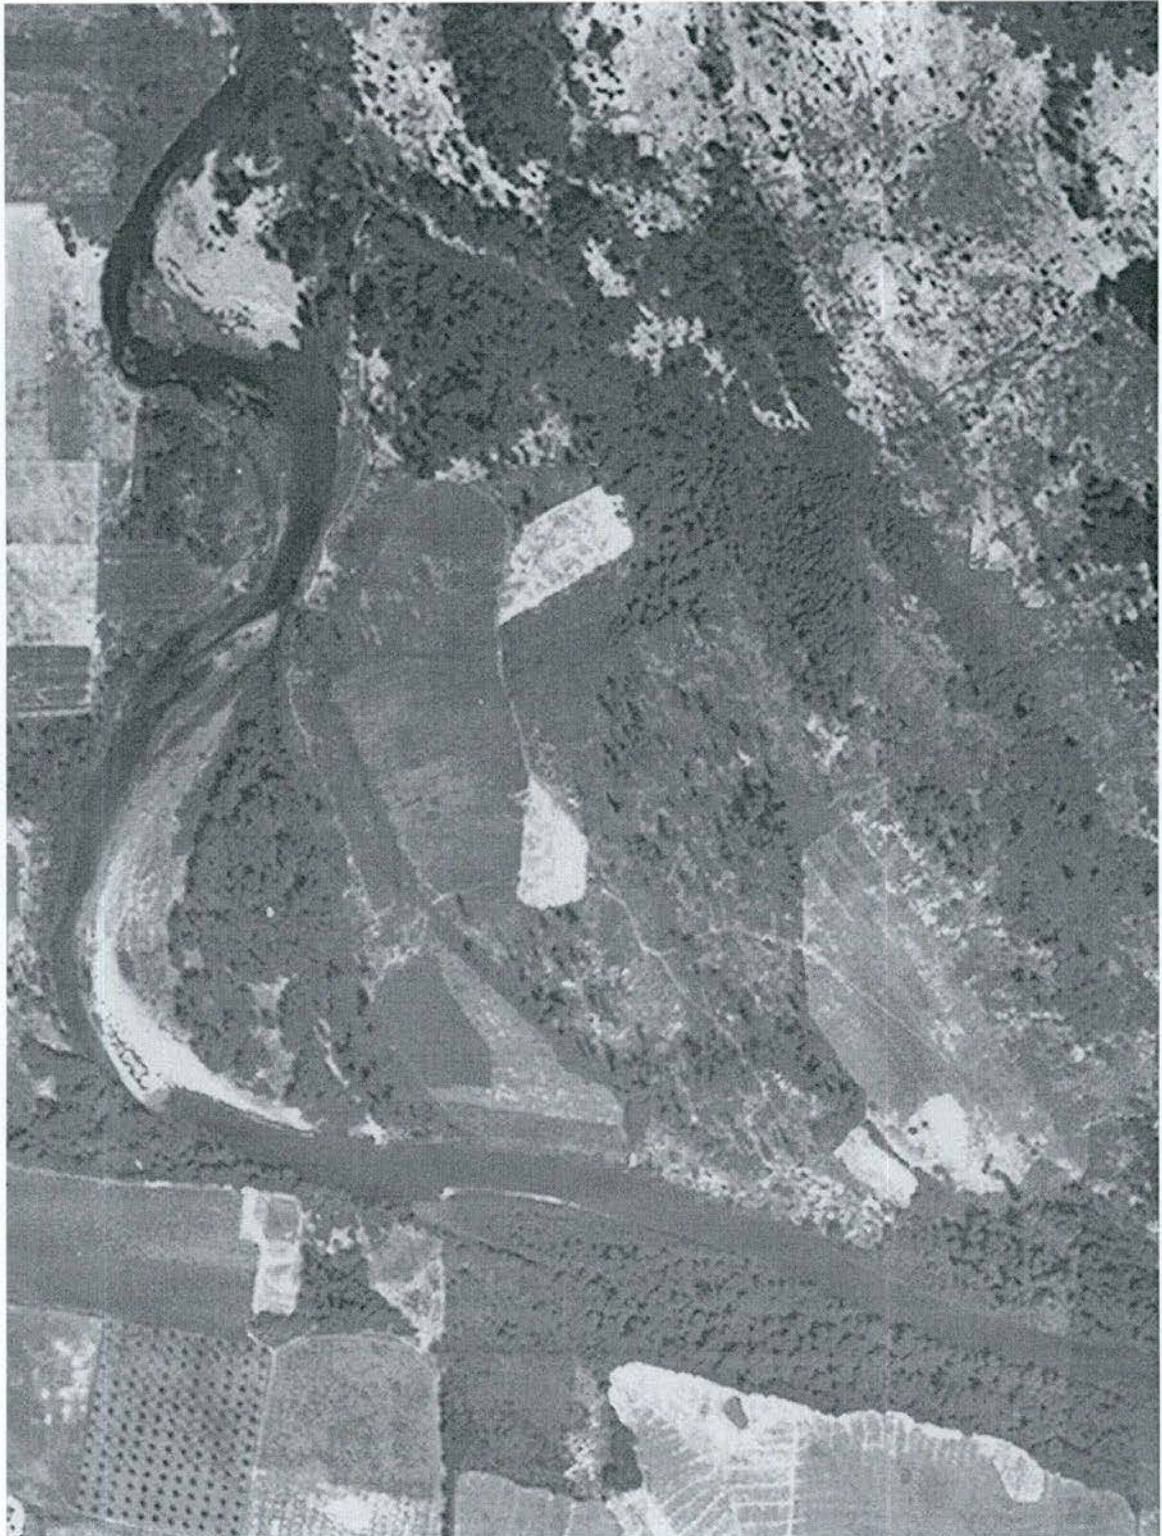
Figure 3. Aerial photo of the South Meadow taken in 1936, showing substantially the same amount of open space as exists today. The Coast Fork Willamette River flows from south to north. This is the earliest known aerial photograph of the site (courtesy FBP).

The ecological restoration project described in this thesis is contained within the 200-acre (80 ha) "South Meadow" area of the HBRA (see Figure 1) (FBP 2004d). Before Euroamericans settled the Willamette Valley beginning in the mid-19th century, the South Meadow was a floodplain forest dominated by Douglas-fir (*Pseudotsuga menziesii*), big-leaf maple (*Acer macrophyllum*), Oregon ash (*Fraxinus latifolia*), black cottonwood (*Populus balsamifera* var. *trichocarpa*), and willows (*Salix* spp.), with patches of open prairie vegetation (see Figure 2 for a mid-19th century map). By 1936, the year of the earliest known aerial photographs of the South Meadow, the site had been substantially cleared, either for cultivation or for pasture (see Figure 3) (FBP 1999e, 2002c).

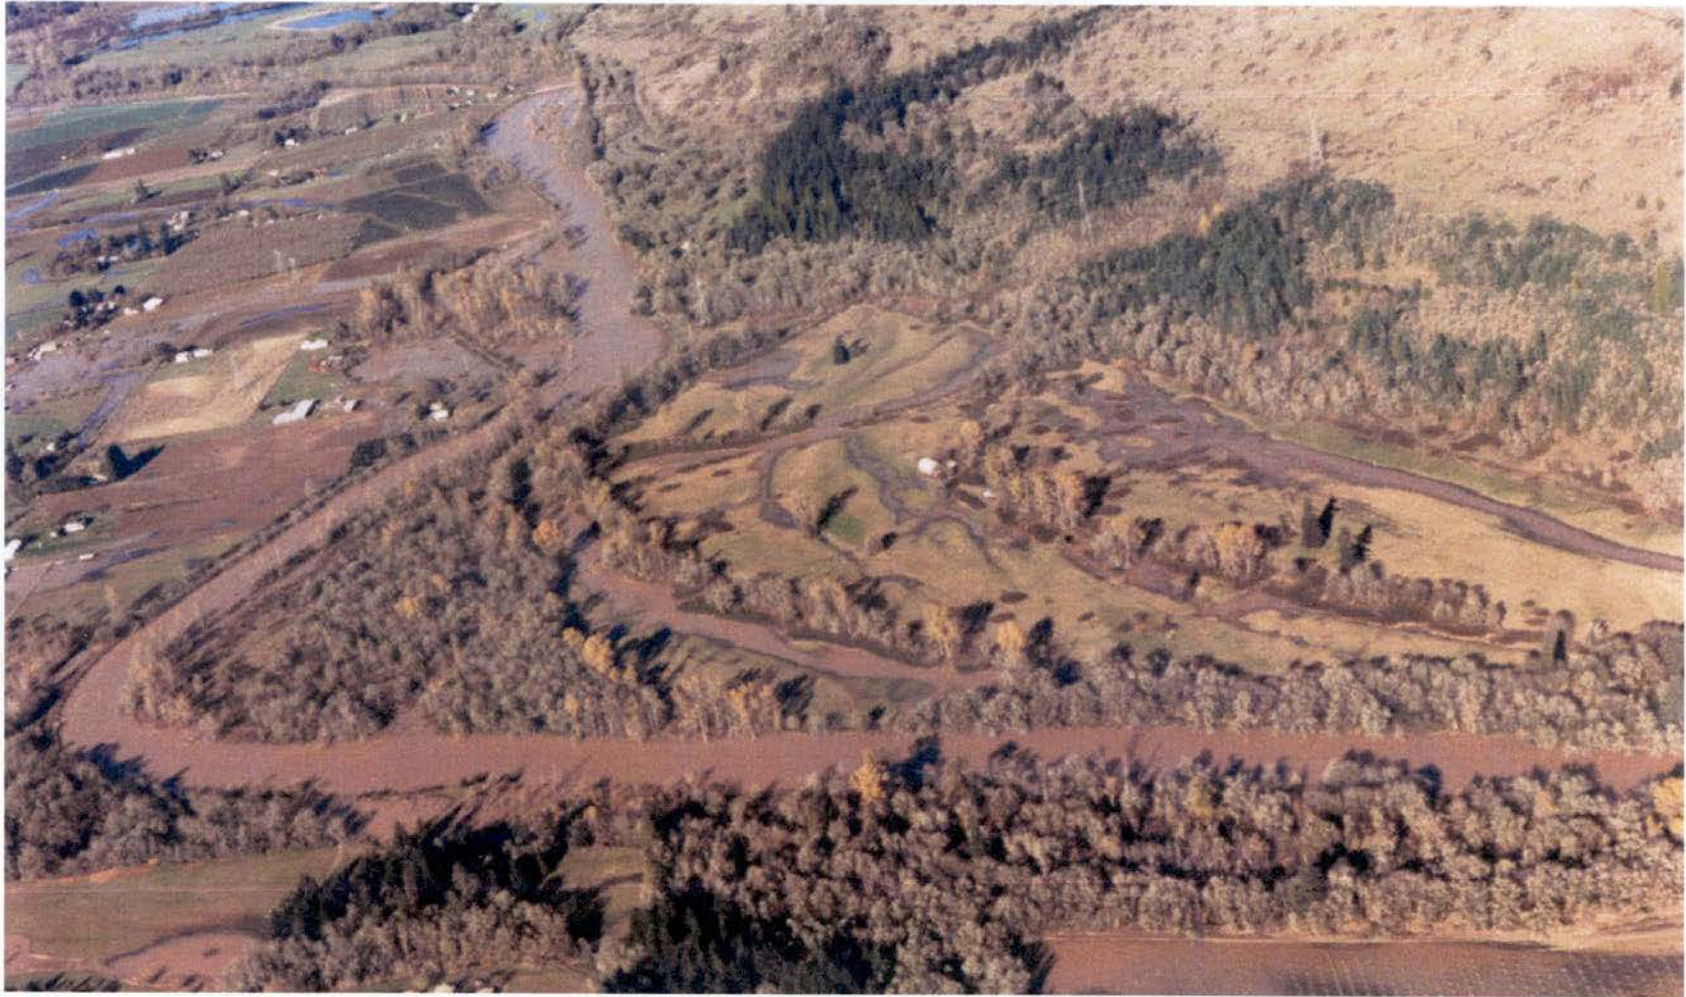
Figure 4. Photograph of the South Meadow as flood waters receded in November, 1996 (courtesy FBP).

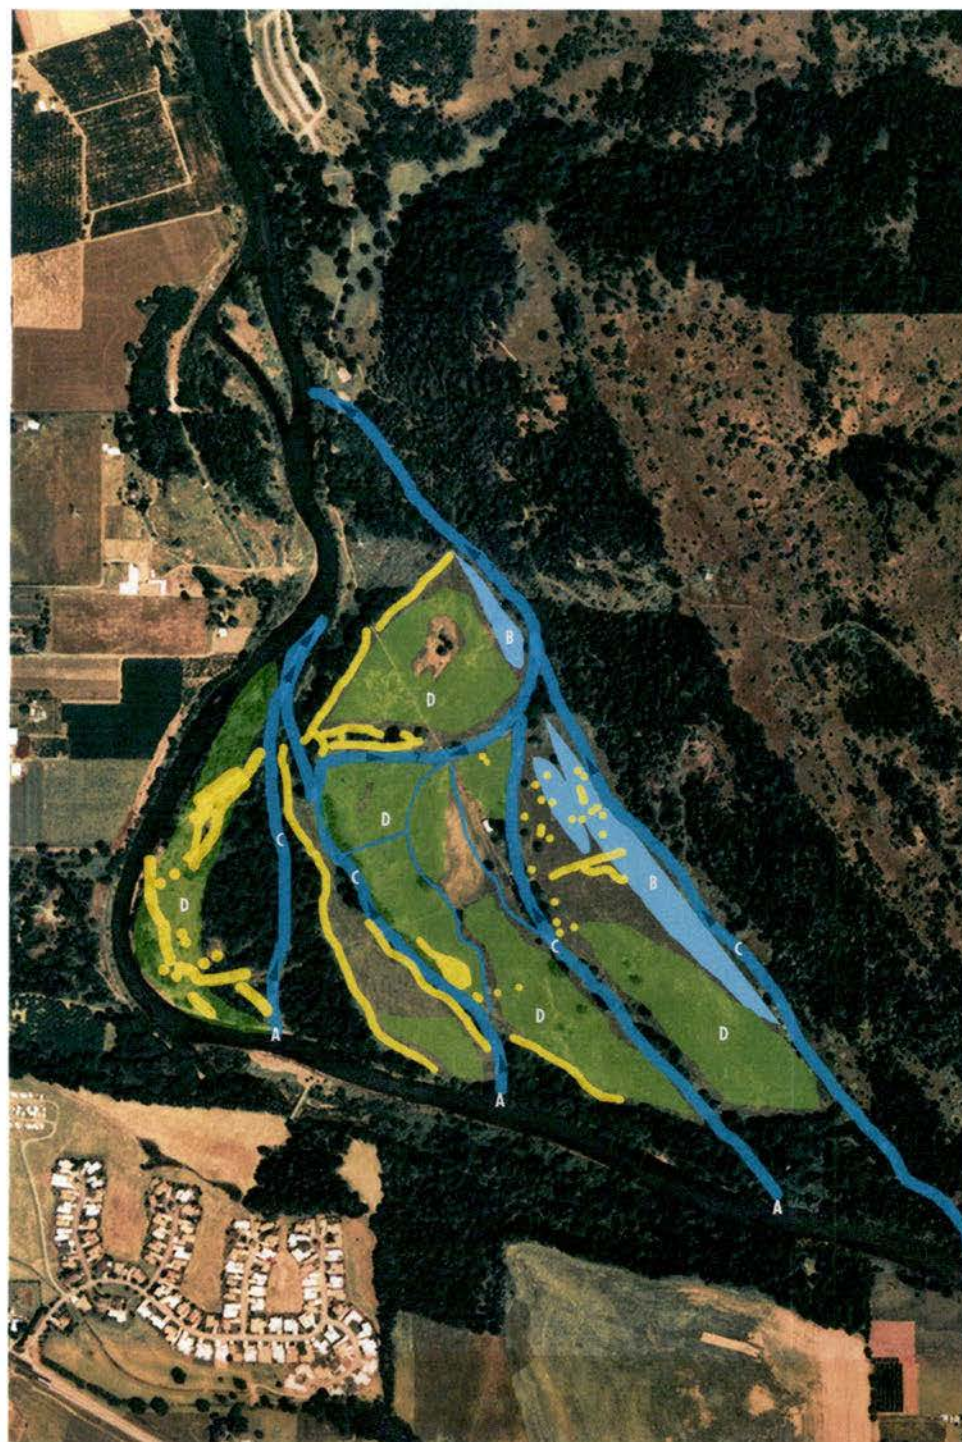
**FIGURE # 3 • PROPOSED HABITAT ENHANCEMENTS • "SOUTH PASTURE," HBRA**  
 Bonneville Power Administration Wildlife Mitigation Project • Produced for Oregon Department of Fish & Wildlife by Friends of Buford Park & Mt. Pisgah • May 1998  
 1993 Aerial Photography • Property Boundaries and Enhancement locations approximate

Restored Channels    Enhanced Wetlands    Vegetation planted    Exotic Vegetation Removal

of the three high-priority areas identified in the report was the HBRA's "South Pasture," the area that is now called the South Meadow<sup>3</sup> (ODFW 1997). The report recommended five restoration activities in the South Meadow (see Figure 6): removing three "plugs" that blocked water flow into historical channels; exploring restoration of wetlands on the east side of the pasture, at the foot of the hill; exploring reestablishment of wetlands and floodplain hydrology in four "abandoned" historical channels after studying the site's hydrology to determine the feasibility of this idea; controlling exotic invasive plants; and restoring riparian forest throughout most of the floodplain (ODFW 1997). These recommendations are essentially the same goals that exist in current planning documents for the South Meadow.

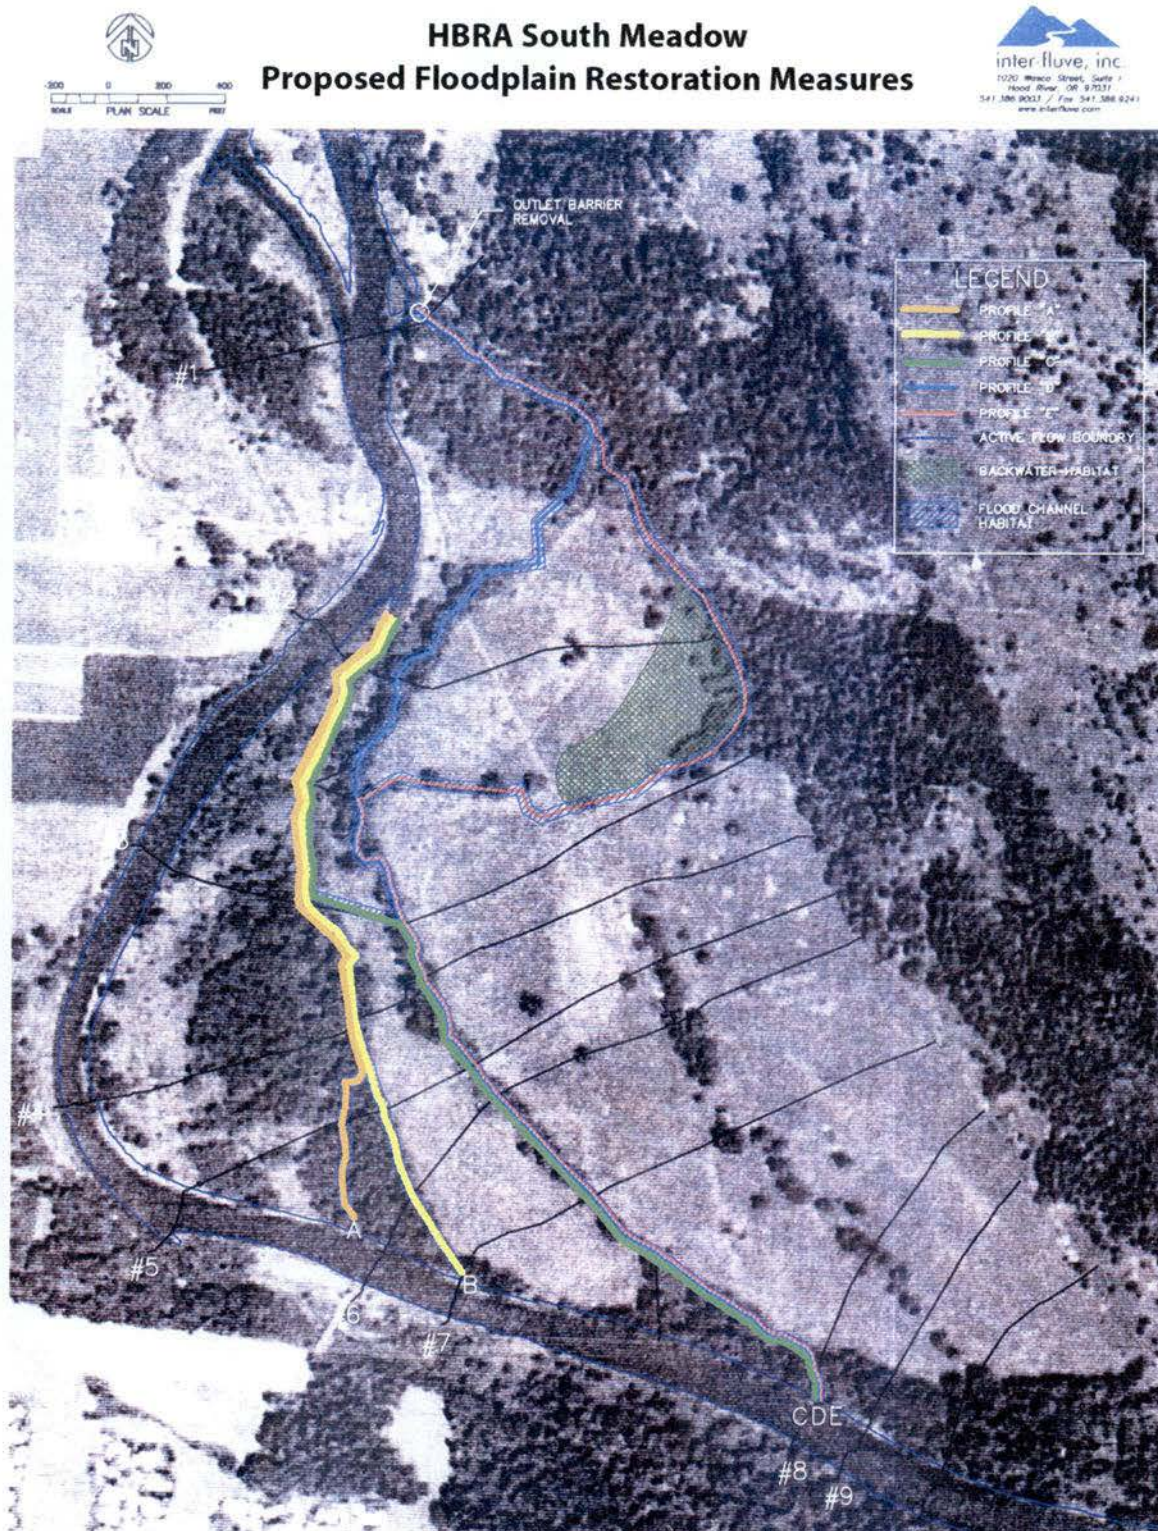
Figure 9. Proposed floodplain restoration measures, September 2002. Note channel letters at the south end of the South Meadow (Inter-fluve 2002).
