MERCURY MINES ALONG THE OAK GROVE FORK OF THE CLACKAMAS RIVER

Michael O'Leary
HC 441: Willamette River Health
Clark Honors College, University of Oregon
June 3, 2004

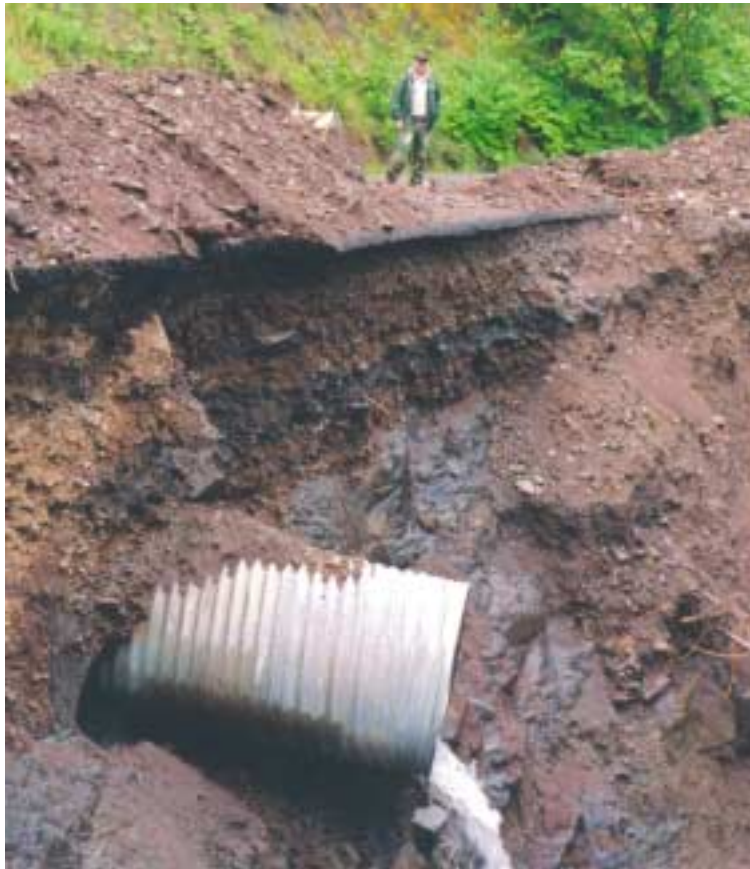
Figure 2. Effects of land movement on Forest Service Road #57.
Note: This is the second time in two years that this road, just uphill from the mines has been forced to close due to major landslides.
Photo by author.

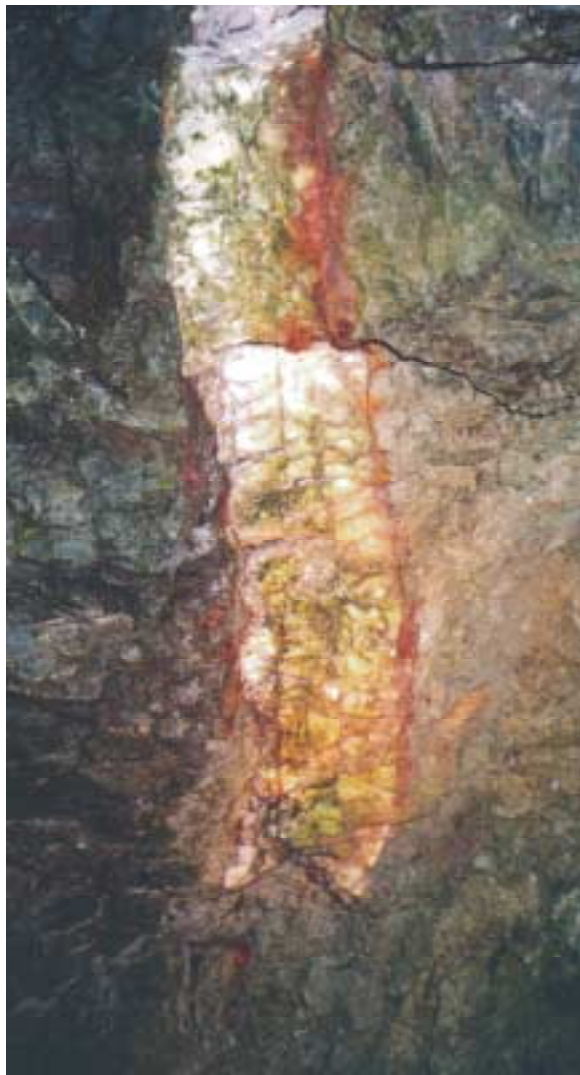
Fig. 3. Calcite vein bearing cinnabar at the Nisbet mine. Note: The white calcite vein is approx. 4" in width, and is generally encased by narrow red veinlets of cinnabar. Photo by author.

Mercury most commonly occurs within cinnabar ore, a reddish crystal of mercuric sulfide (see figs. 3 and 4) (Brooks 19). The fundamental process for deriving the silver-colored elemental mercury from its ore generally relies upon some process of heating the ore in order to cook-out the mercury (see fig. 5) whereby at temperatures in excess of mercury's vaporization point of 300° C the sulfur dioxide cooks-off and produces a vapor of mercuric oxide that upon cooling then separates out to oxygen and elemental mercury, and when the ore is roasted at lower temperatures just beneath mercury's vaporization point, but where it is still highly mobile, metal mercury may also be simply collected in a pan after melting through or around the ore (Brooks 5-7). At the time of the operation of the Kiggins and Nisbet mines, these methods would have commonly been expected to

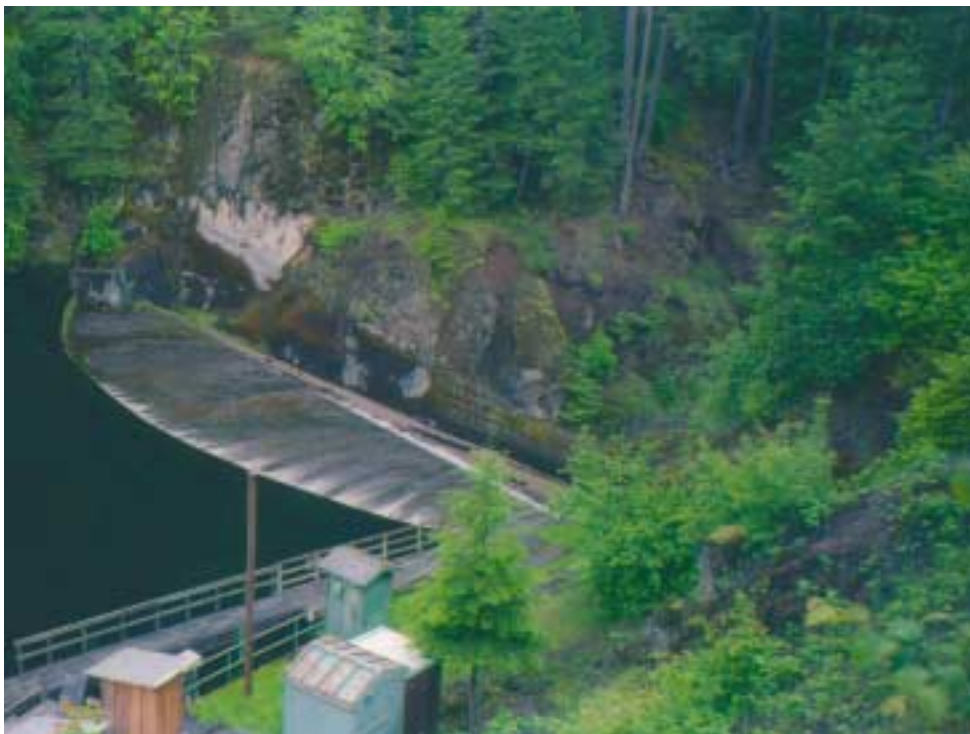
Figure 13. Dam at Lake Harriet on the Oak Grove Fork of the Clackamas above the mines.
Photo by the author.

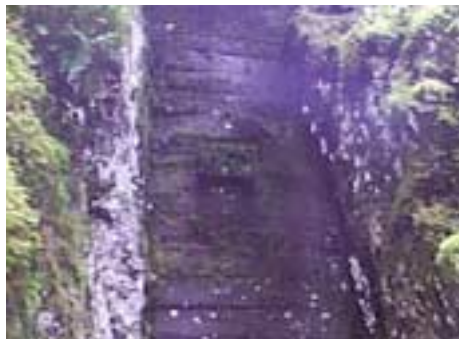
Fig. 14. Furnace at the Kiggins Mine.
Note: The furnace has been built into a natural fissure in the area rock.
Photo original by Bill Tompkins has been cropped by the author.

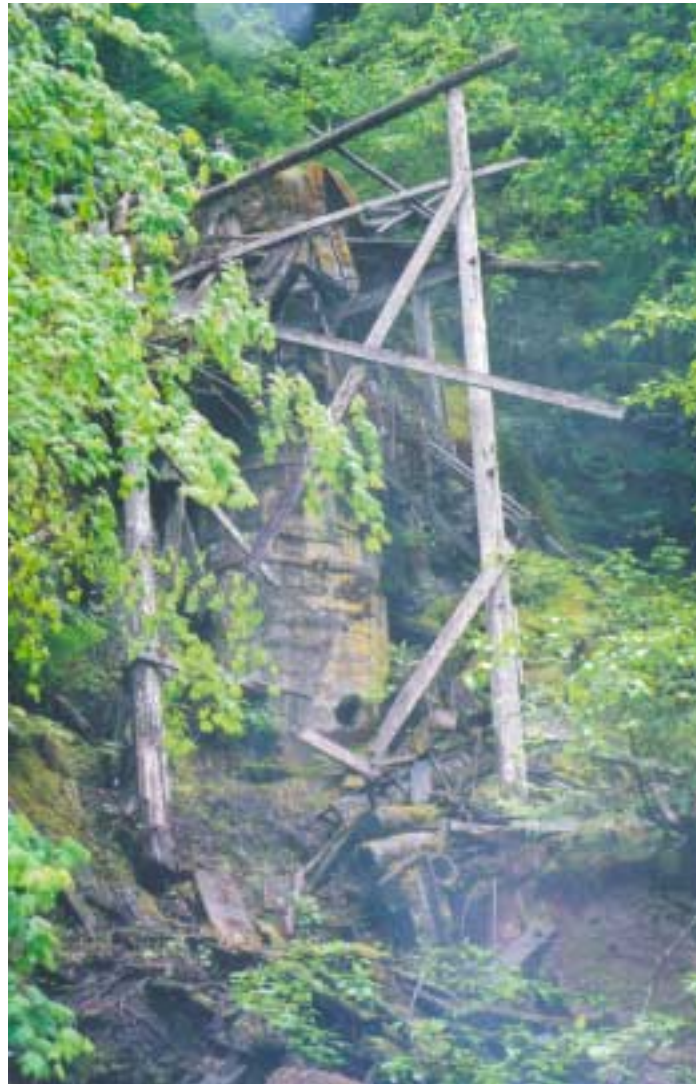
Fig. 15. Furnace at the Nisbet Mine.

Note: Over 20 feet tall, it is surrounded by the remains scaffolding presumably for the service of the furnace operations as well as 10" pipes presumably for condensing mercury vapor back to liquid.

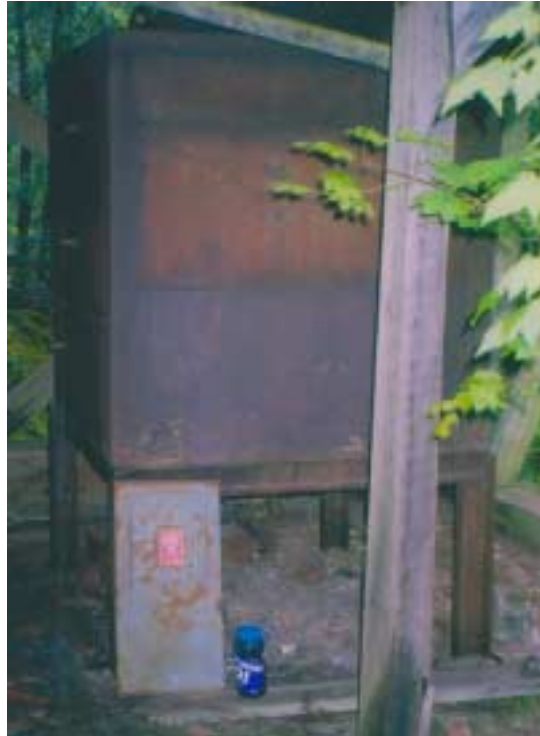
Fig. 16. Retort for roasting ore at the Kiggins Mine.
Note: The photo was taken with a water bottle 8" in height included for scale.
Photo by the author.

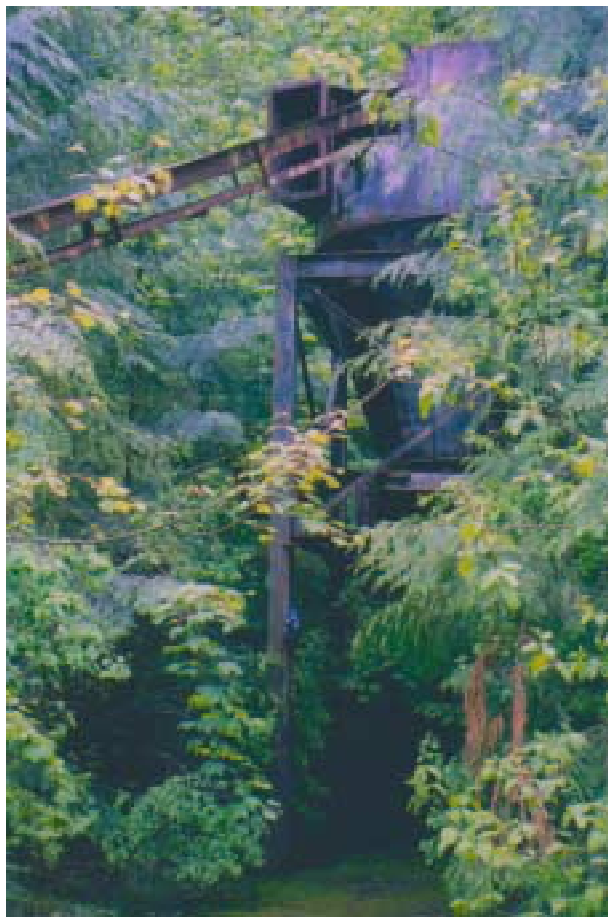
Fig. 18. Conveyor apparatus and ore hopper at the Kiggins mine. Note: The rock crusher that used to be found beneath the ore hopper was removed from the site between 2000 and 2002. Note: The photo was taken with a water bottle 8" in height included for scale. Photo by author.

of the mines, but compared to the complexity of identifying and remediating varied dispersals among soil or water, determining the hazard that mining items pose and executing any clean-up they may require may be the simplest aspects on site to attend to. Not surprisingly, however, the site is less than intact. Over the years a number of pieces of equipment have been carted off, even including an old ore crusher (Tompkins).

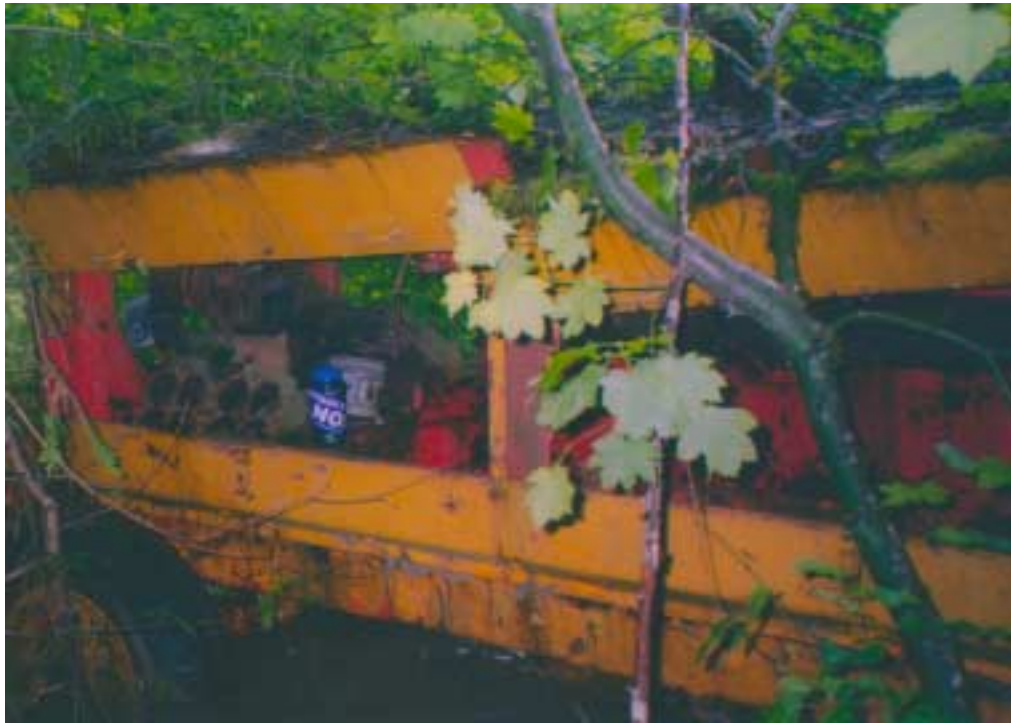
Fig. 19. Diesel motor at the Kiggins Mine.
Note: The photo was taken with a water bottle 8" in height included for scale.
Photo by author.

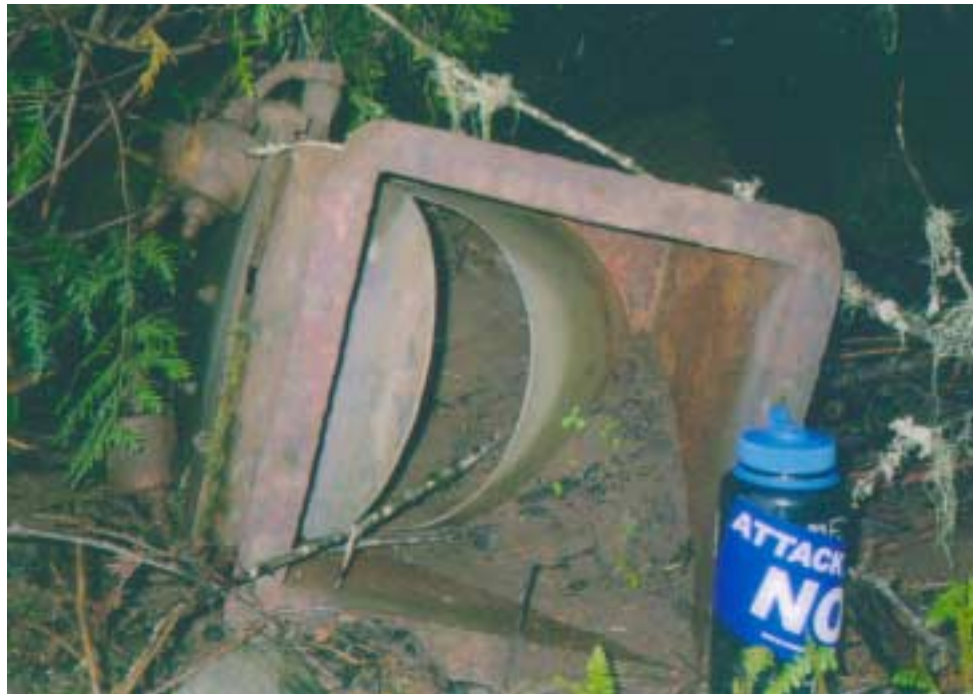
Fig. 20. Ore-car downstream from the Kiggins Mine.
Note: The metal container inset within the ore-car appears to be built-in, although its exact function remains unclear to the author. Note: The photo was taken with a water bottle 8" in height included for scale. Photo by author.
