HISTORIC RESOURCE SURVEY FORM
University of Oregon Cultural Resources Survey
Eugene, Lane County, Oregon
Summer 2006

Current building name: Esslinger (Arthur A.) Hall

Building address: 1525 University Street

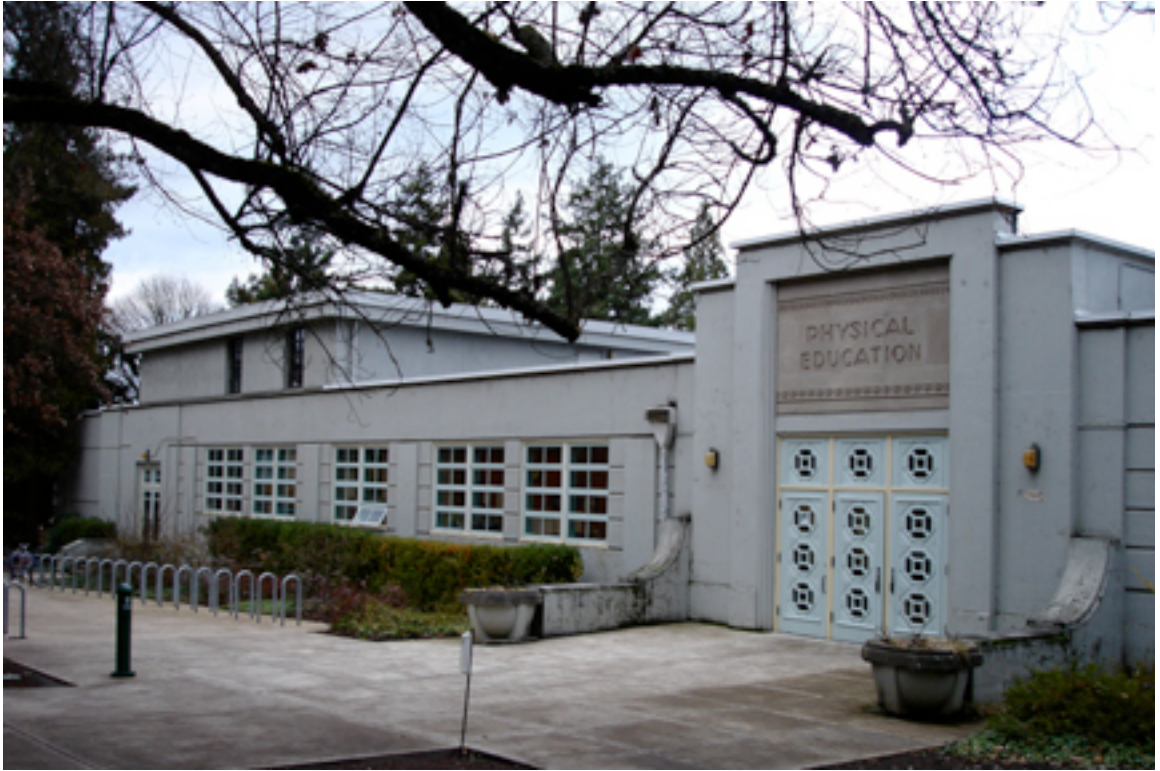
Photo number or name: Esslingercropped.jpg

Comments: The building is a low, horizontal, poured concrete structure that is simply but elegantly detailed. The building's decoration is furnished by the groupings of windows, geometric patterns in the doors and transom panels above the doors, and patterns in the concrete.

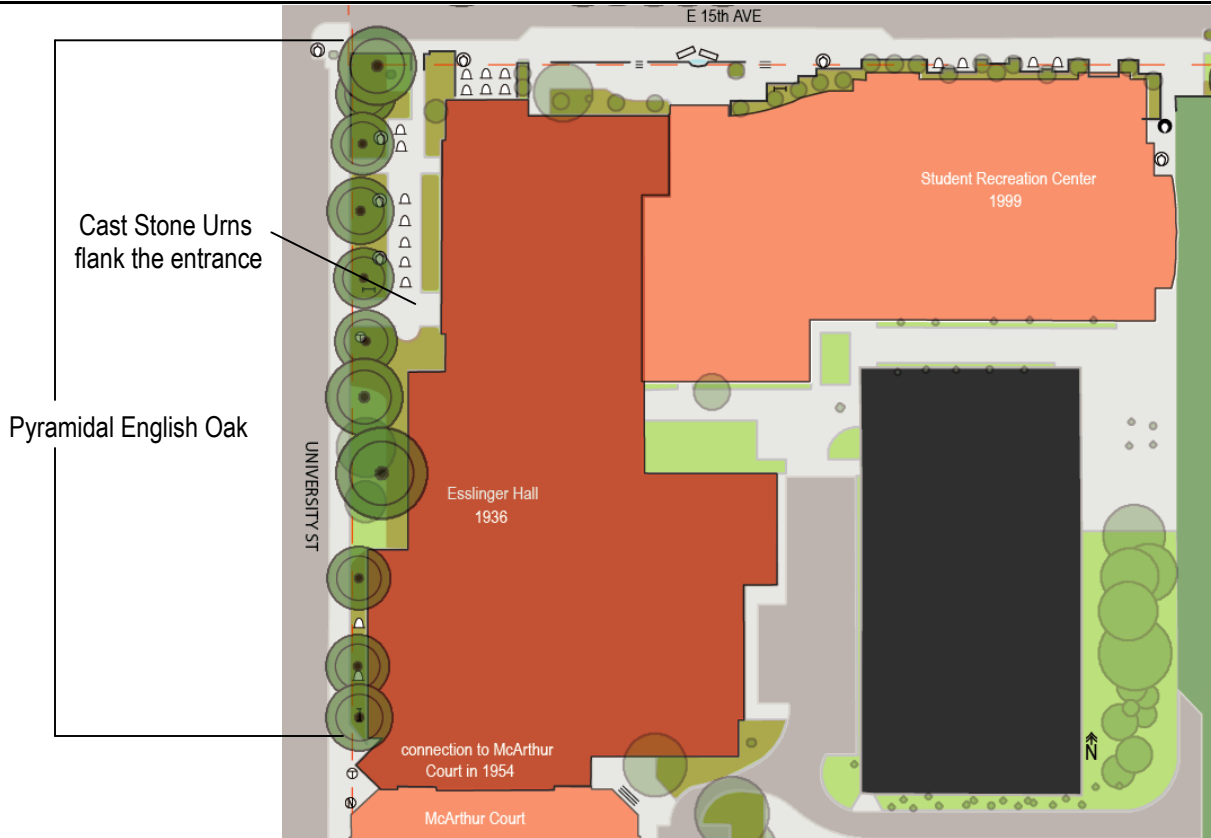
SITE PLAN

Associated resources: University Street Axis, connected to McArthur Court at southwest and Student Recreation Center at the northeast
