*ABBREVIATED PRELIMINARY ASSESMENT*

*MONUMENTAL*

Wallowa Whitman National Forest  
Grant County, Oregon

February 2003

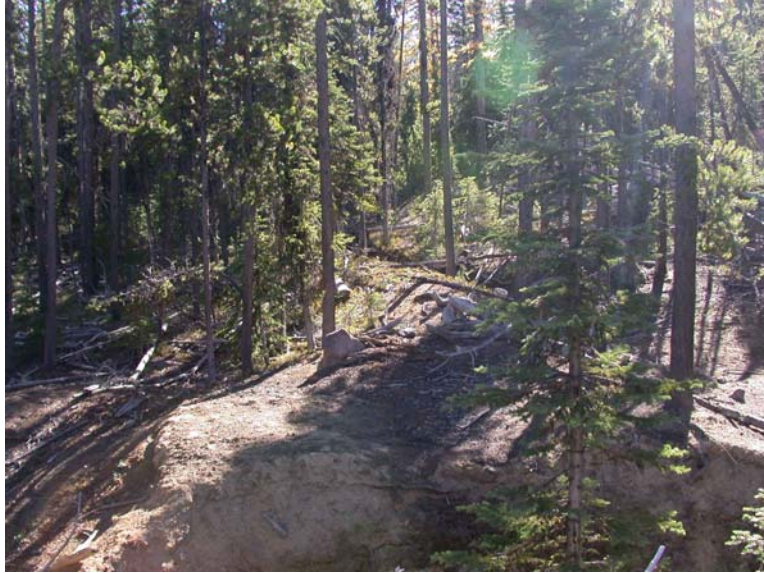
<u>Location</u>	<u>Constituent</u>	<u>Result (mg/kg)</u>	<u>PRG (mg/kg)</u>
Waste Rock by Shaft	Arsenic*	1800	1.6
Waste Rock by Upper Adit	Arsenic	119 to 582	1.6
Mill Site Area	Lead	857 to 2499	750
	Mercury	592	**
	Arsenic	42.5 to 31,181	1.6
Upper Tailings Pond	Arsenic	392 to 3080	1.6
Lower Tailings Pond	Arsenic	2909	1.6

*Waste Rock by Collapsed Shaft*

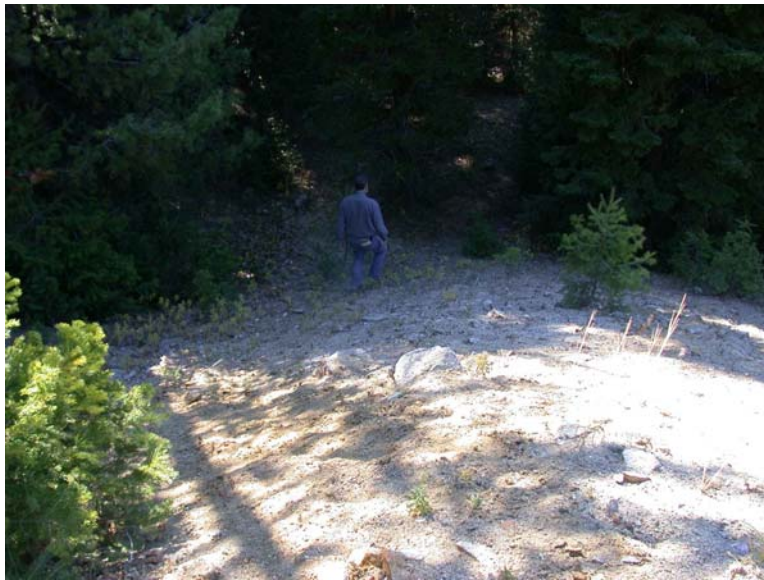
*Waste Rock by Upper Adit*

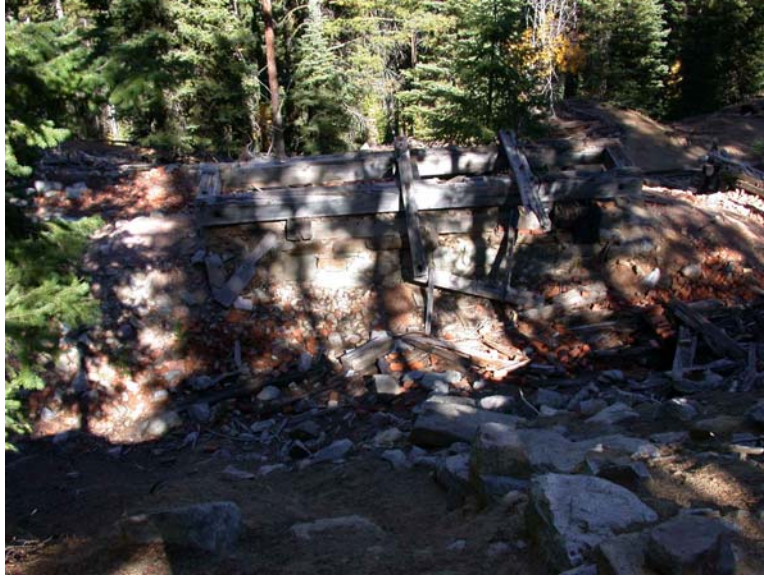
*Processed Material Around Mill Workings*

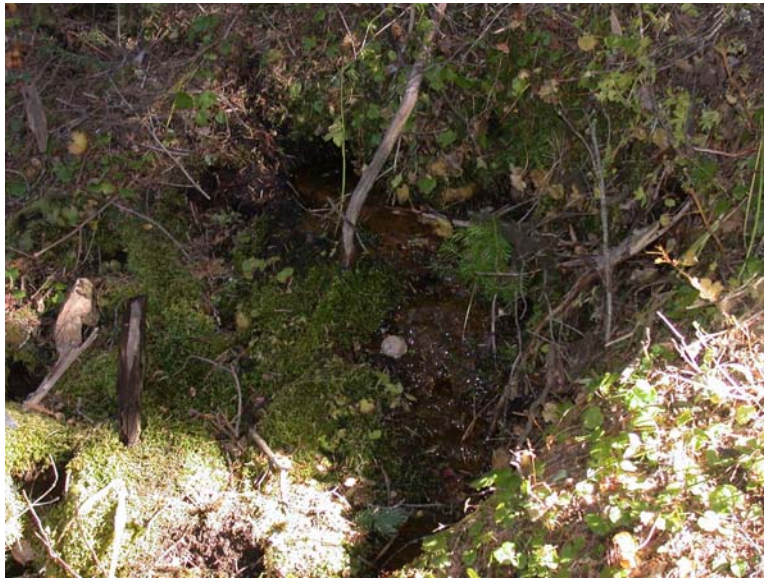
There is water in the upper tailings pond and it flows into the lower pond. This water eventually reaches Granite Creek.

*Seep From Upper Tailings Pond*

Based on the In Situ screening of the tailings/waste piles with the Niton XRF unit, the proximity of the waste piles to Granite Creek, and EPA's APA Checklist (Appendix A), it is recommended that a Site Inspection (SI) be completed. As part of this inspection, water samples from pore spaces of the stream gravels should be collected, where feasible, as well as sampling of the benthic organisms. In addition to testing water samples from the pore spaces of the gravels for the presence of metallic elements, water parameters such as pH, conductivity, turbidity, dissolved oxygen, temperature, total dissolved solids, hardness, and oxygen reduction potential are required. The tailings/waste piles should be sampled at depth and a determination of volumes should be calculated. Acid base accounting (ABA) is required. Sediment samples are to be collected from transects of the stream and preferably at depth and analyzed for total as well as for available metals. Surface water samples are also required.
