ABBREVIATED PRELIMINARY ASSESSMENT

UPPER CENTRAL MINE

Wallowa-Whitman National Forest
Grant County, OR

August 2006

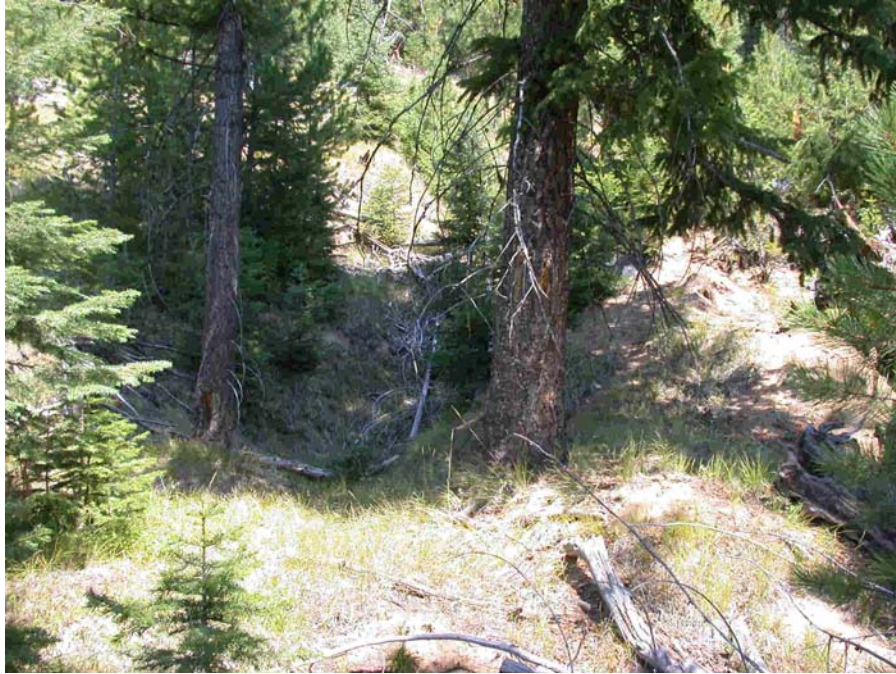
- Adit #1
 - This is the largest of the three general sites.
 - Appears to have two levels.
 - Upper level has approximately 700cy of wasterock.
 - Lower level has approximately 500cy of wasterock
 - Both adits are collapsed and no signs of any water discharge.

Photo 1. Adit #1 (Photo by D. Boles)

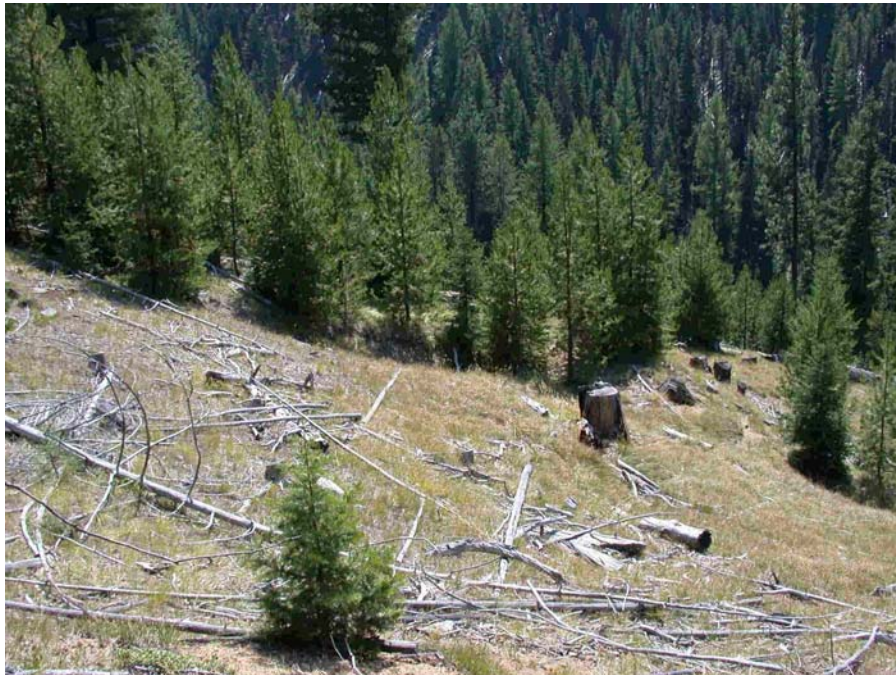
- Adit #2
 - Situated above Adit #1 and #3 and closest one to Forest Service Road 7345, although not readily visible from the road.
 - Adit is approximately 30 feet below the road.
 - Approximately 300cy of wasterock
 - Adit is collapsed and no signs of any water discharge.
- Adit #3
 - Smallest of the workings with 100cy of wasterock.
 - Adit is collapsed and no signs of any water discharge.
 - Workings are visible from Forest Service Road 7345.

Photo 2. Looking towards Adit #3 from Adit #2. Adit #3 is to the left of the stump. (Photo by D. Boles)

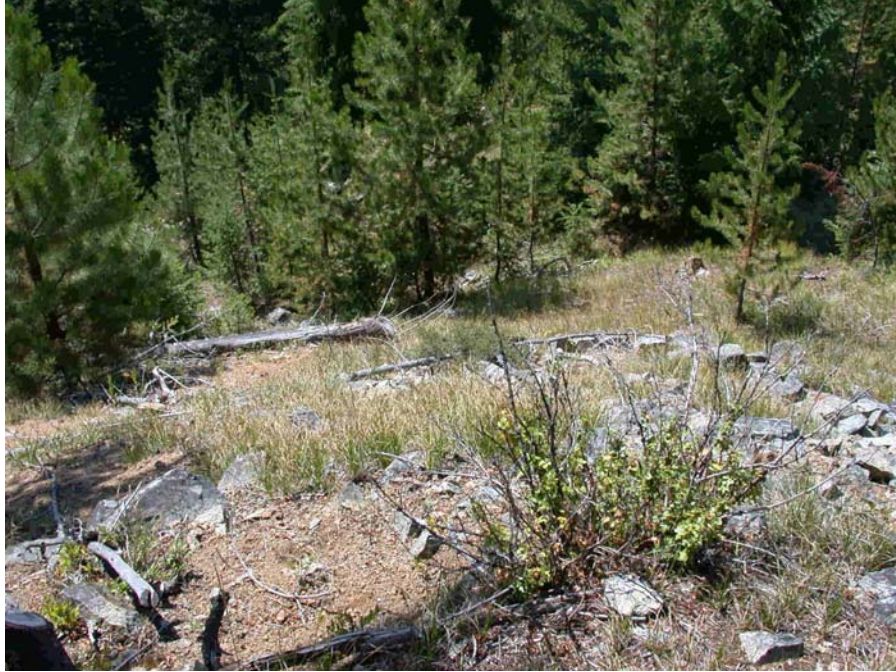
Photo 3. Looking down slope on wasterock associated with Adit #1.
(Photo by D. Boles)
