Restoration of Fish Habitat on Errol Creek

A restoration project proposed
in lieu of a Natural Resource Damage Assessment
of the Thermo Fluids Oil/Acid Spill (March 15, 2004)

Prepared by
Johnson Creek Watershed Council
Contact: Michelle Bussard, Executive Director

May 6, 2004

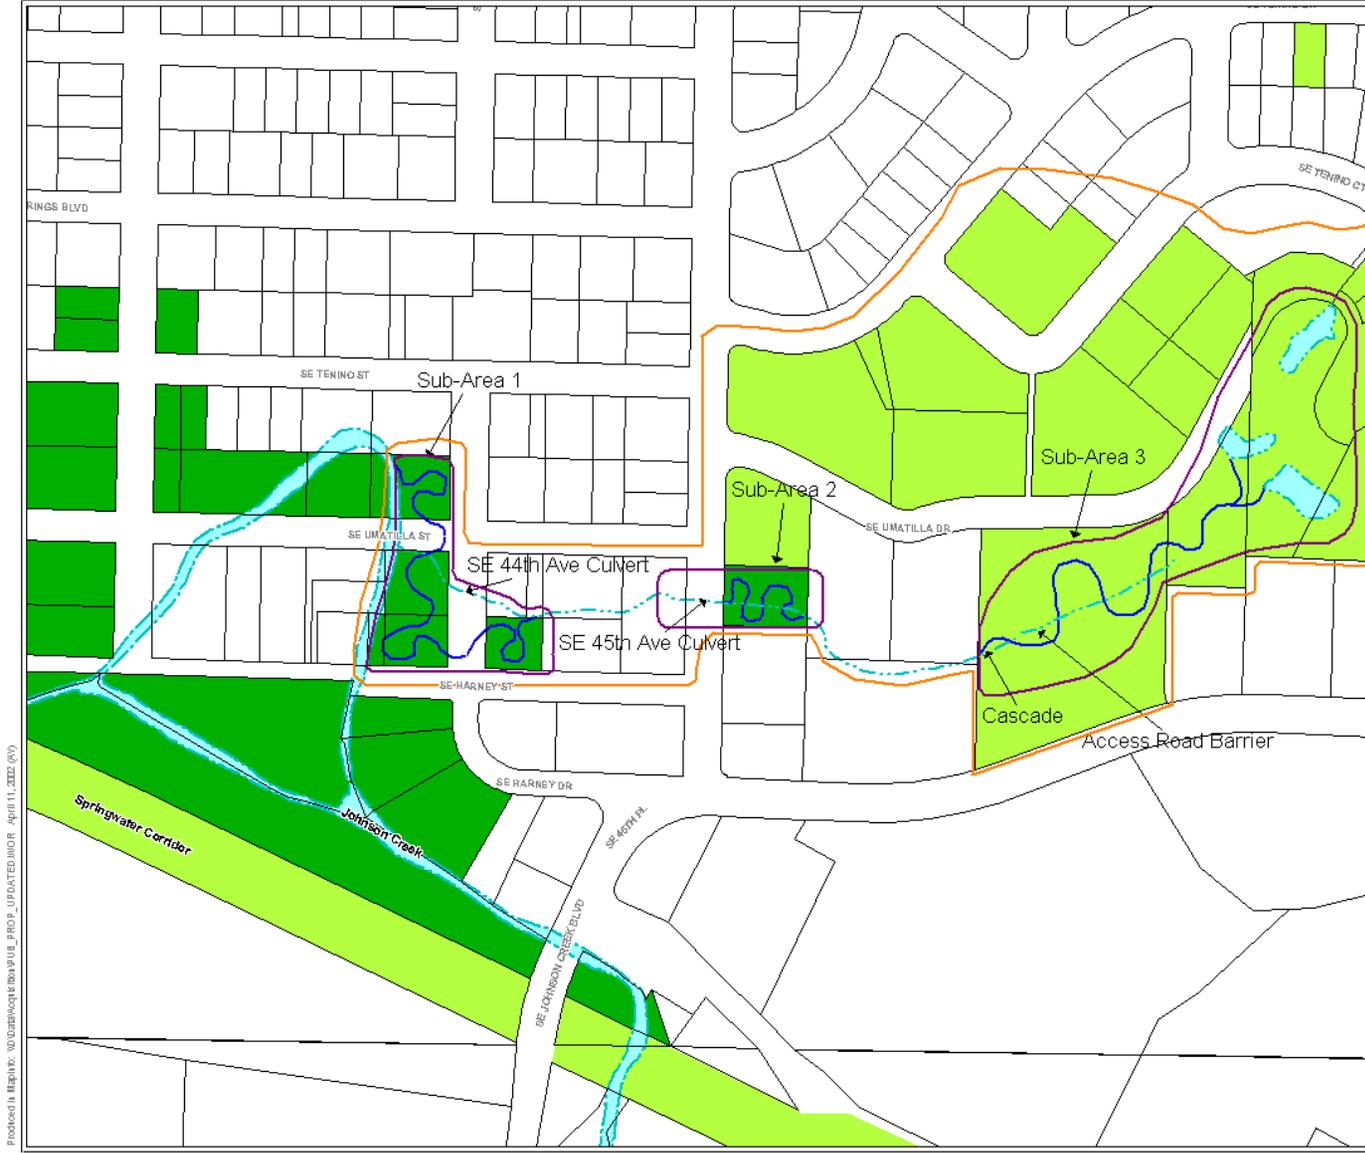
Errol Creek Restoration Project Area

The goal of this project is to restore quality, accessible habitat for fish on the lower portion of Errol Creek (Sub-Area 1 on attached map). Work will begin at the mouth of Errol Creek where a fish barrier will be removed and 800 feet of stream will be remeandered. Gravel will be added to the bottom of the stream to enhance spawning/rearing habitat. Large woody debris will be placed in the creek to create plunge pools and enhance cover habitat for fish. Once the stream channel is restored, the banks will be vegetated with native plants to provide additional cover for fish and decrease solar inputs to the creek. When completed, the project will provide outstanding fish habitat.

Errol Creek is located within the area impacted by the Thermo Fluids spill (see attached map). Our proposed project will improve summer and winter refugia for fish on a portion of this productive reach, and will provide important escape habitat for should future urban stressors impact water quality. Such a refuge was available and apparently used by local fish populations on the day of the spill at nearby Crystal Springs. Had a refuge on Errol Creek been available at the time of the Thermo Fluids spill, the number of fish killed along this reach may have been reduced.
