RESTORATION AND PRESERVATION PLAN WITH DRAWINGS FOR
THE WOODEN BALUSTRADE AND URNS THAT EMBELLISHED
THE ROOF STRUCTURE OF VILLARD HALL

December 1988

A THESIS PROJECT

Presented to the Interdisciplinary Studies Program:
Historic Preservation,
the School of Architecture and Allied Arts,
and the Graduate School of the University of Oregon
in partial fulfillment of the requirements
for the degree of
Master of Science

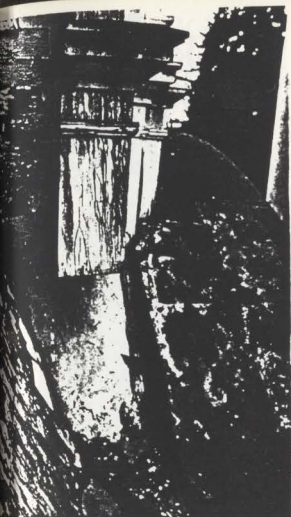
SHEET METAL
FLASHING
c.1949

PLYWOOD
c.1949

Historically Inaccurate
Moulding Profiles

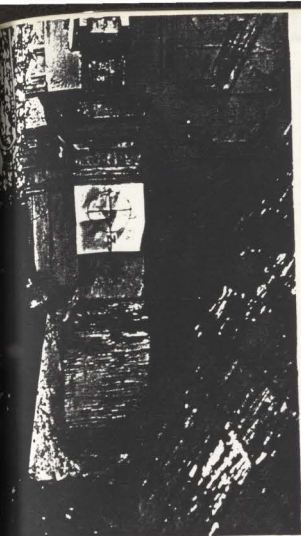
Inaccurate
Molding
Profiles

PLYWOOD
(1949)
