HISTORIC STRUCTURES REPORT:

THE EDUCATION BUILDING AND COMMERCE HALL,
(THE WEST AND EAST WINGS OF THE GILBERT COMPLEX)
ON THE UNIVERSITY OF OREGON CAMPUS, EUGENE

A TERMINAL PROJECT
BY DAVID ADAM SINGER

UNIVERSITY OF OREGON
HISTORIC PRESERVATION DEPARTMENT
MARCH 2000

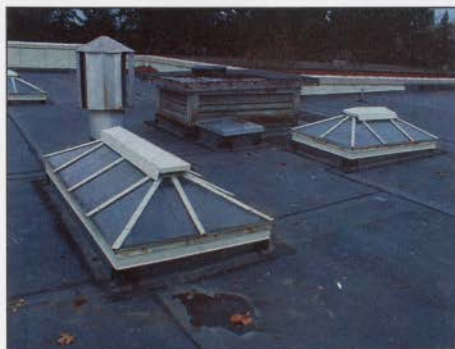
FIGURE 35: GABLED SKYLIGHTS WITH OPERABLE VENT CAPS

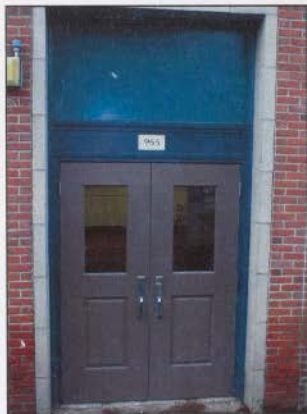
FIGURE 39: PAIRED SOLID WOOD DOORS AT SOUTH ENTRY WITH TRANSOM REMOVED.

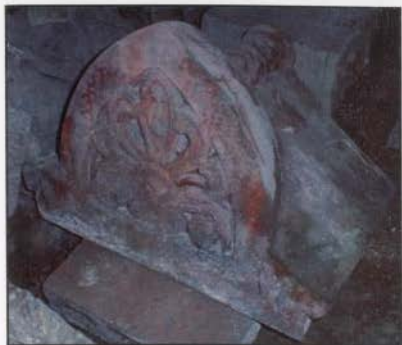
**FIGURE 104: CROWN PIECE**

Type: Crown piece
 Number: 3 total (1 pictured)
 Glazing: Unglazed red clay body
 Size: 27"x17"x19" at front
 Condition: Good Condition
 Original Location: Commerce

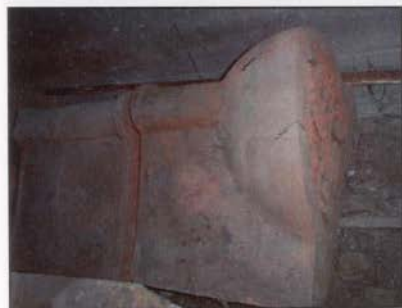
**FIGURE 105: CROWN PIECE**

Type: Crown pieces
 Number: 2 Pictured
 Glazing: Unglazed red clay body
 Size: 27"x17'15" at center
 Condition: Good condition
 Original Location: Commerce

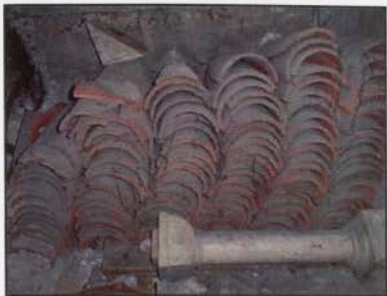
**FIGURE 106: ROOFING TILES**

Type: Roofing tiles
 Number: Approx. 100 each
 Glazing: Unglazed extruded
 Size: 16"x6 1/2"x 1/2"
 Condition: Good to poor
 Original Location: Commerce

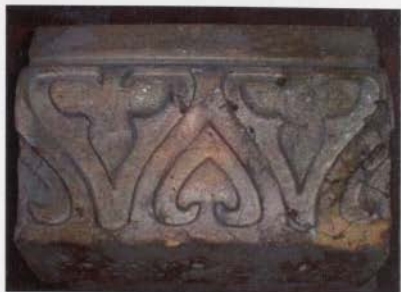
FIGURE 111: BELT COURSE PIECE

Condition: Fair (chipped)
